Building and Timber Pest Inspection Report

Inspection Date: Thu, 26 Feb 2026

Property Address: 2 Foster Way, Berowra NSW 2081, Australia

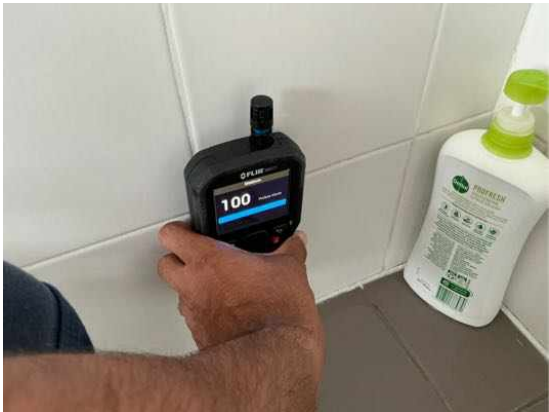
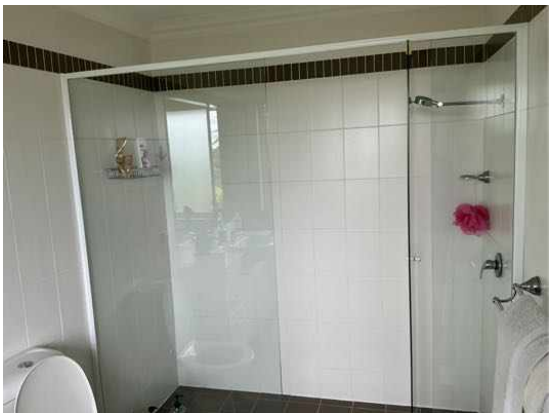
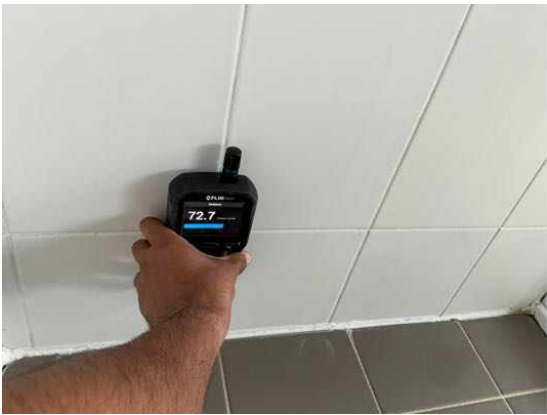
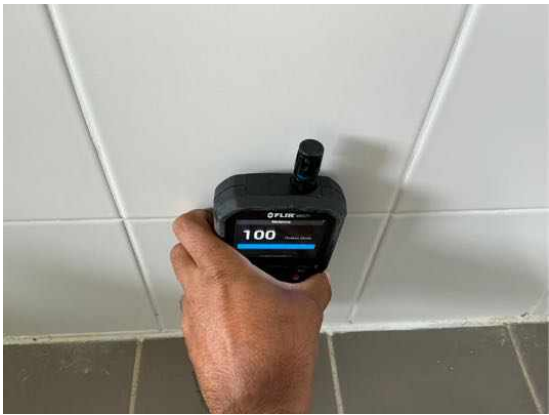
Building: Main Building
 Location: Both Bathrooms
 Finding: Excessive Moisture - Shower Damp
 Information: At the time of inspection, excessive moisture was noted within the shower area, which is a common issue in wet areas due to the continual exposure to water. This condition is typically caused by moisture seeping through grout lines and settling behind tiles,

resulting in localised high-moisture zones. Provided there is no evidence of water staining or elevated moisture readings on the opposite side of the wall, this is considered a minor defect.

However, persistently damp conditions may act as conducive conditions for termite activity, as termites are strongly attracted to moisture-rich environments. It is recommended that the client ensures regular use of the exhaust fan and maintains adequate ventilation after shower use to promote drying and reduce long-term moisture build-up, thereby also reducing the risk of attracting termites.

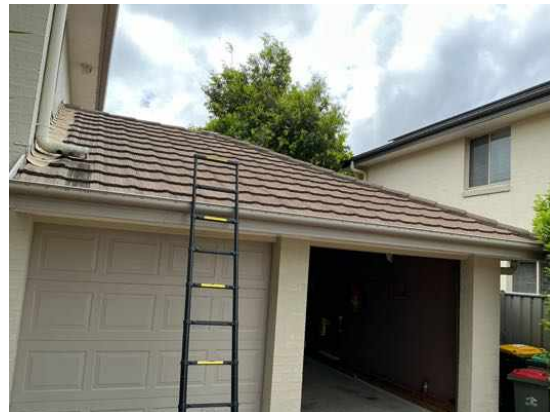
Building: Main Building
 Location: Garage
 Finding: Plant Growth - Gutters
 Information: At the time of inspection, plant growth and debris were noted within sections of the guttering system. Vegetation in gutters can restrict the free flow of rainwater.

It is recommended that the gutters be cleaned and cleared of debris. Regular maintenance and periodic cleaning are advised to help ensure proper drainage.

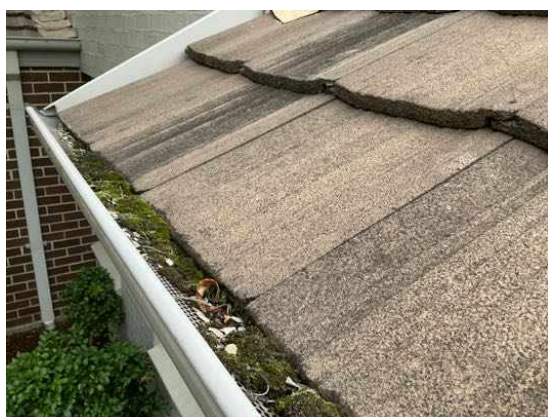
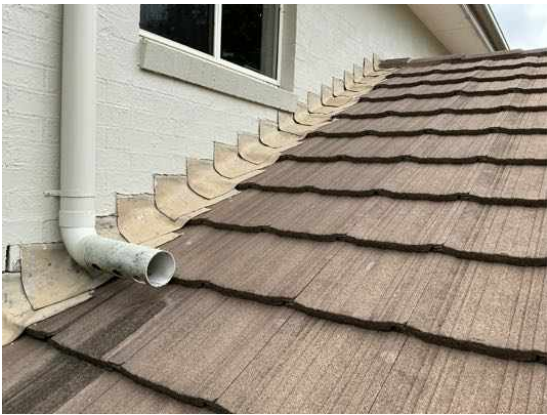
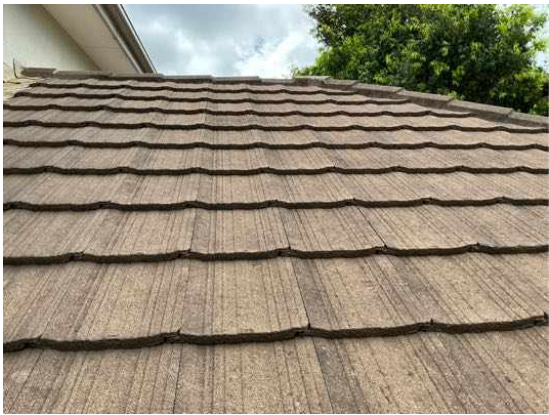
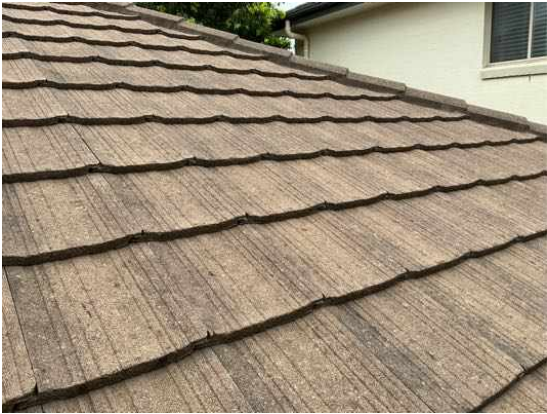
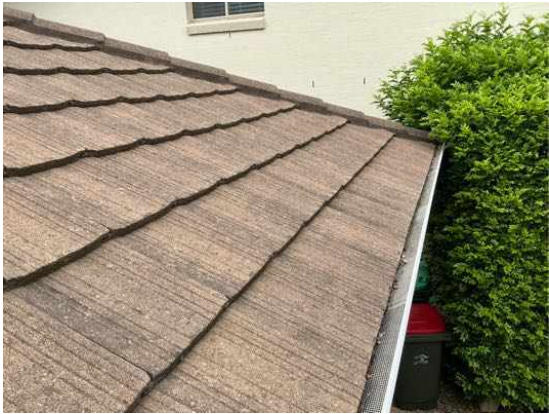
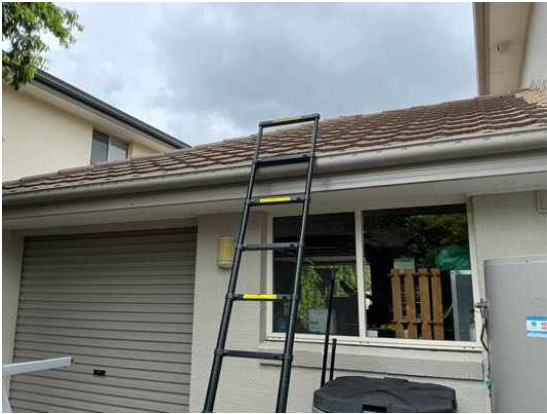
Building: Main Building
Location: Roof Exterior
Finding: Additional Roof Photos

Information: As part of the information provided, please note that the attached roof photos represent the condition of the roof at the time of inspection. These photos are for visual reference only and do not constitute a detailed roofing assessment. Any defects or issues identified with the roof are mentioned separately in the defect statements. It is strongly recommended that the client engage a qualified roofer to conduct a thorough inspection of the roof, ensuring that any potential issues, such as leaks, structural integrity, or wear and tear, are properly identified and addressed.
