# Building and Timber Pest Inspection Report

Inspection Date: Wed, 28 Jan 2026

Property Address: 30 Carver Cres, Baulkham Hills NSW 2153,  
Australia

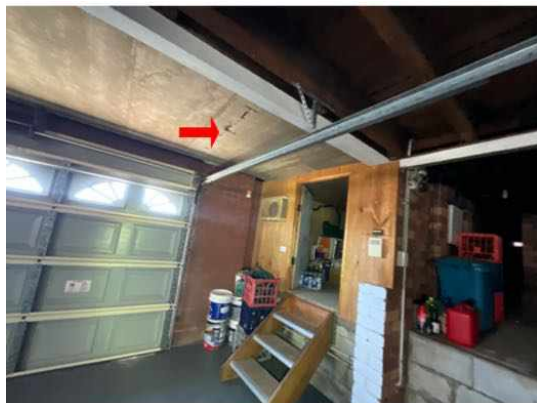
Information: Concrete cancer is the common term used to describe a number of factors which cause concrete construction to deteriorate. Generally, water penetration causes the concrete reinforcement to rust and expand, creating stresses on the surrounding concrete and in turn causing it to spall (or break away). Alternatively, if the cement component is too alkaline, reactions with the general atmosphere occurs and star-shaped cracks appear which allow rainwater to penetrate. Concrete cancer may also originate from poor original water proofing.

In some instances, repairs are possible; however, repair works will generally involve extensive works, including removal of affected concrete and the treatment or replacement of any exposed steel. Some injection of resins or special mortars may also be possible, however this depends on the size and extent of consequent damage.

Ultimately, the cause of the concrete cancer (e.g. poor water proofing) must also be addressed, otherwise the problem is likely to recur. Treatment of concrete cancer can be expensive and, left unmanaged, the problem is likely to worsen over time, potentially leading to the development of major structural defects or safety hazards.

The client is advised to exercise caution and to prepare for the potential cost of remedial and / or replacement works. A structural engineer should be appointed to provide estimates on the required works.

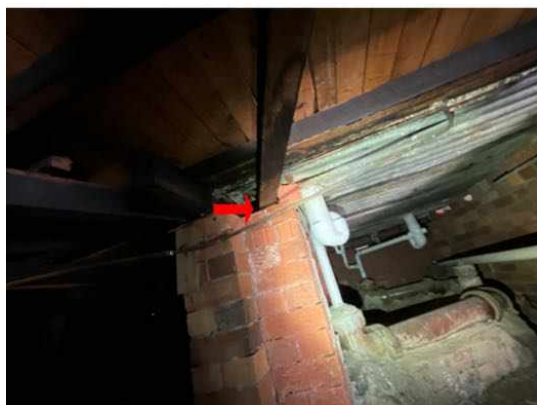
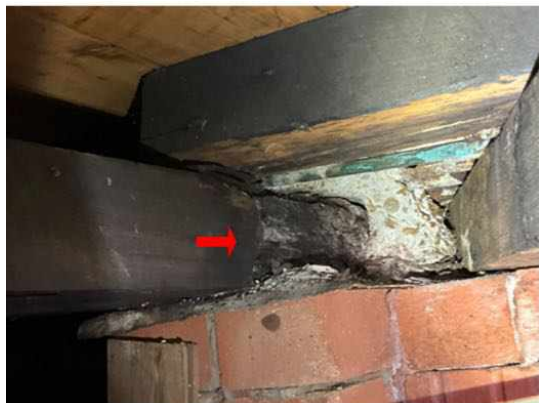
## Finding 2.02

Finding: Subfloor structure - Wood rot

Information: The subfloor structure in this area is showing signs of deterioration and wood rot (fungal decay) of the timbers. It is suspected that this defect has developed as a result of water leak at some stage.

Damp conditions cause the timbers to fail, resulting in the subfloor structures failing to bear the load (or weight) of the building as originally intended. Without repairs and maintenance, including potential replacement of affected elements, it is likely that serious structural faults will result, as well as an array of minor defects.

The presence of wood rot to the subfloor structure is also conducive to termite infestation.

Rectification or replacement of the affected timber building element is required immediately by a licensed builder.

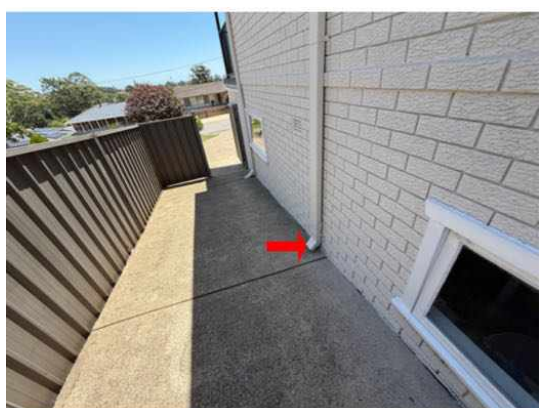
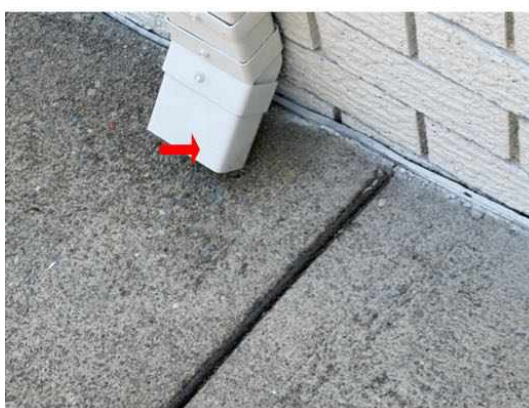
### Finding 3.01

Where roof plumbing doesn't drain adequately, the area at the base perimeter can become excessively damp, potentially creating an environment that is susceptible to rust and corrosion of surrounding building elements, as well as attracting termites and other pests.

It is highly recommended that a plumber be appointed to further inspect the area and to install adequate drainage equipment where necessary.

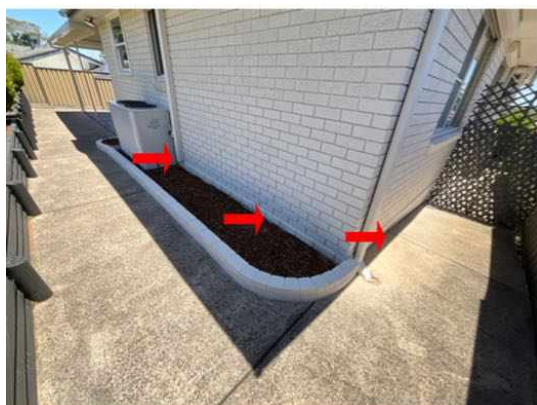
### Finding 3.02

Finding: Air vents - Blocked or inadequate  
 Information: It was noted at the time of inspection that the subfloor area lacks adequate ventilation. The cause of this inadequate ventilation is the state of the air vents to the subfloor area. Where air vents are insufficient in number or are blocked, either fully or partially, subfloor ventilation is decreased.

A well ventilated subfloor aids in maintaining dry conditions, preventing secondary damage such as wood rot and pest activity, as well as preventing the development of mould/fungi and mildew (which can lead to major respiratory issues or safety hazards for occupants, particularly the elderly, the very young and those with existing illnesses).

All air vents should be cleared of blockages to promote adequate air flow to the area. Where ventilation is still insufficient, retrospective installation of air vents may be required. Appointment of a licensed builder may be required to perform these works as necessary.

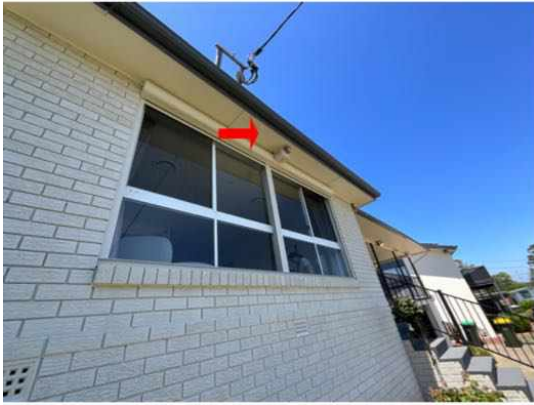
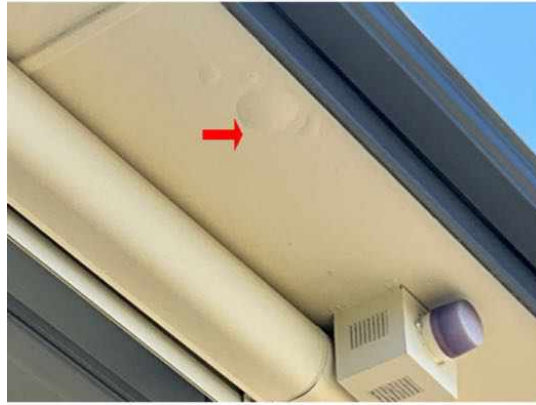
### Finding 3.03

Building: Main Building  
 Location: Front Elevation  
 Finding: Painted surface - Bubbling  
 Information: Sections of paint in this area was found to have bubbled and deteriorated. Paint bubbling is generally an indication of excessive moisture in the area, that is currently hidden by the painted surface.

The presence of excessive moisture can have major implications on associated building elements if left unattended. While only seemingly minor at this stage, the damage cannot be determined due to the paint obstructing any further inspection of the damage.

It is highly advised that the affected paint be cleaned to allow a further, more invasive inspection by a roof plumber. Failure to act on this defect may necessitate major works in the future.

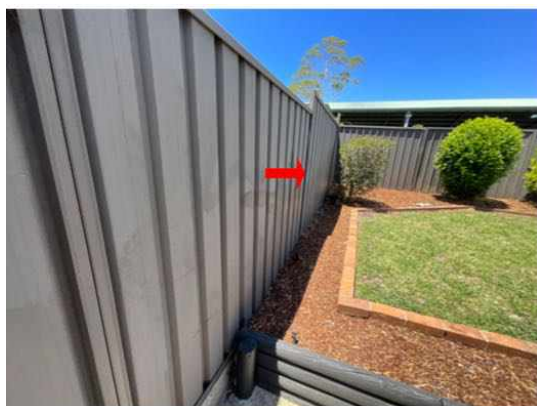
### Finding 3.04

Finding: Fencing - Deteriorated

Information: It was noted at the time of inspection that sections of the fencing in this area has deteriorated. Typically fencing deteriorates due to age and or wear, rot and or rust which is generally expected for a structure of this age, due to prolonged exposure to weather conditions. Sometimes inadequate installation or maintenance can be to blame.

If left unattended, it is likely that further damage will occur. It is suspected that repair of several elements of the fencing may be required however replacement may be a consideration of the client also.

A licensed fencing contractor should be appointed to provide further advice and perform rectification works as necessary.

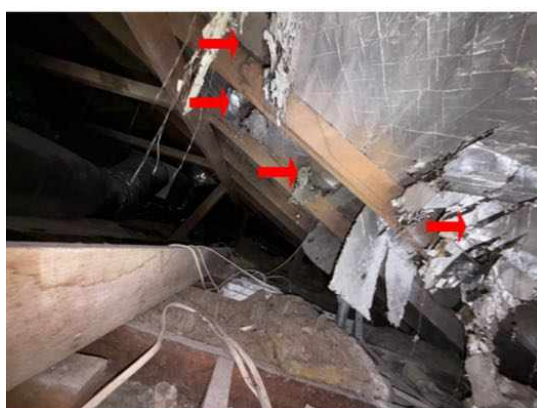
### Finding 3.05

Building:	Main Building
Location:	Roof Void
Finding:	Sarking - Damaged
Information:	Sarking, a laminated aluminium foil applied to the interior of the roof covering, assists in insulating the property and acting as a vapour-barrier to the roof void and, subsequently, to the household.

Where sarking is damaged, both insulation and moisture protection of the property are inhibited. This creates a loss of energy and thus negatively impacts the energy efficiency of the property, allowing potential for moisture ingress from condensation or leaking roof tiles.

It is important to repair any holes or damaged sections of sarking to ensure that the building material is fully functional. A registered builder or qualified carpenter should be consulted to provide further advice on this defect and to perform rectification works at client discretion.

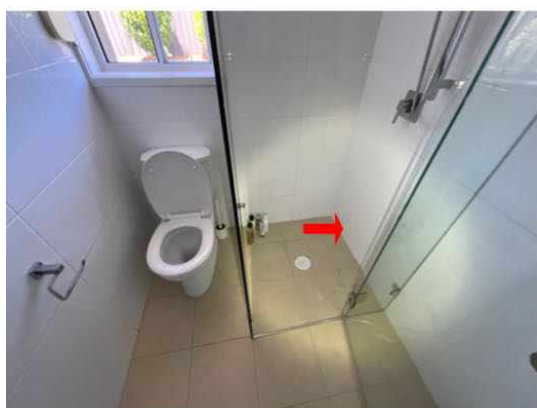
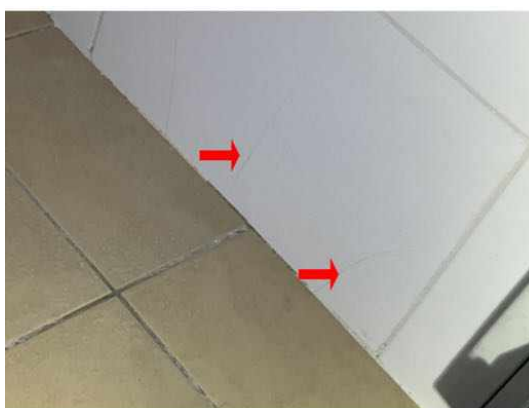
### Finding 3.06

Finding: Wet area tiles - Cracked or damaged  
 Information: Cracking was evident to the tiling in this area at the time of inspection. While the cracking appears to be minor, this area is frequently exposed to water, allowing potential for water penetration into adjoining sections of walls or flooring.

If left unmanaged, water penetration to these areas may lead to subsequent water damage, which is likely necessitate repair work to affected building elements.

A bathroom specialist should be appointed to determine the integrity of the bathroom waterproofing membrane. If the membrane was found to be intact then relatively minor works to replace the cracked tiles should be carried out to ensure no further damage occurs. The re-application of silicone and grouting throughout remaining tile work is also advised, to further protect the area against water penetration.

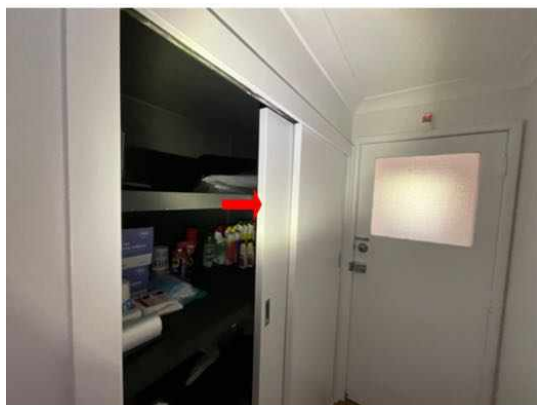
the time of the inspection. Restricted function of the affected door may pose as a potential safety hazard if required for emergency egress from the building.

Generally, factors such as general age of the building element and a lack of maintenance are the usual causes for this type of defect.

Replacement of door hardware or tracks may be required, as well as minor repairs and cleaning. A registered builder will be required to repair the affected doors.

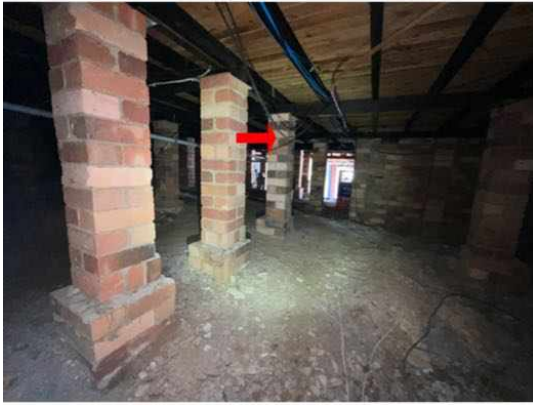
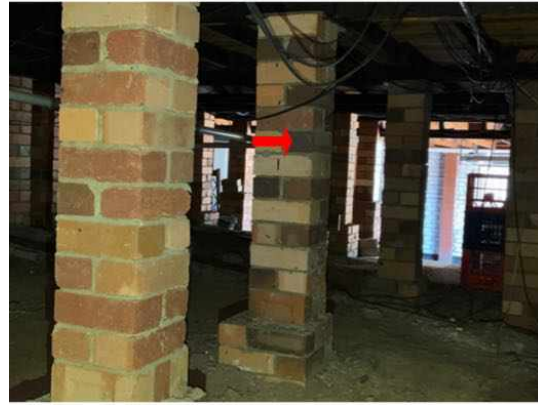
### Finding 3.10

Building:	Main Building
Location:	Subfloor
Finding:	Piers - Leaning
Information:	Pier to the subfloor structure is leaning, indicating that its structural integrity may have been affected. The cause of this instability is likely to be caused by movement / minor subsidence of the pier due to moisture.

Although only minor the pier should be monitored to avoid potential structural damage, which is likely to lead to a range of major and minor defects. Improving site drainage is recommended to avoid further movement / subsidence of the affected pier.

If further movement is evident appointment of a structural engineer is advised to assess the condition of the piers and provide advice on remedial works that may be required.

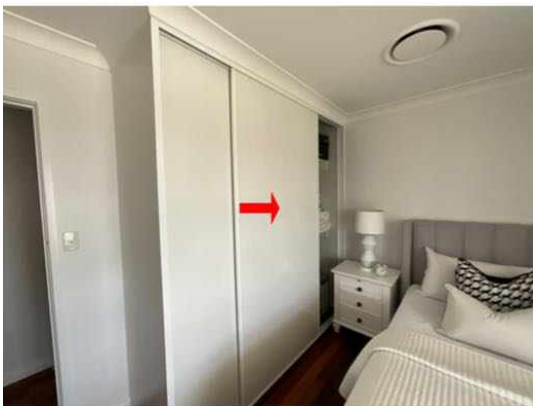
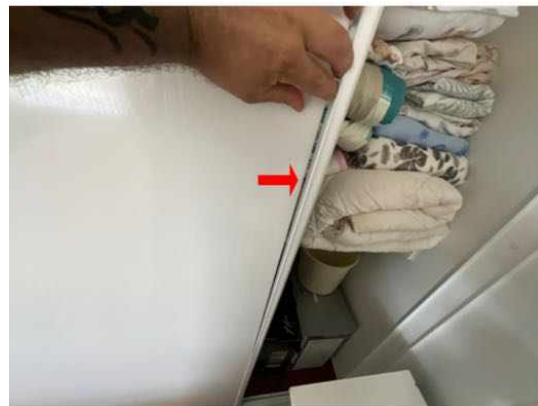
### Finding 3.11

Building:	Main Building
Location:	Bedroom 2
Finding:	Fitting or fixture - Loose
Information:	The fitting in this area is loose and requires adjustment to tighten.

If left unmanaged, the fitting may further deteriorate, causing potential for the development of other minor secondary defects.

A relevant tradesperson should be appointed to perform these rectification works at discretion of the client.

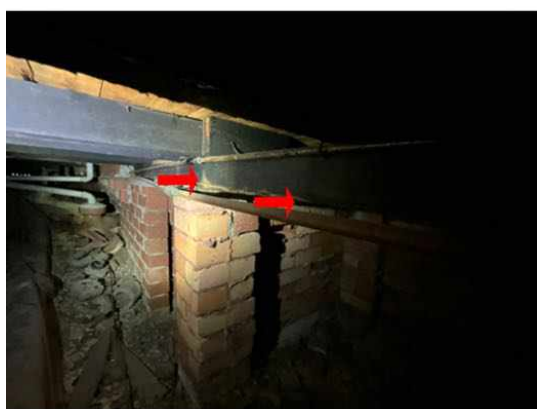
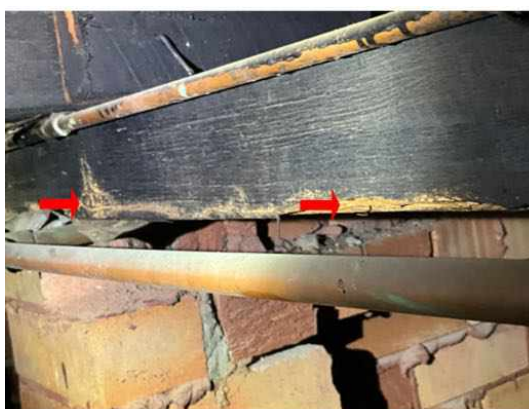
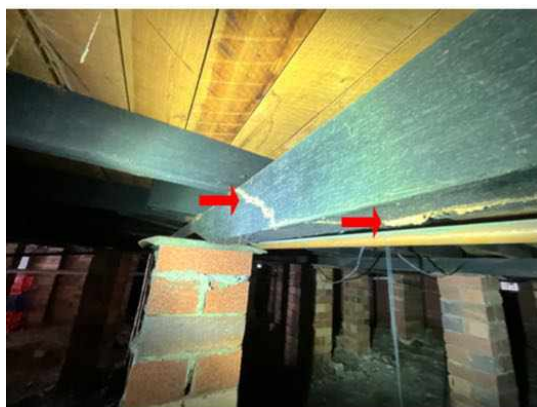
Finding: Evidence of termite damage  
 Information: Despite no live termite or timber pest activity being indicated, previous termite damage was found to have affected this area or otherwise termite workings were identified at the time of inspection. This damage is considered to be inactive.

It is advised that the area be visually inspected frequently to ensure that the condition of affected building materials does not worsen. At the time of inspection, damage is not structural.

A licensed termite specialist should be appointed for an invasive inspection to determine the extent of damages and to provide a chemical barrier.

A licensed builder should then be appointed to replace and affected timber elements.

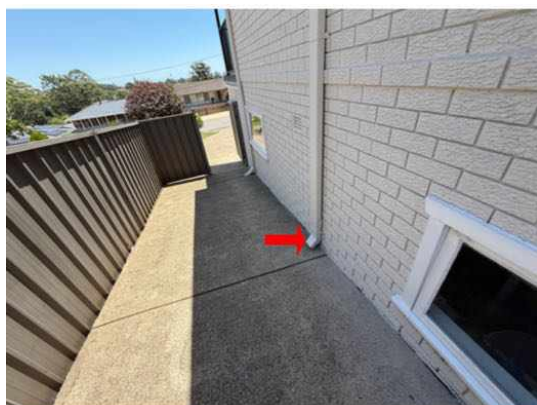
### Finding 6.01

Where roof plumbing doesn't drain adequately, the area at the base perimeter can become excessively damp, potentially creating an environment that is susceptible to rust and corrosion of surrounding building elements, as well as attracting termites and other pests.

It is highly recommended that a plumber be appointed to further inspect the area and to install adequate drainage equipment where necessary.

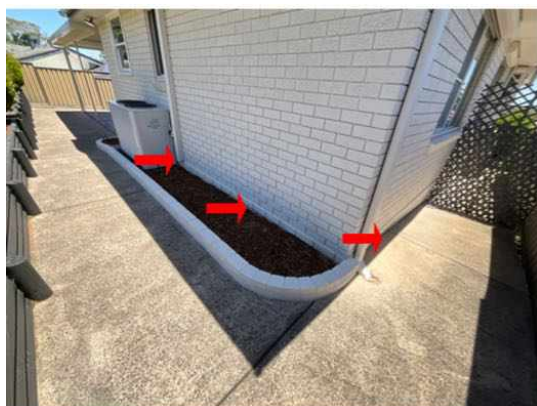
## Finding 6.02

Building:	Main Building
Location:	Rear Elevation
Finding:	Air vents - Blocked or inadequate
Information:	It was noted at the time of inspection that the subfloor area lacks adequate ventilation. The cause of this inadequate ventilation is the state of the air vents to the subfloor area. Where air vents are insufficient in number or are blocked, either fully or partially, subfloor ventilation is decreased.

A well ventilated subfloor aids in maintaining dry conditions, preventing secondary damage such as wood rot and pest activity, as well as preventing the development of mould/fungi and mildew (which can lead to major respiratory issues or safety hazards for occupants, particularly the elderly, the very young and those with existing illnesses).

All air vents should be cleared of blockages to promote adequate air flow to the area. Where ventilation is still insufficient, retrospective installation of air vents may be required. Appointment of a licensed builder may be required to perform these works as necessary.

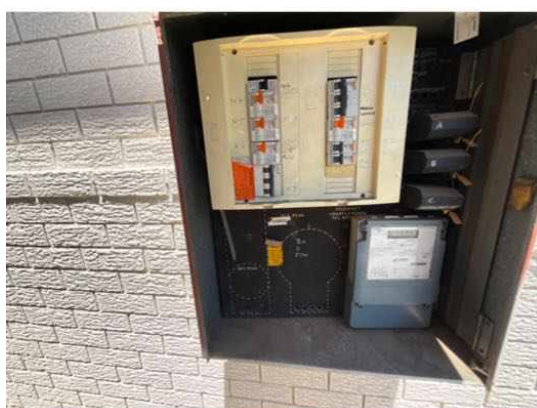
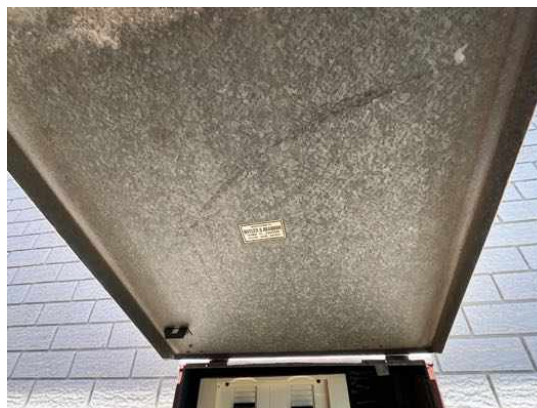
### Finding 6.03

Information: The application of a post-construction chemical termite barrier is highly recommended for all properties, particularly if live termite activity has been found on the site previously. Such barriers are highly effective in preventing termite attack on any timber building elements throughout the property.

A durable notice should be placed in the switchboard unit to indicate current termite barriers. At the time of inspection, it appeared as though no termite management system has been installed, with no evidence to suggest preventative works taking place.

The client may consider gaining further advice from a pest controller as to the costs and procedures involved with this application. It is recommended that obtaining such advice be a short-term priority.

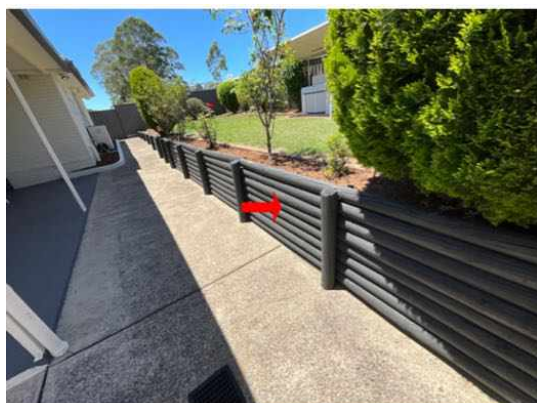
Building:	Main Building
Location:	Fencing & Landscaping
Finding:	Building materials in direct ground contact - conducive to termites
Information:	Where timber elements are in direct contact with the ground and consequently moisture or dampness they become conducive to termite activity. Whether timber is used as a building element part of a fencing structure or stored as an unused item they can provide an environment that is attractive to termite infestation.

When met with excessive moisture timber begins to decay and develop wood rot. Any timbers that are in direct contact with external grounds especially if left untreated or non-durable also provide ingress for subterranean termites into that particular element.

The removal of any such materials that may be conducive to termite activity should be removed as soon as possible to minimise the risk of termite attack.

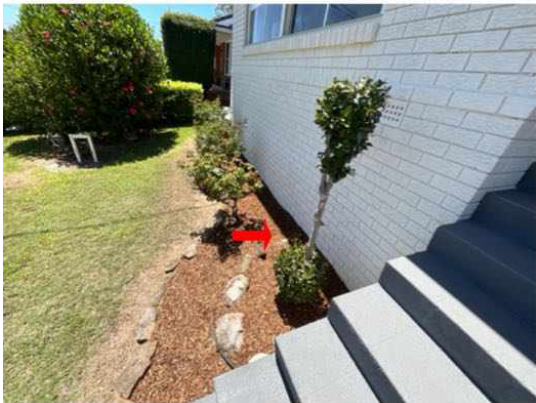
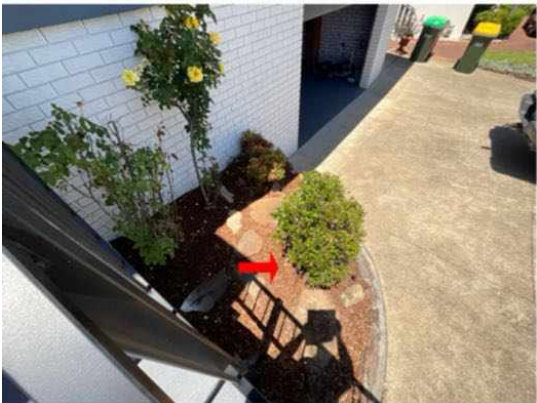
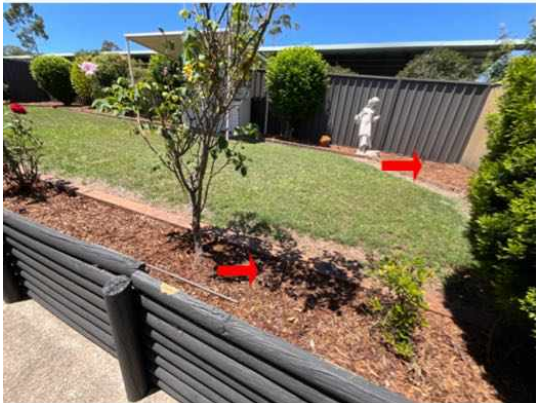
## Finding 6.06

Building:	Main Building
Location:	Garden beds
Finding:	Garden Beds
Information:	Garden beds were found to be evident in the garden area. These garden beds can include untreated timber, and with a combination of moisture from watering hosing can make conditions conducive to termite activity and termite ingress.

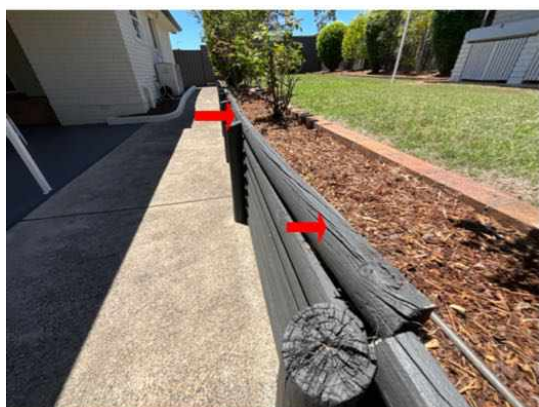
### Finding 7.01

Location:	Retaining walls
Finding:	Wood rot/decay
Information:	This building element shows evidence of wood rot. Wood rot, also known as Fungal Decay, occurs when timbers and other cellulose building materials are exposed to damp conditions on an ongoing basis. This could be the result of exposure to weathering over a prolonged period of time, or the attraction of excessive moisture from other abutting building materials. Contributing factors also include poor air ventilation in the area.

Wood rot is often associated with general damp problems and is evidenced by a `musty` smell or mould and mildew occurring on surfaces. If left unmanaged, damp conditions can lead to further health problems and the decay of timbers will continue.

Early intervention and regular maintenance, particularly of exterior timbers, will prolong the useful life of these building elements. Prior to any works being performed, the cause of the moisture that has created the visible wood rot should be identified and addressed in a suitable manner. Replacement of affected timbers may then be a necessary step in protecting surrounding building elements from such deterioration.

A licensed plumber may be appointed to assess the cause of excessive moisture and to provide advice on any remedial works as required. A licensed carpenter may also be required to replace affected building materials.

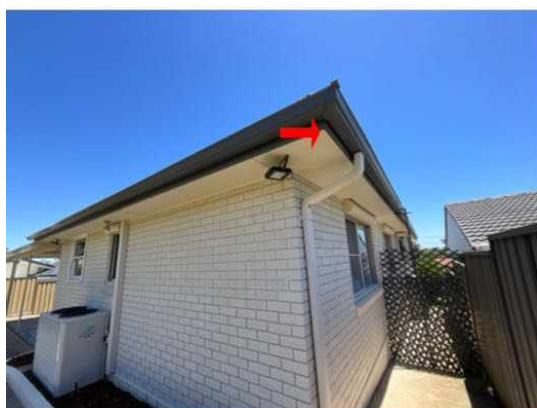
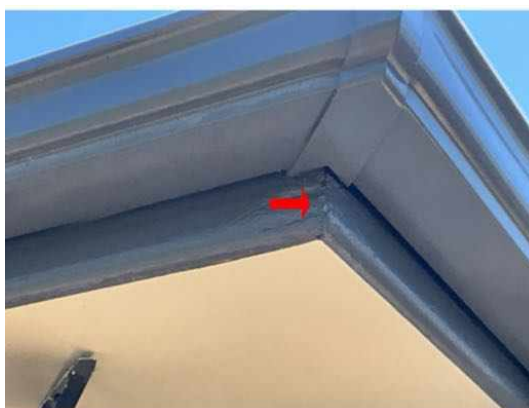
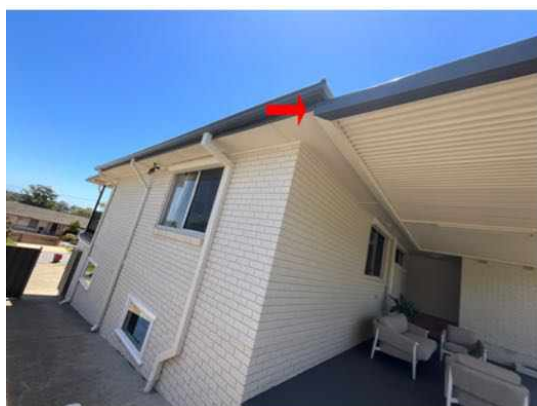
## Finding 7.02

Building:	Main Building
Location:	Fascias
Finding:	Fascias - Wood rot/decay
Information:	Wood rot was found to be affecting fascias and barges in this area, evidenced by the presence of mould on the surface in some areas. Wood rot, also known as Fungal Decay, occurs when timbers and other cellulose building materials are exposed to damp conditions on an ongoing basis.

It is likely that this wood rot has developed as a result of faults in the roof plumbing, creating excessive moisture in this areas. Otherwise frequent exposure to rain and

other weather conditions also make fascias and bargeboards susceptible to accelerated deterioration.

It is advised that a roof plumber be appointed to inspect all roof plumbing and subsequently identify the cause of the wood rot. Replacement of affected fascias and bargeboards may then be a necessary step in protecting surrounding building elements from such deterioration.

A licensed plumber may be appointed to assess the cause of excessive moisture and to provide advice on any remedial works as required. A licensed carpenter may also be required to replace affected building materials.

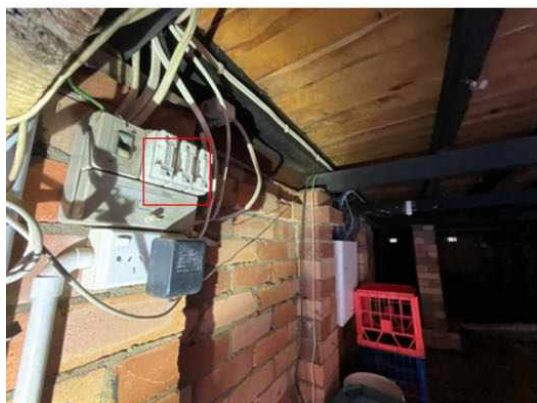
While this on its own on is not considered a defect it is noted for the clients consideration that a switchboard upgrade may be required in the short to mid term to improve the functionality of the electrical system. A licensed electrician could be appointed to provide quotation for the works at the client's discretion which may in turn expose other required works to bring the system up to a compliant state.

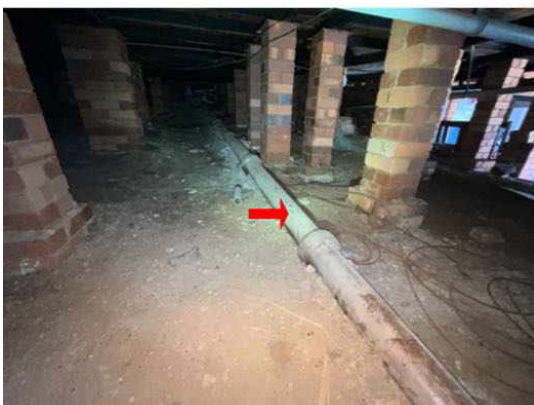
### Noted Item

Building:	Main Building
Location:	Plumbing/electrical/gas/aircon/appliances/pool equipment/fire safety etc
Finding:	Plumbing & Electrical
Information:	Plumbing and electrical inspections including appliances are outside the scope of the building inspection and must be conducted by a Licensed and registered Trades person. It is highly recommended that the client makes immediate arrangements to have the gas appliances checked by a licensed gas plumber to ensure that the appliances are working safely and efficiently. We recommend all other installations be checked also. Whilst we note and comment of visually apparent defects that present during the building inspection, legislation requires the checking and documenting of compliance for plumbing and electrical requirements be done by licensed electrician and plumbers respectively to ensure they are functioning correctly.

Consultation with a licensed plumber is advised. CCTV inspection on pipes may be required.
