Building and Timber Pest Inspection Report

Inspection Date: Mon, 12 Jan 2026

Property Address: 105 Eucalyptus Dr, Macquarie Fields NSW
2564, Australia

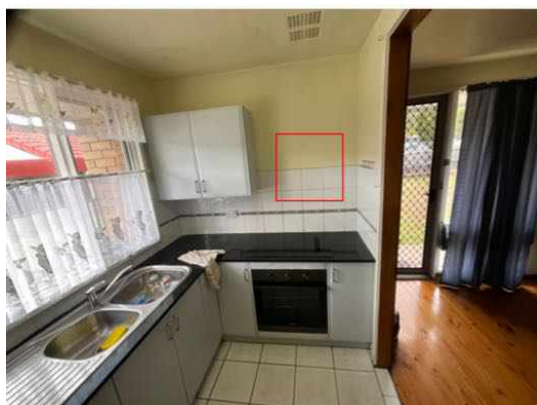
Building:	Main Building
Location:	Kitchen
Finding:	Exhaust fan - missing
Information:	The National Construction Codes 2022 (NCC) Volume Two, Clause 10.7.4

- Requires that an exhaust be installed to kitchen, bathroom, laundry, or toilet and must be discharged to outdoor air or to a space with adequate natural ventilation (like an open verandah).
- Discharging into a roof space, ceiling void, or wall cavity is not permitted unless that space itself is ventilated to the outside.
- If the kitchen has a recirculating rangehood with a charcoal filter (that cleans the air and blows it back into the room), this is allowed under the NCC.

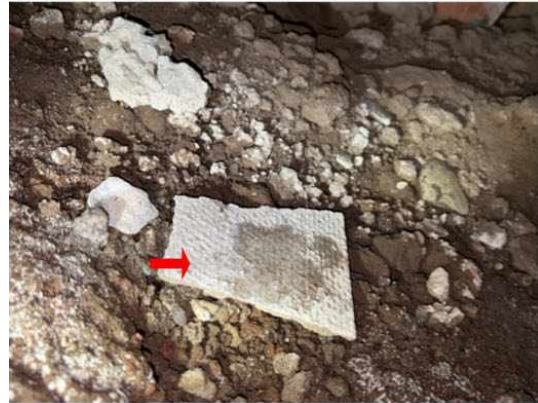
Finding 1.02

Building:	Main Building
Location:	Multiple areas
Finding:	Asbestos - Suspected ACM Identified on Site
Information:	Reporting on Asbestos is outside the Scope of this Report. This suspected defect is highlighted as a caution only. We suspect, based on our experience in the building industry, that there is a higher risk of the identified building element containing asbestos.

As Asbestos Reporting is outside the scope of this report, we advise that you consider a separate Asbestos Inspection and Condition Audit, which can include the taking of samples for definitive confirmation of the presence of Asbestos.

In the interim, the client is advised to act with caution, especially when considering any damage to building materials general wear and tear renovations extensions demolition and general maintenance activities due to the suspected presence of Asbestos.

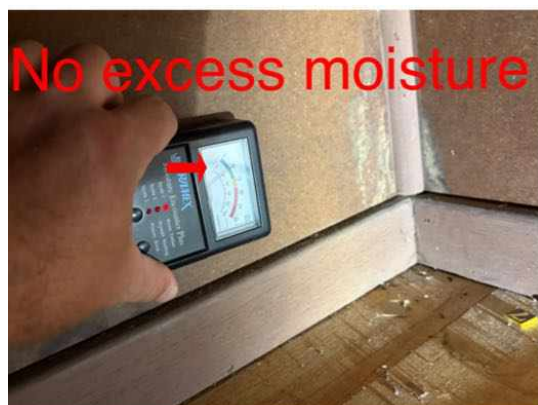
Building: Main Building
 Location: Bathroom
 Finding: Water leak - Inactive
 Information: Water leaks generally occur when a particular area of the property is not weather- or water-tight. While the damage in this area appears to be from an old inactive water leak, the area should be monitored frequently for the recurrence of any dampness.

Repair and / or replacement of previously affected building elements is at client discretion. Consider a further invasive inspection: removal of obstructions around the damaged area may reveal further damage which has been concealed. A more significant or major defect may be identified at this time.

Where recurrence of an active water leak is identified, a bathroom specialist should be appointed immediately to rectify the leak and advise on any further preventative works as necessary.

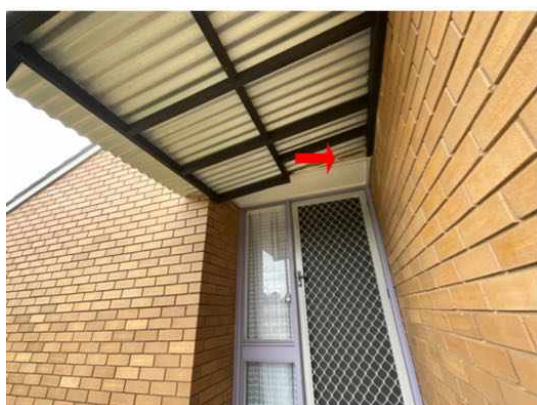
Finding 3.03

Building:	Main Building
Location:	Porch
Finding:	Damp - Rain penetration
Information:	Rain penetration (also known as penetrating damp) is a common form of dampness that can occur through walls, roofs or openings (e.g. windows). In this case rain penetration occurs through the defective roof flashing above.

Trades responsible for such works may include licensed roofing plumber.

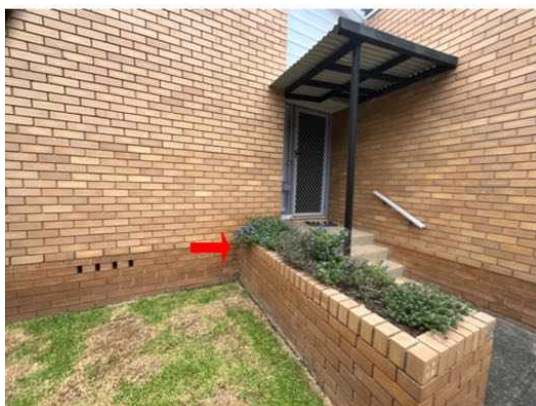
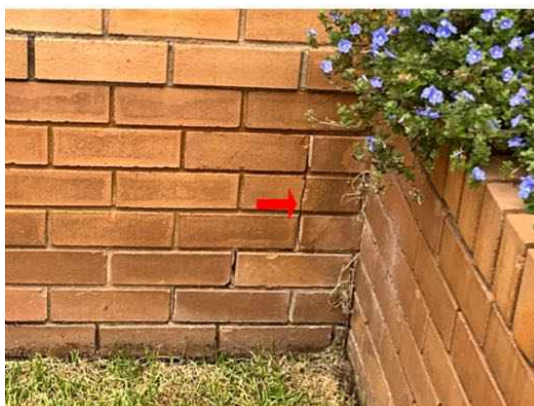
Building:	Main Building
Location:	Front Elevation
Finding:	Damage to Masonry Walls (Cracks) - Category 1
Information:	It has been observed that damage to masonry walls caused by movement of slabs, footings, or other causes, has occurred. The degree of damage falls within Category 1, described as fine cracks, which are less than 1.0mm in width limit, and that do not need repair.

Damage of this category is not considered a defect for rectification. Always contact your building inspector should cracks widen, lengthen, or become more numerous.

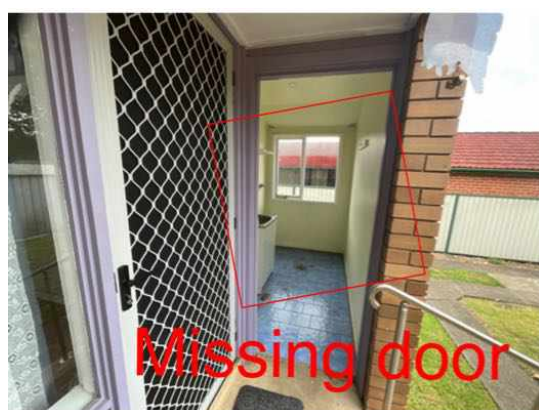
Finding 3.06

Building: Main Building
 Location: Laundry
 Finding: Building element - Missing
 Information: Although some building elements may seem irrelevant or unnecessary, all building elements play a key role in the operation and function of the overall structure and its performance.

Replacement of any missing building element should be conducted as soon as possible to ensure that no damage or functional issues occur to associated building materials.

The appropriate tradesperson should be appointed as soon as possible to replace the missing building element.

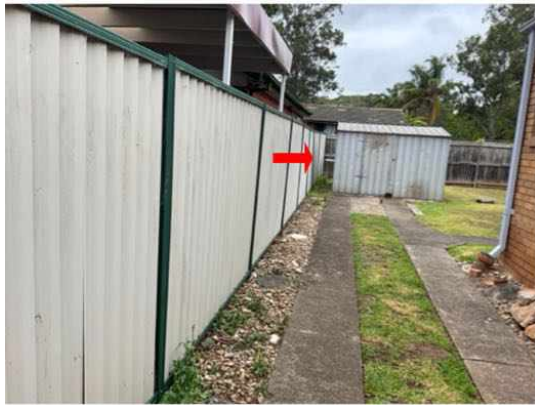
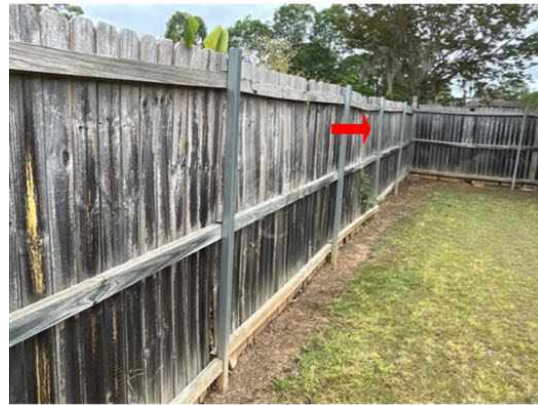
Finding 3.07

Building: Main Building
 Location: Fencing
 Finding: Fencing - Deteriorated
 Information: It was noted at the time of inspection that sections of the fencing in this area has deteriorated. Typically fencing deteriorates due to age and or wear, rot and or rust which is generally expected for a structure of this age, due to prolonged exposure to weather conditions. Sometimes inadequate installation or maintenance can be to blame.

If left unattended, it is likely that further damage will occur. It is suspected that repair of several elements of the fencing may be required however replacement may be a consideration of the client also.

A licensed fencing contractor should be appointed to provide further advice and perform rectification works as necessary.

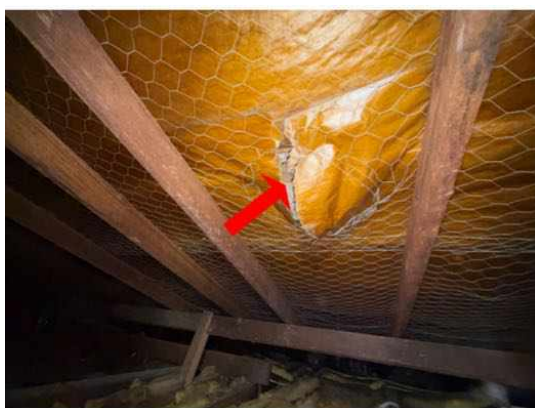
Finding 3.08

Building:	Main Building
Location:	Roof Void
Finding:	Sarking - Damaged
Information:	Sarking, a laminated aluminium foil applied to the interior of the roof covering, assists in insulating the property and acting as a vapour-barrier to the roof void and, subsequently, to the household.

Where sarking is damaged, both insulation and moisture protection of the property are inhibited. This creates a loss of energy and thus negatively impacts the energy efficiency of the property, allowing potential for moisture ingress from condensation or leaking roof tiles.

It is important to repair any holes or damaged sections of sarking to ensure that the building material is fully functional. A registered builder or qualified carpenter should be consulted to provide further advice on this defect and to perform rectification works at client discretion.

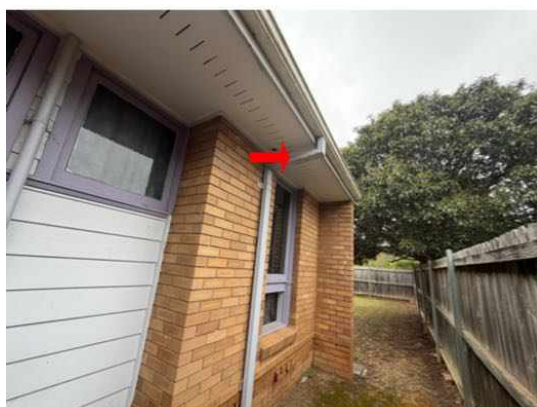
Finding 3.09

Building:	Main Building
Location:	Rear corner

Finding: Roof plumbing - Rusted or corroded
 Information: The roof plumbing has areas of rust and corrosion. It is suspected that this has been caused by blockages, resulting in pooling or standing water, that have prematurely rusted elements of the roof plumbing.

Rusted roof plumbing will generally develop holes and leaks that can affect other building elements with poor drainage of storm water. Poorly drained roof areas will also lead to damp conditions surrounding the base perimeter of the building which, if left unmanaged, can lead to a range of secondary building defects.

Repair and/or replacement of rusted roof plumbing is highly required in order to reinstate the roof drainage system to a fully operational level. To further maintain these areas, gutters should be cleaned frequently, allowing the avoidance of any partial blockages.

A licensed plumber or specialist roof restoration company should be appointed to undertake these works. It is advised that such works be completed as soon as possible to prevent any further damage and deterioration.

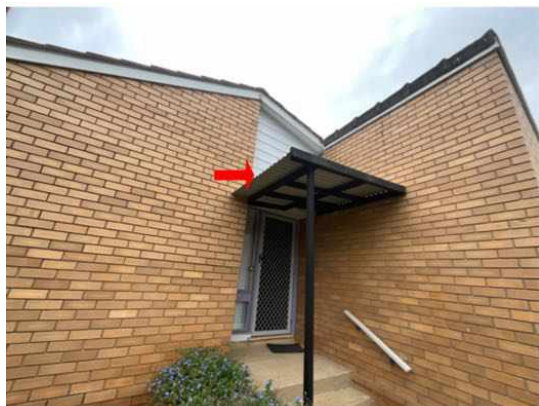
Finding 3.10

Building: Main Building
 Location: Porch
 Finding: Roof plumbing - Missing
 Information: Some sections of the roof are not adequately drained via gutters and downpipes. Gutters and downpipes that are not installed adequately are likely to result in excessively damp conditions against the exterior surfaces and around the base perimeter of the building.

Excessive moisture creates an environment which accelerates the deterioration of building elements in the area, as well as being conducive to termite and pest infestation. Such an environment is likely to necessitate repair and/or replacement of building elements, which are prone to sustaining wood rot, rust or corrosion.

plumbing materials. Depending on the extent of the damage, repair and/or replacement of damaged building elements may be required.

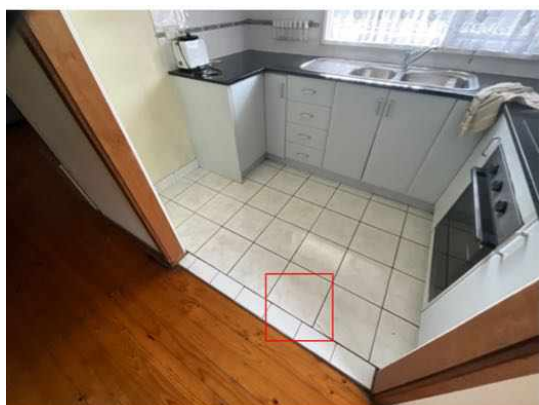
Finding 3.11

Building: Main Building
 Location: Kitchen
 Finding: Cracked floor tiles
 Information:

Cracking in the floor tiles was evident in this area at the time of inspection. It is suspected that this cracking has occurred as a result of minor settlement or shrinkage.

Cracked tiles throughout the household detract from the overall appearance of the affected areas however it is unlikely to create or lead to any secondary defects.

While not considered a matter of urgency, replacement of cracked floor tiles is recommended at the clients discretion. A licensed tiling contractor may be appointed to perform these works. Where cracks become more numerous, contact a licensed building inspector for further investigation.

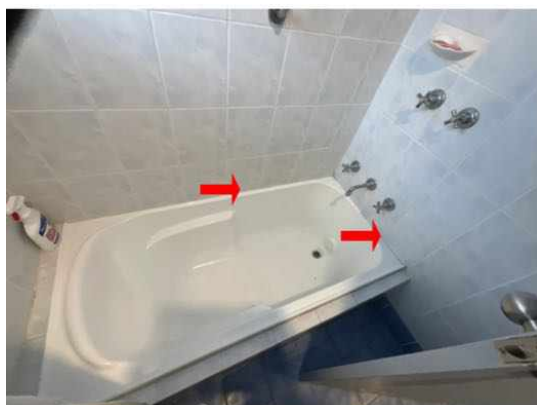
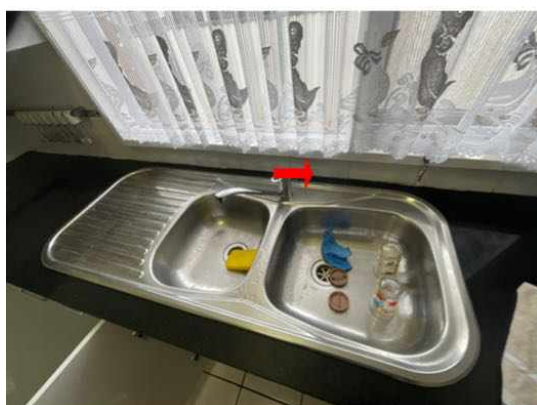
Finding 3.12

Building: Main Building
Location: All Wet Areas
Finding: Sealant and grouting - Missing or damaged
Information:

It was noted on inspection that sealant or grout is degraded to this area.

Different materials and floor areas move at different rates, generally causing cracking to grout or sealant at this point. A flexible sealant is required to allow for expected expansion and contraction, while keeping the joint water tight and protective of all associated building materials.

Flexible and mould resistant materials should be applied to affected areas to prevent any subsequent water damage that is likely to occur. Regular maintenance and replacement of damage or missing or damaged sealant and grout is highly recommended to the wet areas, as this is a regular wear and tear defect. Sealant and grouting in areas that come into regular contact with water should be maintained for the long term care of your property.

A sealant specialist should be appointed to complete these works as soon as possible.

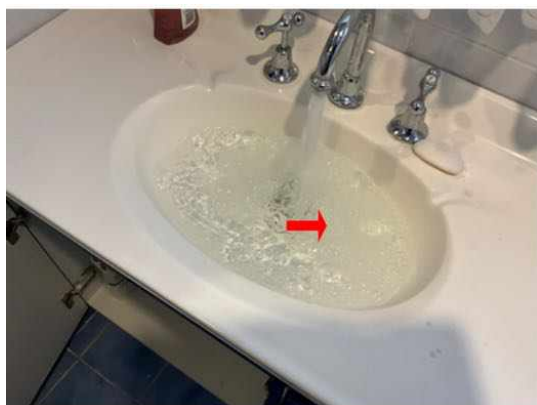
Finding 3.13

The sink/basin drain appeared to be partially blocked at the time of inspection. Blockages here are usually caused by hair and other debris. If left unmanaged, a lack of general maintenance may lead to the development of more significant defects, such as water damage to surrounding building materials.

A licensed plumber should be appointed to remove the blockage at the client discretion.

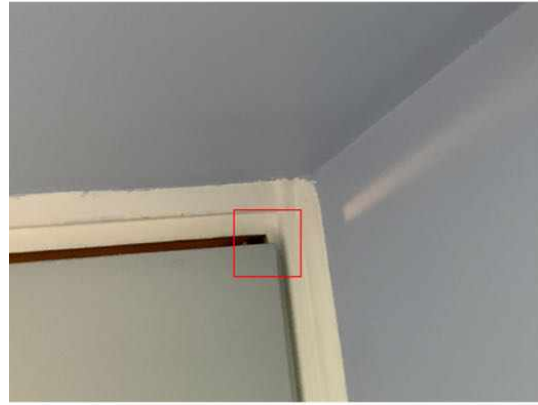
Finding 3.14

Building: Main Building
 Location: Bathroom
 Finding: Door - Binding/jamming
 Information:

Binding and/or jamming of this door is evident during standard operation. This defect inhibits the functionality of the affected door as well as creating potential for secondary defects to associated building elements, such as damage to the floor covering or adjacent frame.

A door that binds to flooring or to the associated door frame may have several causes, ranging from minor defects, such as poor installation of the door or deteriorated hinges.

A licensed carpenter should be appointed to perform minor rectification works at client discretion.

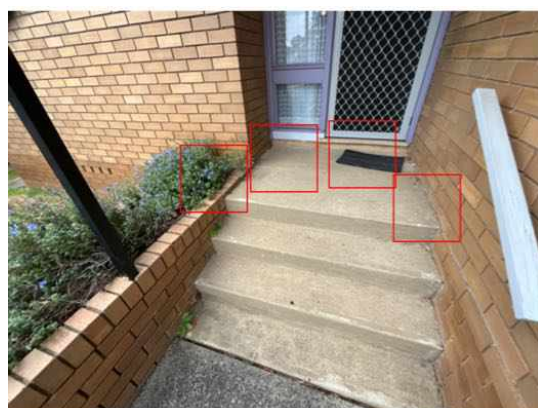
Damp proof course (DPC) is a barrier of impervious material built into a wall or pier to prevent moisture from moving to any part of the building. Where external ground levels are built up over this barrier ingress is provided for moisture from the exterior grounds into the base brickwork or other building material and allowed to rise.

Such conditions attract termites into these damp areas which is likely to lead to infestation if left untreated.

While retrospective fitting of DPC is considered to be impractical works are required in order to prevent the extraction of moisture from the external environment into exterior brickwork or wall materials. Landscaping or re-paving of external grounds may be considered by the client. Regular annual inspections are strongly advised.

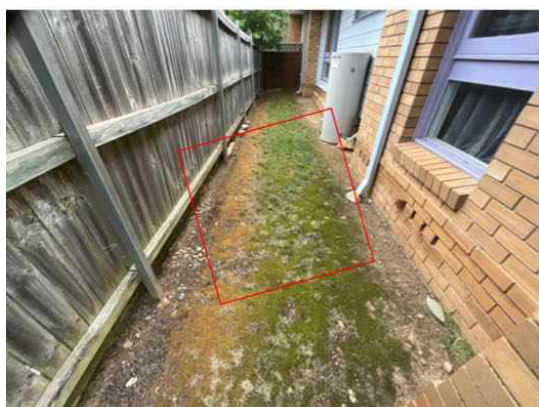
Finding 6.02

Building:	Main Building
Location:	Yard
Finding:	Site drainage— Inadequate
Information:	The site drainage in this area was found to be inadequate at the time of inspection, creating potential for subsequent water damage to associated building elements. This is additionally conducive to termite activity.

Where site drainage is inadequate, installation of an Agricultural (Aggie) Drain may be required. A licensed plumber should be appointed to further inspect the property and perform any remedial works as necessary. Water damage and secondary defects are likely to occur if left unmanaged.

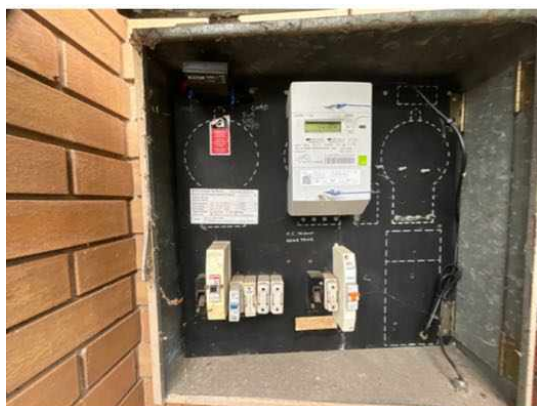
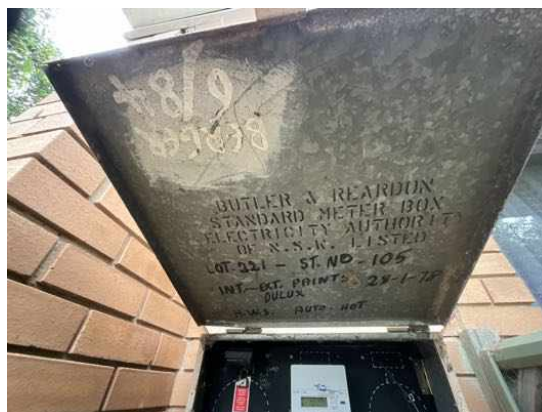
Finding 6.03

Building:	Main Building
Location:	Meterbox
Finding:	Termite Management System - no evidence of installation
Information:	The application of a post-construction chemical termite barrier is highly recommended for all properties, particularly if live termite activity has been found on the site previously. Such barriers are highly effective in preventing termite attack on any timber building elements throughout the property.

The client may consider gaining further advice from a pest controller as to the costs and procedures involved with this application. It is recommended that obtaining such advice be a short-term priority.

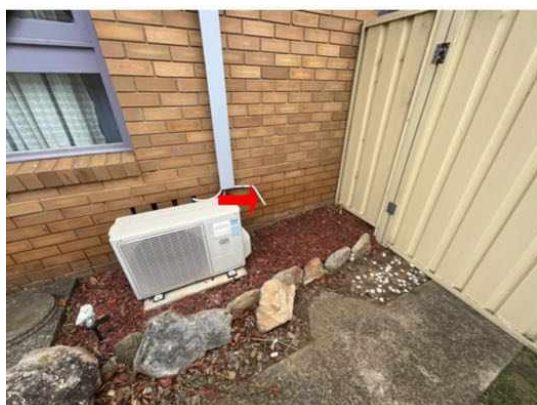
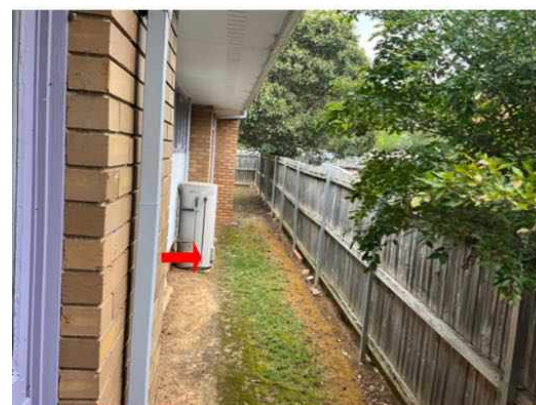
Finding 6.04

Building:	Main Building
Location:	Yard - Side
Finding:	Overflow - Not plumbed for drainage
Information:	The overflow is not plumbed or connected to suitable drainage, which can result in the surrounding area becoming excessively damp.

It is highly recommended that a licensed plumber be appointed to install adequate drainage to the overflow. These works will ensure that the area remains dry and free of any secondary defects.

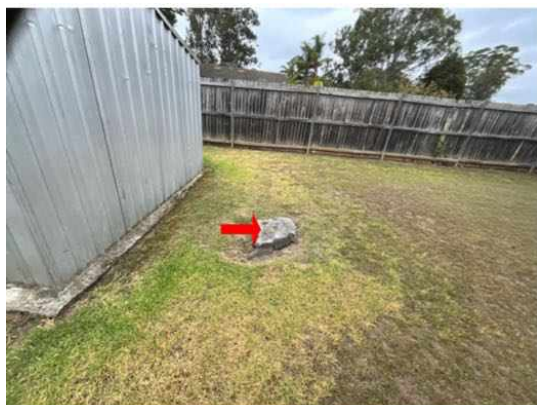
Finding 6.05

Building:	Main Building
Location:	Yard
Finding:	Tree stump - Remove
Information:	Old tree stumps were found around the property. Attached photos are examples of

All tree stumps should be removed where possible. Frequent pest inspections are advised to readily identify any termite activity in these areas.

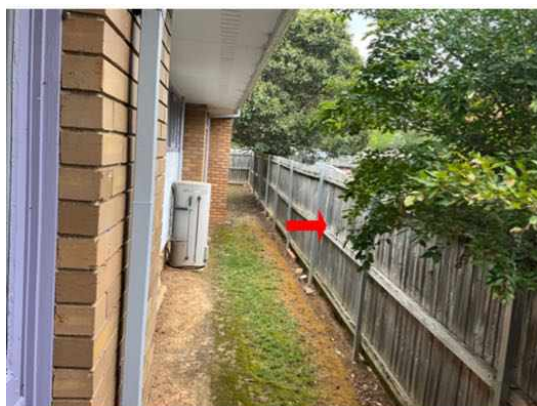
Finding 6.06

Building:	Main Building
Location:	Fencing & Landscaping
Finding:	Building materials in direct ground contact - conducive to termites
Information:	Where timber elements are in direct contact with the ground and consequently moisture or dampness they become conducive to termite activity. Whether timber is used as a building element part of a fencing structure or stored as an unused item they can provide an environment that is attractive to termite infestation.

The removal of any such materials that may be conducive to termite activity should be removed as soon as possible to minimise the risk of termite attack.

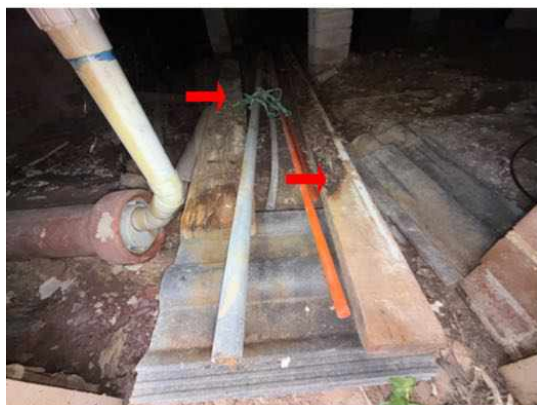
Finding 6.07

Building:	Main Building
Location:	Subfloor
Finding:	Stored timbers - subfloor space or external area
Information:	The storing of timbers in the subfloor space or around the external property increases the risk of termite activity being present. As they are likely to come into contact with weather conditions or excessive moisture wood rot is likely to develop on timbers that are not treated.

It is highly recommended that any stored timbers be immediately removed from areas in which they may attract any termite / timber pest attack. Minimisation of risk / prevention of termite attack is far more adequate than dealing with the presence of termite activity.

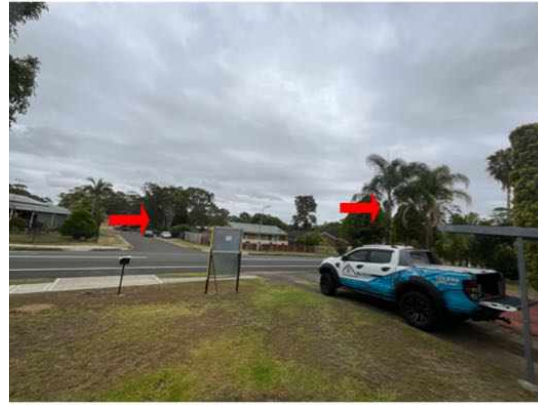
Finding 6.08

Building:	Main Building
Location:	
Finding:	Surrounding bushland - Conducive
Information:	Home and or building is situated in a high risk area for termite activity, due to close proximity to surrounding bushland.

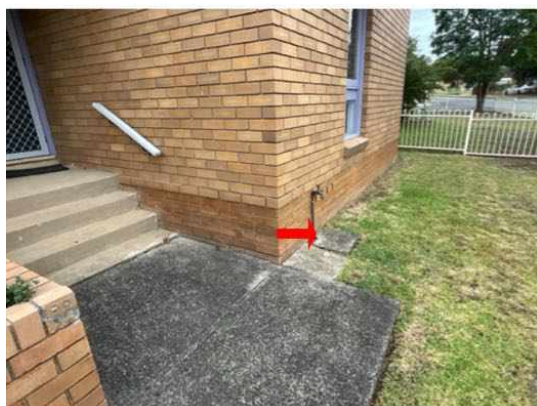
Finding 6.10

Building:	Main Building
Location:	External tap
Finding:	Tap - No drain
Information:	The external tap in this area was noted to have no drain at the time of inspection. This keeps the surrounding surfaces damp while using the tap, which becomes conducive to termite activity. A licensed plumber must be appointed to ensure an appropriate drain is installed.

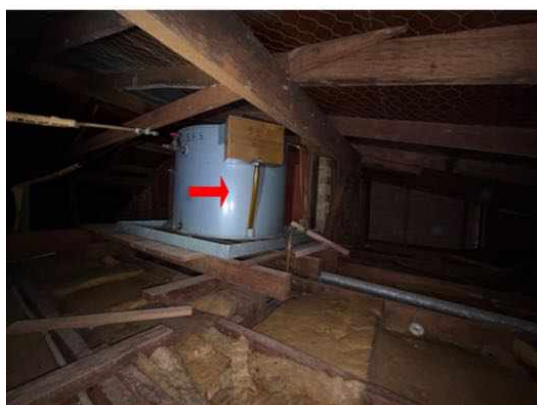
Finding 6.11

Building:	Main Building
Location:	Roof Void
Finding:	Gravity-Fed HWS - Disconnected
Information:	It was noted at the time of inspection that a disconnected gravity-fed hot water system (HWS) remains in this area.

While it is a costly exercise to remove the disused gravity-fed HWS, it is advisable in the short-term future to prevent any further damage to the area. Further consultation with a licensed plumber is required to gain further advice on removal of the structure.

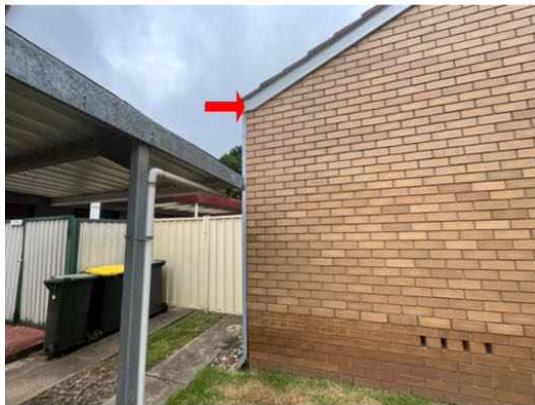
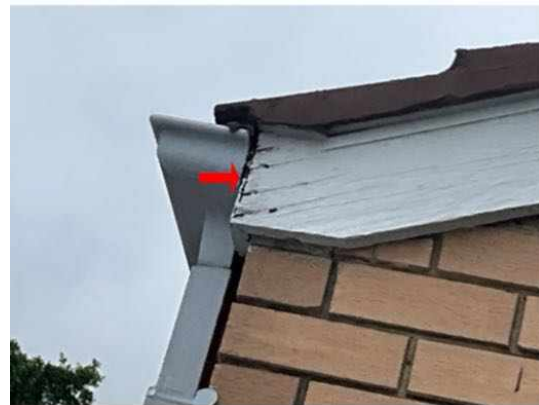
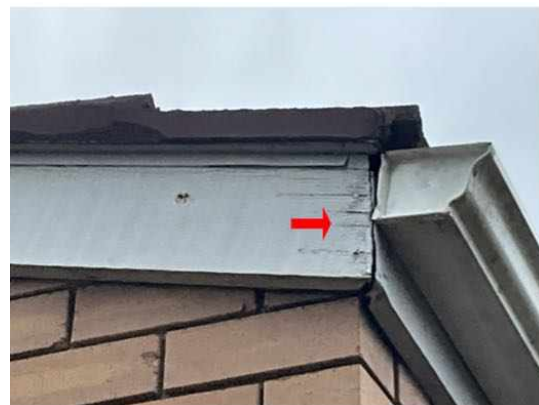
Finding 7.01

Finding: Fascias - Wood rot/decay

A licensed plumber may be appointed to assess the cause of excessive moisture and to provide advice on any remedial works as required. A licensed carpenter may also be required to replace affected building materials.

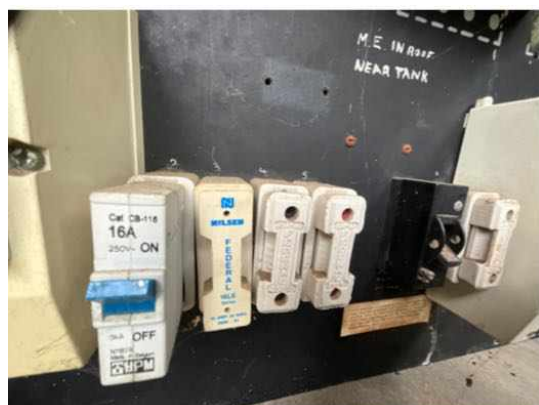
While this on its own on is not considered a defect it is noted for the clients consideration that a switchboard upgrade may be required in the short to mid term to improve the functionality of the electrical system. A licensed electrician could be appointed to provide quotation for the works at the client's discretion which may in turn expose other required works to bring the system up to a compliant state.
