Building and Timber Pest Inspection Report

Inspection Date: Tue, 17 Feb 2026

Property Address: 16 Abernethy St, Shepparton VIC 3630,
Australia

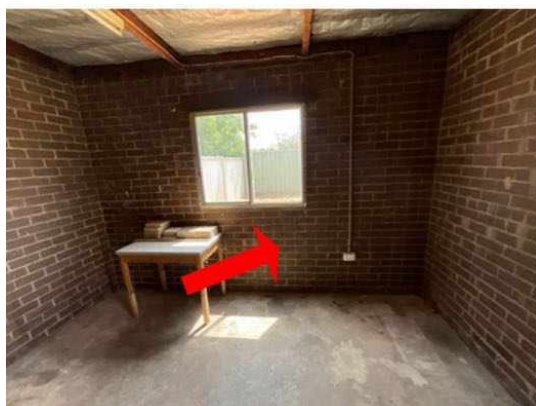
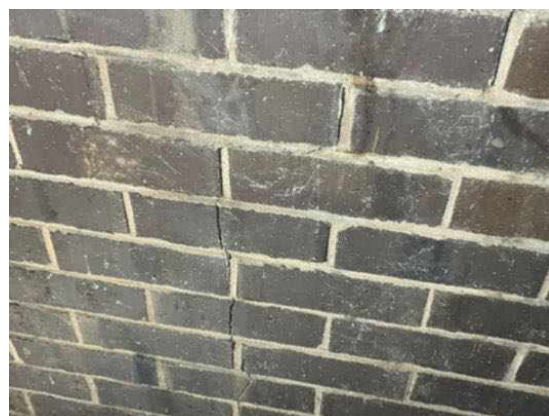
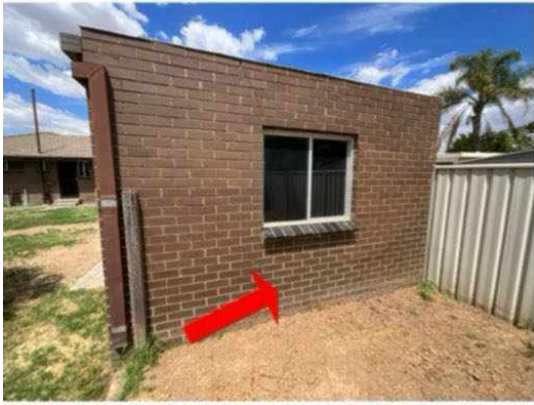
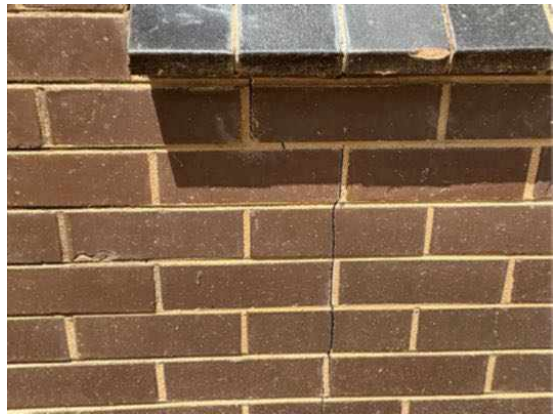
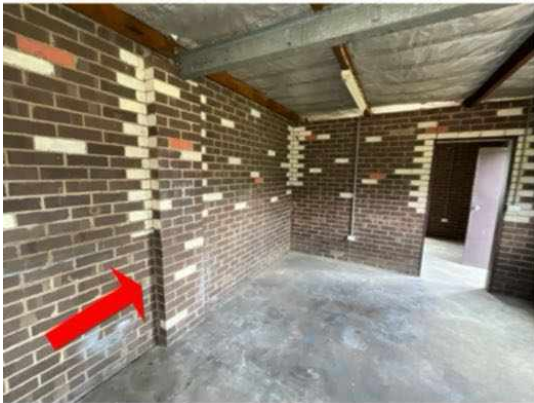
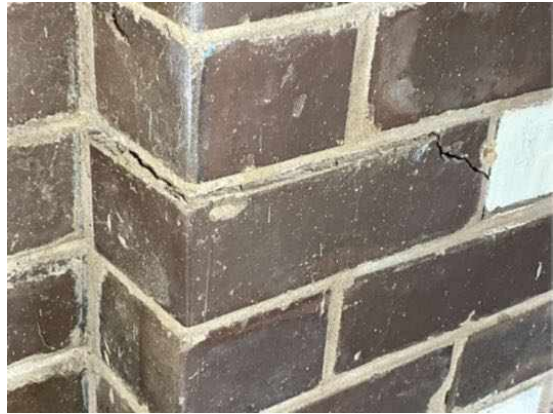
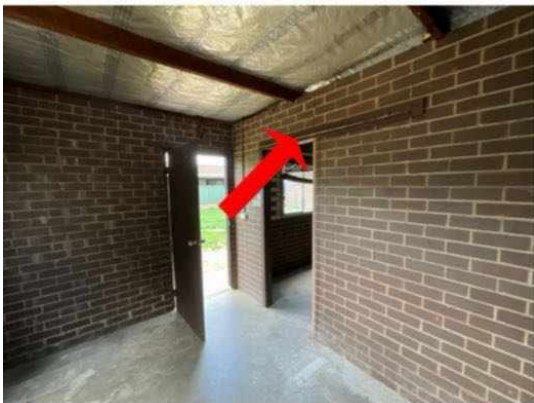
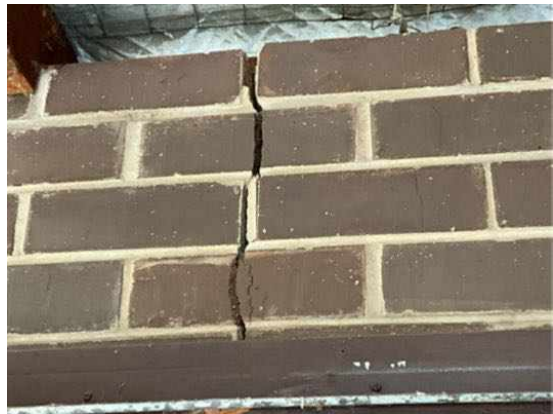
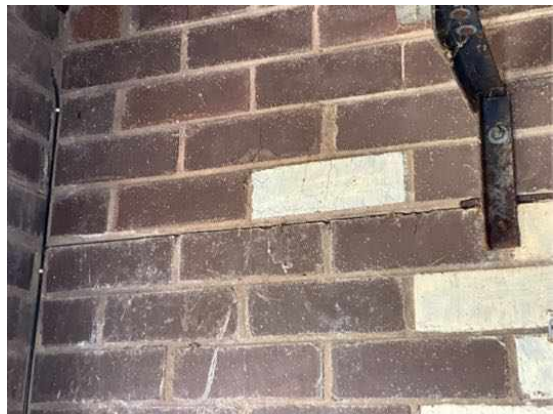
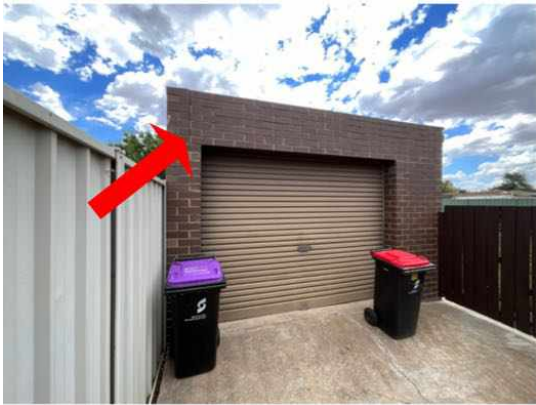
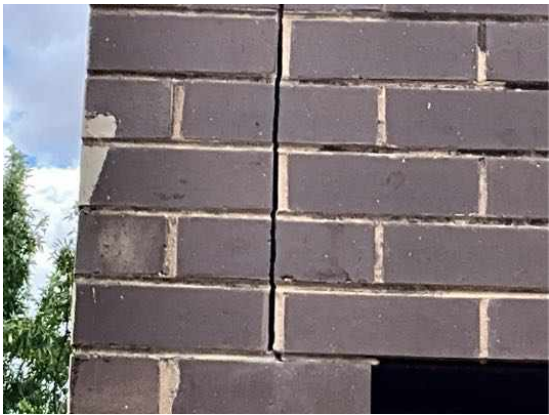
Building: Building 1
Location: Garage
Finding: Brickwork - Cracking noticeable
Information: There were several cracks and or crack repairs evident to external brickwork.

Noticeable cracks are a common occurrence in external brickwork and are a likely result of age expected building movement, general expansion, and/or contraction of building materials in different weather conditions. Noticeable cracks in brickwork may develop if left unattended, with potential for necessitating major remedial works or replacement of the brickwork.

It is highly advised that a qualified bricklayer be appointed to provide necessary works to cracked brickwork to prevent any further damage. Such works should be conducted as soon as possible.

Always monitor these cracks and contact a building inspector should cracks widen, lengthen, or become more numerous.

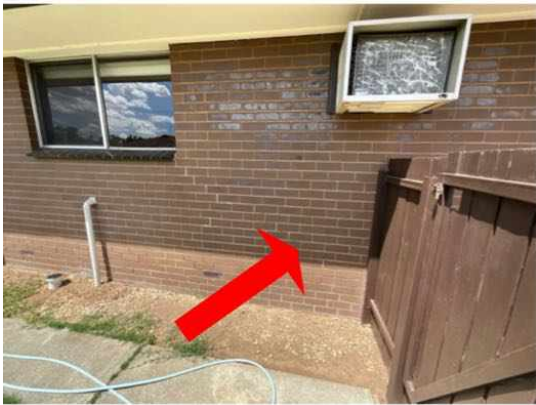
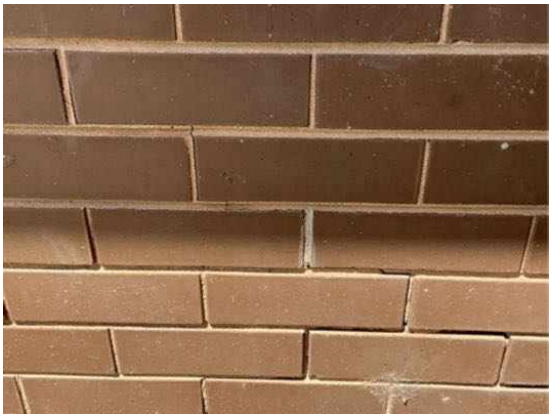
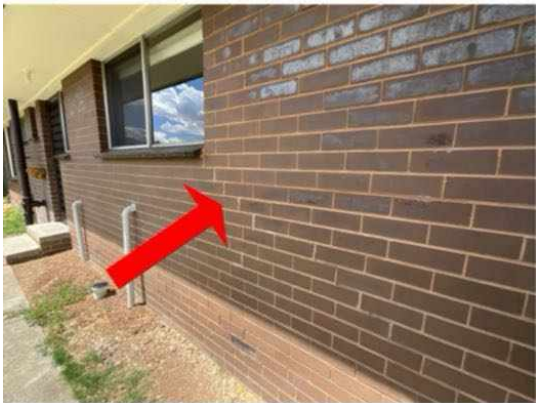
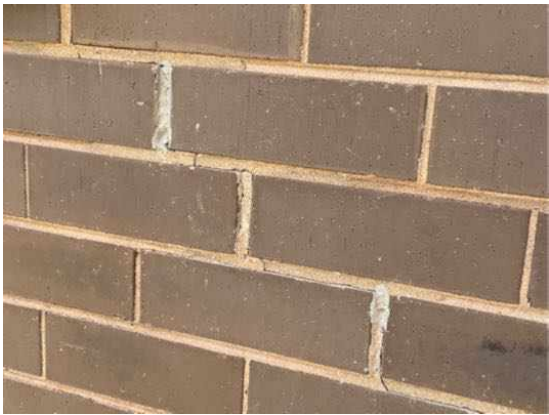
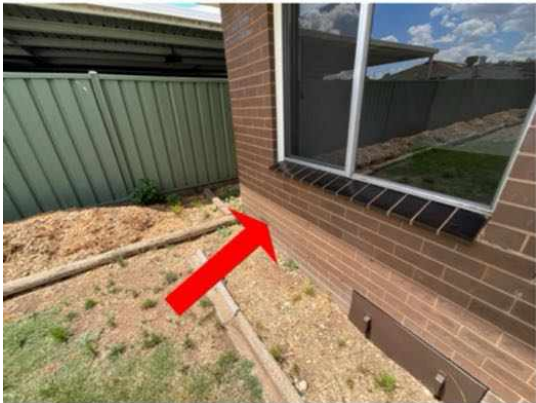
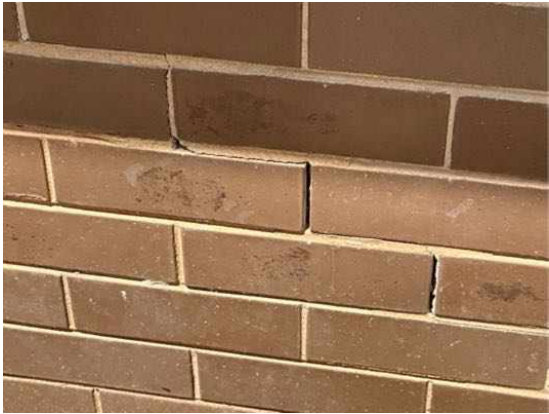
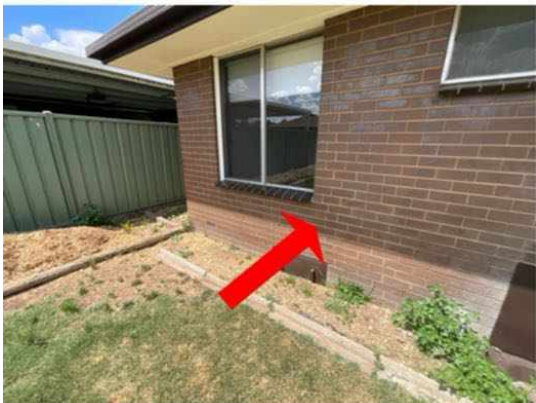
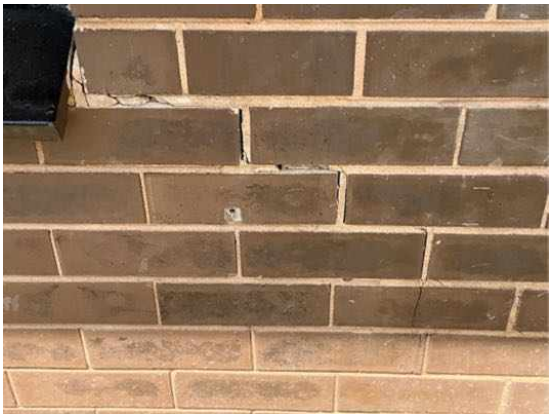
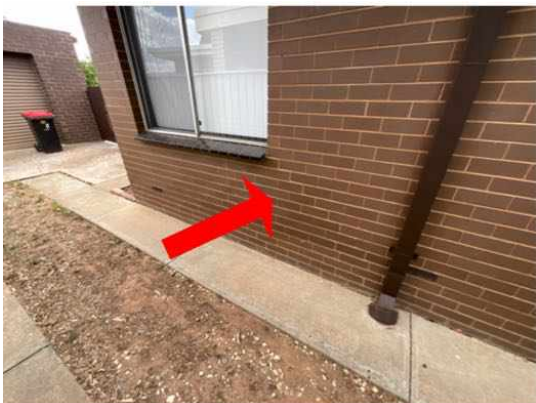
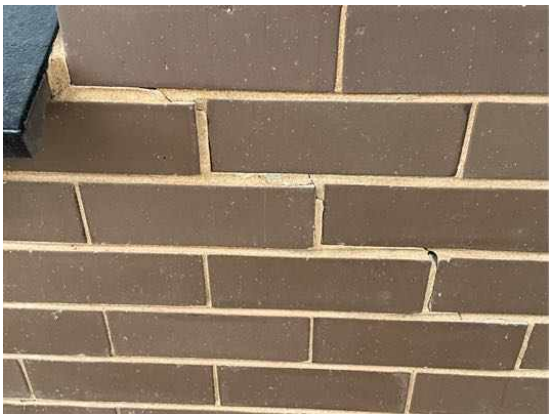
Finding 3.02

Building: Building 1
Location: Back, side wall
Finding: Brickwork - Step cracking
Information: Step cracking was identified to the brickwork in this area at the time of inspection. Step cracking, which is similar to other forms of cracking, has a variety of possible causes. However, the most common is the subsidence of adjacent footings.

Step cracking is a relatively common defect, and is most likely to occur adjacent to windows, doors and other openings. Mortar failure in the gaps between affected bricks indicates the stresses and tensions affecting the wall.

Where step cracking is extensive or severe, the client is advised to consult a structural engineer. Minor step cracking can be used as a warning sign to address factors causing stress to the wall, which can include the effect of surrounding trees, water leaks, soil erosion, or even the presence of reactive soils in the surrounding area.

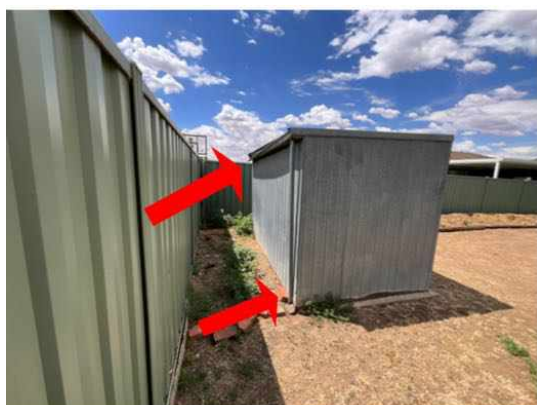
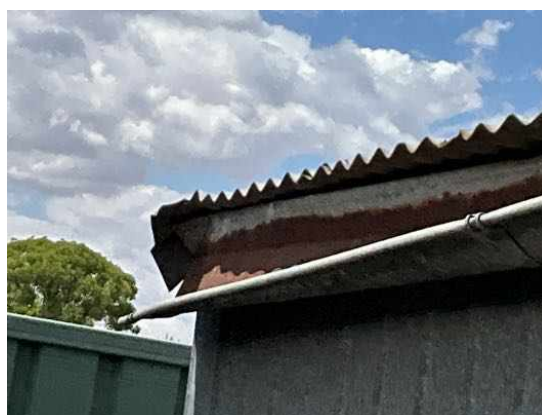
Finding 3.03

Building: Building 1
 Location: Shed
 Finding: Gutters- Deteriorated
 Information: The guttering and some downpipes have deteriorated.

Although not a major problem now, they will deteriorate further if left for an extended period.

Sagging can be seen in the gutter.

A Licensed Plumber should be engaged as soon as possible to advise on any repairs or maintenance that may be required.

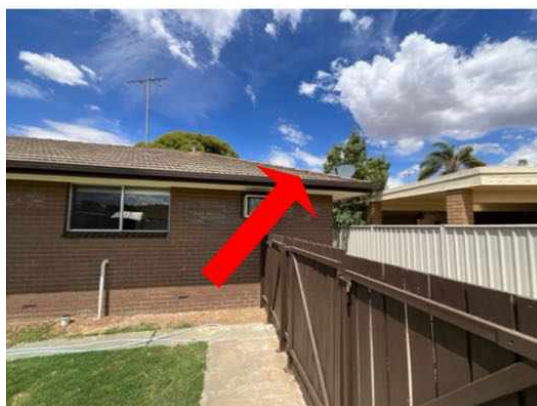
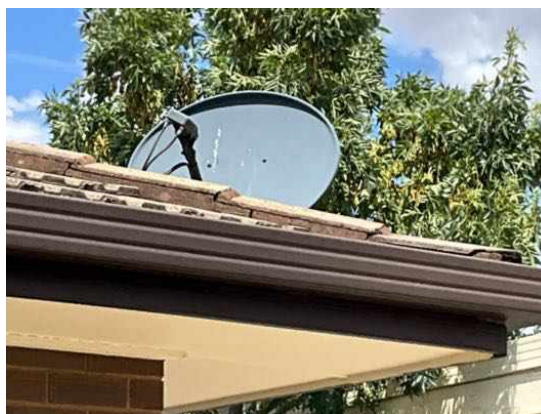
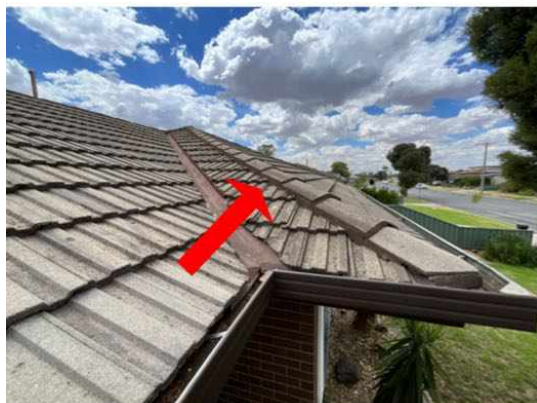
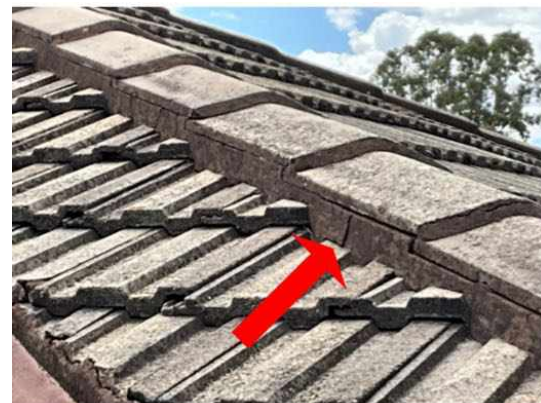
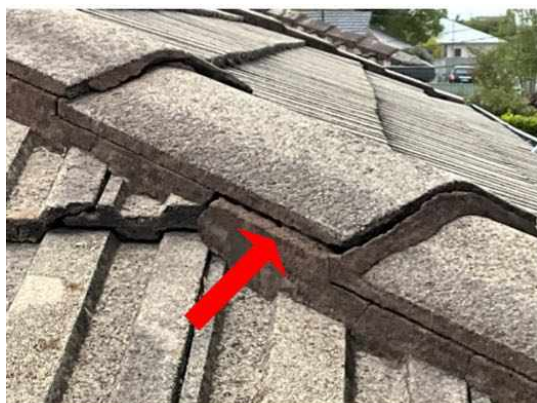
Finding 3.04

Building: Building 1
 Location: Roof Exterior
 Finding: Mortar - Deterioration
 Information: Mortar, or 'bedding', is the material which fills joins and intersections between tiles and other building elements on the exterior roof covering, such as gable ends, hip capping and valleys. Upon inspection of the exterior roof, it was noted that sections of the mortar show varying levels of deterioration.

Mortar generally deteriorates as a result of frequent exposure to weather conditions over a prolonged period of time. Mortar that is deteriorating may allow water ingress into the roof void, putting associated building elements and roofing structures at risk of water damage. Deteriorated mortar also detracts from the functionality of roof tiles and other roofing elements, potentially decreasing weather tightness and roof drainage.

Mortar deterioration can be attended to by a handyman where areas of deterioration are localised and easily accessible. Otherwise, consultation with a roofing contractor is advised where greater works are required.

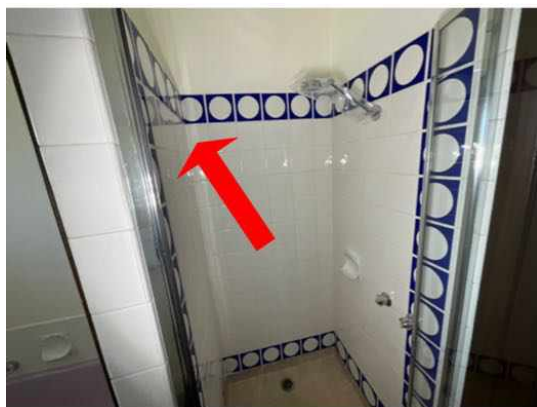
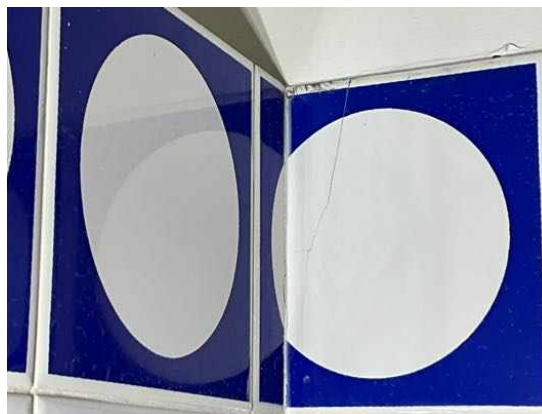
Finding 3.05

Building:	Building 1
Location:	Bathroom
Finding:	Wall Tiles- Cracked
Information:	Cracked tiles within the household detract from the overall appearance of the affected areas, as well as creating potential for water penetration to adjoining building elements. If left unmanaged, water damage may occur as a result of constant water penetration over a prolonged period of time.

While not considered a matter of urgency, replacement of tiles is advised as a solution. A Tiling Contractor may be appointed to perform these works at client discretion.

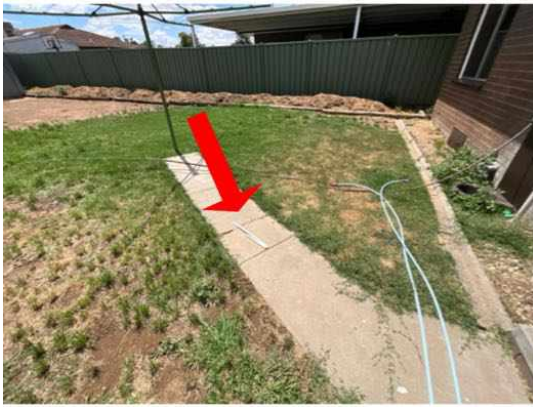
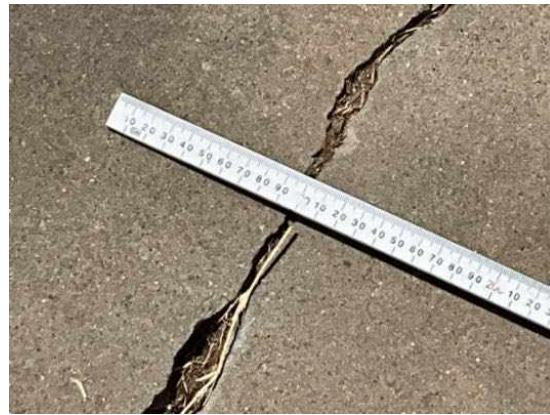
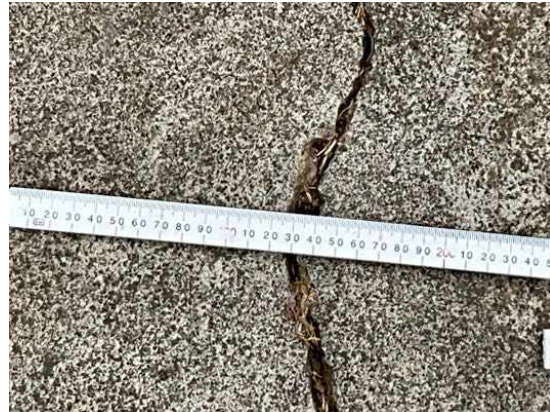
Finding 3.06

Building:	Building 1
Location:	Yard - Back, driveway
Finding:	Cracking - External Concrete Paving Damage Category 4 - Gaps in Slab (4mm - 10mm +)
Information:	Gaps in the slab were identified in external concrete paving. Gaps in the slab are significant and are likely to lead to the development of safety hazards and secondary defects if left unmanaged, such as the creation of a trip hazard.

General age and expected deterioration of the paved areas is a common cause of this type of cracking. However, expansion and contraction of the slab may also have occurred due to environmental factors. Such factors include variable moisture and weather conditions, the presence of trees and their roots having a settling or lifting affect on the soil, or the effect of load bearing, e.g. heavy vehicles over a sustained period of time.

Cracking to this degree may also be due to poor original installation of the concrete. Factors such as poor compaction of the sub surface and/or inadequate reinforcing of the slab may create cracking and other secondary defects. Gaps in the concrete paving may also have a more significant structural cause, such as subsidence of soils.

Where gaps in the concrete paving are adjacent to structural elements of the building, the advice of a Structural Engineer is advisable before undertaking repairs. Significant repair and likely replacement of the concrete paving is probable.

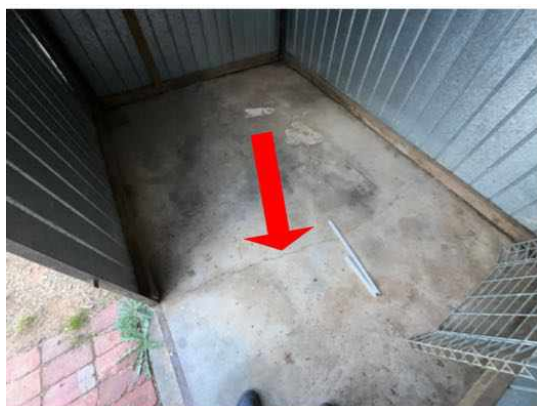
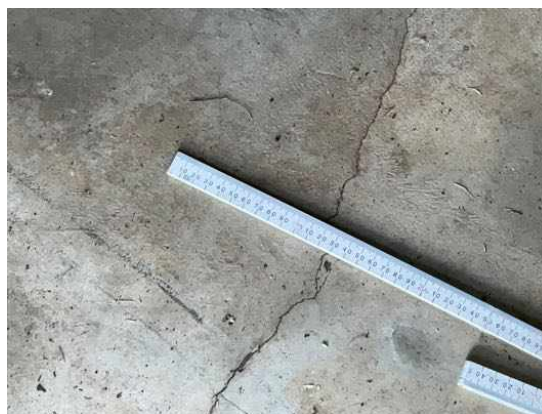
Finding 3.07

Building:	Building 1
Location:	Shed
Finding:	Cracking - External Concrete Paving Damage Category 1 - Fine (less than 2mm)
Information:	Fine cracks were identified in external concrete paving. Although fine cracks are quite noticeable, they are often only considered to be an appearance defect, and usually do not indicate any structural damage. To be considered a Category 1 or fine crack, the crack is found to be less than 2mm in width.

Generally the cause of a hairline crack in existing concrete paving such as driveways and pathways is indicative of the expansion and contraction of the concrete. Such causes are generally due to environmental factors, such as moisture levels, weather conditions, root systems of nearby trees or the soil types on which they are laid.

Fine cracks may also be due to poor original installation of the concrete. Factors such as poor compaction of the sub surface and/or inadequate reinforcing of the slab may create cracking and other secondary defects.

Monitoring of all cracking should be conducted frequently. Always contact a building inspector should cracks widen, lengthen, or become more numerous.

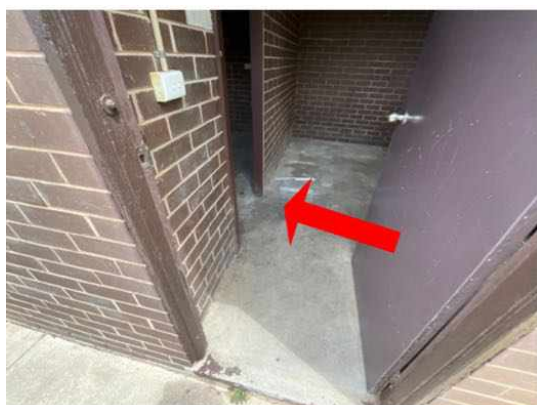
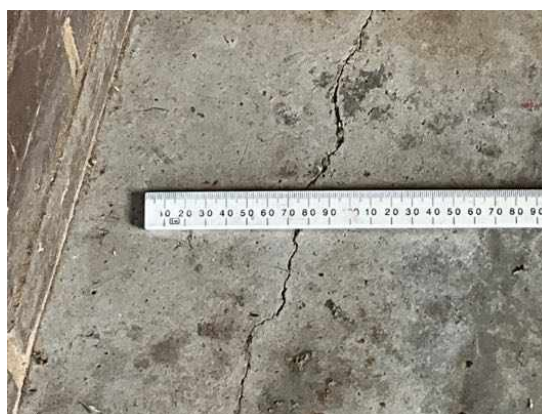
Finding 3.08

Building: Building 1
 Location: Garage
 Finding: Crack in concrete slab - Category 1
 Information: A crack coded as Category 1 was identified in the slab. A Category 1 crack is described as a fine but noticeable crack, with the slab at an otherwise reasonable level.

To be considered Category 1, the approximate width of the crack is less than 1.0mm, or a less than 10mm change in offset when a 3m straight edge is placed over the defect.

Category 1 cracks should be monitored for a period of 12 months. At the end of the monitoring period, identified cracks that are rated greater than Category 2 are considered defects, and require rectification.

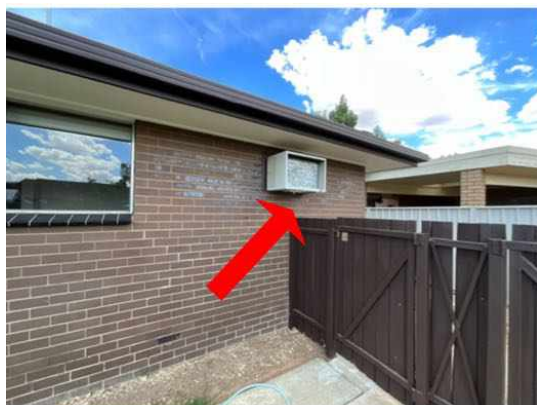
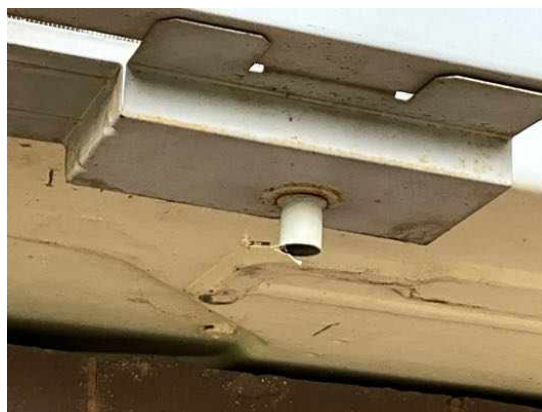
Building: Building 1
 Location: Yard - Back
 Finding: Air conditioner - Disconnected overflow
 Information: The Air Conditioner (A/C) overflow was found to be disconnected from storm water drainage and is creating excessive moisture in the surrounding area.

Such leaking creates an environment which is conducive to an array of defects, including water damage to associated building elements and the attraction of termite or timber pest infestation.

It is highly recommended that a licensed plumber be appointed to connect the A/C overflow in order to prevent such an environment from being created. These minor works should be carried out as soon as possible.

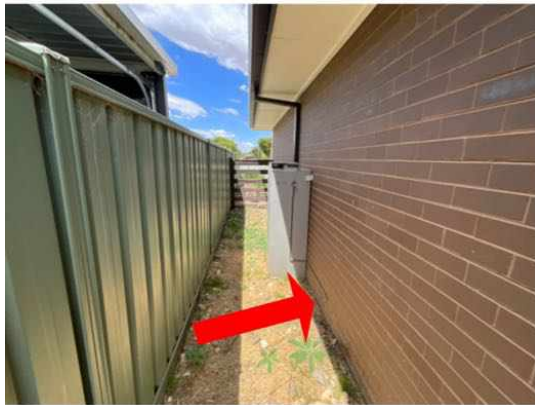
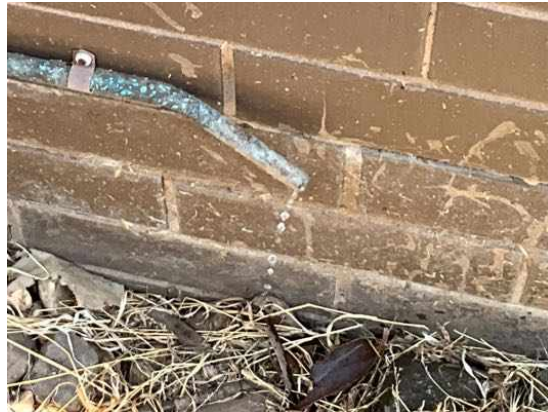
Finding 6.02

Building: Building 1
 Location: Yard - Side
 Finding: HWS Overflow - Not Connected
 Information: The Hot Water System (HWS) overflow was found to be disconnected from storm water drainage and is creating excessive moisture in the surrounding area.

These damp conditions can lead to secondary defects such as rot, rust or corrosion of associated building elements, the formation of fungal decay, or even the creation of potential slip hazards. When coupled with poor site drainage, pooling of water may also attract termite activity to this area.

It is highly recommended that a licensed plumber be appointed to connect the HWS

overflow in order to prevent such an environment from being created. These minor works should be carried out as soon as possible.

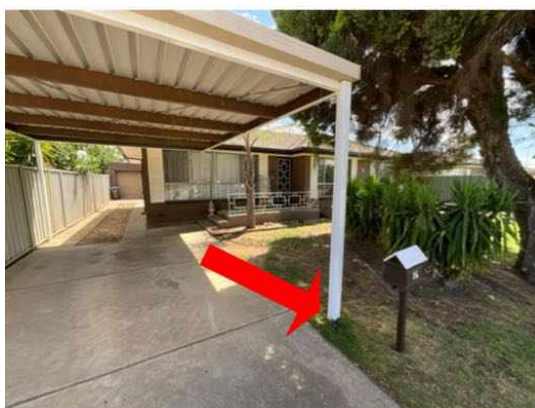
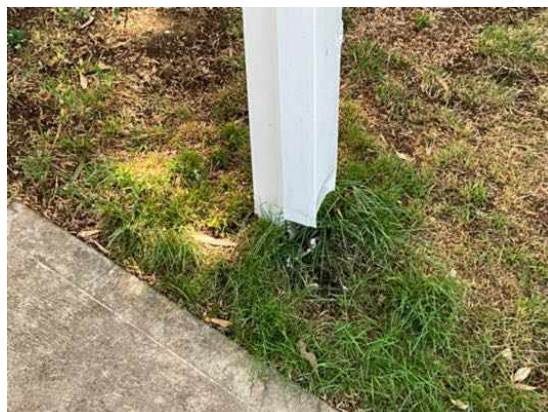
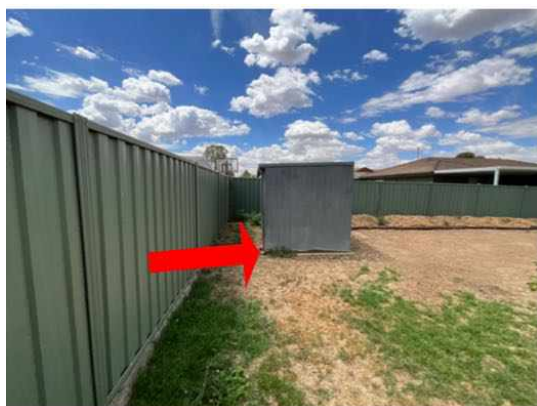
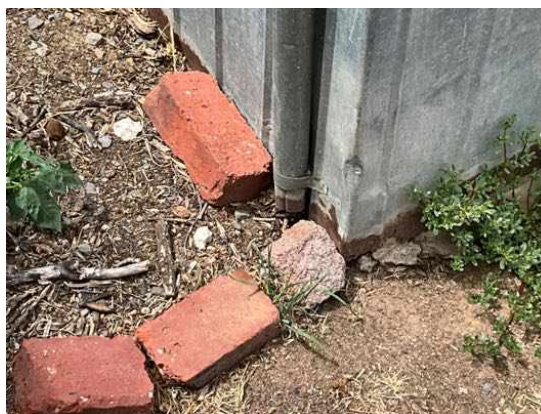
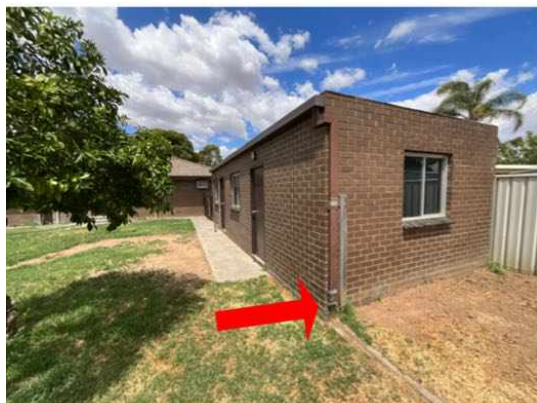
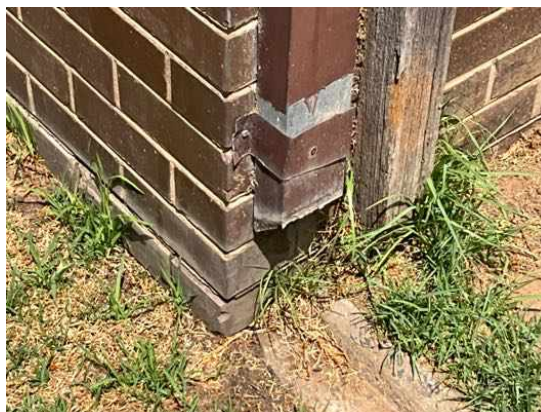
Finding 6.03

Building:	Building 1
Location:	Carport, back yard
Finding:	Stormwater drain - Not connected
Information:	The roof plumbing is not adequately connected to stormwater drainage on the site. This disconnection negatively impacts the functional capacity of the roof plumbing.

Where roof plumbing doesn't drain adequately, the area at the base perimeter can become excessively damp, potentially creating an environment that is susceptible to rust and corrosion of surrounding building elements, as well as attracting termites and other pests.

It is highly recommended that a plumber be appointed to further inspect the area and to install adequate drainage equipment where necessary.

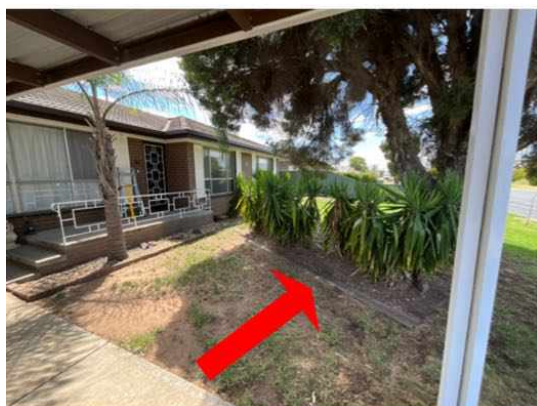
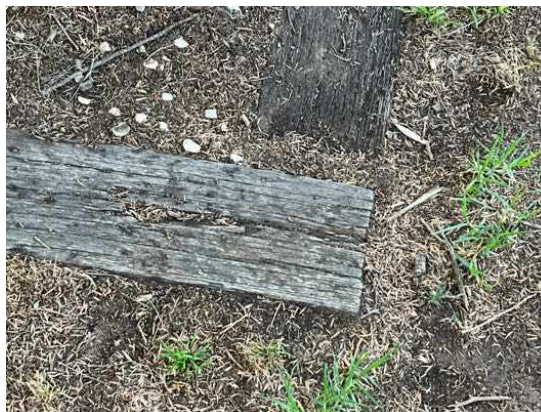
Finding 6.04

Building:	Building 1
Location:	Yard - Front
Finding:	Untreated or non-durable timbers in a hazardous environment
Information:	To reduce the risk of timber pest attack it is essential that timber used in a hazardous environment (e.g. in direct contact with the ground or frequently exposed to damp conditions) is of sufficient durability and/or is adequately preservative treated.

Untreated timbers in direct contact with the ground are likely to develop severe wood rot and/or fungal decay if left unattended creating attraction for subterranean termites to infest the timbers from surrounding areas.

If untreated or non-durable timbers are found to be in a hazardous environment it is highly advised that replacement of these building elements be performed as soon as possible to aid the protection of the property against termite / timber pest attack.

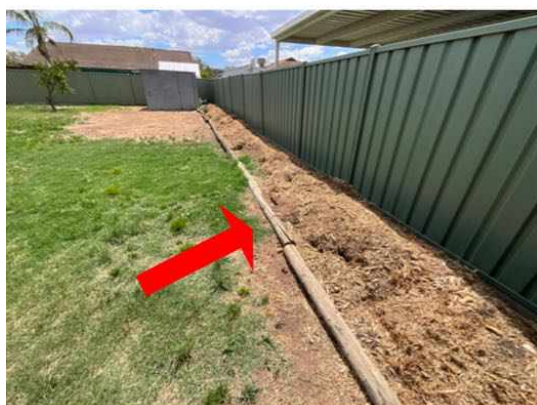
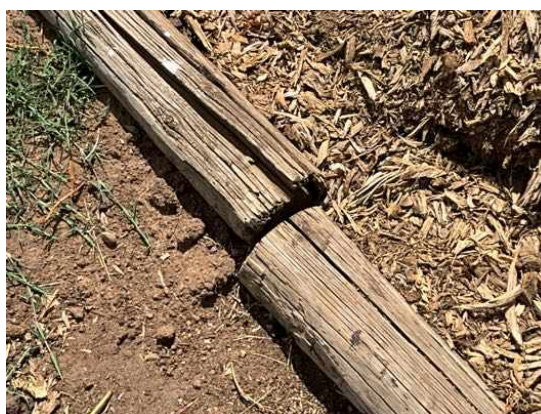
Finding 6.05

Building:	Building 1
Location:	Yard - Back
Finding:	Untreated or non-durable timbers in a hazardous environment
Information:	To reduce the risk of timber pest attack it is essential that timber used in a hazardous environment (e.g. in direct contact with the ground or frequently exposed to damp conditions) is of sufficient durability and/or is adequately preservative treated.

Untreated timbers in direct contact with the ground are likely to develop severe wood rot and/or fungal decay if left unattended creating attraction for subterranean termites to infest the timbers from surrounding areas.

If untreated or non-durable timbers are found to be in a hazardous environment it is highly advised that replacement of these building elements be performed as soon as possible to aid the protection of the property against termite / timber pest attack.

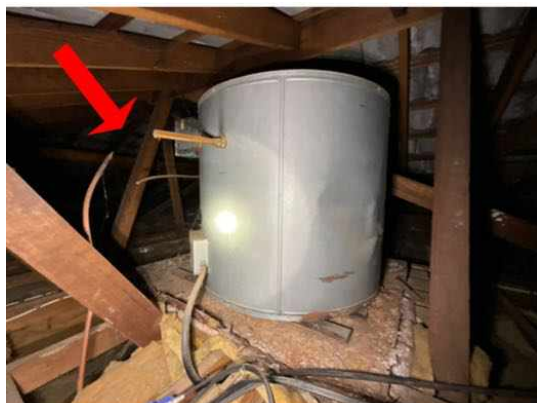
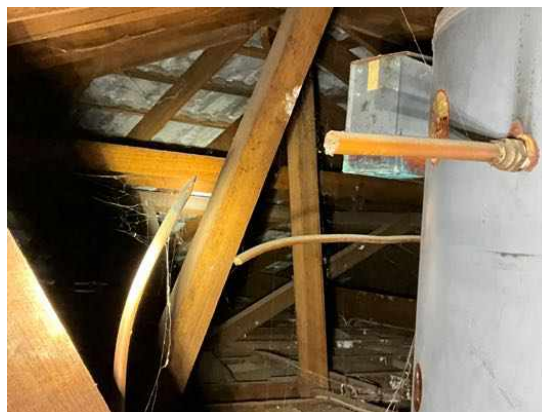
Finding 6.06

Building:	Building 1
Location:	Roof Void
Finding:	Gravity-Fed HWS - Disconnected
Information:	It was noted at the time of inspection that a disconnected gravity-fed hot water

Despite this plumbing structure being unused, it is likely to be storing residual water, and is therefore susceptible to rust and corrosion. If allowed to continue, rust and corrosion is likely to lead to damage to adjoining building elements, and may also make the area susceptible to termite or timber pest activity.

While it is a costly exercise to remove the disused gravity-fed HWS, it is advisable in the short-term future to prevent any further damage to the area. Further consultation with a licensed plumber is required to gain further advice on removal of the structure.

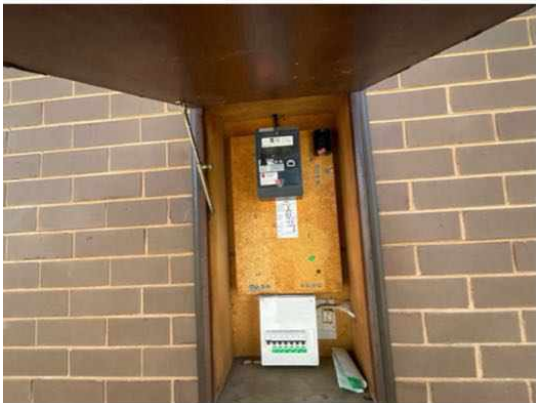
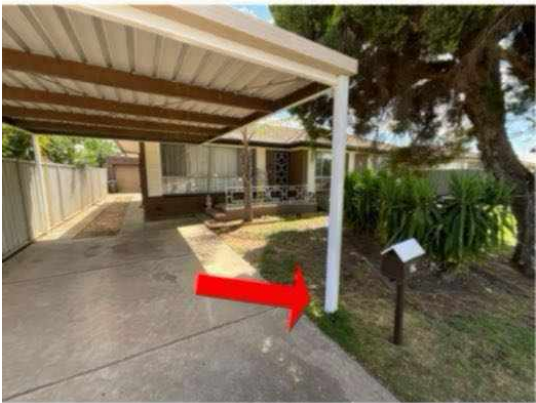
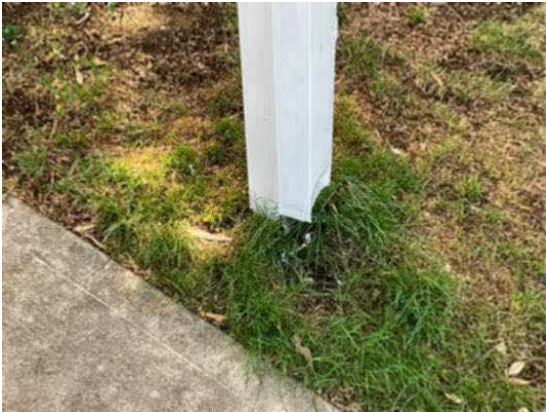
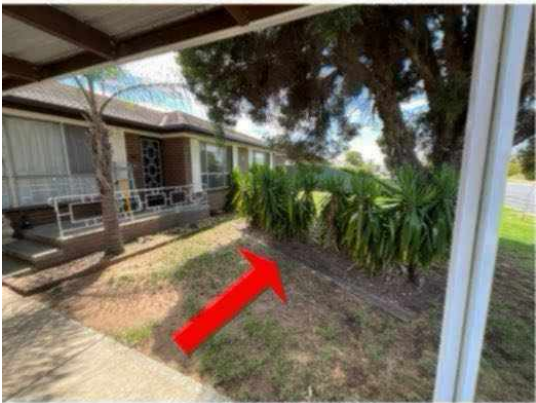
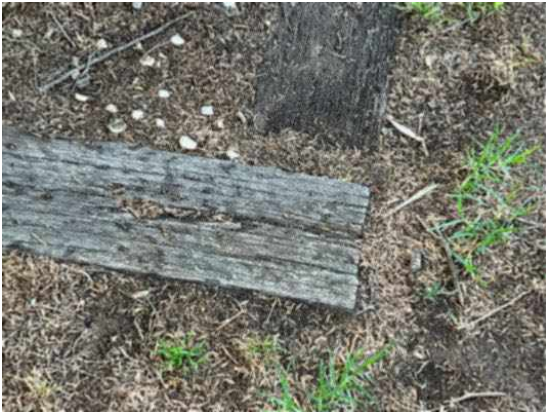
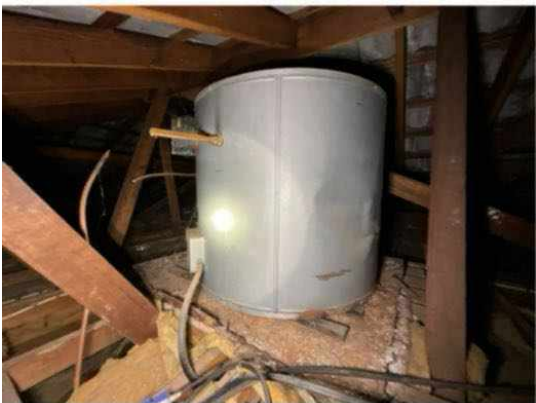
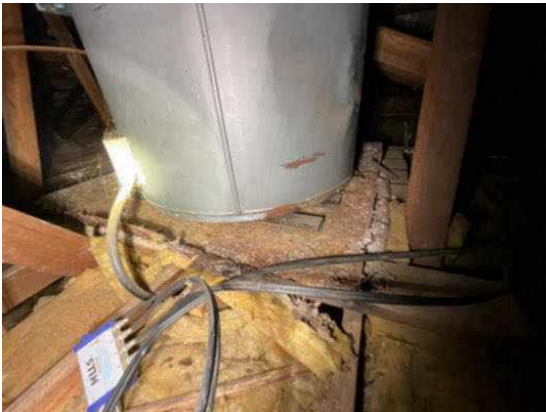
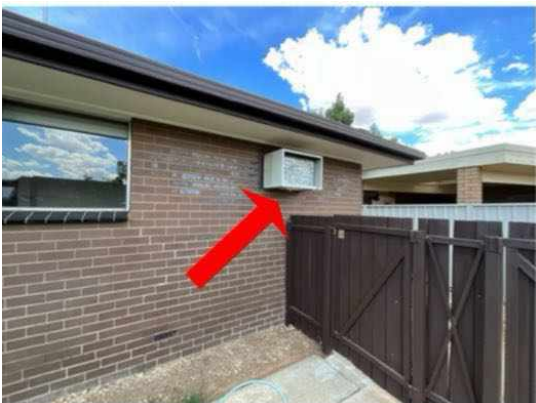
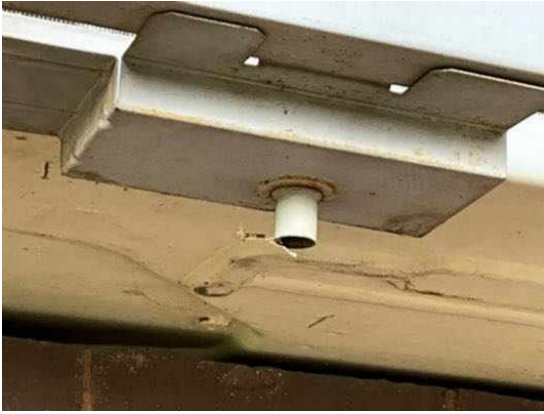
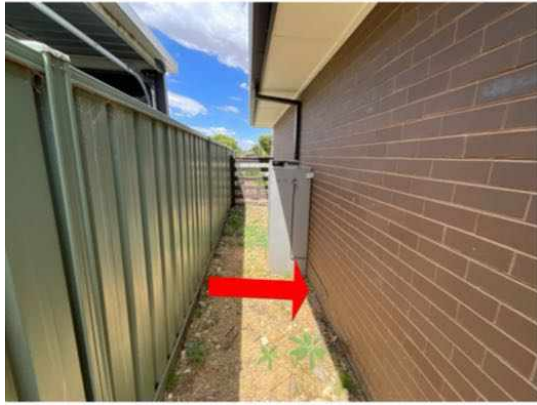
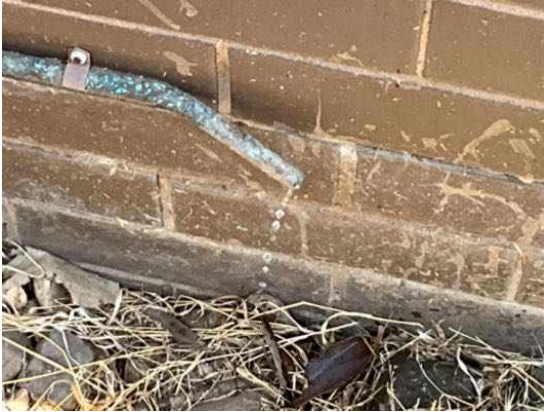
Finding 6.07

Building:	Building 1
Location:	All External Areas
Finding:	Termite Management System - no evidence of a chemical installation
Information:	The application of a post-construction chemical termite barrier is highly recommended for all properties, particularly if live termite activity has been found on the site previously. Such barriers are highly effective in preventing termite attack on any timber building elements throughout the property.

A durable notice should be placed in the switchboard unit to indicate current termite barriers. At the time of inspection, it appeared as though no termite management system has been installed, with no evidence to suggest preventative works taking place.

The client may consider gaining further advice from a pest controller as to the costs and procedures involved with this application. It is recommended that obtaining such advice be a short-term priority.

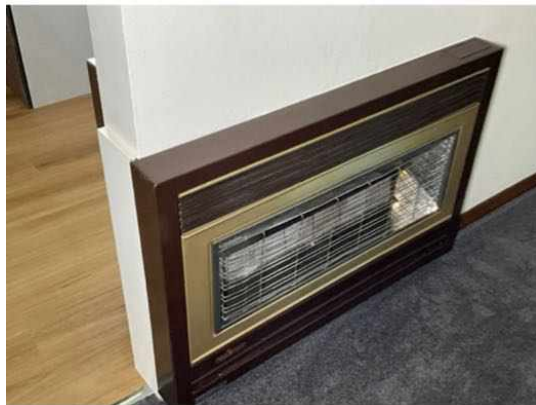
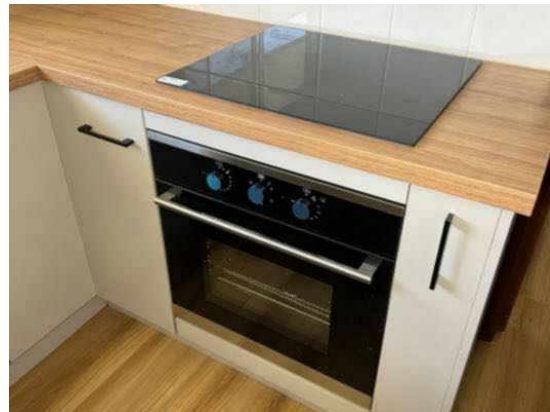
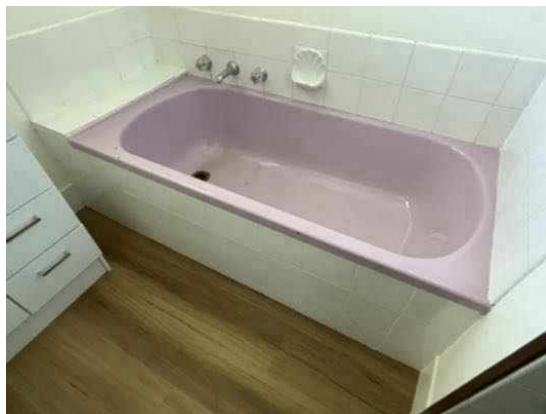
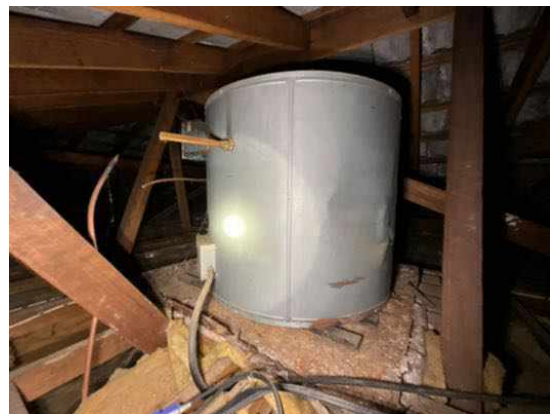
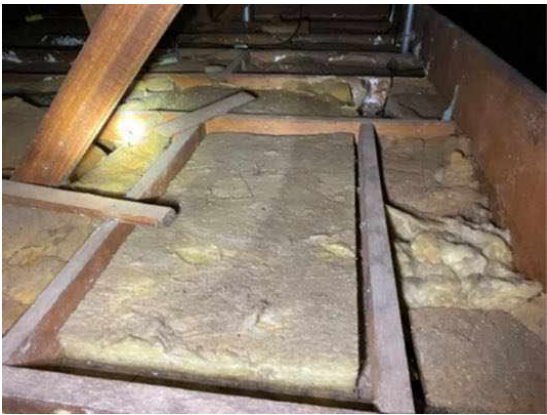
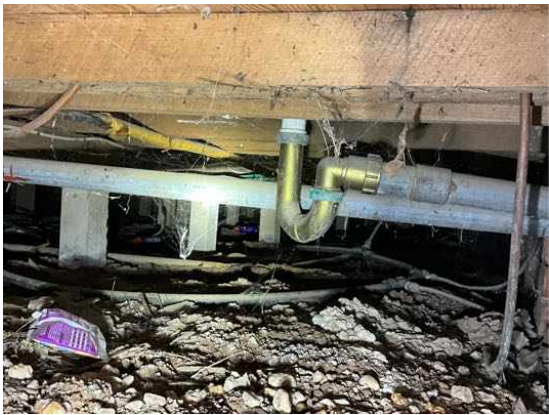
Building: Building 1
Location: All Areas
Finding: Additional Photos - Obstructions and Limitations
Information: These photographs are an indication of the obstructions and limitations which impeded full inspection of the property at the time of inspection. These obstructions can hide an array of defects and should be removed to allow full inspection to be carried out. A re-inspection is recommended once the areas are made accessible.
