# Building and Timber Pest Inspection Report

Inspection Date: Fri, 16 Jan 2026

Property Address: 77 Diamond Parade, Skye VIC 3977,  
Australia

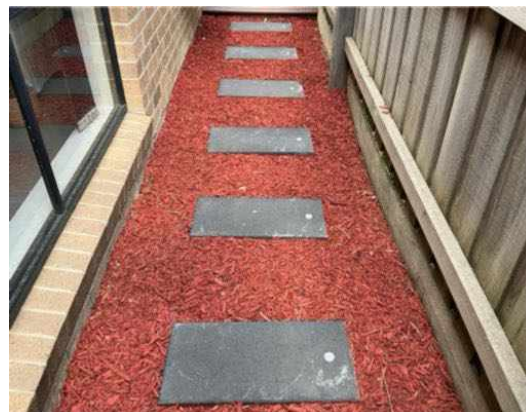
Building: Main Building  
Location: Yards  
Finding: Paving - loose/uneven  
Information: Sections of the external paved area are loose/uneven, creating a potential trip hazard. It appears as though the area has been subject to rough installation.

Where paving creates a trip hazard, personal injury may ensue if due caution is not taken by all persons within this area.

Re-paving of the area is required as soon as possible to remedy this situation. Further consultation with a specialist paver is advised.

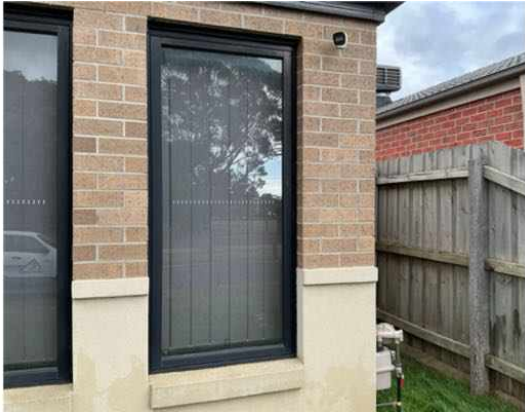
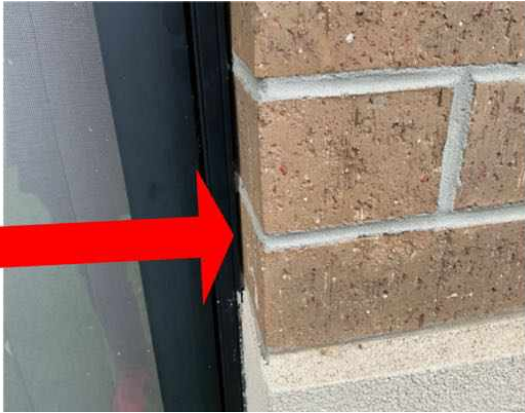
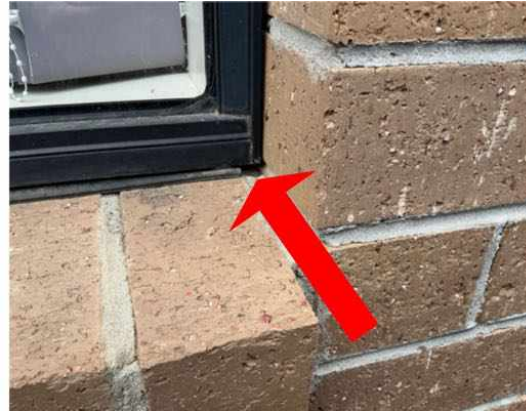
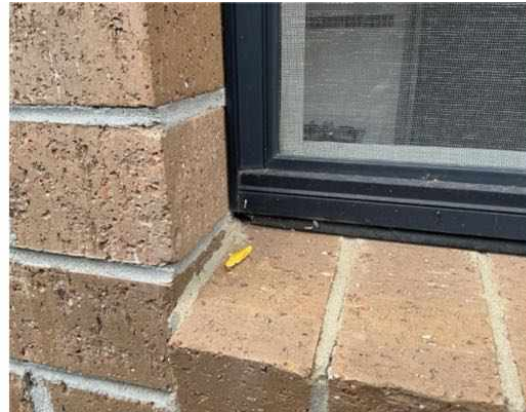
**Finding 3.02**

Building: Main Building  
Location: Various parts of the building  
Finding: A few gaps to the exterior walls/windows  
Information: A few gaps were noticed to some of the exterior walls/windows to the building. These gaps can let in water, drafts, and pests. Overtime moisture ingress may cause damage to internal walls, mould growth, or structural issues. Gaps also reduce the energy efficiency of the property. Recommend engaging a caulker to seal gaps with an exterior grade flexible sealant that is UV and weather resistant to reduce the risk of pest/water penetration to the building as soon as possible.

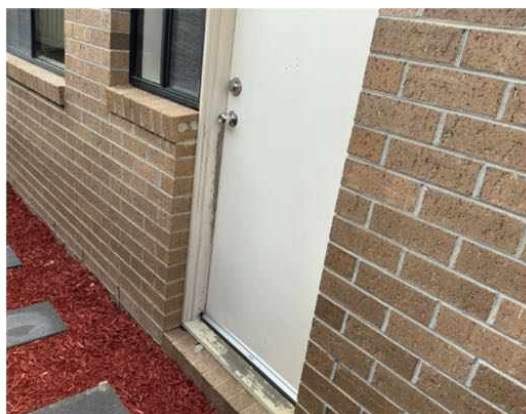
### Finding 3.03

Building:	Main Building
Location:	Laundry and garage
Finding:	External painting deteriorated
Information:	Parts of the external paintwork has been neglected and requires attention to prepare and re-paint.

Whilst incomplete or missing paint finish is generally an appearance defect, it can also lead to the development of secondary building defects over time. Incomplete areas of paint finish expose the area to moisture, potentially accelerating the deterioration of underlying building materials.

Degraded paint finishes should be sanded back, filled, leveled and painted, as applicable. Where inadequate or missing paint protection has led to the deterioration of the associated building element, repair and/or replacement of this building element may be required.

A painting contractor should be appointed as soon as possible to perform necessary works to aid the appearance of the affected area and to ensure the area is protected against further deterioration. Alternatively, the homeowner following manufacturer instructions may perform these works.

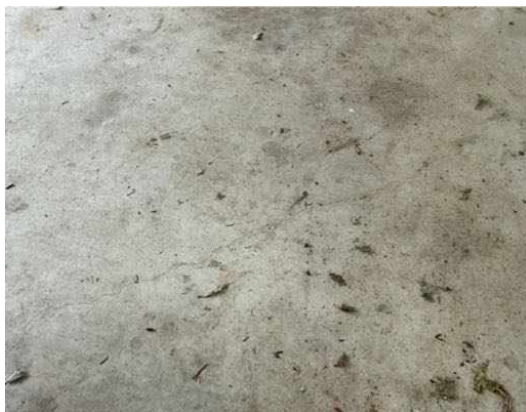
### Finding 3.04

Building:	Main Building
Location:	Garage
Finding:	Garage Cracking - External Concrete Paving Damage Category 1 - Fine (less than 2mm)
Information:	Fine cracks were identified in the garage concrete paving. Although fine cracks are quite noticeable, they are often only considered to be an appearance defect, and usually do not indicate any structural damage. To be considered a Category 1 or fine crack, the crack is found to be less than 2mm in width.

Generally the cause of a hairline crack in existing concrete paving such as driveways and pathways is indicative of the expansion and contraction of the concrete. Such causes are generally due to environmental factors, such as moisture levels, weather conditions, root systems of nearby trees or the soil types on which they are laid.

Fine cracks may also be due to poor original installation of the concrete. Factors such as poor compaction of the sub surface and/or inadequate reinforcing of the slab may create cracking and other secondary defects.

Monitoring of all cracking should be conducted frequently. Always contact a building inspector should cracks widen, lengthen, or become more numerous.

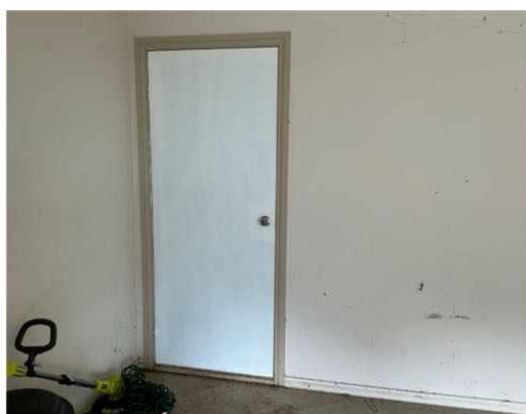
### Finding 3.05

Building: Main Building  
 Location: Garage  
 Finding: Door - Binding/jamming garage  
 Information: Binding and/or jamming of the garage door is evident during standard operation. This defect inhibits the functionality of the affected door as well as creating potential for secondary defects to associated building elements, such as damage to the floor covering.

A door that binds to flooring or to the associated door frame may have several causes, ranging from minor defects, such as poor installation of the door or deteriorated hinges.

For minor causes, a qualified carpenter or general handyperson should be appointed to perform minor rectification works at client discretion.

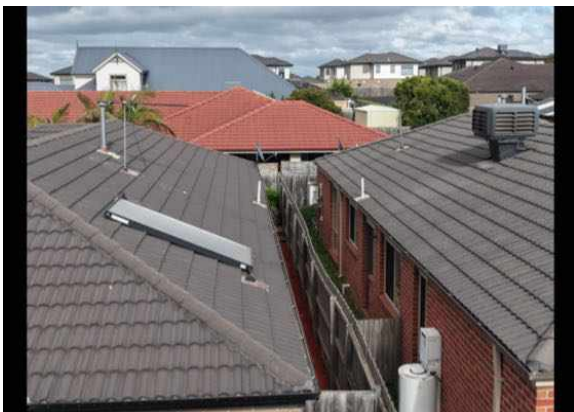
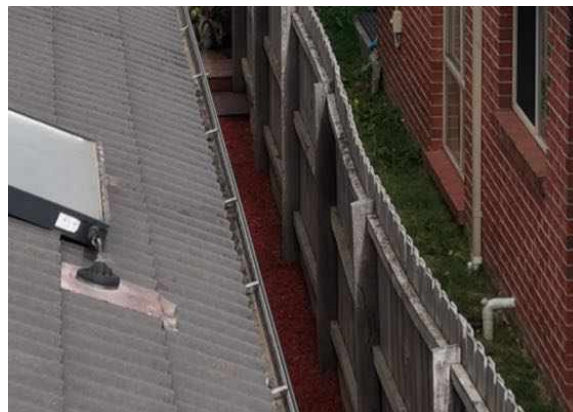
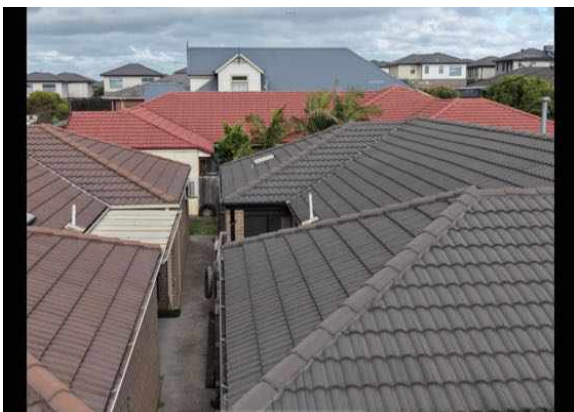
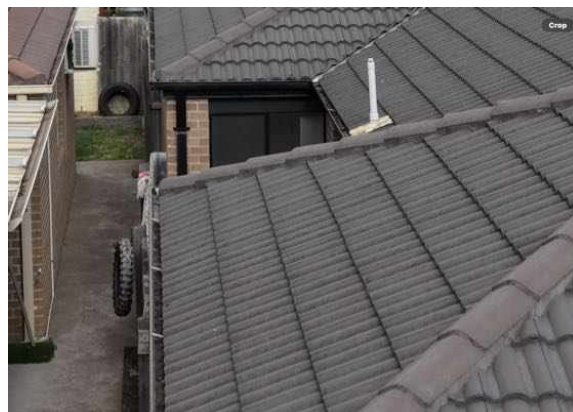
### Finding 3.06

Building: Main Building  
 Location: Roof Exterior  
 Finding: Gutters -Partially Blocked with debris  
 Information: It was noticed on inspection that some of the gutters were partially blocked with

Blocked gutters are likely to lead to high levels of moisture in the affected areas. Such moisture will not only cause rust and decay of the associated building materials, but can also provide conditions that are conducive to termite and timber pest activity. Blockages in gutters should therefore be removed immediately to ensure dry conditions are maintained.

Consult a Licensed Plumber for further specific advice on remedial works that may be required. In the interim, it is highly advised that blocked gutters be removed by the homeowner or a general handyperson as a matter of urgency.

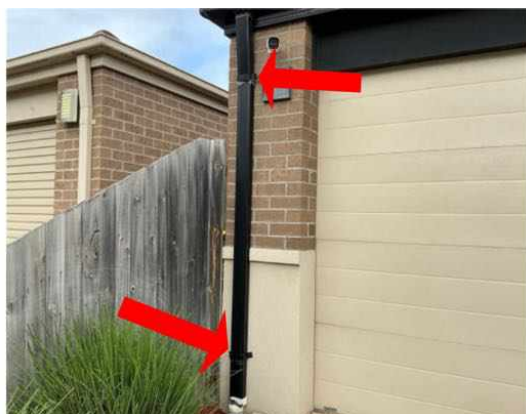
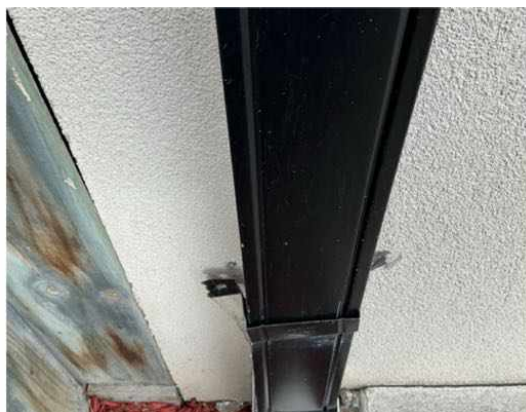
Building:	Main Building
Location:	Exterior walls - front
Finding:	Down pipe clips loose
Information:	The down pipe clips to the front left of the building have come loose due to poor installation.

It is recommended that a plumber be appointed to further inspect the area and to install/repair clips where necessary at the owners discretion.

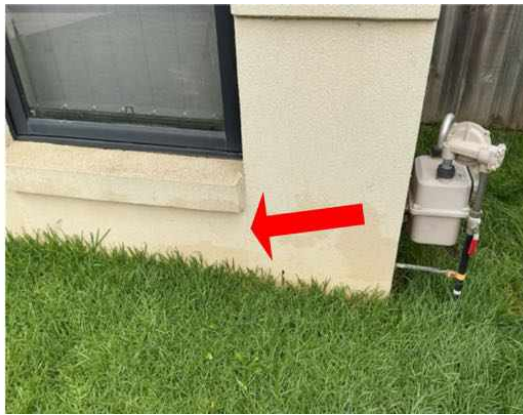
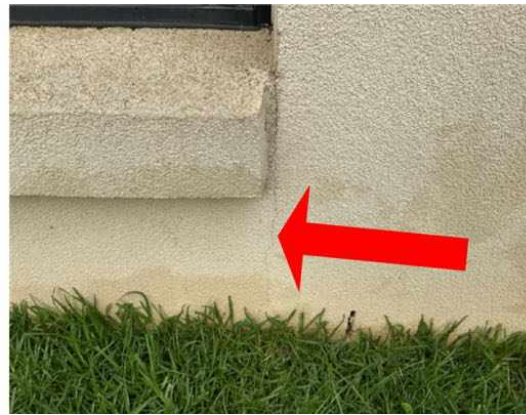
### Finding 3.10

Building:	Main Building
Location:	Exterior walls - front
Finding:	Cracks to external render - Category 1
Information:	It has been observed that cracking to external rendered surfaces has occurred under the front window. The degree of damage falls within Category 1, described as fine cracks that do not need repair and which are less than 1.0mm in width limit. Recommend engaging a renderer to repair to make more aesthetic at the owners discretion.

Damage of this category is not considered a defect for rectification. Always contact your building inspector should cracks widen, lengthen, or become more numerous.

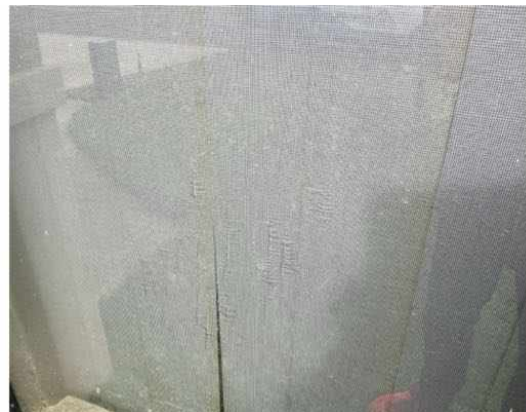
### Finding 3.11

Finding: Flyscreen damaged

Information: The living room flyscreen was found to be damaged at the time of inspection. This can happen overtime with deterioration in harsh weather conditions or accidental impact damage.

Where not replaced, damaged flyscreens allow pest and insect ingress into the adjoining room/s. It is advised that all damaged flyscreens be replaced in order to ensure the full function of all building structures.

A general handyperson may be appointed to replace flyscreens at the discretion of the client.

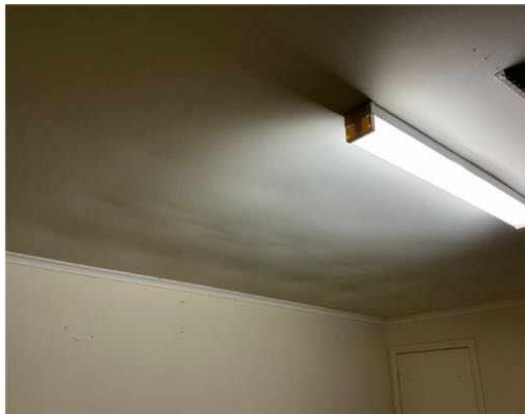
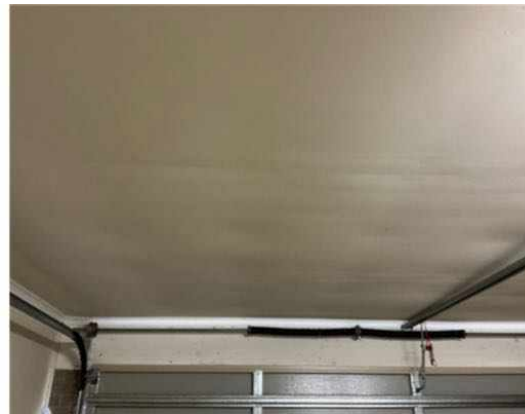
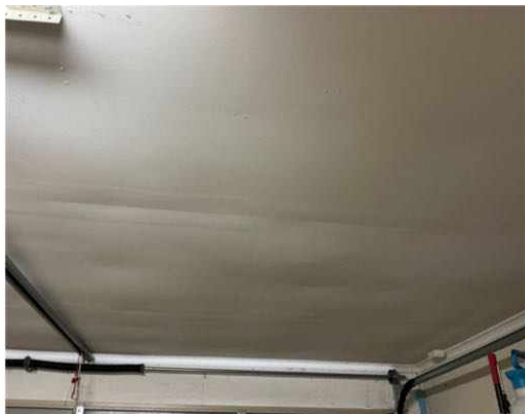
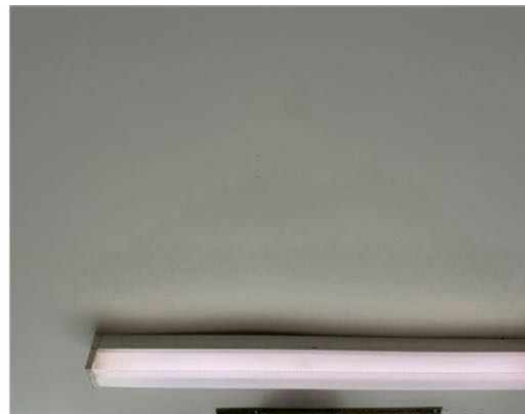
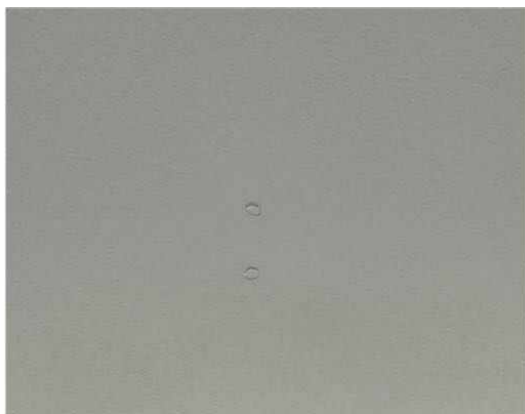
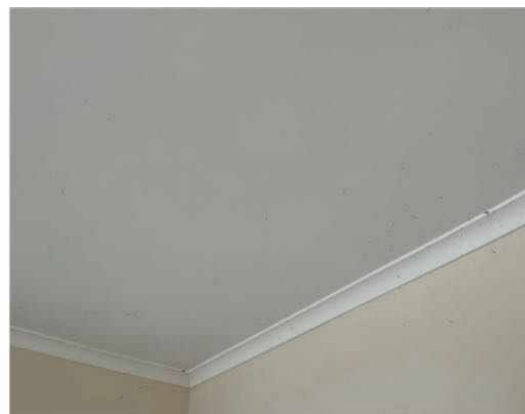
### Finding 3.12

Information: Sections of the garage ceiling were found to be sagging, and some of the nails were popping at the time of inspection. Sagging to the fixed ceiling structure generally

indicates that the building materials/fixings (e.g. nails or glue) have become loose and require reattachment. This is quite a common defect in garages of this age. It is suspected that internal plaster is used where wet board plasterboard should be used and it gets affected by the moisture and condensation in the air. There is normally no insulation in the garage ceiling allowing the moisture to accelerate the deterioration.

Where sagging is evident repairs such as re-gluing or replacing of ceiling sheets, may be required. Such works may be performed by relevant tradespeople, such as plasterers and painters.

The appropriate action should be taken by the client as soon as possible to ensure that any potential further damage is limited.

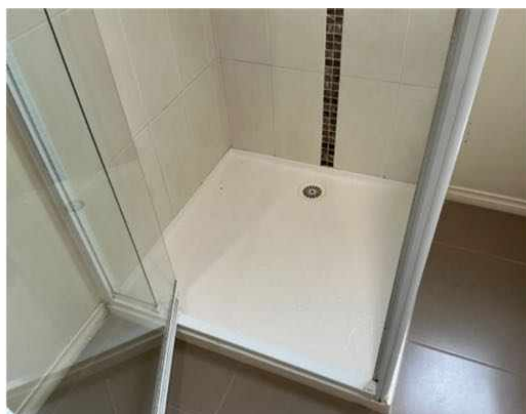
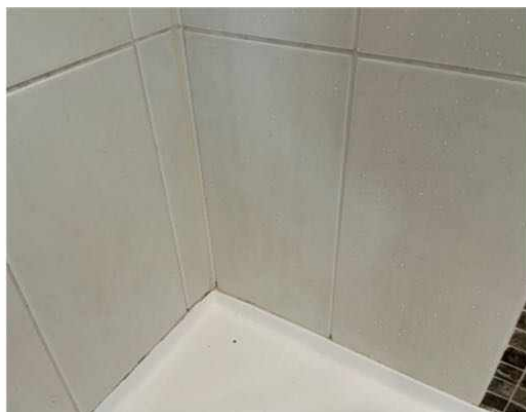
### Finding 3.13

Building:	Main Building
Location:	Ensuite - Master
Finding:	Bathroom Sealant and grouting - Missing or damaged
Information:	It was noted on inspection that sealant or grout is degraded to the tiled shower alcoves and or other areas of the bathrooms.

Different materials and floor areas move at different rates, generally causing cracking to grout or sealant at this point. A flexible sealant is required to allow for expected expansion and contraction, while keeping the joint water tight and protective of all associated building materials.

Flexible and mould resistant materials should be applied to affected areas to prevent any subsequent water damage that is likely to occur. Regular maintenance and replacement of damage or missing or damaged sealant and grout is highly recommended to the wet areas, as this is a regular wear and tear defect. Sealant and grouting in areas that come into regular contact with water should be maintained for the long term care of your property.

A sealant specialist or tiling contractor should be appointed to complete these works as soon as possible

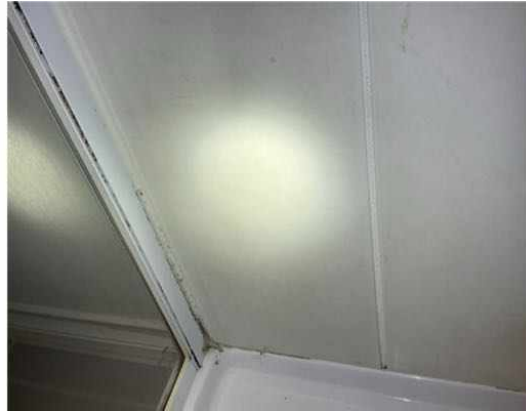
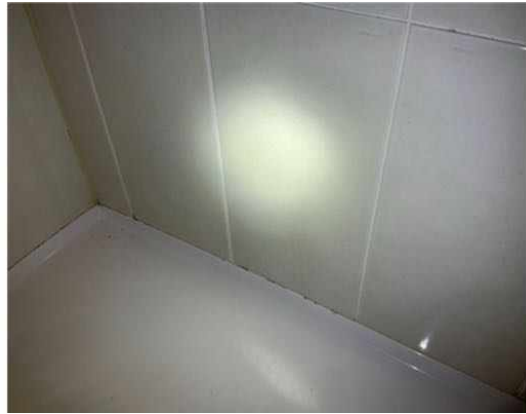
### Finding 3.14

Building:	Main Building
Location:	Bathroom
Finding:	Bathroom Sealant and grouting - Missing or damaged
Information:	It was noted on inspection that sealant or grout is degraded to the tiled shower alcoves and or other areas of the bathrooms.

Different materials and floor areas move at different rates, generally causing cracking to grout or sealant at this point. A flexible sealant is required to allow for expected expansion and contraction, while keeping the joint water tight and protective of all associated building materials.

Flexible and mould resistant materials should be applied to affected areas to prevent any subsequent water damage that is likely to occur. Regular maintenance and replacement of damage or missing or damaged sealant and grout is highly recommended to the wet areas, as this is a regular wear and tear defect. Sealant and grouting in areas that come into regular contact with water should be maintained for the long term care of your property.

A sealant specialist or tiling contractor should be appointed to complete these works as soon as possible

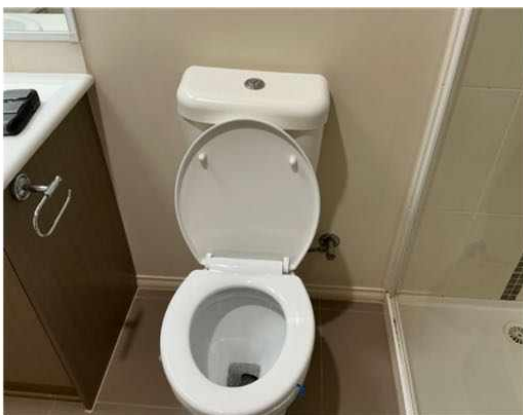
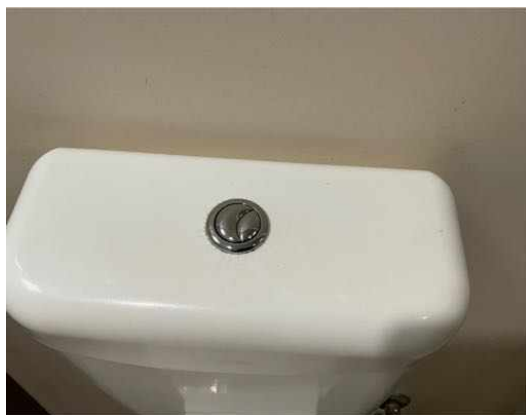
### Finding 3.15

Finding: Toilet button broken

Information: The bathroom toilet button was found to be broken at the time of inspection. It is suspected that this defect has developed due to general aging of the toilet.

It is recommended that the toilet be repaired by a licensed plumbing contractor.

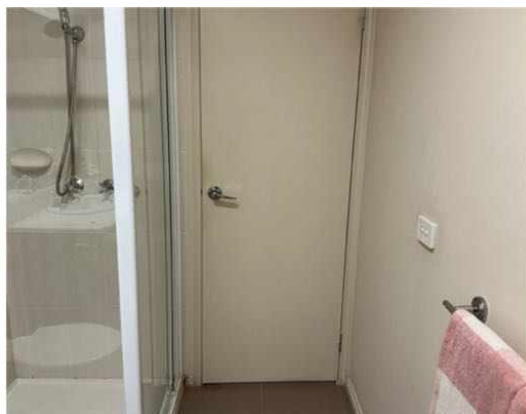
### Finding 3.16

Building: Main Building  
Location: Bathroom  
Finding: Door - Binding/jamming bathroom  
Information: Binding and/or jamming of the bathroom door is evident during standard operation. This defect inhibits the functionality of the affected door as well as creating potential for secondary defects to associated building elements, such as damage to the floor covering.

A door that binds to flooring or to the associated door frame may have several causes, ranging from minor defects, such as poor installation of the door or deteriorated hinges.

For minor causes, a qualified carpenter or general handyperson should be appointed to perform minor rectification works at client discretion.

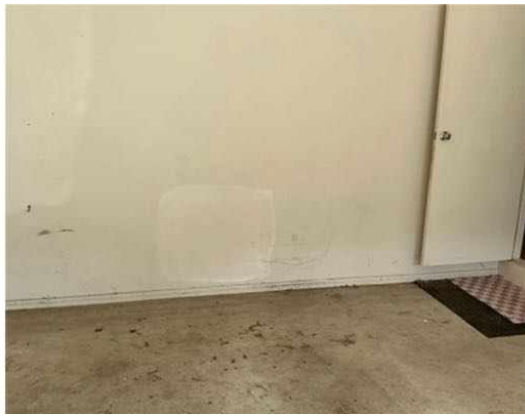
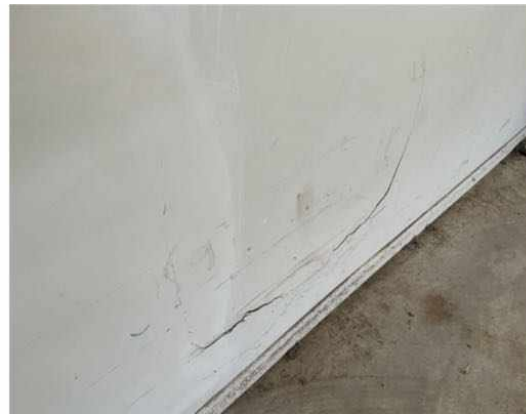
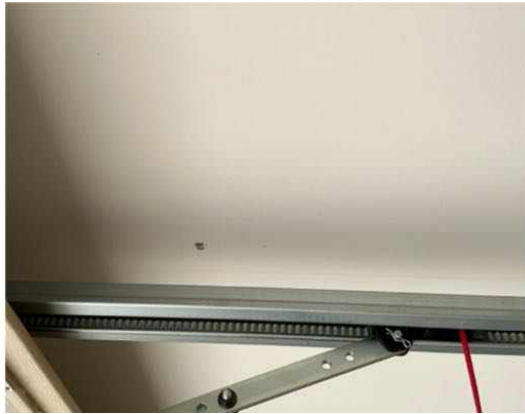
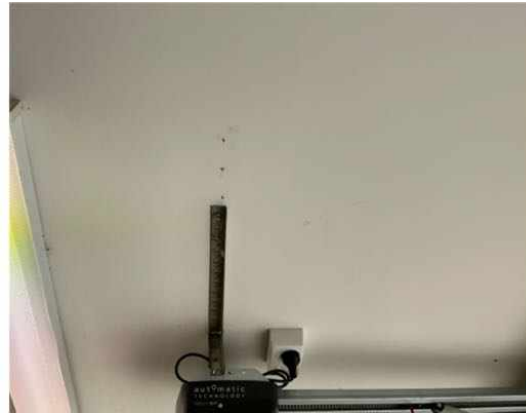
### Finding 3.17

Building: Main Building  
Location: Garage  
Finding: Plaster - Damaged  
Information: Evidence of damage was identified to various parts of the garage plaster by general wear and tear or impact damage. Recommend engaging a plasterer to repair to make more aesthetically pleasing at the owners discretion.

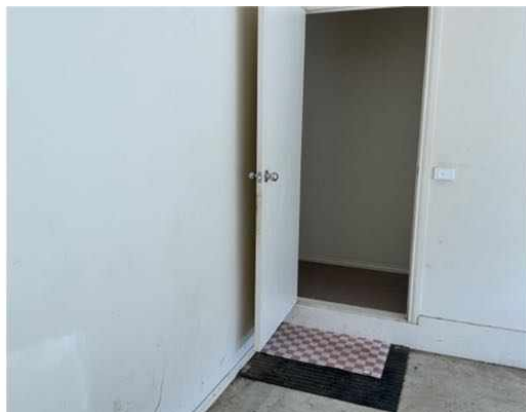
### Finding 3.18

Building:	Main Building
Location:	Garage
Finding:	Garage Door stop missing
Information:	The garage door stop is missing and inadequate to stop the door handle from damaging the wall. Although some building elements may seem irrelevant or unnecessary, all building elements play a key role in the operation and function of the overall structure and its performance.

Re-installation or replacement of the door stop is advised as soon as possible to prevent any subsequent damage to the door or associated structures. A general handyman may be appointed to perform these works at client discretion.

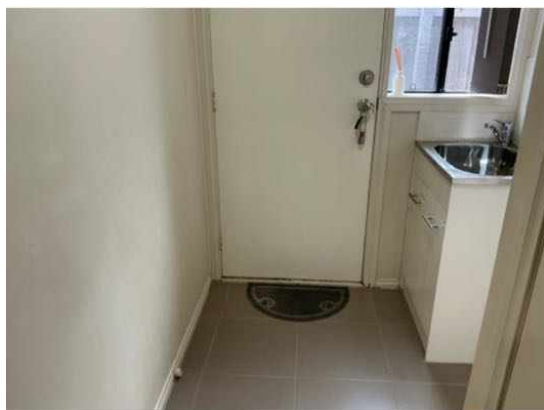
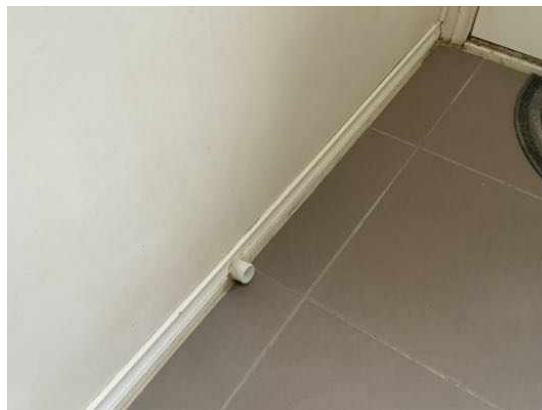
### Finding 3.19

Building:	Main Building
Location:	Laundry
Finding:	Laundry-Door stop inadequate
Information:	The laundry door stop is inadequate to stop the door handle from damaging the wall. Although some building elements may seem irrelevant or unnecessary, all building elements play a key role in the operation and function of the overall structure and its performance.

Re-installation or replacement of the door stop is advised as soon as possible to prevent any subsequent damage to the door or associated structures. A general handyman may be appointed to perform these works at client discretion.

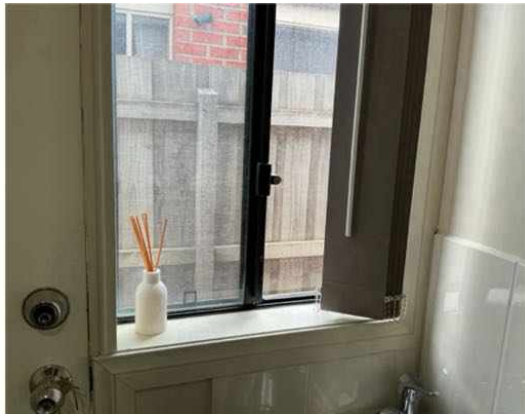
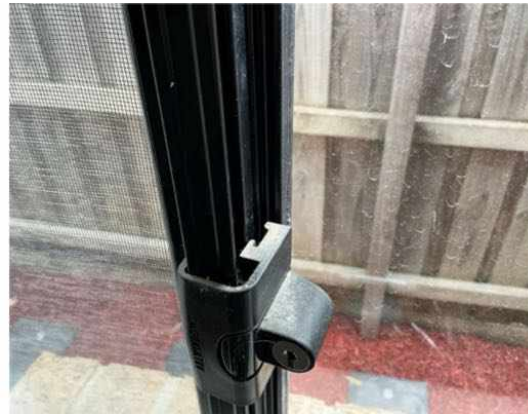
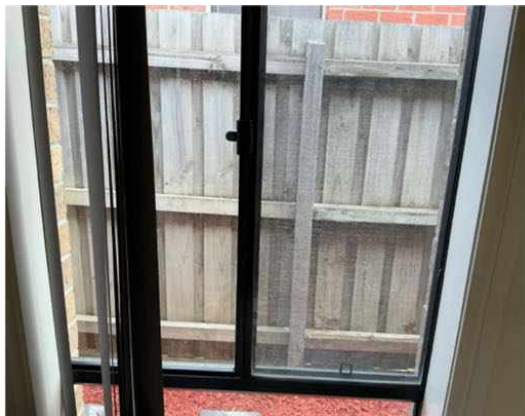
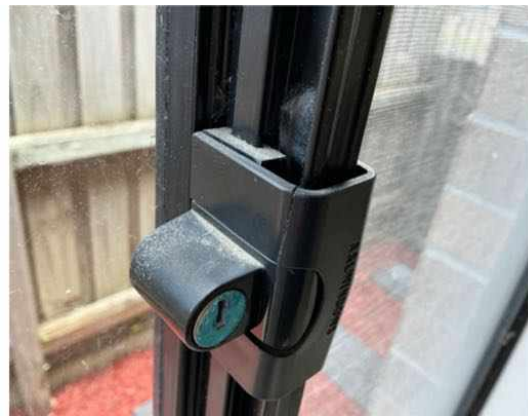
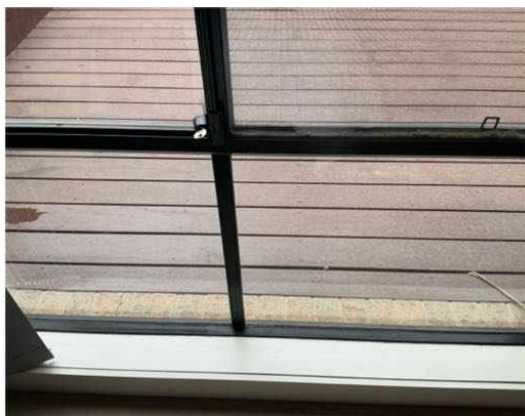
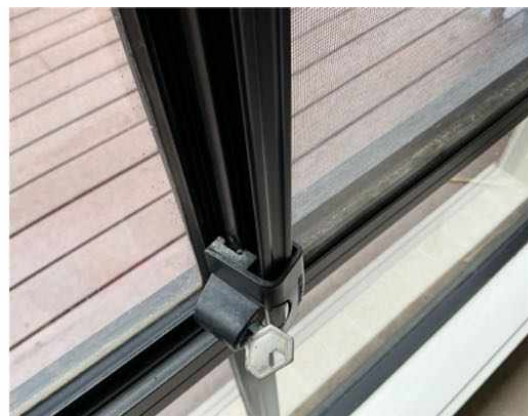
### Finding 3.20

Building:	Main Building
Location:	Various windows
Finding:	Broken window handles
Information:	Various window handles were broken at the time of inspection. Recommend engaging a carpenter to repair/replace to make more operational.

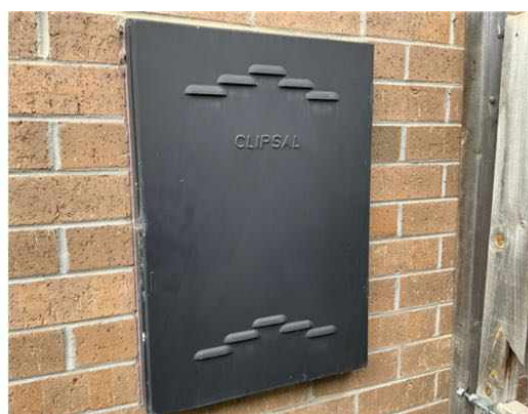
Building:	Main Building
Location:	All External Areas
Finding:	No Termite Management System - no evidence of a chemical installation
Information:	The application of a post-construction chemical termite barrier is highly recommended for all properties, particularly if live termite activity has been found on the site previously. Such barriers are highly effective in preventing termite attack on any timber building elements throughout the property.

A durable notice should be placed in the switchboard unit to indicate current termite barriers. At the time of inspection, it appeared as though no termite management system has been installed, with no evidence to suggest preventative works taking place.

The client may consider gaining further advice from a pest controller as to the costs and procedures involved with this application. It is recommended that obtaining such advice be a short-term priority.

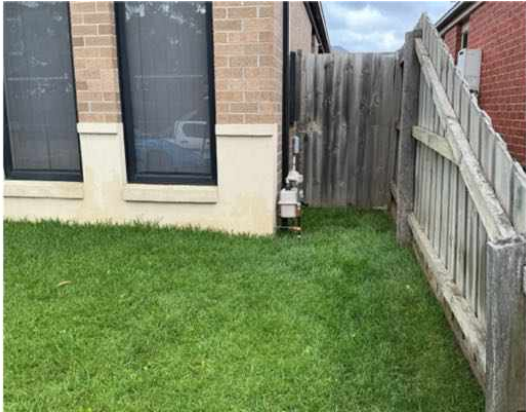
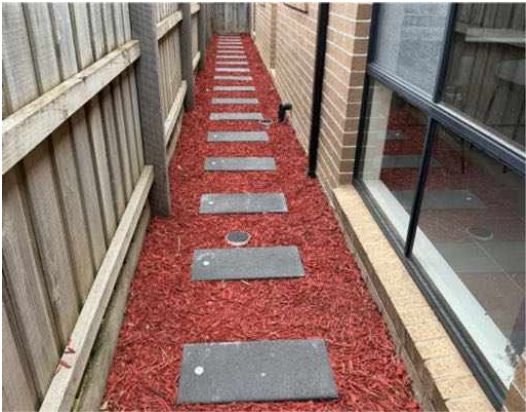
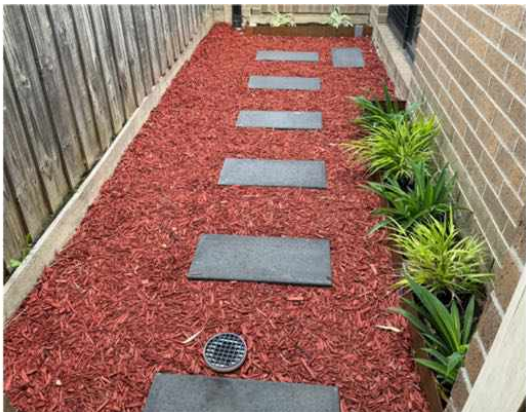
Building: Main Building  
 Location: Yards  
 Finding: Site drainage - poor/inadequate  
 Information: The site drainage to parts of the yards was found to be inadequate at the time of inspection, creating potential for subsequent water damage to associated building elements. Excessive moisture will attract termites.

Where site drainage is inadequate, installation of an Agricultural (Aggie) Drain may be required. A qualified plumber should be appointed to further inspect the property and perform any remedial works as necessary. Water damage and secondary defects are likely to occur if left unmanaged.

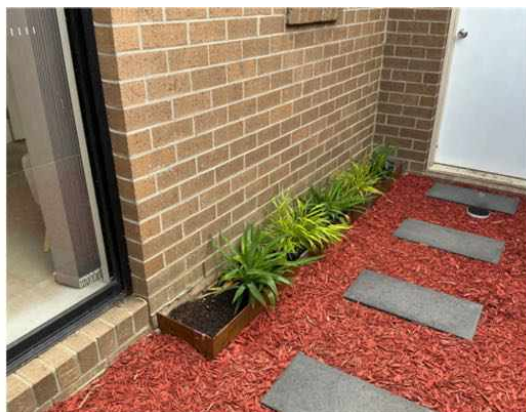
**Finding 6.04**

Building: Main Building  
Location: Yard -Side  
Finding: Garden Beds Conditions Conducive to Termites

Information: Garden beds were found to be evident in close proximity to the building. Garden beds immediately adjacent to the perimeter of the building block the visual inspection of these areas, providing a concealed termite entry point.

These garden beds can include untreated timber, and with a combination of moisture from watering hosing can make conditions conducive to termite activity and termite ingress.

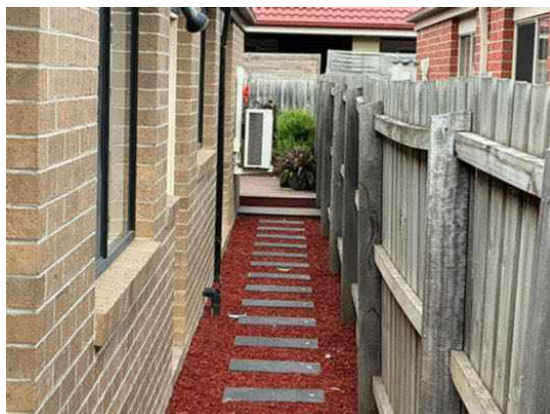
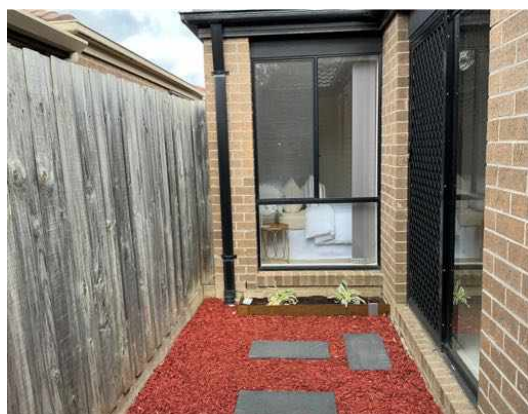
### Finding 6.05

Building: Main Building  
 Location: Various parts of the building  
 Finding: Bridging attachments to buildings  
 Information: Bridging occurs when items against a building provide a concealed entry point for termites into the building or by passing around a termite management system.

Building attachments of this nature need to be frequently inspected for termite activity by a qualified inspector.

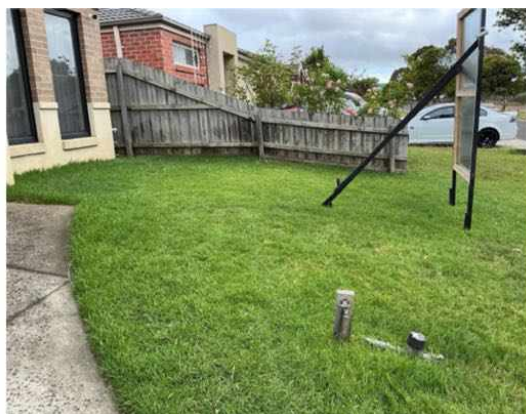
### Finding 6.06

Building:	Main Building
Location:	Various parts of the building
Finding:	In ground contact
Information:	Any timbers in direct ground contact provide opportunity for concealed termite entry and are likely to be subject to premature rot and decay as the soil retains moisture or damp conditions against the timbers.

Remove untreated timber that is in direct contact with external grounds. Consider replacement with more durable materials i.e. treated timber or non timber elements. Frequent pest inspections are advised to readily identify any termite activity in these areas.

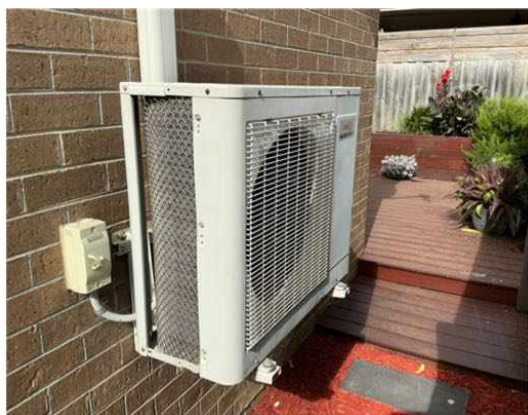
### Finding 6.07

Building:	Main Building
Location:	Yard - Back
Finding:	Air conditioning unit overflow -Not plumbed for drainage
Information:	The overflow to the air conditioning unit is not plumbed or connected to suitable drainage, which has resulted in the surrounding area becoming excessively damp. These damp conditions can lead to secondary defects such as rot, rust or corrosion of associated building elements, the formation of fungal decay, or even the creation of potential slip hazards. When coupled with poor site drainage, pooling of water may also attract termite activity to this area. It is highly recommended that a qualified plumber be appointed to install adequate drainage to the overflow. These

works will ensure that the area remains dry and free of any secondary defects.

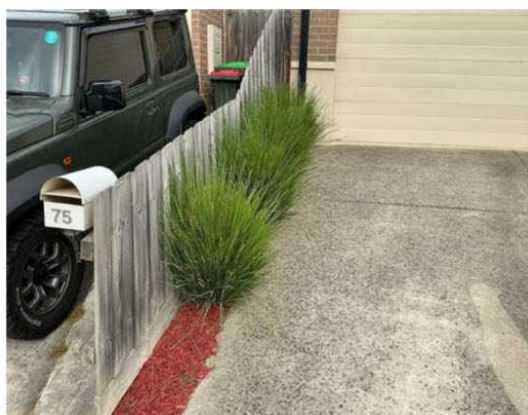
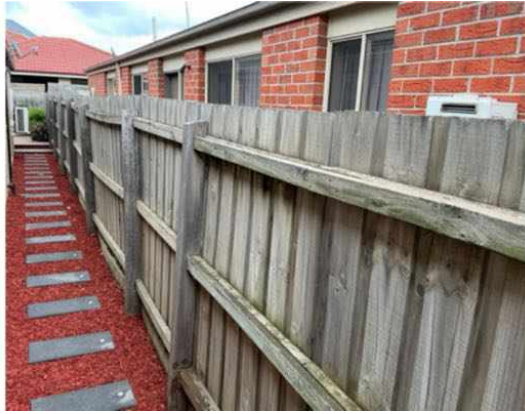
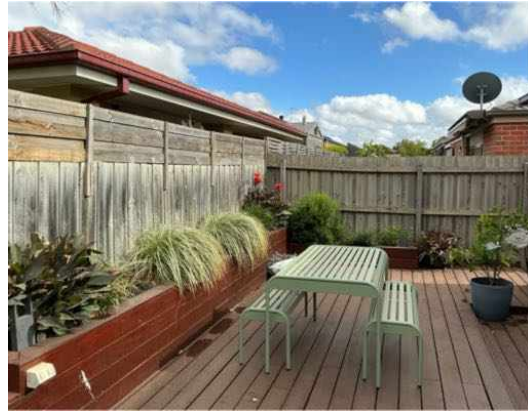
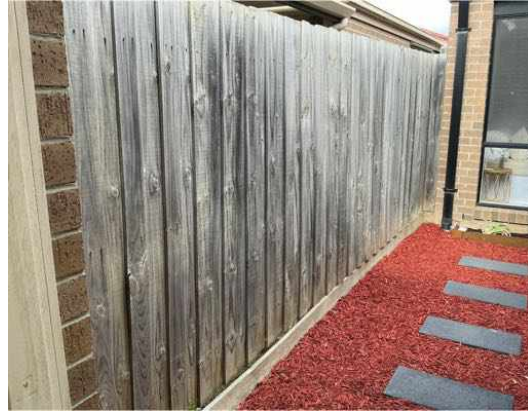
### Finding 7.01

Building: Main Building  
 Location: Yards  
 Finding: Fencing - wood rot-fungal decay  
 Information: It was noted at the time of inspection that sections of the fencing to the property have deteriorated and have fungal decay/wood rot present. Typically fencing deteriorates due to age and or wear, rot and or rust which is generally expected for a structure of this age, due to prolonged exposure to weather conditions. Sometimes inadequate installation or maintenance can be to blame.

If left unattended, it is likely that further damage will occur. It is suspected that repair of several elements of the fencing may be required however replacement may be a consideration of the client also.

A licensed fencing contractor should be appointed to provide further advice and perform rectification works as necessary.
