# Building and Timber Pest Inspection Report

Inspection Date: Thu, 9 Apr 2026

Property Address: 1 Collins St, Rushworth VIC 3612,  
Australia

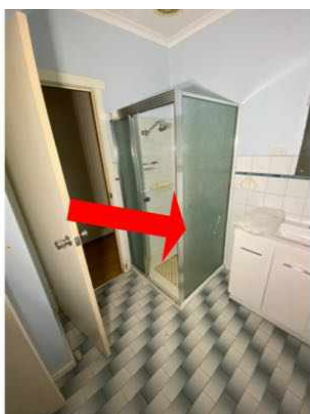
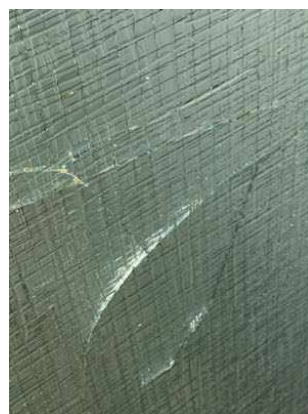
Building:	Building 1
Location:	Bathroom
Finding:	Shower screen - Cracked
Information:	Cracking was evident to the shower screen at the time of inspection, which is suspected to be due to accidental impact damage.

While the cracking appears to be minor, any further impact may lead to additional cracking and or shattering of the shower screen, creating a potential safety hazard in the area. Further damage would almost certainly necessitate replacement of the entire shower screen.

A qualified glazier is required to repair the shower screen as soon as possible. Please be advised that any persons coming into contact with the cracked shower screen should do so with due caution to avoid any personal injury that may ensue.

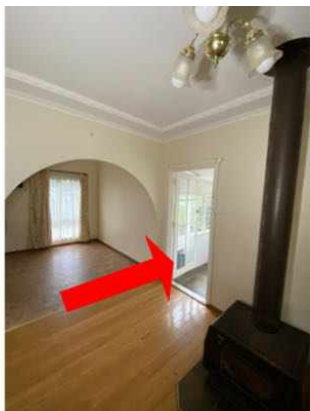
#### Finding 1.02

Building:	Building 1
Location:	Entry
Finding:	Window - Cracked
Information:	Cracks were identified in the window in this area. Cracking in windows is generally the result of impact damage, and is likely to develop further when left unmanaged.

The likelihood of this windowpane further cracking and shattering is increased exponentially, providing a safety hazard in the area. The cracked window also impairs the weather tightness of the building, creating potential for minor water leaks.

A qualified glazier is required to repair the window as soon as possible. Depending on

the extent of the cracking, replacement of the window may be required. Please be advised that any persons coming into contact with the cracked window should do so with due caution to avoid any personal injury that may ensue.

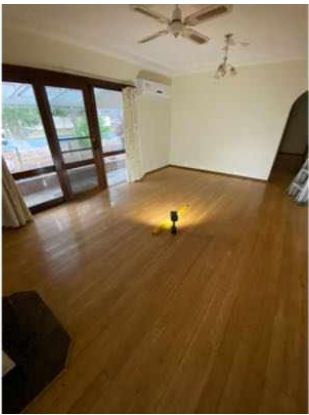
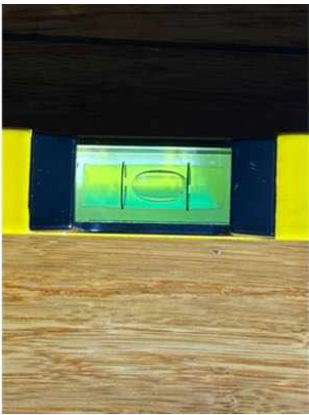
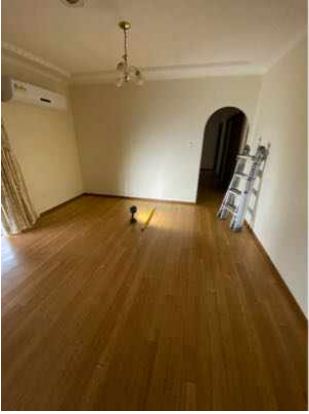
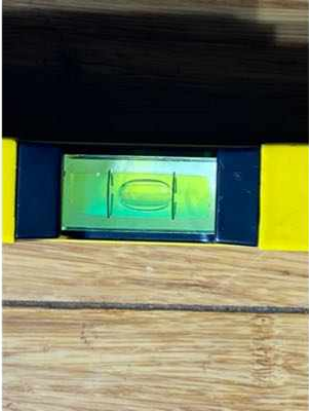
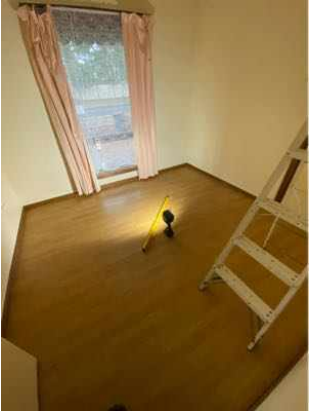
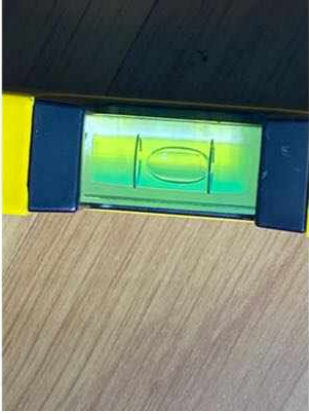
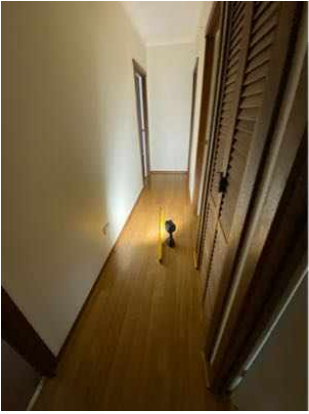
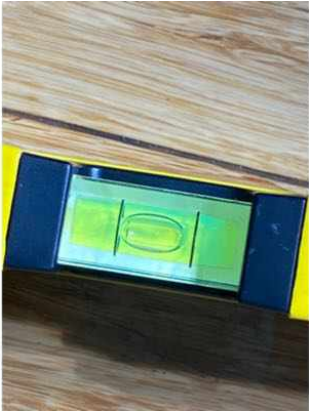
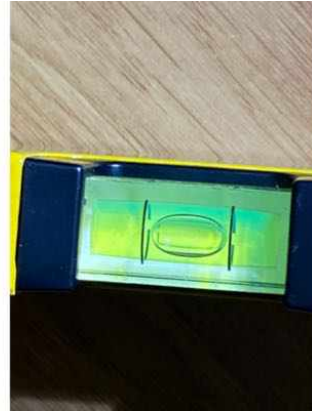
### Finding 3.01

Building: Building 1  
 Location: All Internal Areas  
 Finding: Flooring - Uneven  
 Information: The internal flooring in this area is out of level and uneven. Uneven flooring is likely to indicate minor defects such as expected movement of the foundations of the property, but may also indicate subsidence of the associated subfloor stumps.

It is advised that the flooring be closely monitored to identify any further movement. Where flooring remains relatively unchanged for an extended period of time (i.e. several months), it is likely that this defect has been caused by expected movement of the foundations of the property.

However, where flooring is uneven further, potentially invasive inspection of the subfloor structures and stumps in this area is required. In this case, works to repair are likely to be required, and would be carried out by a registered builder specialising in re-stumping.

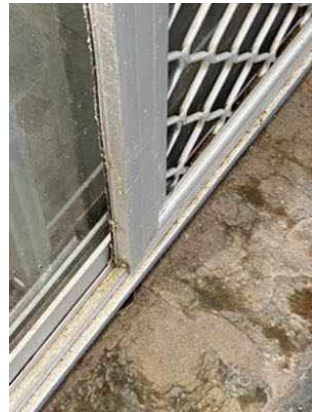
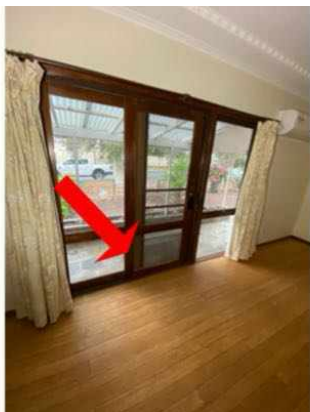
### Finding 3.02

Building: Building 1  
 Location: Living, entry  
 Finding: Door- Stiff to slide  
 Information: The door in this area was jammed and difficult to slide along the associated tracks at the time of the inspection. Restricted function of the affected door may pose as a potential safety hazard if required for emergency egress from the building.

Generally, factors such as general age of the building element and a lack of maintenance are the usual causes for this type of defect.

Replacement of door hardware or tracks may be required, as well as minor repairs and cleaning. A registered builder or general handy person will be required to repair the affected doors.

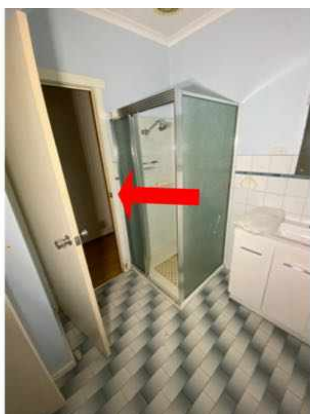
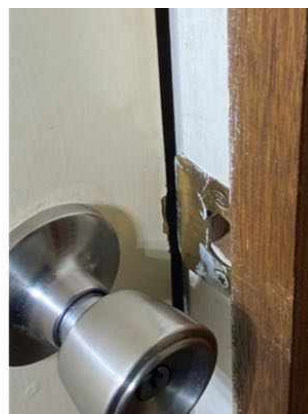
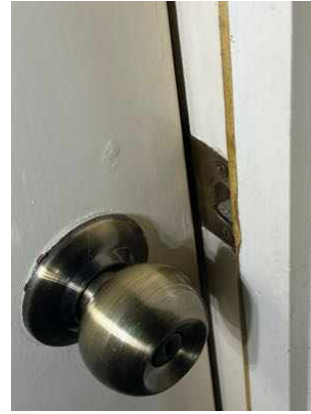
### Finding 3.03

This is a common defect and is expected in a property of this age, whether being due to substandard installation or general deterioration of the door hardware.

Readjustment of the striker plate is recommended at client discretion. Works such as these can be completed by a general handyman or qualified carpenter.

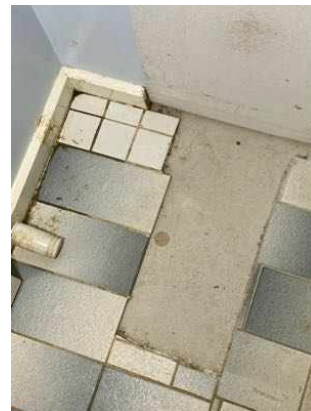
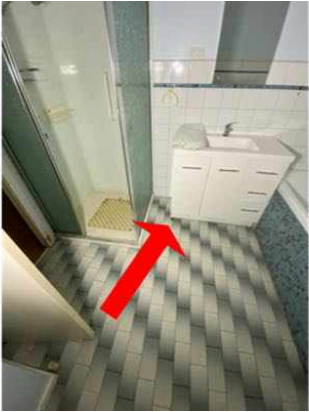
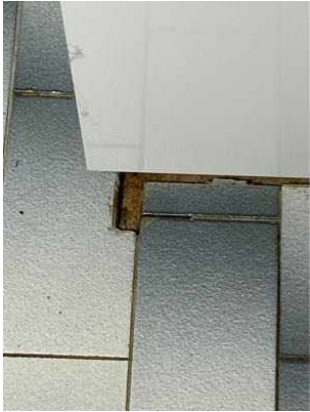
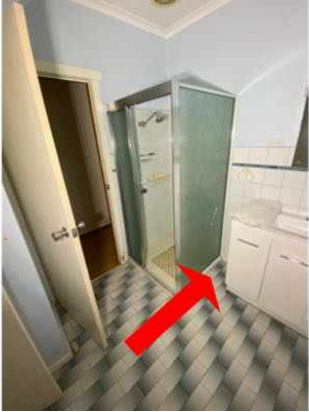
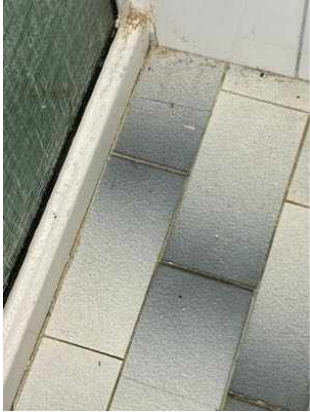
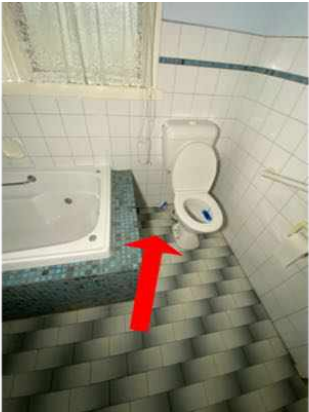
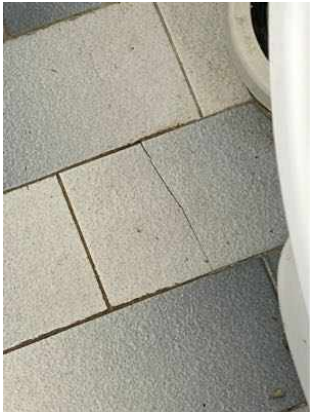
### Finding 3.04

Finding: Cracked floor tiles

Information: Cracking in the floor tiles was evident in this area at the time of inspection. It is suspected that this cracking has occurred as a result of minor settlement or impact damage.

Cracked tiles throughout the household detract from the overall appearance of the affected areas however it is unlikely to create or lead to any secondary defects.

While not considered a matter of urgency, replacement of cracked floor tiles is recommended at the clients discretion. A tiling contractor may be appointed to perform these works. Where cracks become more numerous, contact a licensed building inspector for further investigation.

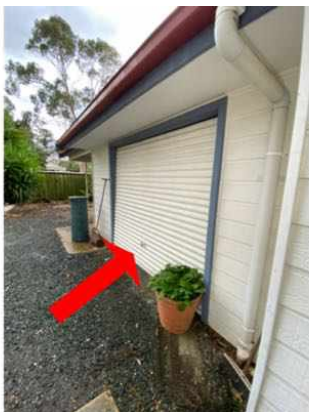
**Finding 3.05**

Building: Building 1  
Location: Garage  
Finding: Garage door  
Information: The garage door locking mechanism shows poor function. A flower pot is used to keep it closed.

A garage specialist or handyman should be contacted soon to improve the area and prevent further deterioration.

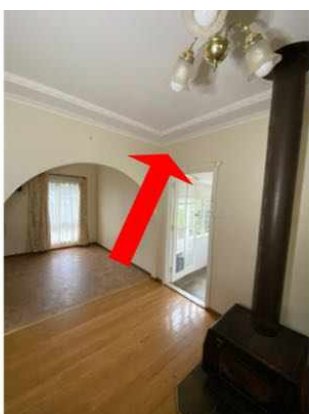
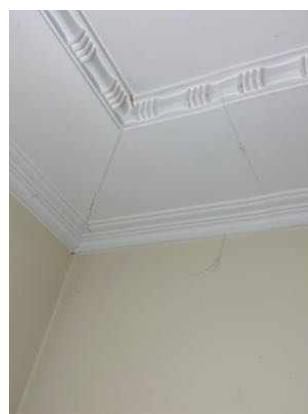
### Finding 3.06

Building:	Building 1
Location:	Living Room
Finding:	Cracking - Damage Category 1 - Fine (up to 1mm)
Information:	Although fine cracks are quite noticeable, they are often only considered to be an appearance defect, and usually do not indicate any structural damage. Generally, the cause of a fine crack is indicative of a separation between building materials and finishes (e.g. paint, plaster, etc.) along joins.

Cracking of this nature can generally be repaired with minor sanding, filling and/or repainting. Such works should be performed by a qualified painter or a general handyman.

Monitoring of all cracking should be conducted frequently. Always contact a building inspector should cracks widen, lengthen, or become more numerous.

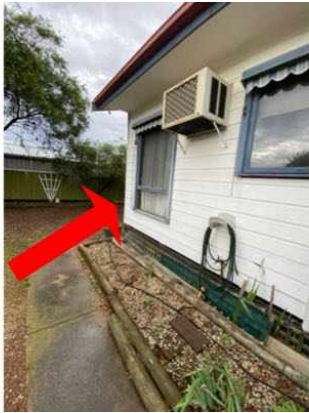
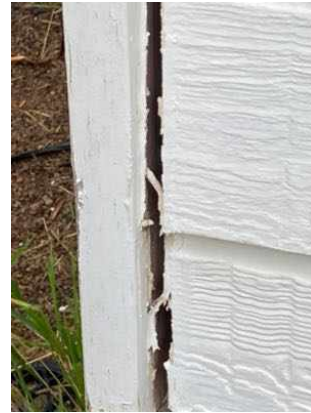
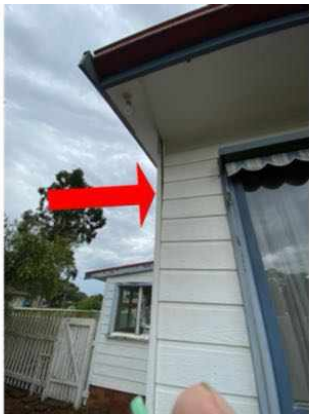
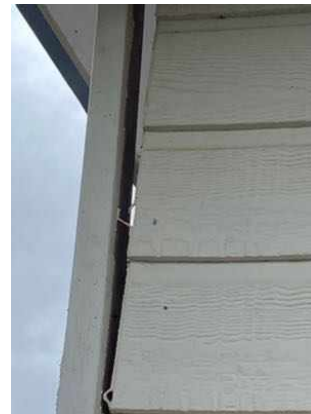
### Finding 3.07

Building:	Building 1
Location:	Yard - Back
Finding:	Timber stripping
Information:	The timber strip that protects the edge of the wall is deteriorated. It has warped and

hangs loose.

A carpenter or handyman should be contacted soon to restore this element and prevent further deterioration.

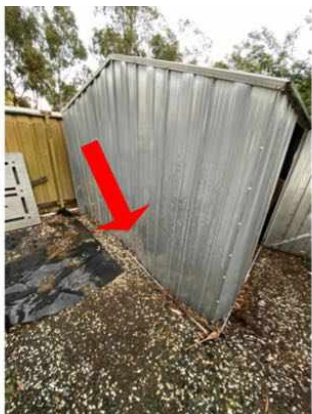
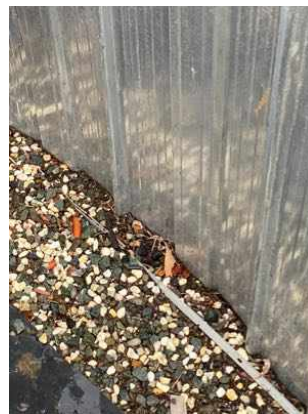
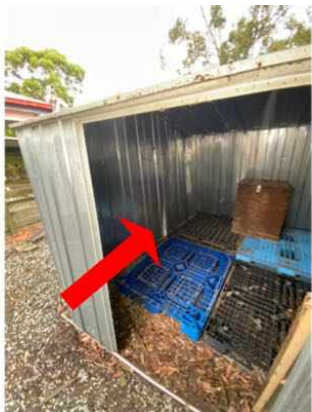
### Finding 3.08

Building: Building 1  
Location: Shed  
Finding: Shed wall- damaged  
Information: The shed wall has been damaged and shows signs of water penetration. Some small amount of rust is evident.

A handy person or shed specialist should be contacted soon to replace or repair the sheeting to prevent further deterioration.

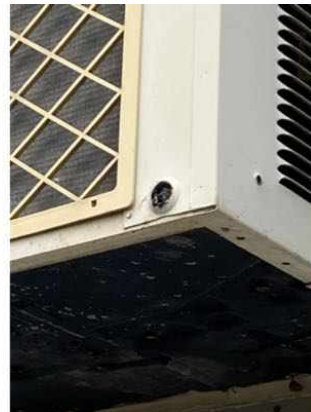
Building: Building 1  
 Location: Yard - Back  
 Finding: Air conditioner - Disconnected overflow  
 Information: The Air Conditioner (A/C) overflow was found to be disconnected from storm water drainage and is creating excessive moisture in the surrounding area.

Such leaking creates an environment which is conducive to an array of defects, including water damage to associated building elements and the attraction of termite or timber pest infestation.

It is highly recommended that a licensed plumber be appointed to connect the A/C

overflow in order to prevent such an environment from being created. These minor works should be carried out as soon as possible.

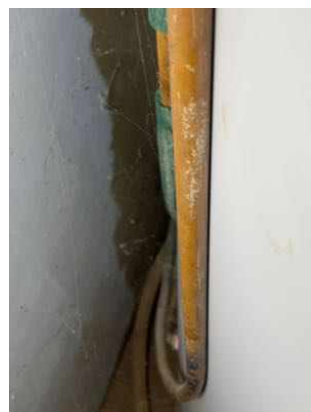
### Finding 6.02

Building: Building 1  
 Location: Garage  
 Finding: HWS Overflow - Not Connected  
 Information: The Hot Water System (HWS) overflow was found to be disconnected from storm water drainage and is creating excessive moisture in the surrounding area.

These damp conditions can lead to secondary defects such as rot, rust or corrosion of associated building elements, the formation of fungal decay, or even the creation of potential slip hazards. When coupled with poor site drainage, pooling of water may also attract termite activity to this area.

It is highly recommended that a licensed plumber be appointed to connect the HWS overflow in order to prevent such an environment from being created. These minor works should be carried out as soon as possible.

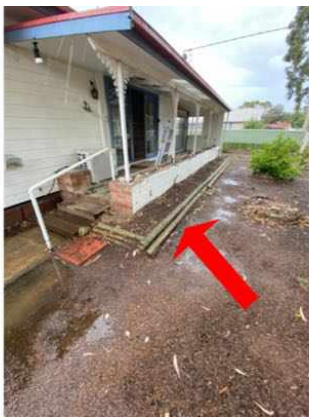
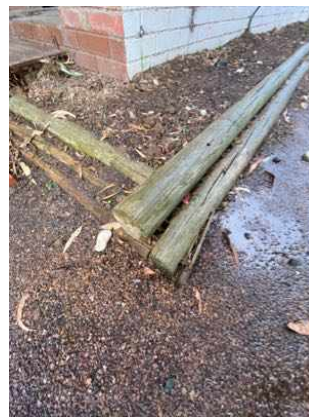
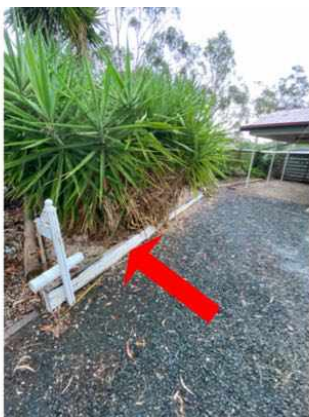
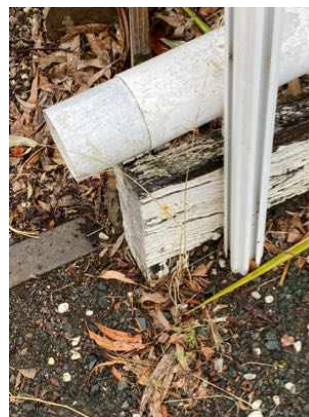
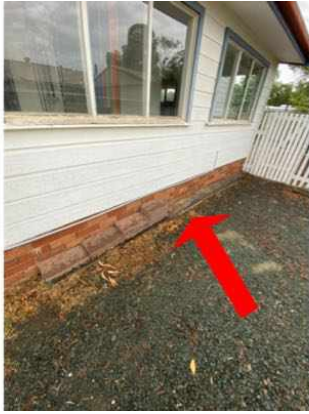
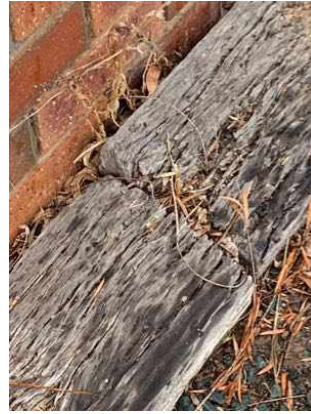
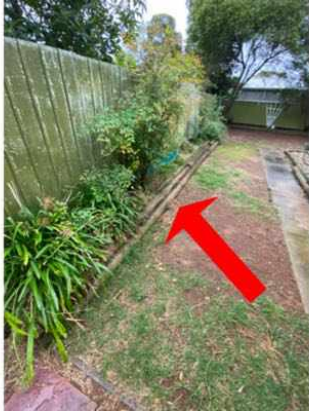
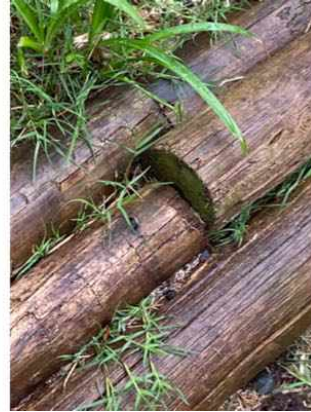
### Finding 6.03

Location: Yard - Back, front  
Finding: Untreated or non-durable timbers in a hazardous environment  
Information: To reduce the risk of timber pest attack it is essential that timber used in a hazardous environment (e.g. in direct contact with the ground or frequently exposed to damp conditions) is of sufficient durability and/or is adequately preservative treated.

Untreated timbers in direct contact with the ground are likely to develop severe wood rot and/or fungal decay if left unattended creating attraction for subterranean termites to infest the timbers from surrounding areas.

If untreated or non-durable timbers are found to be in a hazardous environment it is highly advised that replacement of these building elements be performed as soon as possible to aid the protection of the property against termite / timber pest attack.

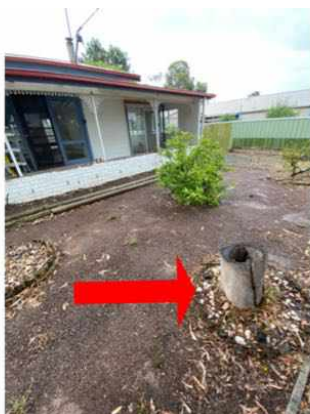
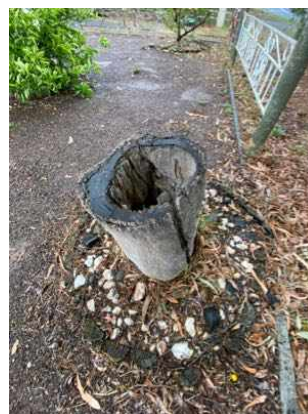
### Finding 6.04

Building:	Building 1
Location:	Yard - Front
Finding:	Tree Stump in Ground
Information:	Any tree stumps in the yard not removed during the tree removal process provides the opportunity for Termite infestation and is likely to be subject to decay from damp conditions against the stump.

All tree stumps should be removed by professional tree removal services where possible. Meanwhile regular inspections are advised to identify any termite activity in the areas identified.

Services for tree stump removal should be contacted as soon as possible to reduce the risk of timber pest attack.

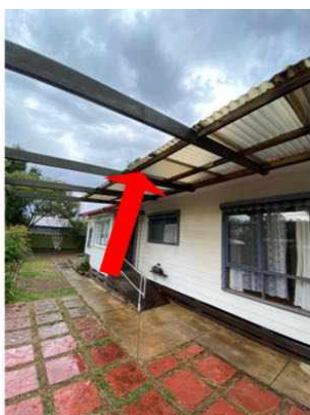
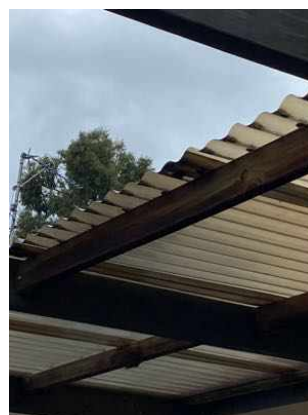
### Finding 6.05

Building:	Building 1
Location:	Alfresco
Finding:	Guttering Missing
Information:	The Guttering in this area was missing at the time of inspection. Guttering, Downpipes and Stormwater drainage are vital to protect the integrity of the structure and to prevent an environment conducive to Timber Pest attack.

A Plumber should be contacted as soon as possible to replace and connect to drainage the missing Guttering.

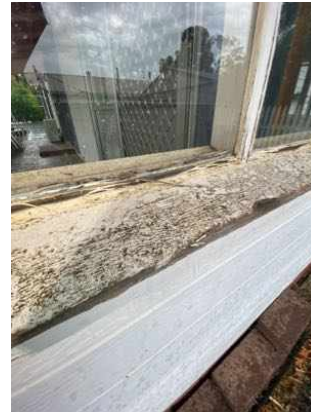
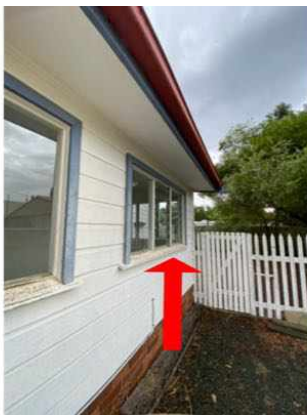
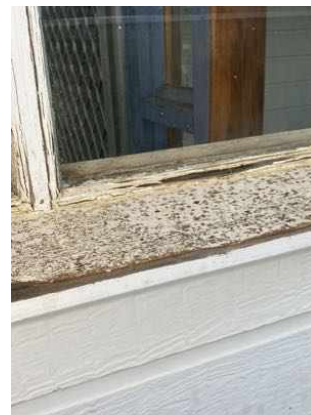
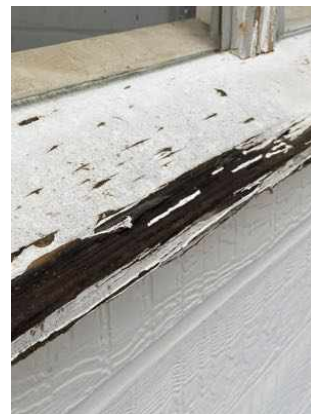
### Finding 6.06

Building:	Building 1
Location:	Timber windows
Finding:	Timber - exposed to weather
Information:	External timbers that are frequently exposed to harsh weather conditions require adequate protection in order to maintain their condition. Where timbers have not been painted or treated adequately, general deterioration is likely to occur at an accelerated rate.

If left unattended, replacement of these timbers is likely to be necessary in the short-

term future. Adequate treatment of these timbers is required as soon as possible by a painting contractor or general handyman.

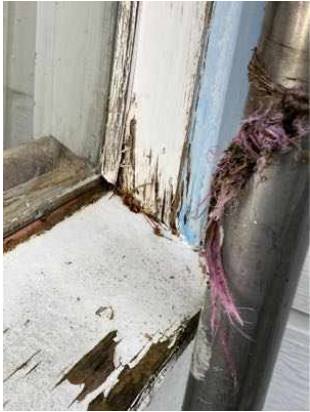
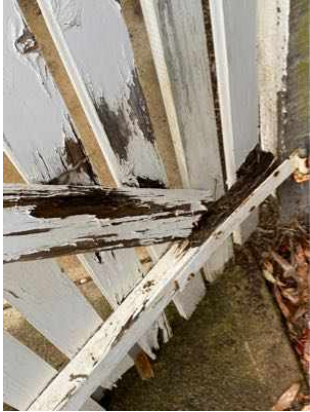
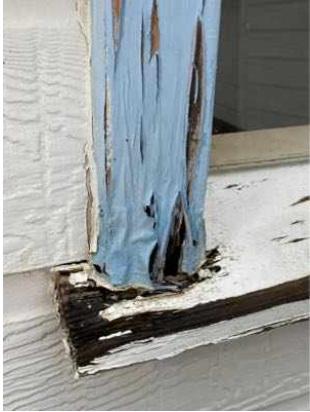
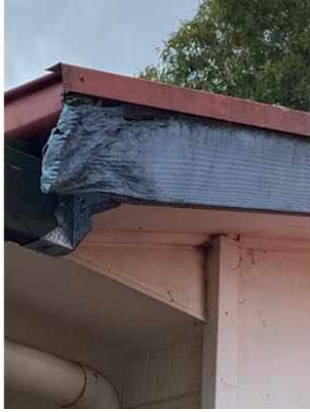
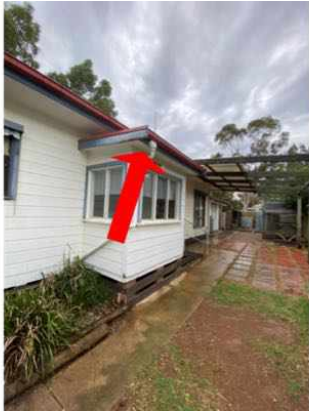
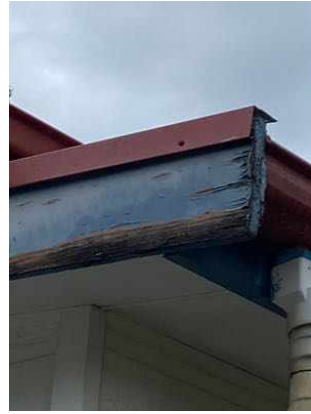
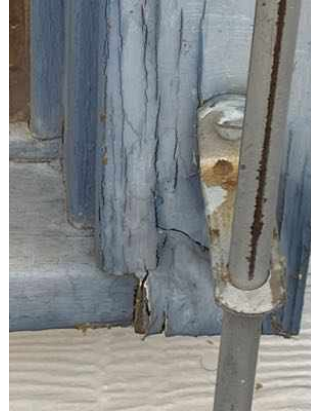
### Finding 7.01

Building:	Building 1
Location:	Several timber areas
Finding:	Fungal decay - present (localised)
Information:	Fungal decay also known as wood decay or wood rot generally refers to the deterioration of timber elements when in contact with excessive levels of moisture for a prolonged period of time.

The development of fungal decay is accelerated by temperatures in the range of 5degreeC to 40degreeC as well as the presence of oxygen. Generally fungal decay develops on timber elements that are in use in an external environment which are exposed to rain penetration.

In this case although the affected timber element is in a decaying state the extent of any visible damage appears to be localised to a specific area and is yet to spread to other parts of the building element or affect adjoining structures. The fungal decay is therefore likely to be of a relatively superficial nature with minimal impact on the structural integrity or tensile strength of the timber element.

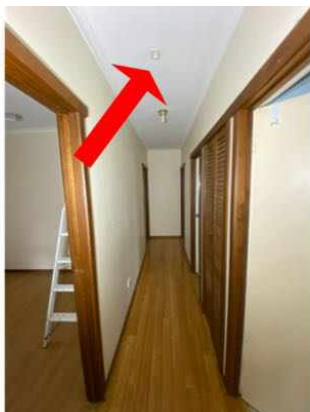
Please note that this defect is highlighted as a caution only. We suspect, based on our experience in the building industry, that the absence of smoke detectors, or their poor condition, should be addressed as a matter of urgency to improve occupant safety.

Always ensure sufficient working and suitable smoke detectors are installed prior to occupying any building. Additionally, it is advised that all smoke detectors be tested by the homeowner on a monthly basis.

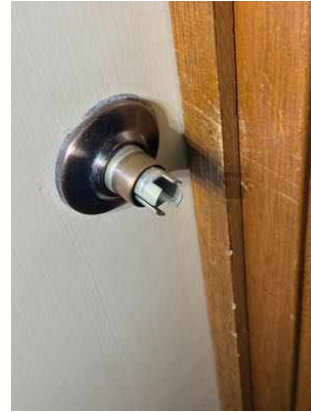
Building: Building 1  
 Location: Bedroom 2  
 Finding: Door handle- Not latching  
 Information: It was noted that the door in this area was not latching during operation at the time of inspection.

It is suspected that this defect has occurred due to minor issues with the associated hinges. Such damage is identified as general wear and tear, which is expected for building elements of this age.

A qualified carpenter or general handyperson may be appointed to perform rectification works as necessary, at client discretion.

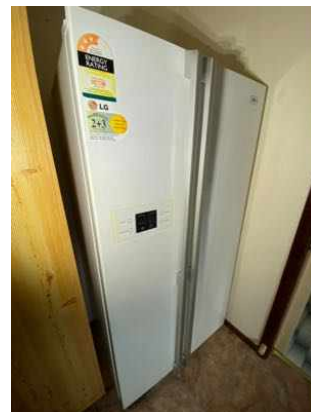
Building:	Building 1
Location:	All Areas
Finding:	Additional Photos - Obstructions and Limitations
Information:	These photographs are an indication of the obstructions and limitations which impeded full inspection of the property at the time of inspection. These obstructions can hide an array of defects and should be removed to allow full inspection to be carried out. A re-inspection is recommended once the areas are made accessible.
