Building and Timber Pest Inspection Report

Inspection Date: Thu, 12 Mar 2026

Property Address: 10 McEwen St, Shepparton VIC 3630,
Australia

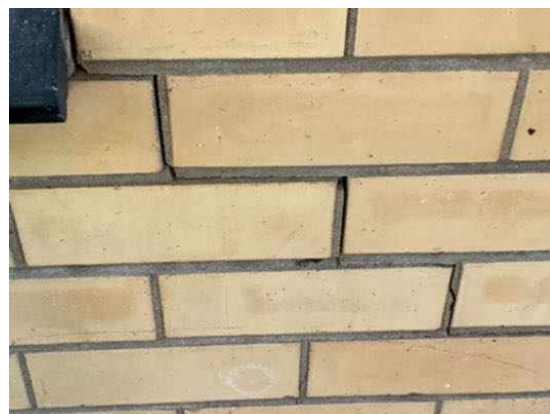
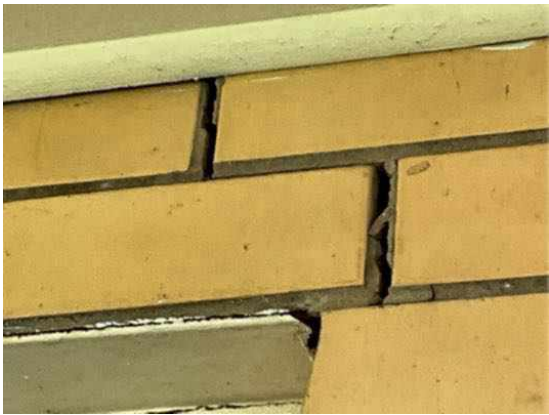
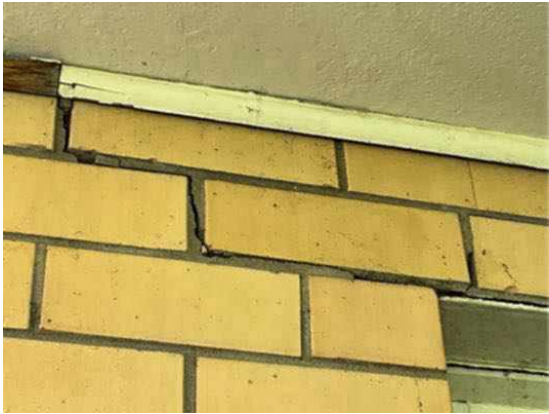
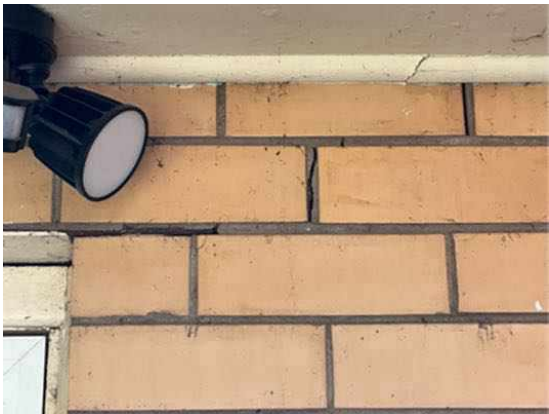
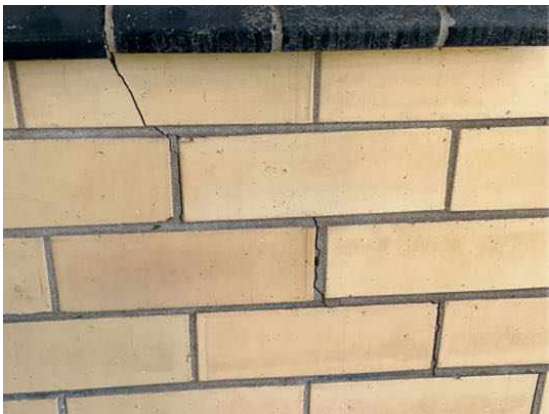
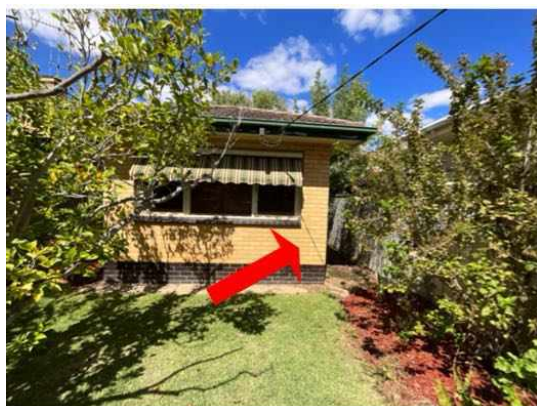
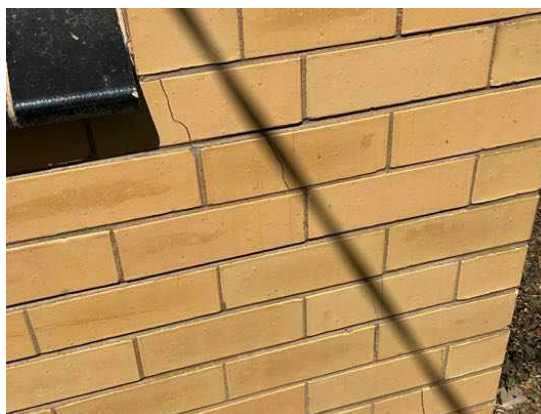
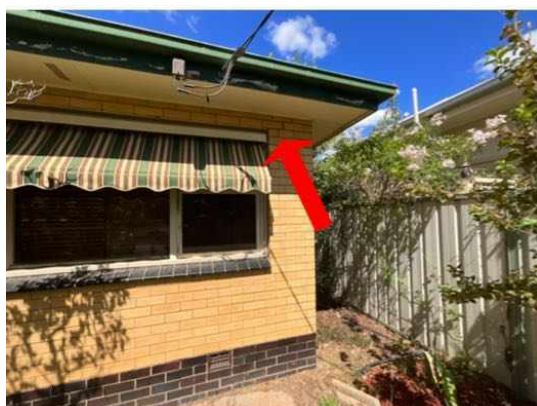
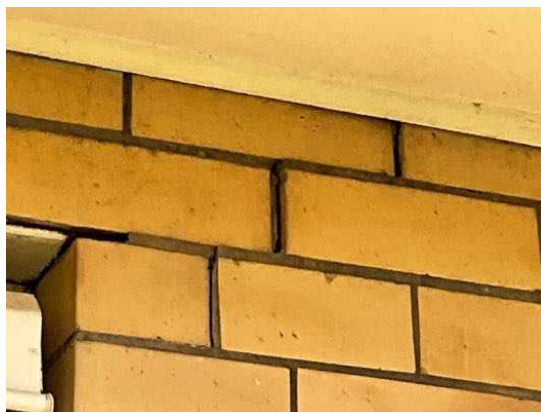
Building: Building 1
Location: Rear, front wall
Finding: Brickwork - Step cracking
Information: Step cracking was identified to the brickwork in this area at the time of inspection. Step cracking, which is similar to other forms of cracking, has a variety of possible causes. However, the most common is the subsidence of adjacent footings.

Step cracking is a relatively common defect, and is most likely to occur adjacent to windows, doors and other openings. Mortar failure in the gaps between affected bricks indicates the stresses and tensions affecting the wall.

Where step cracking is extensive or severe, the client is advised to consult a structural engineer. Minor step cracking can be used as a warning sign to address factors causing stress to the wall, which can include the effect of surrounding trees, water leaks, soil erosion, or even the presence of reactive soils in the surrounding area.

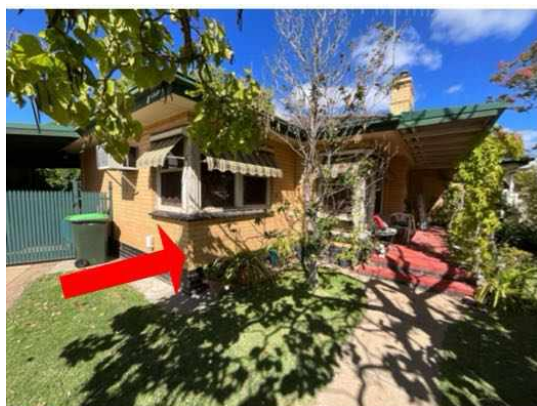
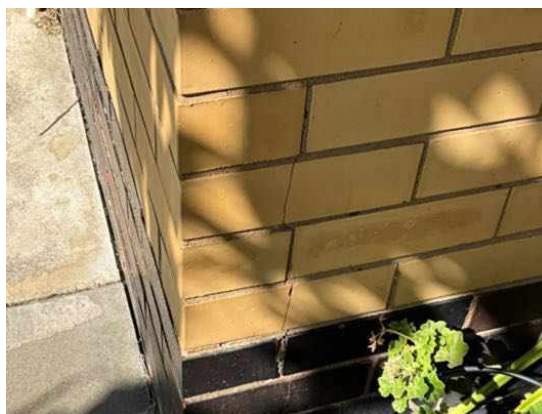
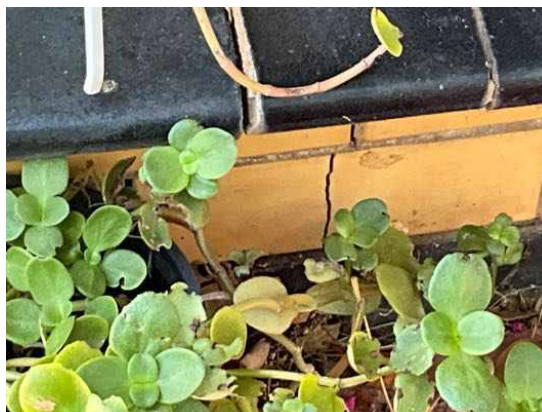
Finding 3.02

Building:	Building 1
Location:	Front wall
Finding:	Brickwork - Cracking [Fine]
Information:	<p>Although fine cracks are quite noticeable, they are often only considered to be an appearance defect and usually do not indicate any structural damage. Generally, the cause of a fine crack is indicative of a separation between brickwork and mortar throughout the structure, but single bricks may also show cracks of this nature.</p> <p>Cracking of this nature can generally be repaired with minor filling and should be conducted by a qualified bricklayer.</p> <p>Always contact a building inspector should cracks widen lengthen or become more numerous.</p>

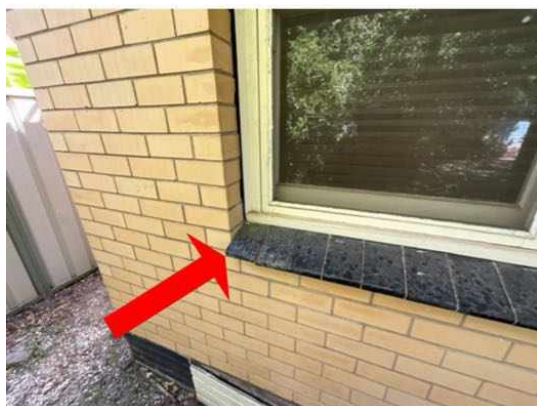
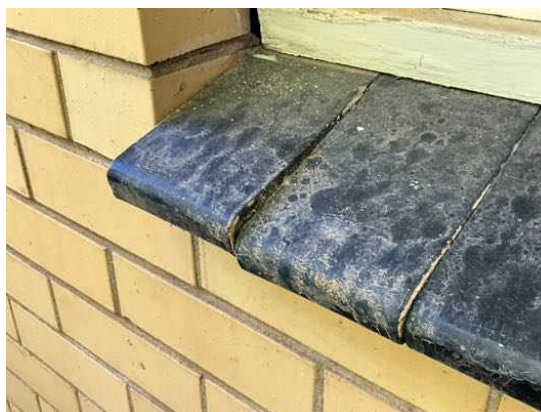
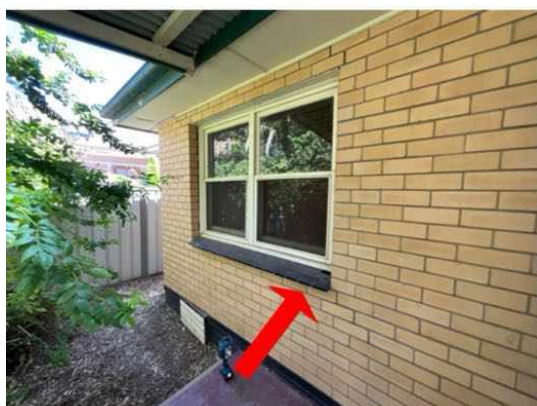
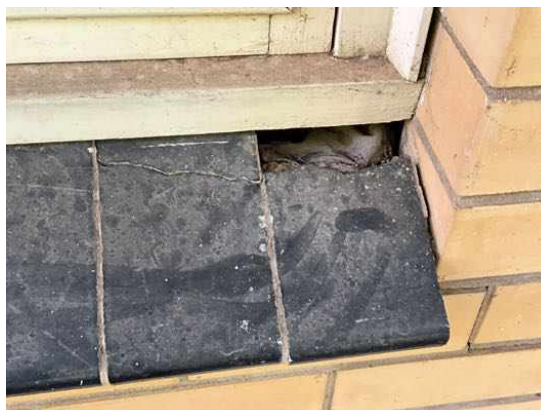
Finding 3.03

Building:	Building 1
Location:	Rear windows
Finding:	Brickwork - Deteriorated mortar
Information:	Mortar, or 'bedding', is the material which fills joints and intersections between bricks in masonry walls and structures. Sections of mortar in this brickwork were identified as having deteriorated, which is generally expected for a property of this age and condition.

Mortar may deteriorate as a result of age of building materials, minor movement of bricks, or frequent exposure to weathering. Mortar should be replaced to ensure that bricks remain in their intended location and to prevent gaps, which would allow water or moisture ingress and secondary damage as a result.

Mortar deterioration can be addressed by a bricklayer where areas of deterioration are localised and easily accessible. Alternatively, appointment of a registered builder is advised, to repoint large areas of decaying mortar. Where secondary structural defects have become evident, consultation with a structural engineer may be required.

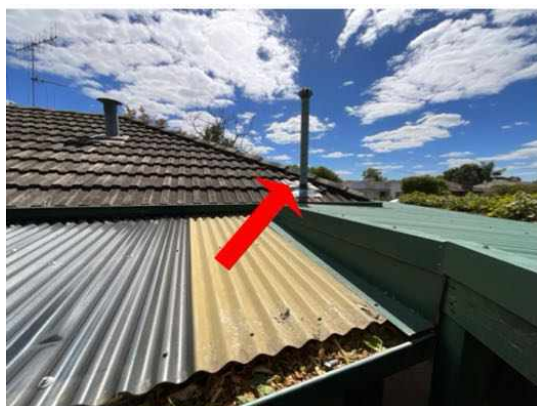
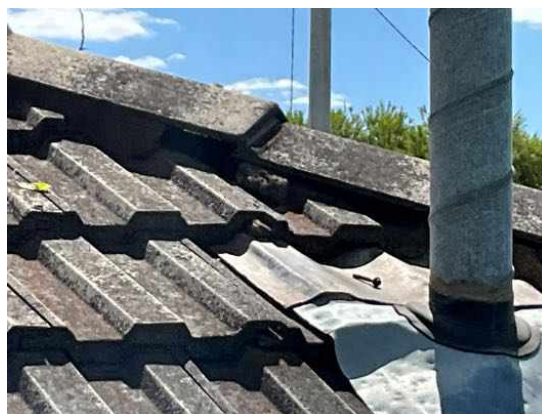
Finding 3.04

Building:	Building 1
Location:	Roof Exterior
Finding:	Mortar - Deterioration
Information:	Mortar, or 'bedding', is the material which fills joints and intersections between tiles and other building elements on the exterior roof covering, such as gable ends, hip capping and valleys. Upon inspection of the exterior roof, it was noted that sections of the mortar show varying levels of deterioration.

Mortar generally deteriorates as a result of frequent exposure to weather conditions over a prolonged period of time. Mortar that is deteriorating may allow water ingress into the roof void, putting associated building elements and roofing structures at risk of water damage. Deteriorated mortar also detracts from the functionality of roof tiles and other roofing elements, potentially decreasing weather tightness and roof drainage.

Mortar deterioration can be attended to by a handyperson where areas of deterioration are localised and easily accessible. Otherwise, consultation with a roofing contractor is advised where greater works are required.

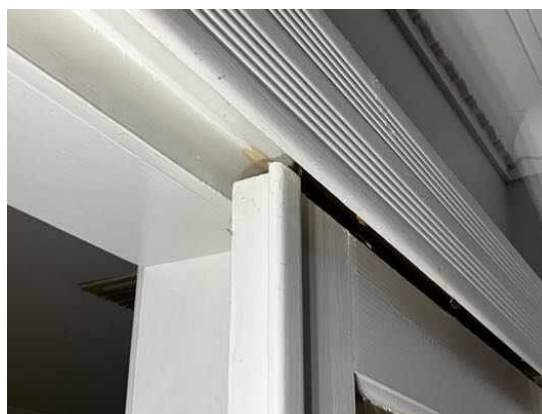
Finding 3.05

Building: Building 1
 Location: Living Room
 Finding: Door- Stiff to slide
 Information: The door in this area was jammed and difficult to slide along the associated tracks at the time of the inspection. Restricted function of the affected door may pose as a potential safety hazard if required for emergency egress from the building.

Generally, factors such as general age of the building element and a lack of maintenance are the usual causes for this type of defect.

Replacement of door hardware or tracks may be required, as well as minor repairs and cleaning. A registered builder or general handy person will be required to repair the affected doors.

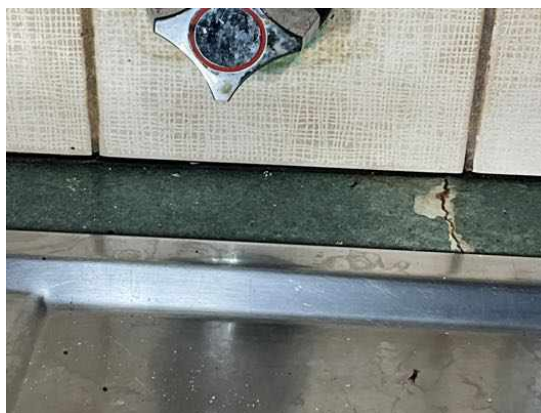
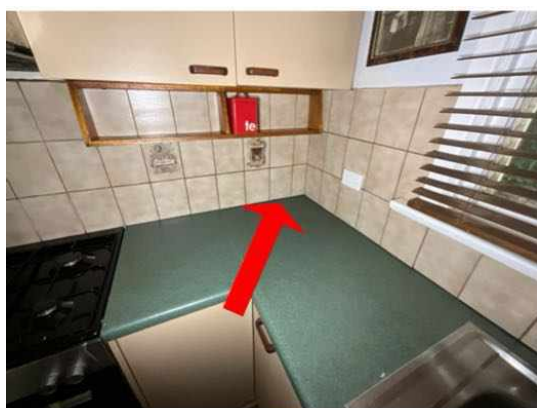
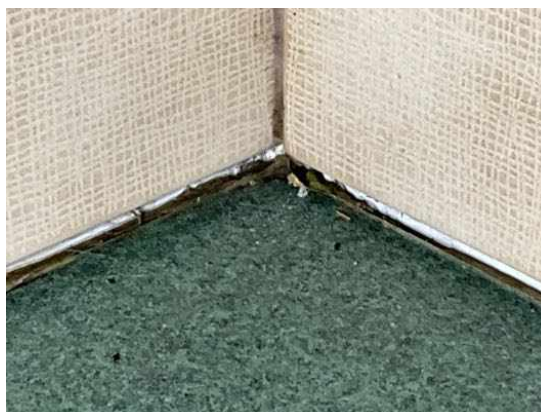
Finding 3.06

Building: Building 1
 Location: Kitchen
 Finding: Inadequate sealant or Grout
 Information: This area has a lack of effective Sealant or Grout. This is allowing the ingress of water to the structure inside the wall.

The presence of water encourages Termite attack, Mould and Fungal Decay.

A Tiler or General Handy person must be contacted as soon as possible to effect repairs and prevent further deterioration.

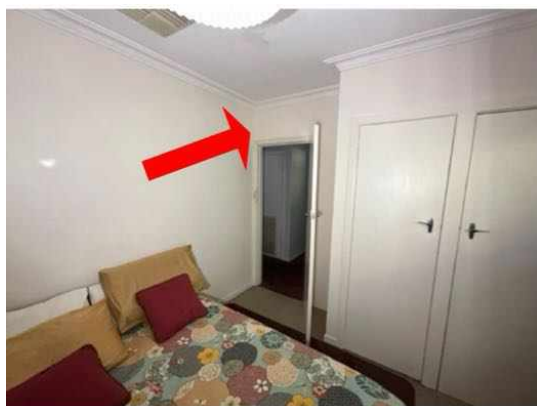
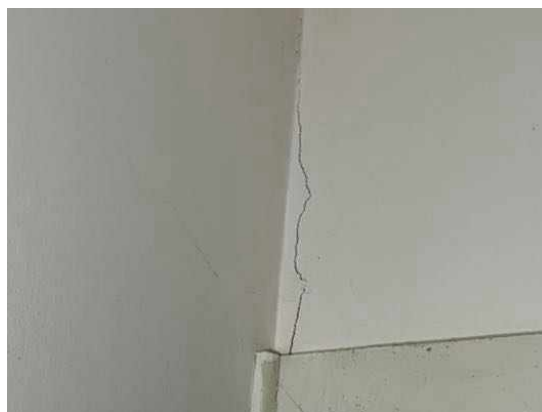
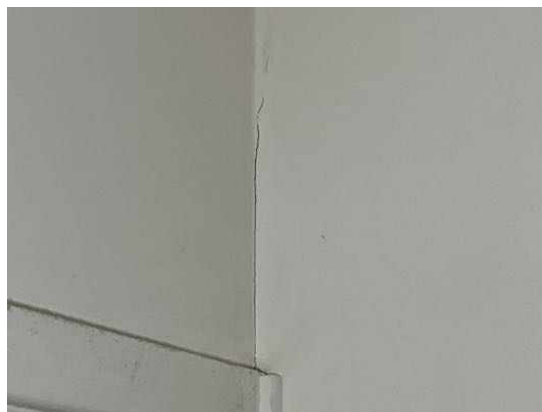
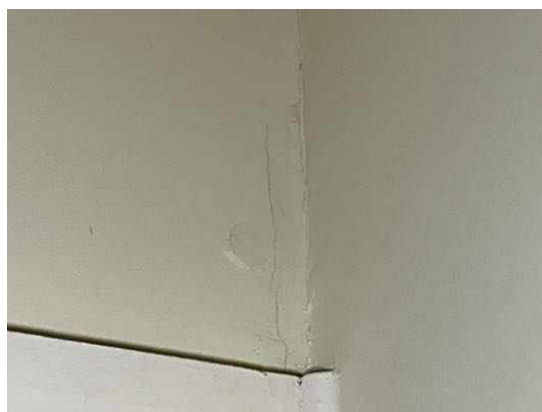
Finding 3.07

Building:	Building 1
Location:	Bed 1,2,3
Finding:	Cracking - Damage Category 1 - Fine (up to 1mm)
Information:	Although fine cracks are quite noticeable, they are often only considered to be an appearance defect, and usually do not indicate any structural damage. Generally, the cause of a fine crack is indicative of a separation between building materials and finishes (e.g. paint, plaster, etc.) along joins.

Cracking of this nature can generally be repaired with minor sanding, filling and/or repainting. Such works should be performed by a qualified painter or a general handyman.

Monitoring of all cracking should be conducted frequently. Always contact a building inspector should cracks widen, lengthen, or become more numerous.

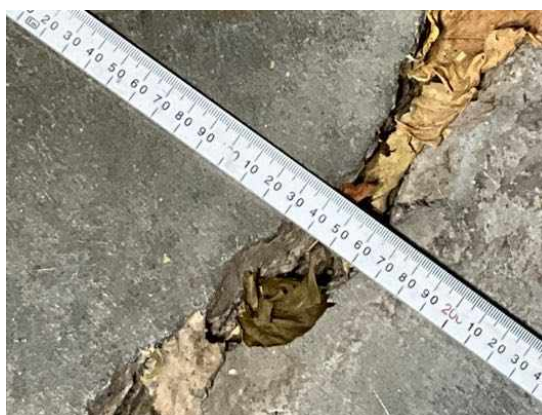
Finding 3.08

Building:	Building 1
Location:	Garage
Finding:	Cracking - External Concrete Paving Damage Category 4 - Gaps in Slab (4mm - 10mm +)
Information:	Gaps in the slab were identified in external concrete paving. Gaps in the slab are significant and are likely to lead to the development of safety hazards and secondary defects if left unmanaged, such as the creation of a trip hazard.

General age and expected deterioration of the paved areas is a common cause of this type of cracking. However, expansion and contraction of the slab may also have occurred due to environmental factors. Such factors include variable moisture and

weather conditions, the presence of trees and their roots having a settling or lifting affect on the soil, or the effect of load bearing, e.g. heavy vehicles over a sustained period of time.

Cracking to this degree may also be due to poor original installation of the concrete. Factors such as poor compaction of the sub surface and/or inadequate reinforcing of the slab may create cracking and other secondary defects. Gaps in the concrete paving may also have a more significant structural cause, such as subsidence of soils.

Where gaps in the concrete paving are adjacent to structural elements of the building, the advice of a Structural Engineer is advisable before undertaking repairs. Significant repair and likely replacement of the concrete paving is probable.

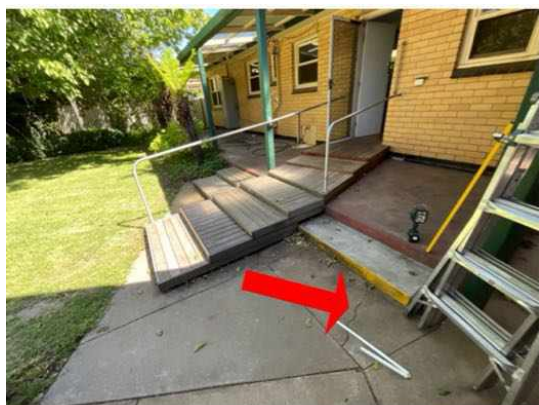
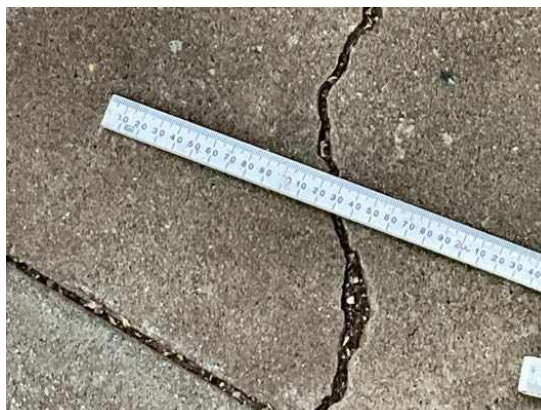
Finding 3.09

Building:	Building 1
Location:	Yard - Back
Finding:	Cracking - External Concrete Paving Damage Category 4 - Gaps in Slab (4mm - 10mm +)
Information:	Gaps in the slab were identified in external concrete paving. Gaps in the slab are significant and are likely to lead to the development of safety hazards and secondary defects if left unmanaged, such as the creation of a trip hazard.

General age and expected deterioration of the paved areas is a common cause of this type of cracking. However, expansion and contraction of the slab may also have occurred due to environmental factors. Such factors include variable moisture and weather conditions, the presence of trees and their roots having a settling or lifting affect on the soil, or the effect of load bearing, e.g. heavy vehicles over a sustained period of time.

Cracking to this degree may also be due to poor original installation of the concrete. Factors such as poor compaction of the sub surface and/or inadequate reinforcing of the slab may create cracking and other secondary defects. Gaps in the concrete paving may also have a more significant structural cause, such as subsidence of soils.

Where gaps in the concrete paving are adjacent to structural elements of the building, the advice of a Structural Engineer is advisable before undertaking repairs. Significant repair and likely replacement of the concrete paving is probable.

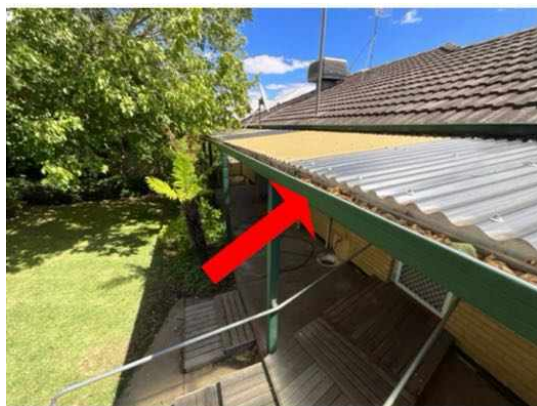
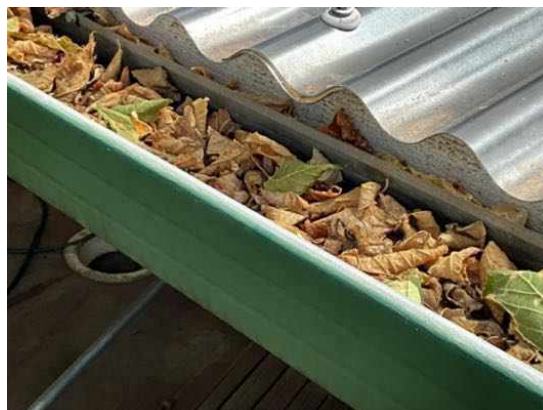
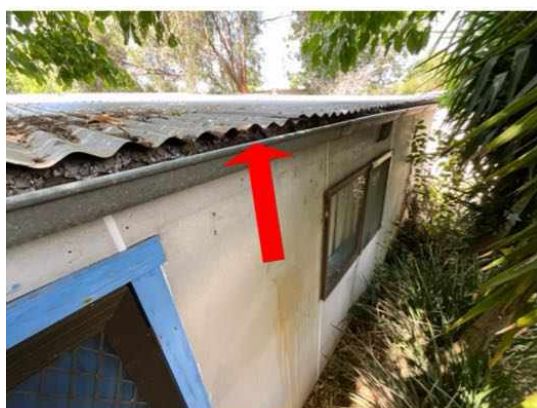
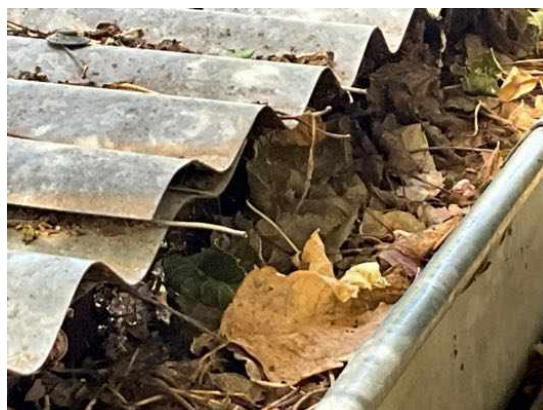
Blocked gutters are likely to lead to high levels of moisture in the affected areas. Such moisture will not only cause rust and decay of the associated building materials, but

can also provide conditions that are conducive to termite and timber pest activity. Blockages in gutters should therefore be removed immediately to ensure dry conditions are maintained.

Consult a Licensed Plumber for further specific advice on remedial works that may be required. In the interim, it is highly advised that blocked gutters be removed by the homeowner or a general handyperson as a matter of urgency.

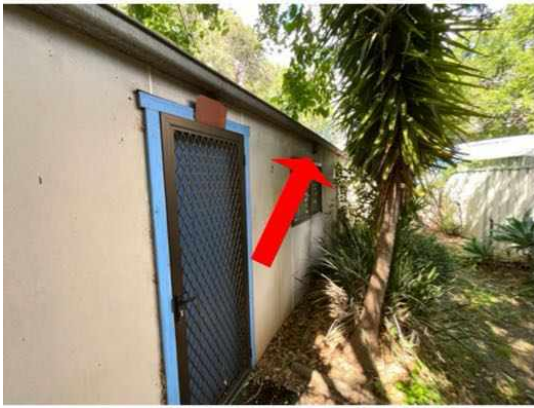
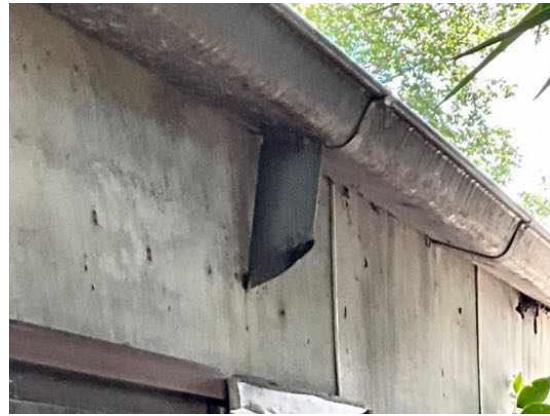
Finding 6.02

Building: Building 1
 Location: Garage
 Finding: Stormwater drain - Not connected
 Information: The roof plumbing is not adequately connected to stormwater drainage on the site. This disconnection negatively impacts the functional capacity of the roof plumbing.

Where roof plumbing doesn't drain adequately, the area at the base perimeter can become excessively damp, potentially creating an environment that is susceptible to rust and corrosion of surrounding building elements, as well as attracting termites and other pests.

It is highly recommended that a plumber be appointed to further inspect the area and to install adequate drainage equipment where necessary.

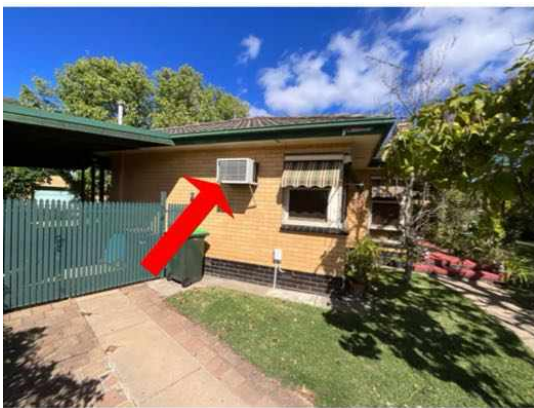
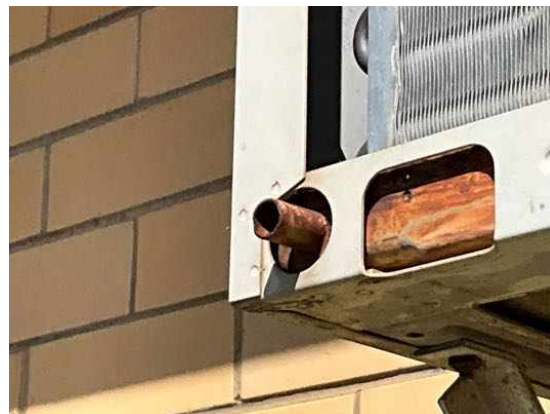
Finding 6.03

Building:	Building 1
Location:	Driveway
Finding:	Air conditioner - Disconnected overflow
Information:	The Air Conditioner (A/C) overflow was found to be disconnected from storm water drainage and is creating excessive moisture in the surrounding area.

Such leaking creates an environment which is conducive to an array of defects, including water damage to associated building elements and the attraction of termite or timber pest infestation.

It is highly recommended that a licensed plumber be appointed to connect the A/C overflow in order to prevent such an environment from being created. These minor works should be carried out as soon as possible.

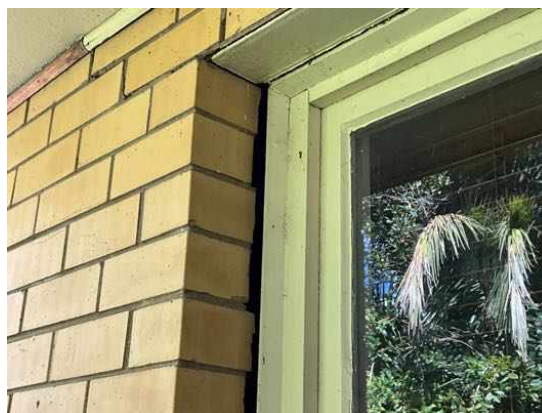
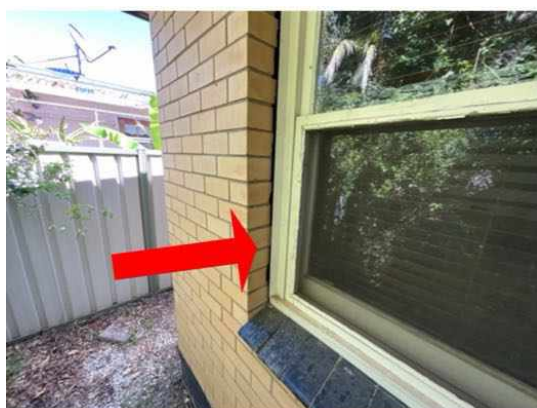
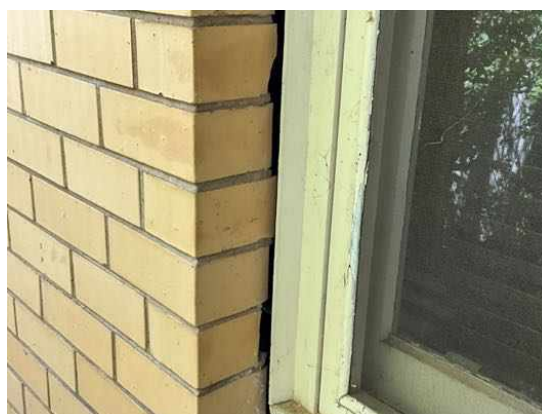
Finding 6.04

Building:	Building 1
Location:	Bed 3
Finding:	Inadequate sealant/caulking
Information:	This area has a lack of effective Sealant or Grout. This may be allowing the ingress of water to the structure.

The presence of water encourages Termite attack, Mould and Fungal Decay.

A Caulker or General Handy person must be contacted soon to effect repairs and prevent possible deterioration.

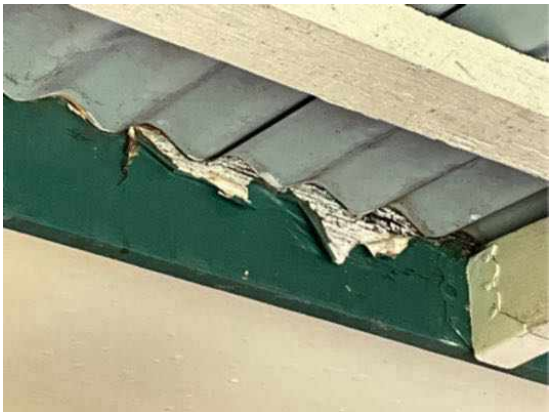
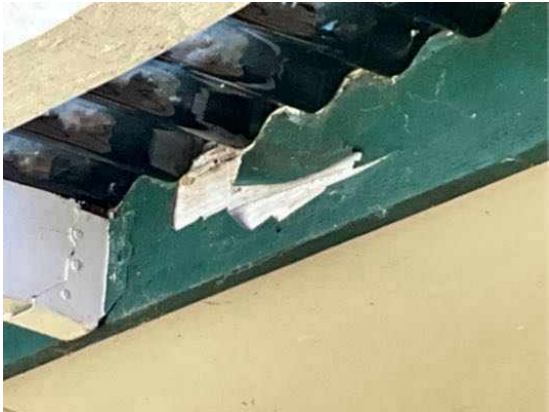
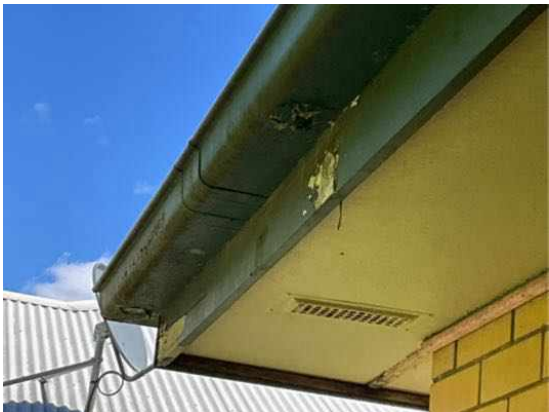
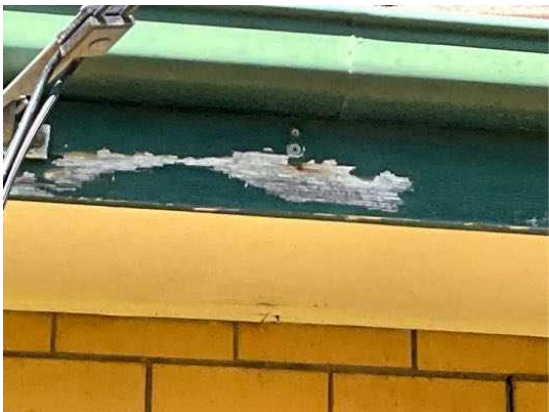
Finding 6.05

Building:	Building 1
Location:	Verandah, eaves >
Finding:	Timber - exposed to weather
Information:	External timbers that are frequently exposed to harsh weather conditions require adequate protection in order to maintain their condition. Where timbers have not been painted or treated adequately, general deterioration is likely to occur at an accelerated rate.

If left unattended, replacement of these timbers is likely to be necessary in the short-term future. Adequate treatment of these timbers is required as soon as possible by a painting contractor or general handyman.

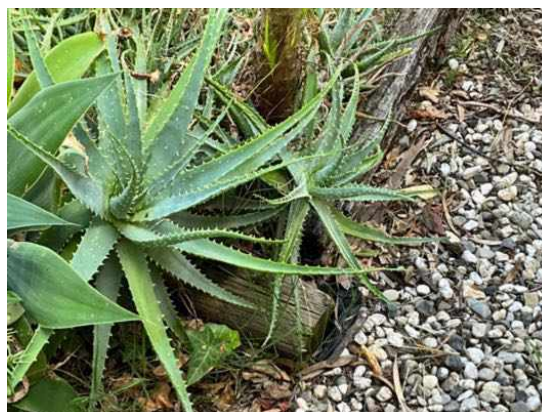
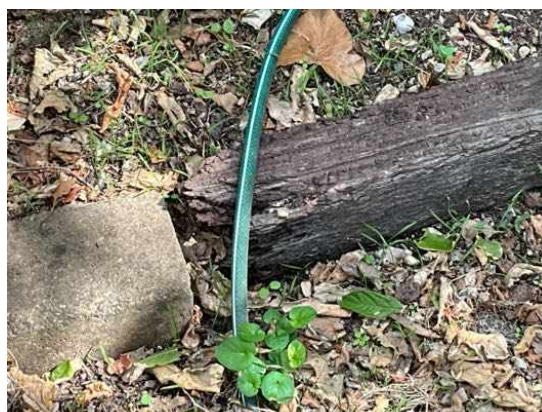
Finding 6.06

Building:	Building 1
Location:	Yard - Back
Finding:	Untreated or non-durable timbers in a hazardous environment
Information:	To reduce the risk of timber pest attack it is essential that timber used in a hazardous environment (e.g. in direct contact with the ground or frequently exposed to damp conditions) is of sufficient durability and/or is adequately preservative treated.

Untreated timbers in direct contact with the ground are likely to develop severe wood rot and/or fungal decay if left unattended creating attraction for subterranean termites to infest the timbers from surrounding areas.

If untreated or non-durable timbers are found to be in a hazardous environment it is highly advised that replacement of these building elements be performed as soon as possible to aid the protection of the property against termite / timber pest attack.

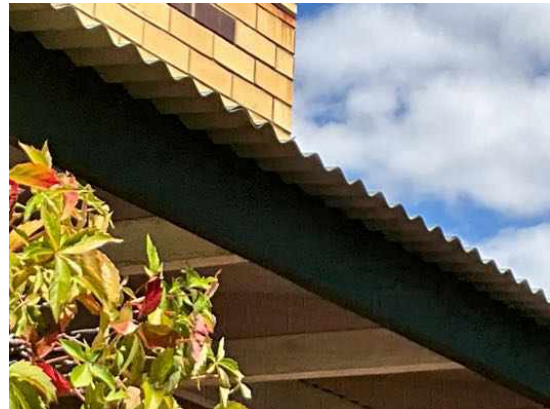
Finding 6.07

Building:	Building 1
Location:	Verandah > Front
Finding:	Guttering Missing
Information:	The Guttering in this area was missing at the time of inspection. Guttering, Downpipes and Stormwater drainage are vital to protect the integrity of the structure and to prevent an environment conducive to Timber Pest attack.

A Plumber should be contacted as soon as possible to replace and connect to drainage the missing Guttering.

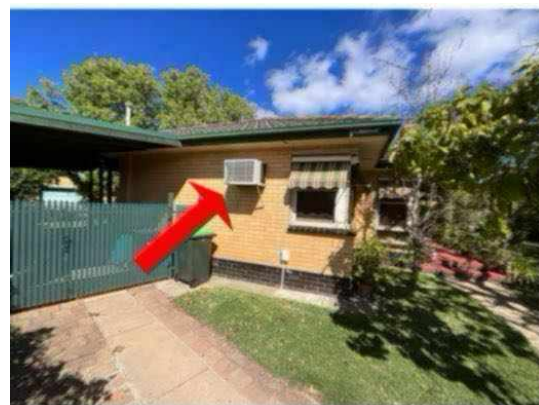
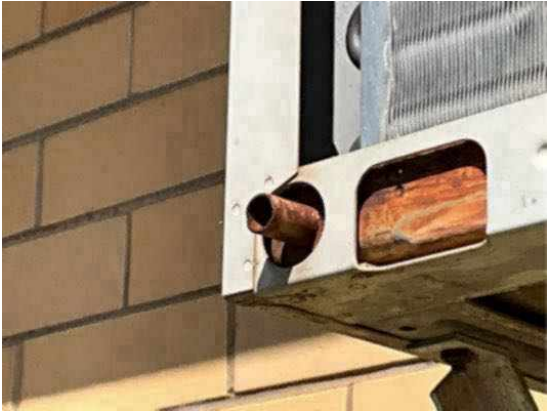
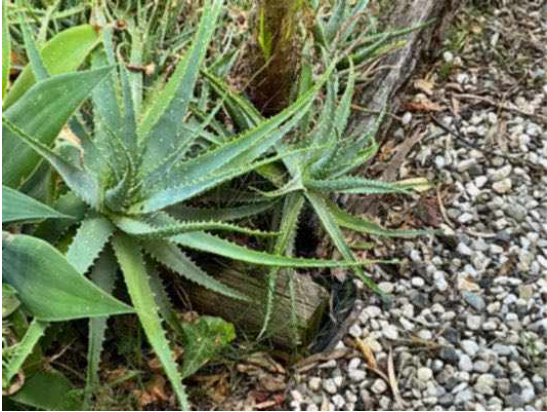
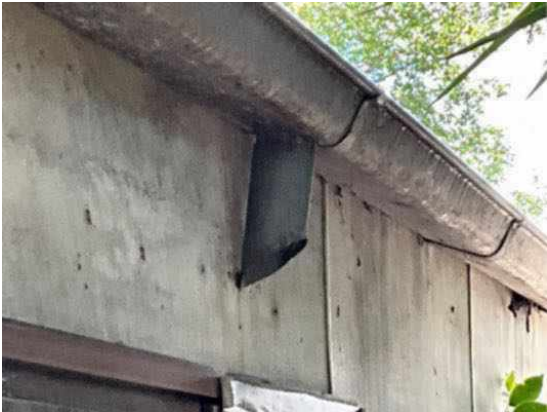
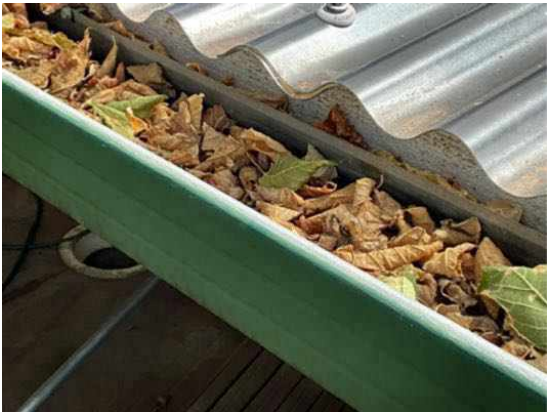
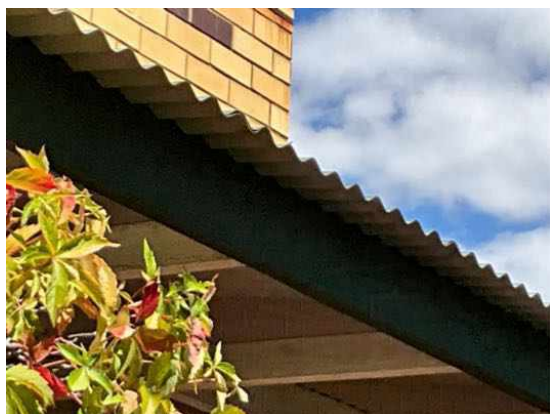
Finding 6.08

Building:	Building 1
Location:	All External Areas
Finding:	Termite Management System - no evidence of a chemical installation
Information:	The application of a post-construction chemical termite barrier is highly recommended for all properties, particularly if live termite activity has been found on the site previously. Such barriers are highly effective in preventing termite attack on any timber building elements throughout the property.

A durable notice should be placed in the switchboard unit to indicate current termite barriers. At the time of inspection, it appeared as though no termite management system has been installed, with no evidence to suggest preventative works taking place.

The client may consider gaining further advice from a pest controller as to the costs and procedures involved with this application. It is recommended that obtaining such advice be a short-term priority.

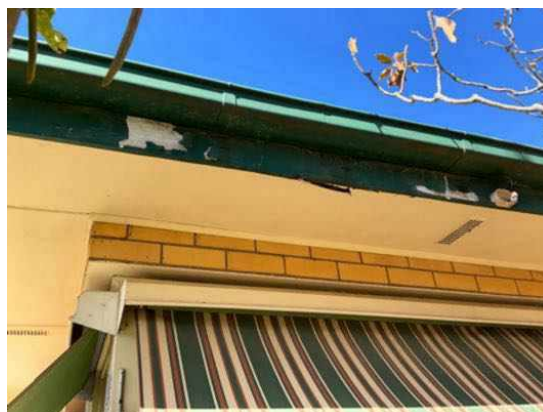
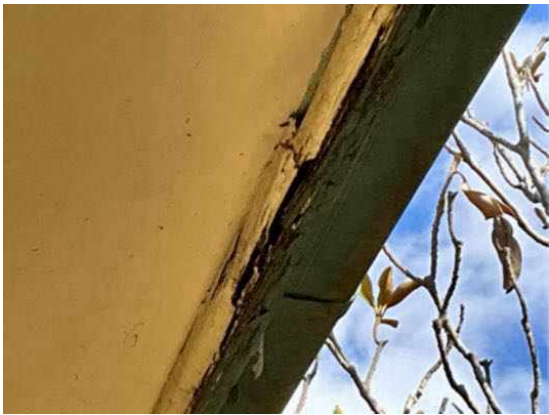
Finding 7.01

Building:	Building 1
Location:	Eaves, garage
Finding:	Fungal decay - present (localised)
Information:	Fungal decay also known as wood decay or wood rot generally refers to the deterioration of timber elements when in contact with excessive levels of moisture for a prolonged period of time.

The development of fungal decay is accelerated by temperatures in the range of 5degreeC to 40degreeC as well as the presence of oxygen. Generally fungal decay develops on timber elements that are in use in an external environment which are exposed to rain penetration.

In this case although the affected timber element is in a decaying state the extent of any visible damage appears to be localised to a specific area and is yet to spread to other parts of the building element or affect adjoining structures. The fungal decay is therefore likely to be of a relatively superficial nature with minimal impact on the structural integrity or tensile strength of the timber element.

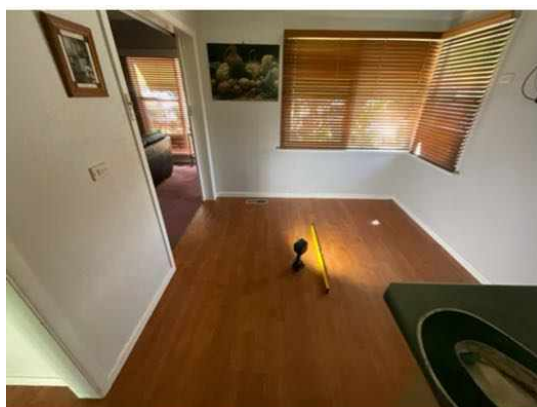
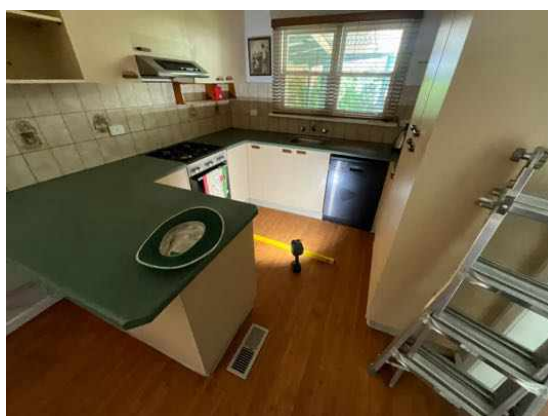
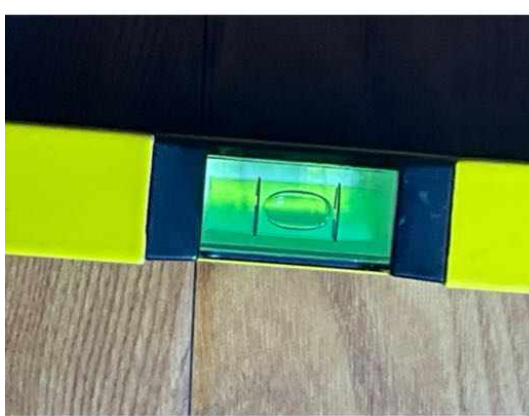
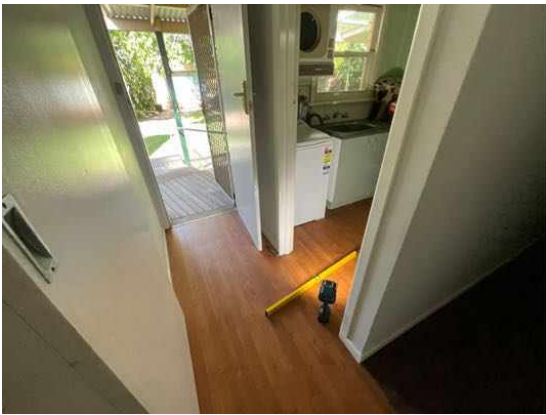
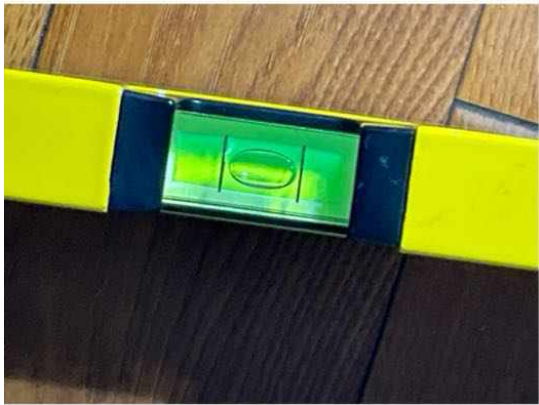
Building: Building 1
 Location: All Internal Areas
 Finding: Flooring - slightly uneven
 Information: The internal flooring in this area is out of level and uneven. Uneven flooring is likely to indicate minor defects such as expected movement of the foundations of the property, but may also indicate subsidence of the associated subfloor stumps.

It is advised that the flooring be closely monitored to identify any further movement. Where flooring remains relatively unchanged for an extended period of time (i.e. several months), it is likely that this defect has been caused by expected movement of the foundations of the property.

However, where flooring is increasingly uneven, potentially invasive inspection of the subfloor structures and stumps in this area is required. In this case, works to repair are likely to be required, and would be carried out by a registered builder specialising in re-stumping.

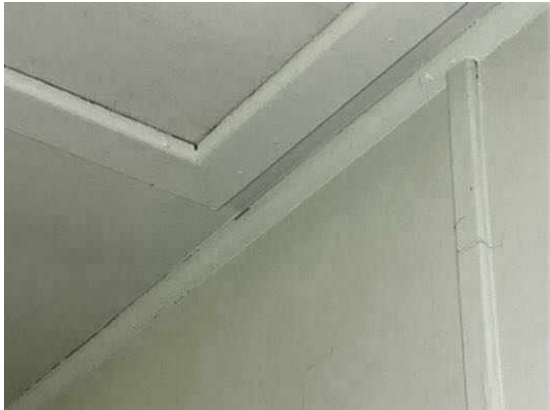
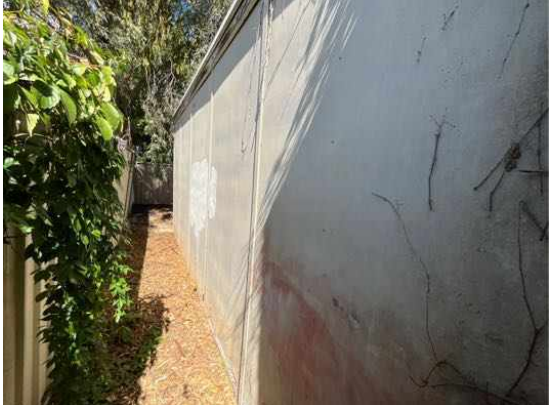
Building: Building 1
Location: All Areas
Finding: Asbestos - Suspected ACM Identified on Site
Information: Reporting on Asbestos is outside the Scope of this Report. This suspected defect is highlighted as a caution only. We suspect, based on our experience in the building industry, that there is a higher risk of the identified building element containing asbestos.

As Asbestos Reporting is outside the scope of this report, we advise that you consider a separate Asbestos Inspection and Condition Audit, which can include the taking of samples for definitive confirmation of the presence of Asbestos.

In the interim, the client is advised to act with caution, especially when considering any damage to building materials general wear and tear renovations extensions demolition and general maintenance activities due to the suspected presence of Asbestos.

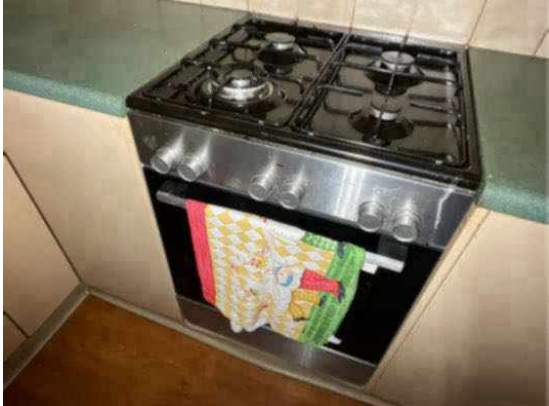
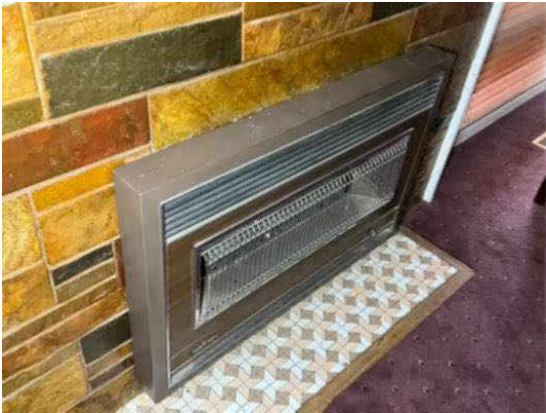
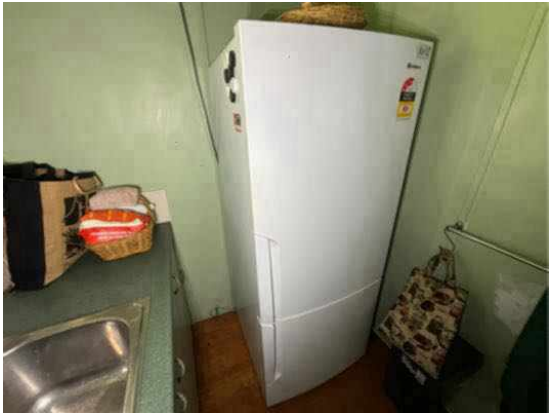
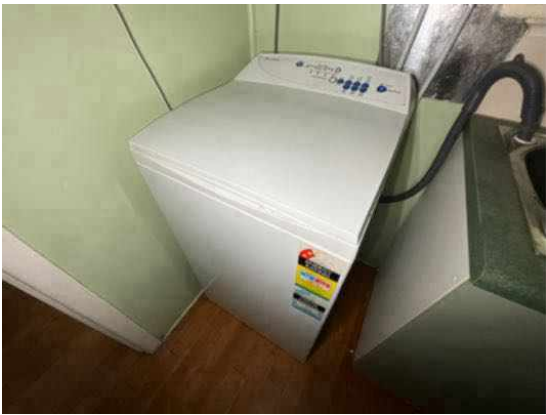
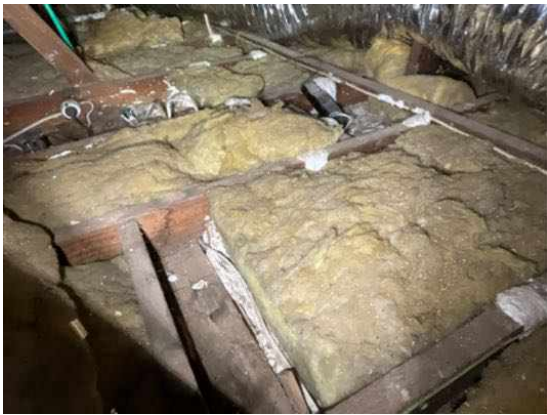
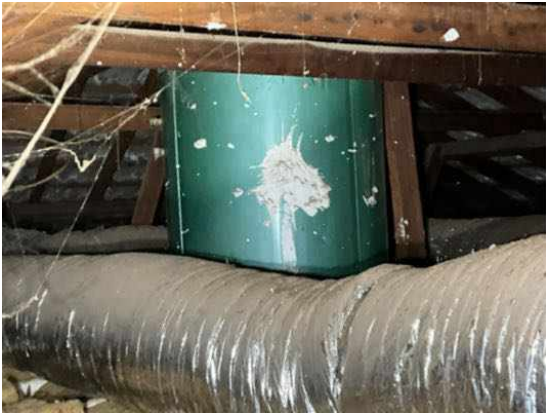
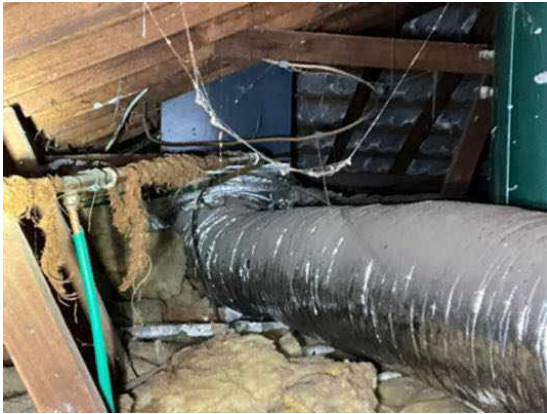
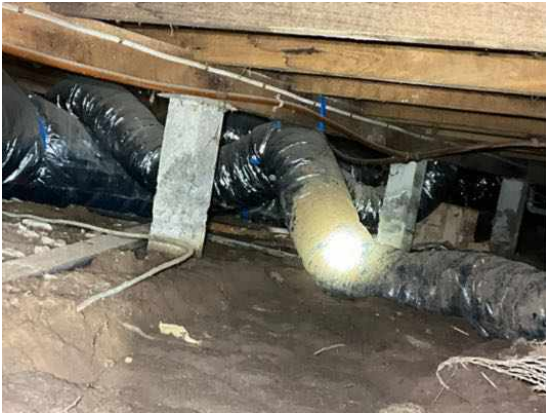
Building: Building 1
Location: All Areas
Finding: Additional Photos - Obstructions and Limitations
Information: These photographs are an indication of the obstructions and limitations which impeded full inspection of the property at the time of inspection. These obstructions can hide an array of defects and should be removed to allow full inspection to be carried out. A re-inspection is recommended once the areas are made accessible.
