# Building and Timber Pest Inspection Report

Inspection Date: Wed, 14 Jan 2026

Property Address: 66B Greenview Dr, Horsley NSW 2530,  
Australia

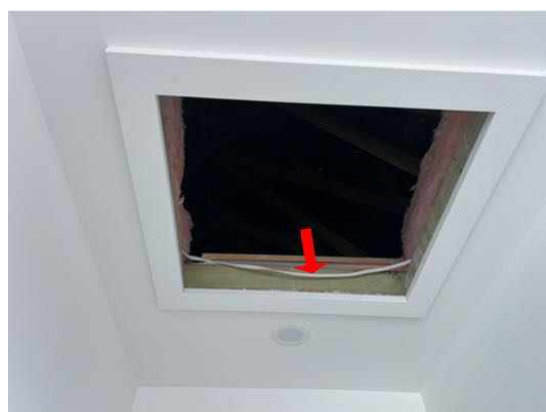
Building:	Main Building
Location:	Hallway
Finding:	Electrical wires exposed - manhole access
Information:	Electrical wiring was observed running directly across the manhole access within the ceiling void. This installation may pose a safety hazard when accessing the roof space, as personal contact or accidental damage to the wiring may occur when using the manhole.

Best practice is for electrical wiring to be routed away from access points to minimise risk. The client should engage a licensed electrician to assess the installation and, if necessary, reposition or protect the wiring in accordance with current electrical standards and safety requirements.

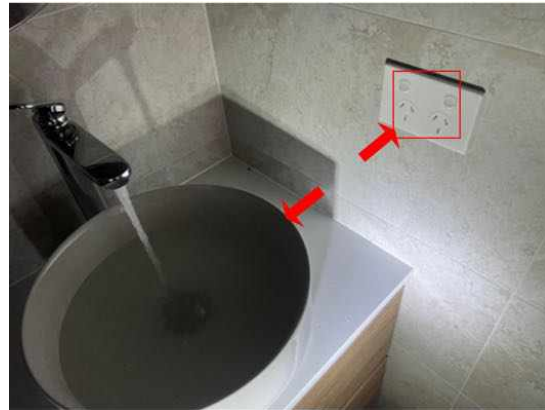
#### Finding 1.02

Building:	Main Building
Location:	Ensuite, Bathroom
Finding:	GPO - Suspected Non-Compliance With Wet-Area Clearances
Information:	A general-purpose outlet was observed installed close to a bathroom basin in a configuration that may not comply with the clearance provisions for basins with a capacity of 45 litres or less. Under AS/NZS 3000 (Wiring Rules), power outlets located near small basins must maintain a minimum 150 mm horizontal clearance from the edge of the water container, a minimum 400 mm clearance above the top of the container, and must be protected by a 30 mA safety switch.

Based on the observed proximity, the installation is suspected to fall short of the required separation distances and should be assessed by a licensed electrician to confirm compliance with AS/NZS 3000 and ensure the outlet is adequately protected

against moisture exposure.

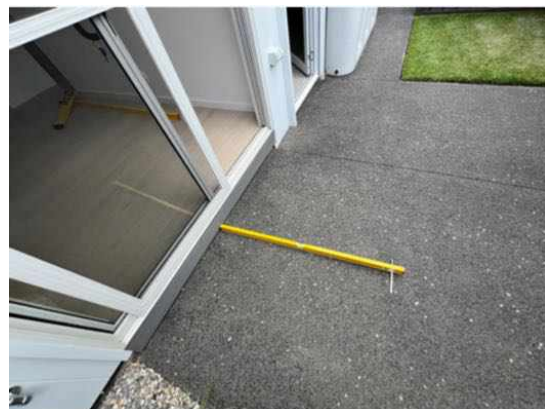
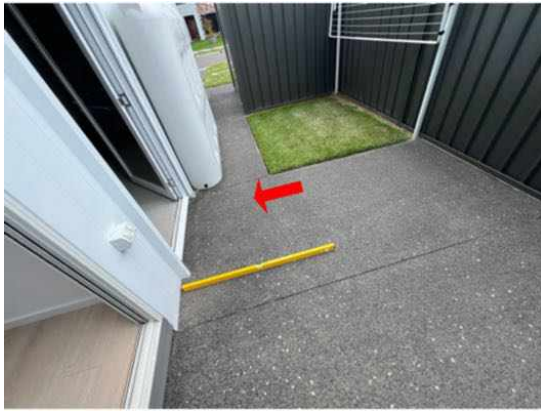
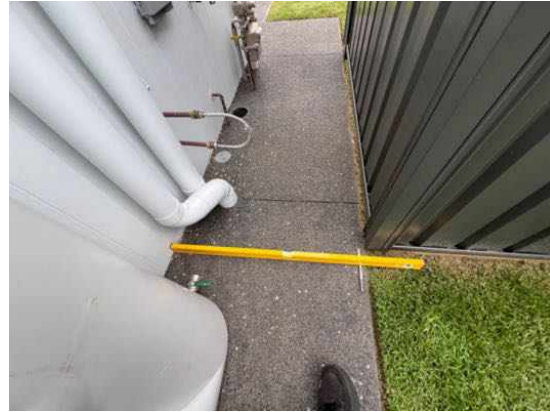
### Finding 2.01

Information: The perimeter paving or ground levels were found to have an inadequate slope away from the adjoining building structure, creating potential for water pooling in this area.

Perimeter paving is required to fall from the building by a minimum of 25mm in the first metre and bare ground should fall away from the house by 50mm in the first meter. This standard ensures that excessive moisture does not pool around the base of building structures, which creates potential for water and structural damage, as well as making the area susceptible to termite and timber pest activity.

Where paving or ground levels do not have adequate fall, a licensed paving contractor should be appointed to install or remove and re-level pavement.

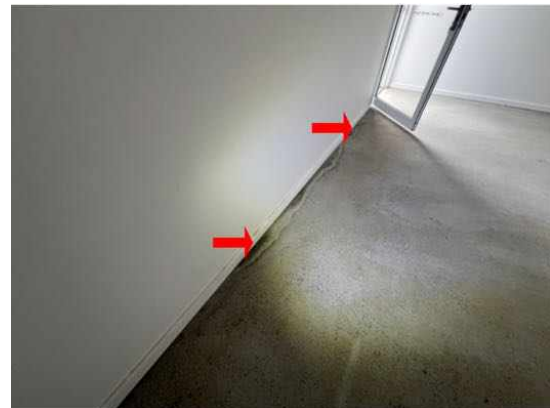
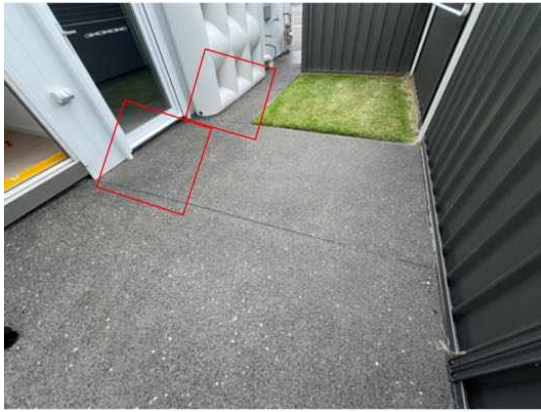
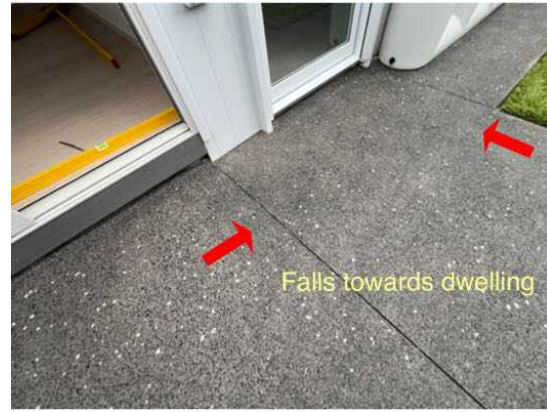
## Finding 2.02

Building: Main Building  
 Location: Yard - Side  
 Finding: Water pooling - against property  
 Information: Water appears to be pooling against the house. It is suspected that this is a result of poor site drainage but may also be due to excessive moisture from an unidentified source.

Where water is pooling against the house water damage to the external wall cladding is imminent.

Such water pooling also increases the risk of termite activity and the development of fungal decay in the area.

Consult a Licensed Plumber regarding the cost of potential site drainage rectification works.

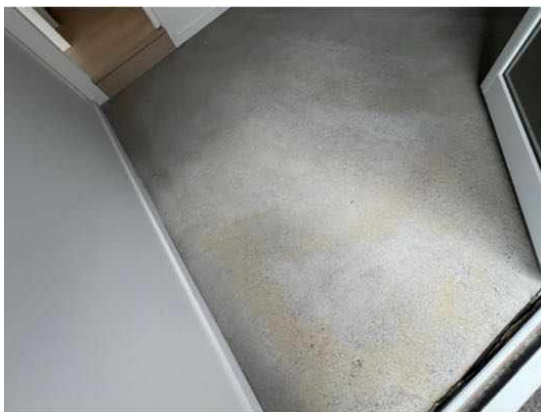
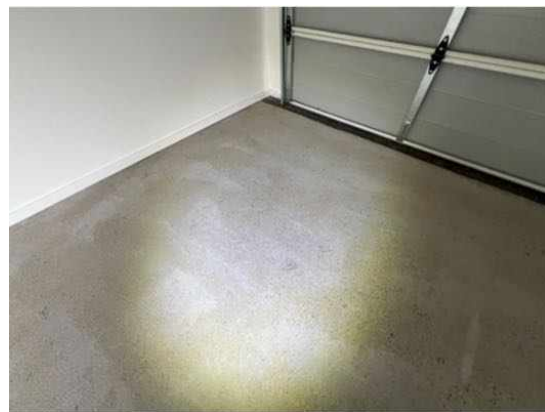
### Finding 3.01

Building:	Main Building
Location:	Garage
Finding:	Finish to Concrete Slab - Guide to Standards and Tolerances Part 2.11
Information:	The concrete slab finish to the garage was observed to be open and porous, with areas where the surface finish appears to have been removed.

The Guide to Standards and Tolerances Part 2.11 - Finish to concrete slabs states that the finish to a concrete slab is defective if it is not suitable for the documented applied finishes such as tiles, polished concrete, carpet or sheet flooring, including set downs where required.

The observed condition raises concern as to whether the slab finish is suitable for its intended use and capable of maintaining durability and serviceability over time. The client should consult with the builder to confirm whether the slab finish complies with the requirements of the Guide to Standards and Tolerances and the intended use of the slab.

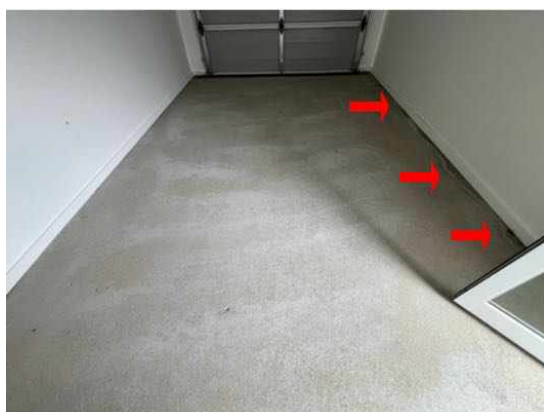
### Finding 3.02

Building:	Main Building
Location:	Garage
Finding:	Water staining
Information:	Water staining was evident in this area at the time of inspection. Water staining indicates that surfaces have been exposed to excessive moisture over time. The minerals and other elements in the water lead to staining, which may graduate to corrosion and deterioration if left unmanaged.

While mostly an appearance defect, water staining can be indicative of more serious defects, which may be currently concealed by other building elements.

Where water staining is active, a licensed plumber must be consulted to identify the cause of the staining and to provide advice on any reparation works that may be required. Replacement of any broken or damaged structures is advised.

Conversely, where water staining is old and inactive, affected building materials may be repaired or replaced at client discretion. A qualified carpenter or registered builder may be appointed to perform these works.

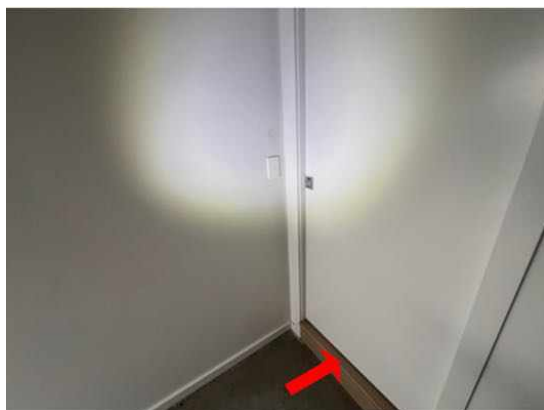
### Finding 3.03

Building:	Main Building
Location:	Garage
Finding:	Doors (External) – Gaps and/or Seals Defective (NCC 3.12.3.3) (new con)
Information:	External doors were identified as not fully sealed to all edges, including the main entry and garage-to-house access doors. All external doors, including those leading from garages, must be fitted with compliant weather seals in accordance with NCC 3.12.3.3 to prevent air and moisture ingress. The client should bring this matter to the certifier's attention to seek clarification on whether the installation meets compliance with the NCC.

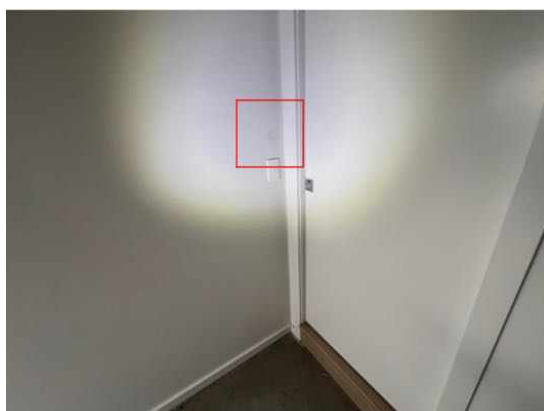
### Finding 3.04

Building:	Main Building
Location:	Garage
Finding:	Plasterboard - damaged
Information:	Sections of plasterboard were observed with visible damage, including dents, gouges, or abrasions. All wall and ceiling linings are required to be presented in an as-new condition at the time of handover, free from visible damage or surface irregularities when viewed from a normal viewing position. The client should consult with the builder to confirm how the damaged areas will be repaired to achieve an acceptable finish prior to handover.

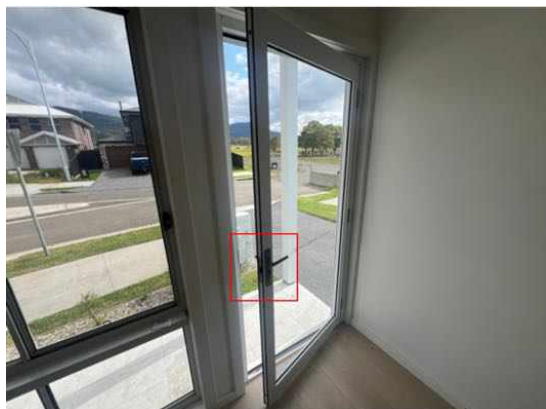
### Finding 3.05

Building:	Main Building
Location:	Entry
Finding:	Lock - Not working
Information:	The lock in this area was not operational at the time of inspection. Where locks have deteriorated to a point where they are no longer usable, the security of the property is immediately compromised.

Repair or replacement of the lock is highly recommended. Consultation with a locksmith or general handyman is required to gain further advice on any added

security that may be available for the area.

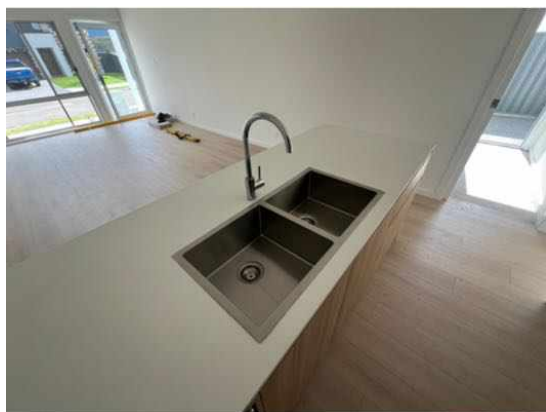
### Finding 3.06

Building:	Main Building
Location:	Kitchen
Finding:	Flexible sealants to junctions - poorly applied (AS 3958.1)
Information:	Sealant was observed to be poorly applied to the kitchen sink, presenting as uneven, smeared, or incomplete.

Flexible sealant is required at junctions to allow for movement while maintaining a watertight finish. As outlined in NSW Standards and Tolerances 12.7, flexible or waterproof sealants are defective if not installed where required by the NCC, AS 3958.1, or the manufacturer's installation requirements.

All affected areas must be properly sealed prior to handover.

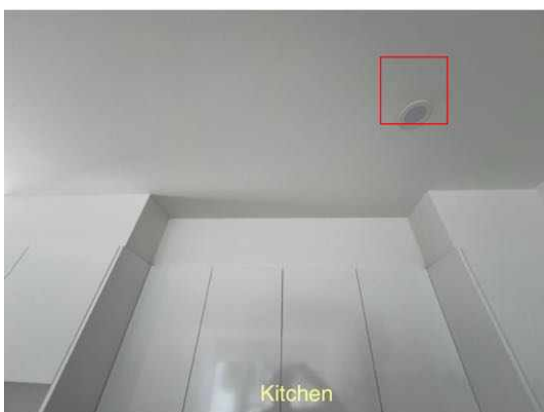
Building: Main Building  
 Location: Kitchen, Bedroom 1, Hallway, Bedroom 3, Ensuite, Bathroom, Garage, External - Bed 1  
 Finding: Painting - Defective (AS 2311)  
 Information: Areas were identified where the surface finish of the painting was found to be defective. This includes areas of over-painting, paint runs, areas starved of paint, sags and/or wrinkling of paint finish etc.

During New Construction Inspections, any irregularity in the paint finish that is detected from a “normal viewing position” is considered a detraction from the area's overall appearance and is therefore considered to be a defect.

The builder should have the painting contractor perform touch-ups to affected areas prior to final handover to bring the paint finish to an acceptable standard.

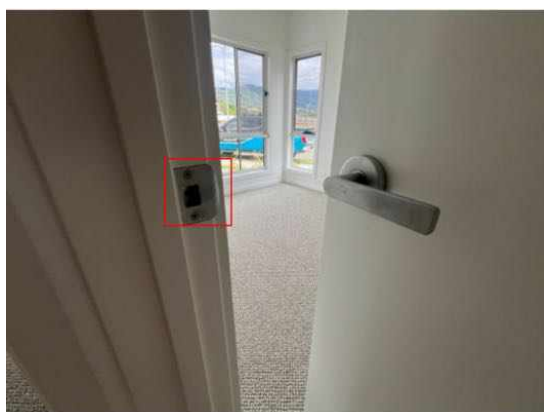
This is a common defect and is expected in a property of this age, whether being due to substandard installation or general deterioration of the door hardware.

Readjustment of the striker plate is recommended at client discretion. Works such as these can be completed by a general handyman or qualified carpenter.

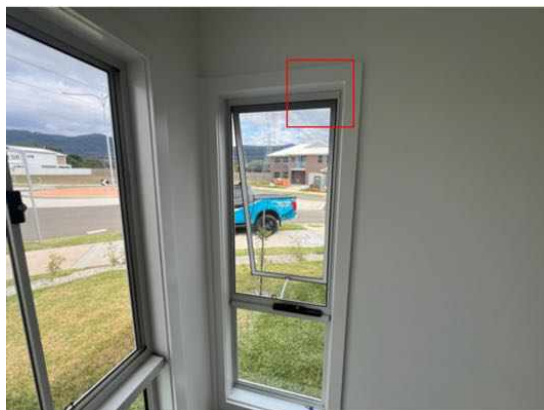
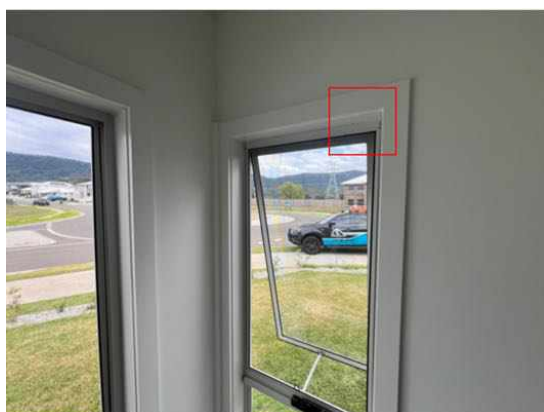
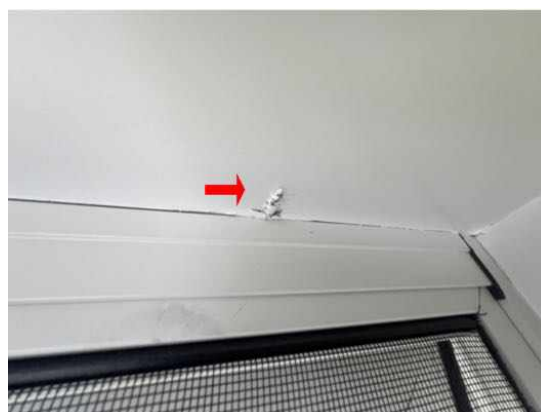
### Finding 3.12

Building:	Main Building
Location:	Bedroom 2, Bedroom 3
Finding:	Window Reveal - Protruding Fixing
Information:	A protruding screw was observed to the timber window reveal, indicating substandard workmanship and incomplete finishing.

Fixings in this condition detract from the overall aesthetic presentation of the window and may present a minor injury risk, particularly where the window is accessed,

It is recommended that the protruding fixing be rectified to improve presentation and reduce the risk of injury.

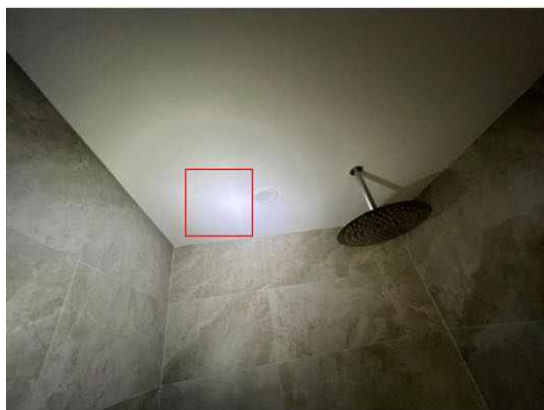
### Finding 3.13

Building:	Main Building
Location:	Ensuite
Finding:	Ceiling - Damaged
Information:	Breakage occurs generally when the building materials have either aged and decayed, or as a result of damage (accidental or deliberate).

Repair and/or replacement of broken elements is advised to ensure that additional secondary defects do not arise as a consequence. Such works are necessary, as all building elements play a key role in the operation and function of the overall structure and its performance.

A plasterer, painter or handyman should be appointed to repair or replace the affected building element prior to any subsequent damage being caused.

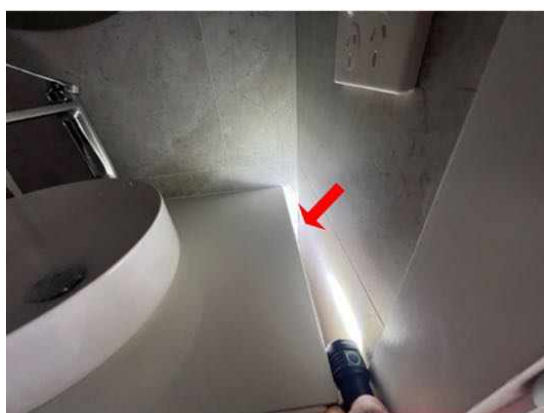
### Finding 3.14

Building:	Main Building
Location:	Ensuite
Finding:	Flexible sealants to junctions - not installed (AS 3958.1)
Information:	Sealant was incomplete at junctions within wet areas. As outlined in NSW Standards and Tolerances 12.7, flexible or waterproof sealants are defective if not installed where required by the NCC, AS 3958.1, or the manufacturer's installation instructions.

All required wet area junctions must be fully sealed with compliant materials prior to handover.

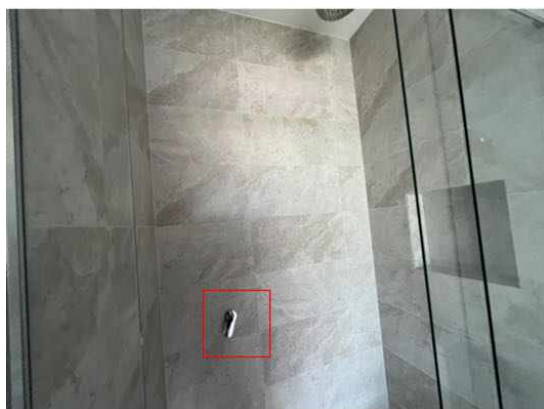
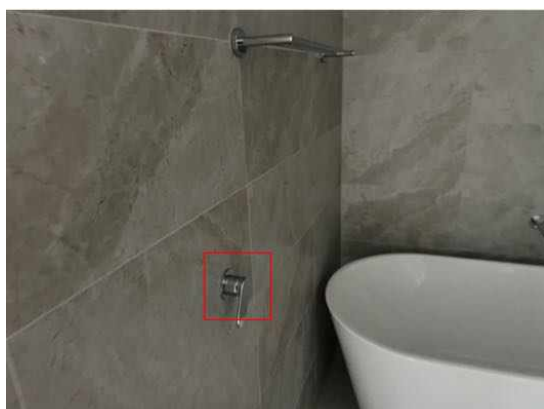
### Finding 3.15

Building:	Main Building
Location:	Ensuite, Bathroom
Finding:	Tap - Water hammer
Information:	This tap shows evidence of water hammer being present. Water hammer, a pressure surge resulting when a fluid is forced to suddenly change direction, is a common defect in plumbing fittings, particularly those that are aged and not frequently maintained. Water hammer is generally caused by factors that create high water pressure in the affected plumbing fixture, usually evidenced by a faint banging noise during operation of the affected tap.

Although water hammer is generally considered to be a minor defect, subsequent damage such as erosion of tap hardware and/or water damage to associated building elements is likely to occur if left unmanaged.

A licensed plumber should be appointed as soon as possible to replace any affected tap hardware and perform any remedial works as necessary. Please be advised that the appointment of a cabinet maker or qualified carpenter may be necessary if water damage to associated building elements has occurred.

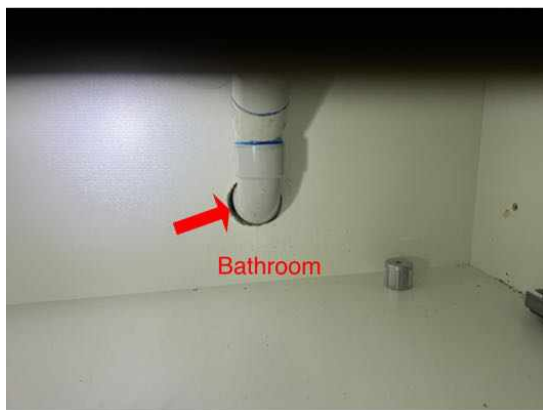
### Finding 3.16

Building:	Main Building
Location:	Bathroom
Finding:	Pipe penetrations through external walls and inside cupboards (ST 7.3)
Information:	Pipe penetrations through walls and joinery were observed without proper sealing or finish.

As outlined in NSW Standards and Tolerances 7.3, penetrations are defective if not properly grouted, not neatly cut to minimum size, or not fitted with tight-fitting cover plates or collars.

All plumbing penetrations must be finished in accordance with these requirements.

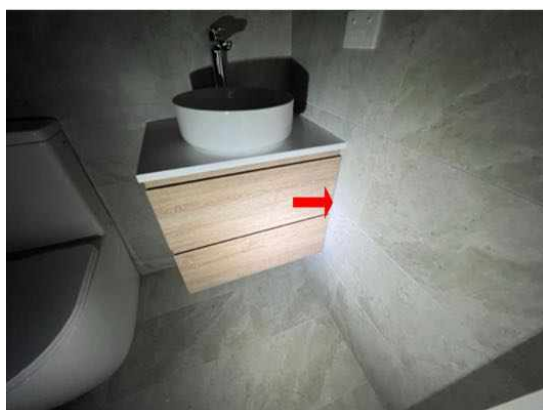
### Finding 3.17

Building:	Main Building
Location:	Bathroom
Finding:	Joinery - Missing Filler (wall)
Information:	No filler has been installed between the joinery doors/drawers and the adjoining surface at the time of inspection. This component is typically included to provide a buffer, preventing direct contact between moving parts and adjacent surfaces while also concealing gaps for a more seamless finish.

The absence of a filler may lead to doors or drawers rubbing against the adjoining surface, potentially causing wear and impacting functionality over time. Additionally, the visible gap detracts from the overall aesthetic appeal of the installation.

It is recommended that a qualified cabinet maker or joiner be engaged to install an appropriate filler to improve both the functionality and appearance of the joinery.

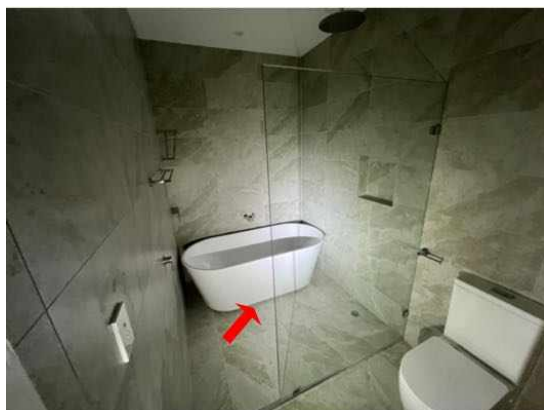
### Finding 3.18

Building:	Main Building
Location:	Bathroom
Finding:	Freestanding Bath - not secure
Information:	The freestanding bath was identified as not being securely fixed to the floor at the time

of inspection, allowing noticeable movement. This condition may result from improper installation or inadequate fixing materials.

If left unmanaged, the movement of the bath could lead to damage to associated plumbing, tiles, or surrounding building elements, as well as reducing its usability.

It is recommended that a licensed plumber be engaged to secure the bath to the floor to prevent further movement and ensure its long-term stability.

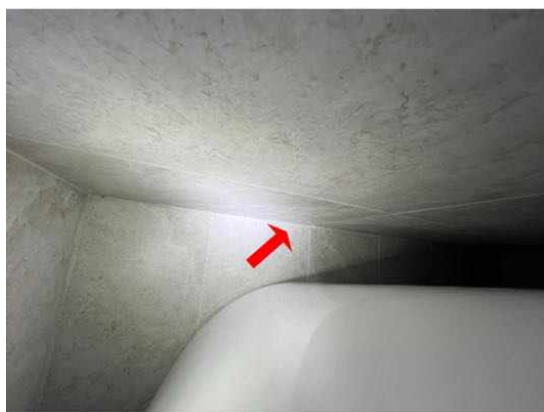
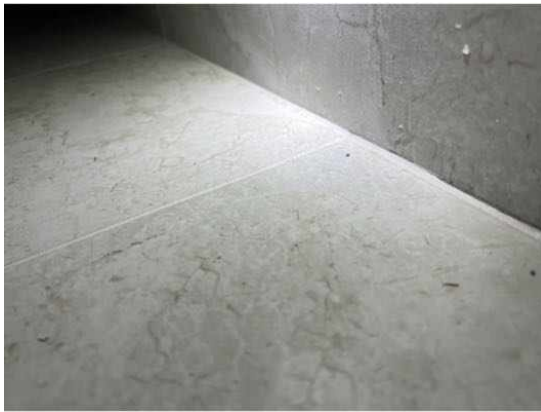
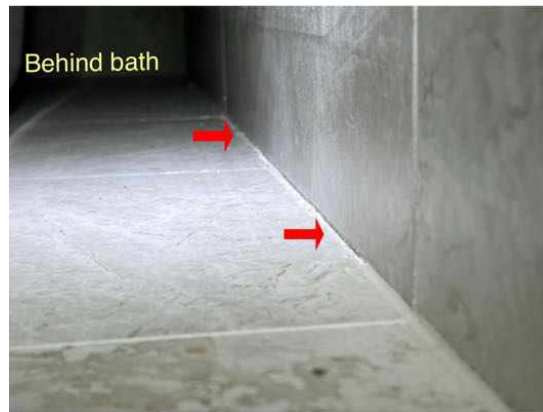
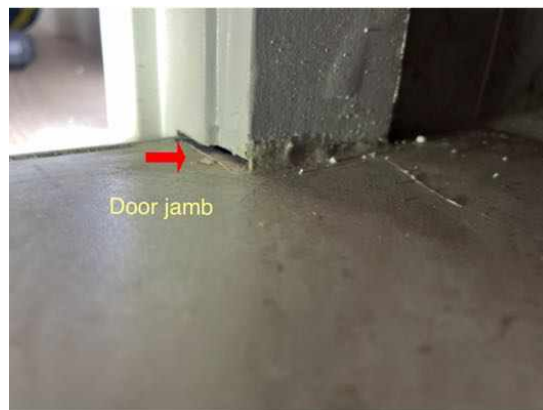
### Finding 3.19

Building:	Main Building
Location:	Bathroom
Finding:	Flexible sealants to junctions - poorly applied (AS 3958.1)
Information:	Sealant was observed to be poorly applied to tiled areas, presenting as uneven, smeared, or incomplete.

Flexible sealant is required at junctions to allow for movement while maintaining a watertight finish. As outlined in NSW Standards and Tolerances 12.7, flexible or waterproof sealants are defective if not installed where required by the NCC, AS 3958.1, or the manufacturer's installation requirements.

All affected areas must be properly sealed prior to handover.

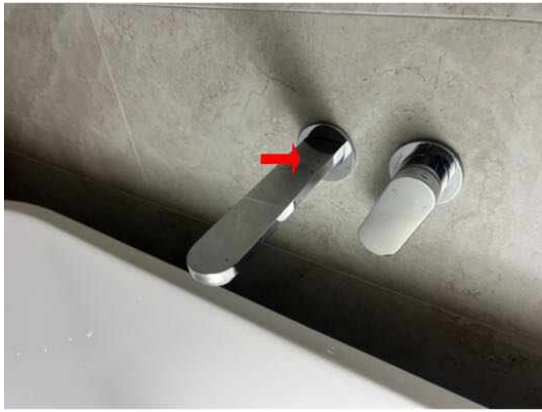
### Finding 3.20

Building:	Main Building
Location:	Bathroom
Finding:	Bath spout - Loose
Information:	The bath spout was observed to be loose at its connection point at the time of inspection. This condition is commonly caused by poor installation, deterioration of sealant, or movement in the fixture over time.

A bath spout may lead to water leakage behind the wall/floor, potentially causing moisture damage and deterioration of associated building elements if left unmanaged.

It is recommended that a licensed plumber be engaged to assess and properly secure the spout to prevent further movement and potential water ingress.

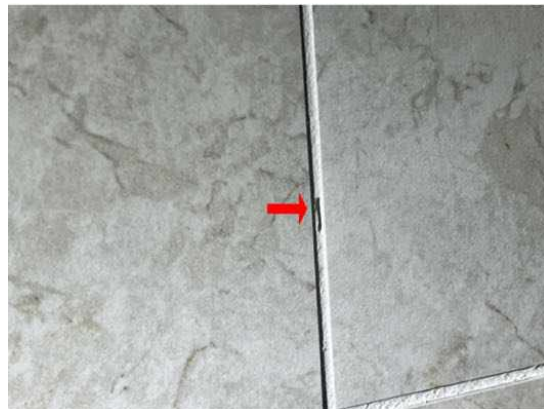
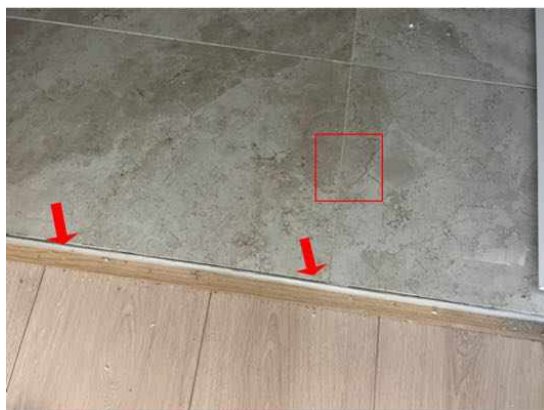
### Finding 3.21

Building: Main Building  
 Location: Bathroom  
 Finding: Grouting and joints - poorly applies (AS 3958.1)  
 Information: Grout was observed with pinholes, voids, and an uneven finish in several areas.

As outlined in NSW Standards and Tolerances 12.6, and in accordance with AS 3958.1 Clause 5.7, finished grout is defective if it is not uniform in colour, smooth, and free from voids, pinholes, or low spots.

All affected grout must be repaired to achieve a consistent and compliant finish prior to handover.

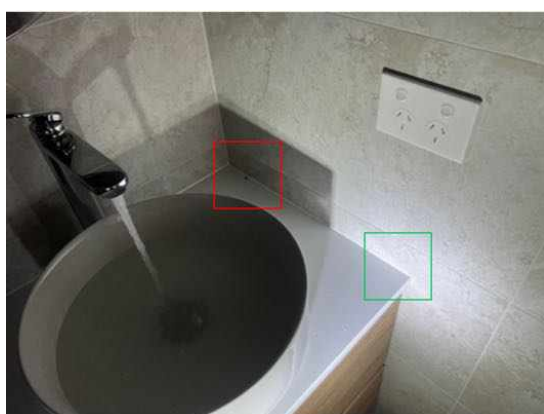
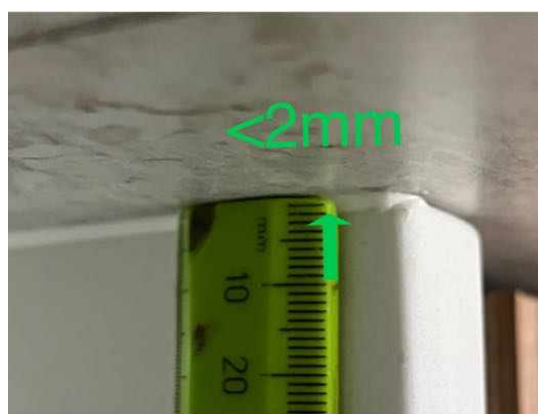
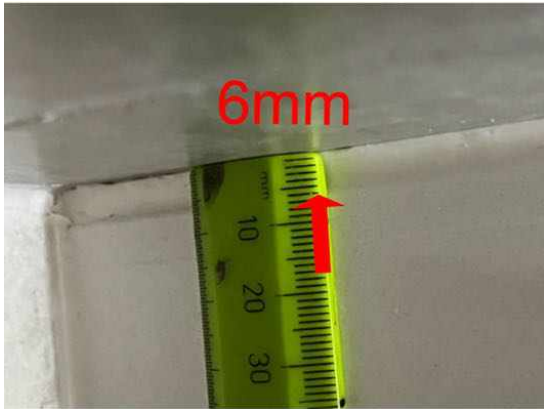
### Finding 3.22

Building:	Main Building
Location:	Bathroom
Finding:	Internal Fixing - Bench Tops, Doors and Drawer Fronts - Guide to Standards & Tolerances Part 11.4, AS 4386.1 (new con)
Information:	Cabinet doors, drawer fronts, or bench tops were observed with inconsistent gaps or misalignment visible from a normal viewing position. The Guide to Standards & Tolerances Part 11.4 states that, unless otherwise specified, cabinet door and drawer fronts are defective if they are not aligned or do not have consistent gaps between them at handover. Where the time limit for defects in bench tops, cabinet doors, drawer fronts, and similar joinery is not documented, it is to be taken as six months from completion. Reference can also be made to AS 4386.1 Domestic Kitchen Assemblies - Kitchen Units, which sets out performance and construction requirements for domestic cabinetry.

The client should consult with the builder to confirm how the installation complies with the Guide to Standards & Tolerances and AS 4386.1.

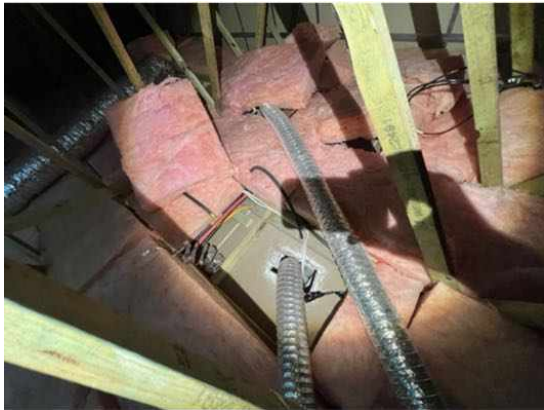
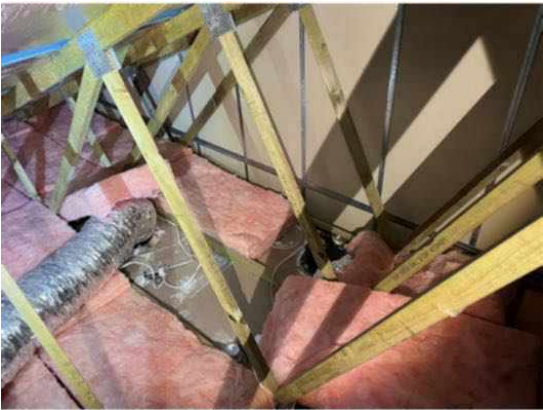
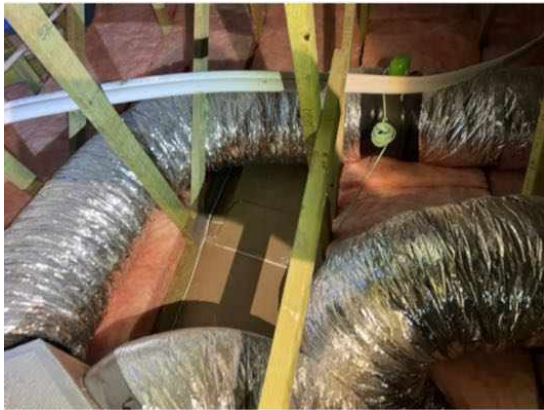
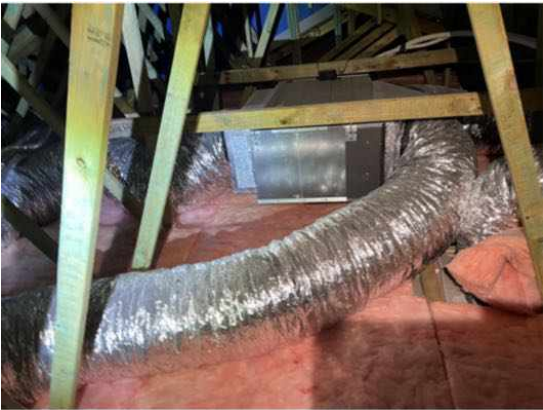
**Finding 3.23**

Building: Main Building  
Location: Roof Void  
Finding: Insulation - Displaced or Incomplete Coverage - AS 4859.1 (new con)  
Information: Sections of insulation were observed to be displaced or incorrectly positioned, likely as a result of post-installation disturbance by other trades. AS 4859.1 Materials for the Thermal Insulation of Buildings requires insulation to maintain continuous and uniform coverage without gaps or compression that could compromise performance. Research indicates that a 5% gap in insulation coverage can result in up to a 50% reduction in the overall thermal efficiency of the building. The client should consult with the builder to confirm that insulation has been reinstated to comply with AS 4859.1

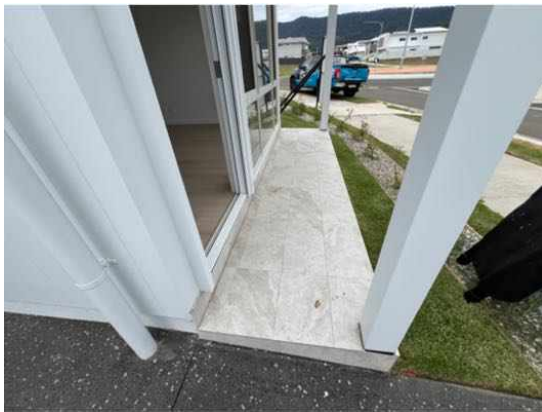
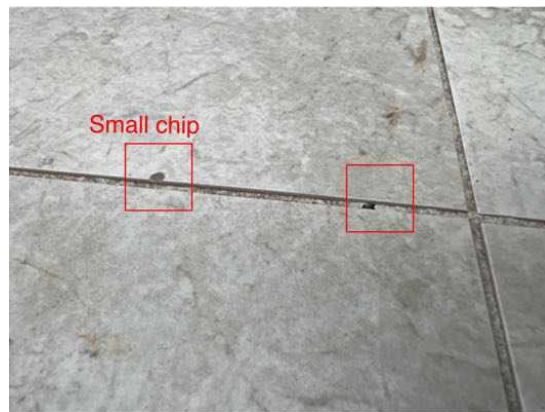
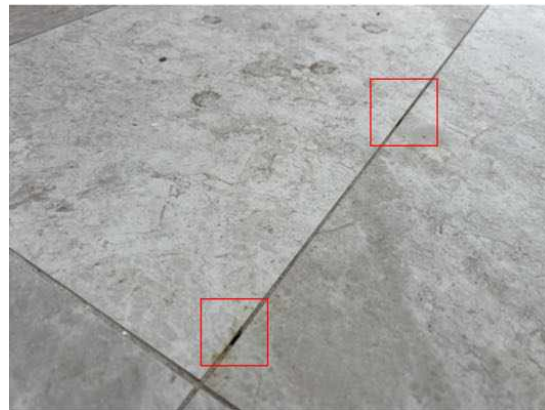
### Finding 3.24

Building:	Main Building
Location:	Porch
Finding:	Grout - Missing (AS 3958.1)
Information:	It was observed that grout is missing in certain areas between tiles.

Missing grout may lead to moisture ingress, tile movement, or deterioration of the surrounding finishes. The affected areas should be re-grouted to ensure durability and compliance with AS 3958.1.

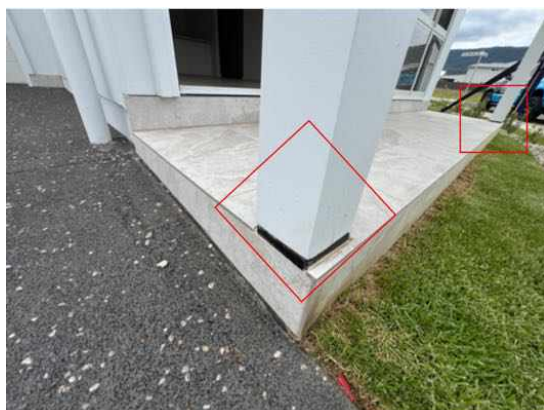
### Finding 6.04

Building: Main Building  
 Location: Porch, Alfresco  
 Finding: Bridging of termite barrier - Posts.  
 Information: Posts that are attached to home from ground to structure without a 75mm inspection

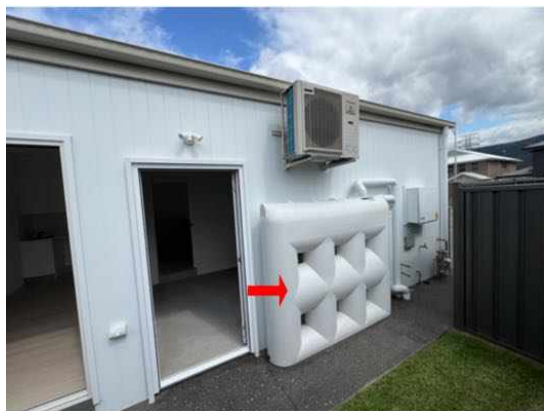
## Finding 6.05

Building:	Main Building
Location:	All External Areas
Finding:	Bridging (water Tank)- Attachments to Buildings
Information:	Water tank against home eliminates the inspection zone (area) and caused bridging and concealed entry. Bridging occurs when items against a building provide a concealed entry point for termites into the building or by passing around a termite management system.

Building attachments of this nature need to be frequently inspected for termite activity by a qualified inspector

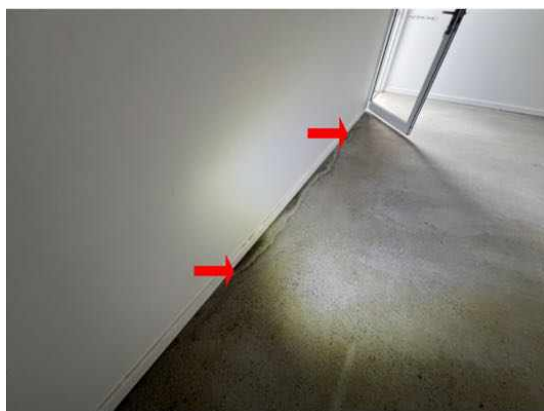
### Finding 6.06

Building:	Main Building
Location:	Garage
Finding:	Evidence of excessive moisture was present at the time of inspection (Photos shown in previous defect section)
Information:	Excessive moisture can attract termites and produce conditions that promote termite attack, fungal growth and wood decay. Excessive moisture is generally caused by deteriorated, inadequate or missing roof drainage, leaking plumbing pipes or fixtures, poorly plumbed HWS overflows or condenser units and poor site drainage. It is highly recommended that all plumbing and drainage fixtures and fittings be maintained regularly in order to prevent excessive moisture being present in the external / internal property.

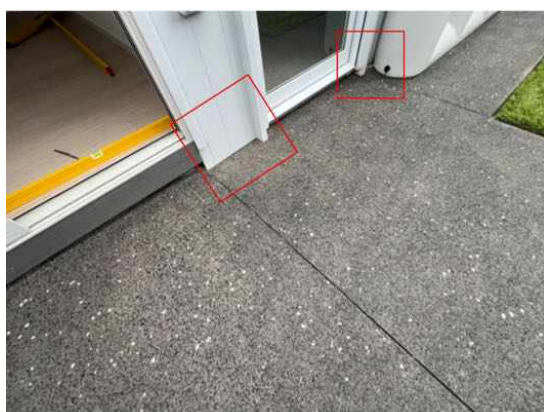
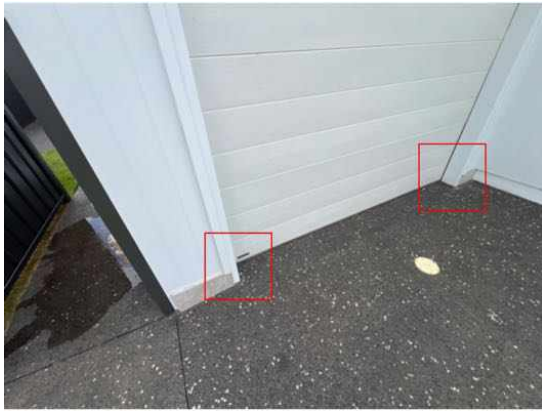
### Finding 6.07

Building:	Main Building
Location:	Yard - Side

Remove untreated timber that is in direct contact with external grounds. Consider replacement with more durable materials i.e. treated timber or non timber elements. Frequent pest inspections are advised to readily identify any termite activity in these areas.
