Building and Timber Pest Inspection Report

Inspection Date: Mon, 16 Mar 2026

Property Address: 4 Nardu Ct, Currimundi QLD 4551,
Australia

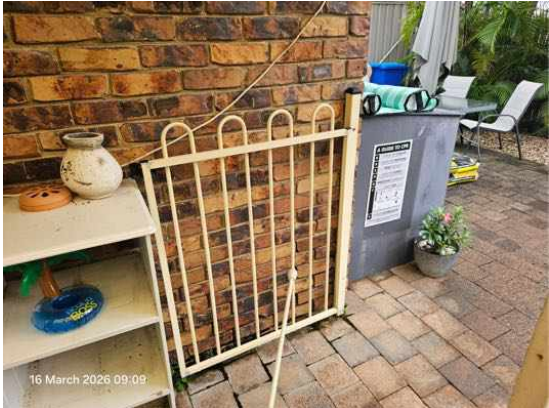
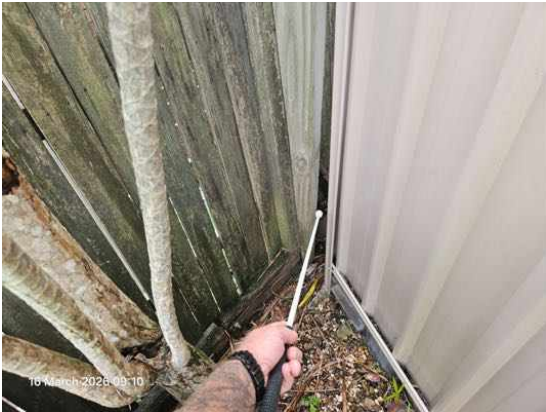
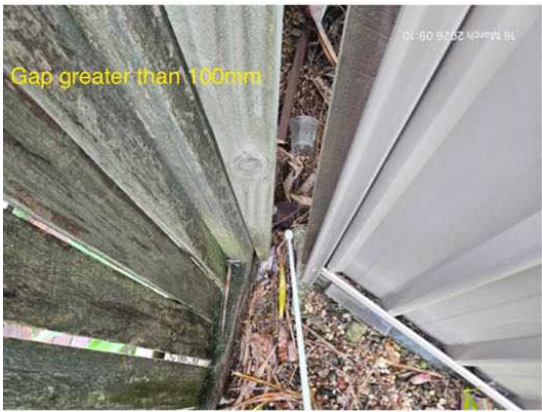
The gate from the rear patio did not operate effectively in the three required positions and at the front colorbond boundary fence intersection, the gap is greater than 100mm.

The recommendation is that these defects be rectified to complete the compliance.

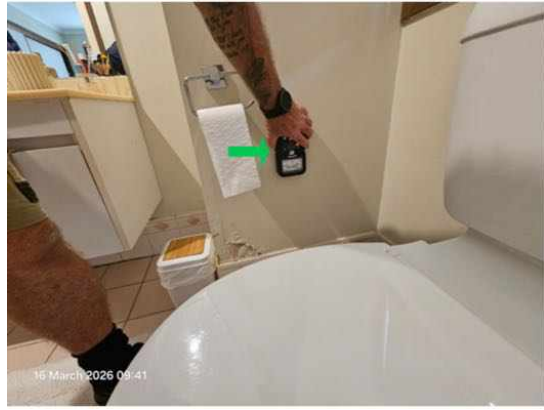
Building:	Main Building
Location:	Ensuite - Master
Finding:	High moisture, damage to external wall
Information:	Elevated moisture was noted in the lower wall surface of the internal and external walls of the ensuite. The levels were higher at floor level and declined as readings were taken higher up the wall surface. The elevated readings are also present on the opposing side in the toilet where damage was noted in the skirting tile level of the plasterboard.

This situation has created a high risk of water ingress damage and a high risk level for timber pests. This is the ideal environment for termites to develop an active presence.

This will require further investigation to identify the source of the leak / water ingress and to assess any related damage to framing. This should be done with some urgency.

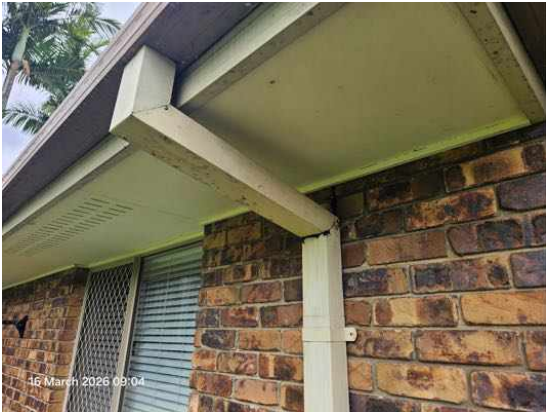
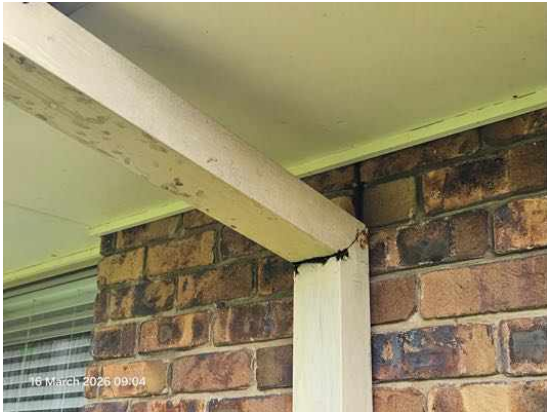
Building:	Main Building
Location:	As shown
Finding:	Downpipe leaking
Information:	During the inspection of the perimeter of the building it was noted that there was two downpipes leaking.

Leaking downpipes can create excess moisture at the building perimeter, leading to conditions conducive attractive to timber pests.

The client could engage a plumber to assess and resolve the leak.

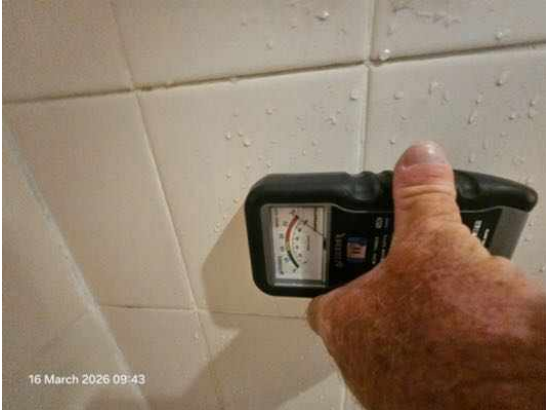
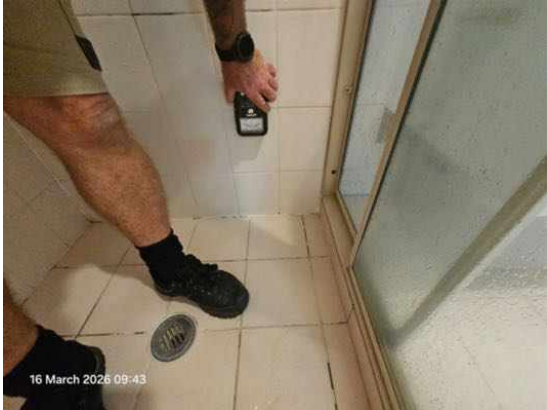
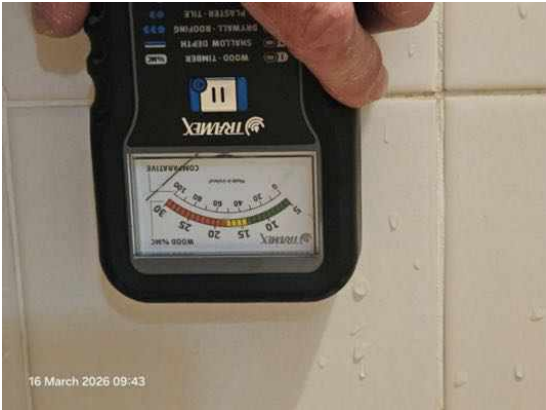
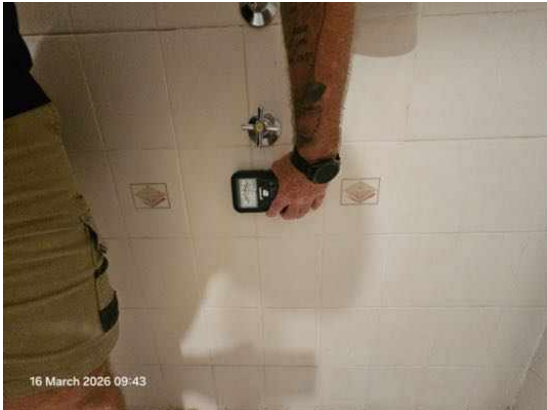
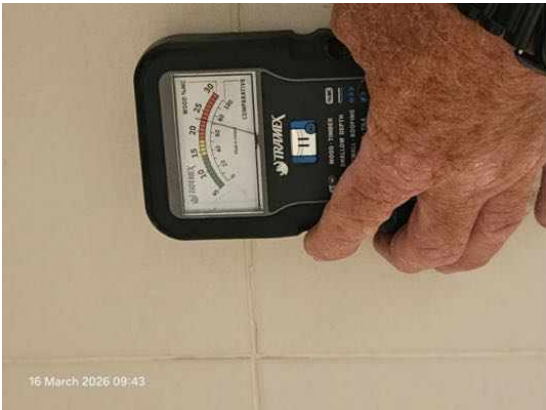
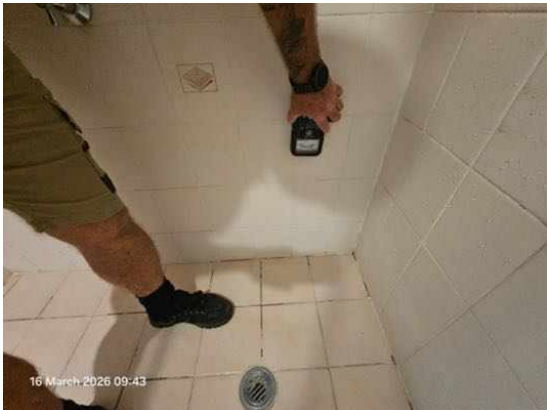
Building:	Main Building
Location:	Ensuite - Master
Finding:	Elevated moisture present - ensuite shower
Information:	Elevated moisture was noted in the tiled wall surfaces of the ensuite shower.

The levels varied at differing points throughout the recess. This could possibly be due to deteriorated grout and silicone sealants and / or plumbing fittings and fixtures. The grouts and sealants can break down over time and become porous, allowing moisture to enter the wall sheet surface behind the tiles. Some deterioration of the grout and sealants was noted.

Moisture was not detected the in the wall on the reverse side of the shower in the hallway.

Elevated moisture can attract timber pests and vermin, and produce conditions that promote timber pest attack, fungal growth and wood decay.

It is recommended that the moisture levels in these areas be monitored over time and the grout and silicone be renewed to possibly eliminate any further moisture penetration.

A licensed tiler and / or sealant specialist could be engaged to renew these elements.

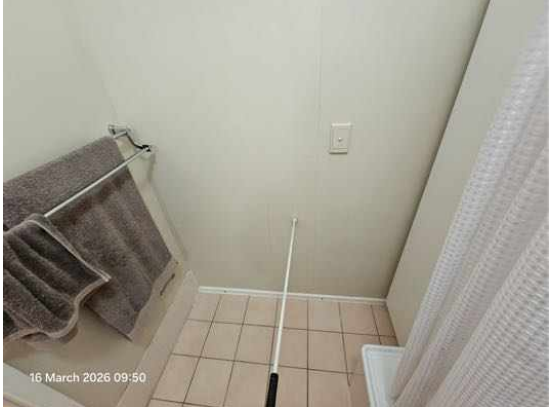
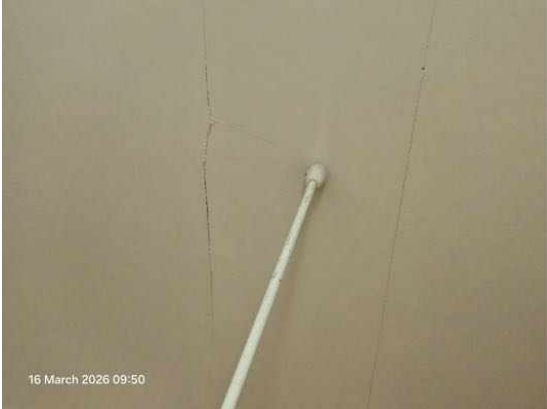
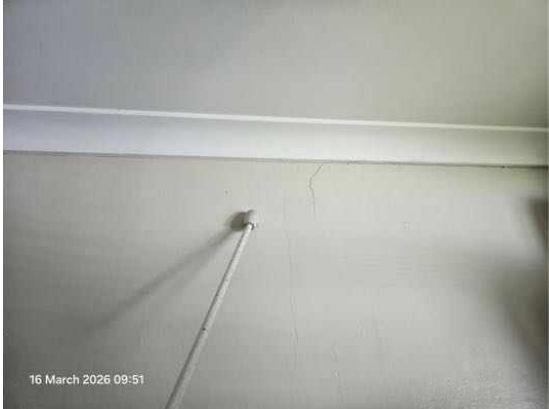
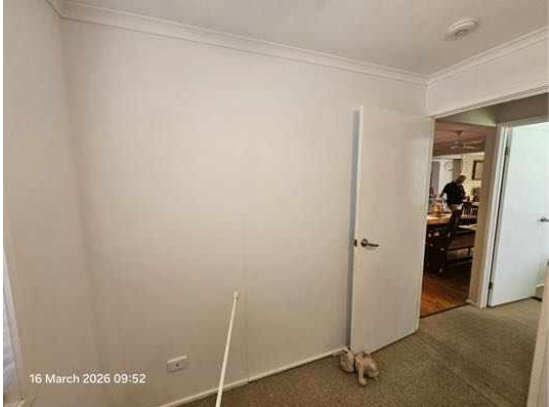
Finding 3.08

Building: Main Building
Location: As shown
Finding: Minor movement cracking
Information: On the day of inspection minor movement cracking and plaster / paint defects were noted.

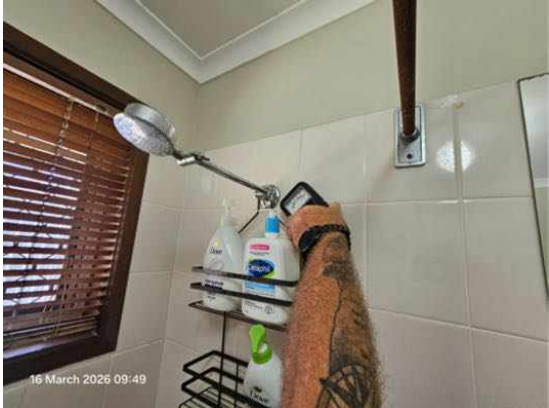
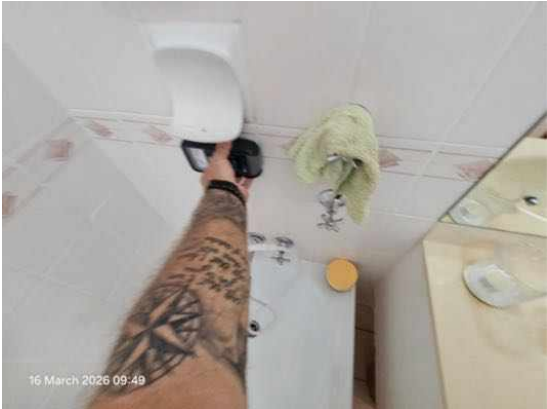
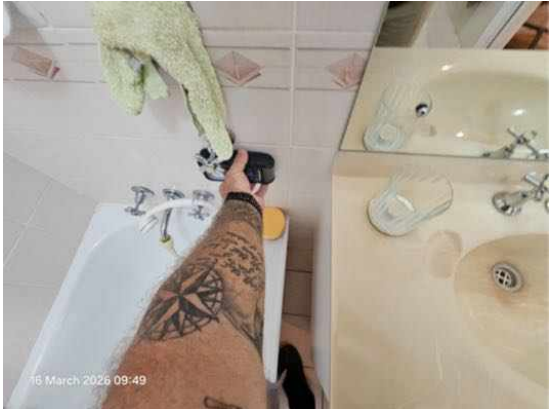
Building: Main Building
Location: Bathroom
Finding: No moisture detected in bathroom
Information: On the day of inspection the shower in the bathroom was measured for moisture using a "Tramex" moisture meter. During this inspection no moisture was detected in these areas and the tiled / sheeted surfaces appear to be in good order.

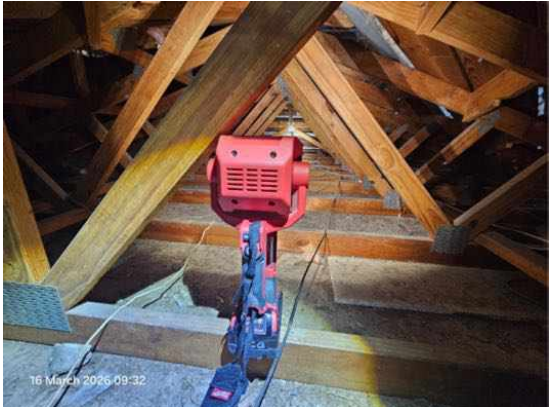
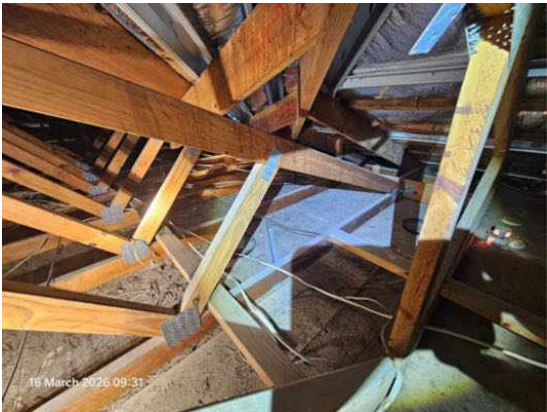
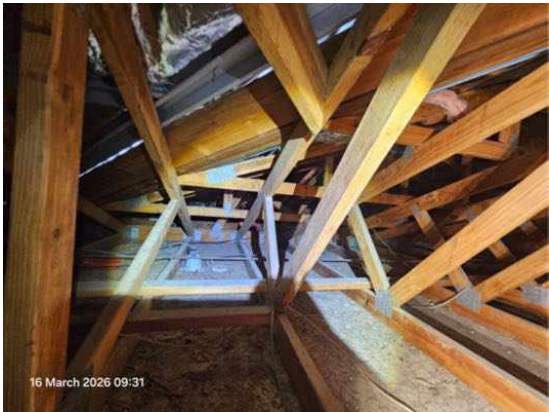
Building: Main Building
Location: All Areas
Finding: Additional Photos - Obstructions and Limitations
Information: These photographs are an indication of the obstructions and limitations which impeded full inspection of the property at the time of inspection. These obstructions can prevent full inspections of the areas shown.

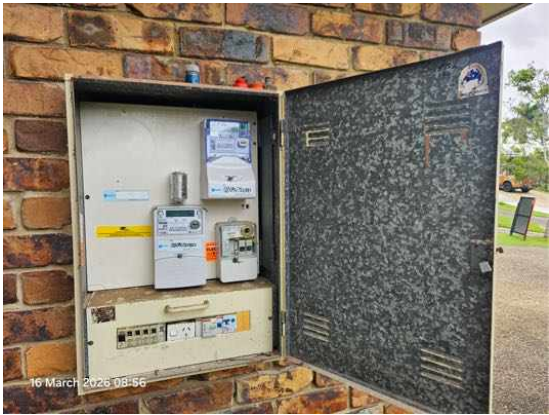
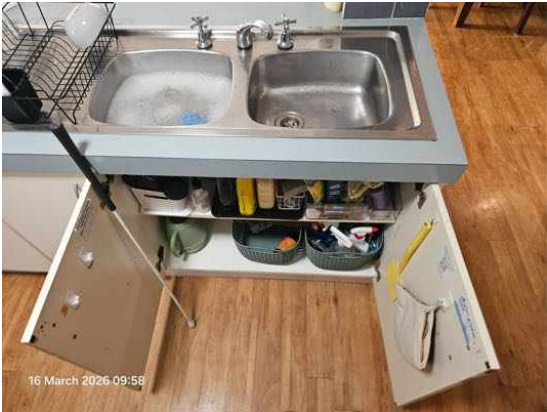
Building: Main Building
Location: Meter box, kitchen cupboard
Finding: Durable pest inspection notice - not assessable
Information: On the day of inspection it was noted that the durable timber pest inspection / treatment notice was missing, not visible or out of date. These notices / stickers are to verify the timber pest inspection dates, the inspector, the currency and type of timber pest system / barrier in place or being used in and around the property.

Annual, or more regular, inspections are crucial in maintaining and managing the properties timber pest risk profile. By not having regular inspections of the property raises the properties risk of undetected defects and damage. Without regular inspection at intervals of not greater than annually the buildings risk profile will categorised as high. Properties with trees within 50m and with gardens close to the building are at greater risk and will have a high risk profile.

It is recommend that a licensed timber pest controller be contacted to assess the properties needs and provide costings for an annual inspection programme.

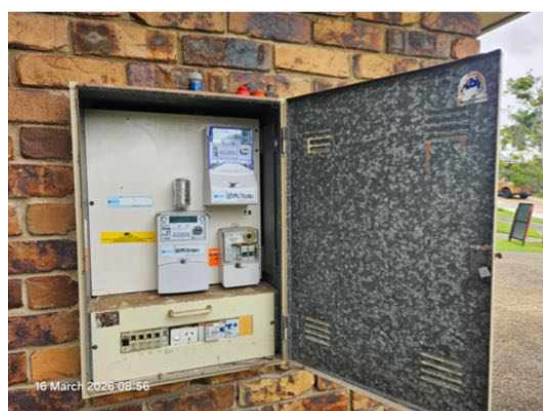
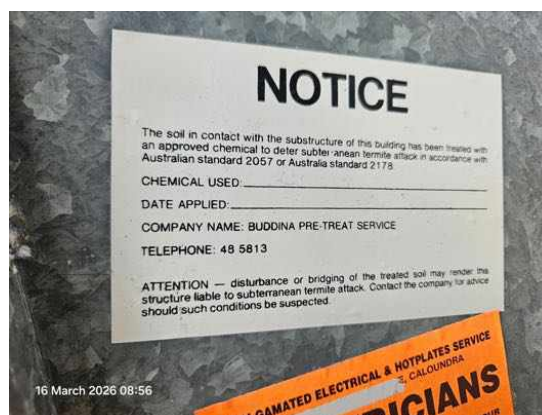
The building originally employed a chemical underslab spray as a barrier system. No other system was identified. A barrier is strongly recommended.

In order for a barrier system to be effective, the property must have regular inspections at intervals of not greater than 12 months. Depending on the risk profile attributed to the property, these inspections may be recommended at lesser time periods.
