Building Inspection Report

Inspection Date: Wed, 1 Apr 2026

Property Address: 512/229 Toorak Rd, South Yarra VIC 3141,
Australia

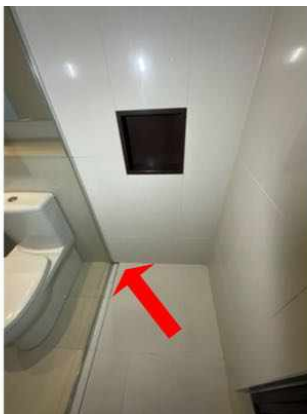
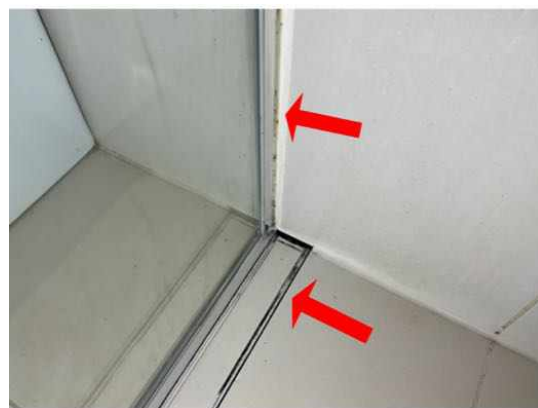
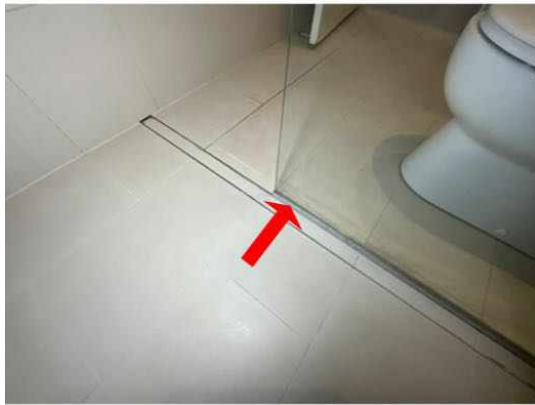
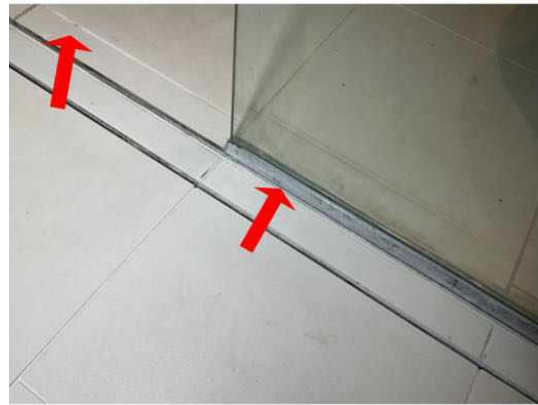
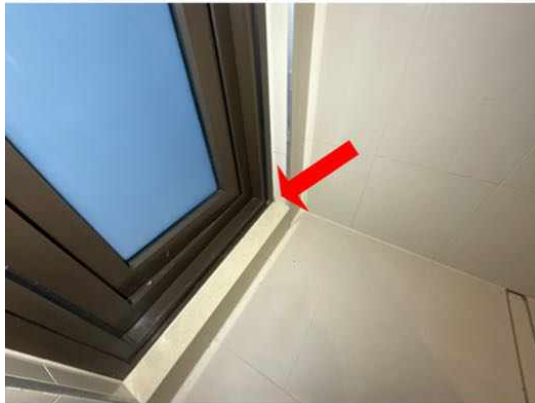
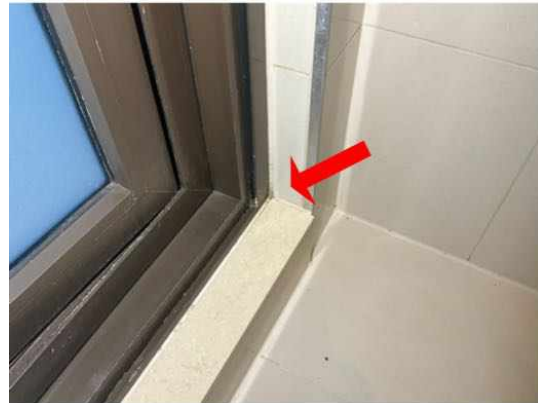
Defects 3.01

Location: Bathroom

Finding: Sealant / Grout - Degraded and mouldy within the shower

Information: Sealant / Grout is degraded in this area. Sealant and grout is used to protect gaps and crevices in building materials to ensure that they are water-tight and prevent water penetration to the associated structures.

Failure to do so is likely to lead to further deterioration of the sealant and grout which in turn can lead to water damage to the surrounding area.

Grout and sealant is deteriorated in some areas within the shower. It is recommended that the shower be freshened up with old grout and sealant scraped out and new grout and sealant installed.

Where sealant or grout is damaged or mouldy , a tiling contractor should be appointed immediately to scrape out and re-apply where necessary.

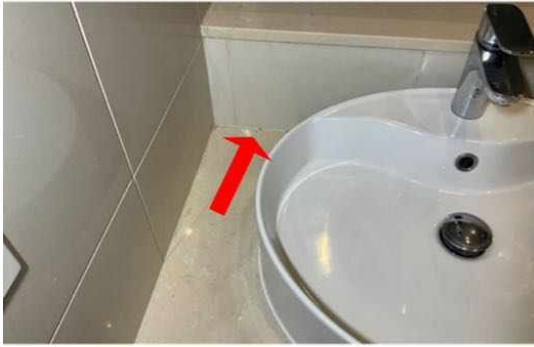
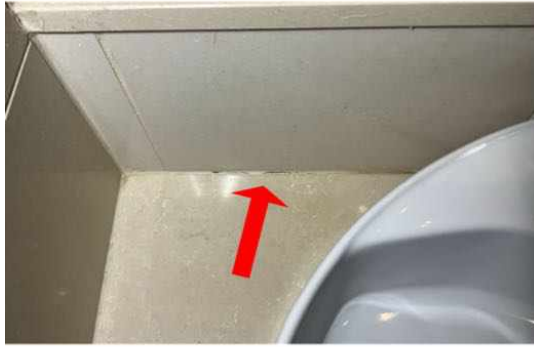
Defects 3.02

Location: Bathroom

Finding: Sealant - Damaged or Missing

Information: Sealant is damaged/ deteriorated behind the vanity in the bathroom. Sealant is used to protect gaps and crevices in building materials to ensure that they are water-tight and prevent water penetration to the associated structures.

Failure to do so may lead to further deterioration of the sealant which in turn can lead to water damage to the surrounding area.

Where sealant is missing or damaged , a competent handyman may be appointed to scrape out and re-apply any silicone where necessary.

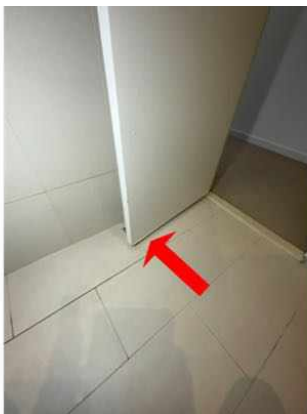
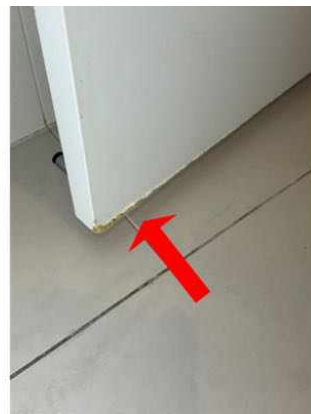
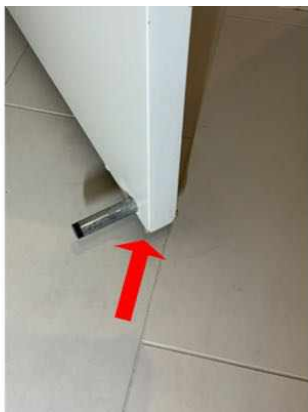
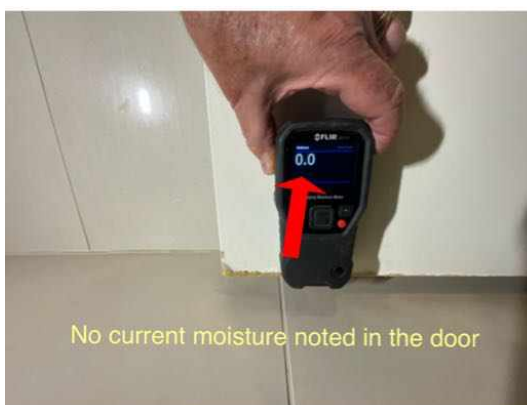
Defects 3.03

Location: Bathroom

Finding: Door showing signs of damage to the base

Information: At the time of inspection there appeared to be some slight moisture damage at the base of the door in bathroom. It is suspected this may have occurred due to water spills within the bathroom.

Doors should be sealed on all faces including top and bottom to prevent moisture seeping into the door structure and potentially causing secondary damage.

A suitably qualified handyman or painter should be engaged to remove doors, repair any damage, paint the door including top and bottom and rehang them.

If the door cannot be repaired, a new door may be required.

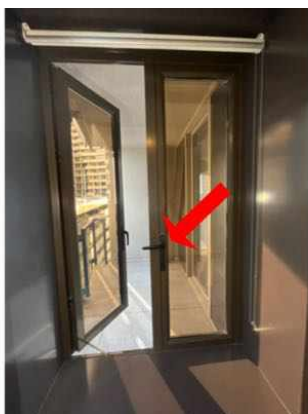
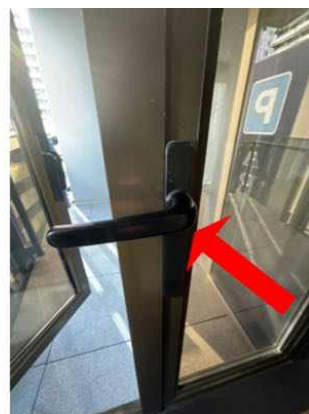
Defects 3.04

Location: Bedroom

Finding: Window - Not able to be opened

Information: This window in the bedroom was not able to be opened at the time of the inspection due to the handle / opening mechanism not working (it just spun around) .

Windows provide ventilation to the adjoining area and should be at a fully operational level to ensure user comfort. If window can not be opened, this can potentially provide a safety matter and must be addressed as a matter of urgency.

A suitably qualified window installer may be engaged to rectify this.

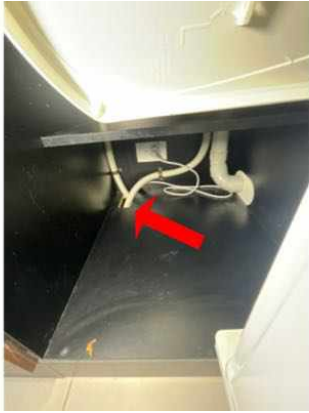
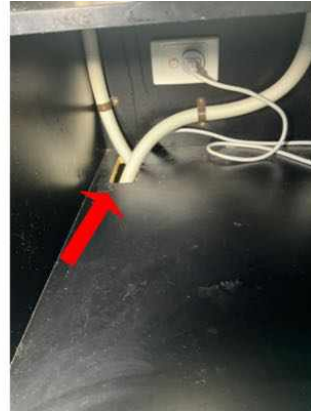
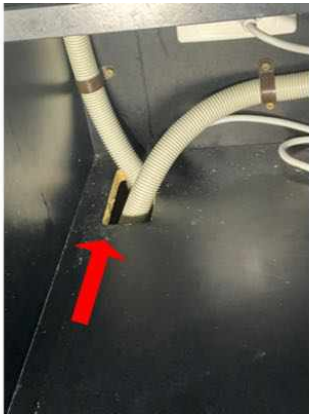
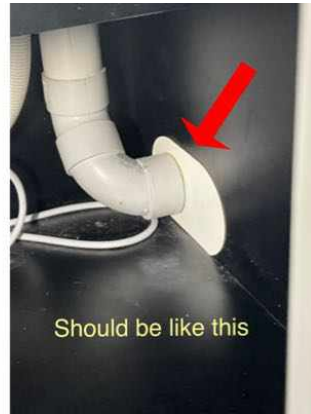
Defects 3.05

Location: Kitchen

Finding: Pipe penetration within kitchen sink cupboard not sealed properly

Information: At the time of inspection the pipe penetration within the kitchen sink cupboard was not properly sealed - with a large gap noted around the pipes.

This has the potential to allow potential pest ingress into the kitchen area.

The gap should be sealed with appropriate material (adhesive backed panels can be used to cover the holes) as per the other pipe intrusion.

This task can be performed by the homeowner or a competent handyman.

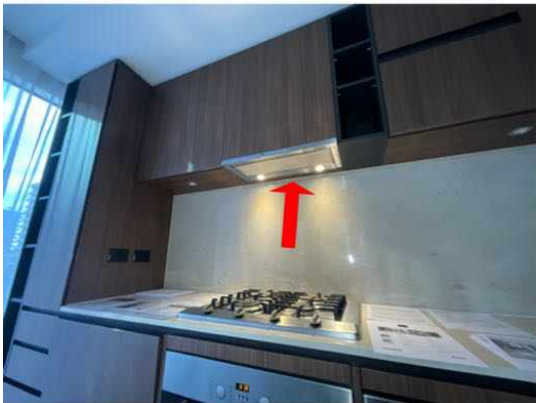
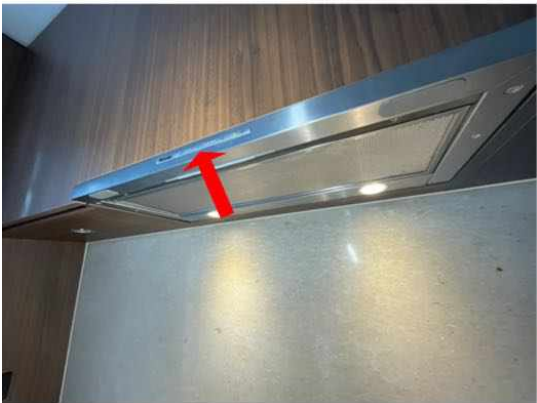
Defects 3.06

Location: Kitchen

Finding: Rangehood - Fan not working

Information: The fan to the rangehood was not working at the time of inspection.

Without a functional fan, a build-up of grease and evaporative moisture is likely to accelerate deterioration of the range hood. This potential build up may also create a minor fire hazard, particularly if left uncleaned.

A licensed electrician should be appointed to repair or replace the range hood to restore it to a fully operational state.

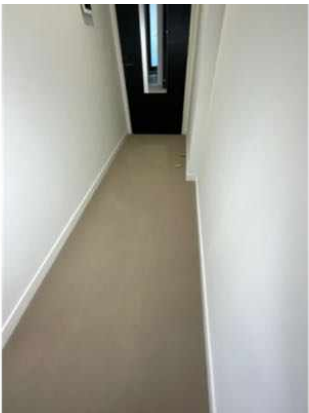
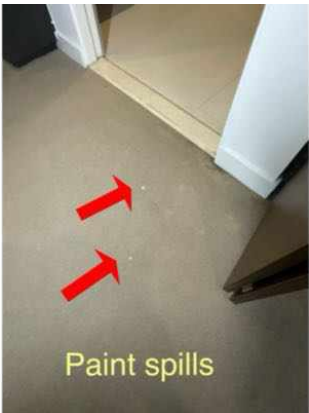
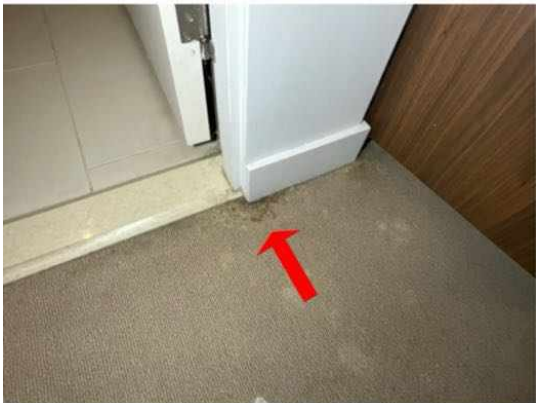
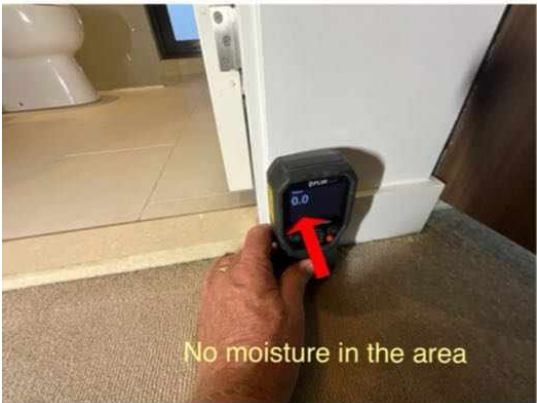
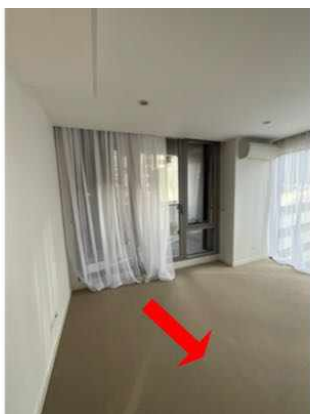
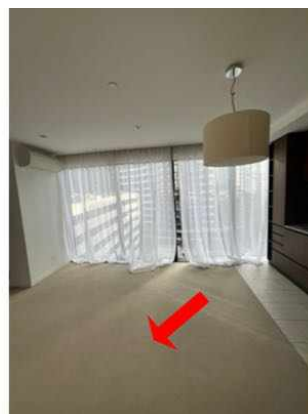
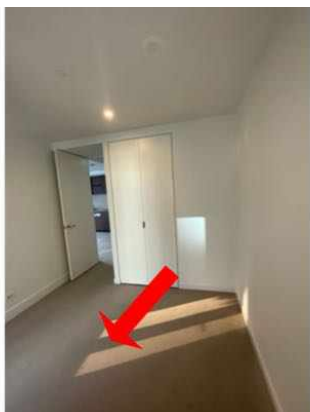
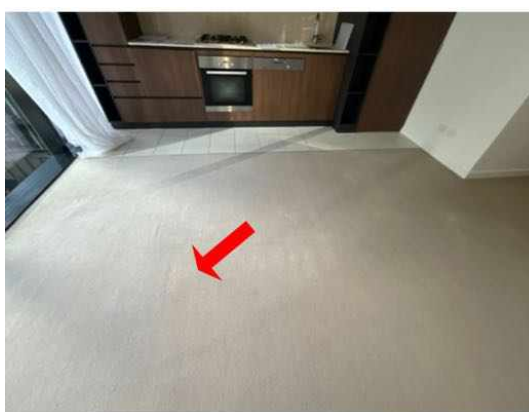
Defects 3.07

Location: All Areas

Finding: Carpet deteriorated in some areas

Information: At the time of inspection, some areas of the carpet throughout the property showed signs of wear . This is consistent with properties of this age, in particular where the property hasn't been looked after.

Should the carpet deteriorate further, the carpet may be replaced at the discretion of the homeowner.

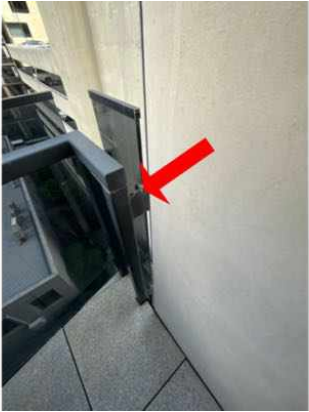
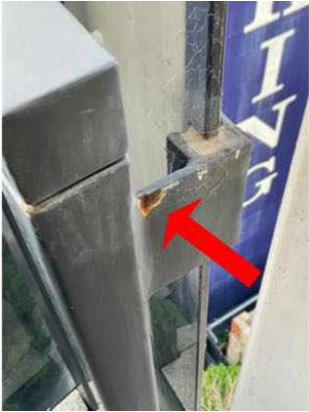
Defects 3.08

Location: Balcony

Finding: Balcony rail - Rusted or corroded

Information: This balcony rail shows evidence of slight rusting and corrosion, which is likely to have developed as a result of excessive exposure to moisture and or inadequate coatings.

As surface rust provides no protection to the underlying iron, the deteriorating condition is likely to worsen if not addressed in the short-term future.

Where possible, the use of galvanized (treated) metals or aluminium coated metals aid in rust prevention, as does regular general maintenance. Rusting and corrosion should be managed by ideally removing or limiting the affected surface from exposure to moisture. Rust formation can be controlled with coatings, such as paint, that isolate the iron from the environment.

Where sealing with a specialised coating is not effective, a registered builder may be appointed to replace any building elements that have been severely affected by rust or water damage.

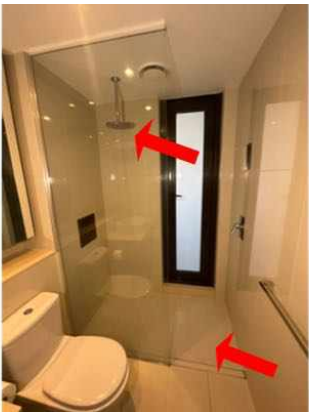
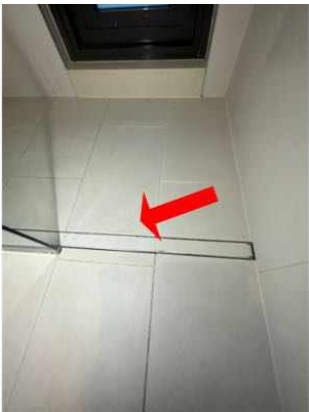
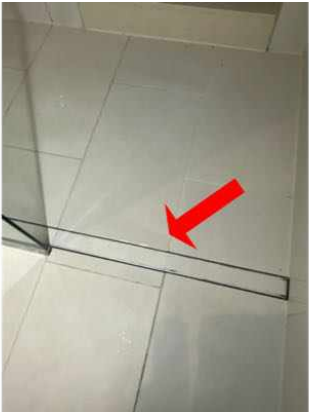
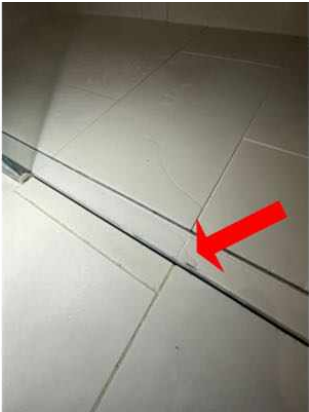
Building:
Location: Bathroom
Finding: Additional Photos for your information - water from shower may escape when in use
Information: It was noted at the time of inspection that water from the shower runs to the very edge of the shower enclosure. Whilst there is a small lip at the edge of the shower enclosure, it is suspected that water may escape this area when the shower is being used.

Monitoring of the area should be conducted to ensure that the moisture stays within the shower enclosure.

Should water escape, consultation with a bathroom specialist is advised to look at ways to retain the water within the shower.

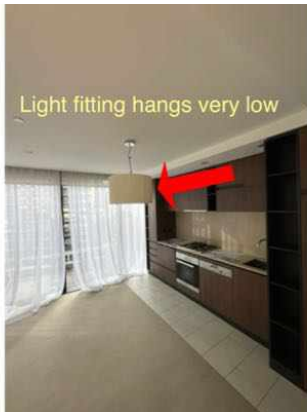
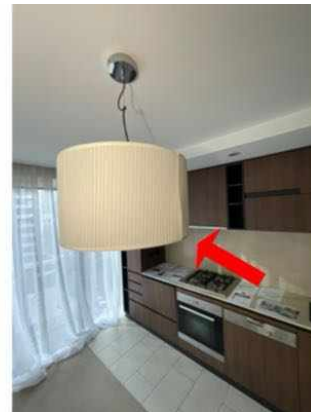
Location: All Areas
Finding: Light fitting hangs low
Information: It was noted at the time of inspection that the light fitting within the living area hung very low.

This may pose a problem and can be rectified with installing a new light fitting at the discretion of the homeowner.

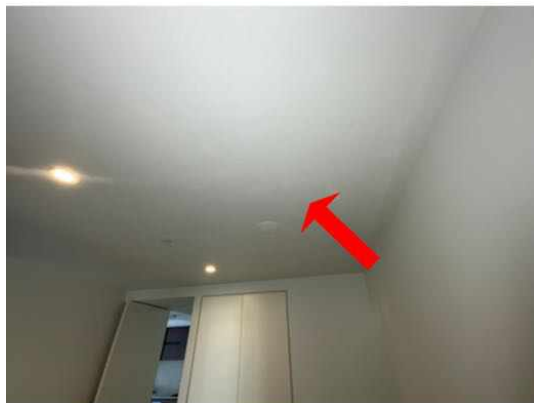
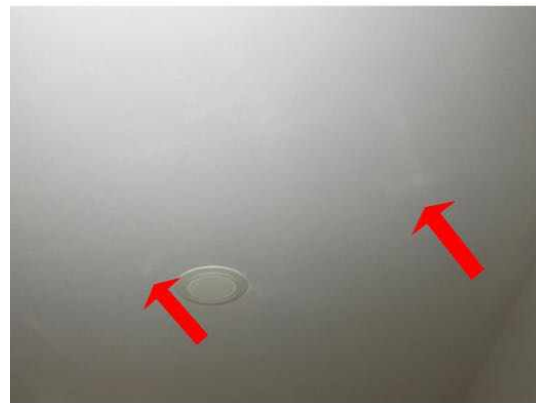
Building:
Location: Bedroom
Finding: Additional Photos for your information - ceiling has been re painted in some areas
Information: Additional photos are provided for your general reference.
