Building and Timber Pest Inspection Report

Inspection Date: Wed, 28 Jan 2026

Property Address: 11 Tilgman St, Berry NSW 2535, Australia

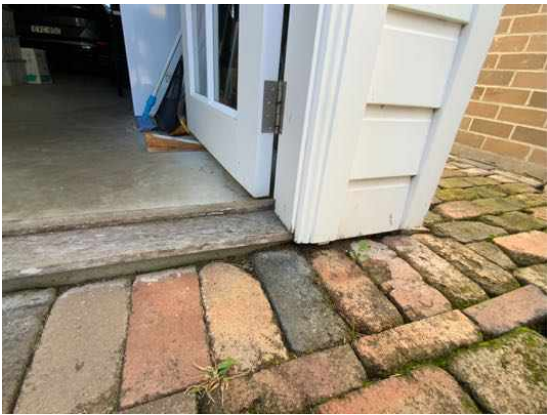
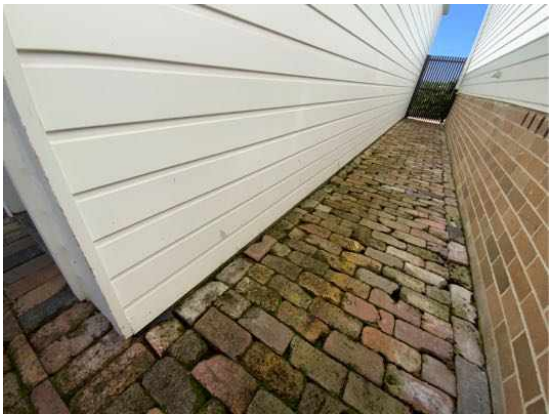
Where the slab edge cannot be properly inspected, it is highly recommended that termite or timber pest inspections be carried out every 6-12 months to aid protection of the property against infestation.

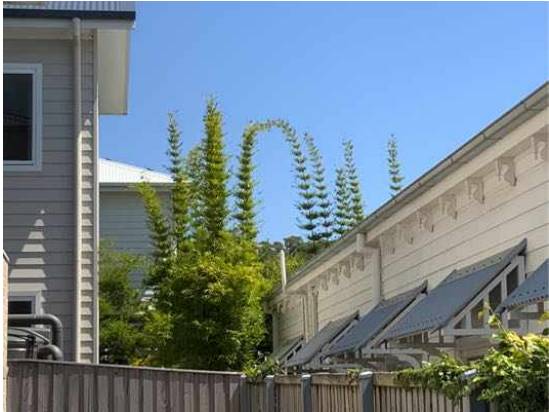
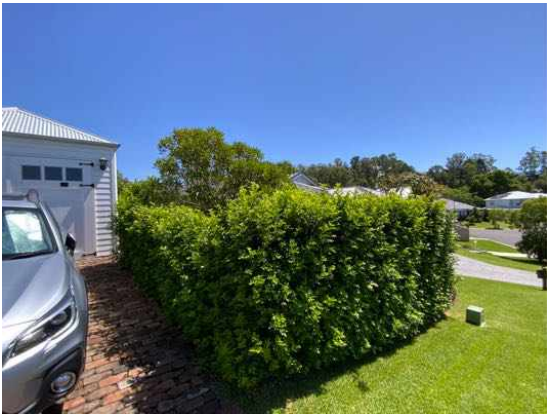
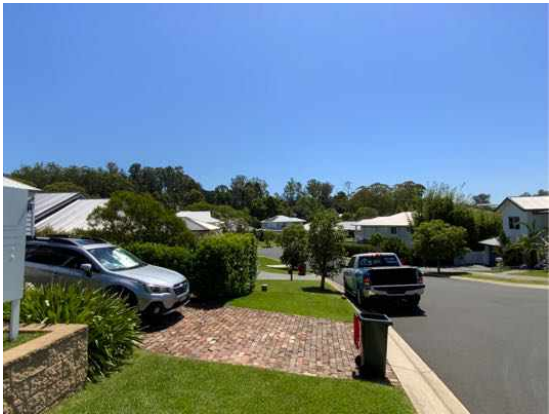
Finding 6.06

Building: Main Building
Location: All Areas
Finding: Trees within 50m of the property
Information: Trees within 50m of the property can be conducive to termite activity. It is recommended an invasive inspection of all trees with 50m to the property be carried out by a qualified pest control expert.

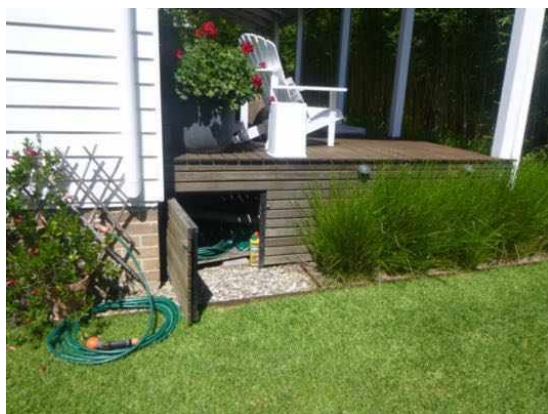
Finding 6.07

Location: Subfloor
Finding: Subfloor - Lack of ventilation
Information: It was noted at the time of inspection that the subfloor area lacks adequate ventilation. Ventilation can be restricted by a variety of minor defects, including obstructions in the subfloor space, a lack of vents or a low clearance.

A well ventilated subfloor aids in maintaining dry conditions, preventing secondary damage such as wood rot and pest activity, as well as preventing the development of mould and mildew (which can lead to respiratory safety hazards for occupants).

The initial step in improving ventilation is to ensure that the subfloor area is free of any debris or stored items. Where ventilation is still inadequate, it is advised to ensure that all vents are clear of blockages, and additional vents may be installed.

The client may also consider mechanical ventilation (powered fans) to improve subfloor airflow. Remedial works should be conducted as a matter of urgency to protect against the development of potentially harmful subfloor conditions.

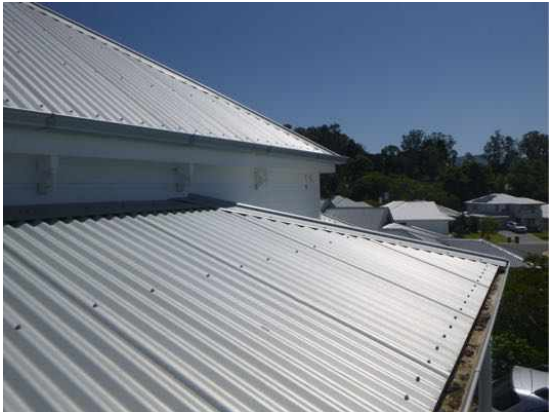
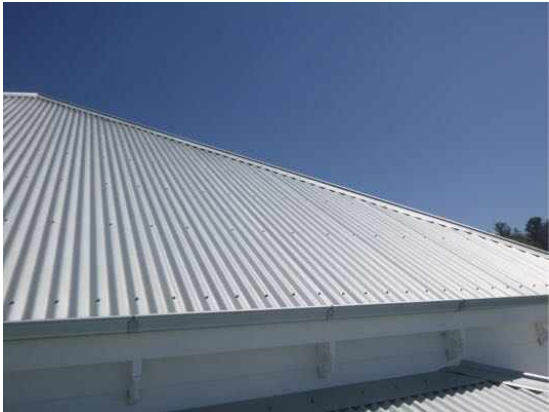
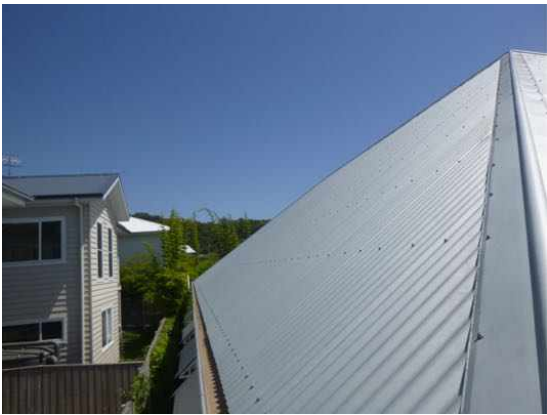
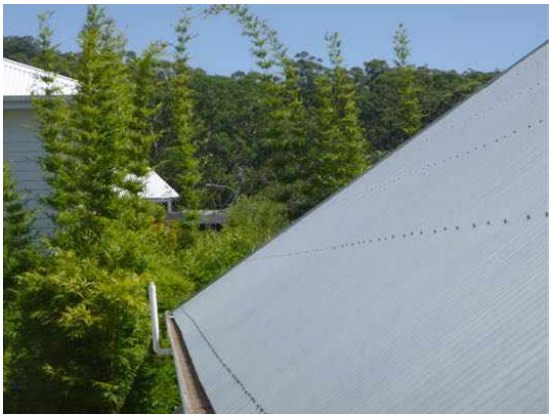
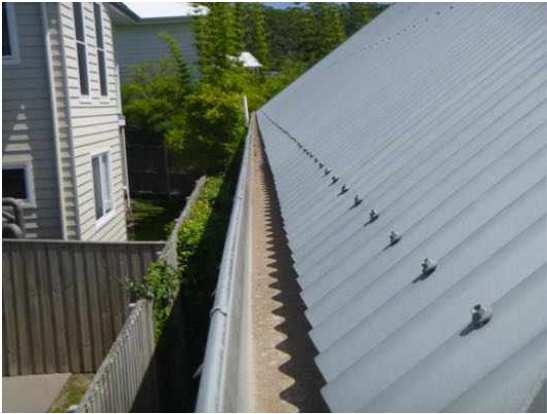
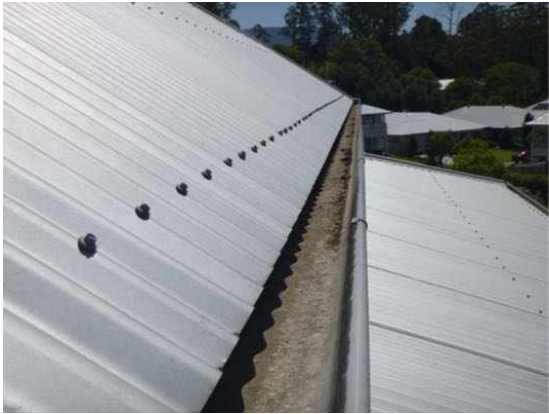
Building: Main Building
Location: Roof Exterior
Finding: Additional Photos - Obstructions and Limitations
Information: These photographs are an indication of the obstructions and limitations which impeded full inspection of the property at the time of inspection. These obstructions can hide an array of defects and should be removed to allow full inspection to be carried out. A re-inspection is recommended once the areas are made accessible.

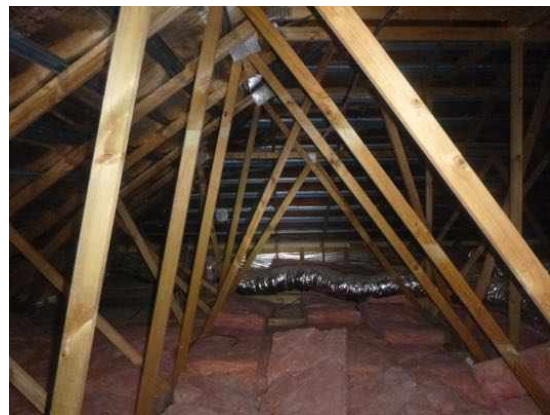
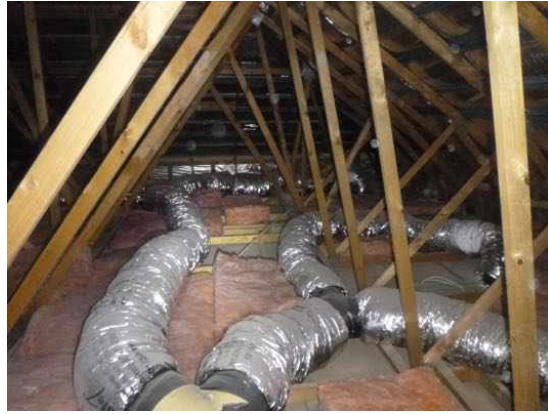
Building: Main Building
 Location: Roof Void
 Finding: Additional Photos - Obstructions and Limitations
 Information: These photographs are an indication of the obstructions and limitations which impeded full inspection of the property at the time of inspection. These obstructions can hide an array of defects and should be removed to allow full inspection to be carried out. A re-inspection is recommended once the areas are made accessible.

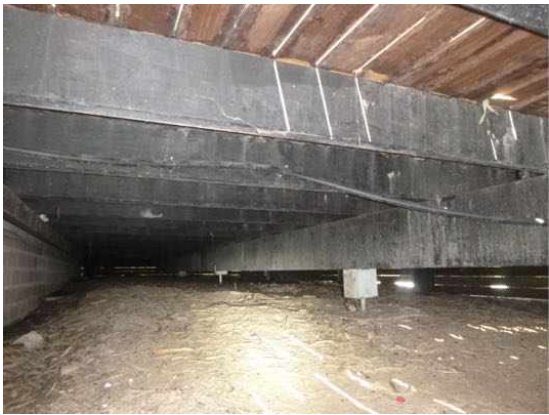
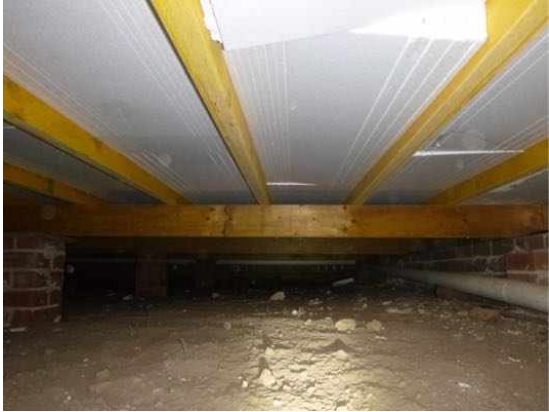
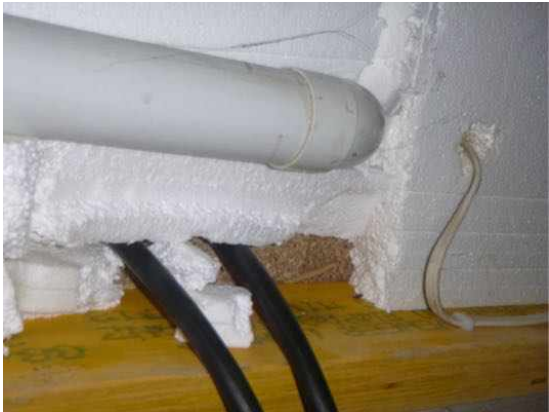
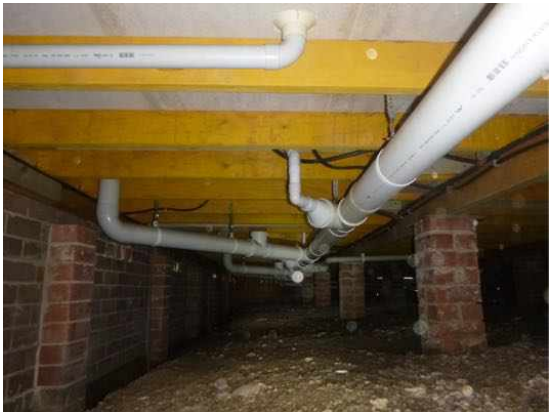
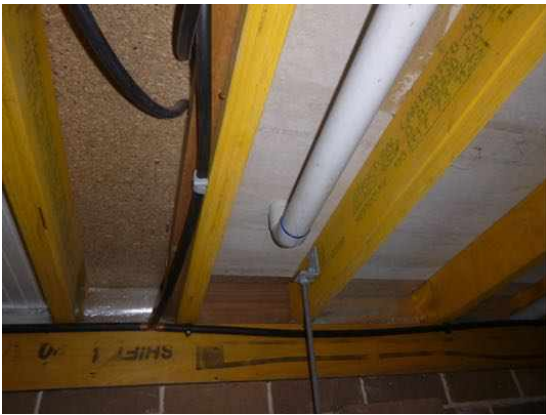
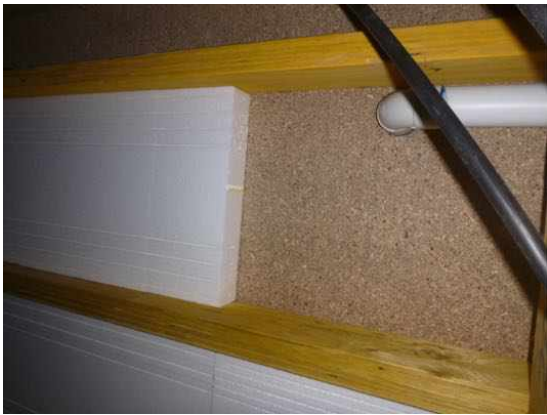
Building:	Main Building
Location:	Subfloor
Finding:	Additional Photos - Obstructions and Limitations
Information:	These photographs are an indication of the obstructions and limitations which impeded full inspection of the property at the time of inspection. These obstructions can hide an array of defects and should be removed to allow full inspection to be carried out. A re-inspection is recommended once the areas are made accessible.

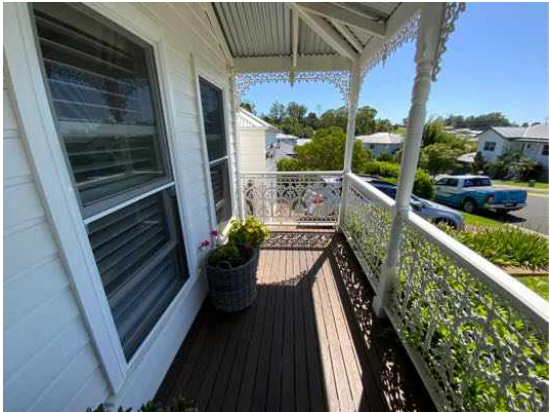
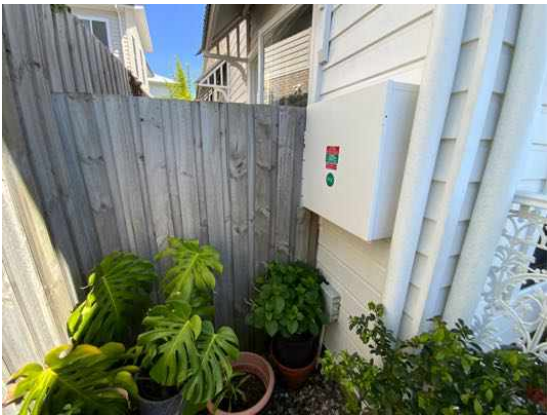
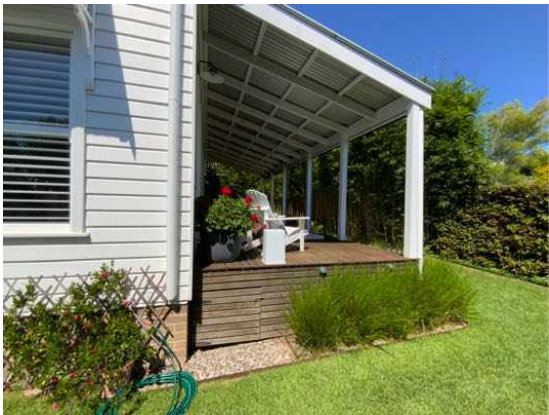
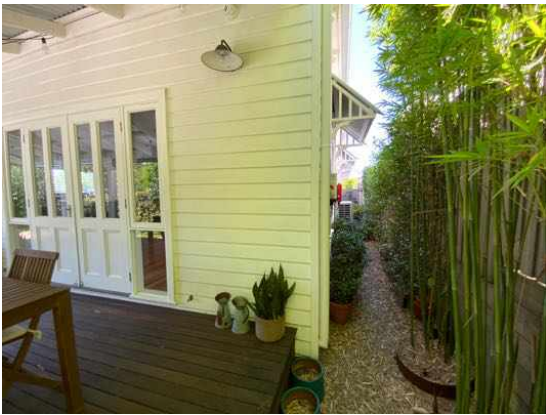
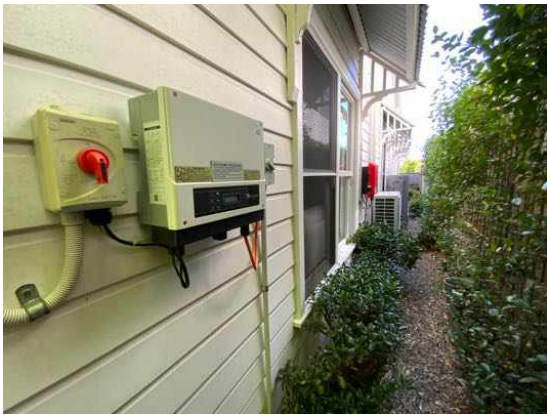
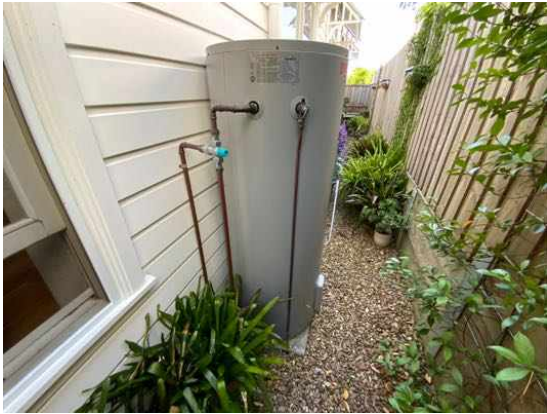
Building: Main Building
Location: All Areas
Finding: Additional Photos - Obstructions and Limitations
Information: These photographs are an indication of the obstructions and limitations which impeded full inspection of the property at the time of inspection. These obstructions can hide an array of defects and should be removed to allow full inspection to be carried out. A re-inspection is recommended once the areas are made accessible.

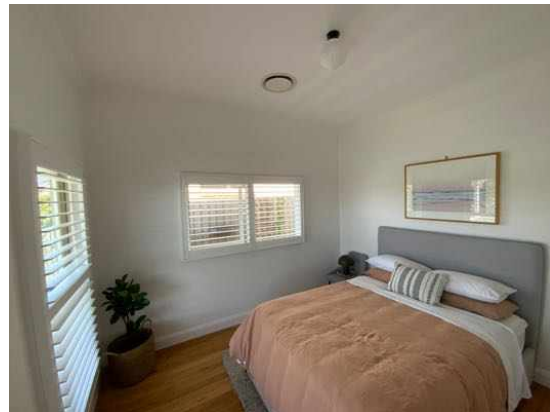
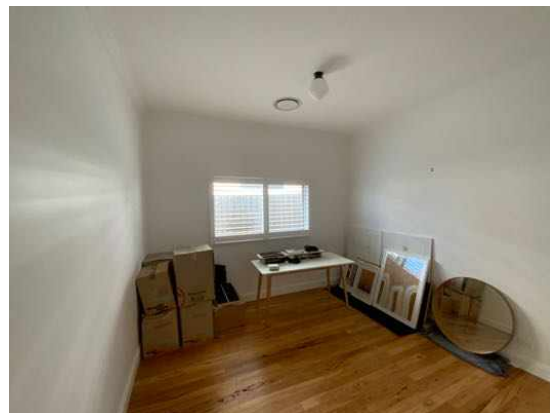
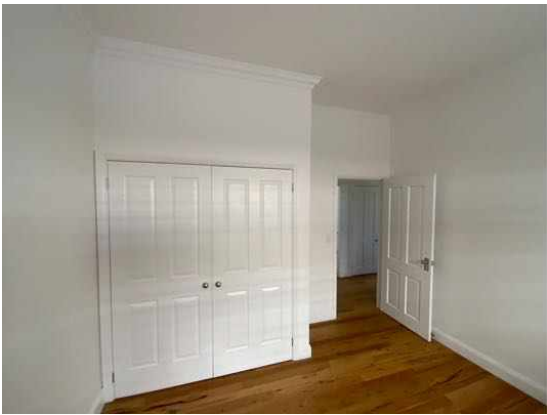
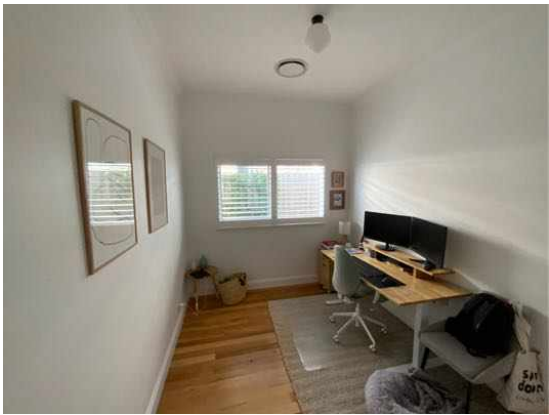
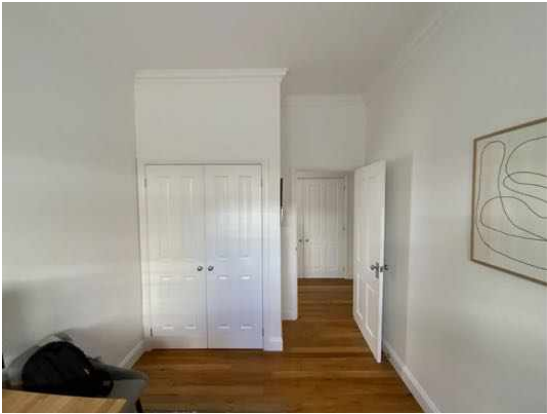
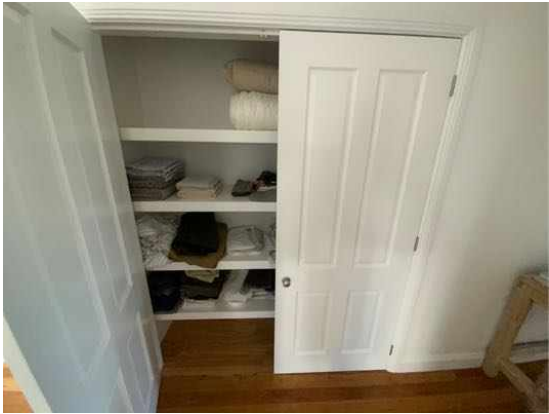
Finding: Additional Photos - Obstructions and Limitations

Information: These photographs are an indication of the obstructions and limitations which impeded full inspection of the property at the time of inspection. These obstructions can hide an array of defects and should be removed to allow full inspection to be carried out. A re-inspection is recommended once the areas are made accessible.

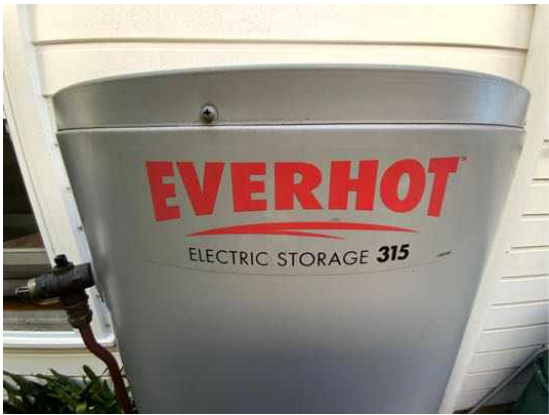
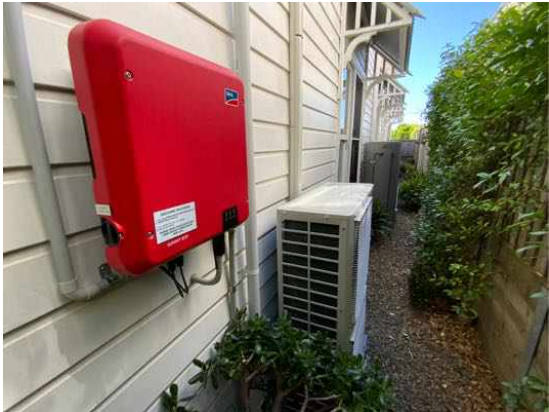
Building: Main Building
 Location: All Areas
 Finding: Additional Photos
 Information:

Additional photos are provided for your general reference. Arrows have been included to highlight areas of importance. Please discuss these photos with your building consultant for clarification.
