Building and Timber Pest Inspection Report

Inspection Date: Wed, 28 Jan 2026

Property Address: 7/90 Hillside Dr, Urunga NSW 2455,
Australia

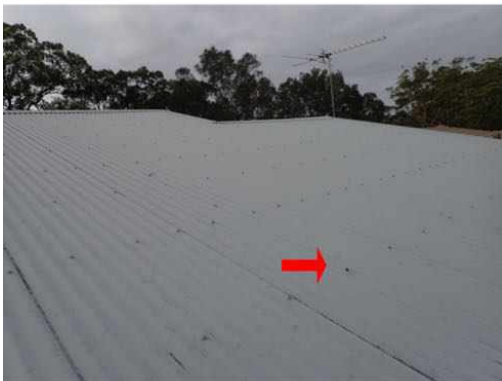
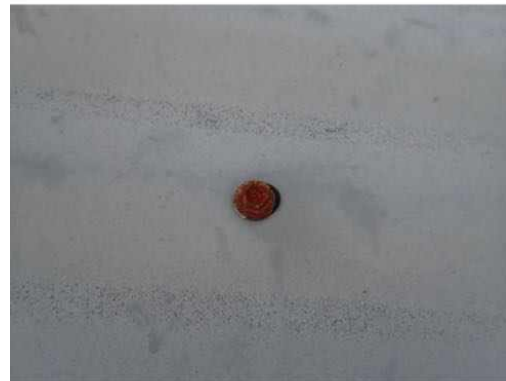
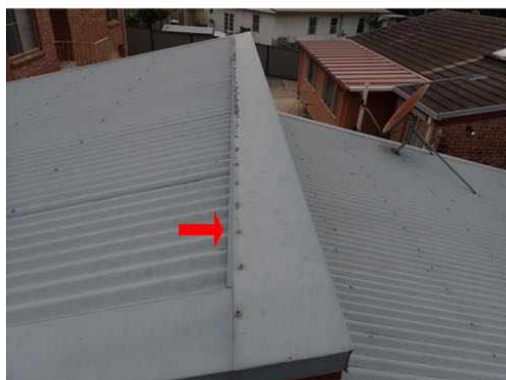
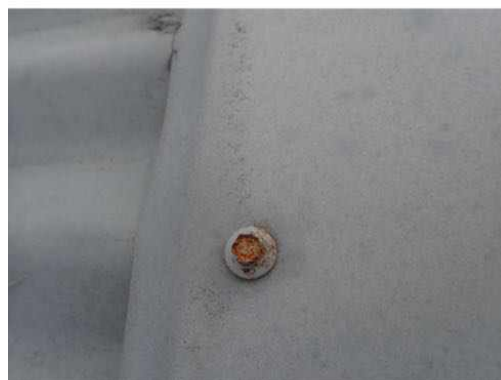
Finding 3.01

Building:	Main Building
Location:	Roof
Finding:	Rusted Roofing Screw Heads
Information:	Surface rust was identified to roofing screw heads at multiple locations. This indicates deterioration of the protective coating and may lead to corrosion and potential leaks if left unaddressed. In simple terms, some roof screws are rusting and could eventually allow water entry. Replacement with corrosion-resistant fasteners is recommended. Repairs should be carried out by a licensed roofing contractor or suitably experienced handyman.

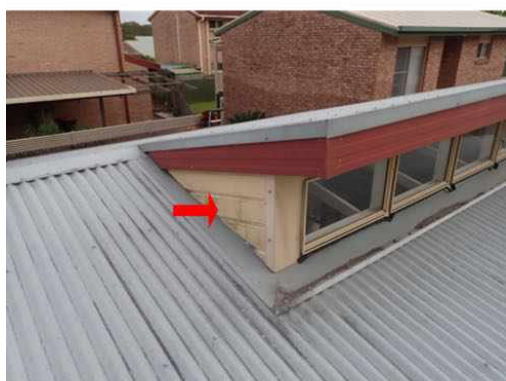
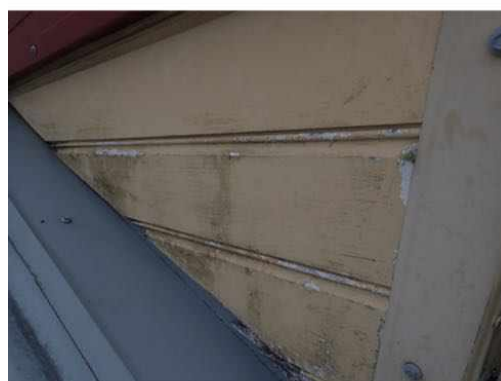
Finding 3.02

Building:	Main Building
Location:	Roof
Finding:	Weatherboards to Roof Area Requiring Maintenance
Information:	A small section of weatherboards located at the roof area were found to be in need of general maintenance, including sanding back and repainting. This condition is consistent with age and weather exposure and, if left unaddressed, may lead to further deterioration of the timber. Maintenance should be carried out by a painter or suitably qualified handyman.

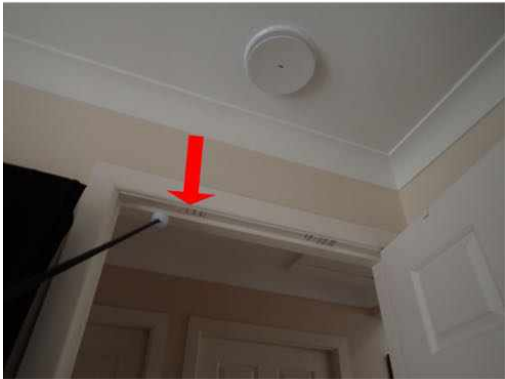
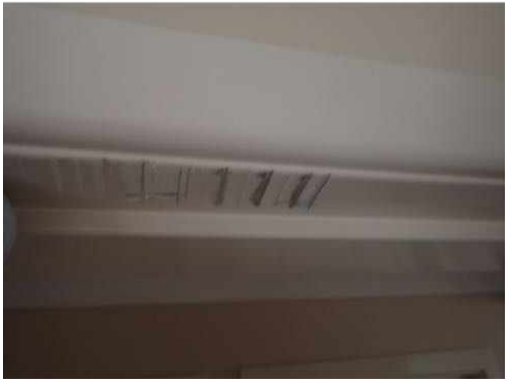
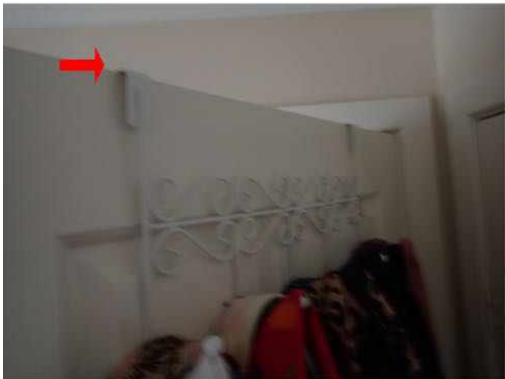
Finding 3.03

Building:	Main Building
Location:	Bedroom
Finding:	Damage to Bedroom Door Jamb
Information:	Damage was identified to the bedroom door jamb consistent with impact from a clothes hanger. This defect is cosmetic in nature and does not affect the structural performance or operation of the door. Rectification is discretionary and may be carried out for appearance purposes. Repairs can be undertaken by a carpenter or suitably qualified handyman.

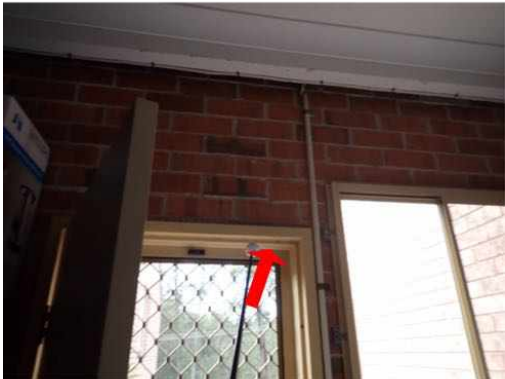
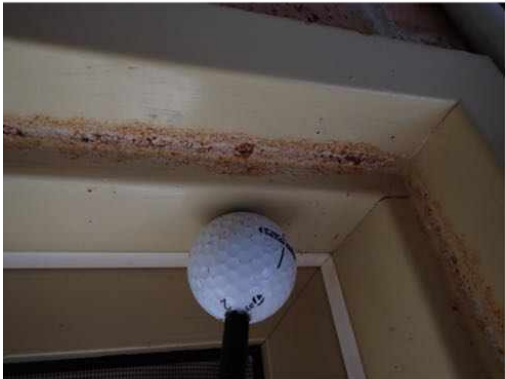
Finding 3.04

Building: Main Building
Location: Garage
Finding: Minor Surface Rust to Garage Door Jamb
Information: Minor surface rust was identified to the garage door jamb. This appears to be a cosmetic condition; however, if left untreated, corrosion may progress and affect the metal over time. Light sanding, rust treatment, and repainting are recommended to help prevent further deterioration. Repairs can be carried out by a painter or suitably qualified handyman.

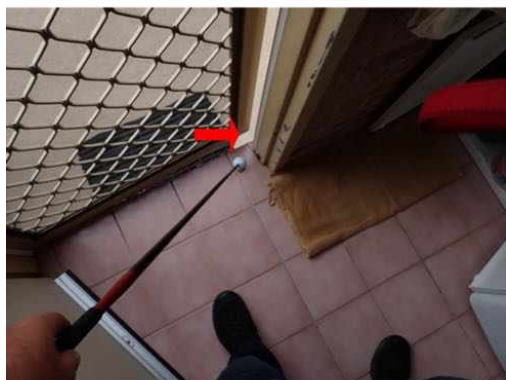
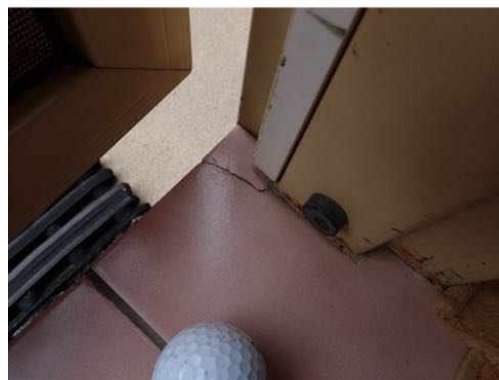
Finding 3.05

Building:	Main Building
Location:	Garage
Finding:	Small Crack in Garage Door Sill Tile
Information:	A small crack was identified in the tile located at the garage door sill. This appears to be a minor, non-structural defect, likely related to impact or normal movement. While currently cosmetic in nature, cracks can worsen over time and may allow moisture ingress. Monitoring and repair or replacement of the affected tile can be undertaken as required by a tiler or suitably qualified tradesperso

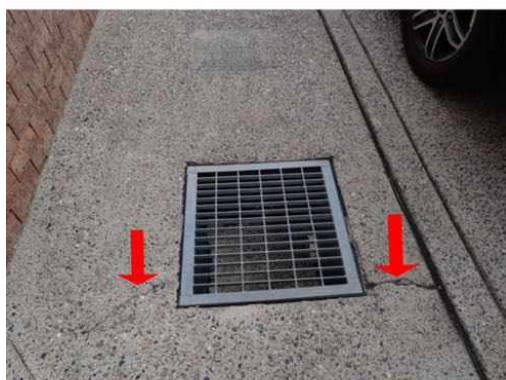
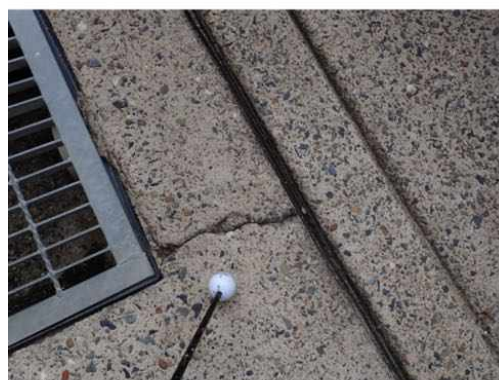
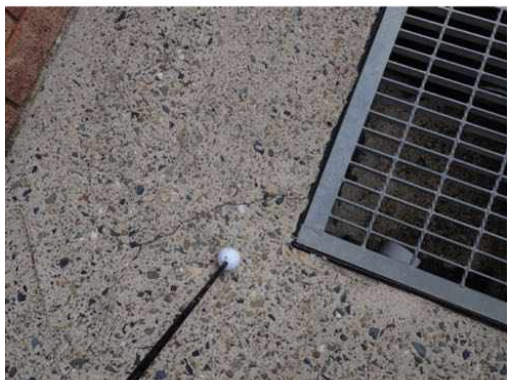
Finding 3.06

Building:	Main Building
Location:	Drive way
Finding:	Minor Cracks in Driveway Concrete
Information:	Minor cracking was identified in the driveway concrete. This condition is common and typically associated with normal shrinkage, ground movement, or age-related wear. While not considered structural at the time of inspection, cracks may widen over time and allow water ingress. Ongoing monitoring and sealing or repair as required is recommended. Repairs can be carried out by a concreter or suitably qualified contractor.

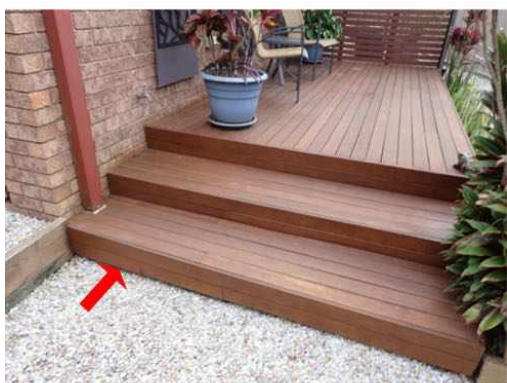
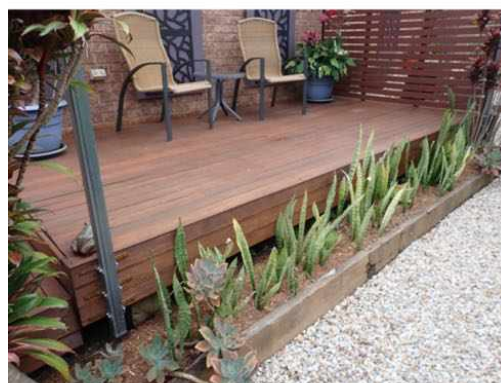
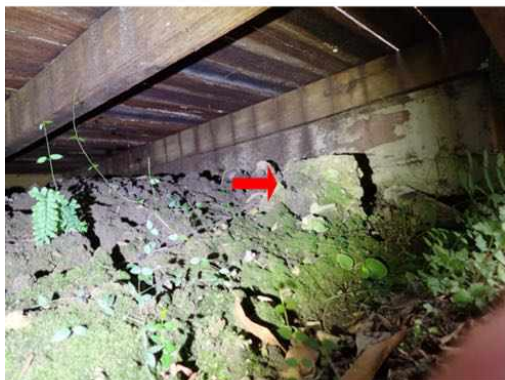
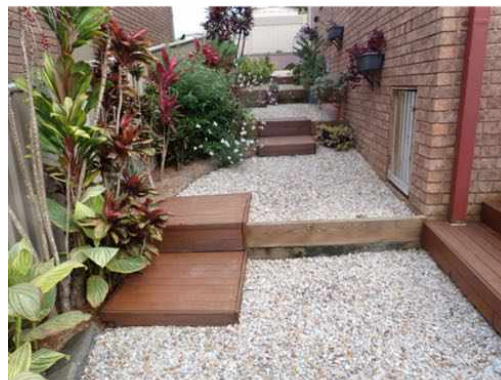
Finding 6.01

Building:	Main Building
Location:	Yard
Finding:	Landscaping Timber in Contact with Ground
Information:	Landscaping timber construction was identified in direct contact with the ground. This condition is conducive to timber decay and termite activity. Ongoing monitoring is recommended, with annual inspections advised to identify early signs of deterioration or timber pest activity. Where practicable, timber should be isolated from ground contact to reduce future risk. Assessment and any necessary rectification should be carried out by a suitably qualified carpenter or licensed timber pest technician.

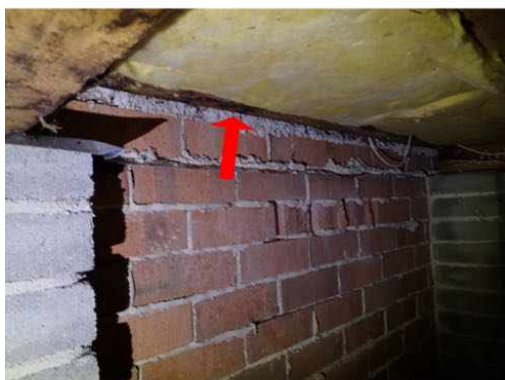
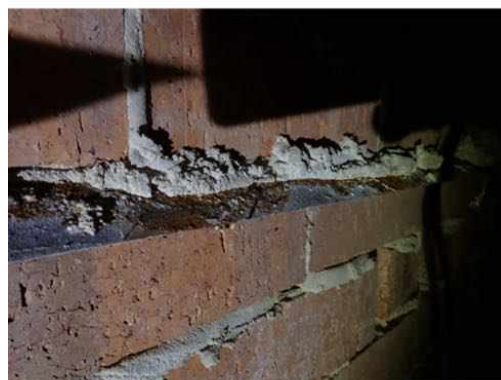
Finding 6.02

Building:	Main Building
Location:	Subfloor
Finding:	Minor Surface Rust to Perimeter Brick Wall Ant Caps
Information:	Minor surface rust was identified to sections of the metal ant caps located on the perimeter brick walls. This appears to be an age- and exposure-related condition and, while minor at the time of inspection, ongoing corrosion may reduce the effectiveness of the ant caps over time. Monitoring and maintenance, including cleaning, rust treatment, or replacement where required, is recommended. Works should be carried out by a suitably qualified pest management contractor or handyman.

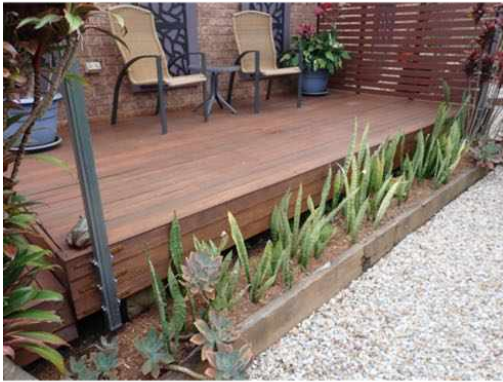
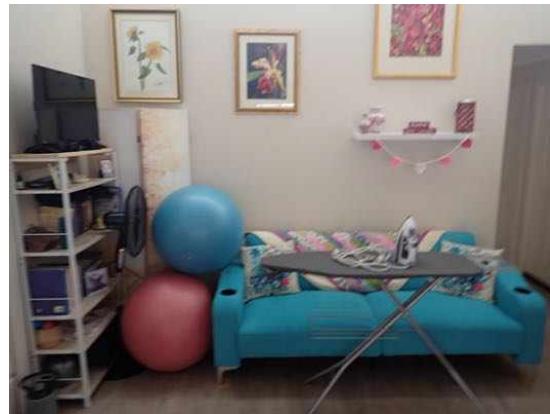
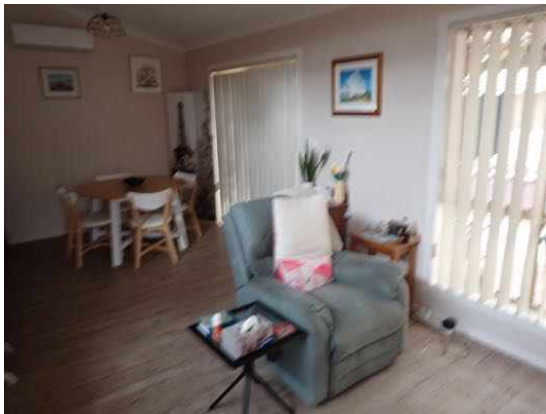
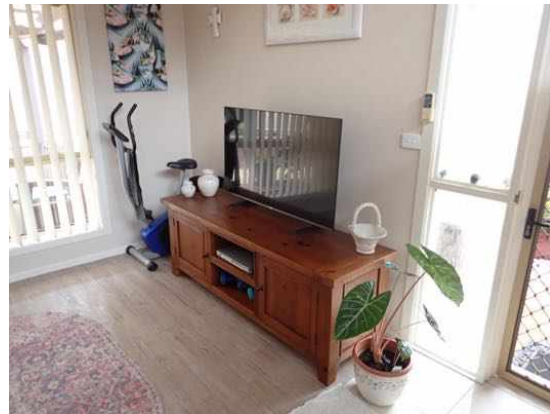
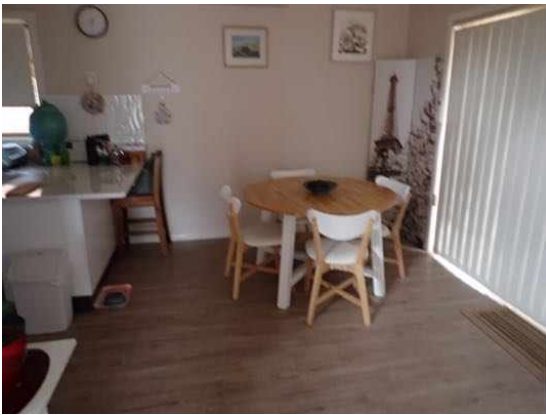
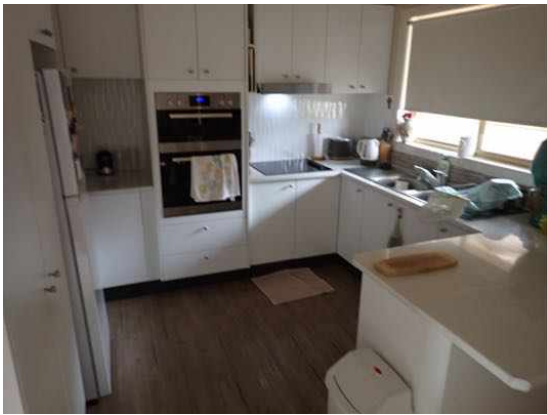
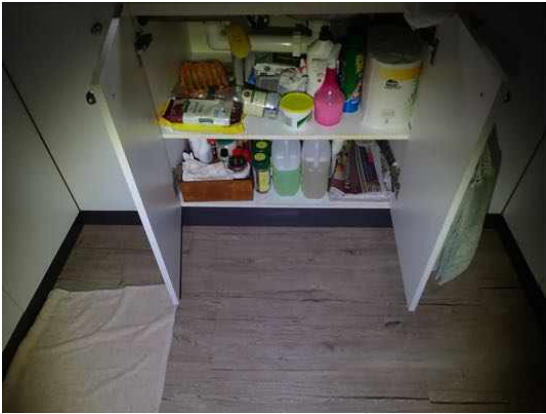
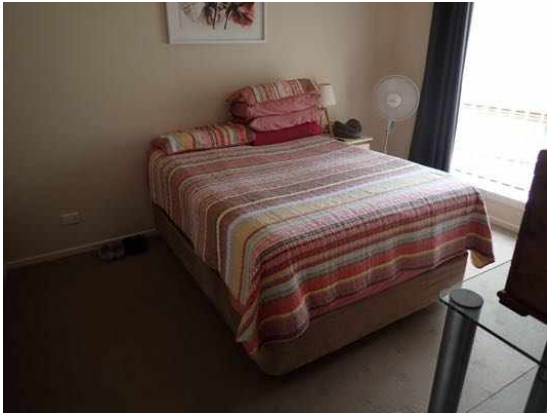
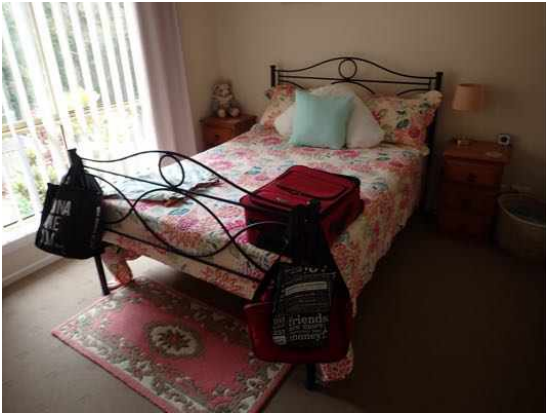
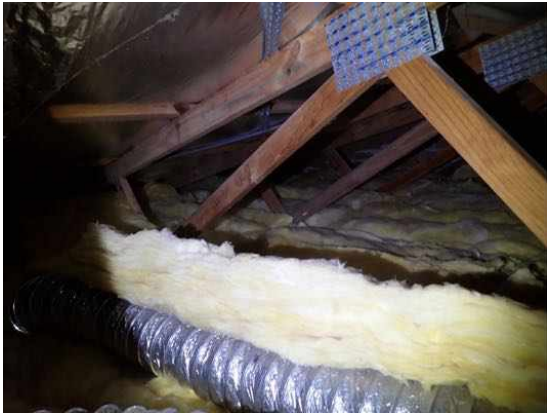
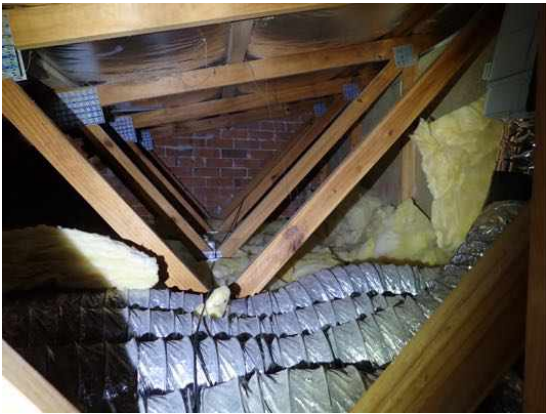
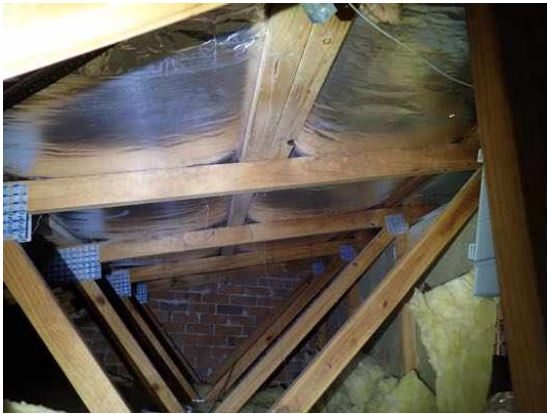
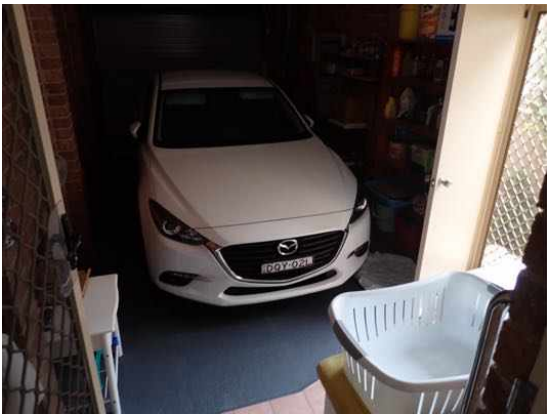
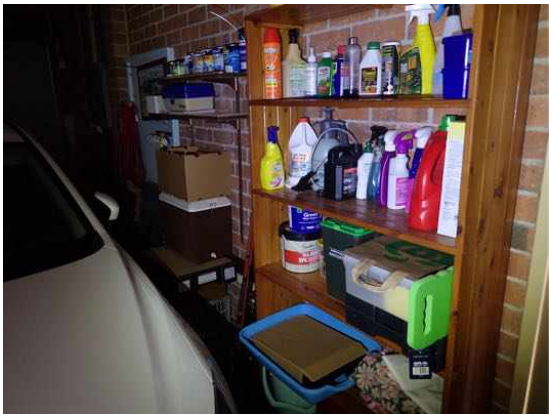
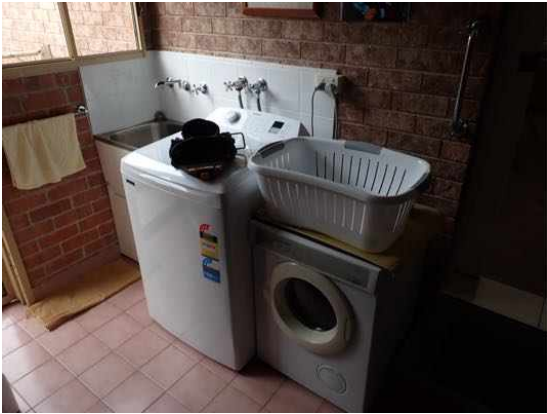
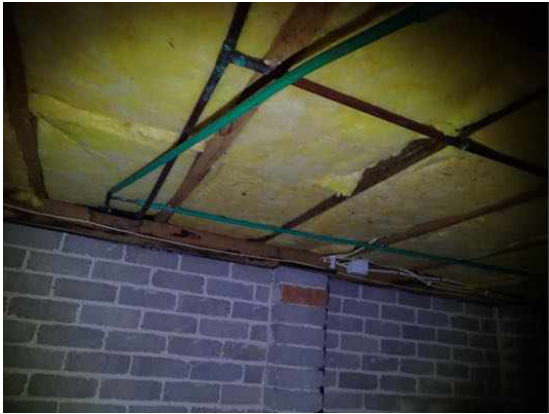
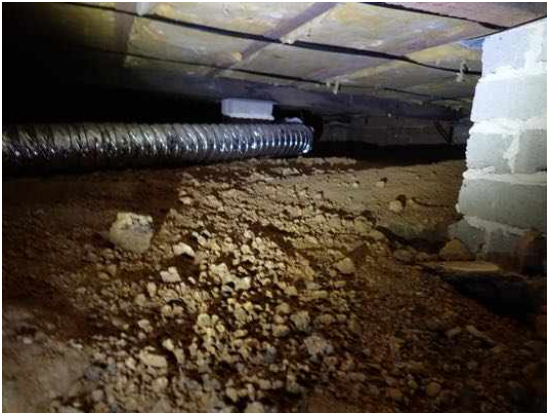
Noted Item

Building: Main Building
Location: All Areas
Finding: Additional Photos - Obstructions and Limitations
Information: These photographs are an indication of the obstructions and limitations which impeded full inspection of the area at the time of inspection. These obstructions can hide an array of defects and should be removed to allow full inspection to be carried out. A re-inspection is recommended once the areas are made accessible.
