Building Inspection Report

Inspection Date: Tue, 17 Mar 2026

Property Address: 15 Hilma St, Sunshine West VIC 3020,
Australia

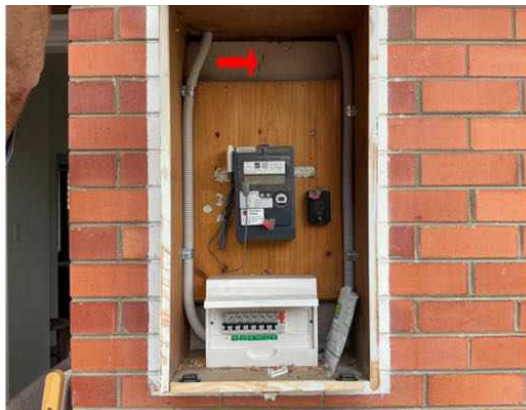
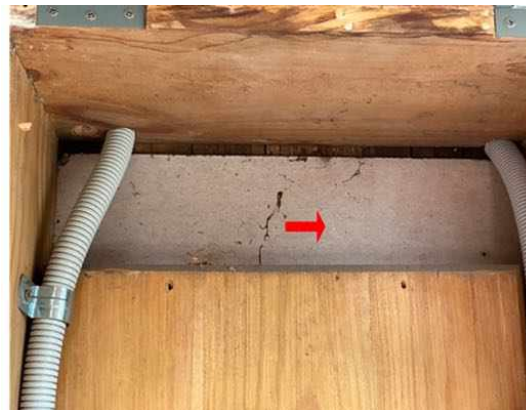
Defects 1.01

Building:	Main Building
Location:	Electrical Switchboard
Finding:	Asbestos - Suspected ACM Identified on Site
Information:	Reporting on Asbestos is outside the Scope of this Report. This suspected defect is highlighted as a caution only. We suspect, based on our experience in the building industry, that there is a higher risk of the identified building element containing asbestos.

As Asbestos Reporting is outside the scope of this report, we advise that you consider a separate Asbestos Inspection and Condition Audit, which can include the taking of samples for definitive confirmation of the presence of Asbestos.

In the interim, the client is advised to act with caution, especially when considering any damage to building materials general wear and tear renovations extensions demolition and general maintenance activities due to the suspected presence of Asbestos.

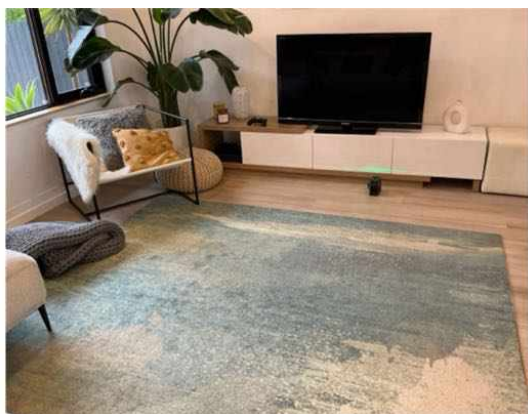
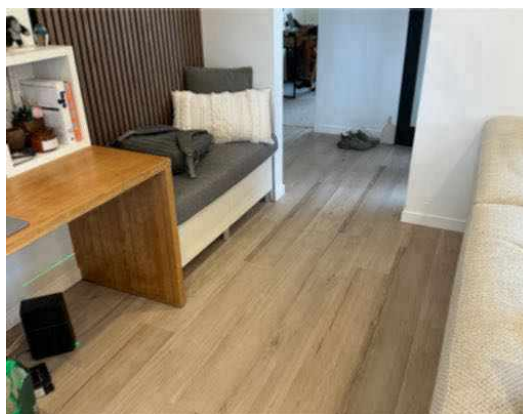
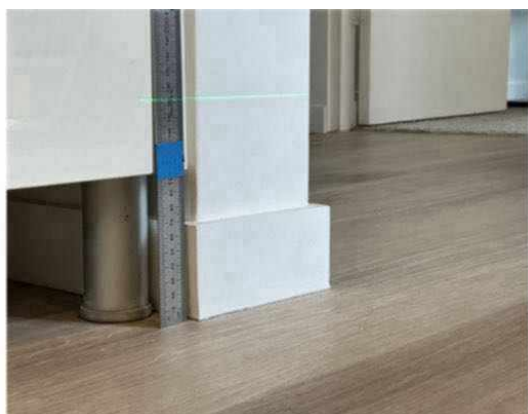
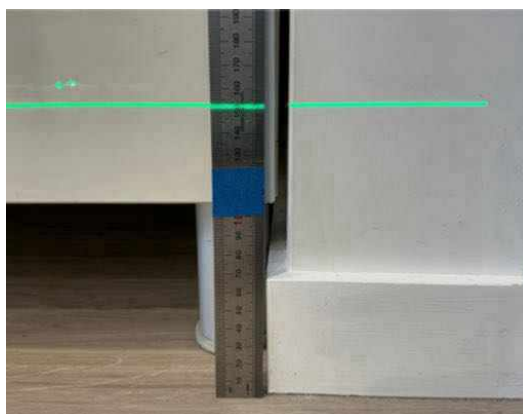
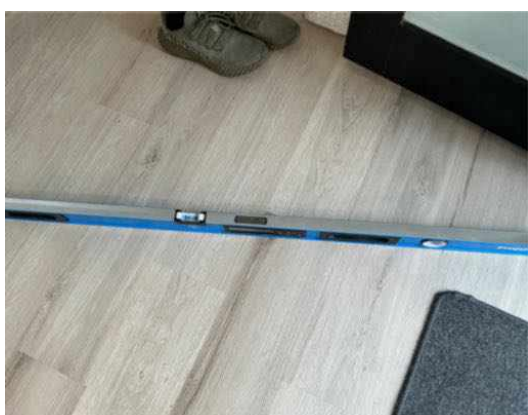
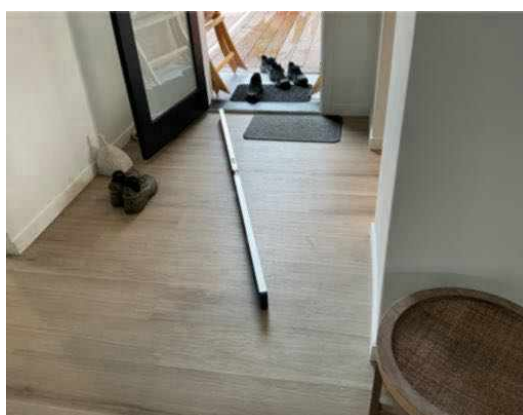
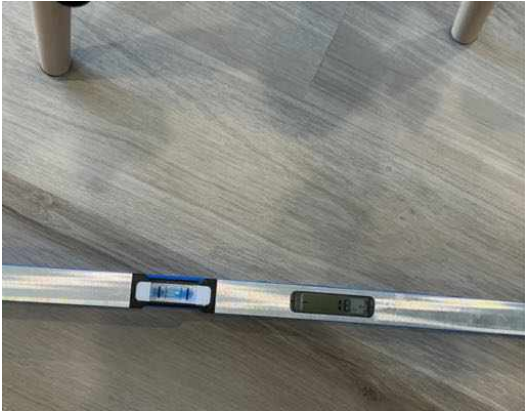
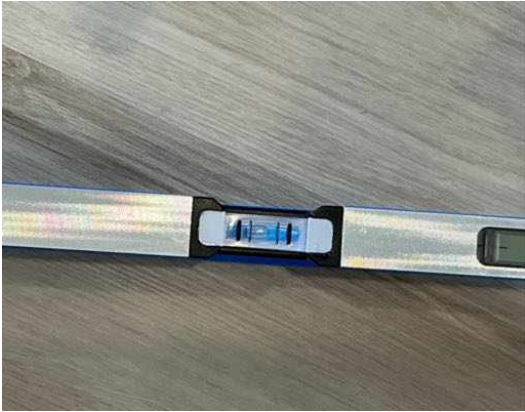
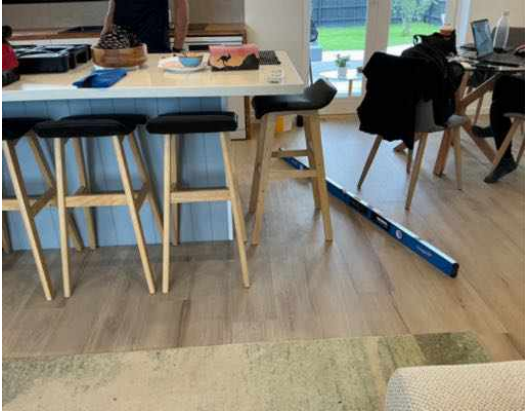
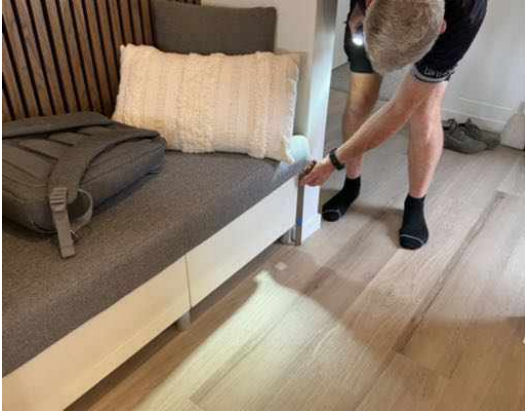
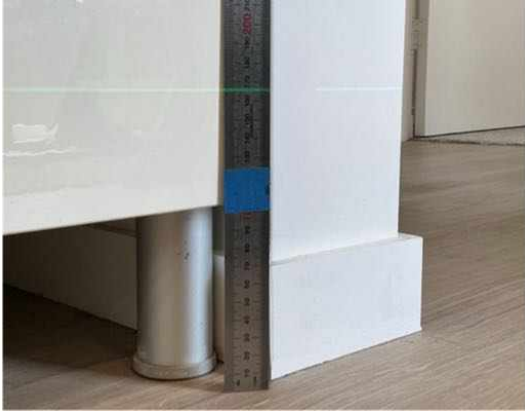
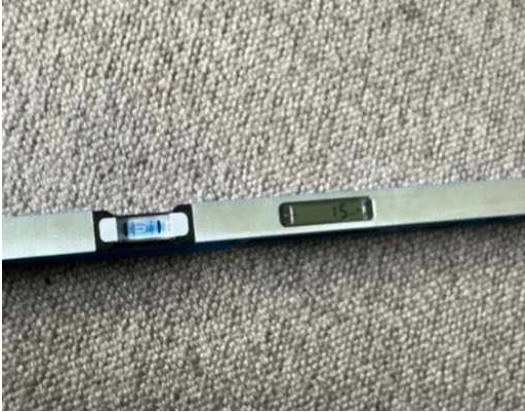
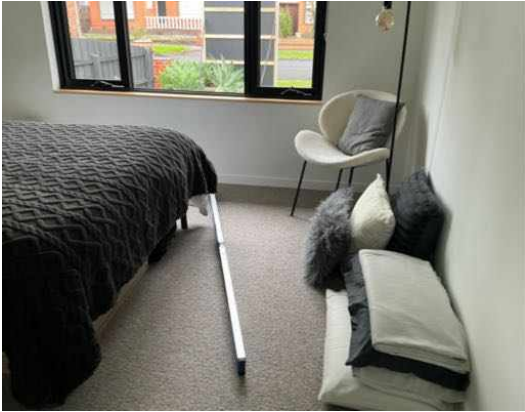
Defects 2.01

Building:	Main Building
Location:	All Areas
Finding:	Flooring - Uneven
Information:	The internal flooring in this area is out of level and uneven. Uneven flooring is likely to indicate minor defects such as expected movement of the foundations of the property, but may also indicate subsidence of the associated subfloor stumps.

The major defect is uneven flooring throughout that was found to be well beyond tolerance for a building of this construction method. A specialist Restumping expert will be able to assess the subfloor structures and recommend and quote on any Restumping/stabilization works required.

There was no access to the subfloor at the time of inspection therefore the condition of the subfloor could not be ascertained.

It is advised that the flooring be closely monitored to identify any further movement. Where flooring remains relatively unchanged for an extended period of time (i.e. several months), it is likely that this defect has been caused by expected movement of the foundations of the property.

However, where flooring is uneven further, potentially invasive inspection of the subfloor structures and stumps in this area is required. In this case, works to repair are likely to be required, and would be carried out by a registered builder specialising in re-stumping.

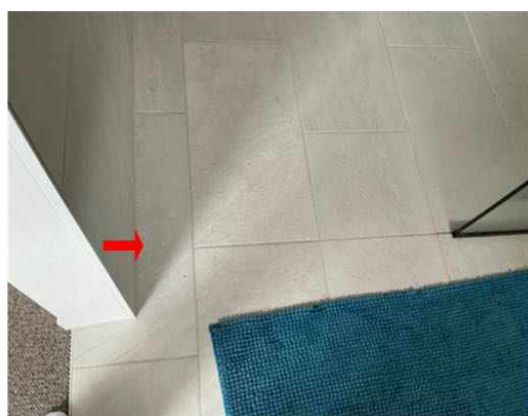
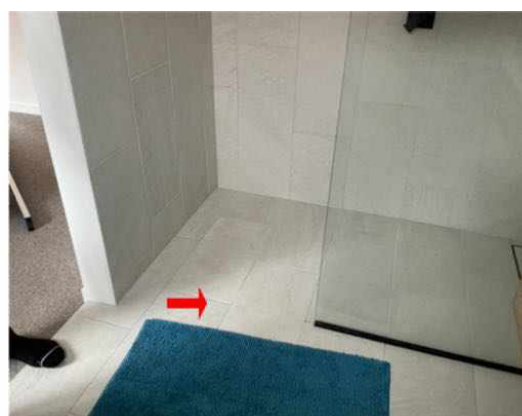
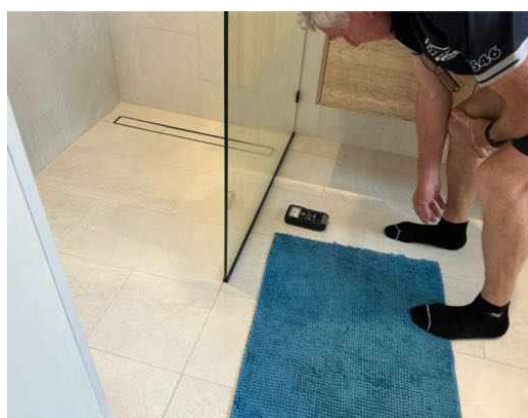
Defects 2.02

Building: Main Building
 Location: Ensuite
 Finding: Waterstop - missing
 Information: It was identified that there is a performance issue with a shower base tiling as it does not have any water stop installed in this area

This is a defect with reference to Standards and Tolerances. AS 3740.

The Shower floors have been tiled in a non compliant manner and will not perform as intended as water stops have not been installed or installed incorrectly.

This shower base tiling will need to be reworked in order to comply.

These works are to be completed prior to final Handover.

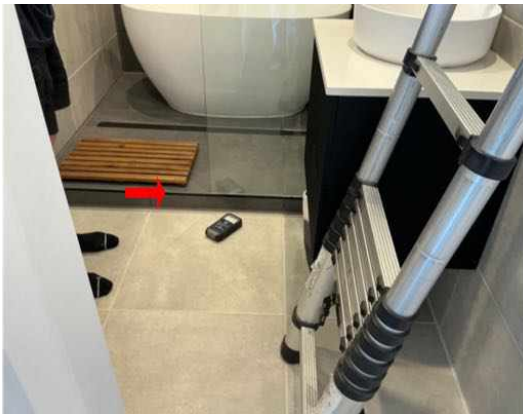
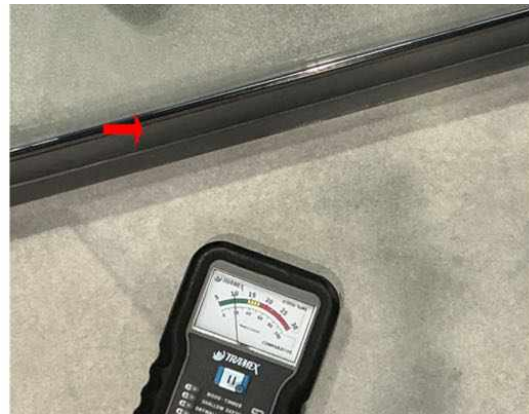
Defects 2.03

Building: Main Building
 Location: Bathroom
 Finding: Shower component - defective Non Compliant (No upstand or waterstop at raised shower hob)
 Information: It was identified that there is a performance issue with a shower base tiling component raised hob does not have any water stop installed

This is a defect with reference to Standards and Tolerances. AS 3740.

This shower base tiling will need to be reworked in order to comply.

These works are to be completed prior to final Handover.

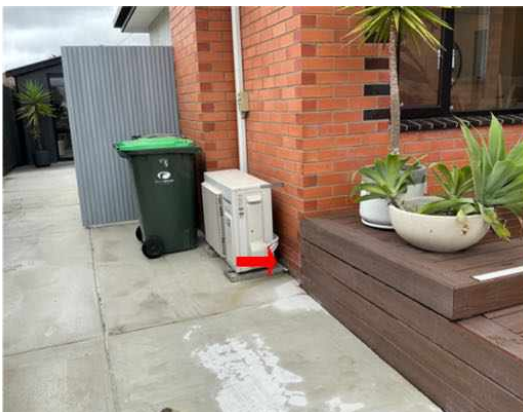
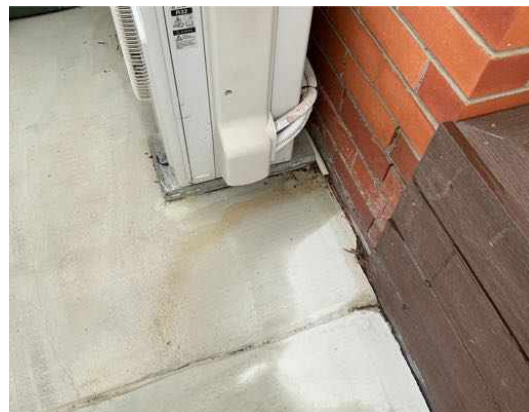
Defects 3.01

Building:	Main Building
Location:	All Areas
Finding:	Air conditioner - Disconnected overflow
Information:	The Air Conditioner (A/C) overflow was found to be disconnected from storm water drainage and is creating excessive moisture in the surrounding area.

Such leaking creates an environment which is conducive to an array of defects, including water damage to associated building elements and the attraction of termite or timber pest infestation.

It is highly recommended that a licensed plumber be appointed to connect the A/C overflow in order to prevent such an environment from being created. These minor works should be carried out as soon as possible.

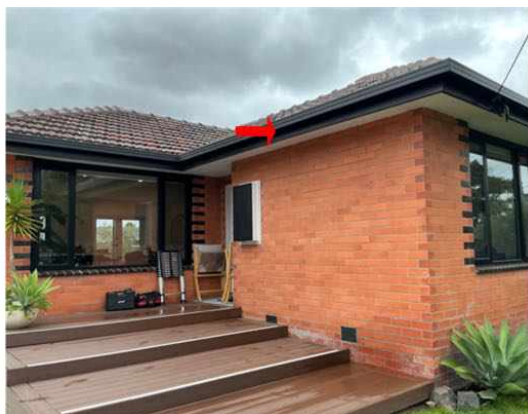
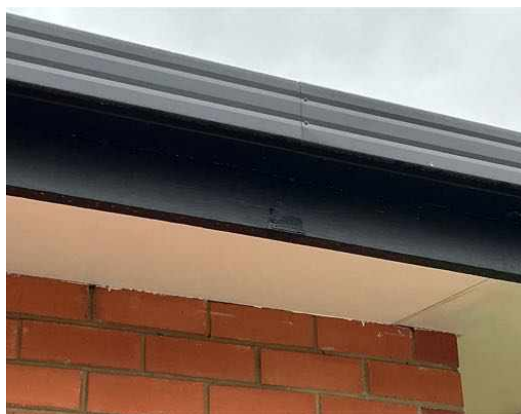
Defects 3.02

Building:	Main Building
Location:	Front Elevation
Finding:	Roof plumbing - Rusted or corroded
Information:	The roof plumbing has areas of rust and corrosion. It is suspected that this has been caused by blockages, resulting in pooling or standing water, that have prematurely rusted elements of the roof plumbing.

Rusted roof plumbing will generally develop holes and leaks that can affect other building elements with poor drainage of storm water. Poorly drained roof areas will also lead to damp conditions surrounding the base perimeter of the building which, if left unmanaged, can lead to a range of secondary building defects.

Repair and/or replacement of rusted roof plumbing is highly required in order to reinstate the roof drainage system to a fully operational level. To further maintain these areas, gutters should be cleaned frequently, allowing the avoidance of any partial blockages.

A licensed plumber or specialist roof restoration company should be appointed to undertake these works. It is advised that such works be completed as soon as possible to prevent any further damage and deterioration.

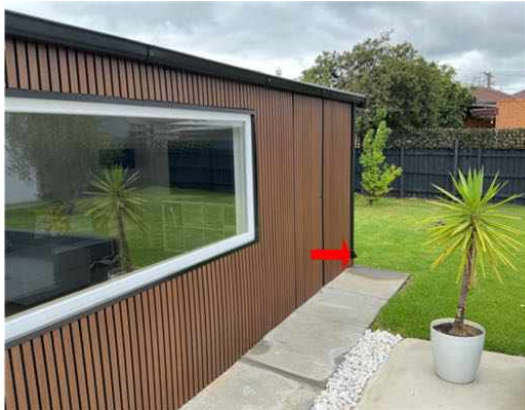
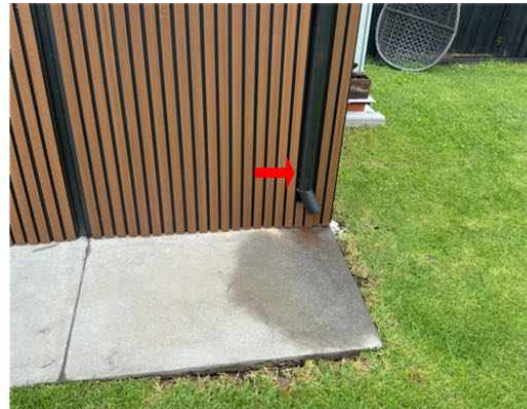
Defects 3.03

Building:	Main Building
Location:	Shed
Finding:	Stormwater drain - Not connected
Information:	The roof plumbing is not adequately connected to stormwater drainage on the site. This disconnection negatively impacts the functional capacity of the roof plumbing.

Where roof plumbing doesn't drain adequately, the area at the base perimeter can become excessively damp, potentially creating an environment that is susceptible to rust and corrosion of surrounding building elements, as well as attracting termites and other pests.

It is highly recommended that a plumber be appointed to further inspect the area and to install adequate drainage equipment where necessary.

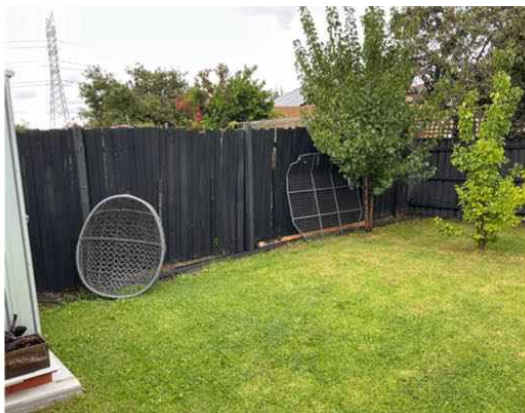
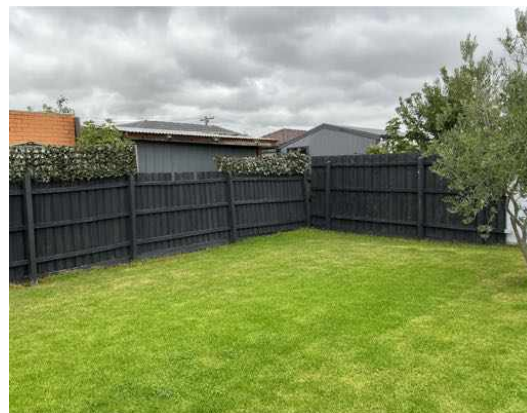
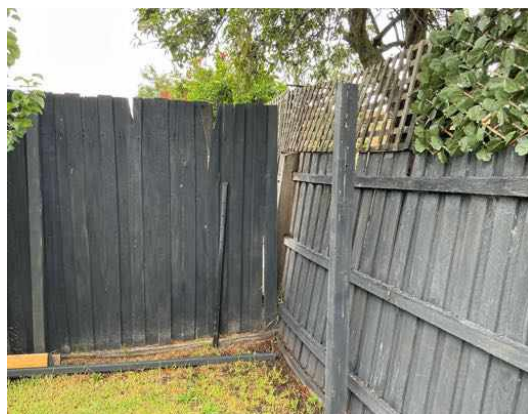
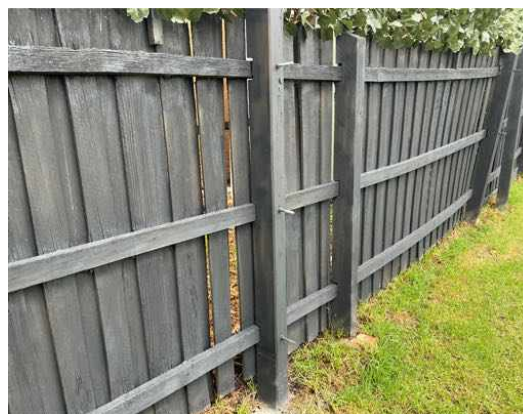
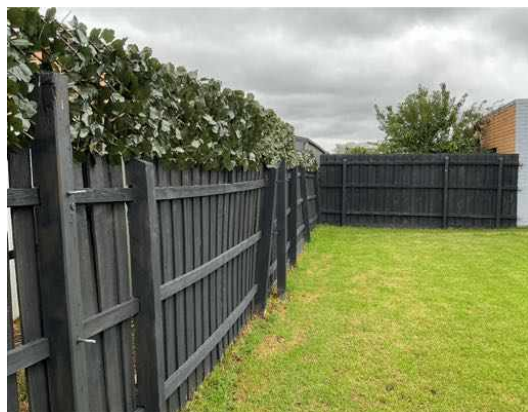
Defects 3.04

Location: Fencing

Finding: Fencing - Deteriorated

Information: It was noted at the time of inspection that sections of the fencing throughout the property have deteriorated. Typically fencing deteriorates due to age and or wear, rot and or rust which is generally expected for a structure of this age, due to prolonged exposure to weather conditions. Sometimes inadequate installation or maintenance can be to blame.

If left unattended, it is likely that further damage will occur. It is suspected that repair of several elements of the fencing may be required however replacement may be a consideration of the client also.

A licensed fencing contractor should be appointed to provide further advice and perform rectification works as necessary.

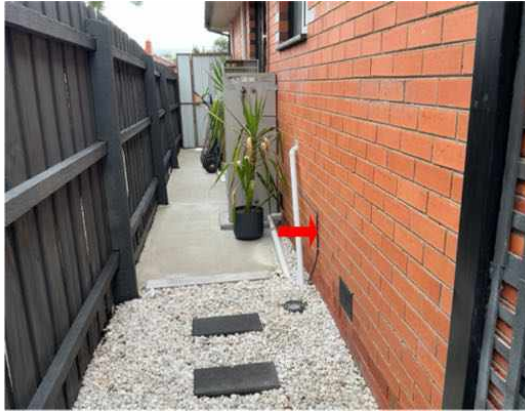
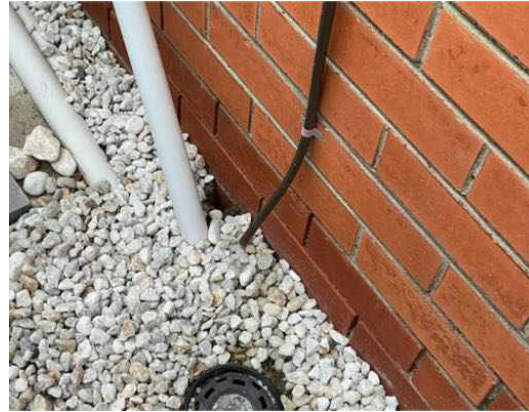
Defects 3.05

Building:	Main Building
Location:	Side elevation
Finding:	HWS Overflow - Not Connected
Information:	The Hot Water System (HWS) overflow was found to be disconnected from storm water drainage and is creating excessive moisture in the surrounding area.

These damp conditions can lead to secondary defects such as rot, rust or corrosion of associated building elements, the formation of fungal decay, or even the creation of potential slip hazards. When coupled with poor site drainage, pooling of water may also attract termite activity to this area.

It is highly recommended that a licensed plumber be appointed to connect the HWS overflow in order to prevent such an environment from being created. These minor works should be carried out as soon as possible.

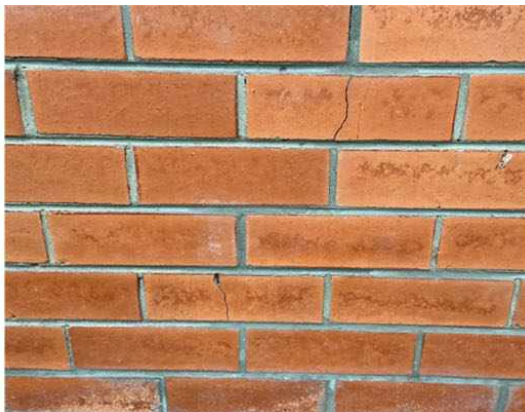
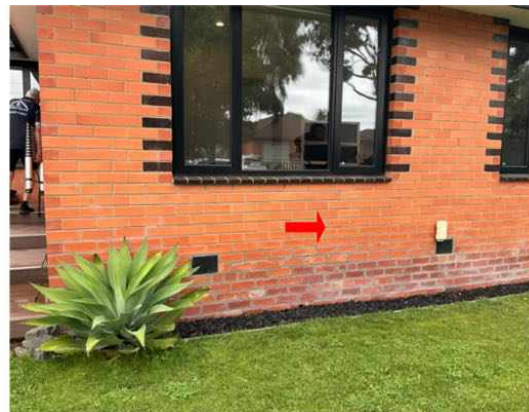
Defects 3.06

Building:	Main Building
Location:	Exterior walls - front
Finding:	Brickwork - Cracking [Fine]
Information:	Although fine cracks are quite noticeable, they are often only considered to be an appearance defect and usually do not indicate any structural damage. Generally, the cause of a fine crack is indicative of a separation between brickwork and mortar throughout the structure, but single bricks may also show cracks of this nature.

Cracking of this nature can generally be repaired with minor filling and should be conducted by a qualified bricklayer.

Always contact a building inspector should cracks widen lengthen or become more numerous.

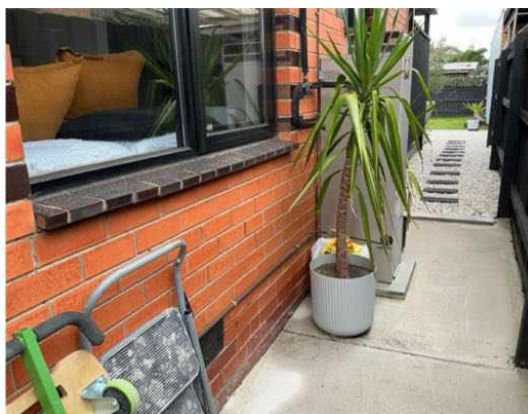
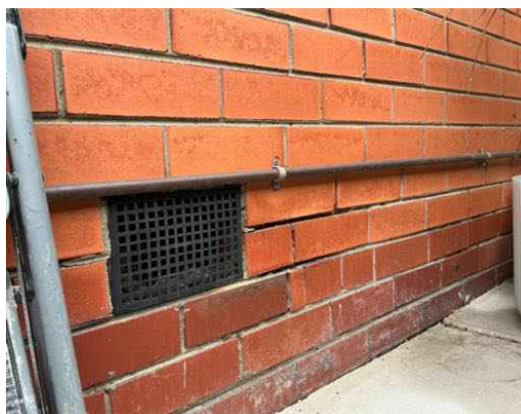
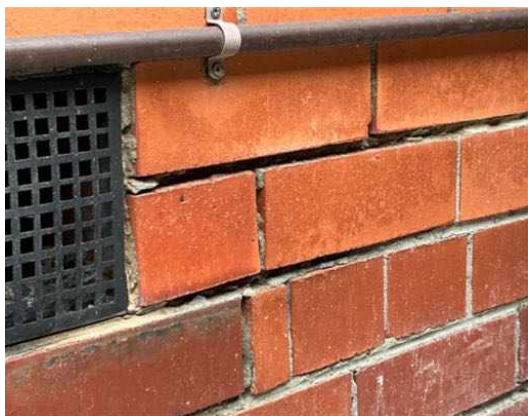
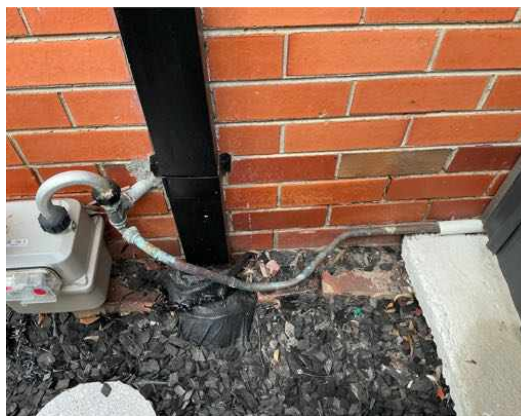
Defects 3.07

Building:	Main Building
Location:	Brickwork
Finding:	Brickwork - Deteriorated mortar
Information:	Mortar, or 'bedding', is the material which fills joins and intersections between bricks in masonry walls and structures. Sections of mortar in this brickwork were identified as

having deteriorated, which is generally expected for a property of this age and condition.

Mortar may deteriorate as a result of age of building materials, minor movement of bricks, or frequent exposure to weathering. Mortar should be replaced to ensure that bricks remain in their intended location and to prevent gaps, which would allow water or moisture ingress and secondary damage as a result.

Mortar deterioration can be addressed by a bricklayer where areas of deterioration are localised and easily accessible. Alternatively, appointment of a registered builder is advised, to repoint large areas of decaying mortar. Where secondary structural defects have become evident, consultation with a structural engineer may be required.

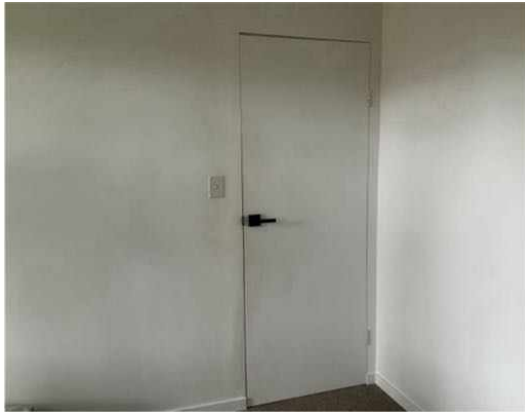
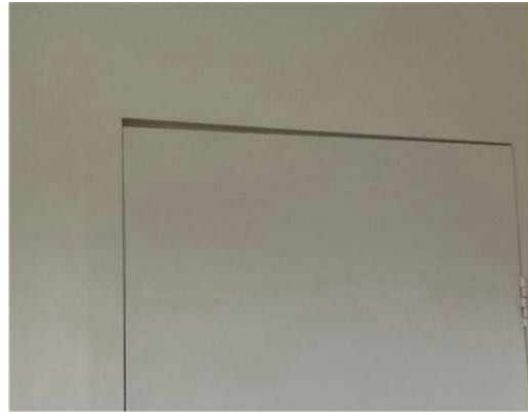
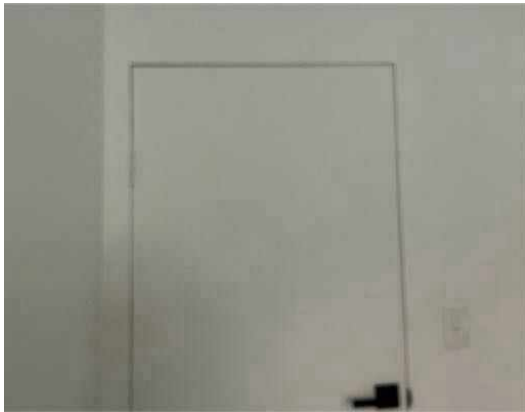
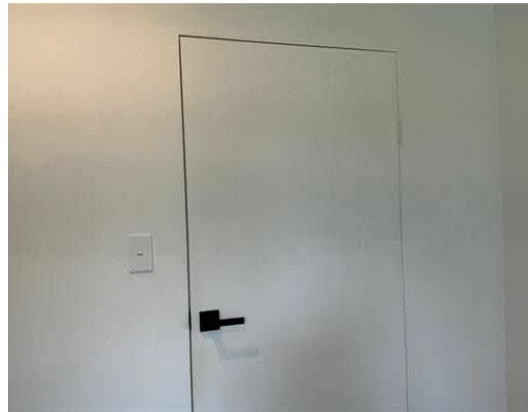
Defects 3.08

Building:	Main Building
Location:	All Areas
Finding:	Door - Gap
Information:	A significant gap was identified between the door and door frame in this area. Where large gaps to the head or foot of door frames appear, it may indicative of a variety of defects, ranging from uneven framework, sagging hinges or uneven flooring.

A gap to the head of the door may also indicate movement of the foundation of the property, which is a common occurrence and does not indicate structural damage.

A qualified carpenter should be appointed to perform remedial works to restore the door to a fully operational level.

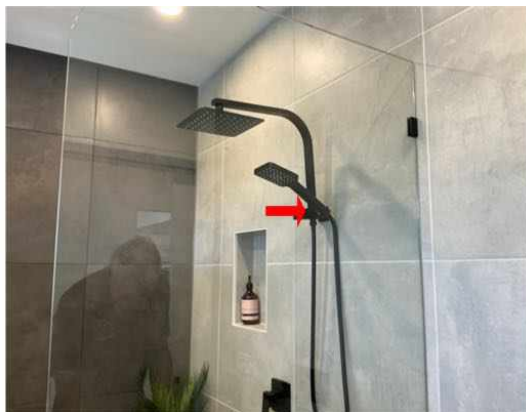
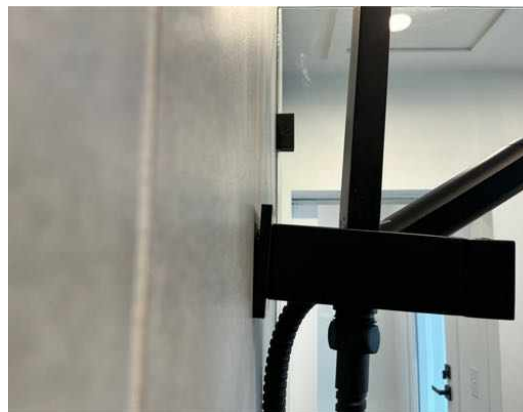
Defects 3.09

Building: Main Building
Location: Bathroom
Finding: Fitting or fixture - Loose
Information: The fitting in this area is loose and requires adjustment to tighten.

If left unmanaged, the fitting may further deteriorate, causing potential for the development of other minor secondary defects.

A relevant tradesperson should be appointed to perform these rectification works at discretion of the client.

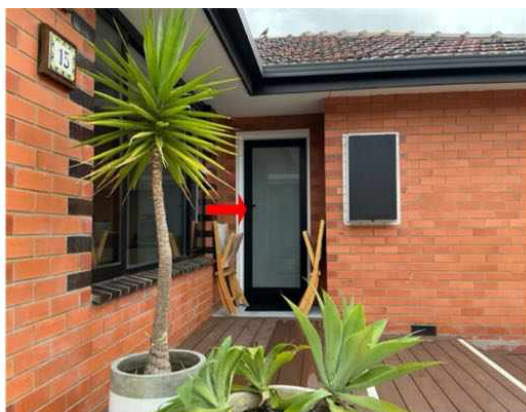
Defects 3.10

Building:	Main Building
Location:	Entry
Finding:	Door - Binding/jamming
Information:	Binding and/or jamming of this door is evident during standard operation. This defect inhibits the functionality of the affected door as well as creating potential for secondary defects to associated building elements, such as damage to the floor covering.

A door that binds to flooring or to the associated door frame may have several causes, ranging from minor defects, such as poor installation of the door or deteriorated hinges, through to major structural issues, such as damage to subfloor structures.

Where door binding/jamming appears to indicate major structural issues, a registered builder specialising in re-stumping should be appointed to provide an estimate on the cost of rectification.

For minor causes, a qualified carpenter or general handyperson should be appointed to perform minor rectification works at client discretion.

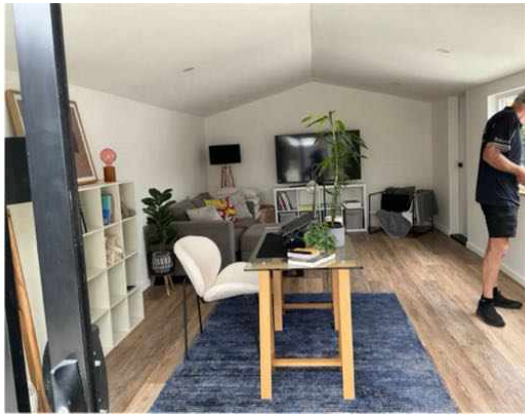
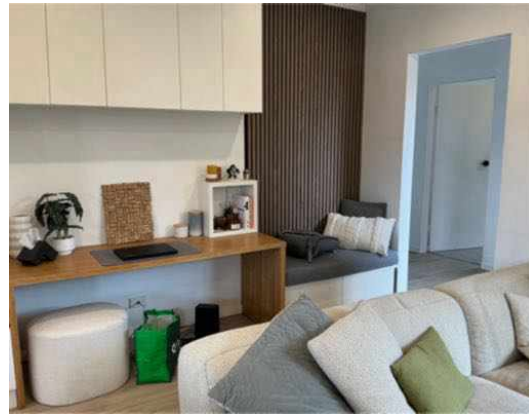
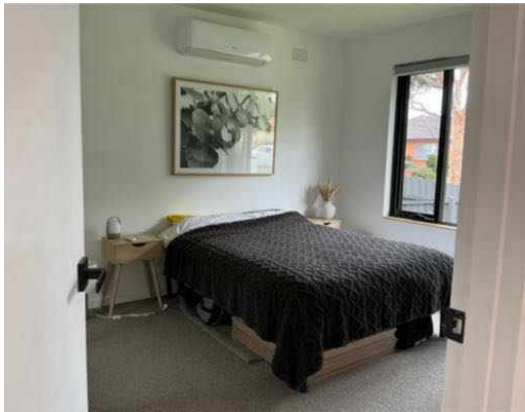
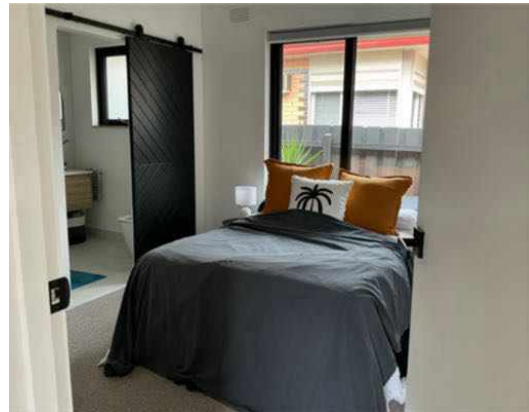
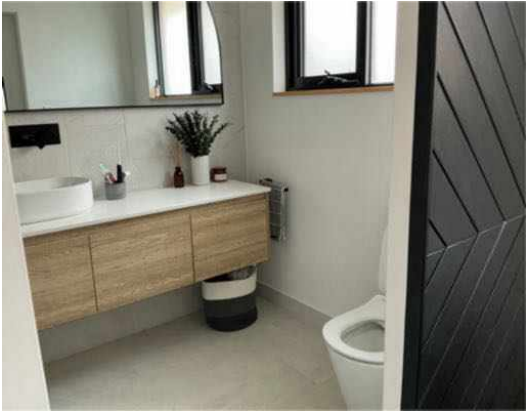
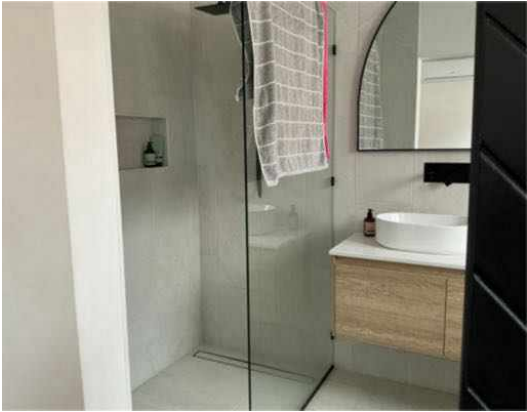
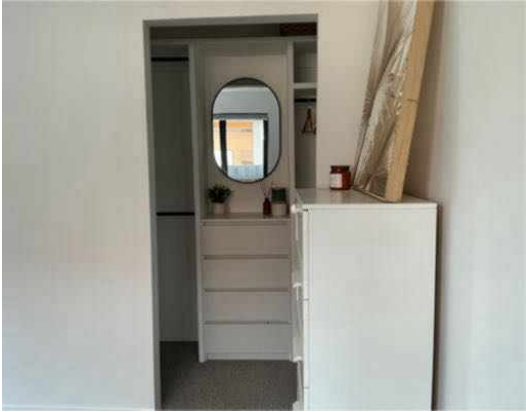
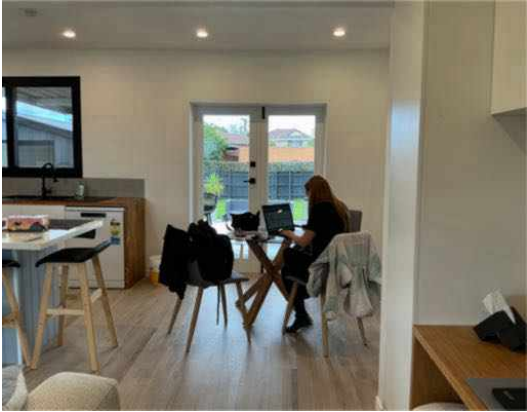
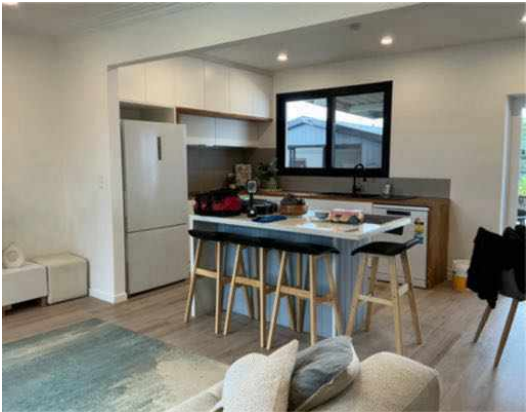
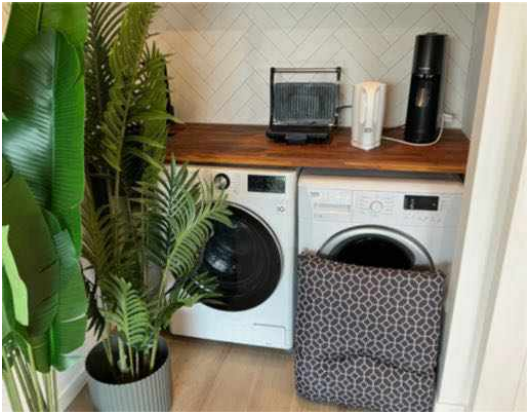
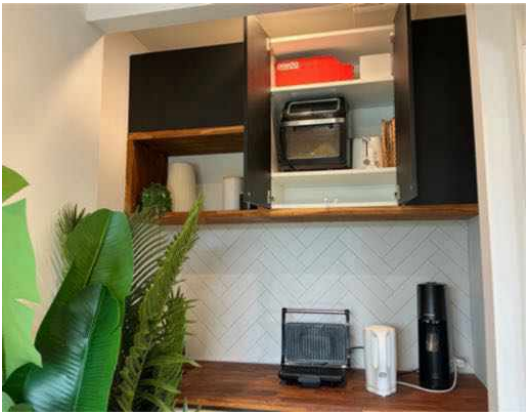
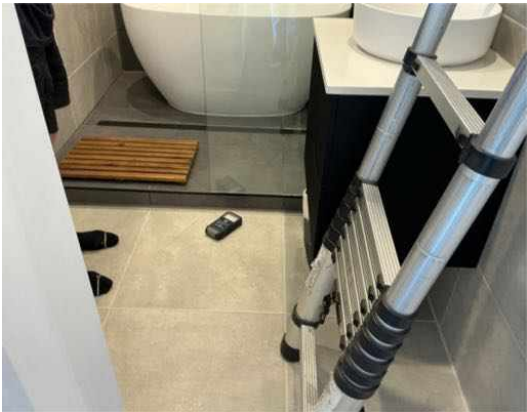
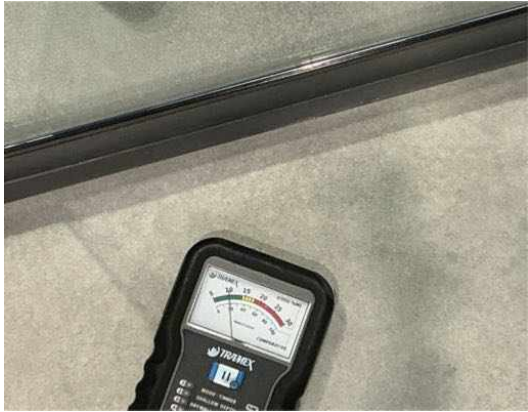
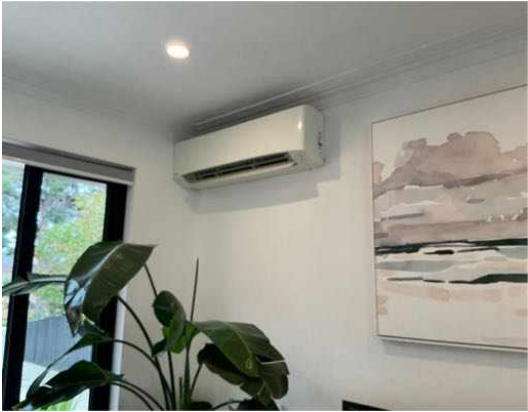
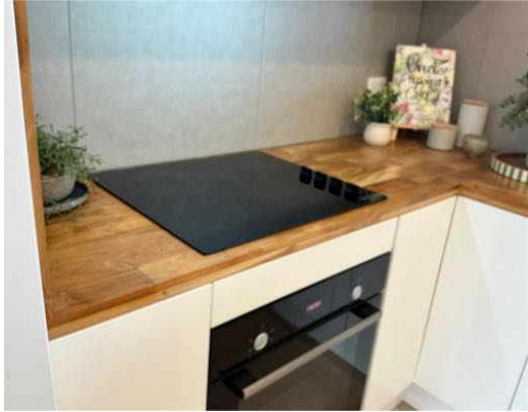
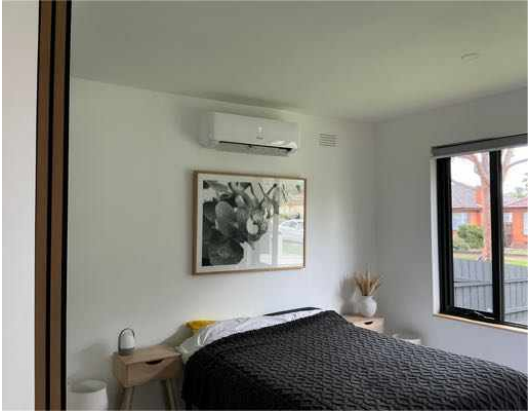
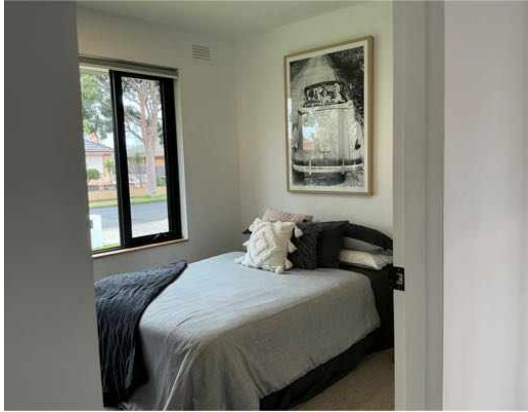
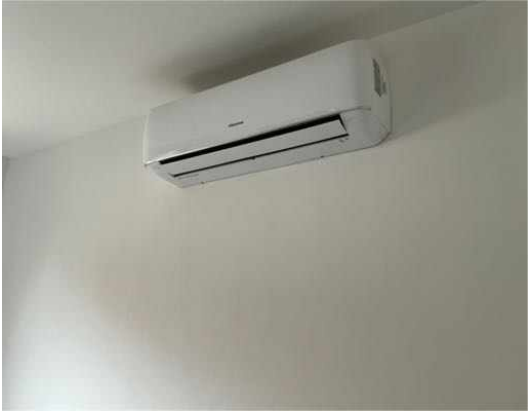
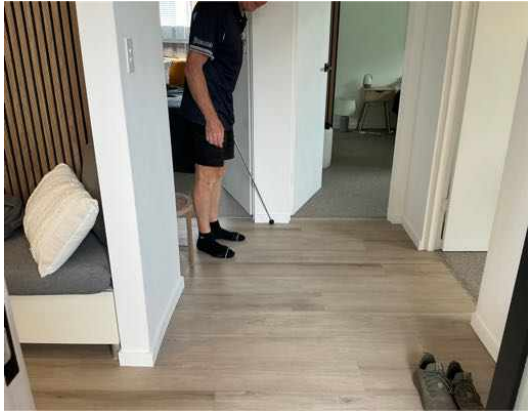
Building: Main Building
Location: All Areas
Finding: Additional Photos and Obstructions and Limitations
Information: These are additional photographs and photographs of the obstructions and limitations inside and outside (furniture, landscaping etc) which may impede full inspection of the property at the time of inspection. These obstructions can hide an array of defects and may be removed to allow full inspection to be carried out. A re-inspection may be made if clients require once the areas are made accessible.

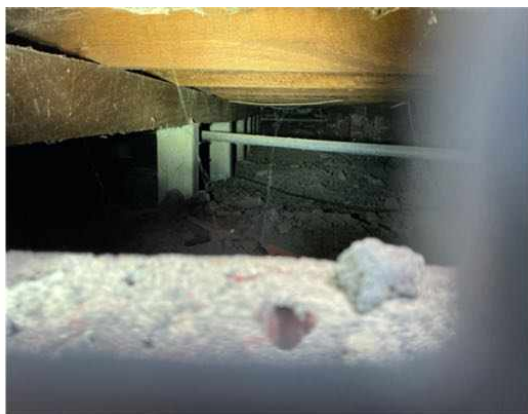
Building: Main Building
Location: Subfloor
Finding: Additional Photos
Information: Additional photos are provided for your general reference

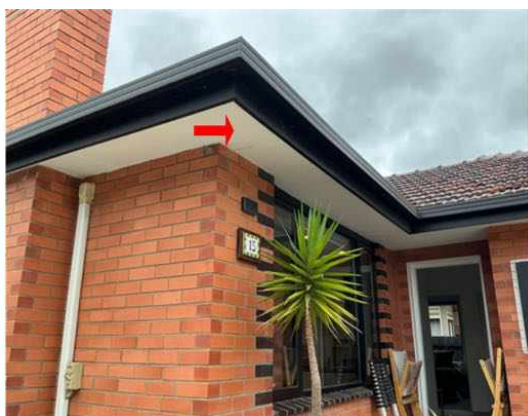
Building: Main Building
Location: Eaves
Finding: Asbestos - Suspected ACM Identified on Site
Information: Reporting on Asbestos is outside the Scope of this Report. This suspected defect is highlighted as a caution only. We suspect, based on our experience in the building industry, that there is a higher risk of the identified building element containing asbestos.

As Asbestos Reporting is outside the scope of this report, we advise that you consider a separate Asbestos Inspection and Condition Audit, which can include the taking of samples for definitive confirmation of the presence of Asbestos.

In the interim, the client is advised to act with caution, especially when considering any damage to building materials general wear and tear renovations extensions demolition and general maintenance activities due to the suspected presence of Asbestos.

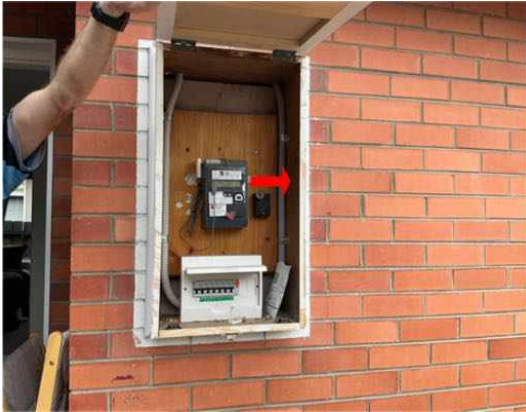
Building:	Main Building
Location:	Electrical Switchboard
Finding:	Termite Management System - no evidence of a chemical installation
Information:	<p>The application of a post-construction chemical termite barrier is highly recommended for all properties, particularly if live termite activity has been found on the site previously. Such barriers are highly effective in preventing termite attack on any timber building elements throughout the property.</p> <p>A durable notice should be placed in the switchboard unit to indicate current termite barriers. At the time of inspection, it appeared as though no termite management system has been installed, with no evidence to suggest preventative works taking place.</p> <p>The client may consider gaining further advice from a pest controller as to the costs and procedures involved with this application. It is recommended that obtaining such</p>

advice be a short-term priority.

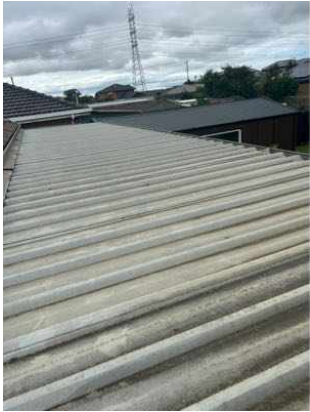
Location: All Areas
Finding: Additional Photos
Information: Additional photos are provided for your general reference
