# Building and Timber Pest Inspection Report

Inspection Date: Fri, 13 Feb 2026

Property Address: 29 Squirrel Glider Dr, Thurgoona NSW  
2640, Australia

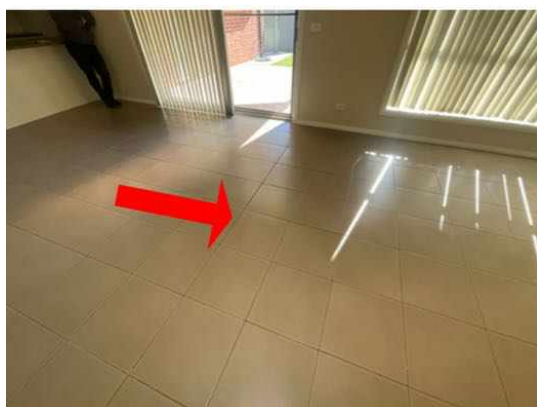
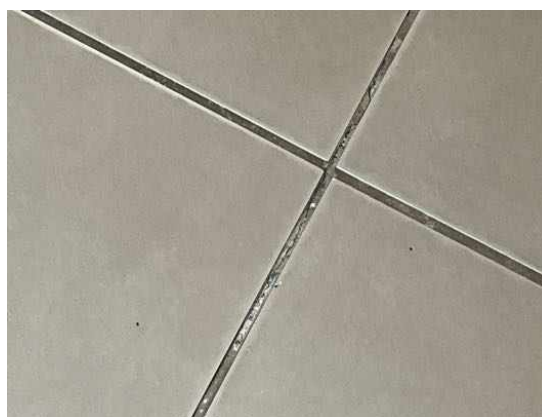
#### Finding 3.01

Building: Building 1  
 Location: Dining Room  
 Finding: Inadequate sealant or Grout  
 Information: This area has a lack of effective Sealant or Grout. This is allowing the ingress of water to the structure inside the wall.

The presence of water encourages Termite attack, Mould and Fungal Decay.

A Tiler or General Handy person must be contacted as soon as possible to effect repairs and prevent further deterioration.

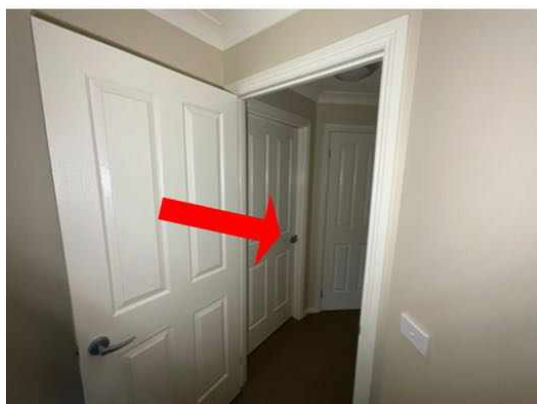
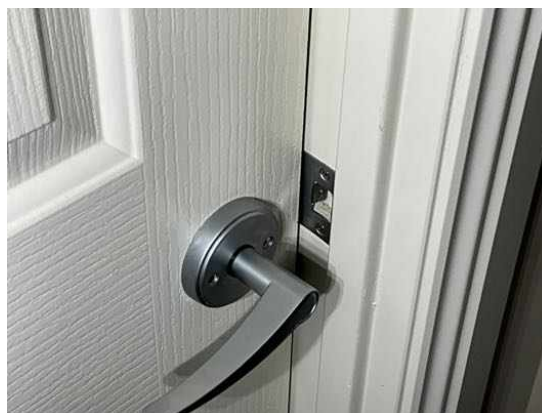
#### Finding 3.02

Building: Building 1  
 Location: Bedroom 3  
 Finding: Door - Striker plate misaligned  
 Information: The striker plate to this door appears to have become misaligned and has consequently resulted in the door's operation being compromised.

This is a common defect and is expected in a property of this age, whether being due

to substandard installation or general deterioration of the door hardware.

Readjustment of the striker plate is recommended at client discretion. Works such as these can be completed by a general handyman or qualified carpenter.

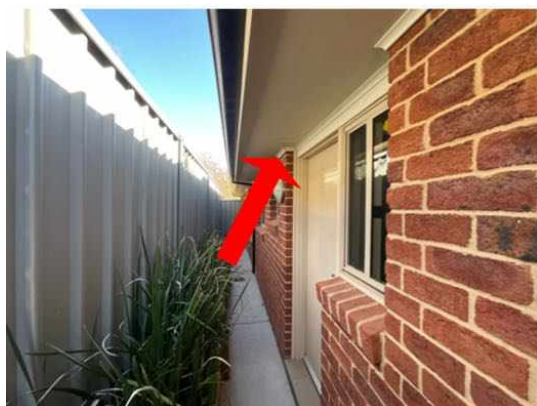
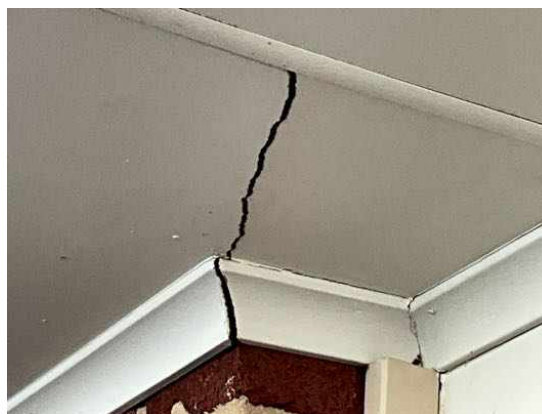
### Finding 3.03

Finding: Cracking - Damage Category 2 - Noticeable (up to 5mm)

Information: Noticeable cracks are a common occurrence as a result of many primary defects. Such causes may include age, general wear and tear, expected building movement, general expansion/contraction of building materials in different weather conditions, and/or minor failings in the installation or application of building materials.

Noticeable cracks may result in minor sticking or jamming of associated doors and windows, which require easement. However, noticeable cracks are easily filled and repaired. A plasterer can be consulted to install an expansion joint at this point to allow for this movement during different weather conditions.

Monitoring of all cracking should be conducted frequently. Always contact a building inspector should cracks widen, lengthen, or become more numerous. Additionally, your building inspector should also be contacted if associated building elements such as doors and windows become more difficult to operate over time.

Relevant tradespeople, such as carpenters, painters and plasterers, should be appointed to perform remedial works, as deemed necessary.

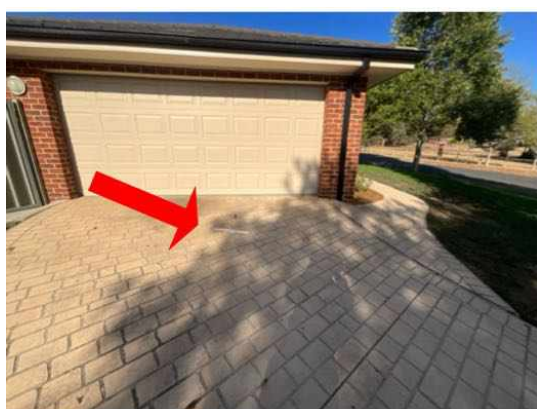
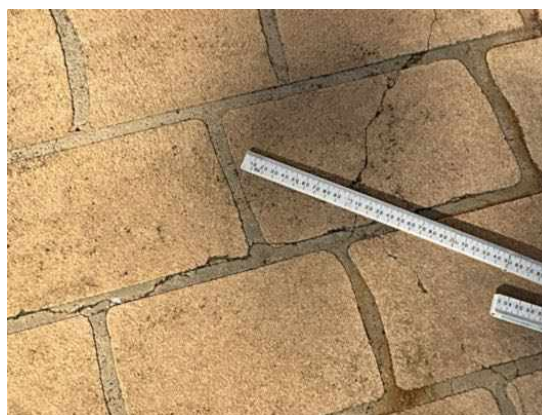
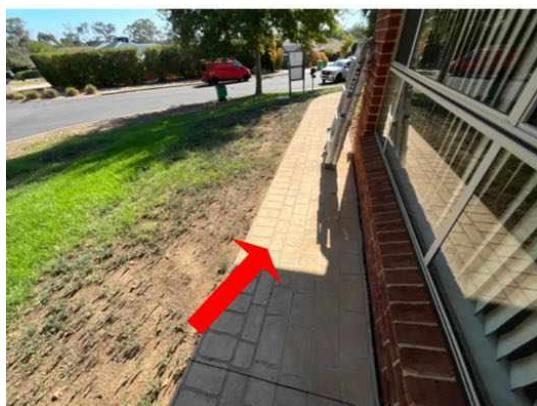
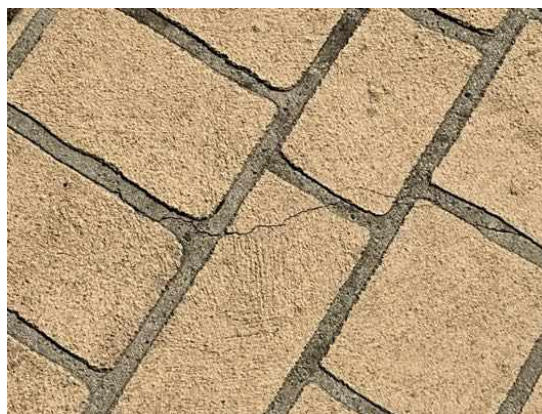
### Finding 3.04

Building:	Building 1
Location:	Driveway area
Finding:	Cracking - External Concrete Paving Damage Category 1 - Fine (less than 2mm)
Information:	Fine cracks were identified in external concrete paving. Although fine cracks are quite noticeable, they are often only considered to be an appearance defect, and usually do not indicate any structural damage. To be considered a Category 1 or fine crack, the crack is found to be less than 2mm in width.

Generally the cause of a hairline crack in existing concrete paving such as driveways and pathways is indicative of the expansion and contraction of the concrete. Such causes are generally due to environmental factors, such as moisture levels, weather conditions, root systems of nearby trees or the soil types on which they are laid.

Fine cracks may also be due to poor original installation of the concrete. Factors such as poor compaction of the sub surface and/or inadequate reinforcing of the slab may create cracking and other secondary defects.

Monitoring of all cracking should be conducted frequently. Always contact a building inspector should cracks widen, lengthen, or become more numerous.

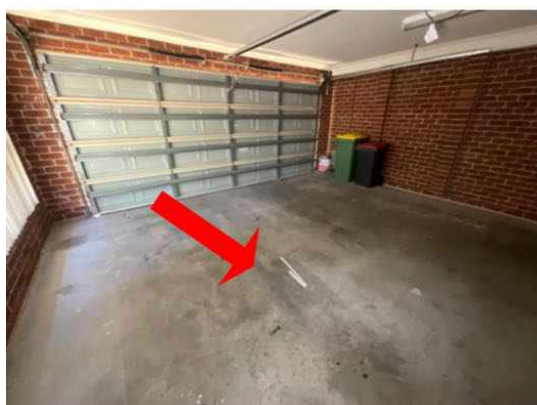
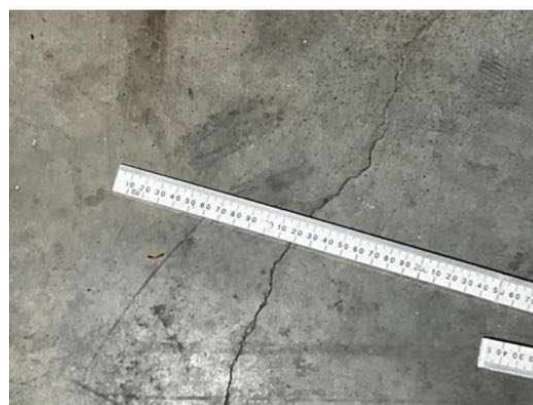
### Finding 3.05

Building: Building 1  
 Location: Garage  
 Finding: Crack in concrete slab - Category 1  
 Information: A crack coded as Category 1 was identified in the slab. A Category 1 crack is described as a fine but noticeable crack, with the slab at an otherwise reasonable level.

To be considered Category 1, the approximate width of the crack is less than 1.0mm, or a less than 10mm change in offset when a 3m straight edge is placed over the defect.

Category 1 cracks should be monitored for a period of 12 months. At the end of the monitoring period, identified cracks that are rated greater than Category 2 are considered defects, and require rectification.

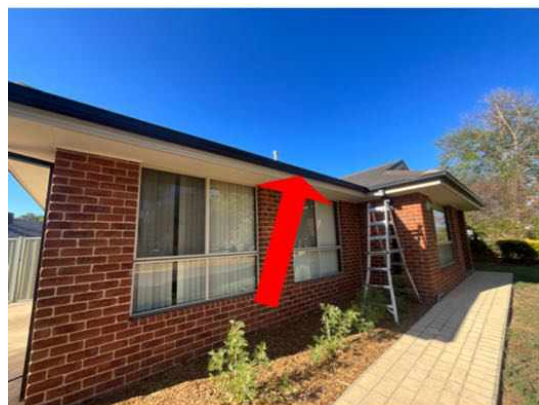
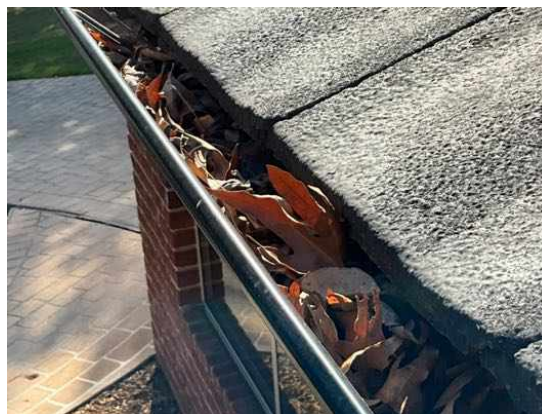
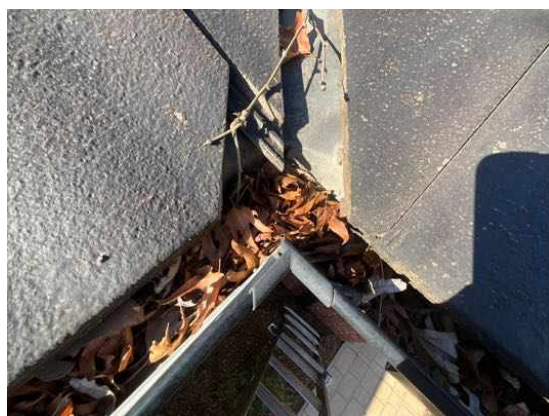
### Finding 6.01

Finding: Gutters- Blocked

Information: Roof plumbing structures, such as guttering and downpipes, should be free of all debris to prevent blockages. Blockages of the guttering and downpipes will lead to pooling and accumulated water overflows, which is likely to subsequently flood eaves and exterior walls.

Blocked gutters are likely to lead to high levels of moisture in the affected areas. Such moisture will not only cause rust and decay of the associated building materials, but can also provide conditions that are conducive to termite and timber pest activity. Blockages in gutters should therefore be removed immediately to ensure dry conditions are maintained.

Consult a Licensed Plumber for further specific advice on remedial works that may be required. In the interim, it is highly advised that blocked gutters be removed by the homeowner or a general handyperson as a matter of urgency.

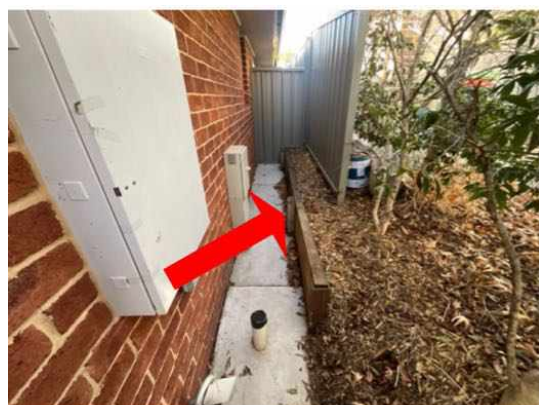
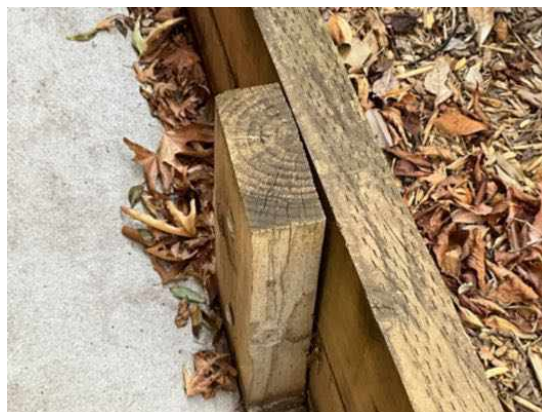
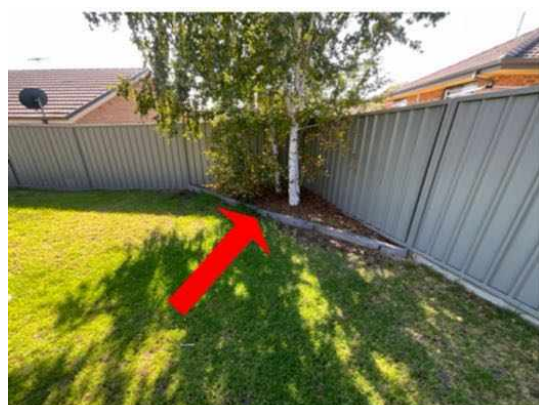
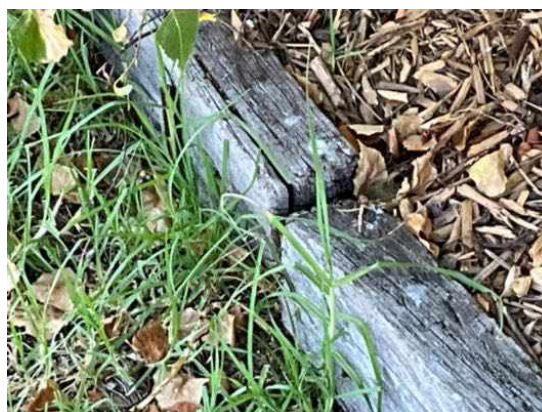
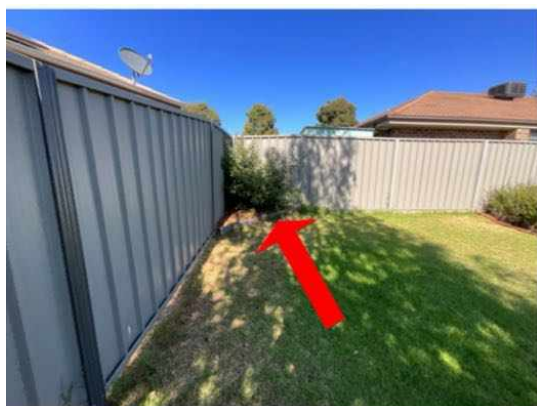
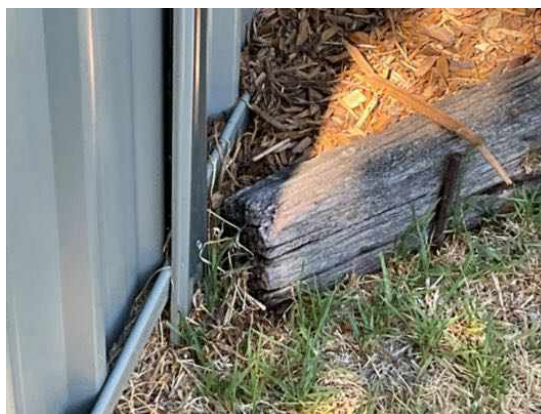
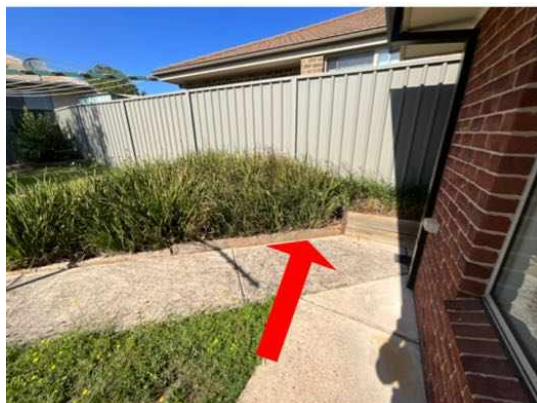
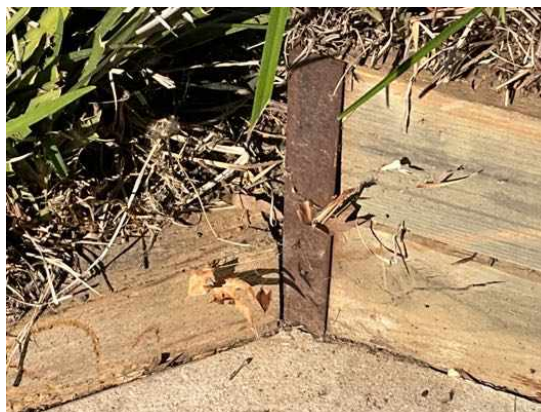
## Finding 6.02

Building:	Building 1
Location:	Yard - Side, back
Finding:	Untreated or non-durable timbers in a hazardous environment
Information:	To reduce the risk of timber pest attack it is essential that timber used in a hazardous environment (e.g. in direct contact with the ground or frequently exposed to damp conditions) is of sufficient durability and/or is adequately preservative treated.

Untreated timbers in direct contact with the ground are likely to develop severe wood rot and/or fungal decay if left unattended creating attraction for subterranean termites to infest the timbers from surrounding areas.

If untreated or non-durable timbers are found to be in a hazardous environment it is highly advised that replacement of these building elements be performed as soon as possible to aid the protection of the property against termite / timber pest attack.

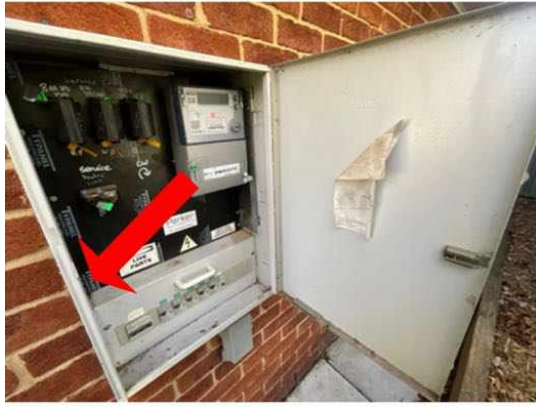
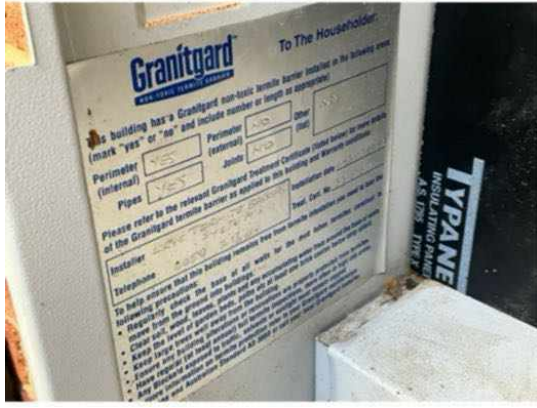
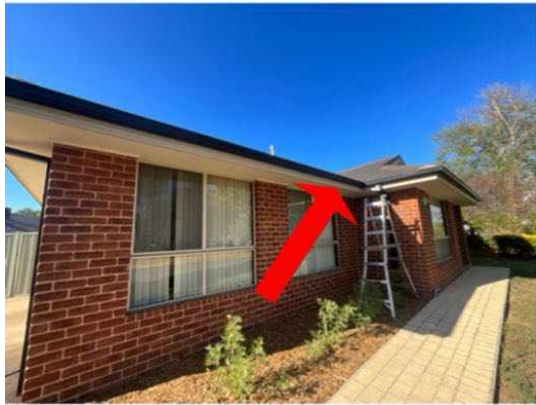
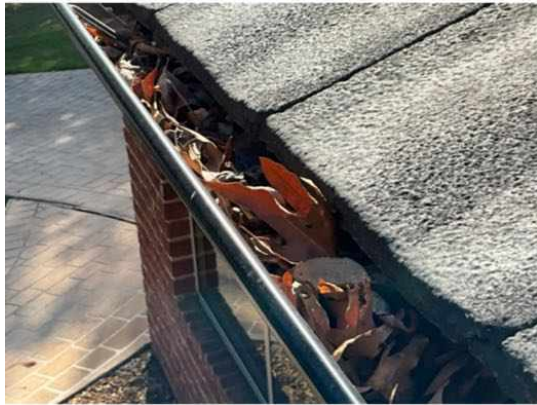
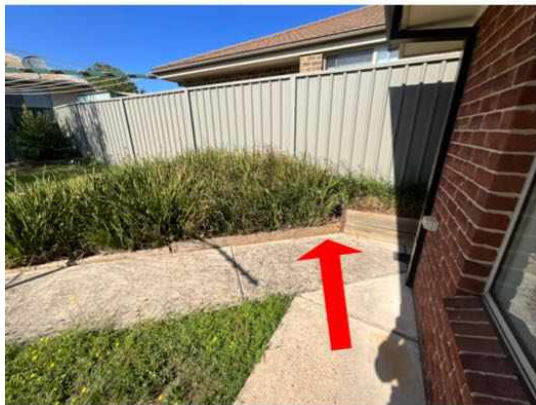
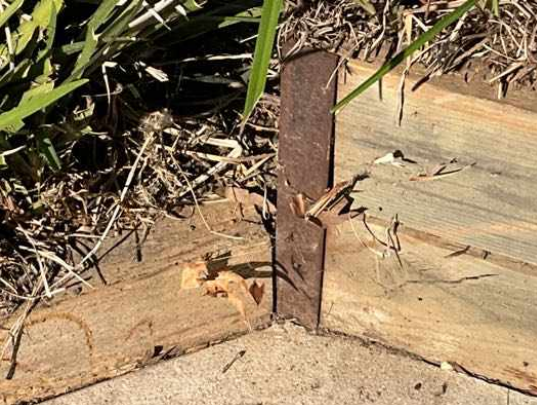
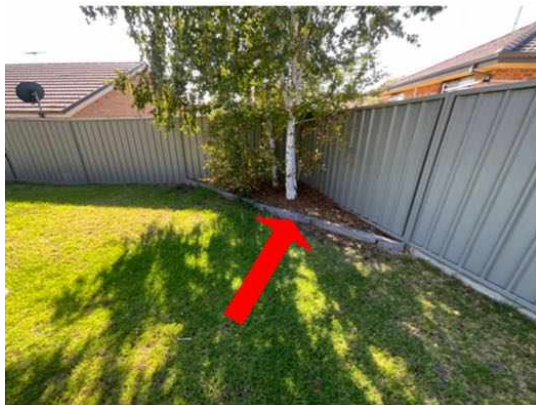
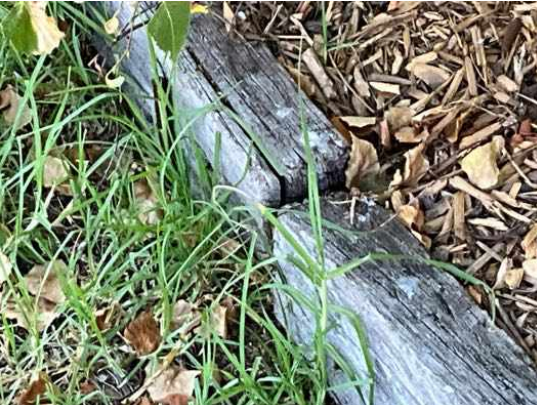
### Finding 6.03

Building:	Building 1
Location:	All External Areas
Finding:	Termite Management System - no evidence of a chemical installation
Information:	The application of a post-construction chemical termite barrier is highly recommended for all properties, particularly if live termite activity has been found on the site previously. Such barriers are highly effective in preventing termite attack on any timber building elements throughout the property.

A durable notice should be placed in the switchboard unit to indicate current termite barriers. At the time of inspection, it appeared as though no termite management system has been installed, with no evidence to suggest preventative works taking place.

The client may consider gaining further advice from a pest controller as to the costs and procedures involved with this application. It is recommended that obtaining such advice be a short-term priority.

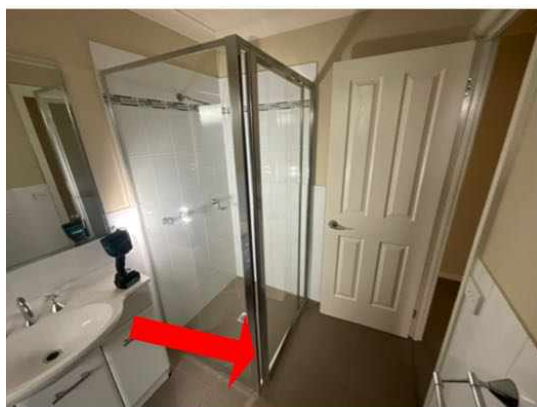
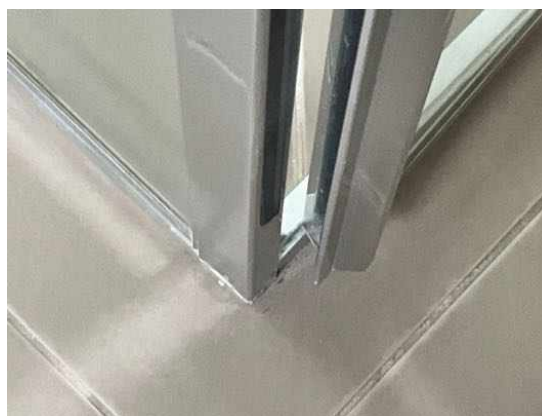
Building: Building 1  
 Location: Bathroom  
 Finding: Shower Door- jamming  
 Information: The door to the shower alcove is sticking during normal operation. Poor operation of building elements is inconvenient and potentially dangerous to the elderly or younger members of the home.

A Handy person or bathroom specialist should be contacted soon to adjust the door to prevent any further deterioration.

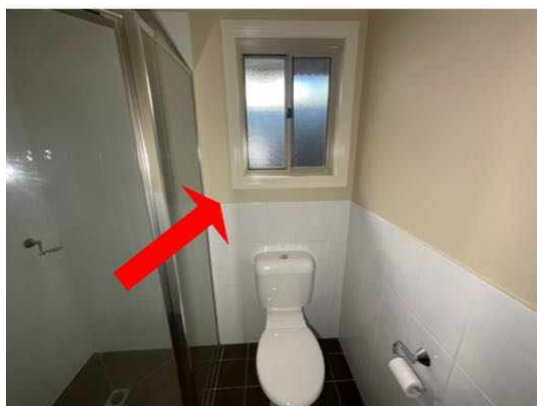
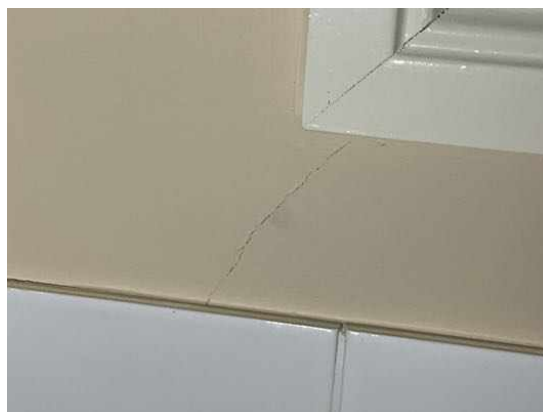
Building: Building 1  
 Location: Ensuite  
 Finding: Cracking - Damage Category 1 - Fine (up to 1mm)  
 Information: Although fine cracks are quite noticeable, they are often only considered to be an appearance defect, and usually do not indicate any structural damage. Generally, the cause of a fine crack is indicative of a separation between building materials and finishes (e.g. paint, plaster, etc.) along joins.

Cracking of this nature can generally be repaired with minor sanding, filling and/or repainting. Such works should be performed by a qualified painter or a general handyman.

Monitoring of all cracking should be conducted frequently. Always contact a building inspector should cracks widen, lengthen, or become more numerous.

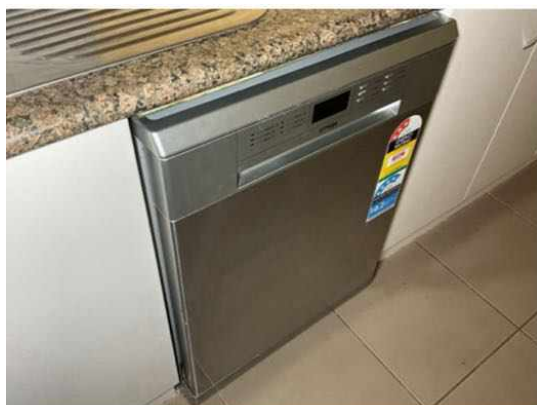
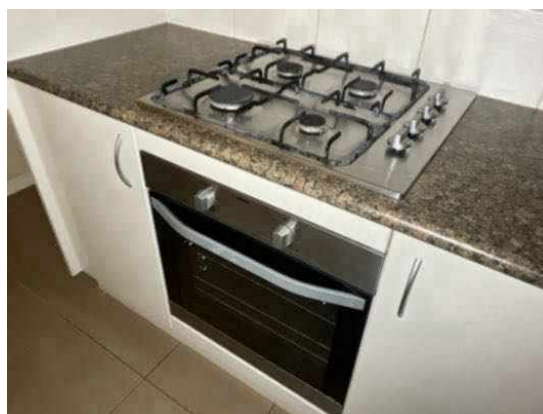
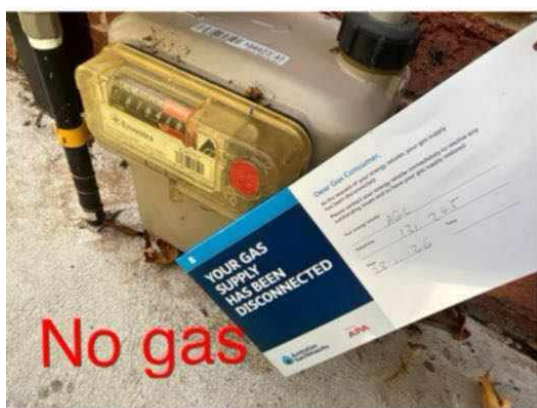
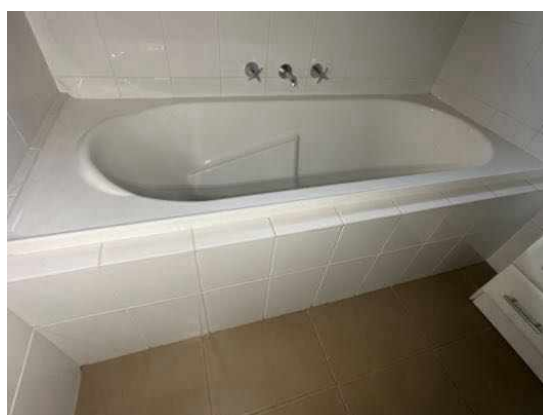
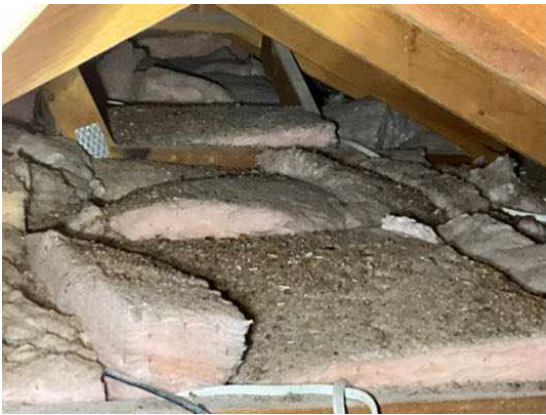
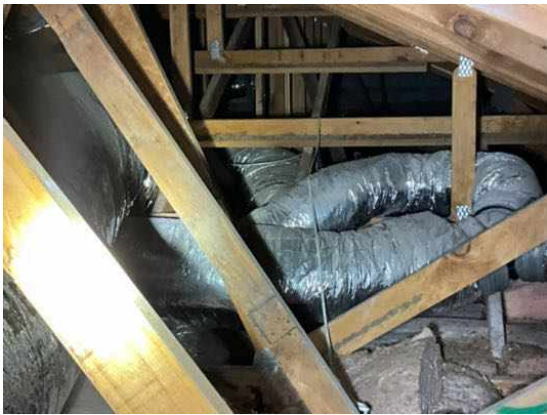
Building: Building 1  
Location: All Areas  
Finding: Additional Photos - Obstructions and Limitations  
Information: These photographs are an indication of the obstructions and limitations which impeded full inspection of the property at the time of inspection. These obstructions can hide an array of defects and should be removed to allow full inspection to be carried out. A re-inspection is recommended once the areas are made accessible.
