## Building Inspection Report

Inspection Date: Fri, 9 Jan 2026

Property Address: 3 Traine Ct, Amaroo ACT 2914, Australia

The following apply: This inspection and report were limited to the assessment of works associated with the removal of the fireplace and associated components only.

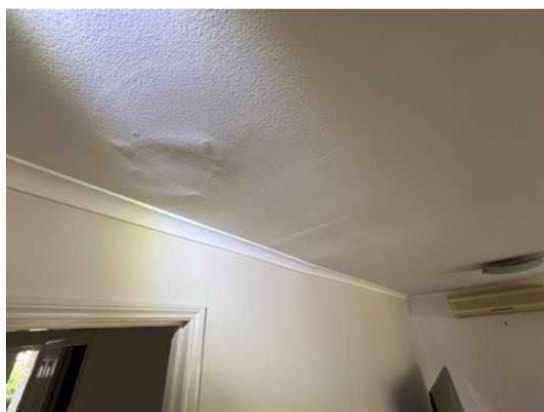
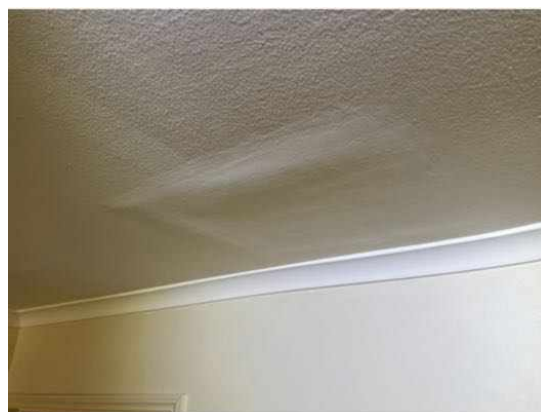
#### Defects 3.01

Building: Main Building  
 Location: Living Room  
 Finding: Ceiling - Incomplete or substandard works  
 Information: The works to this area appear to be incomplete or have been completed to a substandard level.

Works that have not been completed to a satisfactory level create potential for the development of building defects and may impede on the safety and integrity of the overall structure.

Evidence of remedial works associated with a former flue penetration was observed within the ceiling and roof space. These works include a localised patch repair to the ceiling lining, with insulation missing or not reinstated to the area where the flue previously penetrated the plasterboard. While the ceiling patch appears serviceable, the workmanship and detailing are considered substandard and detract from the overall finish.

It is highly recommended that a licensed plasterboard contractor should be appointed to repair the ceiling. To ensure the safety of the area and the longevity of all associated building elements.

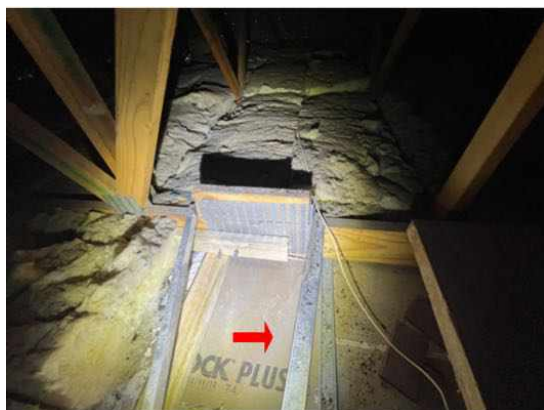
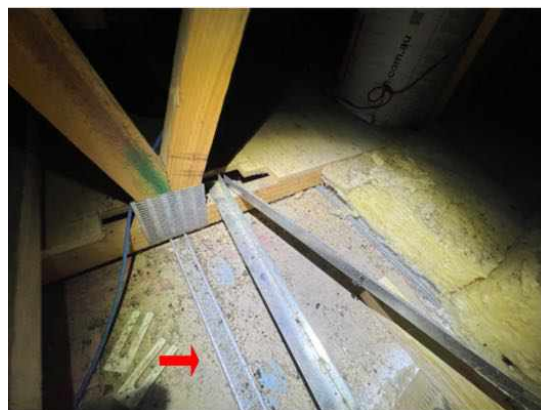
#### Defects 3.02

Building: Main Building  
 Location: Living Room  
 Finding: Insulation - Missing  
 Information: Upon inspection of the roof void it was noted that insulation is not present.

Insufficient insulation will result in a comparatively higher cost to heat and cool a property as there is a lack of Insulation (or uneven coverage of insulation) which works as a barrier to heat transfer. This helps to keep out unwanted heat in summer and preserves warmth inside your home in winter. It can also help soundproof your home from unwanted airborne noise transfer.

Where insulation is absent, the area does not meet current Australian Standards. Installation of adequate insulation is required and should be conducted as soon as possible.

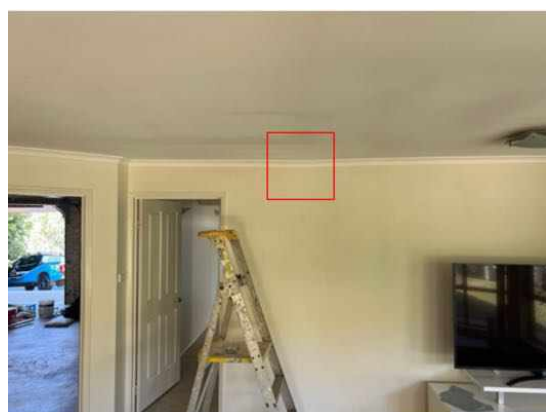
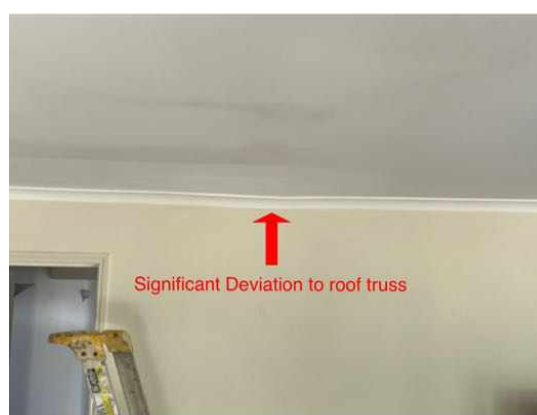
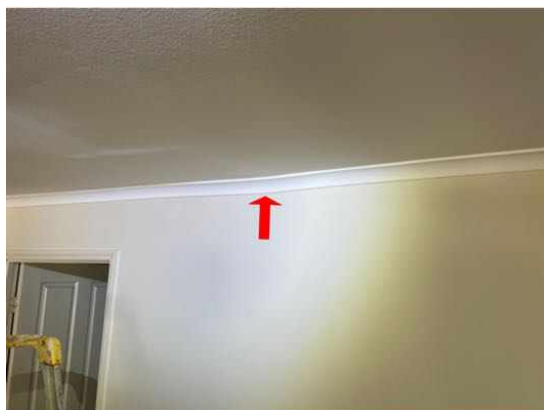
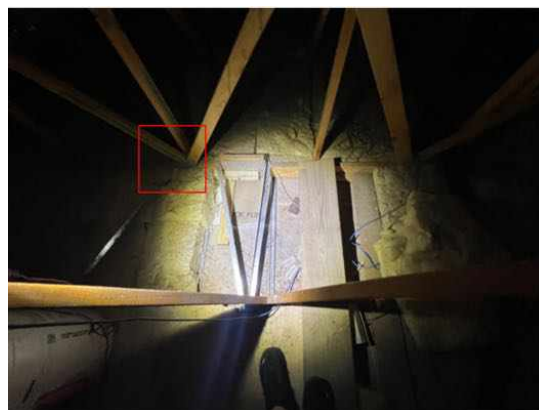
#### Noted Item

For completeness, a deviation to the ceiling line consistent with the orientation and camber of the engineered roof trusses was also observed. This condition is unrelated to the removal of the fireplace or flue works and appears attributable to the truss configuration and ceiling fixing arrangement.

Building:	Main Building
Location:	Living Room
Finding:	Ceiling - Truss Line Deviation
Information:	A noticeable deviation was observed to the ceiling line along the cornice within the living room. The ceiling surface tracks out of alignment through the corner line, creating a visible convex profile rather than a straight plane.

This condition is consistent with the orientation of the engineered roof trusses running at right angles to the room. The camber of the truss, combined with the ceiling battens being fixed to the opposing face of the truss, has resulted in the ceiling lining following the truss profile rather than forming a uniform level finish. This deviation is attributable to the truss geometry itself and is not related to the installation or removal of the fireplace.

While this issue is primarily aesthetic, the extent of the deviation is readily noticeable and may be considered unacceptable to some occupants. It also raises questions regarding whether the truss camber and ceiling fixing arrangement are performing as intended for this space.

Further assessment is recommended to confirm whether the truss profile and ceiling alignment are within acceptable tolerances. This should be reviewed by a registered builder, the original truss manufacturer, or a structural engineer to determine whether any rectification or adjustment is required.

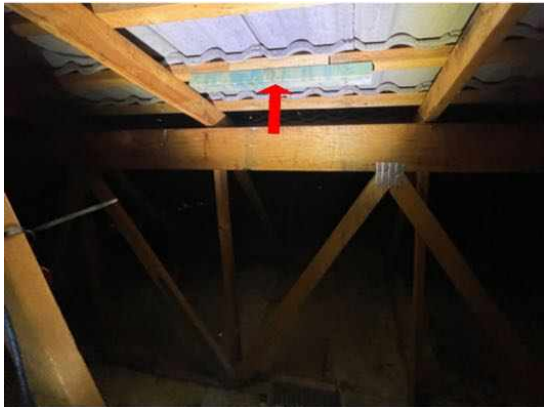
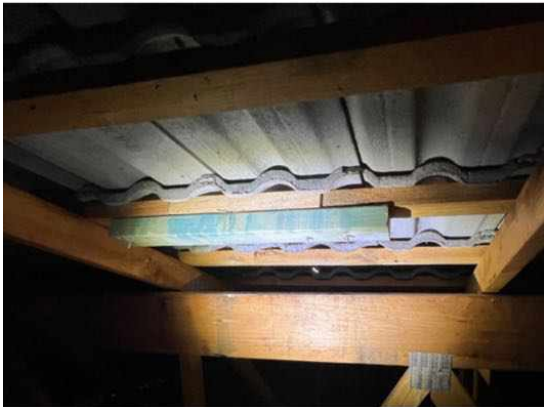
### Noted Item

Within the roof space, a localised repair to a roof batten was observed where the batten had been cut to accommodate the flue. Although the repair appears functional and is not expected to deteriorate in the short term, the length and detailing of the patch are below a typical professional standard.

Building:	Main Building
Location:	Living Room
Finding:	Roof Batten - Localised Patch Repair
Information:	A localised batten repair was observed within the roof space where a batten had previously been cut to accommodate a flue penetration. A short section of replacement timber has been installed and fixed to reinstate support to the roof covering.

While the repair appears to be performing its intended function and no immediate issues were observed, the length and detailing of the replacement section are considered substandard when compared to common roofing practice. The repair does not extend a sufficient distance beyond the original cut to provide a neat, uniform, and well-finished outcome.

Although deterioration or failure is not anticipated in the short term, substandard detailing of this nature may be more prone to movement or loosening over time and does not reflect a professional standard of workmanship.

Further review by a carpenter or roofing contractor is recommended to improve the detailing if desired, particularly if additional roof works are undertaken in the future.

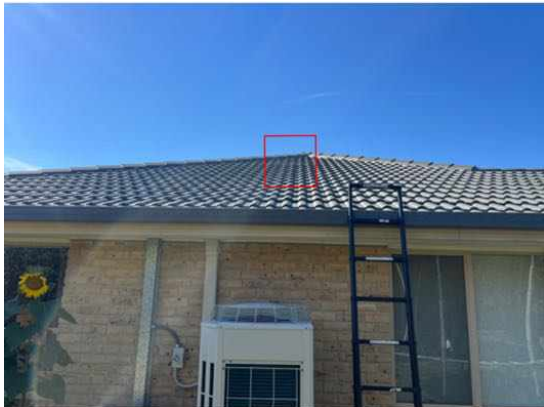
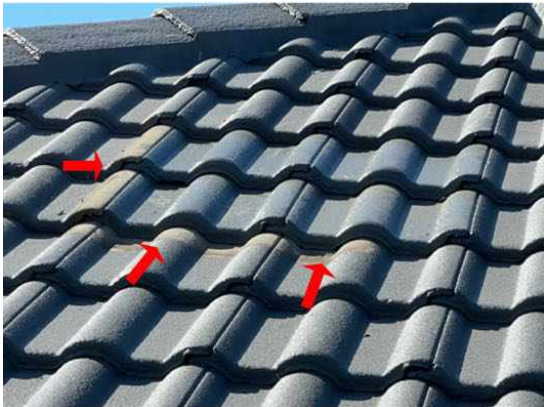
**Noted Item**

Externally, roof tiles were reinstated to the former flue location. The tiles appear adequately positioned; however, they are visually inconsistent with the surrounding roof surface, which has been recently restored and painted. This inconsistency is considered aesthetic only.

Building: Main Building  
Location: Roof Exterior  
Finding: Roof Tiles - Localised Visual Inconsistency  
Information: Roof tiles were reinstated to the area where the flue penetrates the roof surface. While the tiles appear to be adequately positioned, the finish in this localised area is visually inconsistent with the surrounding roof covering, which has been recently restored and painted.

The affected tiles appear unpainted or less clean when compared to adjacent areas, resulting in a noticeable variation in appearance. This is considered an aesthetic matter only and does not indicate a functional defect.

If a uniform appearance is desired, the tiles may require cleaning or repainting to better match the surrounding roof surfaces.
