Building Inspection Report

Inspection Date: Mon, 16 Feb 2026

Property Address: 22/13 Jordan St, Gladesville NSW 2111,
Australia

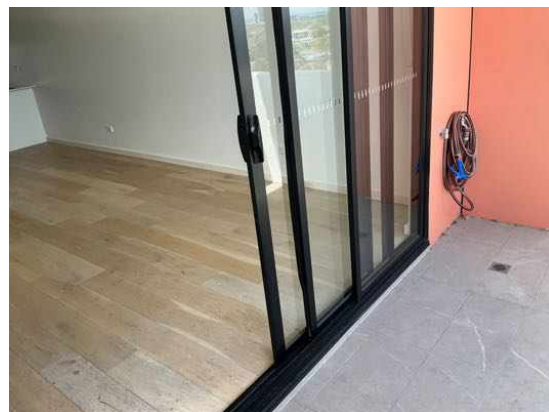
Defects 3.02

Building: Main Building
Location: All Areas
Finding: Maintenance and/or Wear and tear on building elements
Information: It was observed at the time of inspection that some building elements and areas around the property require general maintenance and/or exhibit signs of wear and tear. These typically include minor imperfections such as paint scuff marks, scratches on surfaces, small chips, nails or hooks left in walls from previous picture hanging, and other superficial blemishes.

These are generally considered minor items that are common in established homes. While they may be noticeable on visual inspection, they do not affect the structural integrity or functionality of the property. In most cases, these issues can be easily addressed by a qualified handyman as part of routine maintenance.

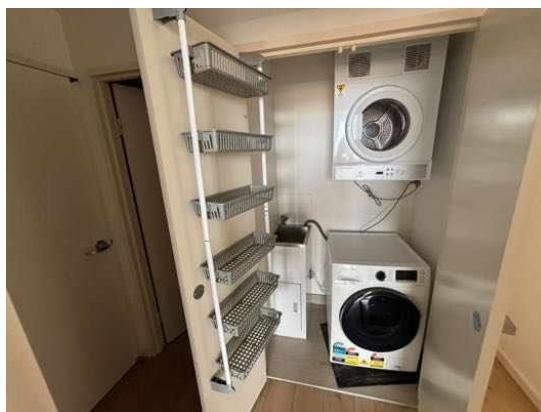
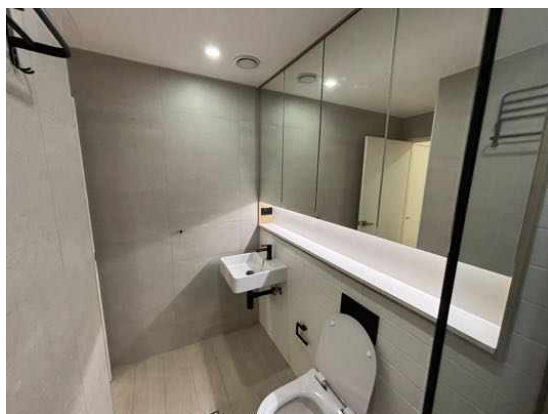
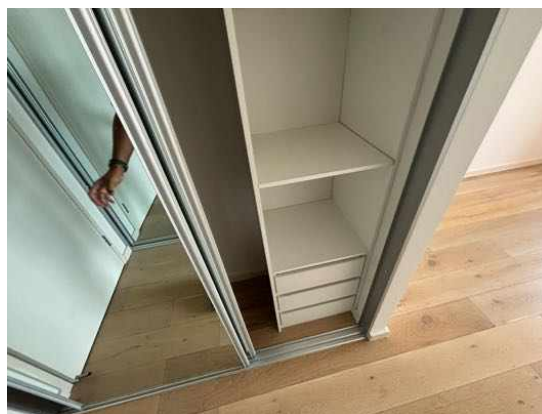
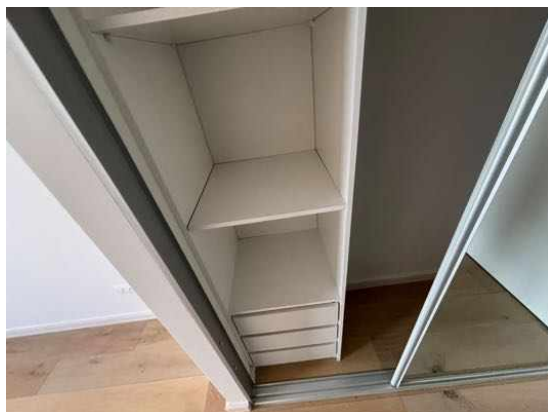
Information: The accompanying photographs provide clear evidence of the obstructions and limitations that restricted a comprehensive inspection of the internal areas of the property at the time of assessment. These obstructions, which may include furniture, personal belongings, stored items, or structural elements such as wall coverings and built-ins, significantly hindered the ability to thoroughly evaluate these areas. It is important to note that such obstructions can potentially conceal a wide array of defects, ranging from hidden structural damage, water leaks, pest infestations, or electrical issues, to deteriorating materials that may not be visible during the initial inspection.

The presence of these impediments means that critical areas of the property were not accessible, and therefore, any underlying defects that may affect the integrity and safety of the property could remain undetected. These hidden defects, if left unaddressed, could worsen over time and may result in costly repairs or pose potential safety hazards to the occupants.

It is highly recommended that all obstructions be cleared to facilitate a complete and thorough inspection of the internal areas. Once the obstructions have been removed and full access is available, a re-inspection should be carried out to ensure that any previously concealed issues can be properly identified and rectified. This follow-up inspection will provide a more accurate assessment of the property's internal condition and help the client make informed decisions about any necessary repairs or maintenance.

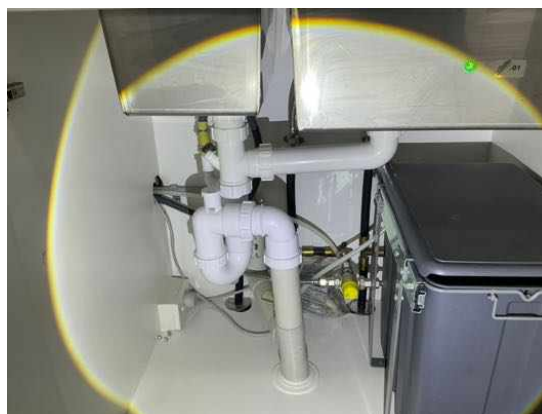
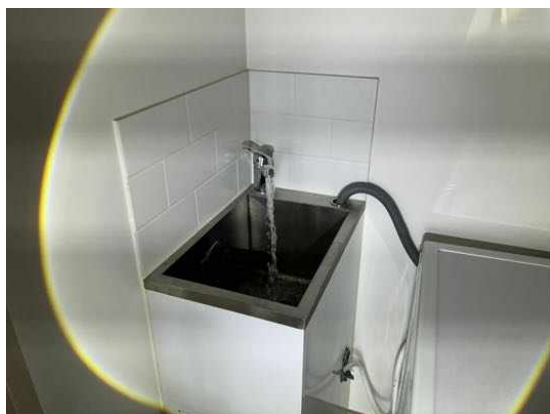
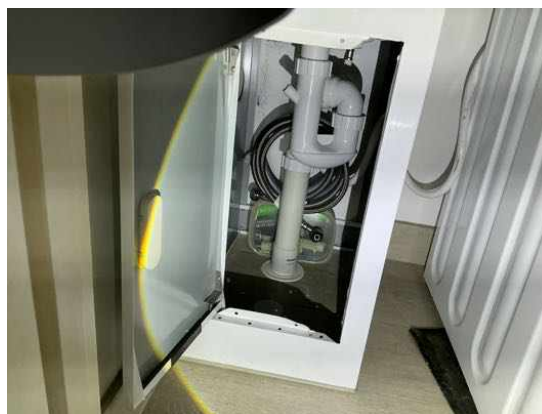
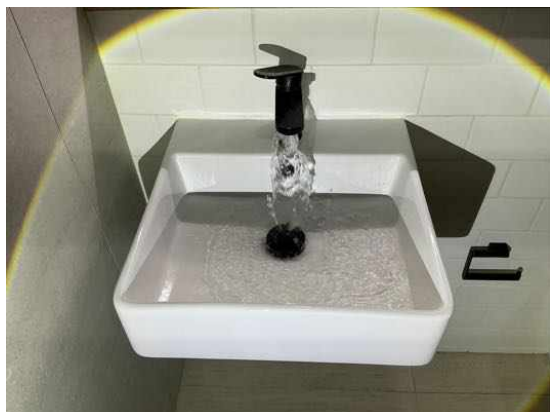
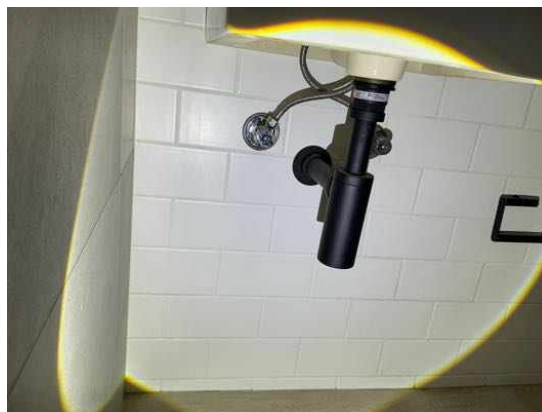
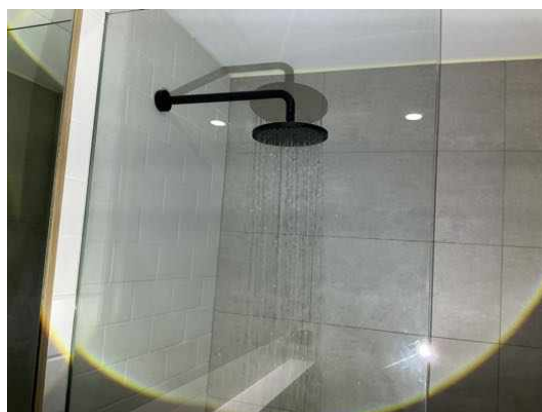
Building: Main Building
Location: All Areas
Finding: FYI - Taps, Drainage and Toilets Tested
Information: During the inspection, taps, drainage systems, and toilets were checked for both water flow and drainage efficiency, as well as inspected for any visible signs of leakage. At the time of the inspection, no issues were noted in these areas, and unless highlighted in a separate defect statement, no immediate remedial work appears to be necessary for these items. Any relevant photos documenting these inspections may be found in the additional photos section for reference.

However, it is important to note that while a thorough inspection of cupboards and cabinetry was conducted, the presence of obstructions, such as stored items or fixtures, may have limited full visibility of potential water damage or hidden defects. These obstructions can conceal underlying issues that may not be immediately visible during the initial inspection. Furthermore, conditions can change after the inspection has been carried out, and defects or damage could be revealed once obstructions are removed or as time progresses.

Given this, it is strongly recommended that a re-inspection be conducted after all obstructions have been removed from the cupboards to allow for a full and thorough assessment of these areas. This will ensure that any concealed damage or defects are identified and addressed in a timely manner. Regular maintenance and monitoring of plumbing and drainage systems are also advised to ensure long-term functionality and to prevent future problems from arising.

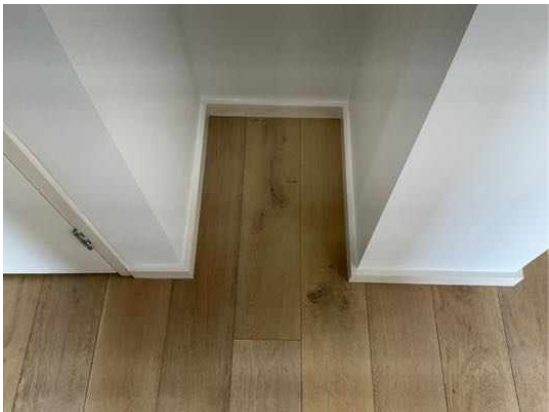
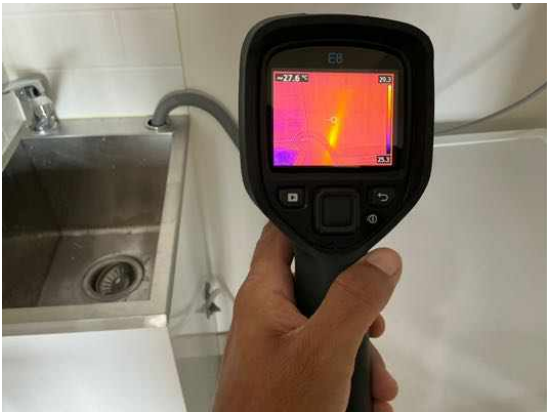
Building:	Main Building
Location:	Hallway, Kitchen, Laundry
Finding:	Hot Water Pipework Located Behind Plasterboard
Information:	At the time of inspection, thermal imaging identified a vertical hot water pipe running through the wall junction behind the plasterboard lining. While the pipework is not visible externally, the thermal camera confirmed the presence of active hot water flow within this section of wall. This pipework is likely part of the building's shared plumbing infrastructure and may service other units within the complex.

The client is advised not to install nails, screws, wall anchors, shelving brackets or any fixings into this section of wall, as penetrating the plasterboard in this location may damage the concealed pipework and result in significant water damage. In strata properties, such pipework is often common property and may affect neighbouring units if compromised. Any future works involving wall penetration in this area should first be confirmed with Strata Management and, where necessary, investigated by a licensed plumber to determine exact pipe locations before proceeding.

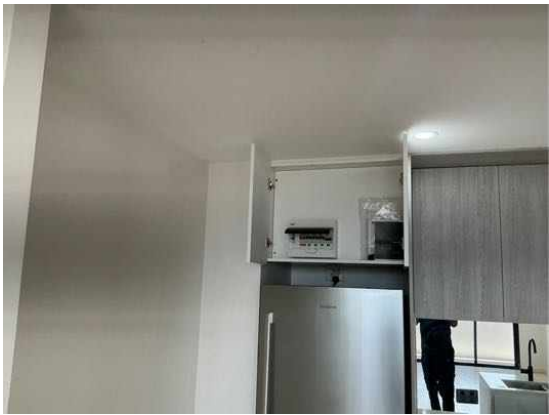
Building: Main Building
Location: Kitchen
Finding: Electrical Meter Box
Information: Electrical meter box is located in kitchen cabinets
