Building and Timber Pest Inspection Report

Inspection Date: Fri, 13 Mar 2026

Property Address: 67 Penrose Rd, Bundanoon NSW 2578,
Australia

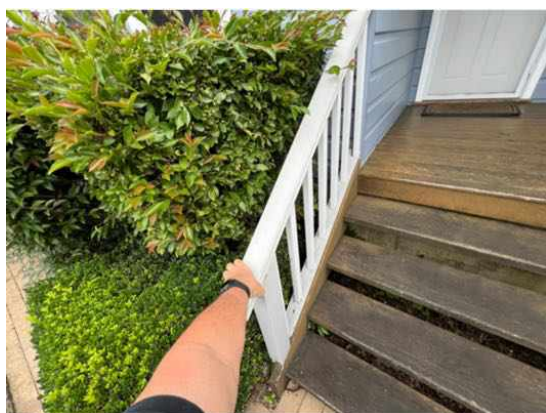
Building:	Main Building
Location:	Verandah
Finding:	Stair Balustrade - Lateral Movement
Information:	Lateral movement was observed in the stairs' balustrade at the time of inspection. This may be due to inadequate fixings, deterioration of materials, or substandard installation.

A loose balustrade presents a significant safety risk, as it may not provide adequate support or restraint, particularly under load. If left unmanaged, further movement or potential failure of the structure may occur.

It is recommended that a registered builder or carpenter be engaged urgently to assess and rectify the issue to ensure the balustrade is securely fixed.

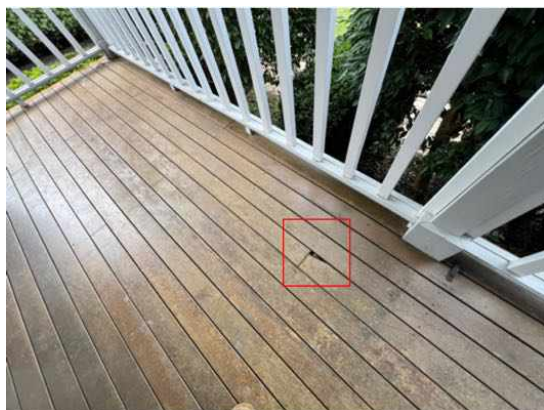
Finding 3.03

Building:	Main Building
Location:	Verandah
Finding:	Decking board - Damaged
Information:	Breakage occurs generally when the building materials have either aged and decayed, or as a result of damage (accidental or deliberate).

Repair and/or replacement of broken elements is advised to ensure that additional secondary defects do not arise as a consequence. Such works are necessary, as all building elements play a key role in the operation and function of the overall structure and its performance.

A carpenter should be appointed to repair or replace the affected building element prior to any subsequent damage being caused.

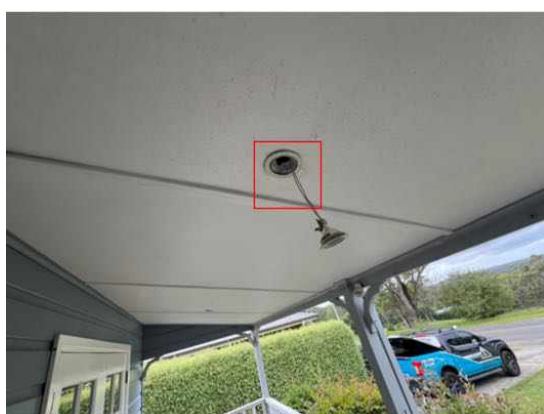
Finding 3.04

Building:	Main Building
Location:	Verandah
Finding:	Light fitting - Damaged
Information:	The light fitting in this area was found to be damaged at the time of inspection. Damage occurs generally when the building materials have aged and decayed, but may also be indicative of impact damage to the building element (accidental or deliberate).

Left unmanaged, the fitting is unlikely to cause further damage to surrounding building elements. However, the broken light fitting may expose electrical works, and may create a minor safety hazard if there is potential contact with persons in the area.

Repair and/or replacement of the damaged fitting is advised. A Licensed electrician should be appointed to repair/replace the light fitting at the client's discretion.

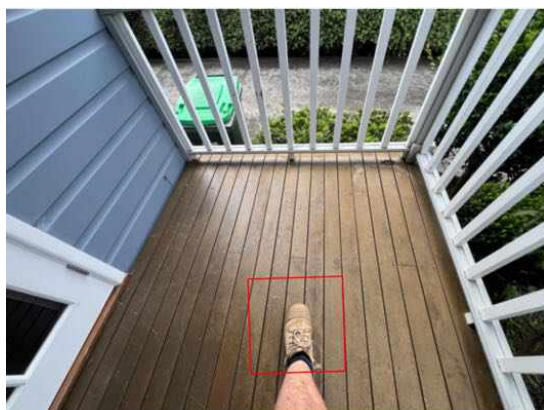
Finding 3.05

Building:	Main Building
Location:	Verandah
Finding:	Timber Deck - Bouncy Surface.
Information:	The timber deck was identified as being bouncy at the time of inspection. A bouncy

Bouncy boards likely due to insufficient thickness, excessive spacing of joists, or material deterioration. It also typically indicates that the deck boards or subframe structures are inadequately secured to the supporting joists or bearers. It may also result from gaps between the subframe and support posts, which require packing.

A registered builder, licensed carpenter or deck specialist should be engaged to assess and rectify the issue to ensure the deck's stability and longevity.

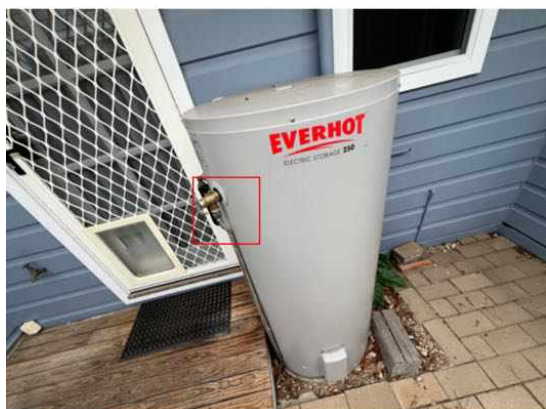
Building:	Main Building
Location:	Exterior walls - left side
Finding:	Hot Water System (HWS) - Relief Valve Leak
Information:	The Hot Water System (HWS) overflow valve was observed to be leaking, causing excessive moisture in the surrounding area.

Prolonged damp conditions can lead to secondary defects such as rot, rust, or corrosion of associated building elements, as well as the formation of fungal decay and potential slip hazards. Where poor site drainage is also present, pooling water may further increase the risk of termite activity.

It is highly recommended that a licensed plumber be engaged to assess and rectify the leak at the overflow valve to prevent further moisture-related issues. These minor works should be carried out as soon as possible.

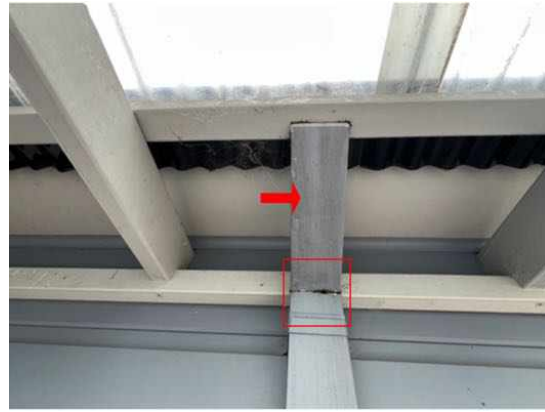
Finding 3.09

Building:	Main Building
Location:	Exterior walls - left side, right side
Finding:	Downpipe - Water staining
Information:	Water staining was evident in this area at the time of inspection. Water staining indicates that surfaces have been exposed to excessive moisture over time. The minerals and other elements in the water lead to staining, which may graduate to corrosion and deterioration if left unmanaged.

While mostly an appearance defect, water staining can be indicative of more serious defects, which may be currently concealed by other building elements.

Where water staining is active, a licensed roof plumber must be consulted to identify the cause of the staining and to provide advice on any reparation works that may be required. Replacement of any broken or damaged structures is advised.

Conversely, where water staining is old and inactive, affected building materials may be repaired or replaced at client discretion. A qualified carpenter or registered builder may be appointed to perform these works.

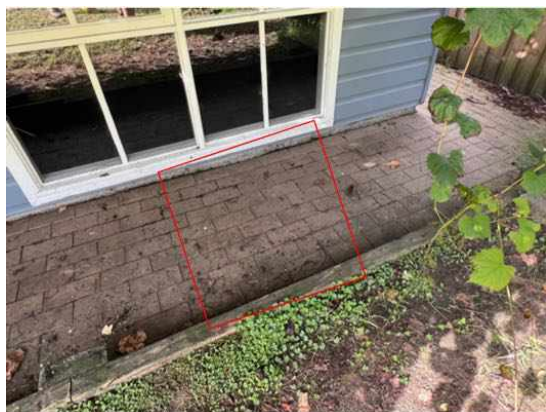
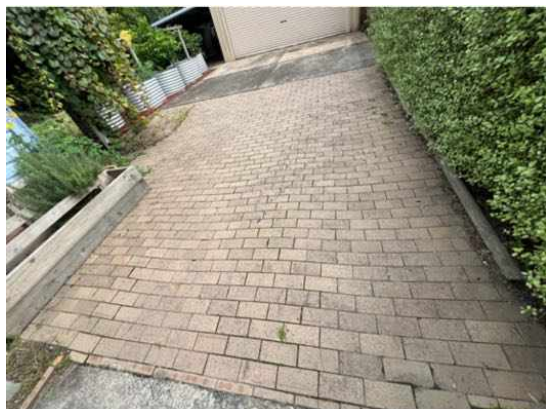
Building:	Main Building
Location:	Exterior walls - rear, Pergola, Driveway
Finding:	Paving - Uneven
Information:	Sections of the external paved area are uneven, creating a potential trip hazard. It

appears as though the area has been subject to rough installation, or that paving sections have lifted due to movements in the foundation of the property.

Where paving creates a trip hazard, personal injury may ensue if due caution is not taken by all persons within this area.

Re-paving of the area is required as soon as possible to remedy this situation. Further consultation with a specialist concreter is advised.

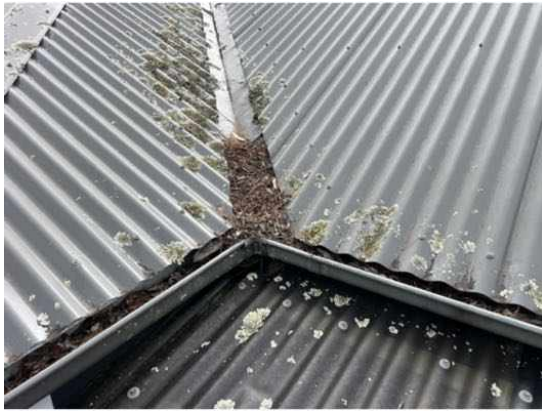
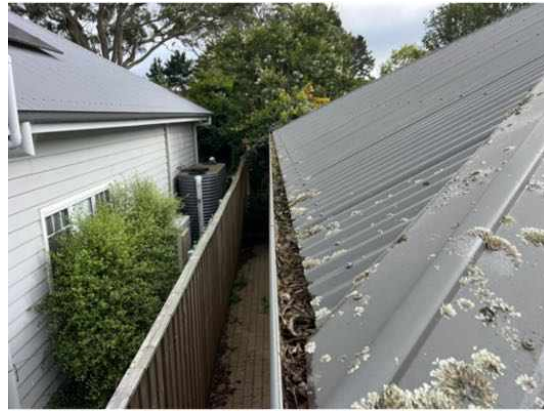
Building: Main Building
Location: Roof Exterior
Finding: Metal Roof - Lichen Growth
Information: Upon inspection of the exterior roofing, sections of the Colorbond metal roof were observed to have lichen growth present. While the roof sheeting itself appeared to be in generally fair condition, the presence of lichen indicates ongoing exposure to moisture and environmental conditions.

Lichen growth on metal roofing can retain moisture against the roof surface and, if left unmanaged, may contribute to deterioration of protective coatings over time. In addition, accumulated growth may restrict the effective flow of rainwater toward gutters and drainage points.

It is recommended that the roof be cleaned to remove lichen growth using appropriate, non-abrasive methods suitable for metal roofing. A roof maintenance or roof restoration contractor can be consulted for further advice at the client's discretion.

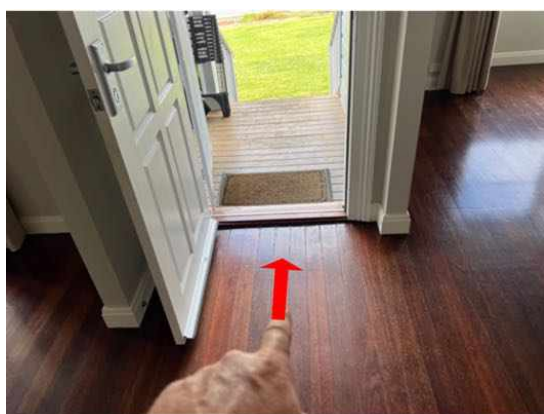
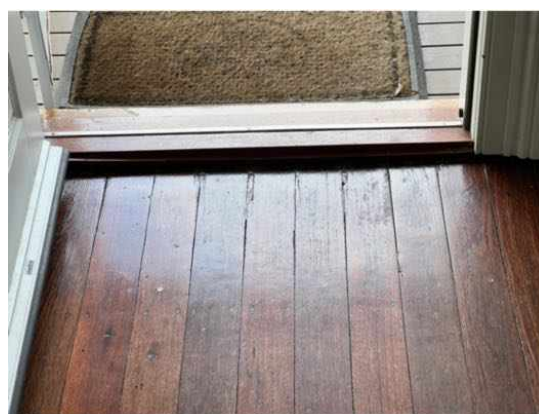
Finding 3.25

Building:	Main Building
Location:	Entry
Finding:	Flooring - Uneven
Information:	The internal flooring in this area is out of level and uneven. Uneven flooring is likely to indicate minor defects such as expected movement of the foundations of the

However, where flooring is uneven further, potentially invasive inspection of the subfloor structures and stumps in this area is required. In this case, works to repair are likely to be required, and would be carried out by a registered builder specialising in re-stumping.

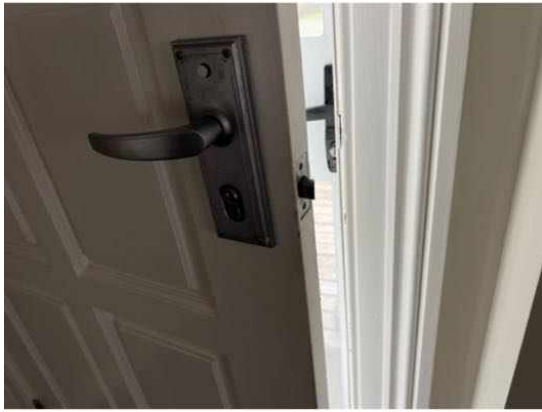
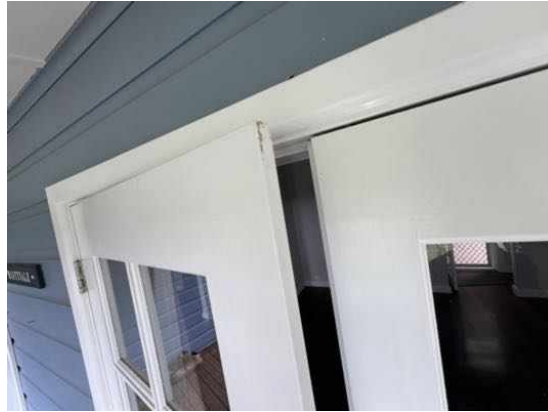
Finding 3.26

Building:	Main Building
Location:	Entry, Dining room, Bedroom 3
Finding:	Doors - Binding/Jamming
Information:	Binding and/or jamming of several doors throughout the property were evident during standard operation. This defect inhibits the functionality of affected doors as well as creating potential for secondary defects to associated building elements, such as damage to the floor covering.

For minor causes, a qualified carpenter or general handyperson should be appointed to perform minor rectification works at client discretion.

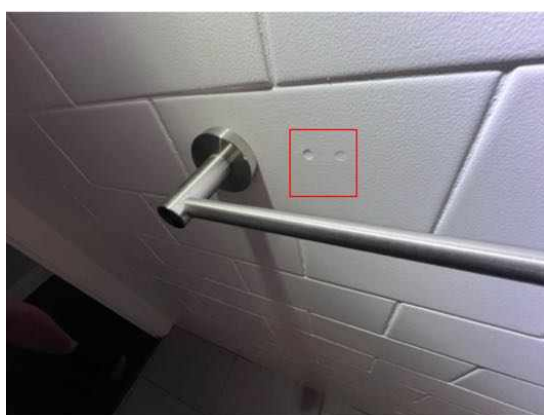
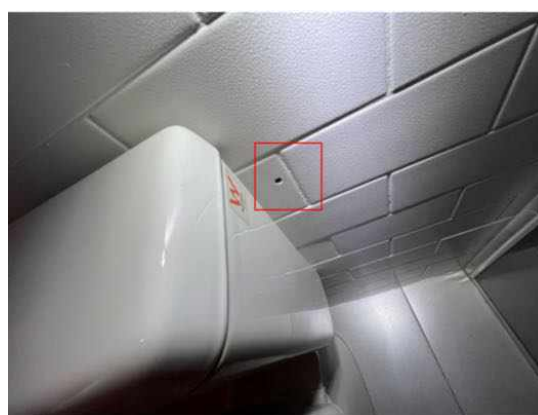
Finding 3.31

Building:	Main Building
Location:	Bathroom
Finding:	Surface - Holes
Information:	Holes in surfaces are generally indicative of impact damage, whether accidental or deliberate, or a failing of the surface material.

Repair or replacement of the affected building element is recommended as soon as possible to ensure that any secondary defects are minimised. A qualified carpenter or general handyperson should be appointed to perform these works.

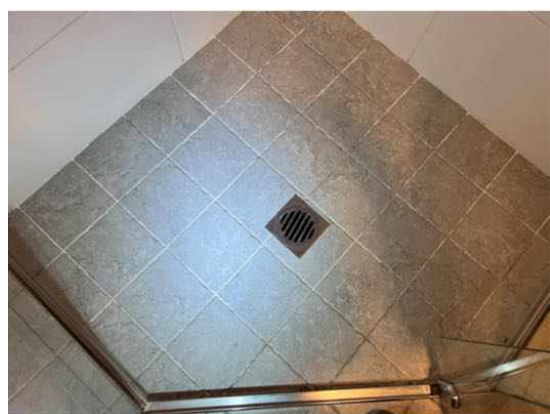
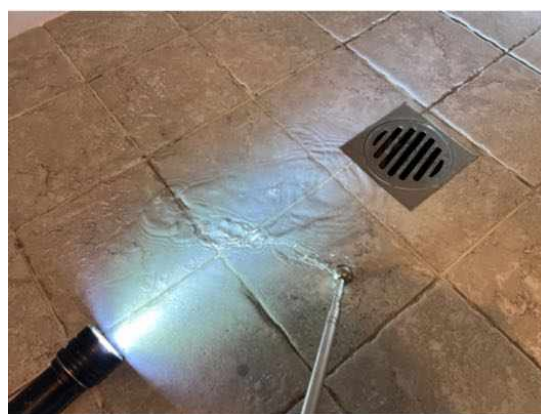
Finding 3.39

Building:	Main Building
Location:	Ensuite
Finding:	Shower base - Water pooling
Information:	Evidence of water pooling around the floor waste in the shower recess was noticed at the time of inspection. It is suspected that this excessive moisture is attributed to insufficient fall in the shower floor tiles.

Remedial works may involve some sections of tiling and flooring repair and replacement. A tiling contractor or bathroom specialist should be appointed to provide further advice on reparation options and to perform works as necessary.

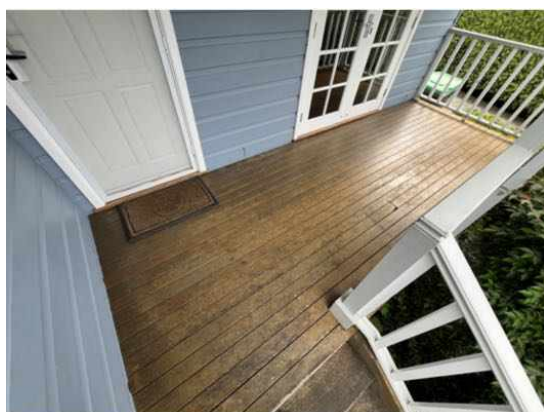
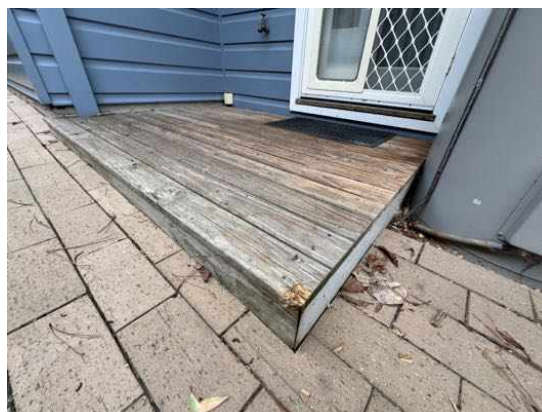
Finding 6.07

Building:	Main Building
Location:	Verandah, Exterior walls - left side
Finding:	Bridging (decking)- Attachments to Buildings.
Information:	Decking to the front porch and side patio abut dwelling causing bridging and concealment. Bridging occurs when items against a building provide a concealed entry point for termites into the building or by passing around a termite management system.

Building attachments of this nature need to be frequently inspected for termite activity by a qualified inspector.
