Building and Timber Pest Inspection Report

Inspection Date: Tue, 10 Mar 2026

Property Address: 7A Eucalyptus Ct, Broadford VIC 3658,
Australia

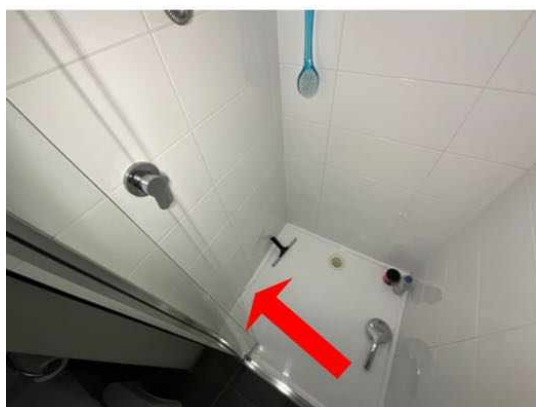
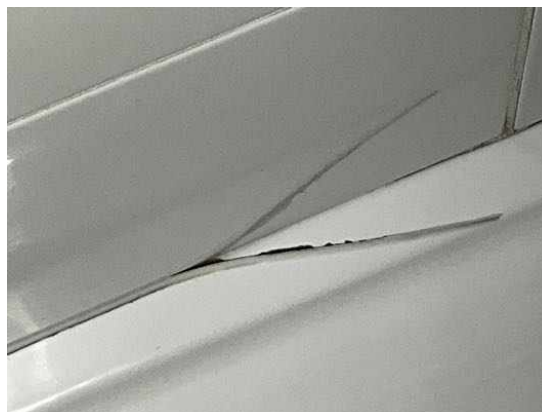
Finding 3.01

Building: Building 1
 Location: Ensuite
 Finding: Inadequate sealant or Grout
 Information: This area has a lack of effective Sealant or Grout. This is allowing the ingress of water to the structure inside the wall.

The presence of water encourages Termite attack, Mould and Fungal Decay.

A Tiler or General Handy person must be contacted as soon as possible to effect repairs and prevent further deterioration.

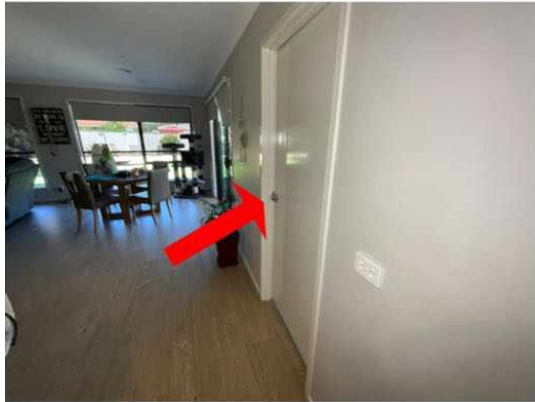
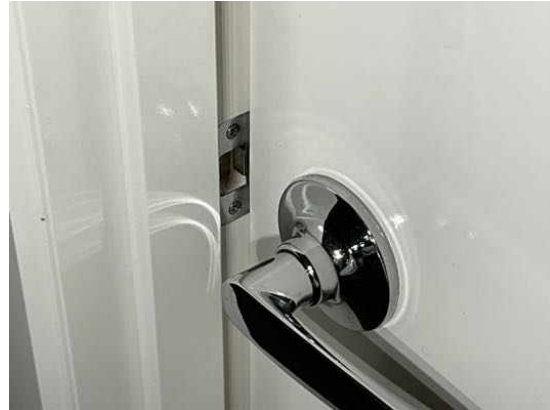
Finding 3.02

Building: Building 1
 Location: Laundry
 Finding: Door - Striker plate misaligned
 Information: The striker plate to this door appears to have become misaligned and has consequently resulted in the door's operation being compromised.

This is a common defect and is expected in a property of this age, whether being due

to substandard installation or general deterioration of the door hardware.

Readjustment of the striker plate is recommended at client discretion. Works such as these can be completed by a general handyman or qualified carpenter.

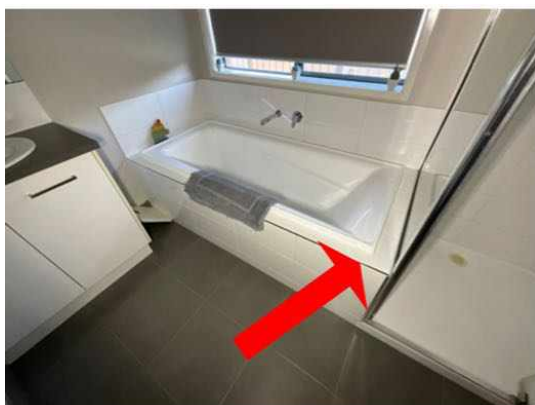
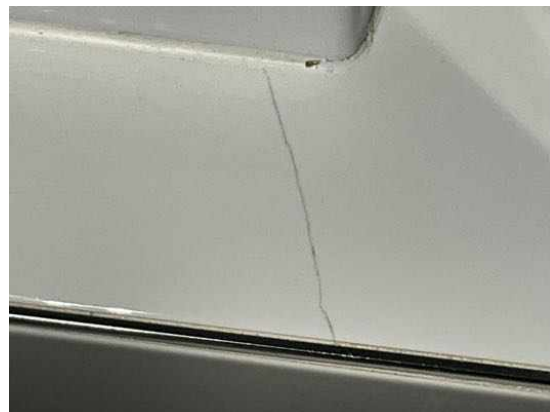
Finding 3.03

Building:	Building 1
Location:	Bathroom
Finding:	Wall Tiles- Cracked
Information:	Cracked tiles within the household detract from the overall appearance of the affected areas, as well as creating potential for water penetration to adjoining building elements. If left unmanaged, water damage may occur as a result of constant water penetration over a prolonged period of time.

While not considered a matter of urgency, replacement of tiles is advised as a solution. A Tiling Contractor may be appointed to perform these works at client discretion.

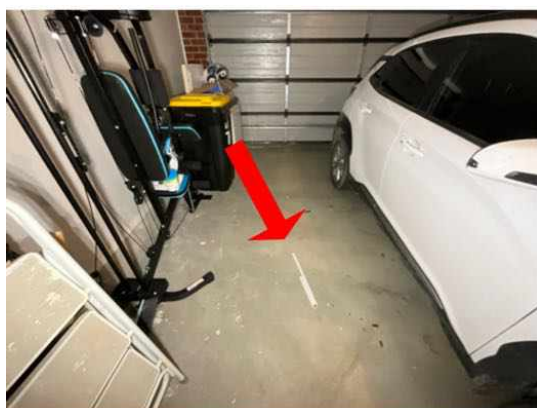
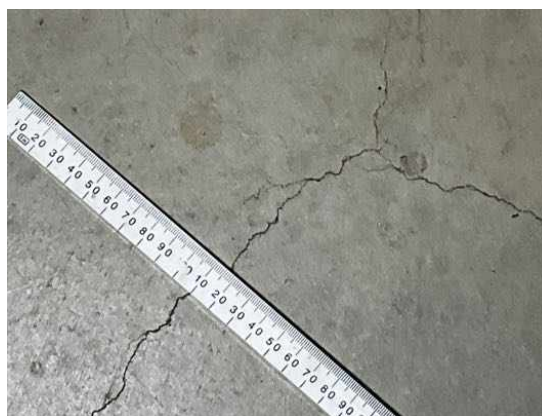
Finding 3.04

Building:	Building 1
Location:	Garage
Finding:	Crack in concrete slab - Category 1

Information: A crack coded as Category 1 was identified in the slab. A Category 1 crack is described as a fine but noticeable crack, with the slab at an otherwise reasonable level.

To be considered Category 1, the approximate width of the crack is less than 1.0mm, or a less than 10mm change in offset when a 3m straight edge is placed over the defect.

Category 1 cracks should be monitored for a period of 12 months. At the end of the monitoring period, identified cracks that are rated greater than Category 2 are considered defects, and require rectification.

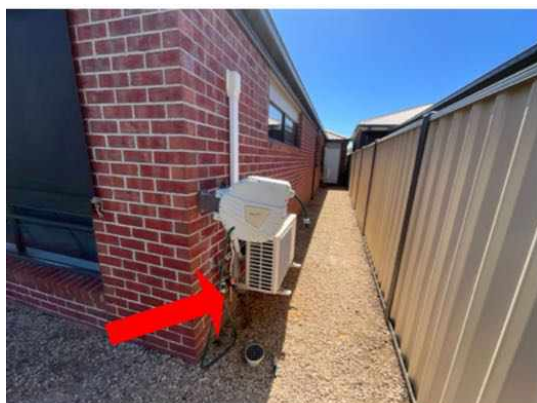
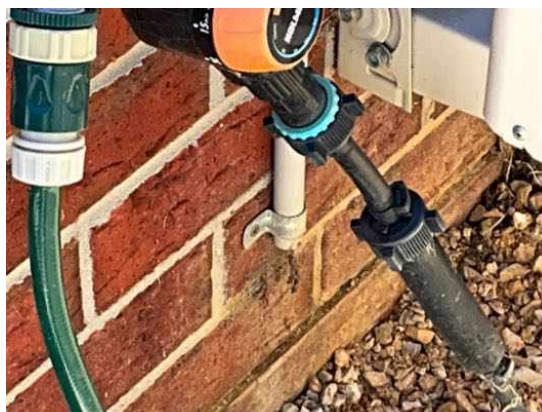
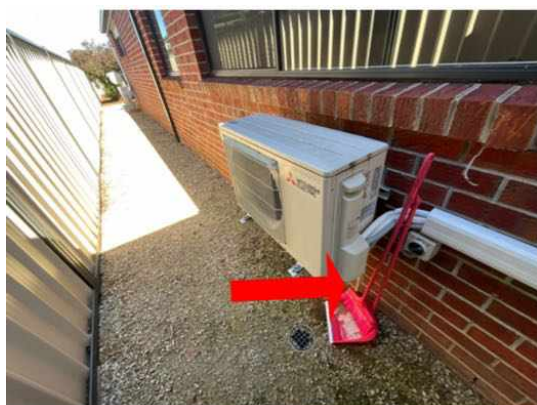
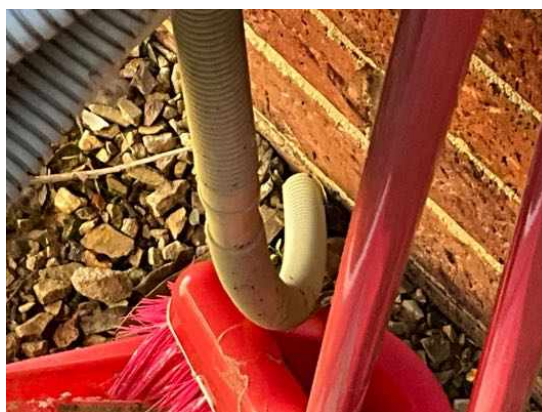
Finding 6.01

Building: Building 1
 Location: Yard - Side
 Finding: Air conditioner - Disconnected overflow
 Information: The Air Conditioner (A/C) overflow was found to be disconnected from storm water drainage and is creating excessive moisture in the surrounding area.

Such leaking creates an environment which is conducive to an array of defects, including water damage to associated building elements and the attraction of termite or timber pest infestation.

It is highly recommended that a licensed plumber be appointed to connect the A/C overflow in order to prevent such an environment from being created. These minor works should be carried out as soon as possible.

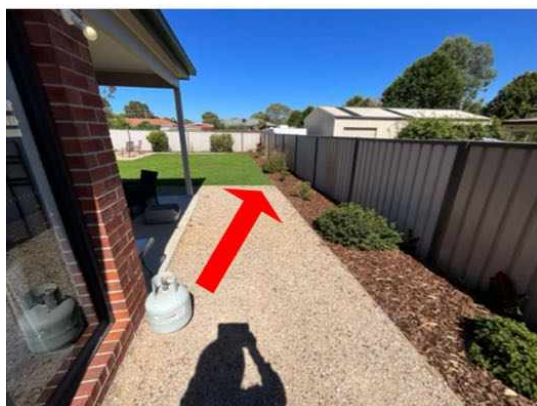
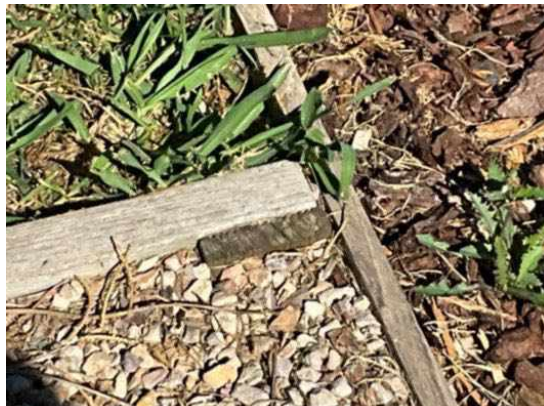
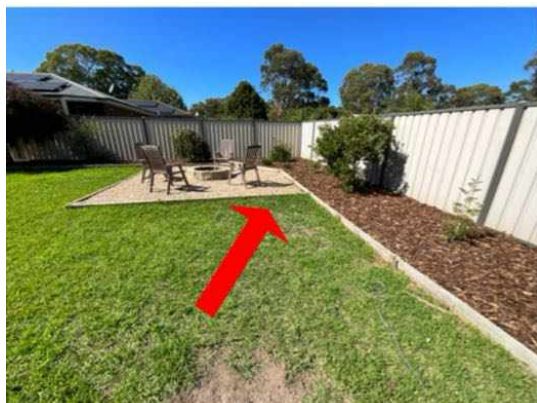
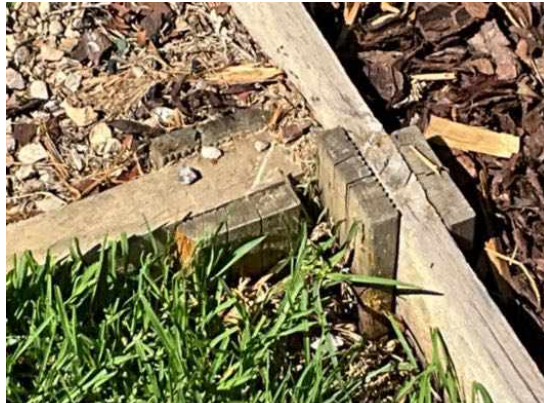
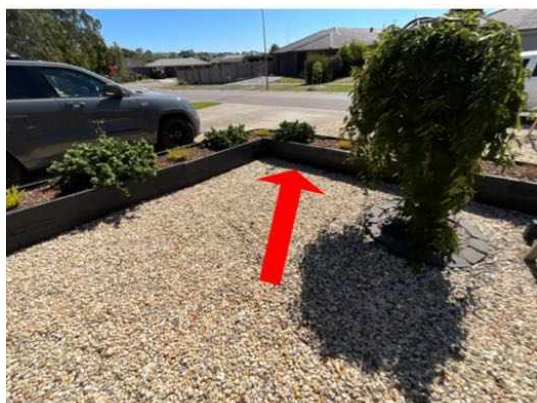
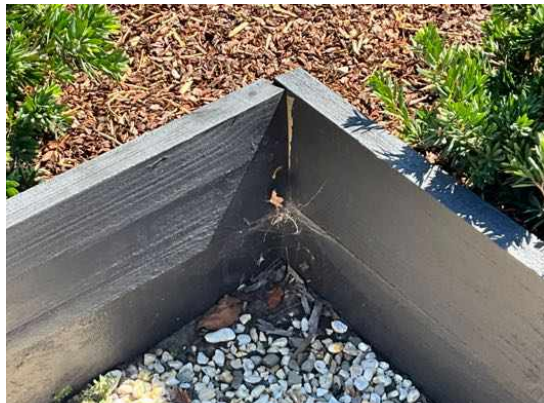
Finding 6.02

Building:	Building 1
Location:	Yard - Back, front
Finding:	Untreated or non-durable timbers in a hazardous environment
Information:	To reduce the risk of timber pest attack it is essential that timber used in a hazardous environment (e.g. in direct contact with the ground or frequently exposed to damp conditions) is of sufficient durability and/or is adequately preservative treated.

Untreated timbers in direct contact with the ground are likely to develop severe wood rot and/or fungal decay if left unattended creating attraction for subterranean termites to infest the timbers from surrounding areas.

If untreated or non-durable timbers are found to be in a hazardous environment it is highly advised that replacement of these building elements be performed as soon as possible to aid the protection of the property against termite / timber pest attack.

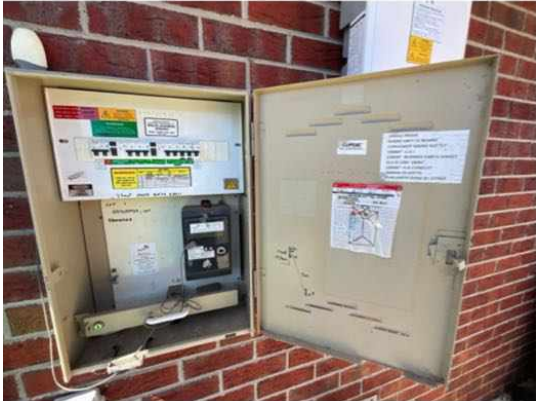
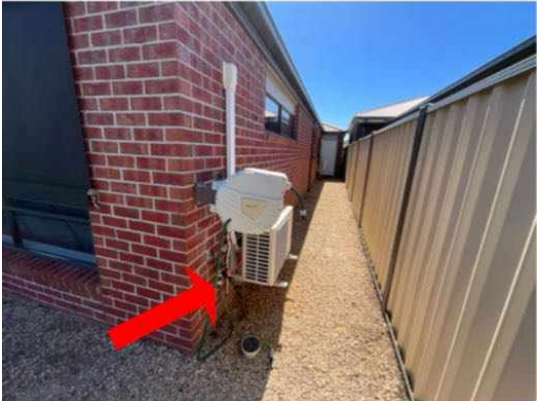
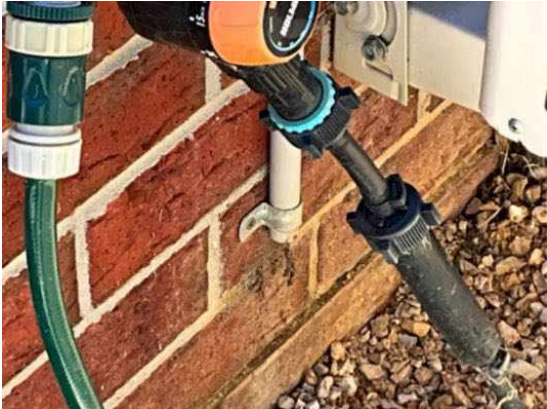
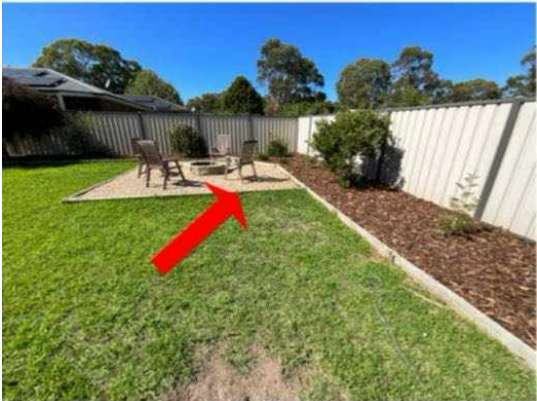
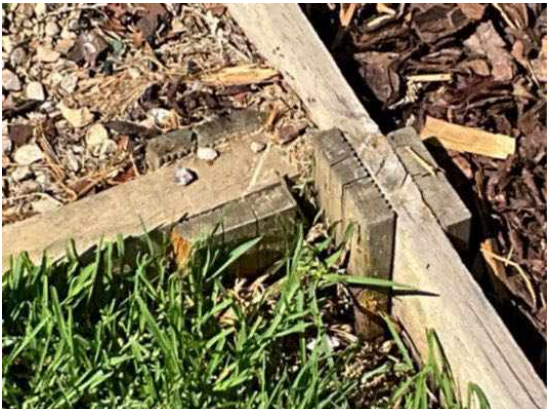
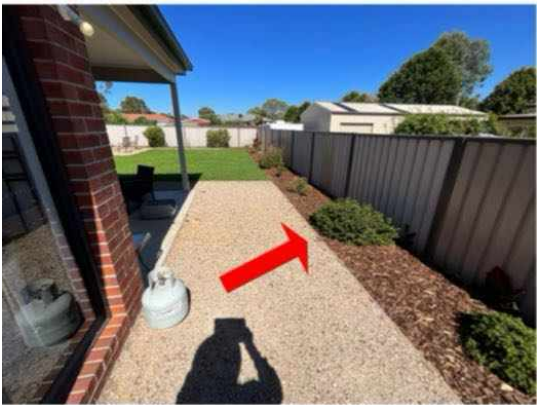
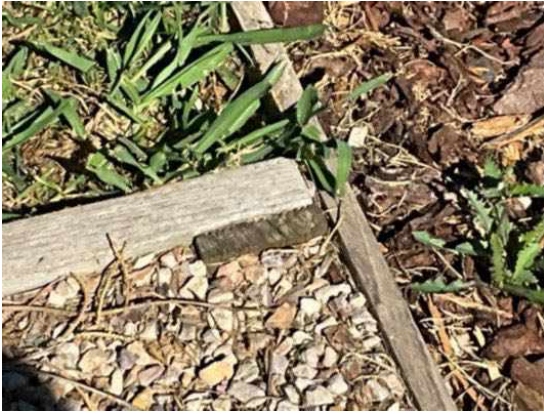
Finding 6.03

Building: Building 1
 Location: All External Areas
 Finding: Termite Management System - no evidence of a chemical installation
 Information: The application of a post-construction chemical termite barrier is highly recommended for all properties, particularly if live termite activity has been found on the site previously. Such barriers are highly effective in preventing termite attack on any timber building elements throughout the property.

A durable notice should be placed in the switchboard unit to indicate current termite barriers. At the time of inspection, it appeared as though no termite management system has been installed, with no evidence to suggest preventative works taking

place.

The client may consider gaining further advice from a pest controller as to the costs and procedures involved with this application. It is recommended that obtaining such advice be a short-term priority.

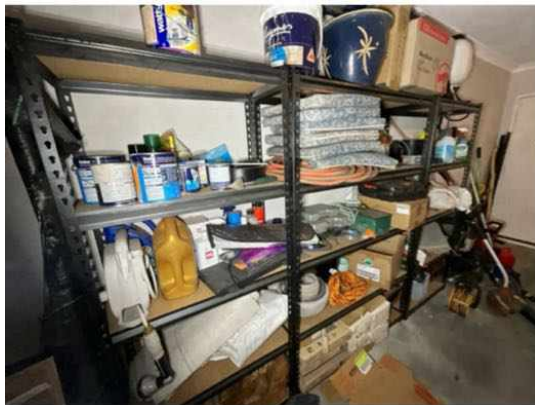
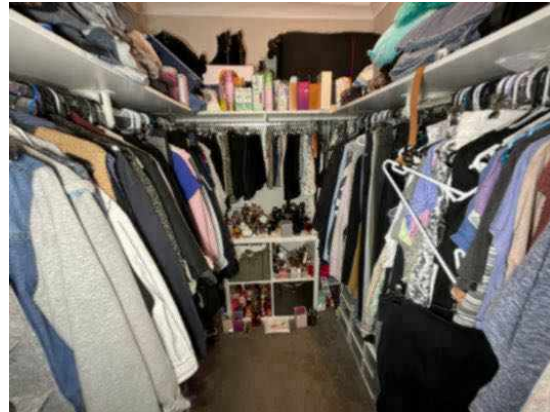
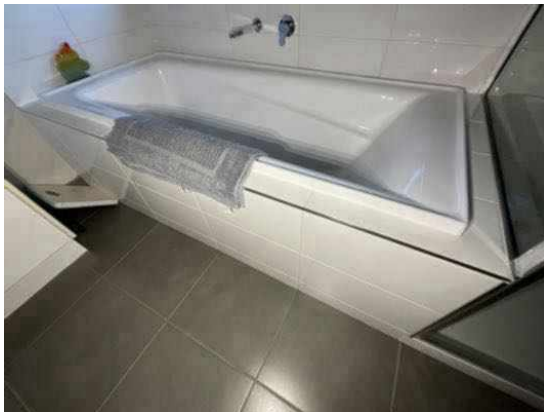
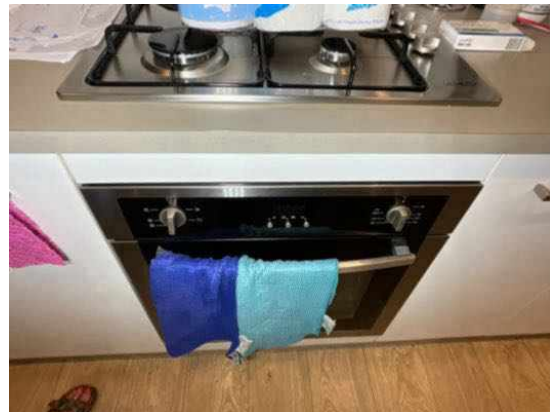
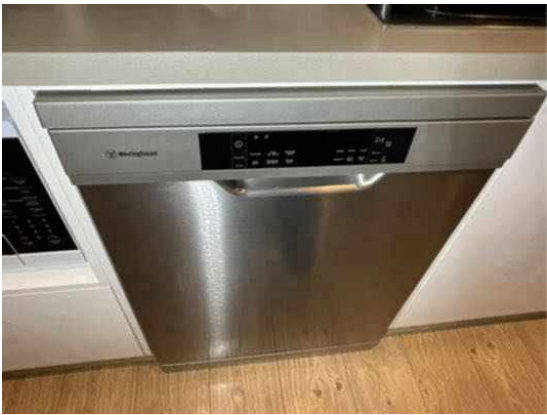
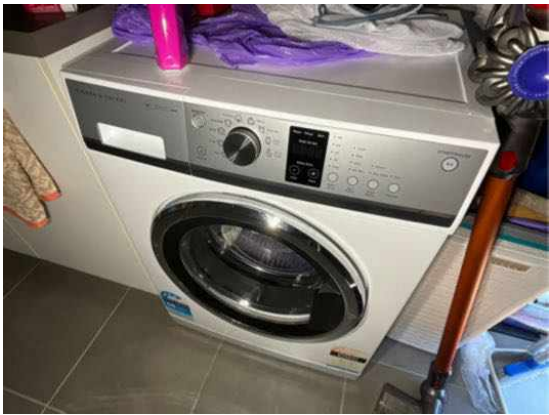
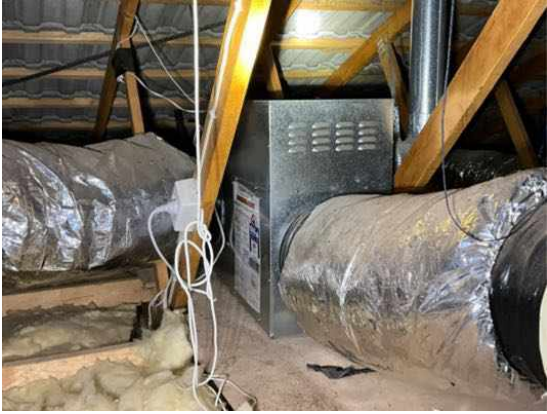
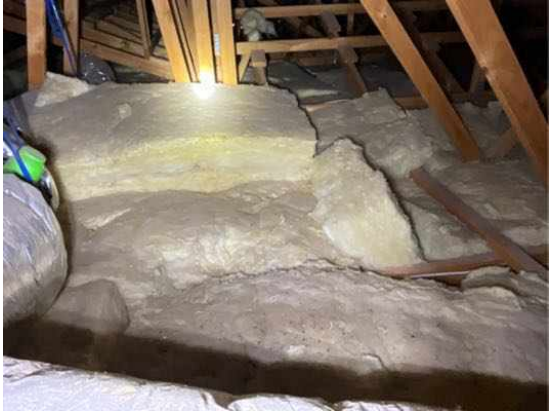
Noted Item

Building: Building 1
Location: All Areas
Finding: Additional Photos - Obstructions and Limitations
Information: These photographs are an indication of the obstructions and limitations which impeded full inspection of the property at the time of inspection. These obstructions can hide an array of defects and should be removed to allow full inspection to be carried out. A re-inspection is recommended once the areas are made accessible.
