Building and Timber Pest Inspection Report

Inspection Date: Thu, 12 Mar 2026

Property Address: 10 McEwen St, Shepparton VIC 3630,
Australia

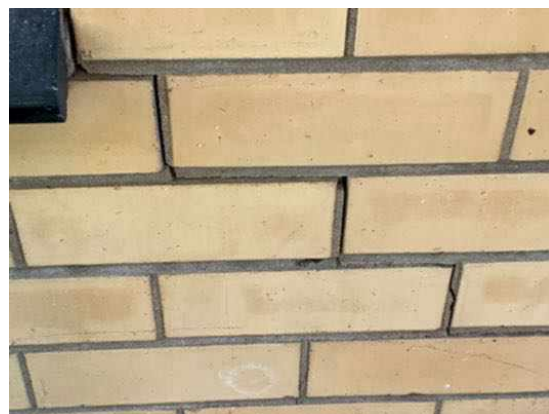
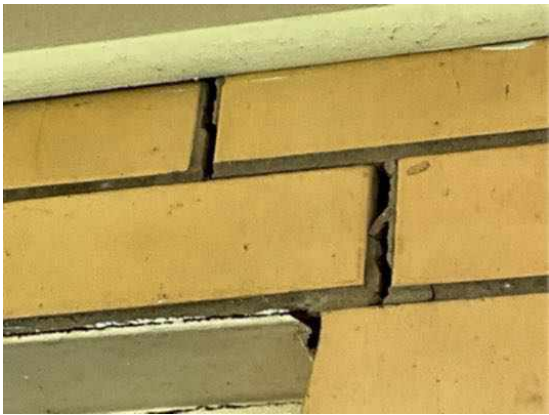
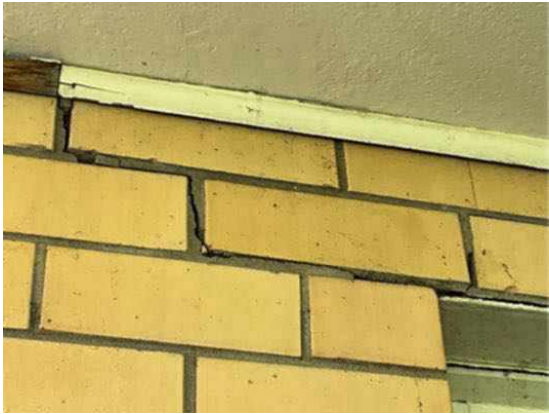
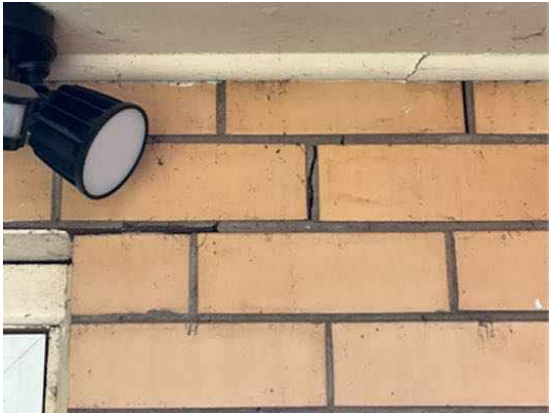
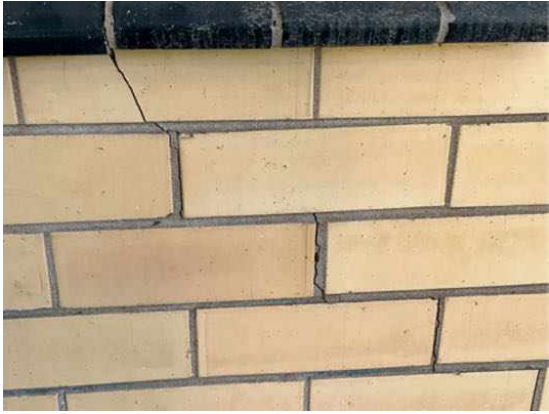
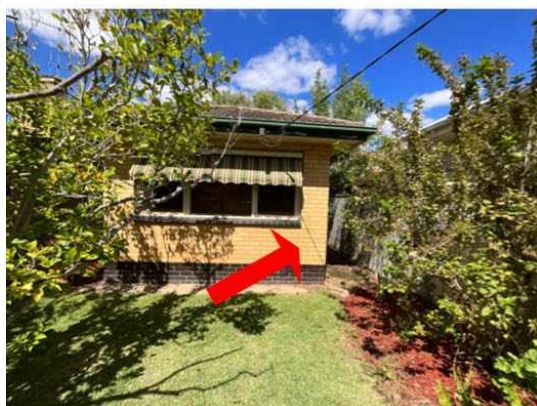
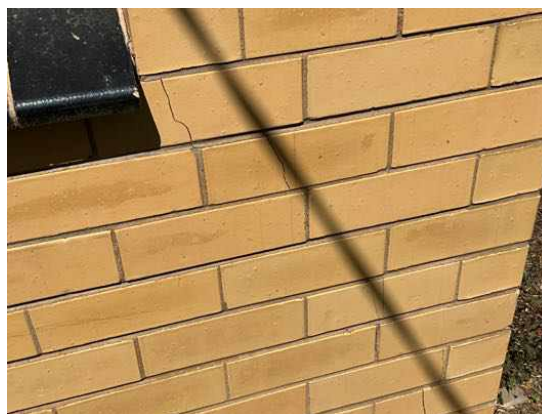
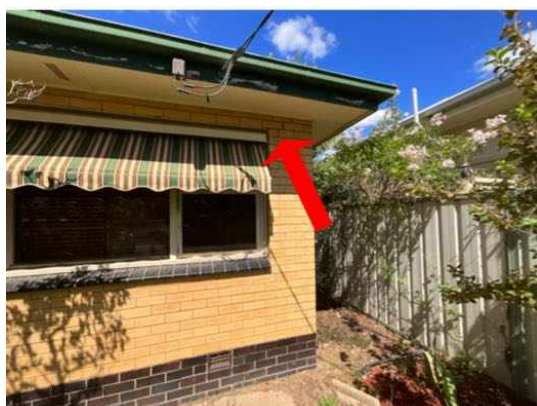
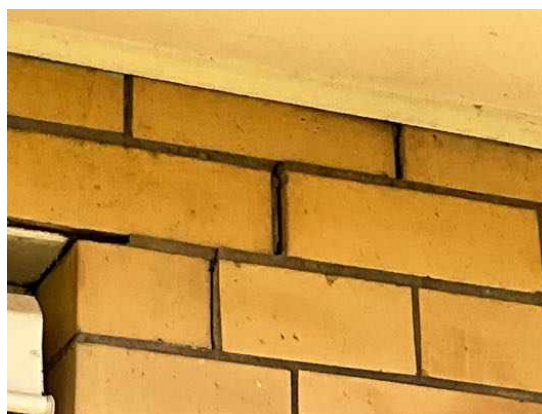
Building: Building 1
Location: Rear, front wall
Finding: Brickwork - Step cracking
Information: Step cracking was identified to the brickwork in this area at the time of inspection. Step cracking, which is similar to other forms of cracking, has a variety of possible causes. However, the most common is the subsidence of adjacent footings.

Step cracking is a relatively common defect, and is most likely to occur adjacent to windows, doors and other openings. Mortar failure in the gaps between affected bricks indicates the stresses and tensions affecting the wall.

Where step cracking is extensive or severe, the client is advised to consult a structural engineer. Minor step cracking can be used as a warning sign to address factors causing stress to the wall, which can include the effect of surrounding trees, water leaks, soil erosion, or even the presence of reactive soils in the surrounding area.

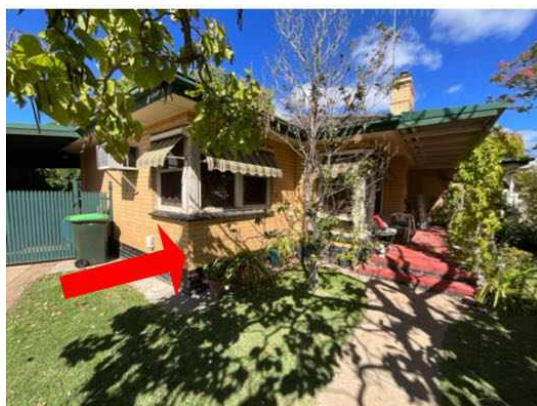
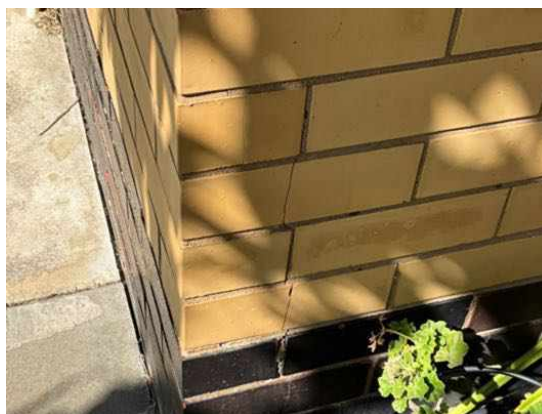
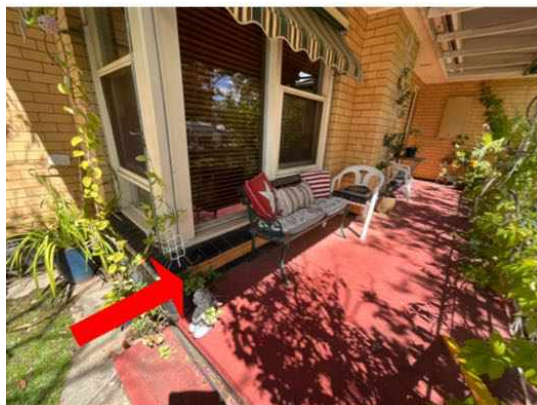
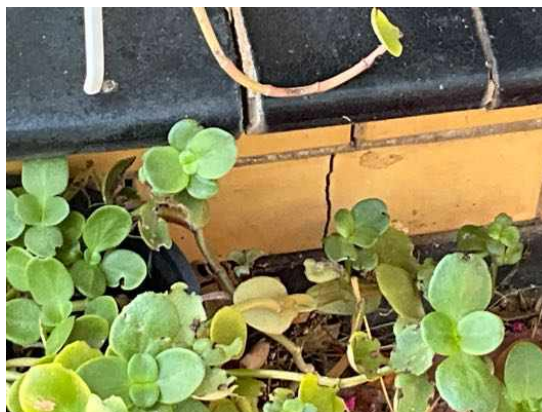
Finding 3.02

Building:	Building 1
Location:	Front wall
Finding:	Brickwork - Cracking [Fine]
Information:	Although fine cracks are quite noticeable, they are often only considered to be an appearance defect and usually do not indicate any structural damage. Generally, the cause of a fine crack is indicative of a separation between brickwork and mortar throughout the structure, but single bricks may also show cracks of this nature.

Cracking of this nature can generally be repaired with minor filling and should be conducted by a qualified bricklayer.

Always contact a building inspector should cracks widen lengthen or become more numerous.

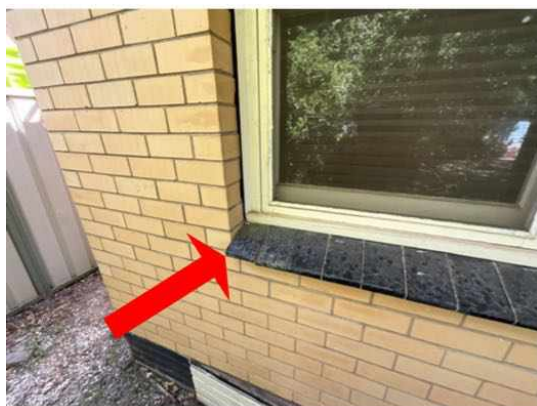
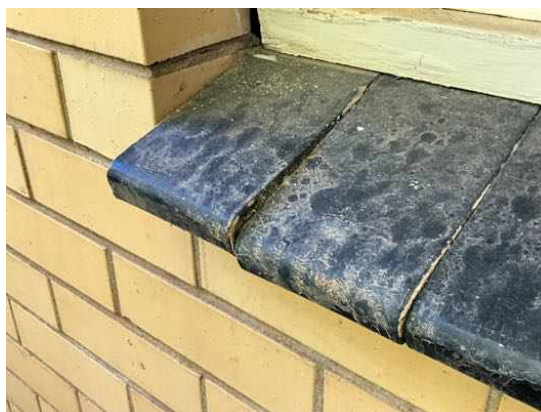
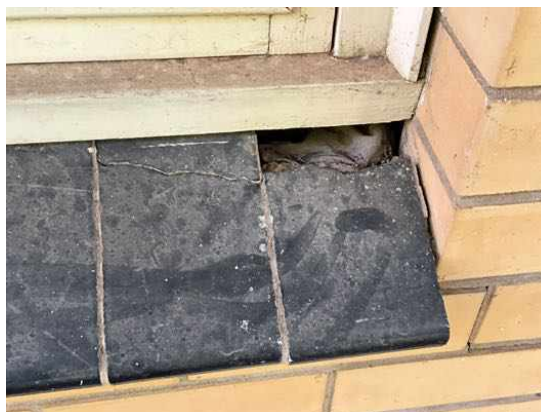
Finding 3.03

Building:	Building 1
Location:	Rear windows
Finding:	Brickwork - Deteriorated mortar
Information:	Mortar, or 'bedding', is the material which fills joints and intersections between bricks in masonry walls and structures. Sections of mortar in this brickwork were identified as having deteriorated, which is generally expected for a property of this age and condition.

Mortar may deteriorate as a result of age of building materials, minor movement of bricks, or frequent exposure to weathering. Mortar should be replaced to ensure that bricks remain in their intended location and to prevent gaps, which would allow water or moisture ingress and secondary damage as a result.

Mortar deterioration can be addressed by a bricklayer where areas of deterioration are localised and easily accessible. Alternatively, appointment of a registered builder is advised, to repoint large areas of decaying mortar. Where secondary structural defects have become evident, consultation with a structural engineer may be required.

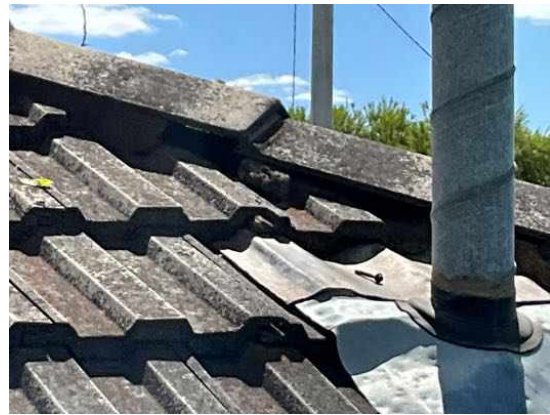
Finding 3.04

Building:	Building 1
Location:	Roof Exterior
Finding:	Mortar - Deterioration
Information:	Mortar, or 'bedding', is the material which fills joints and intersections between tiles and other building elements on the exterior roof covering, such as gable ends, hip capping and valleys. Upon inspection of the exterior roof, it was noted that sections of the mortar show varying levels of deterioration.

Mortar generally deteriorates as a result of frequent exposure to weather conditions over a prolonged period of time. Mortar that is deteriorating may allow water ingress into the roof void, putting associated building elements and roofing structures at risk of water damage. Deteriorated mortar also detracts from the functionality of roof tiles and other roofing elements, potentially decreasing weather tightness and roof drainage.

Mortar deterioration can be attended to by a handyperson where areas of deterioration are localised and easily accessible. Otherwise, consultation with a roofing contractor is advised where greater works are required.

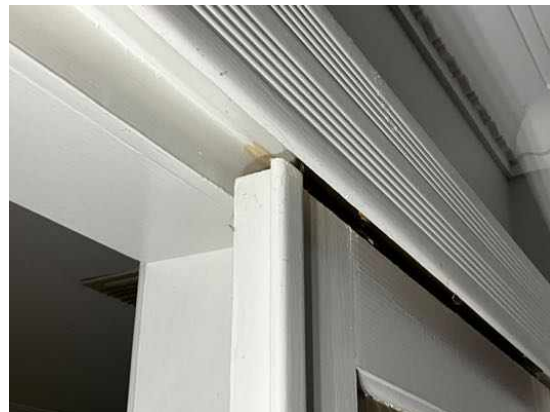
Finding 3.05

Building: Building 1
 Location: Living Room
 Finding: Door- Stiff to slide
 Information: The door in this area was jammed and difficult to slide along the associated tracks at the time of the inspection. Restricted function of the affected door may pose as a potential safety hazard if required for emergency egress from the building.

Generally, factors such as general age of the building element and a lack of maintenance are the usual causes for this type of defect.

Replacement of door hardware or tracks may be required, as well as minor repairs and cleaning. A registered builder or general handy person will be required to repair the affected doors.

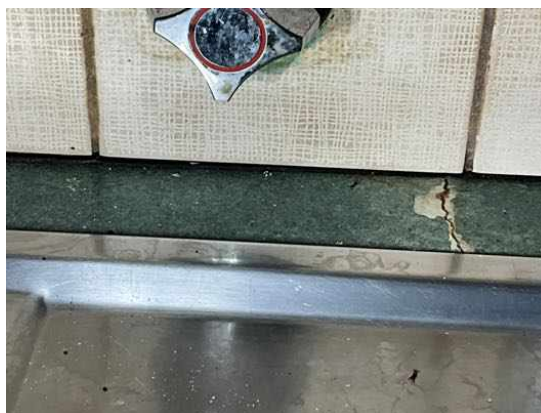
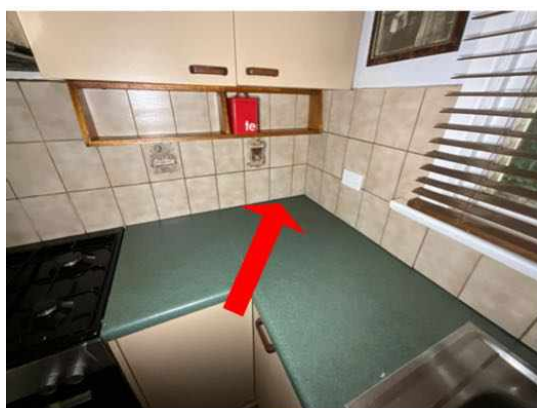
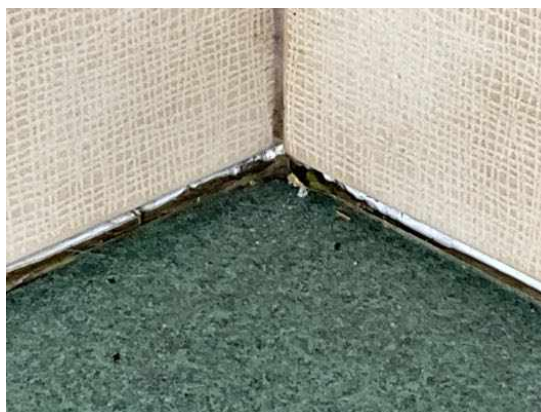
Finding 3.06

Building: Building 1
 Location: Kitchen
 Finding: Inadequate sealant or Grout
 Information: This area has a lack of effective Sealant or Grout. This is allowing the ingress of water to the structure inside the wall.

The presence of water encourages Termite attack, Mould and Fungal Decay.

A Tiler or General Handy person must be contacted as soon as possible to effect repairs and prevent further deterioration.

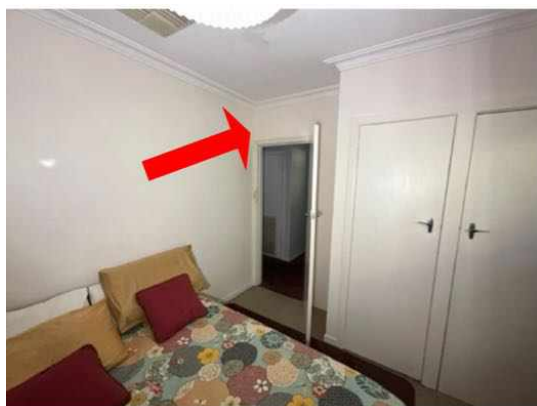
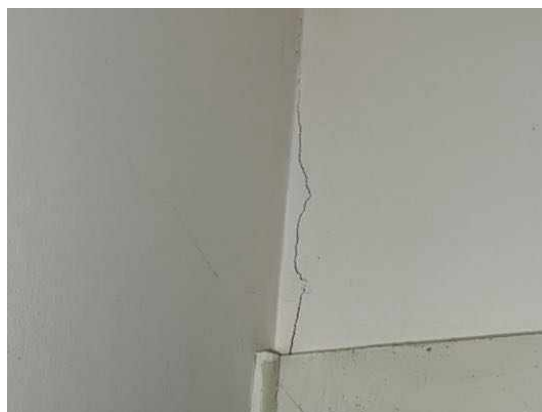
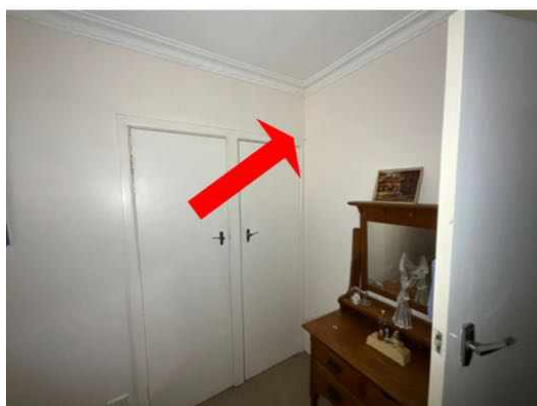
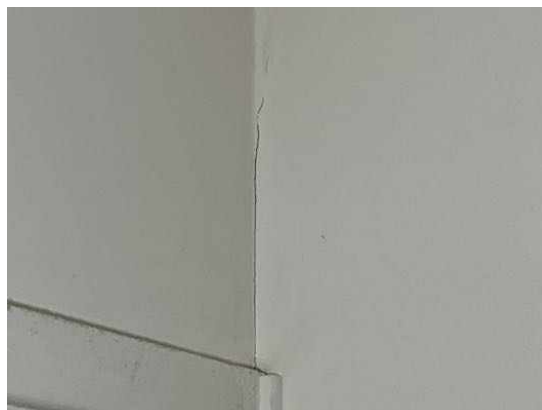
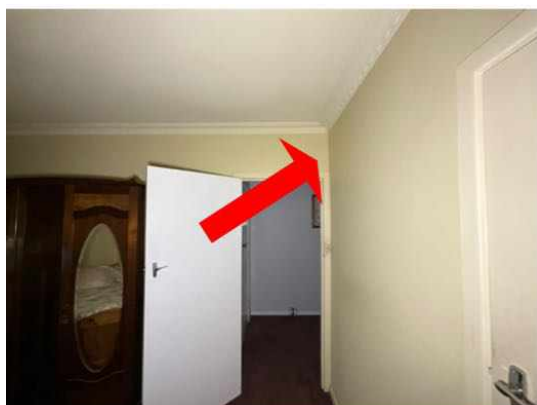
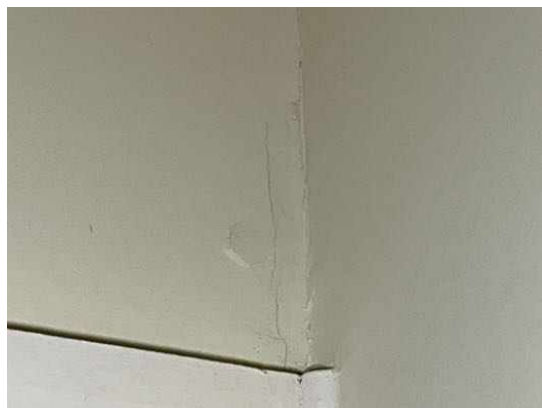
Finding 3.07

Building:	Building 1
Location:	Bed 1,2,3
Finding:	Cracking - Damage Category 1 - Fine (up to 1mm)
Information:	Although fine cracks are quite noticeable, they are often only considered to be an appearance defect, and usually do not indicate any structural damage. Generally, the cause of a fine crack is indicative of a separation between building materials and finishes (e.g. paint, plaster, etc.) along joins.

Cracking of this nature can generally be repaired with minor sanding, filling and/or repainting. Such works should be performed by a qualified painter or a general handyman.

Monitoring of all cracking should be conducted frequently. Always contact a building inspector should cracks widen, lengthen, or become more numerous.

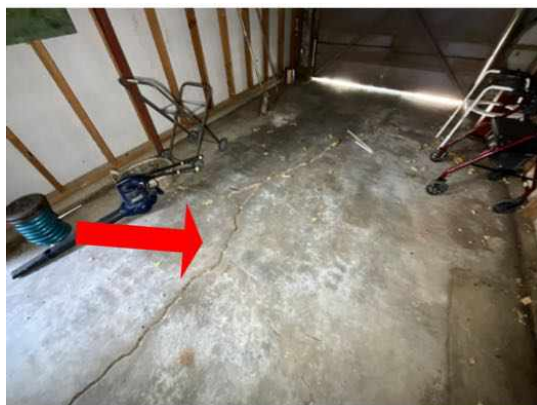
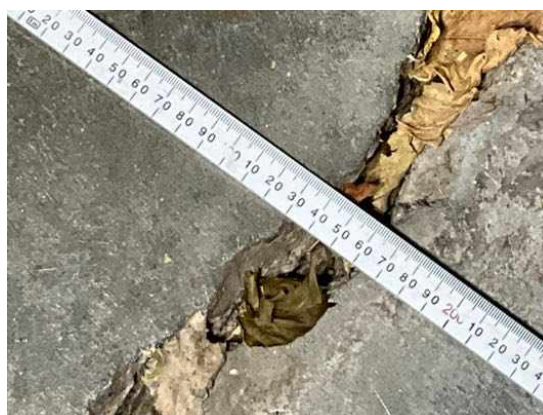
Finding 3.08

Building:	Building 1
Location:	Garage
Finding:	Cracking - External Concrete Paving Damage Category 4 - Gaps in Slab (4mm - 10mm +)
Information:	Gaps in the slab were identified in external concrete paving. Gaps in the slab are significant and are likely to lead to the development of safety hazards and secondary defects if left unmanaged, such as the creation of a trip hazard.

General age and expected deterioration of the paved areas is a common cause of this type of cracking. However, expansion and contraction of the slab may also have occurred due to environmental factors. Such factors include variable moisture and

weather conditions, the presence of trees and their roots having a settling or lifting affect on the soil, or the effect of load bearing, e.g. heavy vehicles over a sustained period of time.

Cracking to this degree may also be due to poor original installation of the concrete. Factors such as poor compaction of the sub surface and/or inadequate reinforcing of the slab may create cracking and other secondary defects. Gaps in the concrete paving may also have a more significant structural cause, such as subsidence of soils.

Where gaps in the concrete paving are adjacent to structural elements of the building, the advice of a Structural Engineer is advisable before undertaking repairs. Significant repair and likely replacement of the concrete paving is probable.

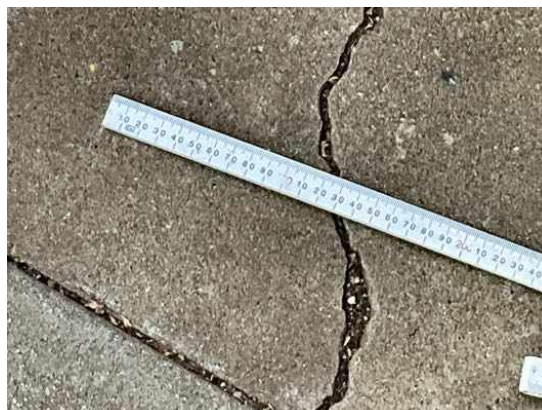
Finding 3.09

Building:	Building 1
Location:	Yard - Back
Finding:	Cracking - External Concrete Paving Damage Category 4 - Gaps in Slab (4mm - 10mm +)
Information:	Gaps in the slab were identified in external concrete paving. Gaps in the slab are significant and are likely to lead to the development of safety hazards and secondary defects if left unmanaged, such as the creation of a trip hazard.

General age and expected deterioration of the paved areas is a common cause of this type of cracking. However, expansion and contraction of the slab may also have occurred due to environmental factors. Such factors include variable moisture and weather conditions, the presence of trees and their roots having a settling or lifting affect on the soil, or the effect of load bearing, e.g. heavy vehicles over a sustained period of time.

Cracking to this degree may also be due to poor original installation of the concrete. Factors such as poor compaction of the sub surface and/or inadequate reinforcing of the slab may create cracking and other secondary defects. Gaps in the concrete paving may also have a more significant structural cause, such as subsidence of soils.

Where gaps in the concrete paving are adjacent to structural elements of the building, the advice of a Structural Engineer is advisable before undertaking repairs. Significant repair and likely replacement of the concrete paving is probable.

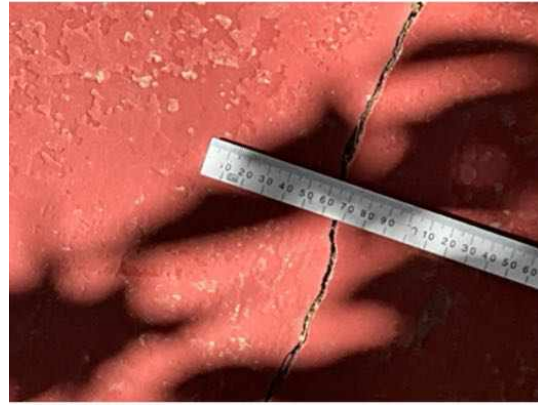
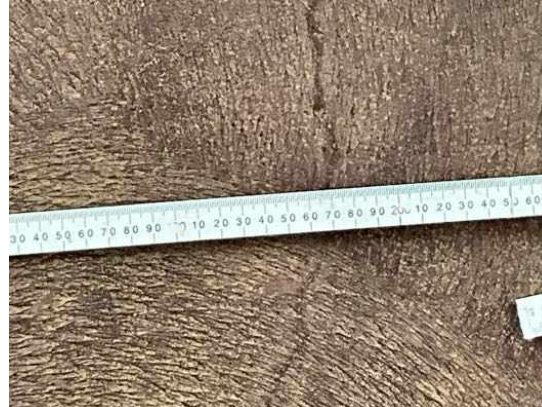
Finding 3.10

Building:	Building 1
Location:	Verandah
Finding:	Cracking - External Concrete Paving Damage Category 3 - Wide Cracks (2mm - 4mm)
Information:	Wide cracks were identified in external concrete paving. Wide cracks are significant and are likely to lead to the development of safety hazards and secondary defects if left unmanaged.

General age and expected deterioration of the paved areas is a common cause of this type of cracking. However, expansion and contraction of the slab may also have occurred due to environmental factors. Such factors include variable moisture and weather conditions, the presence of trees and their roots having a settling or lifting effect on the soil, or the effect of load bearing, e.g. heavy vehicles over a sustained period of time.

Cracking to this degree may also be due to poor original installation of the concrete. Factors such as poor compaction of the sub surface and/or inadequate reinforcing of the slab may create cracking and other secondary defects. Wide cracks may also have a more significant structural cause, such as subsidence of soils.

Where the crack is located adjacent to structural elements of the building, the advice of a Structural Engineer is advisable before undertaking repairs. Significant repair and likely replacement of the concrete paving is probable.

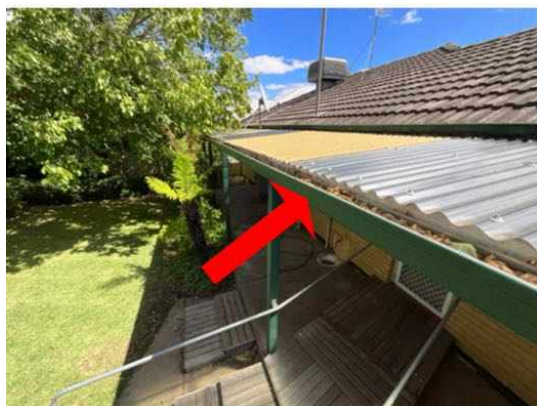
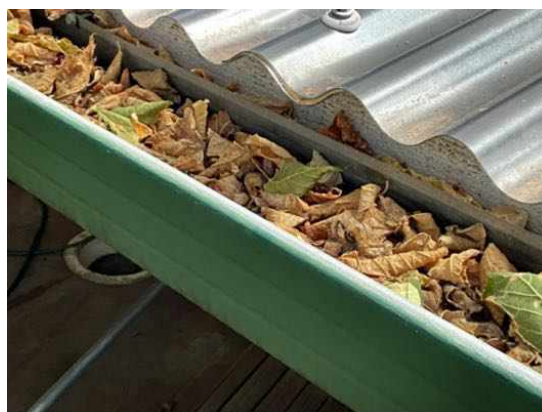
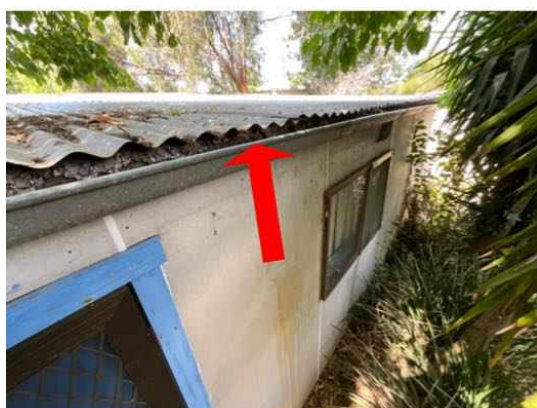
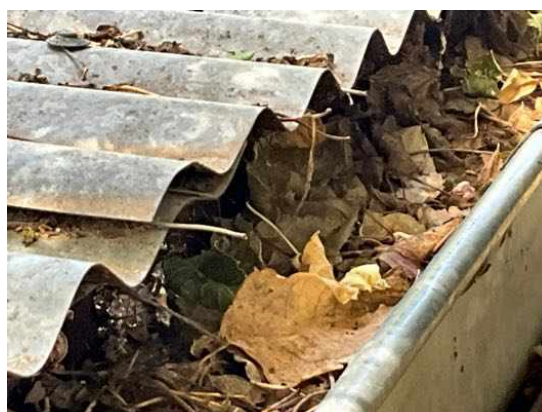
Blocked gutters are likely to lead to high levels of moisture in the affected areas. Such moisture will not only cause rust and decay of the associated building materials, but

can also provide conditions that are conducive to termite and timber pest activity. Blockages in gutters should therefore be removed immediately to ensure dry conditions are maintained.

Consult a Licensed Plumber for further specific advice on remedial works that may be required. In the interim, it is highly advised that blocked gutters be removed by the homeowner or a general handyperson as a matter of urgency.

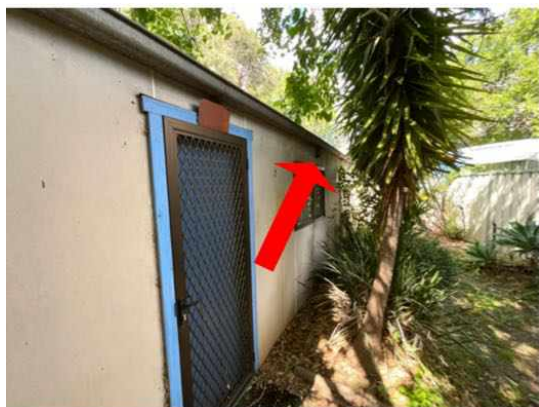
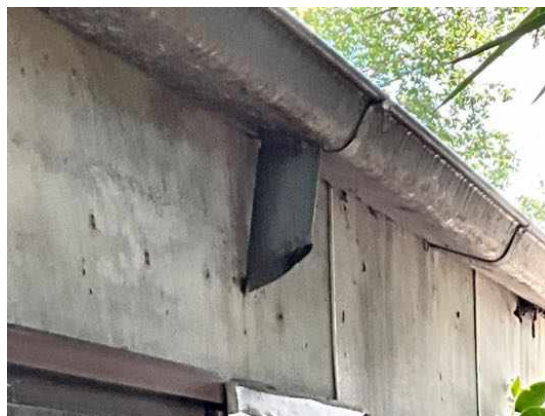
Finding 6.02

Building:	Building 1
Location:	Garage
Finding:	Stormwater drain - Not connected
Information:	The roof plumbing is not adequately connected to stormwater drainage on the site. This disconnection negatively impacts the functional capacity of the roof plumbing.

Where roof plumbing doesn't drain adequately, the area at the base perimeter can become excessively damp, potentially creating an environment that is susceptible to rust and corrosion of surrounding building elements, as well as attracting termites and other pests.

It is highly recommended that a plumber be appointed to further inspect the area and to install adequate drainage equipment where necessary.

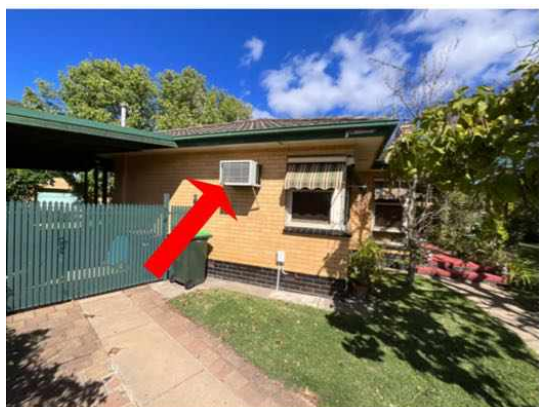
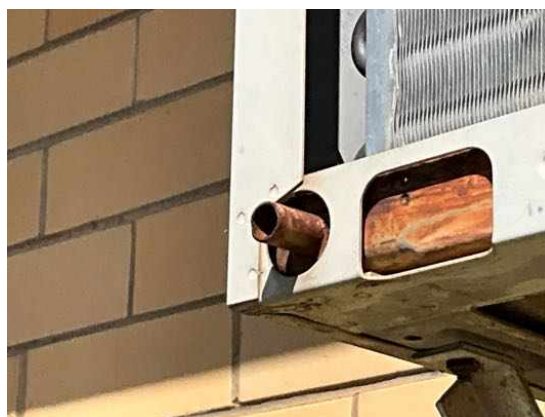
Finding 6.03

Building: Building 1
Location: Driveway
Finding: Air conditioner - Disconnected overflow
Information: The Air Conditioner (A/C) overflow was found to be disconnected from storm water drainage and is creating excessive moisture in the surrounding area.

Such leaking creates an environment which is conducive to an array of defects, including water damage to associated building elements and the attraction of termite or timber pest infestation.

It is highly recommended that a licensed plumber be appointed to connect the A/C overflow in order to prevent such an environment from being created. These minor works should be carried out as soon as possible.

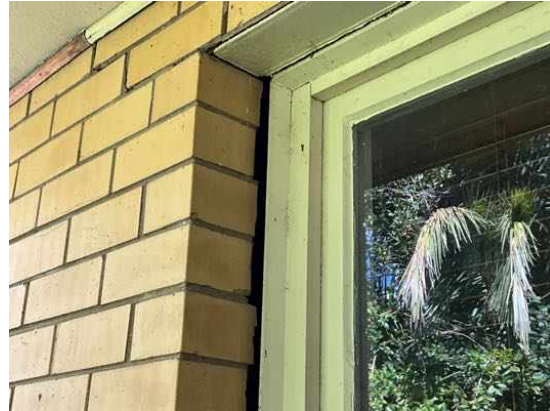
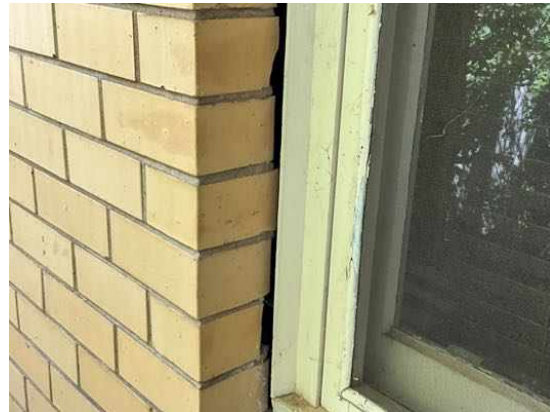
Finding 6.04

Building: Building 1
Location: Bed 3
Finding: Inadequate sealant/caulking
Information: This area has a lack of effective Sealant or Grout. This may be allowing the ingress of water to the structure.

The presence of water encourages Termite attack, Mould and Fungal Decay.

A Caulker or General Handy person must be contacted soon to effect repairs and prevent possible deterioration.

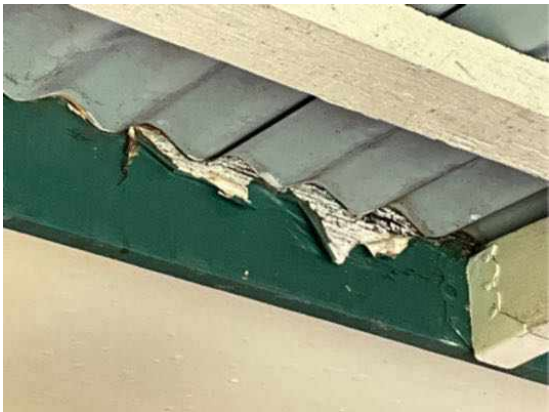
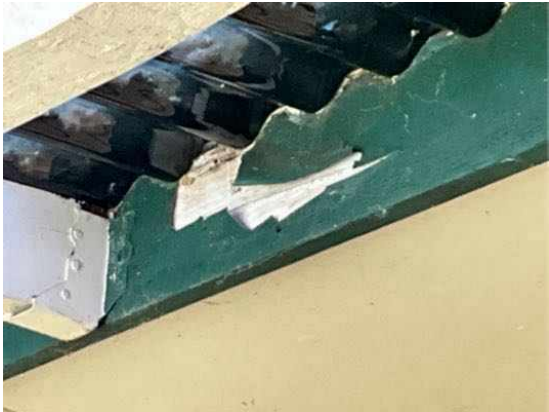
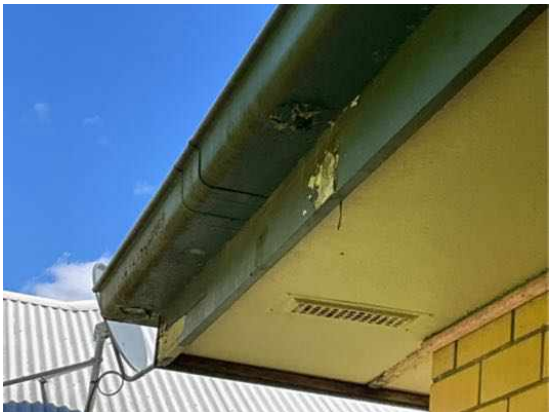
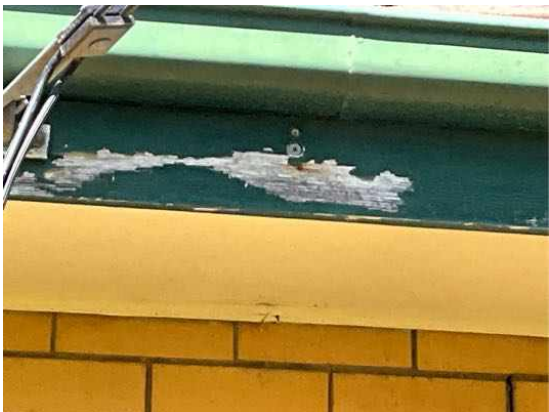
Finding 6.05

Building:	Building 1
Location:	Verandah, eaves >
Finding:	Timber - exposed to weather
Information:	External timbers that are frequently exposed to harsh weather conditions require adequate protection in order to maintain their condition. Where timbers have not been painted or treated adequately, general deterioration is likely to occur at an accelerated rate.

If left unattended, replacement of these timbers is likely to be necessary in the short-term future. Adequate treatment of these timbers is required as soon as possible by a painting contractor or general handyman.

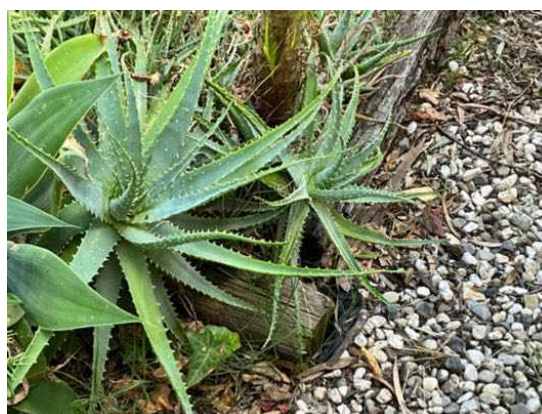
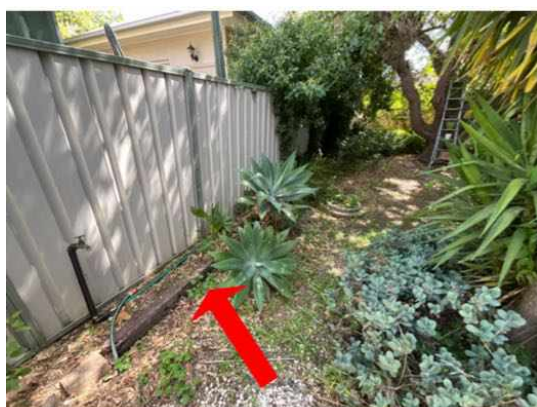
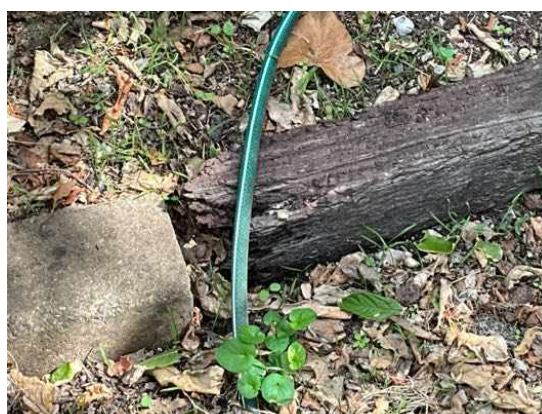
Finding 6.06

Building:	Building 1
Location:	Yard - Back
Finding:	Untreated or non-durable timbers in a hazardous environment
Information:	To reduce the risk of timber pest attack it is essential that timber used in a hazardous environment (e.g. in direct contact with the ground or frequently exposed to damp conditions) is of sufficient durability and/or is adequately preservative treated.

Untreated timbers in direct contact with the ground are likely to develop severe wood rot and/or fungal decay if left unattended creating attraction for subterranean termites to infest the timbers from surrounding areas.

If untreated or non-durable timbers are found to be in a hazardous environment it is highly advised that replacement of these building elements be performed as soon as possible to aid the protection of the property against termite / timber pest attack.

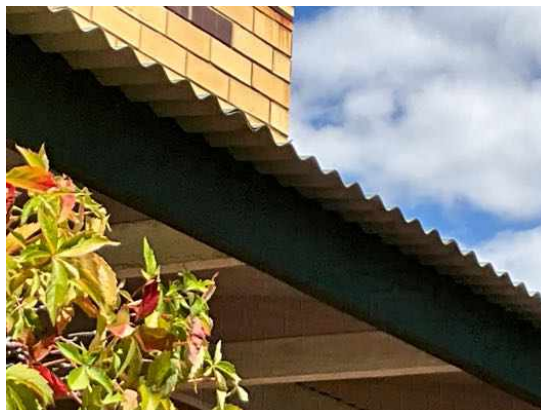
Finding 6.07

Building:	Building 1
Location:	Verandah > Front
Finding:	Guttering Missing
Information:	The Guttering in this area was missing at the time of inspection. Guttering, Downpipes and Stormwater drainage are vital to protect the integrity of the structure and to prevent an environment conducive to Timber Pest attack.

A Plumber should be contacted as soon as possible to replace and connect to drainage the missing Guttering.

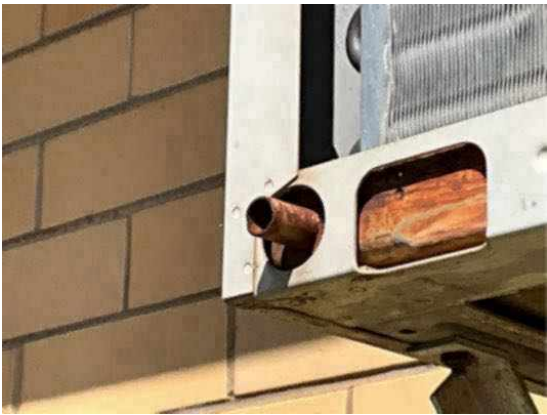
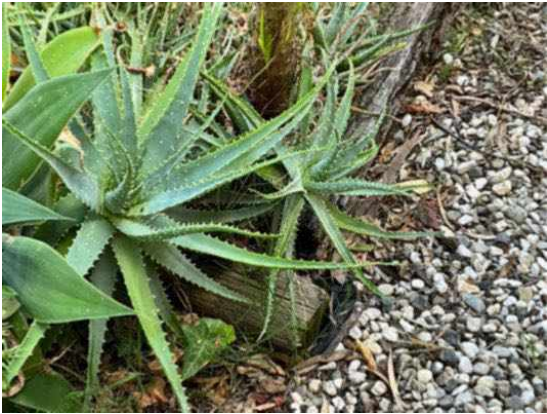
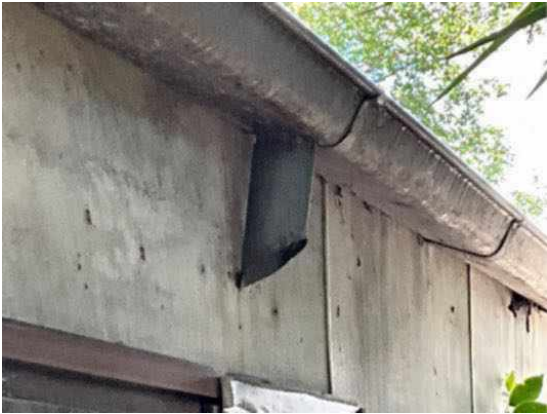
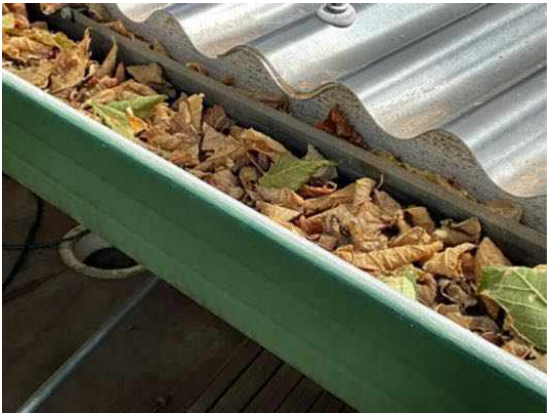
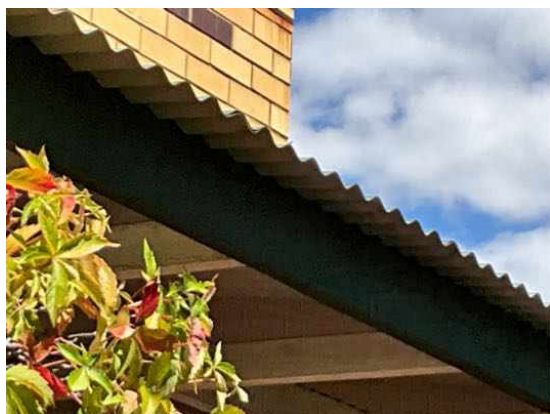
Finding 6.08

Building:	Building 1
Location:	All External Areas
Finding:	Termite Management System - no evidence of a chemical installation
Information:	The application of a post-construction chemical termite barrier is highly recommended for all properties, particularly if live termite activity has been found on the site previously. Such barriers are highly effective in preventing termite attack on any timber building elements throughout the property.

The client may consider gaining further advice from a pest controller as to the costs and procedures involved with this application. It is recommended that obtaining such advice be a short-term priority.

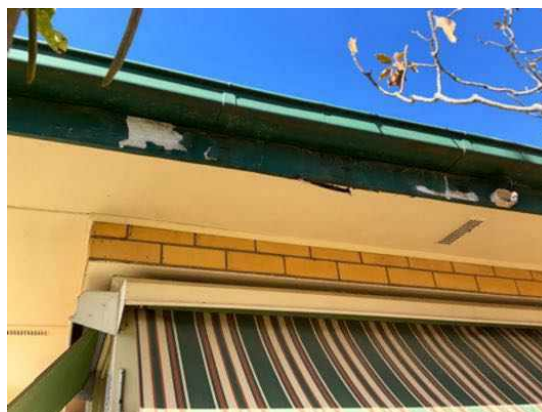
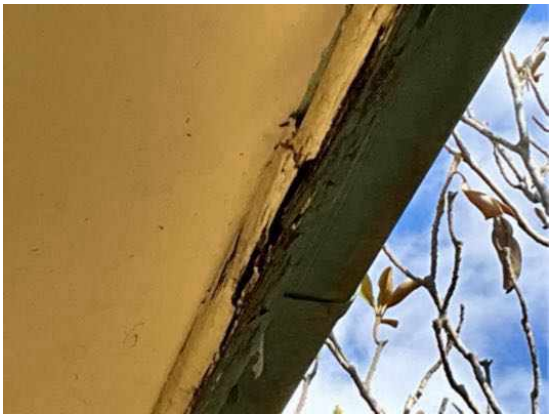
Finding 7.01

Building:	Building 1
Location:	Eaves, garage
Finding:	Fungal decay - present (localised)
Information:	Fungal decay also known as wood decay or wood rot generally refers to the deterioration of timber elements when in contact with excessive levels of moisture for a prolonged period of time.

The development of fungal decay is accelerated by temperatures in the range of 5degreeC to 40degreeC as well as the presence of oxygen. Generally fungal decay develops on timber elements that are in use in an external environment which are exposed to rain penetration.

In this case although the affected timber element is in a decaying state the extent of any visible damage appears to be localised to a specific area and is yet to spread to other parts of the building element or affect adjoining structures. The fungal decay is therefore likely to be of a relatively superficial nature with minimal impact on the structural integrity or tensile strength of the timber element.

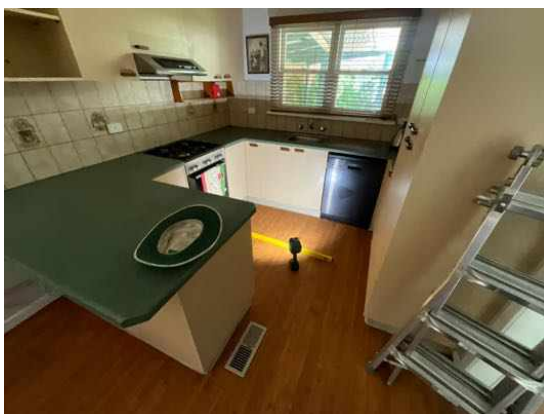
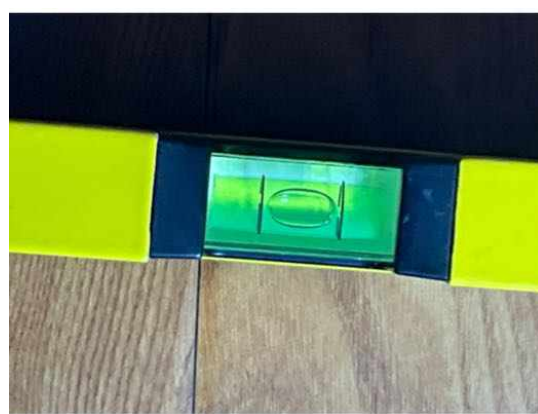
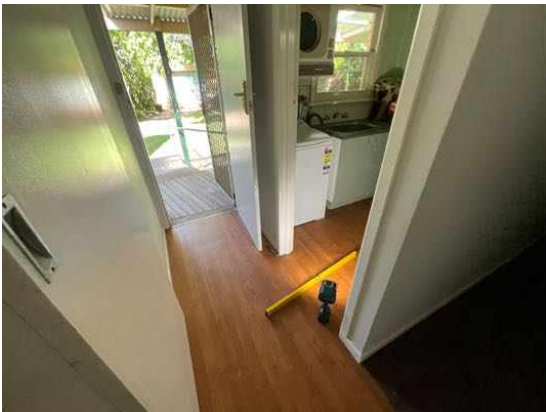
Building: Building 1
 Location: All Internal Areas
 Finding: Flooring - slightly uneven
 Information: The internal flooring in this area is out of level and uneven. Uneven flooring is likely to indicate minor defects such as expected movement of the foundations of the property, but may also indicate subsidence of the associated subfloor stumps.

It is advised that the flooring be closely monitored to identify any further movement. Where flooring remains relatively unchanged for an extended period of time (i.e. several months), it is likely that this defect has been caused by expected movement of the foundations of the property.

However, where flooring is increasingly uneven, potentially invasive inspection of the subfloor structures and stumps in this area is required. In this case, works to repair are likely to be required, and would be carried out by a registered builder specialising in re-stumping.

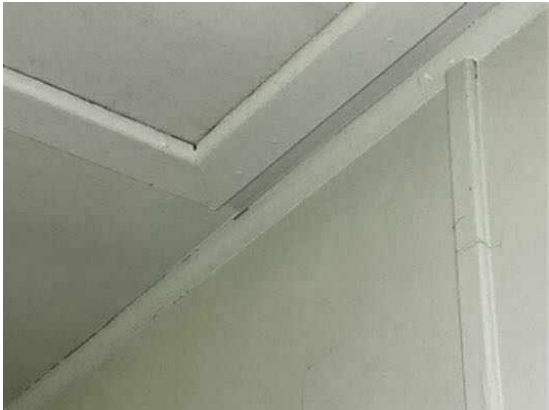
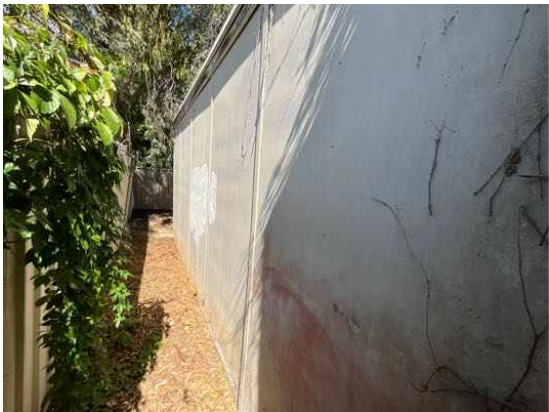
Building: Building 1
Location: All Areas
Finding: Asbestos - Suspected ACM Identified on Site
Information: Reporting on Asbestos is outside the Scope of this Report. This suspected defect is highlighted as a caution only. We suspect, based on our experience in the building industry, that there is a higher risk of the identified building element containing asbestos.

As Asbestos Reporting is outside the scope of this report, we advise that you consider a separate Asbestos Inspection and Condition Audit, which can include the taking of samples for definitive confirmation of the presence of Asbestos.

In the interim, the client is advised to act with caution, especially when considering any damage to building materials general wear and tear renovations extensions demolition and general maintenance activities due to the suspected presence of Asbestos.

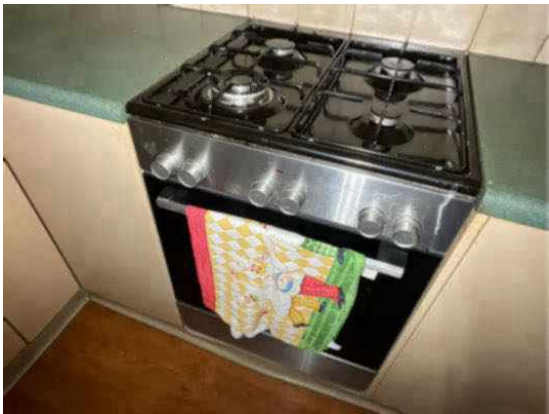
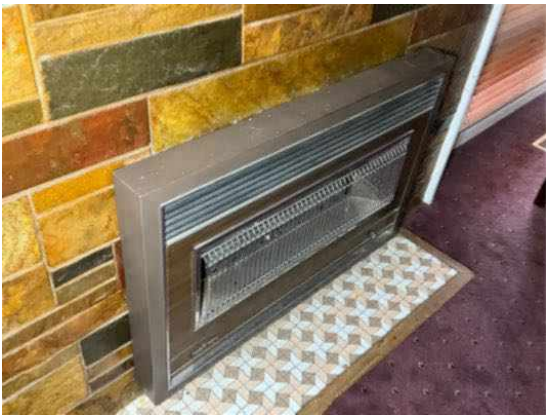
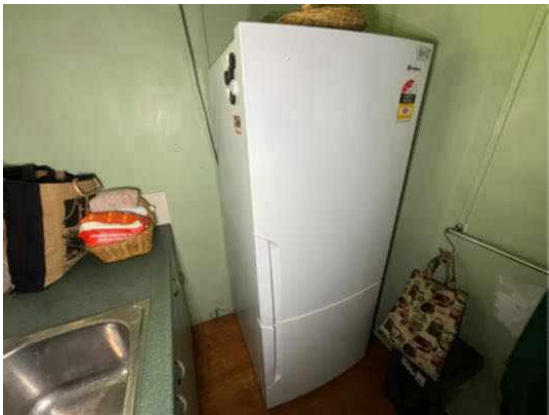
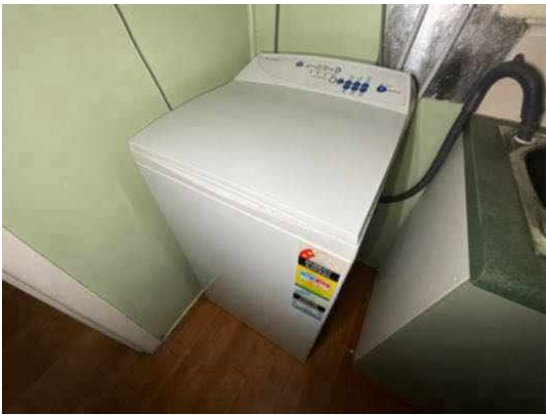
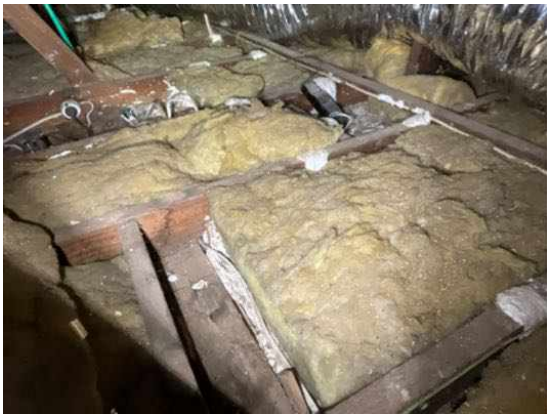
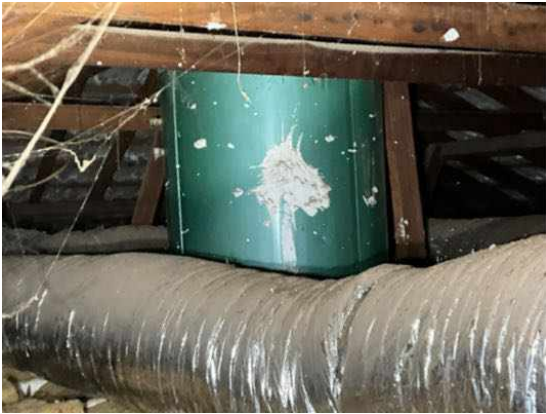
Building: Building 1
Location: All Areas
Finding: Additional Photos - Obstructions and Limitations
Information: These photographs are an indication of the obstructions and limitations which impeded full inspection of the property at the time of inspection. These obstructions can hide an array of defects and should be removed to allow full inspection to be carried out. A re-inspection is recommended once the areas are made accessible.
