Building and Timber Pest Inspection Report

Inspection Date: Thu, 22 Jan 2026

Property Address: 29 Wardell Rd, Lewisham NSW 2049,
Australia

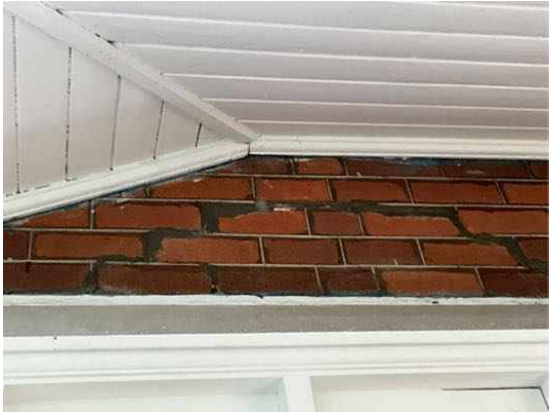
Building: Main Building
Location: All Areas
Finding: Brickwork - Cracking in External Wall
Information: The external wall displays several cracks, some of which follow a stepped pattern, indicative of movement within the structure. The cracks appear to vary in width, and some may be deep enough to compromise the weatherproofing of the wall, potentially allowing water ingress. These cracks suggest either settlement of the foundations, shrinkage, or thermal expansion/contraction of the building materials.

- **Structural Risk:** While the cracks may not indicate immediate danger of structural collapse, they pose a moderate risk by allowing further movement or deterioration over time. If left unattended, these cracks may widen, leading to more severe structural instability.
- **Water Ingress Risk:** There is a high risk of water ingress through the cracks, which could cause internal damage such as mold growth or moisture damage, especially during heavy rainfall.
- **Safety Risk:** If the cracks continue to propagate or are symptomatic of more significant underlying issues (e.g., foundation movement), there could be a moderate to high risk to the structural integrity of the building.

This defect could be classified as a major defect in accordance with Australian Standard AS4349 if the structural movement is confirmed and the cracks are found to be indicative of more severe underlying problems. If the cracks are cosmetic, it may be considered a minor defect but still requires prompt attention.

- **Engage a Structural Engineer:** A structural engineer should be consulted to assess the underlying cause of the cracks, particularly if there is suspicion of foundation movement or structural weakness.
- **Repair by a Licensed Builder:** Once the cause is identified, a licensed builder experienced in masonry work should undertake the necessary repairs. This may involve crack stitching, mortar repair, or even foundation stabilization if required.
- **Monitor for Further Movement:** Ongoing monitoring of the area should be conducted to check for further cracking or movement.

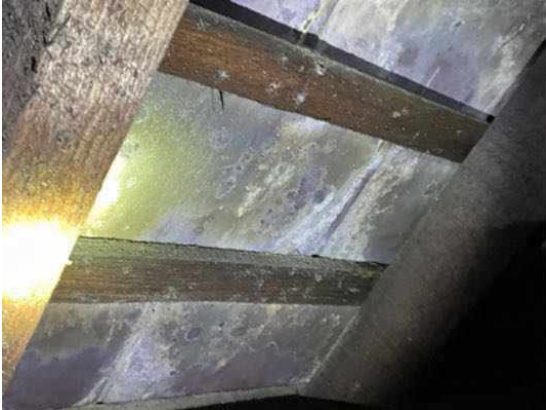
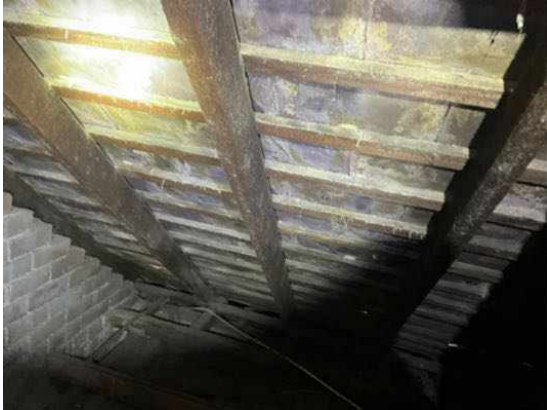
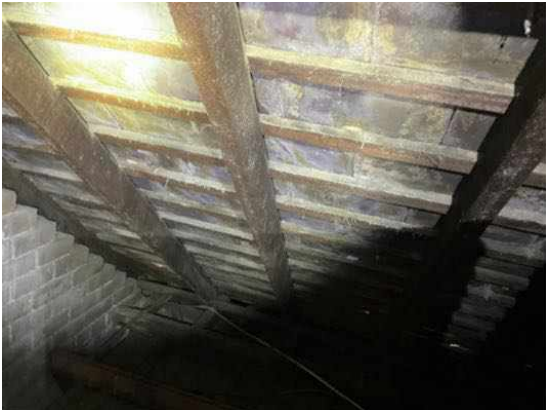
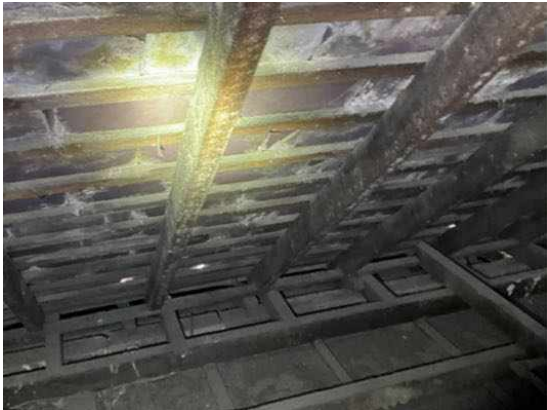
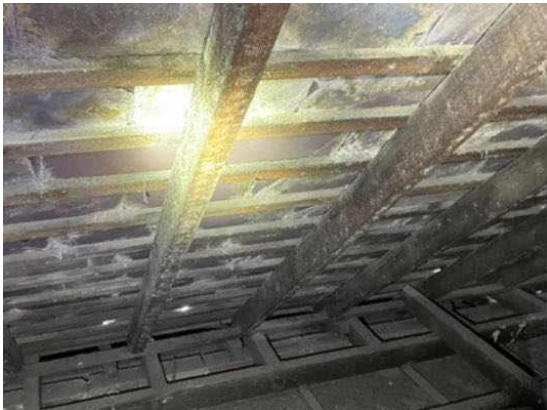
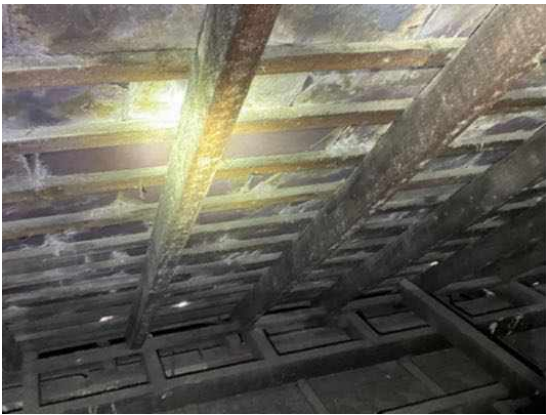
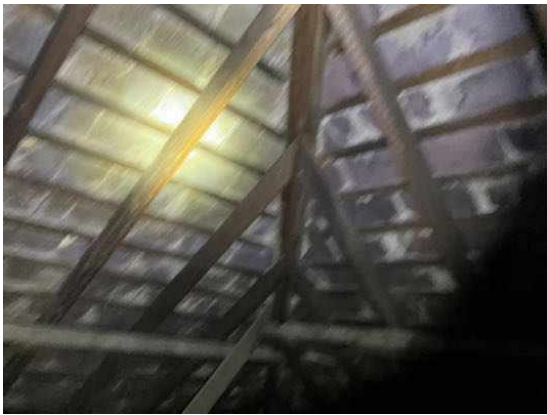
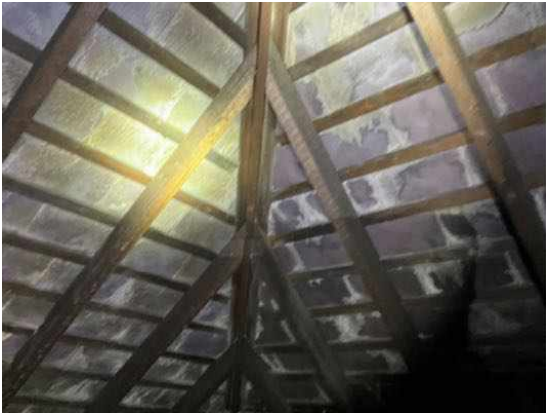
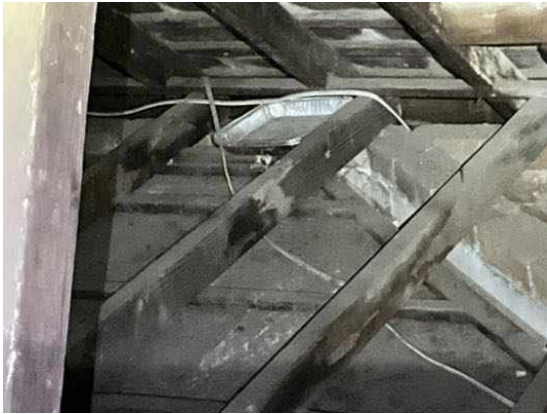
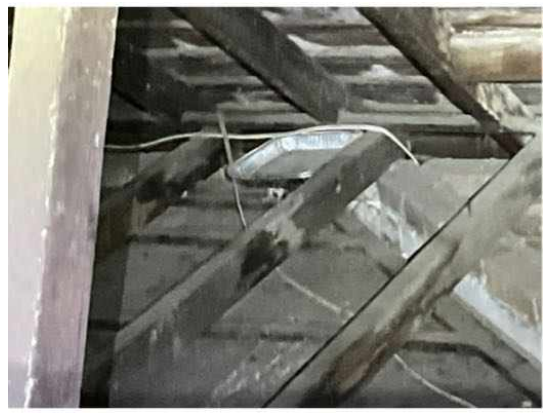
| Finding: | Roof void - Suspected water leak with tray |
| Information: | Evidence of a suspected water leak was observed in the roof void, with tray placed beneath the roof structure to collect water. This indicates an ongoing or previous roof leak, likely from damaged roof covering, flashing. |
| Risk: | High. Ongoing moisture intrusion can lead to timber rot, mould growth, insulation damage, and electrical hazards if not addressed promptly. |

| Recommended Action: | It is recommended to engage a licensed roofing contractor to inspect the roof coverings, flashings, and penetrations. Repairs should be carried out as needed to prevent further internal damage. |

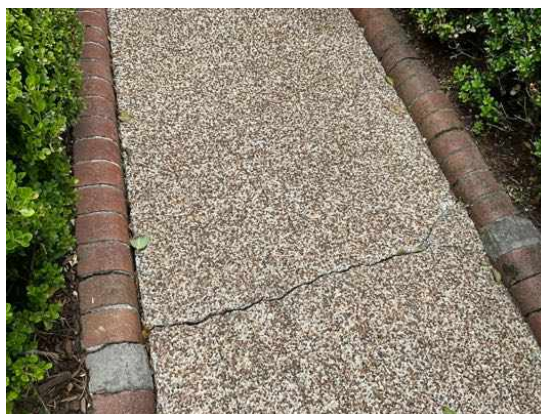
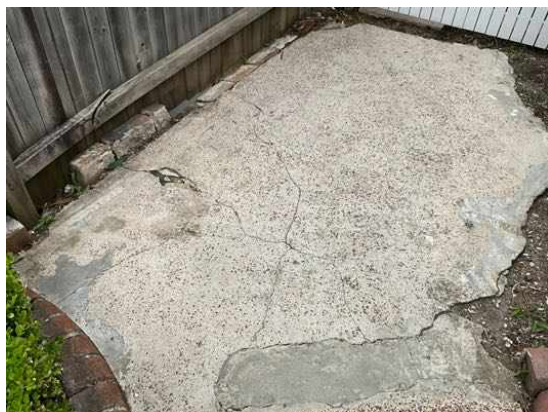
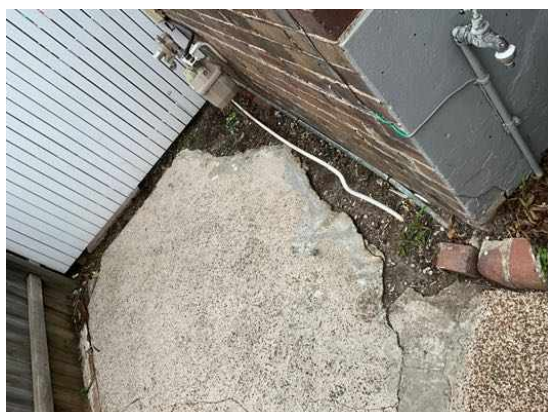
Finding 3.01

| Finding: | Noticeable Cracking in Concrete Slab |
| Information: | Noticeable cracking has been observed in the concrete slab, failing to meet the required construction and quality standards. |

- Cracks are visible on the surface and may extend through the depth of the slab.
- Evidence of improper curing or inadequate reinforcement leading to cracking.

- Compromised structural integrity of the slab, potentially leading to failure under load.
- Water ingress through cracks, causing corrosion of reinforcement and further weakening the structure.
- Potential trip hazards and aesthetic issues, reducing the overall value and safety of the property.
- Increased maintenance and repair costs due to ongoing deterioration.

- A structural engineer should be engaged to assess the extent of the cracking and recommend appropriate repair methods.
- A licensed contractor or concrete repair specialist should carry out the recommended repairs under the guidance of the structural engineer.

A detailed inspection should be conducted post-repair to confirm compliance with the required standards and to ensure that the structural integrity of the concrete slab has been restored.

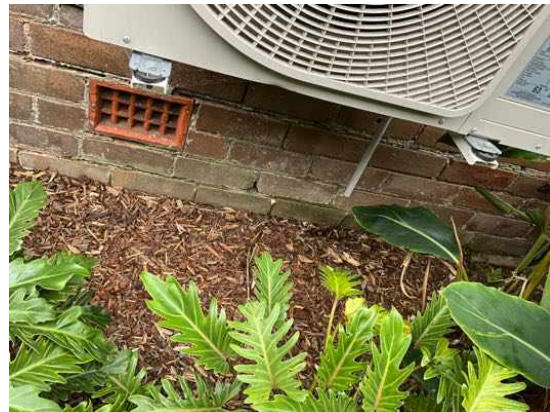
Finding 3.02

Building: Main Building
 Location: Exterior walls - left side
 Finding: Air conditioner - Disconnected overflow
 Information: The Air Conditioner (A/C) overflow was found to be disconnected from storm water drainage and is creating excessive moisture in the surrounding area.

Such leaking creates an environment which is conducive to an array of defects, including water damage to associated building elements and the attraction of termite or timber pest infestation.

It is highly recommended that a licensed plumber be appointed to connect the A/C

overflow in order to prevent such an environment from being created. These minor works should be carried out as soon as possible.

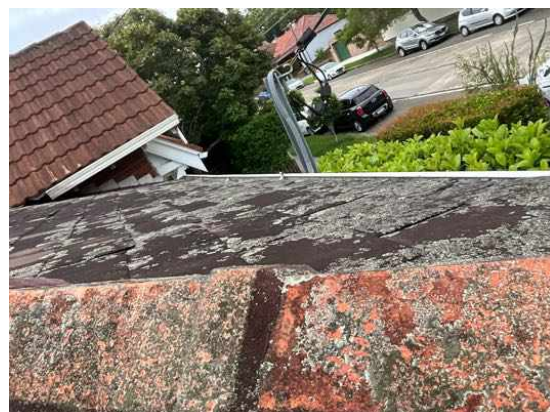
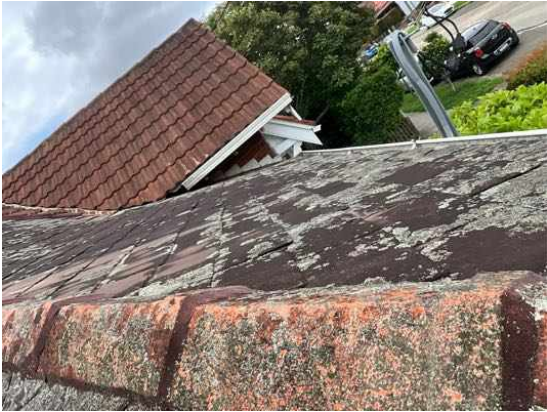
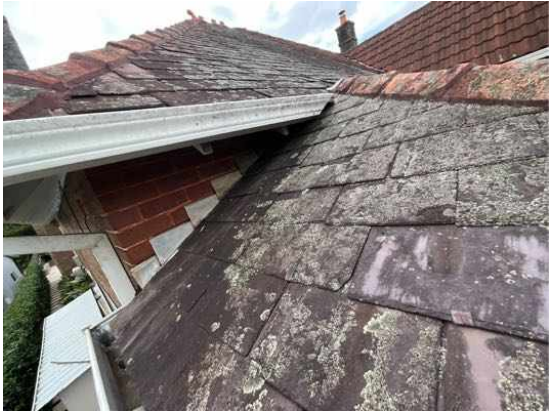
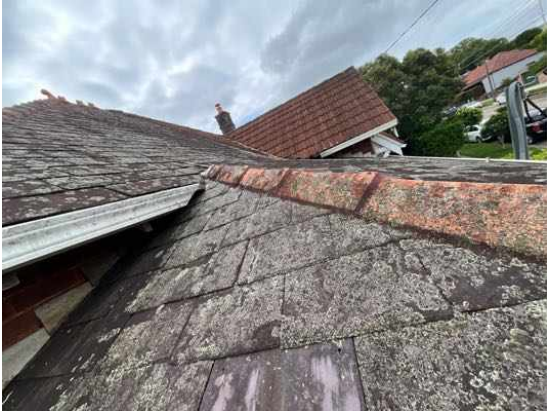
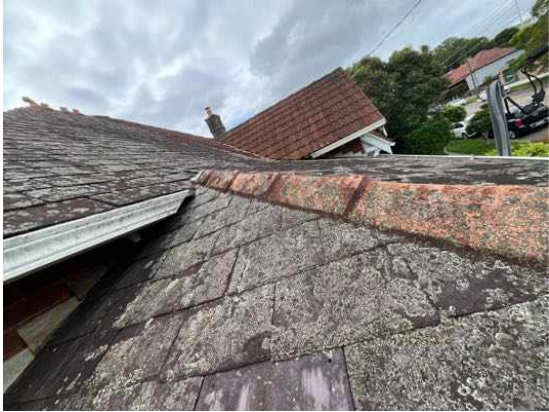
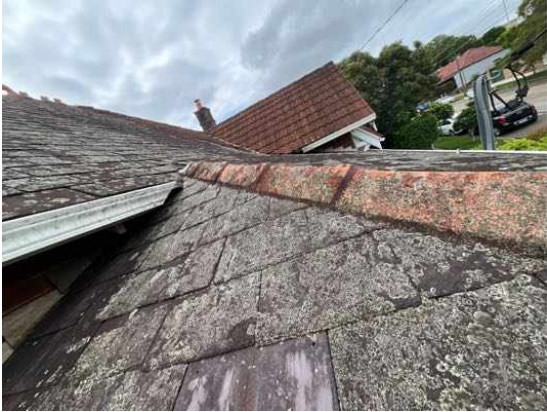
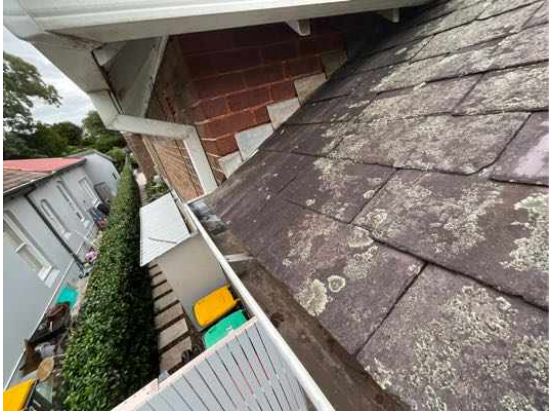
Finding 3.03

| Information: | Upon inspection of the exterior roofing, the majority of roof was not in a fair condition. While weathering of the roof is consistent with the age of the property, maintenance works are required. |

Isolated areas of mortar have come loose in the valleys and minor cracking is also present. Re-pointing and re-sealing the may be considered as an interim solution by the client to help preserve and extend the life span of the tiles.

Where left unmanaged, deteriorating roof are likely to lead to a number of secondary defects, including minor water leaks and weather exposure to internal roofing structures.

Consultation with a roofing contractor is highly advised to gain advice on cost of remedial works that may be required in the short to medium term. Remedial works are likely to increase the longevity of the exterior roofing structure.

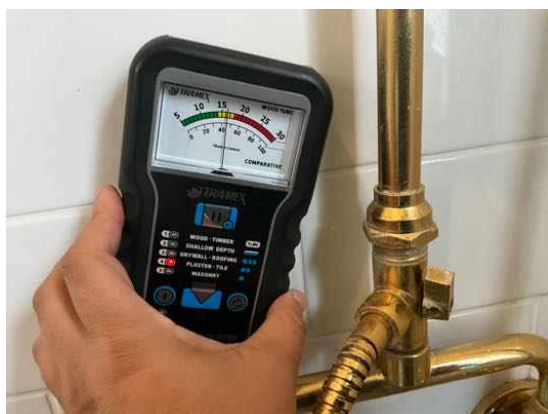
Finding 3.04

Building: Main Building
Location: Bathroom
Finding: Evidence of excessive moisture was present at the time of inspection
Information: Excessive moisture is present behind the bathroom tiles, indicating a potential water leakage issue within the wall.

The prolonged presence of moisture can lead to mold growth, deteriorate the structure, and create an environment conducive to health hazards. Additionally, it may compromise the adhesive holding the tiles, leading to their detachment.

A licensed plumber or a qualified contractor specializing in water damage remediation

should investigate the source of the moisture, fix any leaks, and address the damage. Additionally, replacing affected tiles and ensuring proper waterproofing are crucial to preventing future issues.

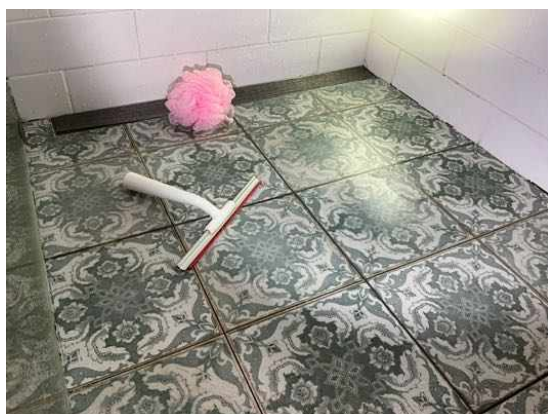
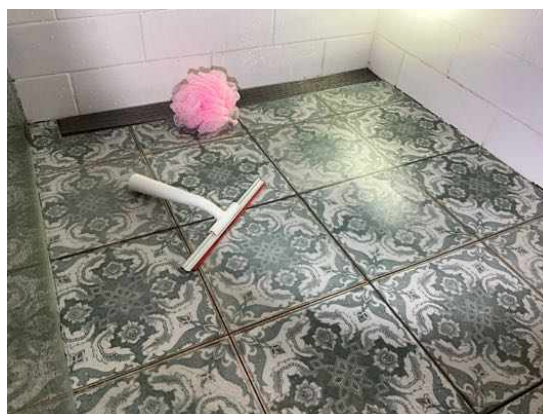
Finding 3.05

| Information: | Evidence of water pooling around the floor waste in the shower recess was noticed at the time of inspection. It is suspected that this excessive moisture is attributed to insufficient fall in the shower floor tiles. |

This pooling is minor overall but is still considered unsatisfactory, as standard tiling practices would not permit this situation to occur. Pooling water around floor wastes can create a slip hazard in extreme cases and create conditions that are conducive to mould growth over time. Where left unmanaged, the degradation of sealant and grouting is also likely to occur, possibly necessitating further repair works.

Remedial works may involve some sections of tiling and flooring repair and replacement. A tiling contractor or bathroom specialist should be appointed to provide further advice on reparation options and to perform works as necessary.

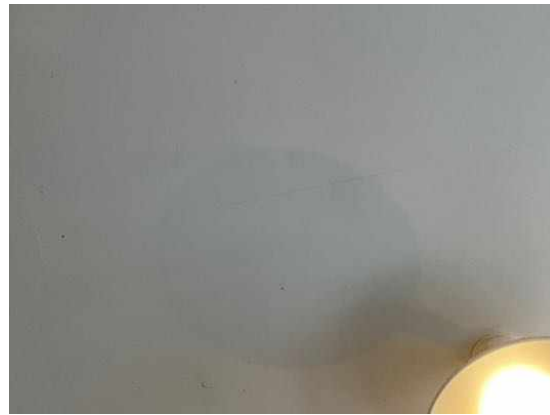
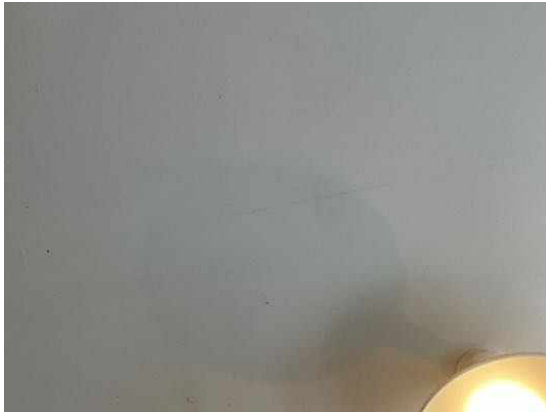
Finding 3.07

Building: Main Building
Location: Kitchen
Finding: Ceiling – Plasterboard Fine Cracking
Information: Fine cracking was observed to the ceiling plasterboard. This is commonly associated with normal building movement, shrinkage, or minor settlement and is generally cosmetic in nature.

However, cracking may worsen over time and affect appearance if left unattended.

Recommendation / Who can fix it: Repair and monitoring by a qualified plasterer or painter is recommended.

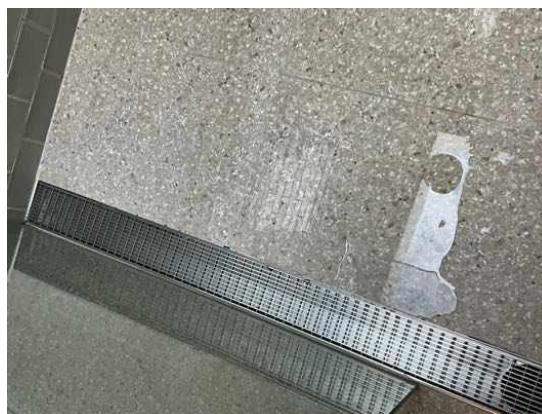
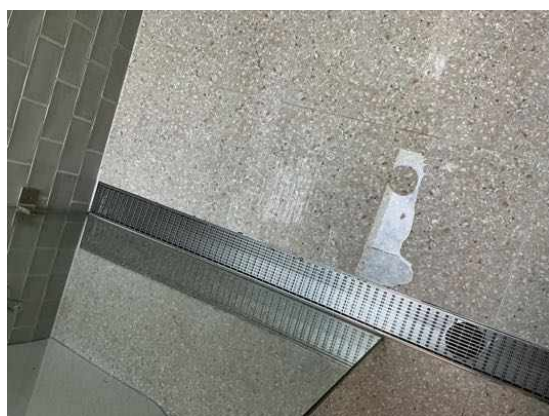
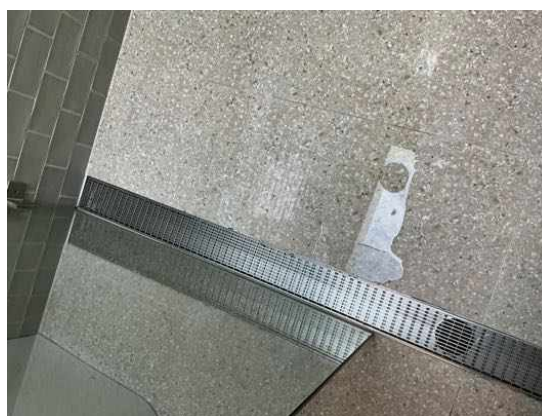
Finding: Shower base - Water pooling
Information: Evidence of water pooling around the floor waste in the shower recess was noticed at the time of inspection. It is suspected that this excessive moisture is attributed to insufficient fall in the shower floor tiles.

This pooling is minor overall but is still considered unsatisfactory, as standard tiling practices would not permit this situation to occur. Pooling water around floor wastes can create a slip hazard in extreme cases and create conditions that are conducive to mould growth over time. Where left unmanaged, the degradation of sealant and grouting is also likely to occur, possibly necessitating further repair works.

Remedial works may involve some sections of tiling and flooring repair and replacement. A tiling contractor or bathroom specialist should be appointed to provide further advice on reparation options and to perform works as necessary.

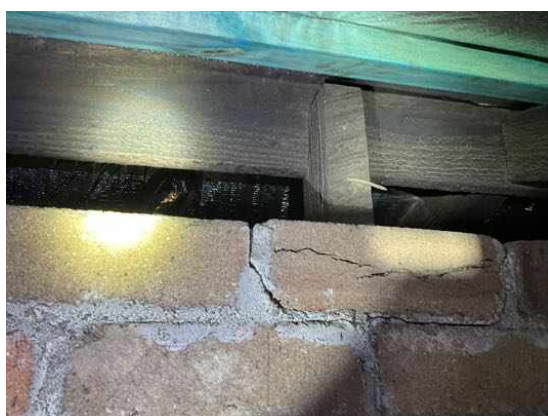
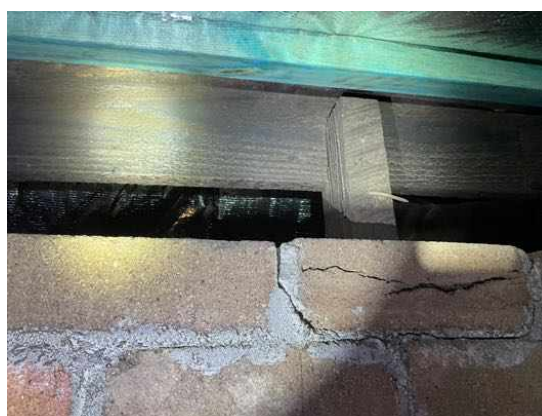
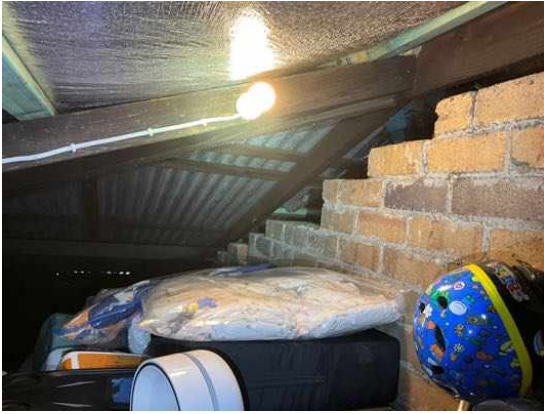
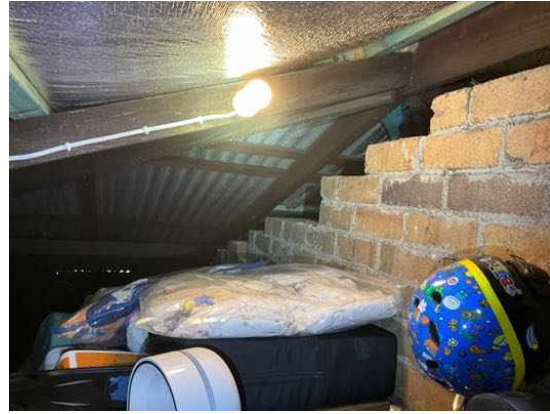
Finding 3.11

Building: Main Building
Location: Roof Void
Finding: Roof void - Brickwork incomplete
Information: Incomplete or missing brickwork was observed in the roof cavity. This section of the wall is not fully built up to meet the roof line, leaving gaps that compromise the integrity of the building envelope.

- Pest Entry: Open areas may allow vermin or insects to enter the roof space, leading to infestations and associated health hazards.
- Structural Integrity: Depending on the extent of the missing brickwork, there may be a reduction in the overall strength and stability of the wall, especially under wind load or other stresses.

- A licensed bricklayer or builder experienced in remedial work should be engaged to assess and complete the missing brickwork to ensure proper sealing and support.
- A structural engineer may be required to assess the impact of the missing brickwork on the structural integrity of the building and specify any necessary reinforcement.

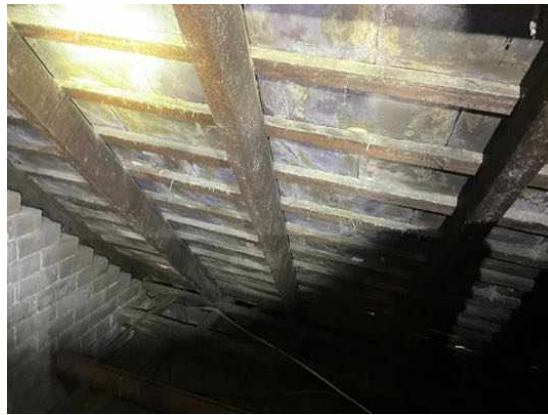
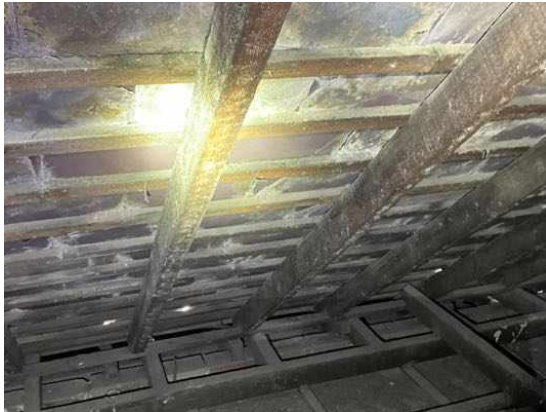
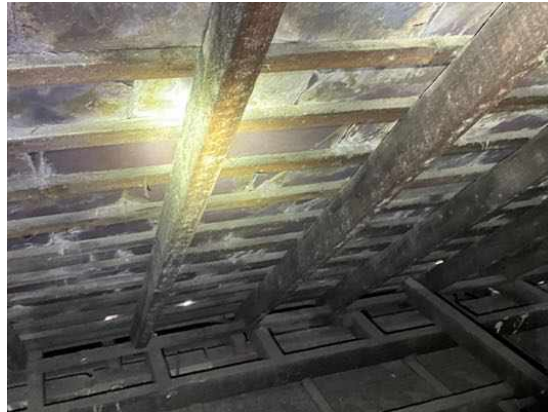
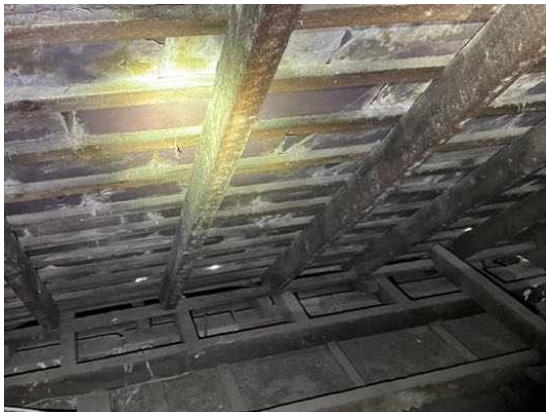
| Finding: | Sarking - Missing |
| Information: | Sarking is missing under the roof sheeting. Sarking acts as an insulator that helps with noise reduction and protects against water penetration. Sarking plays a key role in the operation and function of the overall roofing structure and its performance. |

Although not a requirement at the time of construction, replacement of any missing building element is advisable (although this can be quite expensive to do after the time of construction). Where sarking is missing, regular inspections of the roof tiles for cracking and potential moisture penetration is required.

Sarking may be retrospectively fitted by a registered builder at the discretion of the client.

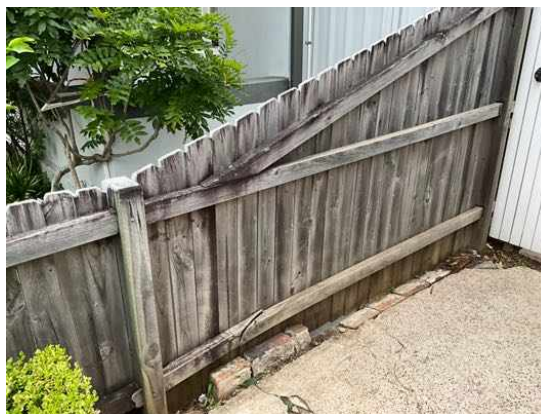
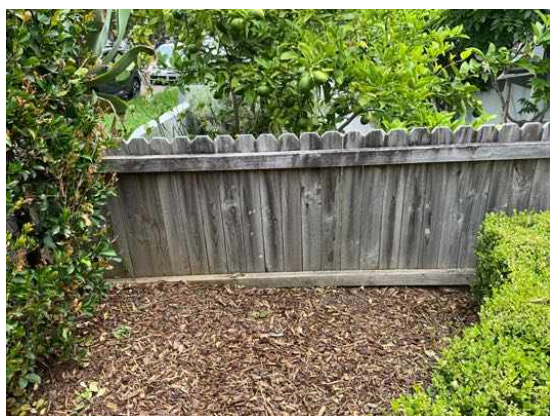
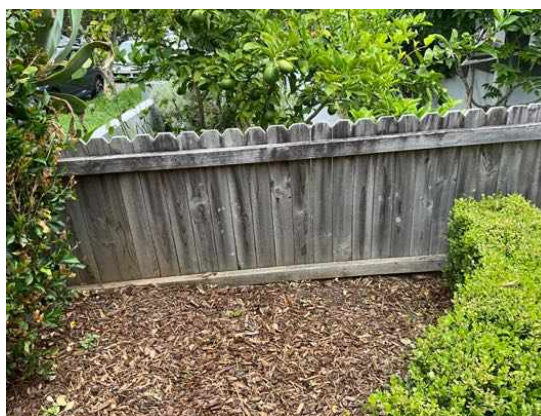
| Finding: | Timber on ground / conducive conditions to termite damage |
| Information: | Timber on the ground is indeed conducive to termite damage. Termites are known to thrive in moist environments, and wood in contact with soil or moisture is more susceptible to infestation. |

To prevent this, it's important to keep timber elevated and away from direct ground contact. Regular inspections and proper termite control measures are also essential to protect your wooden structures from termite damage.

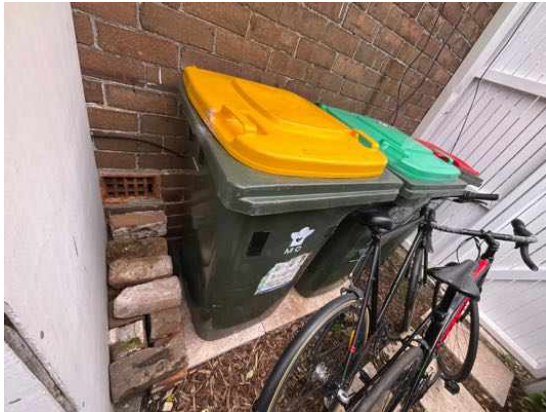
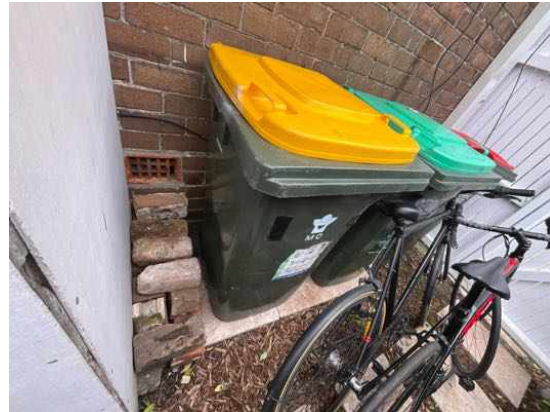
Finding 6.04

Where bridging has occurred full inspection is prevented and termites may enter a property in a concealed or undetected manner.

Recommended moving obstructions away from the external walls for further and future inspections.

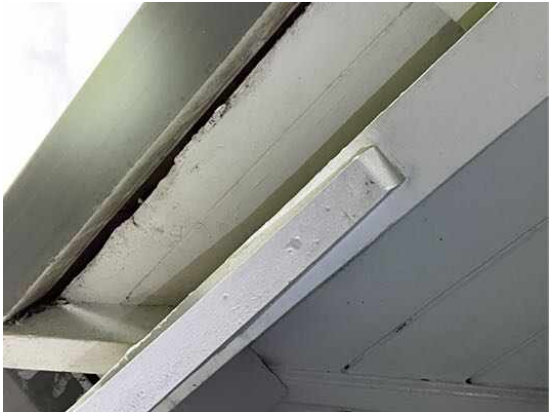
Early intervention and regular maintenance, particularly of exterior timbers, will prolong the useful life of these building elements. Prior to any works being performed, the cause of the moisture that has created the visible wood rot should be identified and addressed in a suitable manner. Replacement of affected timbers may then be a necessary step in protecting surrounding building elements from such deterioration.

A qualified plumber may be appointed to assess the cause of excessive moisture and to provide advice on any remedial works as required. A qualified carpenter or registered builder may also be required to replace affected building materials.
