Building and Timber Pest Inspection Report

Inspection Date: Thu, 8 Jan 2026

Property Address: 7 Alan St, Shepparton VIC 3630, Australia

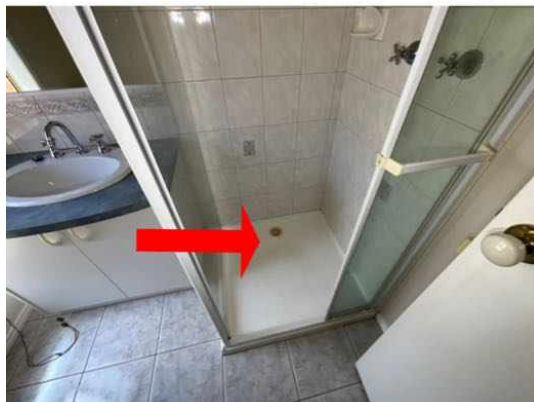
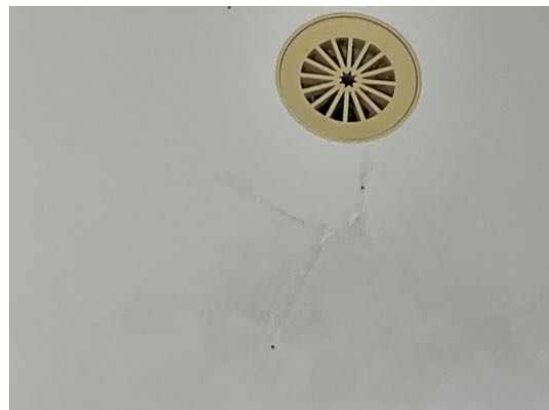
Finding 3.01

Building: Building 1
Location: Ensuite
Finding: Shower base - Cracked
Information: Cracking was evident to the shower base at the time of inspection. The cracking is more than likely due to impact damage, but may have also been caused by general ageing and deterioration of associated building elements. While the cracking appears to be minor, any additional impact may lead to further cracking.

As this area is frequently exposed to water, any cracking is likely to allow water penetration to adjoining building elements. If left unmanaged, water penetration may cause water damage to these elements, and necessitate additional reparation works.

Appointment of a tiling contractor is required to repair the cracked shower base, so as to ensure no further water penetration occurs. Replacement of the shower base may be required, dependent on the extent of the cracking.

Where water damage has affected the associated building elements, the relevant tradesperson should be appointed to perform rectification works as necessary.

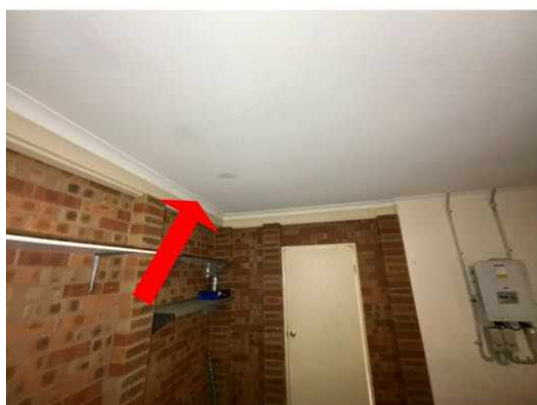
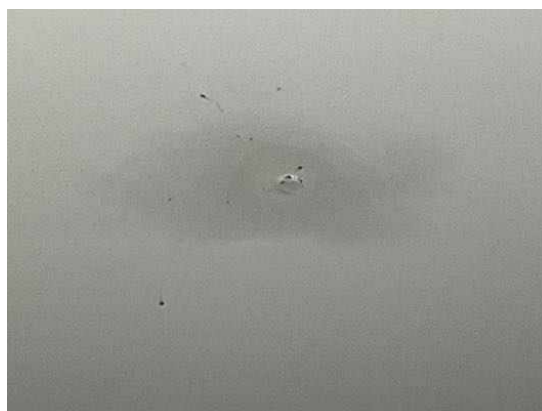
Finding 3.02

Building: Building 1
 Location: Garage
 Finding: Ceiling nails - Popping
 Information: Numerous popped nails were identified in the internal ceiling at the time of inspection. Nails and screws hold simply by the friction between them and the surface they are applied to. Over time, the nails and screws can back out, which is often a result of general ageing and deterioration of the building structure.

If left unmanaged, the ceiling sheets may become loose and unstable, increasing the rate of deterioration of the internal ceiling and creating potential for the development of secondary defects.

Re-fastening of popped nails will help to maintain the stability of the internal ceiling and associated building elements. Such minor works will also help to improve the appearance of the affected area and secure the ceiling sheets, so as to prevent the onset of ceiling sagging. These works should be performed by a qualified carpenter or plasterer at client discretion.

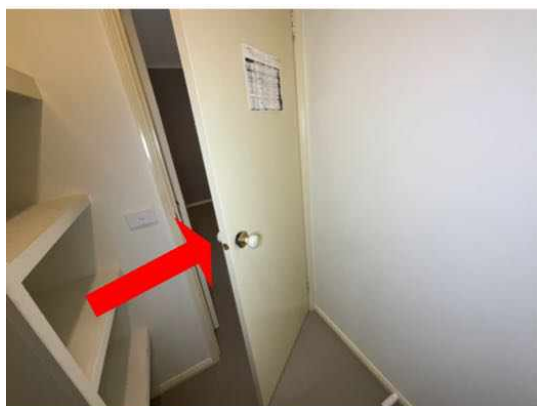
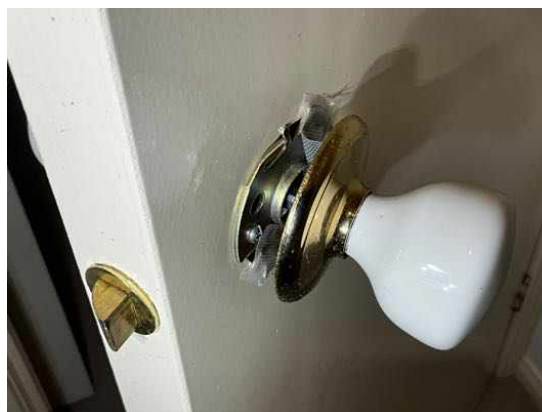
Finding 3.03

Building: Building 1
 Location: Walk In Robe
 Finding: Door handle- Poor operation
 Information: The door handle/ catch in this area was found to be faulty during the visual inspection. This is most probably because of a lack of maintenance or wear and tear over time.

A general Handy person or lock specialist should be contacted to make needed repairs at the discretion of the owner and restore full function.

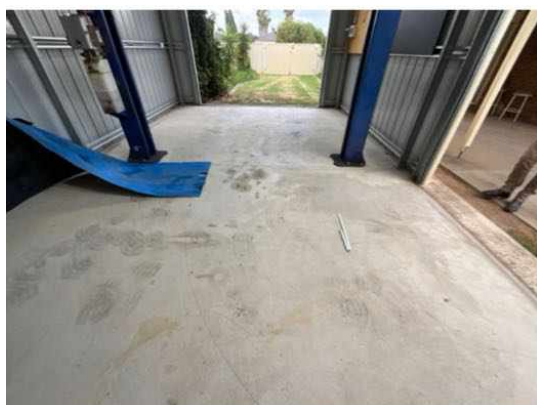
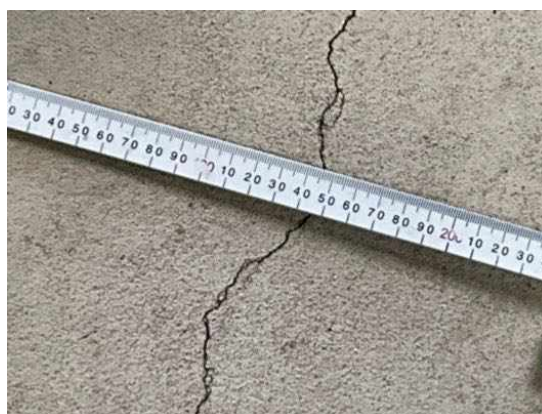
Finding 3.04

Building: Building 1
 Location: Garage 2
 Finding: Crack in concrete slab - Category 1
 Information: A crack coded as Category 1 was identified in the slab. A Category 1 crack is described as a fine but noticeable crack, with the slab at an otherwise reasonable level.

To be considered Category 1, the approximate width of the crack is less than 1.0mm, or a less than 10mm change in offset when a 3m straight edge is placed over the defect.

Category 1 cracks should be monitored for a period of 12 months. At the end of the monitoring period, identified cracks that are rated greater than Category 2 are considered defects, and require rectification.

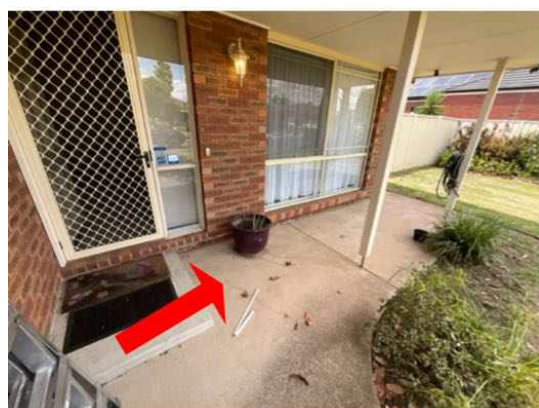
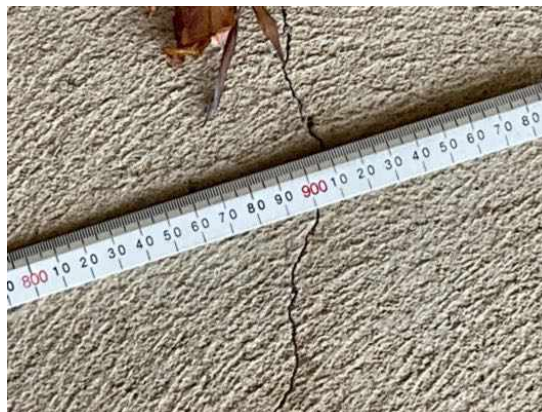
Finding 3.05

Building: Building 1
 Location: Entry
 Finding: Cracking - External Concrete Paving Damage Category 1 - Fine (less than 2mm)
 Information: Fine cracks were identified in external concrete paving. Although fine cracks are quite

noticeable, they are often only considered to be an appearance defect, and usually do not indicate any structural damage. To be considered a Category 1 or fine crack, the crack is found to be less than 2mm in width.

Generally the cause of a hairline crack in existing concrete paving such as driveways and pathways is indicative of the expansion and contraction of the concrete. Such causes are generally due to environmental factors, such as moisture levels, weather conditions, root systems of nearby trees or the soil types on which they are laid.

Fine cracks may also be due to poor original installation of the concrete. Factors such as poor compaction of the sub surface and/or inadequate reinforcing of the slab may create cracking and other secondary defects.

Monitoring of all cracking should be conducted frequently. Always contact a building inspector should cracks widen, lengthen, or become more numerous.

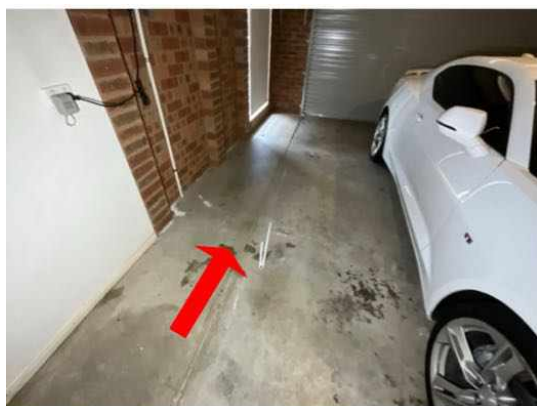
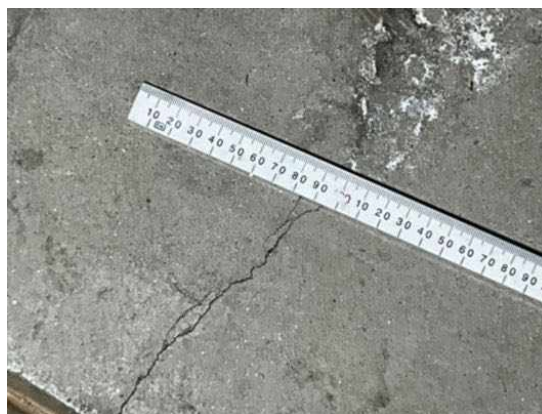
Finding 3.06

Building:	Building 1
Location:	Garage 1
Finding:	Crack in concrete slab - Category 1
Information:	A crack coded as Category 1 was identified in the slab. A Category 1 crack is described as a fine but noticeable crack, with the slab at an otherwise reasonable level.

To be considered Category 1, the approximate width of the crack is less than 1.0mm, or a less than 10mm change in offset when a 3m straight edge is placed over the defect.

Category 1 cracks should be monitored for a period of 12 months. At the end of the monitoring period, identified cracks that are rated greater than Category 2 are considered defects, and require rectification.

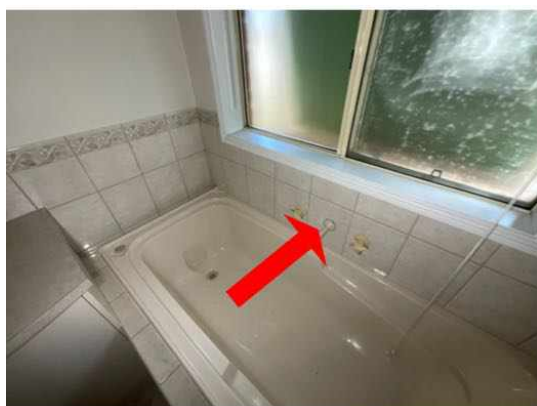
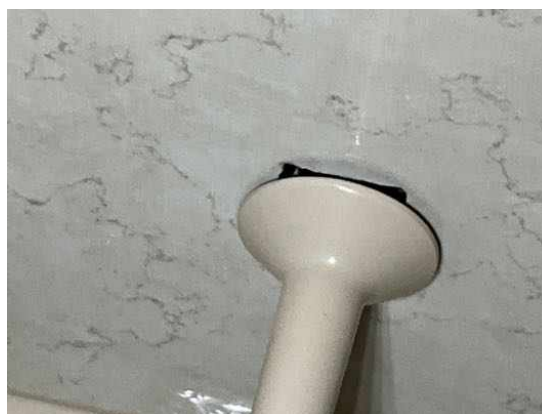
Finding 6.01

Building: Building 1
Location: Bathroom
Finding: Inadequate sealant or Grout
Information: This area has a lack of effective Sealant or Grout. This is allowing the ingress of water to the structure inside the wall.

The presence of water encourages Termite attack, Mould and Fungal Decay.

A Tiler or General Handy person must be contacted as soon as possible to effect repairs and prevent further deterioration.

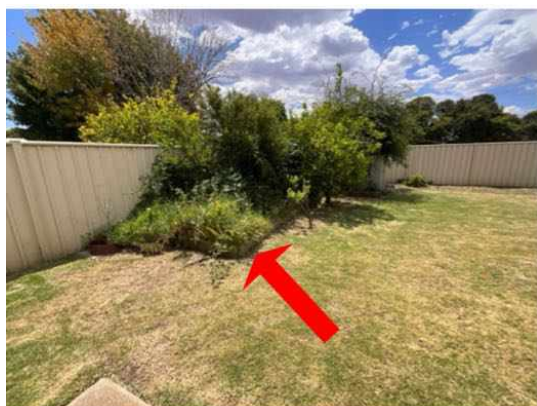
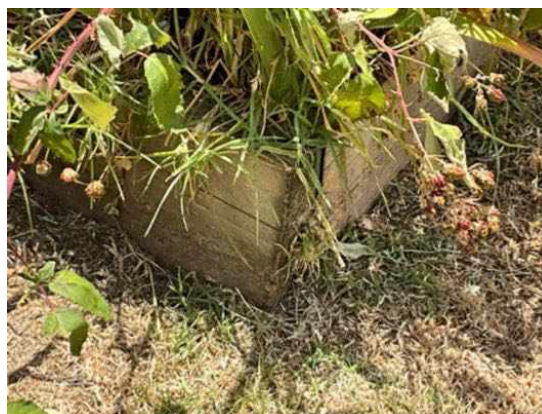
Finding 6.02

Building:	Building 1
Location:	Yard - Back
Finding:	Untreated or non-durable timbers in a hazardous environment
Information:	To reduce the risk of timber pest attack it is essential that timber used in a hazardous environment (e.g. in direct contact with the ground or frequently exposed to damp conditions) is of sufficient durability and/or is adequately preservative treated.

Untreated timbers in direct contact with the ground are likely to develop severe wood rot and/or fungal decay if left unattended creating attraction for subterranean termites to infest the timbers from surrounding areas.

If untreated or non-durable timbers are found to be in a hazardous environment it is highly advised that replacement of these building elements be performed as soon as possible to aid the protection of the property against termite / timber pest attack.

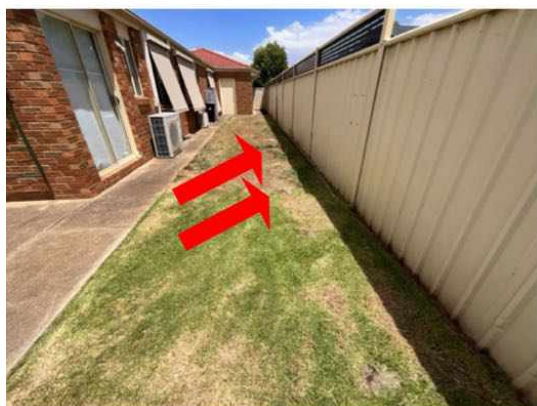
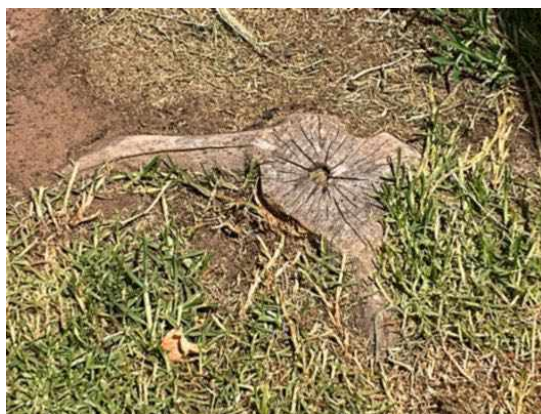
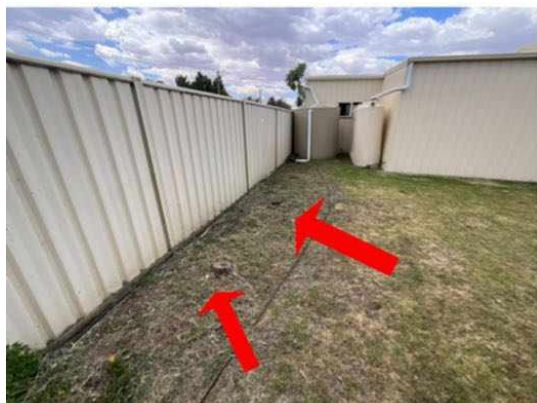
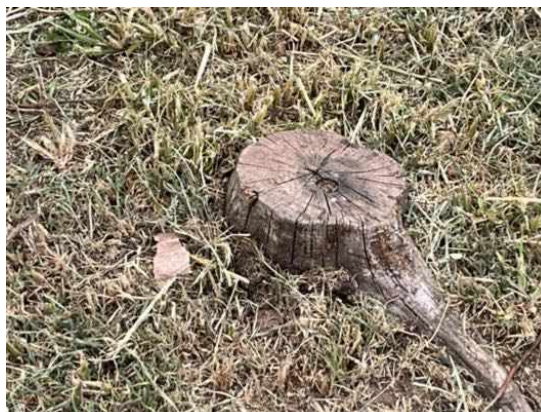
Finding 6.03

Building:	Building 1
Location:	Yard - Back
Finding:	Tree Stump in Ground
Information:	Any tree stumps in the yard not removed during the tree removal process provides the opportunity for Termite infestation and is likely to be subject to decay from damp conditions against the stump.

All tree stumps should be removed by professional tree removal services where possible. Meanwhile regular inspections are advised to identify any termite activity in the areas identified.

Services for tree stump removal should be contacted as soon as possible to reduce the risk of timber pest attack.

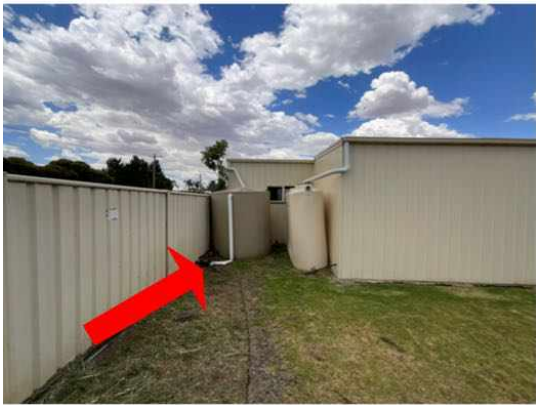
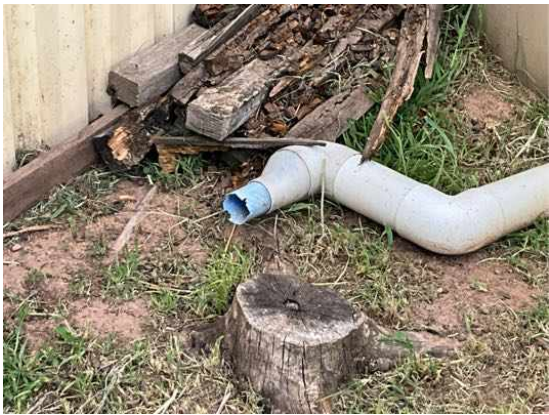
Finding 6.04

Building:	Building 1
Location:	Yard - Back
Finding:	Overflow - Not plumbed for drainage
Information:	The overflow is not plumbed or connected to suitable drainage, which has resulted in the surrounding area becoming excessively damp. These damp conditions can lead to secondary defects such as rot, rust or corrosion of associated building elements, the formation of fungal decay, or even the creation of potential slip hazards. When coupled with poor site drainage, pooling of water may also attract termite activity to this area. It is highly recommended that a qualified plumber be appointed to install adequate drainage to the overflow. These works will ensure that the area remains dry and free of any secondary defects.

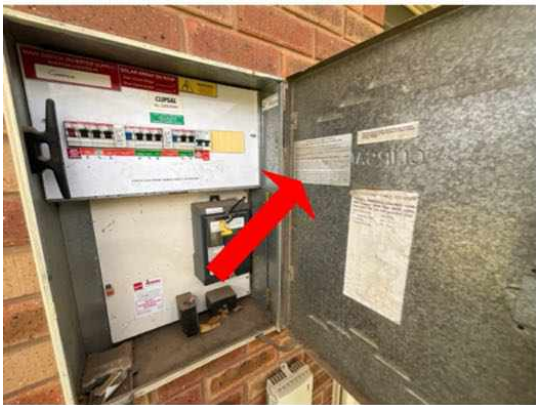
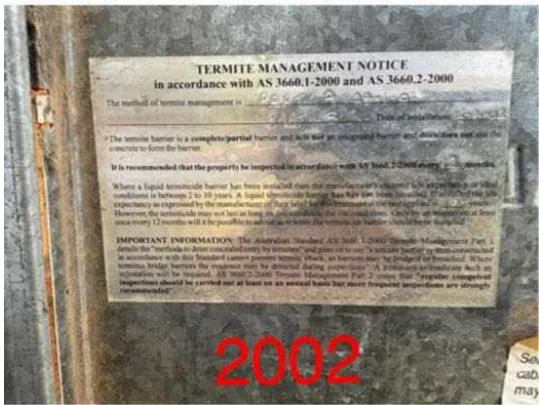
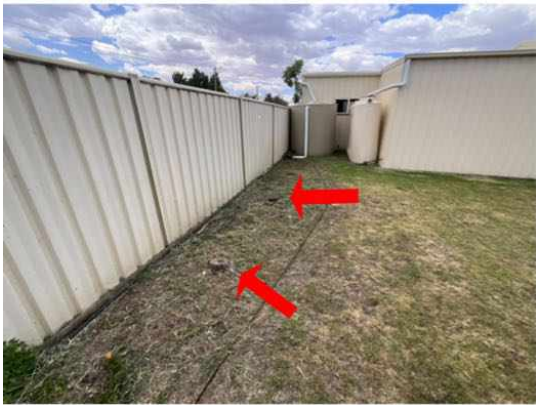
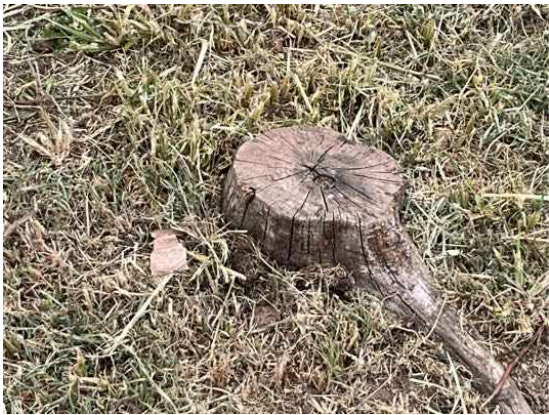
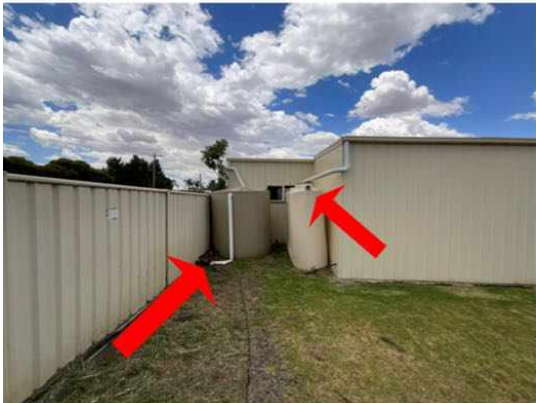
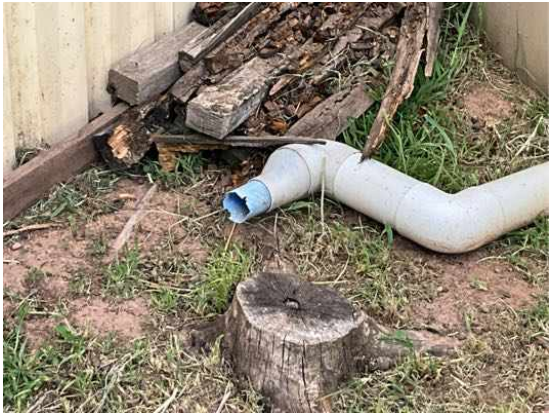
Finding 6.05

Building: Building 1
 Location: All External Areas
 Finding: Termite Management System - no evidence of a chemical installation
 Information: The application of a post-construction chemical termite barrier is highly recommended for all properties, particularly if live termite activity has been found on the site previously. Such barriers are highly effective in preventing termite attack on any timber building elements throughout the property.

A durable notice should be placed in the switchboard unit to indicate current termite barriers. At the time of inspection, it appeared as though no termite management system has been installed, with no evidence to suggest preventative works taking place.

The client may consider gaining further advice from a pest controller as to the costs and procedures involved with this application. It is recommended that obtaining such advice be a short-term priority.

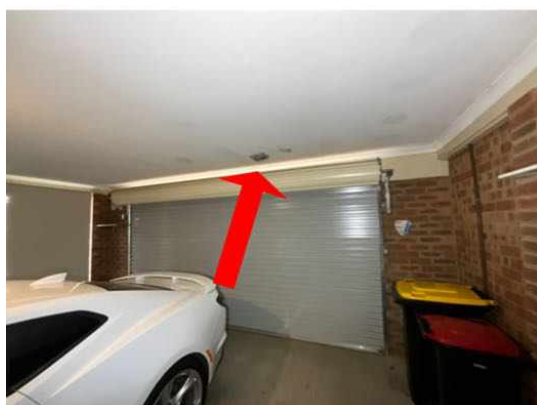
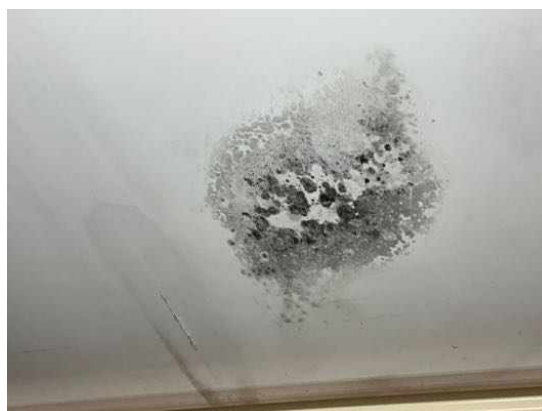
Noted Item

Building: Building 1
 Location: Garage
 Finding: Mould - Present
 Information: Where evidence of mould growth was noted, there may be environmental, biological or health issues associated with the report. A specialist inspection by a suitably qualified environmental health inspector is warranted, where mould is extensive or where any queries regarding air quality spores or other related issues apply.

Generally, the client is advised to ensure that the general environment is free of moisture and humidity to aid in the prevention of mould formation and development. Any mould found during the inspection should be cleaned immediately by a cleaning contractor or the homeowner as applicable.

Please note that severely affected building elements may require replacement by a registered builder or qualified carpenter.

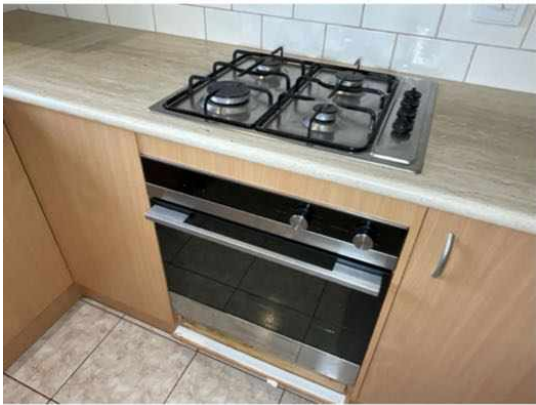
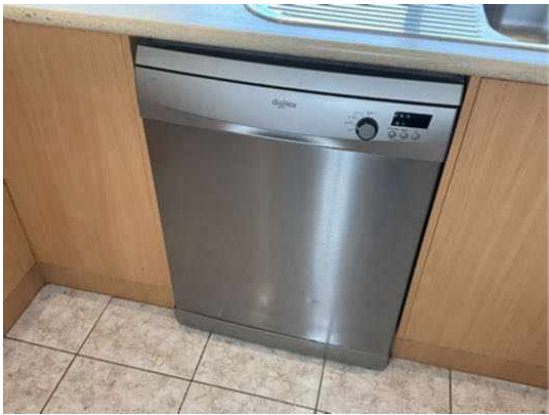
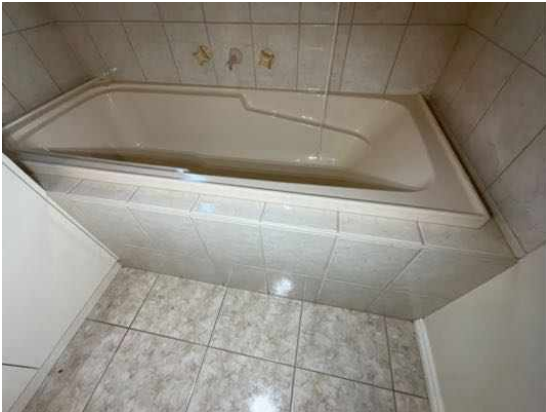
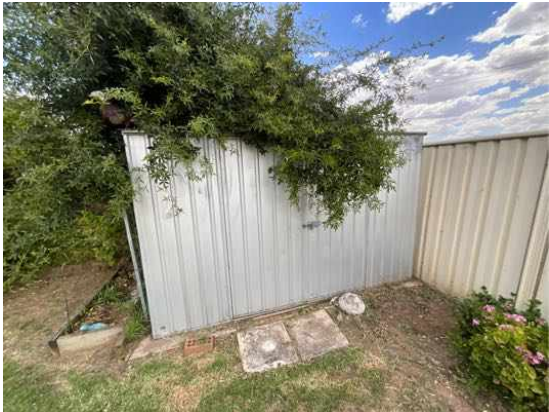
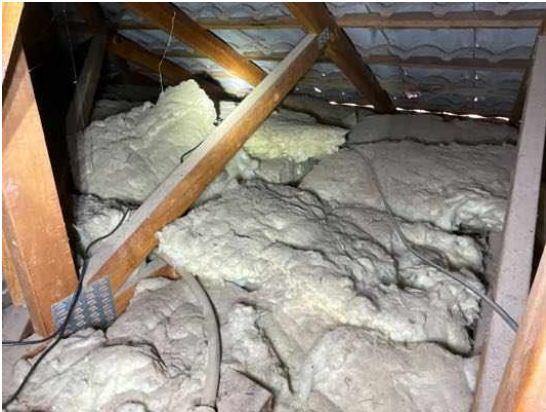
Noted Item

Building: Building 2
 Location: All Areas
 Finding: Additional Photos - Obstructions and Limitations
 Information: These photographs are an indication of the obstructions and limitations which impeded full inspection of the property at the time of inspection. These obstructions can hide an array of defects and should be removed to allow full inspection to be carried out. A re-inspection is recommended once the areas are made accessible.
