Timber Pest Inspection Report

Inspection Date: Fri, 13 Feb 2026

Property Address: 13 Zealandia Rd W, Croydon North VIC
3136, Australia

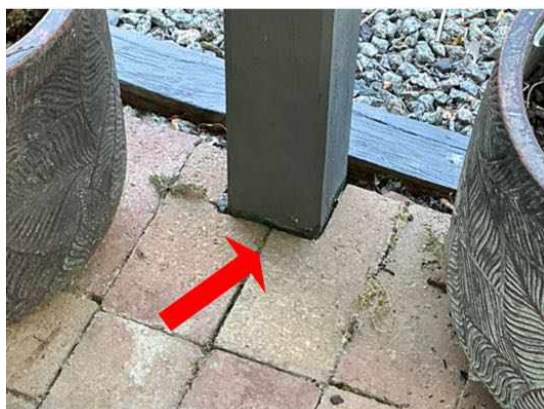
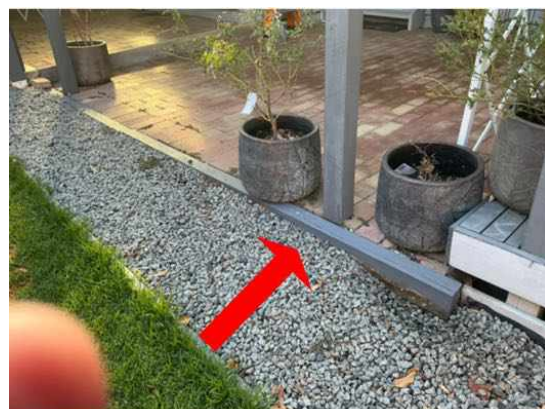
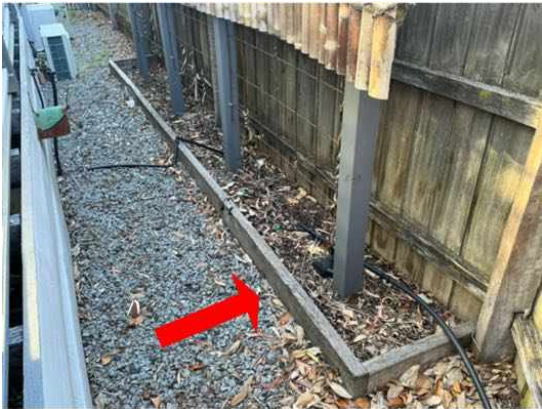
Termite and Timber Pest 4.01

Building: Main Building
Location: All External Areas >
Finding: Untreated or non-durable timbers in a hazardous environment- garden
Information: To reduce the risk of timber pest attack it is essential that timber used in a hazardous environment (e.g. in direct contact with the ground or frequently exposed to damp conditions) is of sufficient durability and/or is adequately preservative treated.

Untreated timbers in direct contact with the ground are likely to develop severe wood rot and/or fungal decay if left unattended creating attraction for subterranean termites to infest the timbers from surrounding areas.

If untreated or non-durable timbers are found to be in a hazardous environment it is highly advised that replacement of these building elements be performed as soon as possible to aid the protection of the property against termite / timber pest attack.

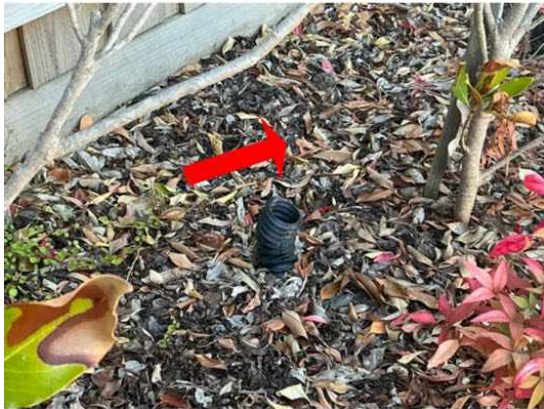
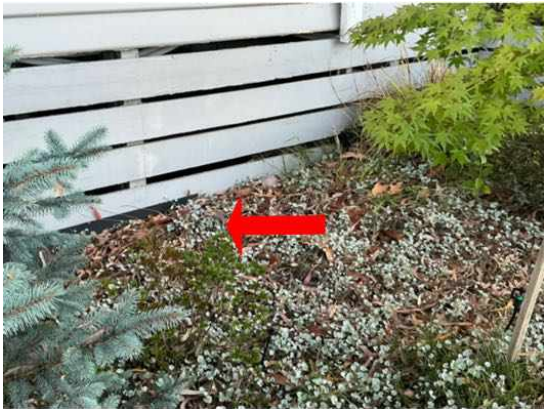
Termite and Timber Pest 4.02

Building: Main Building
Location: All External Areas
Finding: Garden Beds - Conditions Conducive to Termites
Information: Garden beds were found to be evident in the garden area. These garden beds can include untreated timber, and with a combination of moisture from watering hosing can make conditions conducive to termite activity and termite ingress.

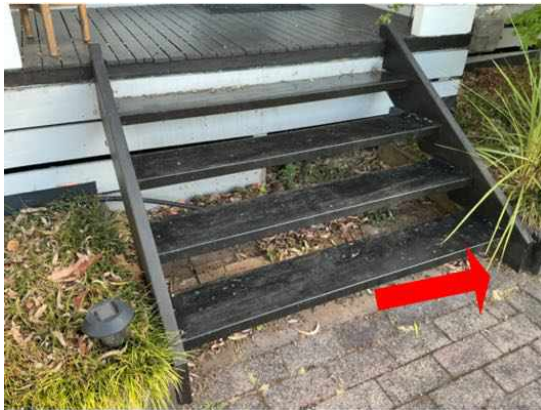
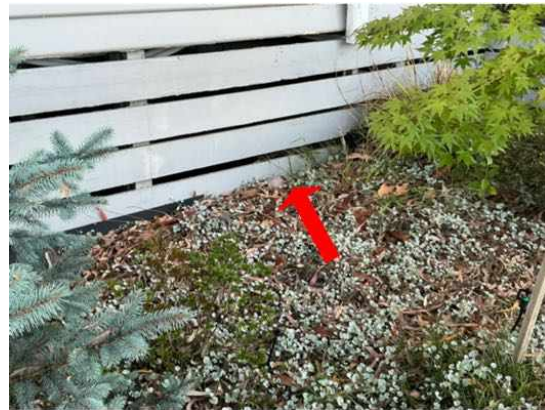
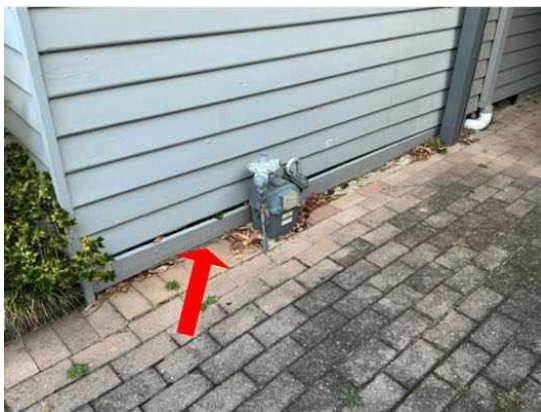
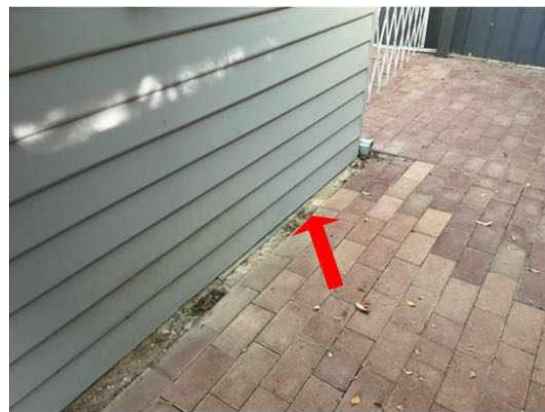
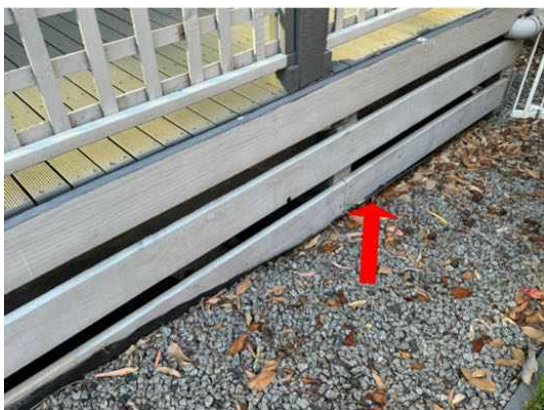
Termite and Timber Pest 4.04

Building:	Main Building
Location:	All Areas
Finding:	Untreated or non-durable timbers in a hazardous environment- building
Information:	To reduce the risk of timber pest attack it is essential that timber used in a hazardous environment (e.g. in direct contact with the ground or frequently exposed to damp conditions) is of sufficient durability and/or is adequately preservative treated.

Untreated timbers in direct contact with the ground are likely to develop severe wood rot and/or fungal decay if left unattended creating attraction for subterranean termites to infest the timbers from surrounding areas.

If untreated or non-durable timbers are found to be in a hazardous environment it is highly advised that replacement of these building elements be performed as soon as possible to aid the protection of the property against termite / timber pest attack.

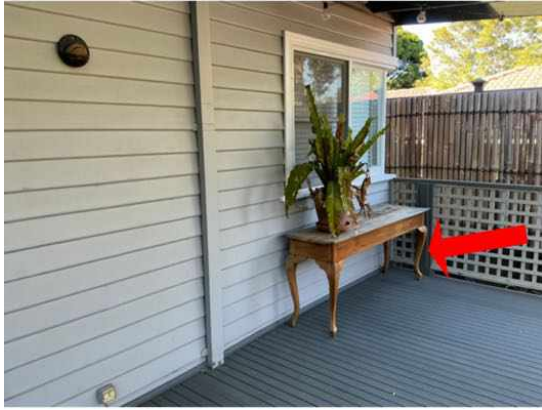
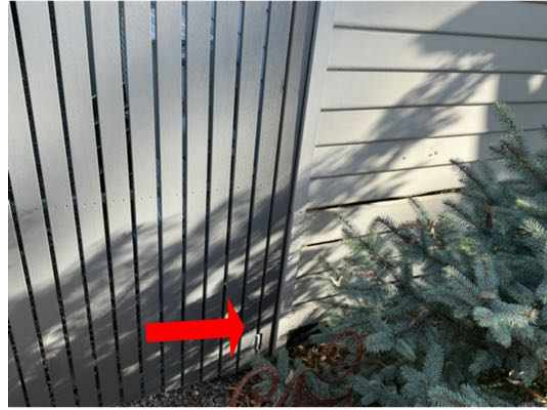
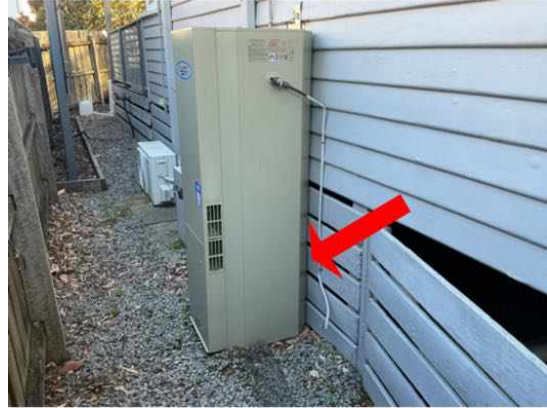
Termite and Timber Pest 4.05

Building: Main Building
Location: All External Areas
Finding: Bridging or breaching of termite barriers - adjacent internal flooring
Information: Bridging is the spanning of a termite barrier or inspection zone so that subterranean termites are provided with passage over or around that barrier.

Breaching is the making of a hole or gap in a termite barrier so that termites are provided with a passage through that barrier.

It is important for internal flooring to be raised above adjacent external ground levels. Where external ground levels are above internal flooring water pooling and subsequent internal flooding is likely to occur which may attract termite activity to the internal area.

It is highly advised that a landscaper or paver be appointed to lower external grounds that are raised above adjacent internal flooring. Alternatively if external grounds and internal flooring is level installation of a raised door sill may be appropriate in preventing any water pooling in the area.

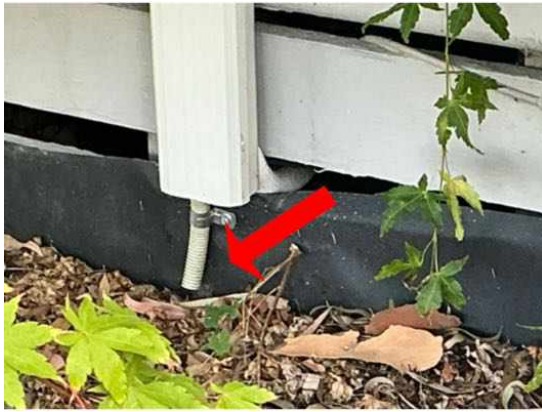
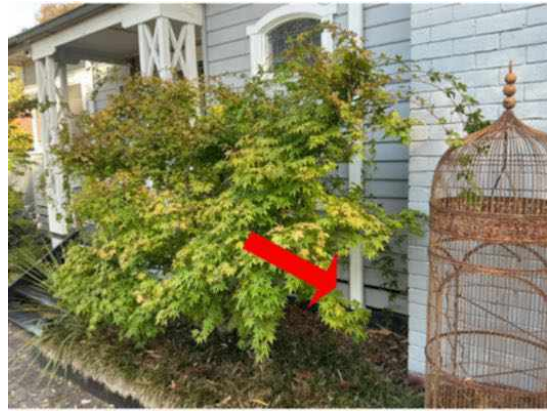
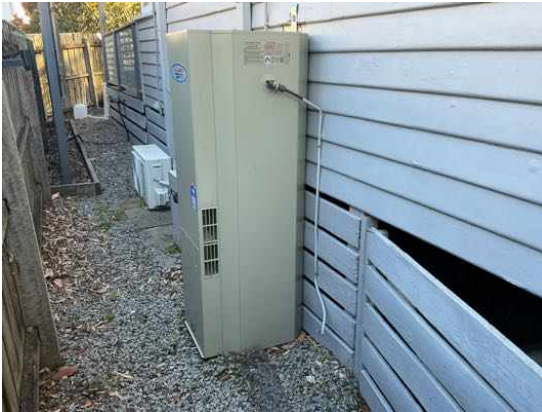
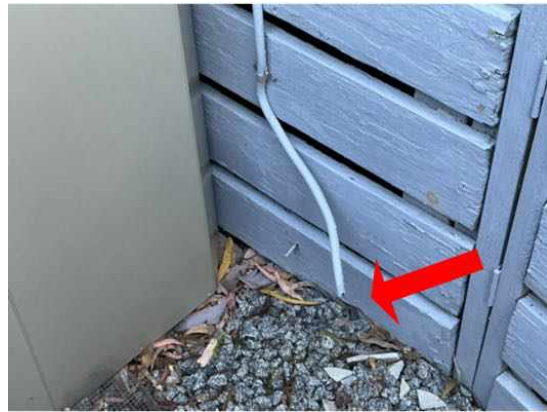
Termite and Timber Pest 4.06

Building:	Main Building
Location:	Front Elevation
Finding:	Air conditioner and hot water heater condenser pipe not connected
Information:	The A/C and water heater condenser overflow where found to be disconnected from the stormwater system and is creating excessive moisture to the surrounding area.

Such leaking creates an environment which is conducive to an array of defects including water damage to associated building materials and the attraction of termites or timber pest infestation.

A Licensed plumber should be engaged to review as soon as possible

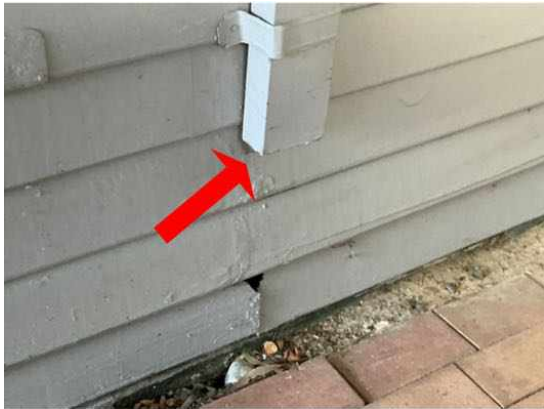
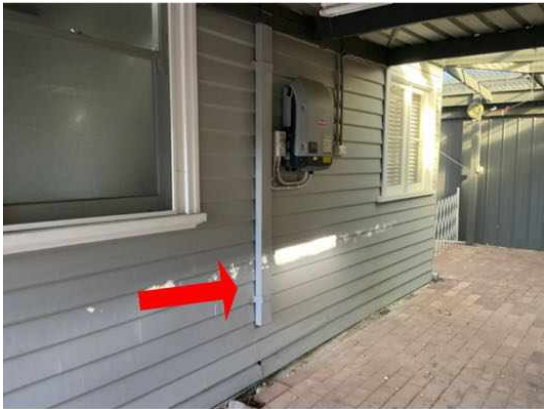
Termite and Timber Pest 4.07

Building: Main Building
Location: Carport
Finding: Downpipe disconnected TP
Information: It was noted that the downpipe to the carport was disconnected.

Downpipes disconnected can cause flooding and over saturation of the surrounding foundation soils,

Moisture ingress to the building and footing movement may occur should the moisture content of the soil be not be kept constant.

Excessive moisture levels in the soil can be conducive to termite infestation

A licensed plumber should review at the owner discretion.

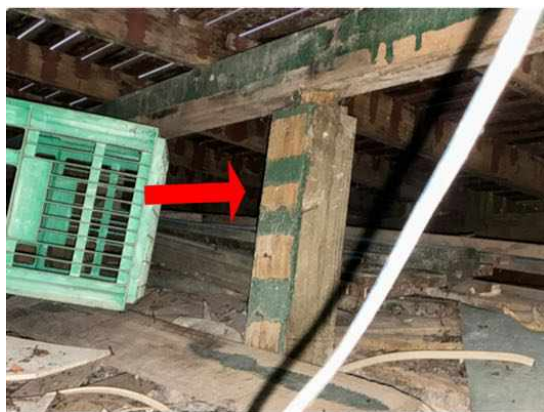
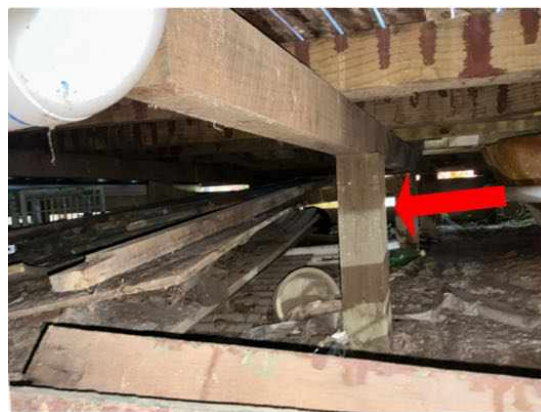
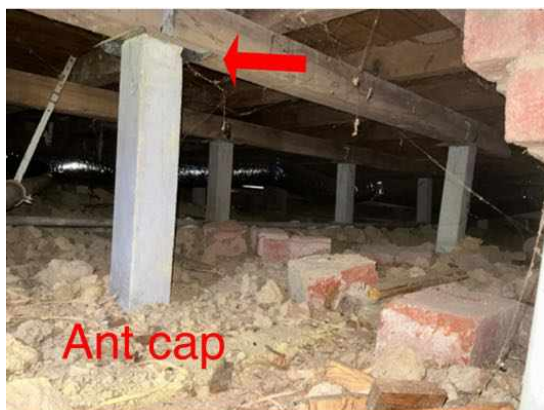
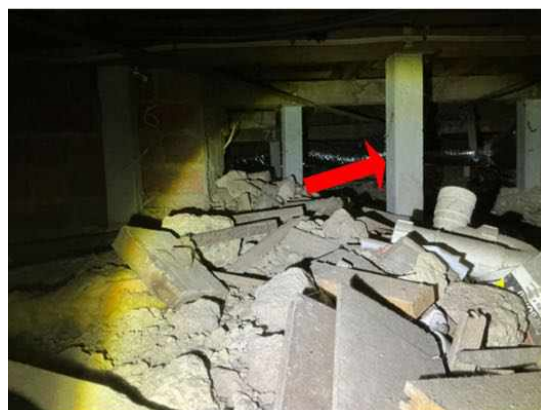
Termite and Timber Pest 4.08

Building: Main Building
Location: Subfloor
Finding: Ant caps -part installed
Information: Ant caps have been part installed to the subfloor structure at the time of inspection. Generally, ant caps are installed to the intersection between the top of the stumps (or piers) and the subfloor structures. It was noted at the time of the inspection that the stumps were concrete and timber some with and someone without ant caps

Installed during the construction process, ant caps are designed to easily identify termite or pest ingress from stumps to the adjoining bearers.

Where ant caps have not been installed, frequent monitoring of these areas should be carried out in order to identify any signs of termite or timber pest workings.

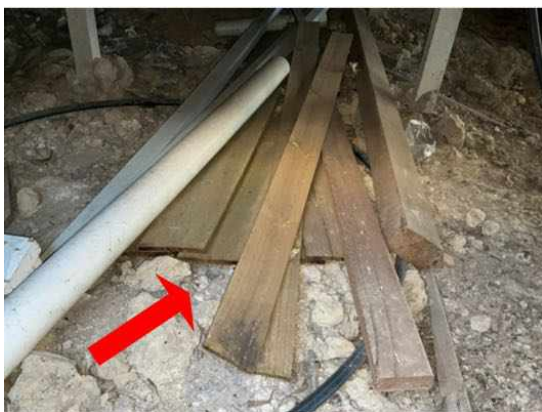
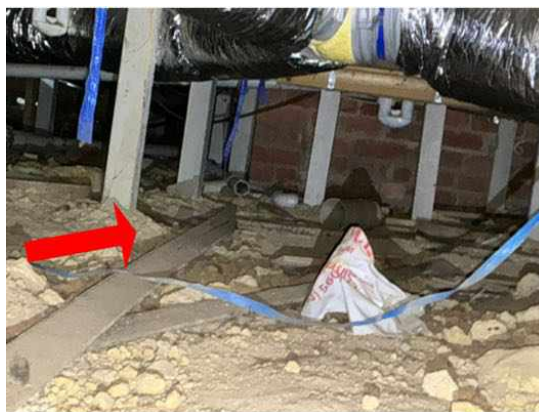
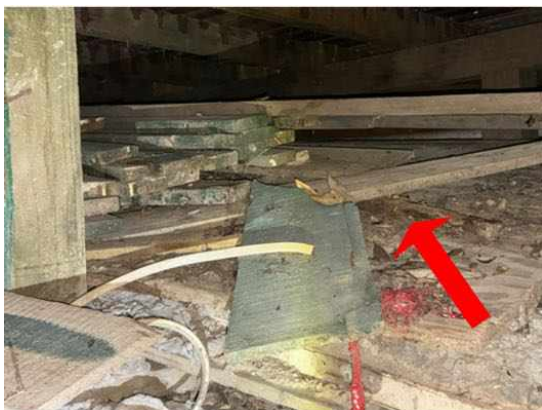
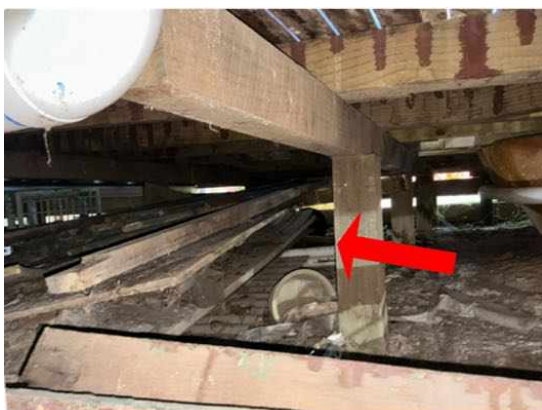
Termite and Timber Pest 4.09

Building:	Main Building
Location:	Subfloor
Finding:	Stored timbers - subfloor space or external area
Information:	The storing of timbers in the subfloor space or around the external property increases the risk of termite activity being present. As they are likely to come into contact with weather conditions or excessive moisture wood rot is likely to develop on timbers that are not treated.

It is highly recommended that any stored timbers be immediately removed from areas in which they may attract any termite / timber pest attack. Minimisation of risk / prevention of termite attack is far more adequate than dealing with the presence of termite activity.

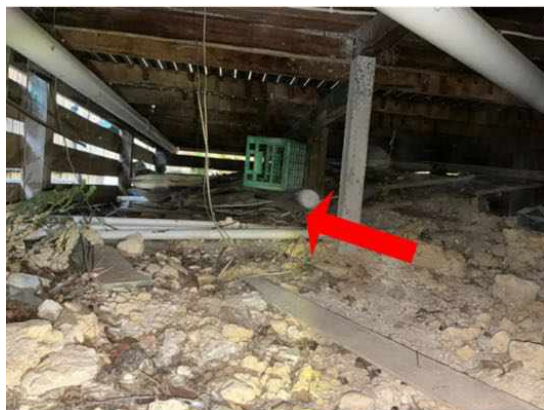
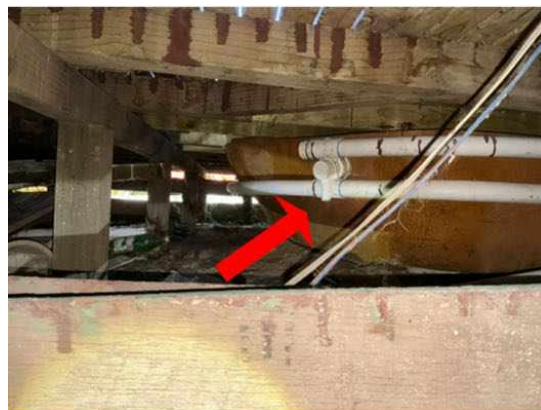
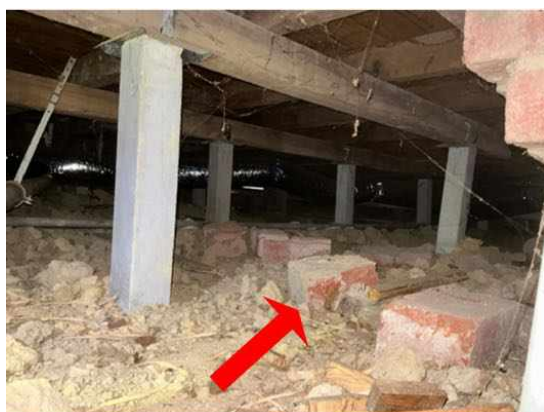
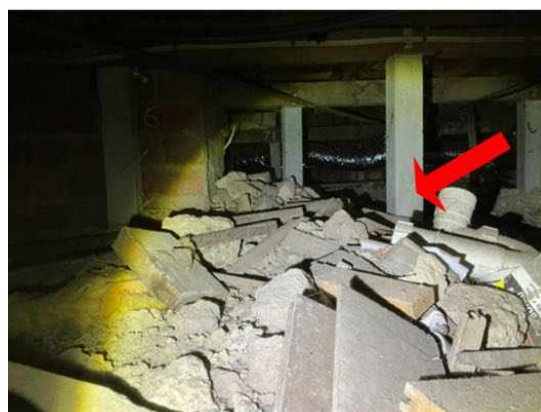
Termite and Timber Pest 4.10

Finding: Subfloor - Debris

Information: An array of debris was found in the subfloor area at the time of inspection. Debris in this area restricts subfloor ventilation and creates potential for concealed pest entry. Stored timbers and other materials may also make the area susceptible to termite activity and wood rot.

A clear and empty subfloor will be better ventilated and easier to maintain in a dry condition. The removal of any timber debris is vital in minimising the risk of termite or wood borer activity.

Debris in the subfloor should be removed as soon as possible. Depending on the location and amount of debris and stored items, the homeowner may elect to undertake this task. Alternatively there are a large number of rubbish removal subcontractors that could undertake these works.

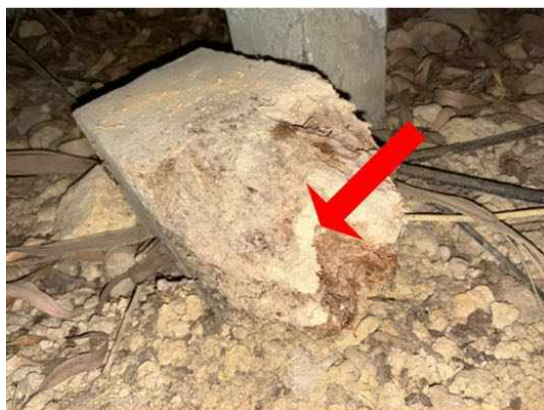
Termite and Timber Pest 4.11

Building:	Main Building
Location:	Subfloor
Finding:	Evidence of termite damage - minor
Information:	Despite no live termite or timber pest activity being indicated, previous termite damage was found to have affected this area. This damage is considered to be inactive and is minor in nature.

It is advised that the area be visually inspected frequently to ensure that the condition of affected building materials does not worsen. At the time of inspection, damage is not structural and is only considered to be superficial.

This property is highly susceptible to timber pest activity. No live timber pest activity was observed during the inspection although previous minor timber pest damage was observed in the subfloor area. This appeared to be limited to a timber offcut in contact with the ground.

A building contractor may be appointed to provide a further invasive inspection if further damage is evident.

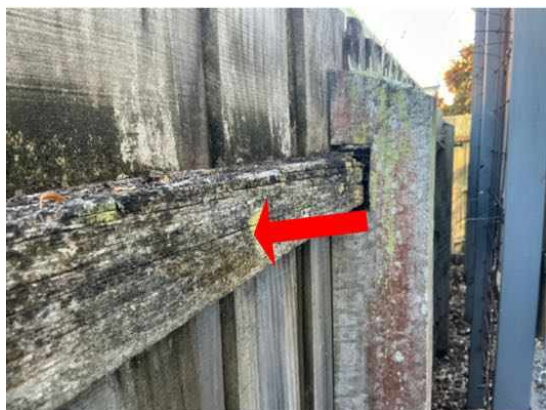
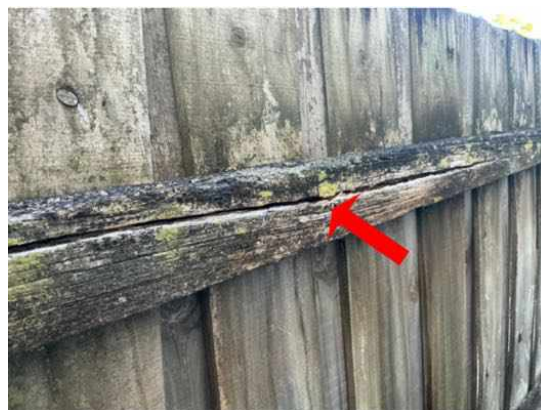
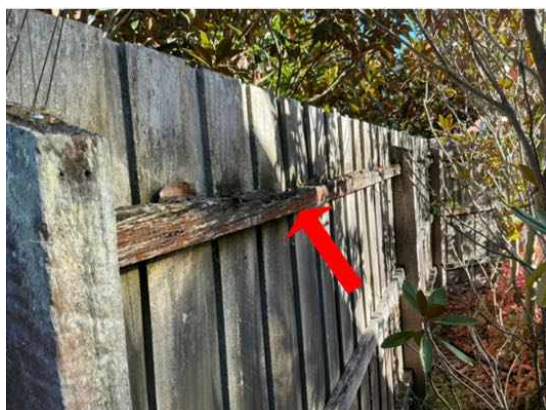
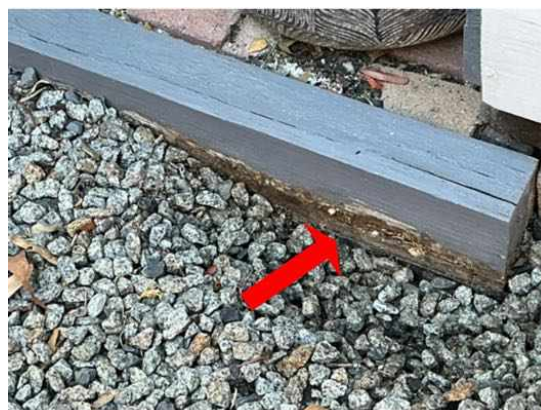
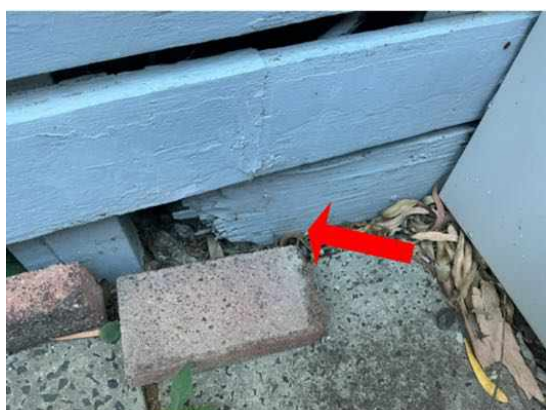
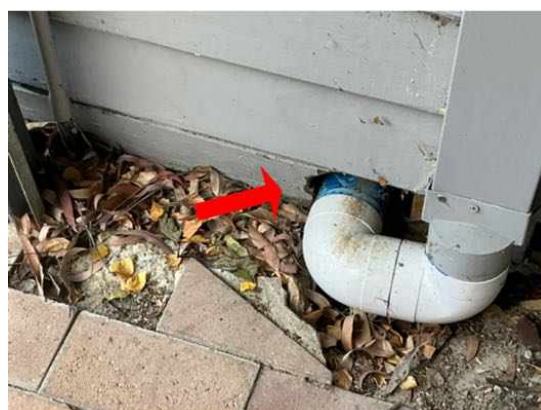
Termite and Timber Pest 7.01

Building:	Main Building
Location:	All External Areas
Finding:	Fungal decay - present (widespread)
Information:	Fungal decay is also known as wood decay or wood rot generally refers to the deterioration of timber elements when in contact with excessive levels of moisture for a prolonged period of time.

The development of fungal decay is accelerated by temperatures in the range of 5degreeC to 40degreeC as well as the presence of oxygen. Generally fungal decay develops on timber elements that are in use in an external environment which are exposed to rain penetration.

In this case, fungal decay appears to have become widespread and is likely to have affected any adjoining timber elements/structures. The widespread development of fungal decay is likely to have heavily impacted the structural integrity and tensile strength of the affected timber elements and the associated structure.

Timbers affected by widespread fungal decay should be replaced immediately. The cause of the moisture that has led to the development of such decay should also be identified and dealt with in an appropriate manner.

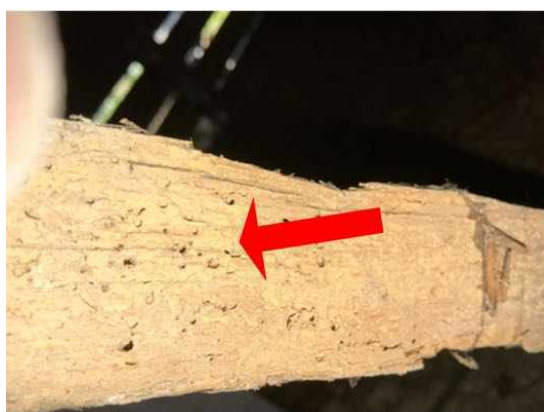
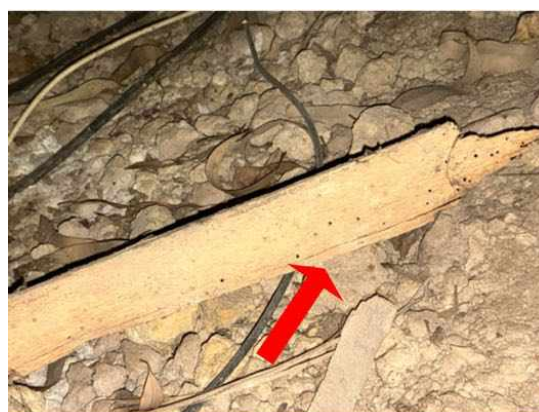
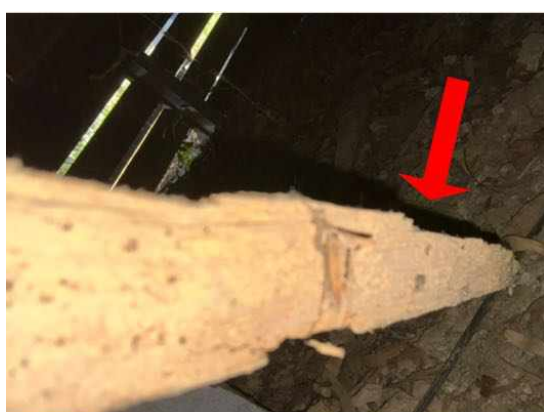
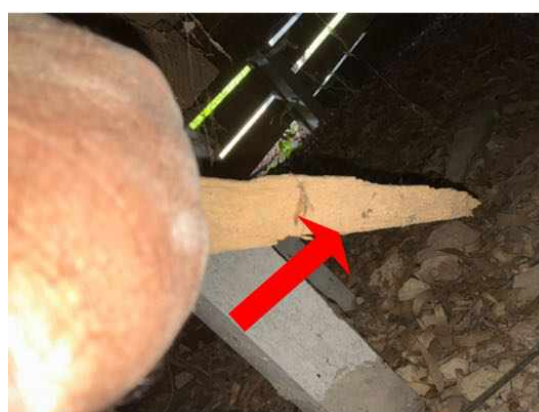
Termite and Timber Pest 8.01

Building:	Main Building
Location:	Subfloor
Finding:	Evidence of wood borer activity identified
Information:	Wood borers small beetles that colonise in exposed timber elements are a common timber pest that are regularly mistaken for termites. The borers are often delivered to site within timber used for construction. Although wood borer activity is generally not detrimental to the affected timber they may lead to serious damage and necessitate

replacement of certain building elements if left unattended.

The Lyctid borer which generally attacks hardwoods such as subfloor and roofing structures is generally identified by fine dust, surrounding the affected timbers.

The other commonly known borer the Anobium borer is more likely to attack floorboards and may cause severe structural damage to flooring areas.

As no live wood borer activity was identified treatment is not required at this time. Replacement of affected timbers may be considered by the client for superficial reasons.

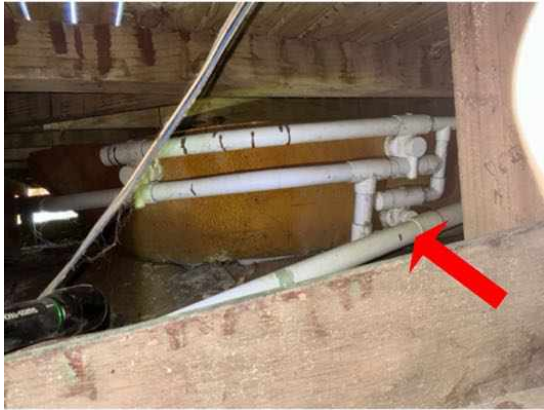
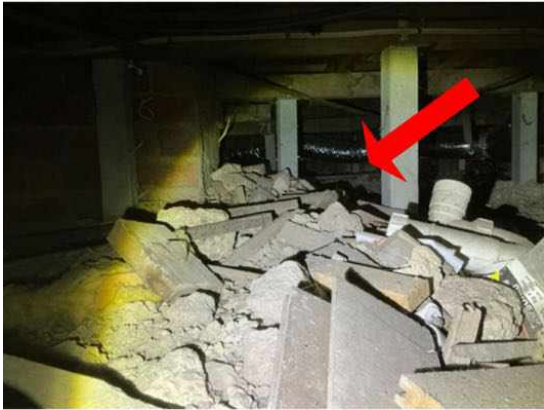
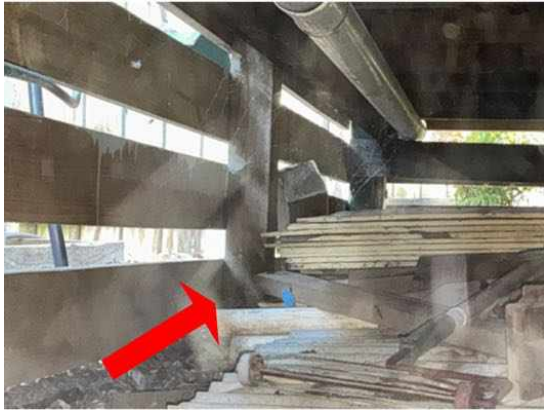
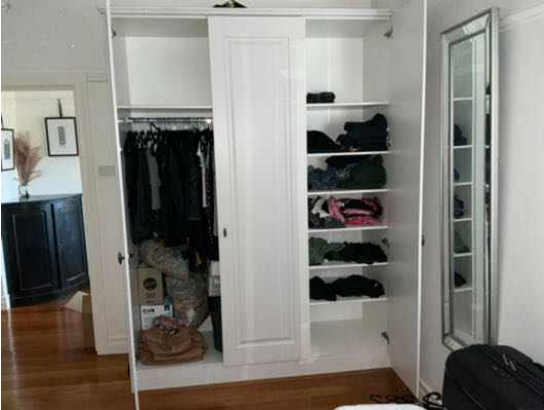
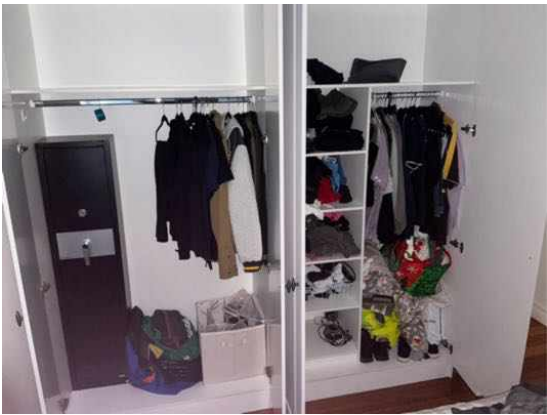
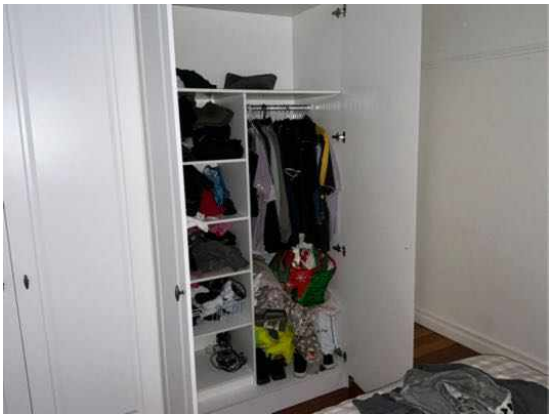
Building: Main Building
Location: All Areas
Finding: Additional Photos - Obstructions and Limitations
Information: These photographs are an indication of the obstructions and limitations which impeded full inspection of the property at the time of inspection. These obstructions can hide an array of defects and should be removed to allow full inspection to be carried out. A re-inspection is recommended once the areas are made accessible.
