Building and Timber Pest Inspection Report

Inspection Date: Tue, 10 Feb 2026

Property Address: 335 Driftway Dr, Pemulwuy NSW 2145,
Australia

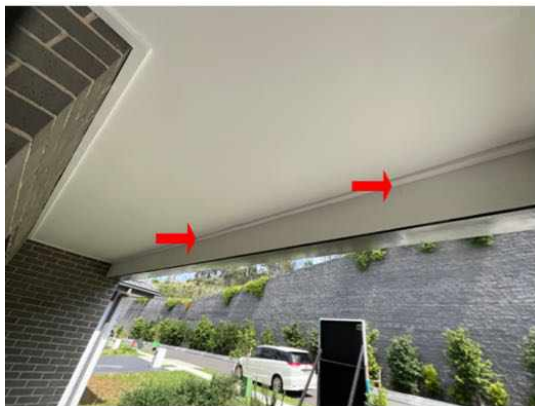
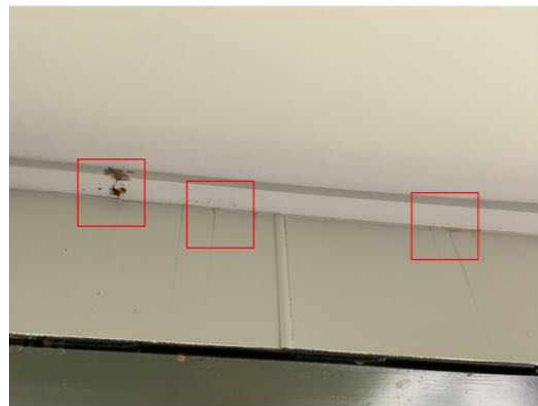
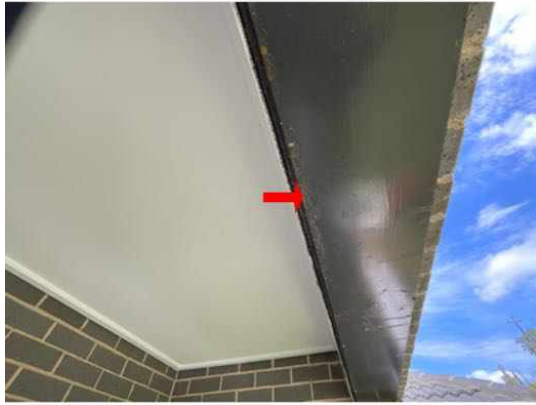
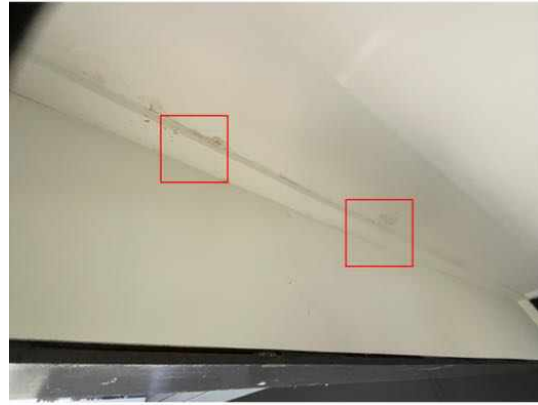
Finding 2.01

Building: Main Building
Location: Porch
Finding: Waterproofing damage - Suspected
Information: Water damage was identified under the balcony at the time of inspection. Internal water leaks can be detrimental to surrounding building elements. The potential cause in this area is damage to the balcony floor waterproofing membrane.

Attracting termites, corrosion, mould, decay and water damage are potential outcomes where a minor water leak is left unattended. More serious defects may also result, such as electrical hazards, or water damage to structural building elements.

In extreme cases, structural damage may develop due to a prolonged water leak. It is highly advised that this issue be addressed immediately by a licensed builder as a matter of relative urgency.

The balcony floor waterproofing membrane appears to have been damaged, with water damage to the surfaces underneath. A licensed builder must be appointed urgently for further assessment and rectifications.

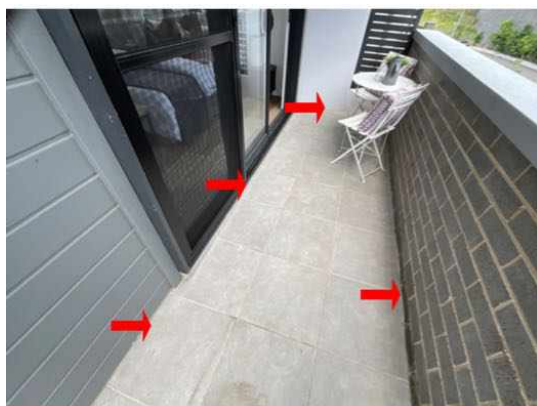
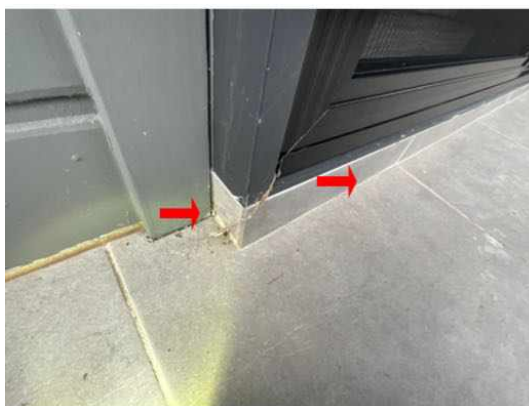
Finding 3.01

Building: Main Building
Location: Balcony
Finding: Sealant and grouting - Missing or damaged
Information:

It was noted on inspection that sealant or grout is degraded to this area.

Different materials and floor areas move at different rates, generally causing cracking to grout or sealant at this point. A flexible sealant is required to allow for expected expansion and contraction, while keeping the joint water tight and protective of all associated building materials.

Flexible and mould resistant materials should be applied to affected areas to prevent any subsequent water damage that is likely to occur. Regular maintenance and replacement of damage or missing or damaged sealant and grout is highly recommended to the wet areas, as this is a regular wear and tear defect. Sealant and grouting in areas that come into regular contact with water should be maintained for the long term care of your property.

A sealant specialist should be appointed to complete these works as soon as possible.

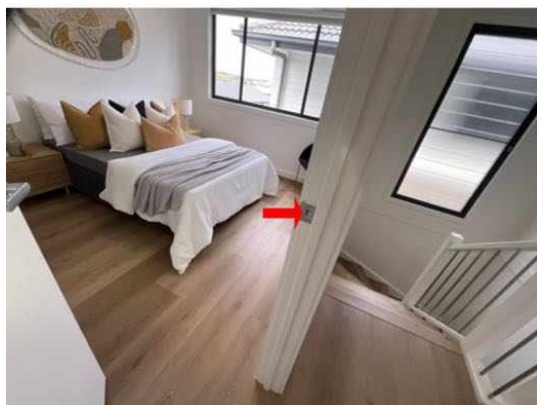
Finding 3.02

Building: Main Building

Location: Bedroom 2

Finding: Door - Striker plate misaligned

Information: The striker plate to this door appears to have become misaligned and has consequently resulted in the door's operation being compromised.

This is a common defect and is expected in a property of this age, whether being due to substandard installation or general deterioration of the door hardware.

Readjustment of the striker plate is recommended at client discretion. Works such as these can be completed by a general handyman or qualified carpenter.

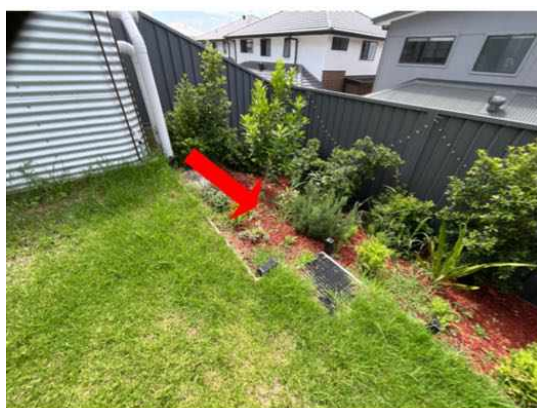
Finding 6.01

Building:	Main Building
Location:	Garden beds
Finding:	Garden Beds
Information:	Garden beds were found to be evident in the garden area. These garden beds can include untreated timber, and with a combination of moisture from watering hosing can make conditions conducive to termite activity and termite ingress.

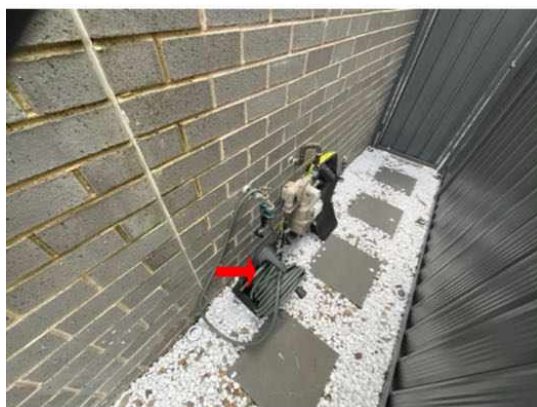
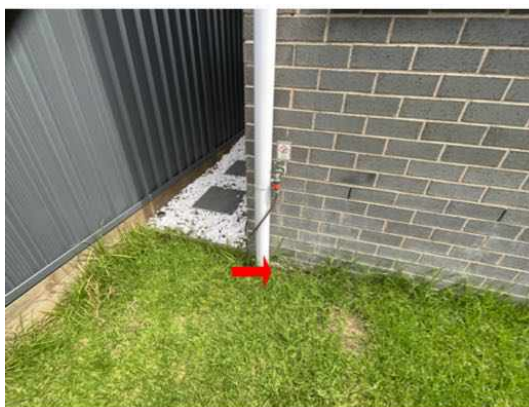
Finding 6.02

Building:	Main Building
Location:	External tap
Finding:	Tap - No drain
Information:	The external tap in this area was noted to have no drain at the time of inspection.

This keeps the surrounding surfaces damp while using the tap, which becomes conducive to termite activity.

A licensed plumber must be appointed to ensure an appropriate drain is installed.

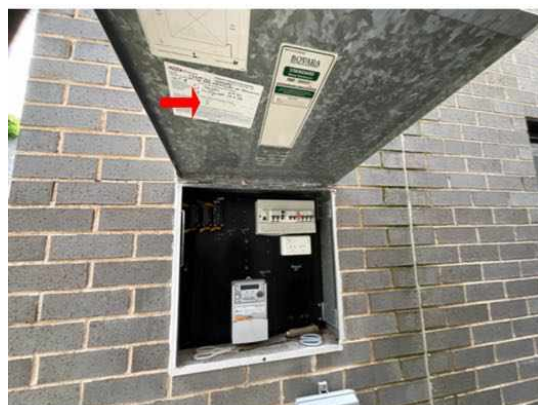
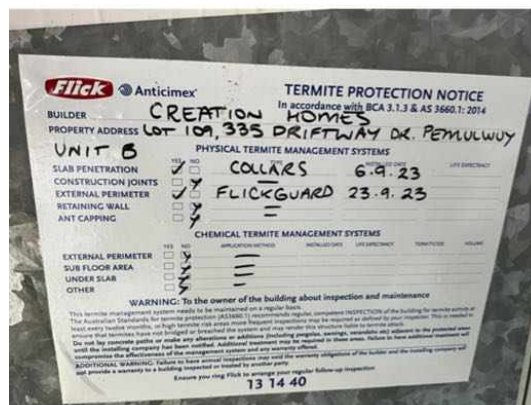
Building: Main Building
 Location: Meterbox
 Finding: Evidence of a previous termite management system was identified
 Information: There are a number of factors which indicate the presence of a previously installed or applied termite barrier. The most common are a durable notice (to the inside of your meter box) observable physical barriers installed to building perimeter and in ground reticulation systems.

Where a Termite Management System has been identified you should refer to the type of barrier date of installation warranty conditions and any documentation provided by a builder or past owner. Consult the company who installed the barrier to confirm whether the system is still under warranty.

Most chemical termite management systems expire and require replenishment and all physical systems are primarily designed to prevent concealed entry.
