Building and Timber Pest Inspection Report

Inspection Date: Wed, 11 Mar 2026

Property Address: 27 Sanctuary Point Rd, Sanctuary Point
NSW 2540, Australia

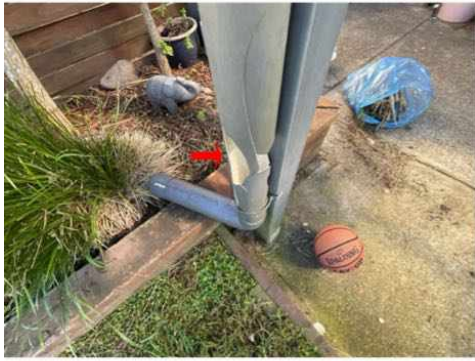
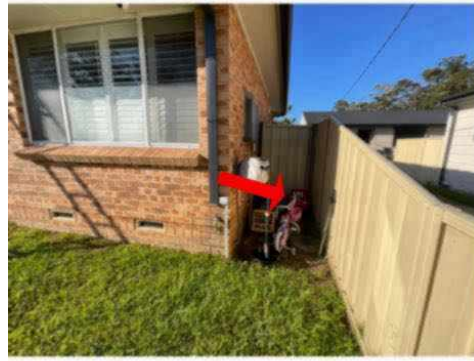
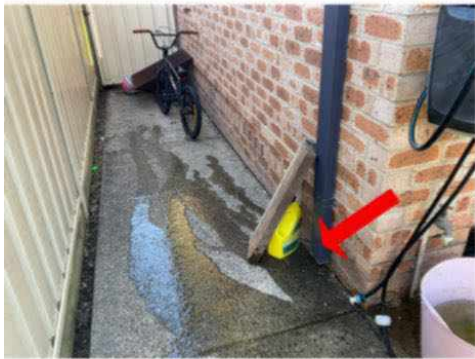
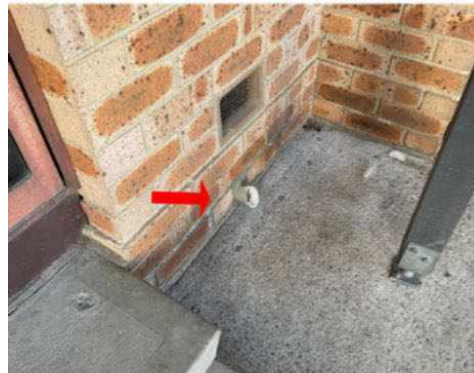
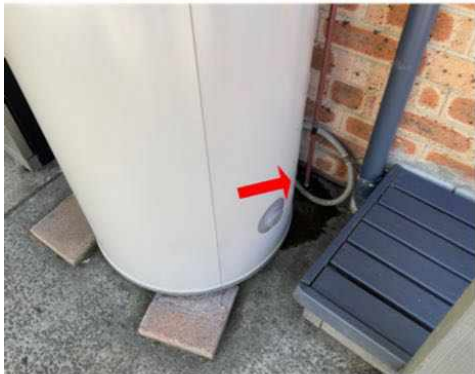
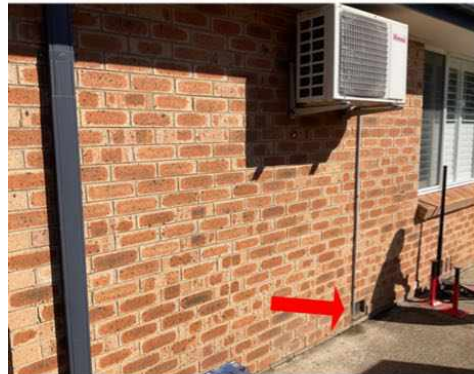
Building:	Building 1
Location:	Right wall and right rear downpipe
Finding:	Site drainage - Inadequate
Information:	The site drainage in the right wall area was found to be inadequate at the time of inspection, creating potential for subsequent water damage to associated building elements.

The front right wall corner is lower than the surrounding ground allowing some water to pool. Some downpipes are not plumbed to drains and the rear downpipe is cracked requiring replacement. The air conditioner and hot water system and bathroom overflows all run against the house walls.

It is important that water does not lie against the base of walls; surrounding paths and ground levels should be sloped to drain water away from walls. Downpipes should not discharge stormwater onto lower walls or plinths. Stormwater should be carried away by large, regularly cleaned drains. Ground levels may need to be lowered to expose a buried DPC.

Where site drainage is inadequate, installation of an Agricultural (Aggie) Drain may be required. A qualified plumber should be appointed to further inspect the property and perform any remedial works as necessary. Secondary defects are likely to occur if left unmanaged.

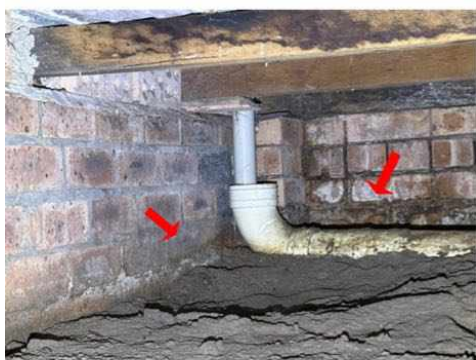
Finding 3.02

Building:	Building 1
Location:	Subfloor
Finding:	Damp - Rising
Information:	Rising damp describes the upward movement of water in low sections of building elements (e.g. walls) by capillary action - the movement of water through porous materials such as bricks, sandstone or mortar.

Rising damp is generally managed by the installation of a damp proof course during construction. A Damp Proof Course (DPC) is an impermeable barrier at the base of the wall above ground level. However, many 19th Century buildings have no damp course installed, or the materials have failed. The DPC may have been omitted as a

consequence of poor workmanship, or it may have been bridged where materials built up against the side of the house allow moisture ingress above the DPC level.

The first step in addressing rising damp is to diagnose the cause. The identified cause should be addressed first before addressing the appearance and other defects which have resulted from the rising damp. If the original cause is not resolved, further cases of damp are likely to ensue, resulting in secondary defects.

Consultation with a qualified plumber is advised immediately to identify the cause of the damp and perform remedial works as required. Installation of front drainage should assist in reducing the rising damp in the subfloor.

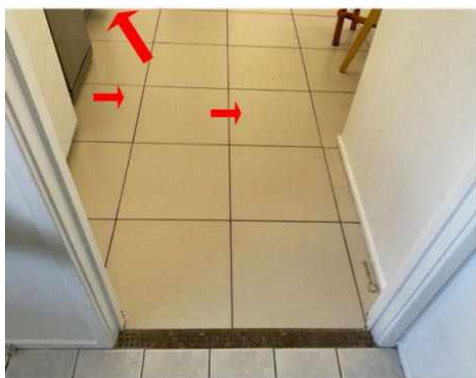
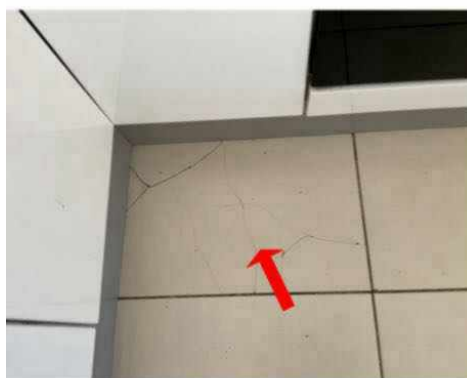
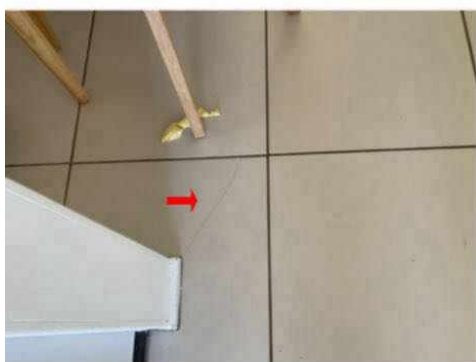
Finding 3.03

Building:	Building 1
Location:	Central areas
Finding:	Tiles cracked
Information:	Cracked tiles were evident at the time of inspection. It is suspected that this cracking has occurred as a result of minor settlement or impact damage.

Cracked tiles throughout the household detract from the overall appearance of the affected areas. In wet areas of kitchens and bathrooms, it can lead to water damage of adjoining walls and floors.

Replacement of cracked tiles is recommended as soon as possible. A tiling contractor may be appointed to perform these works. Where cracks become more numerous, contact a licensed building inspector for further investigation.

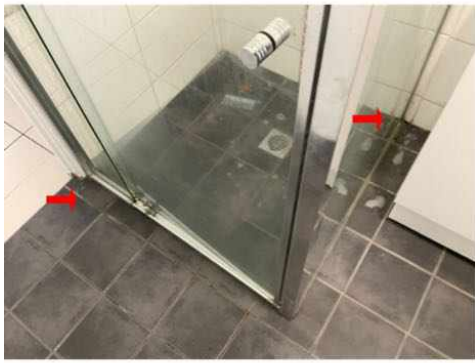
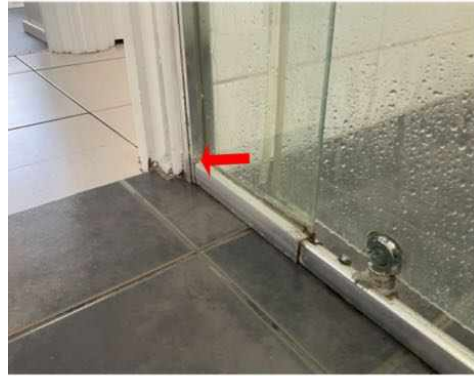
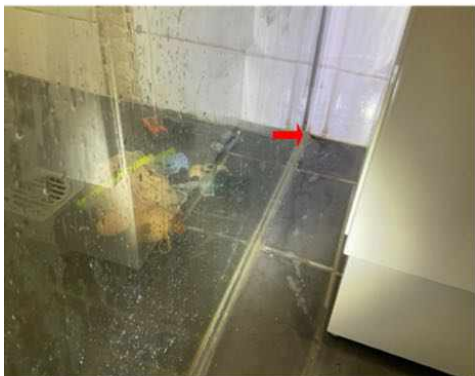
Finding 3.04

Building:	Building 1
Location:	Bathroom
Finding:	Shower screen - Leaking
Information:	Leaking was evident to the shower screening at the time of inspection. It is suspected that the leaking has occurred as a result missing sealant. Leaking from the shower , where left unattended, is likely to lead to water damage to adjoining flooring and walls. Such damage can lead to water damage and necessitate extensive remedial works being required. Active water leaks may also create an environment that is susceptible to the formation and development of mould.

Appointment of a sealant expert is required to repair or replace this missing sealant. Such works should be performed as soon as possible to ensure that no further damage occurs.

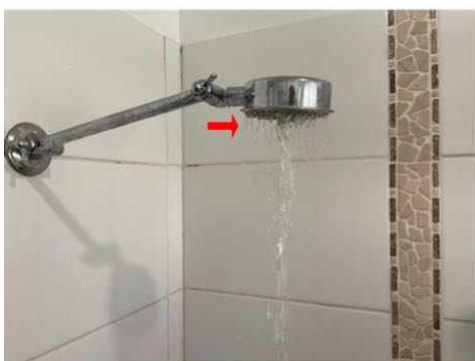
Finding 3.05

Building: Building 1
Location: Bathroom
Finding: Low hot water pressure to shower
Information: The shower rose showed low water pressure on testing, resulting in poor water flow during use. This issue affects normal operation. A licensed plumber is required to investigate and carry out any necessary repairs to restore adequate water pressure. The ageing fitting may be the problem,.

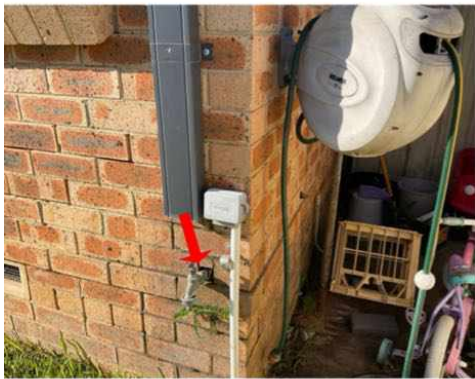
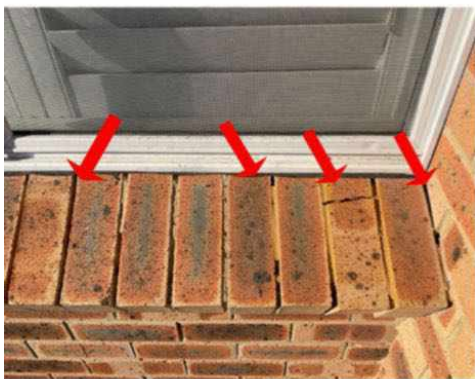
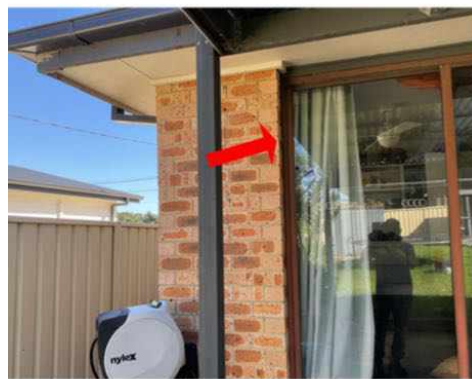
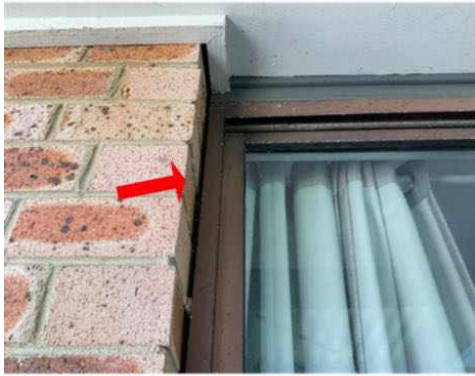
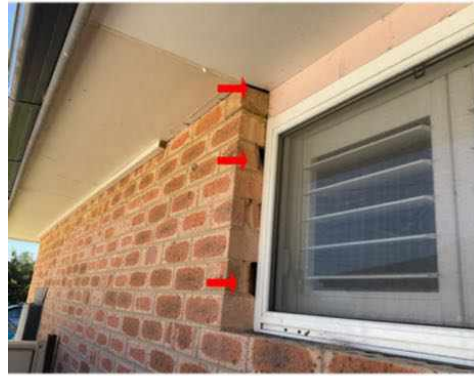
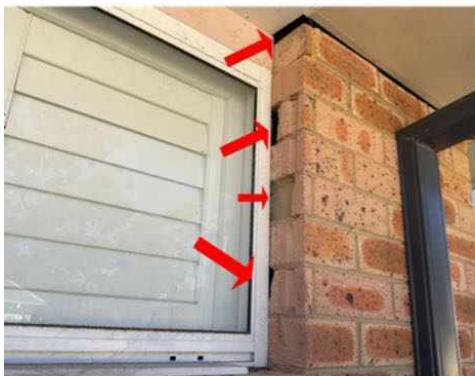
Finding 3.06

Building: Building 1
Location: Some wall areas
Finding: Sealant (external) - Missing.
Information: It was noted on inspection that areas of external sealant was missing to small areas of the external walls.

Flexible sealants should be applied to these affected areas to prevent any subsequent water damage that is likely to occur.

A sealant specialist or skilled handy person should be appointed to complete these works as soon as possible

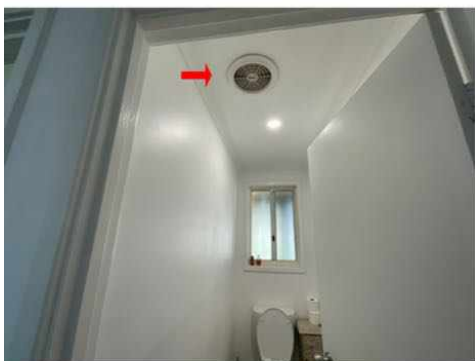
Finding 3.07

Building: Building 1
Location: Toilet (WC)
Finding: Exhaust fan - Not operating
Information: The exhaust fan in this area is not operating. A Licensed Electrician is required to check for any secondary or concealed damage and consider repair or replacement.

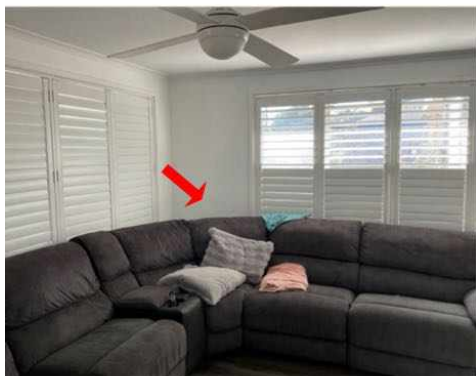
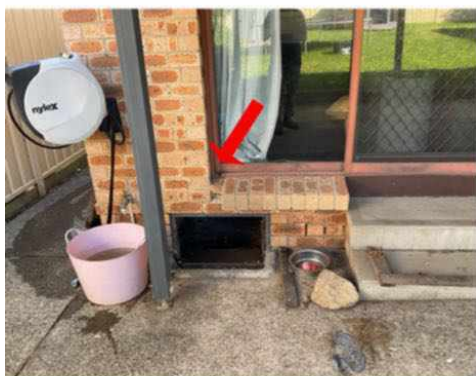
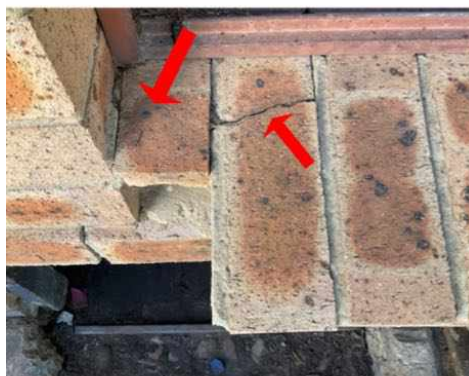
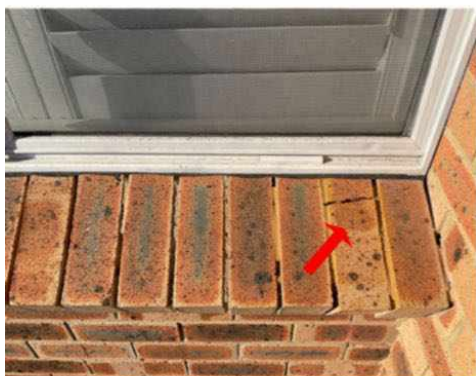
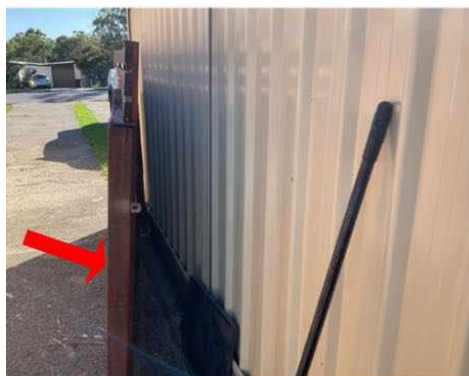
Building: Building 1
 Location: Pictured external areas
 Finding: Building elements - Damaged
 Information: Evidence of minor missing or damaged areas was identified at the time of the inspection. These include -

1. There is a small hole in the lounge wall from a removed power point.
2. The right gate is screwed shut and not operational, the left gate is damaged.
3. Some small areas of brickwork are damaged.

A carpenter and bricklayer would be the trade responsible for rectification of these areas when convenient.

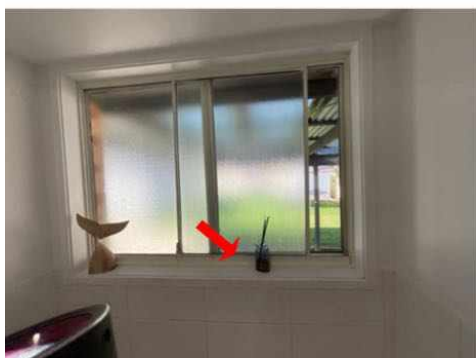
Finding 3.10

Building: Building 1
 Location: Bathroom and kitchen
 Finding: Windows - Stiff to slide
 Information:

The windows in these areas was difficult to operate at the time of the inspection. Windows provide ventilation to the adjoining area and should be at a fully operational level to ensure user comfort. Restricted function of the window may also pose as a potential safety hazard if required for emergency egress from the building.

Generally, factors such as general age of the building element and a lack of maintenance are the usual causes for this type of defect.

A general handy person will be required to repair the window.

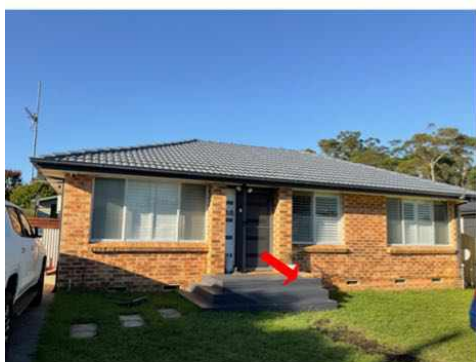
Building:	Building 1
Location:	Subfloor
Finding:	Evidence of termite damage - minor
Information:	Despite no live termite or timber pest activity being indicated, previous very minor termite damage was found to have affected the front middle subfloor area. The owner reported minor damage in the roof void however this could not be located due to low clearance and extensive insulation.

See the 10 photos of “Obstructions and Limitations of the ROOF CAVITY” at the end of this report. This damage is considered to be inactive and is minor in nature.

No live termites were found at the time of the inspection.

It is advised that the area be visually inspected frequently to ensure that the condition of affected building materials does not worsen. At the time of inspection, damage is not structural and is only considered to be superficial.

A building contractor may be appointed to provide a further invasive inspection if further damage is evident.

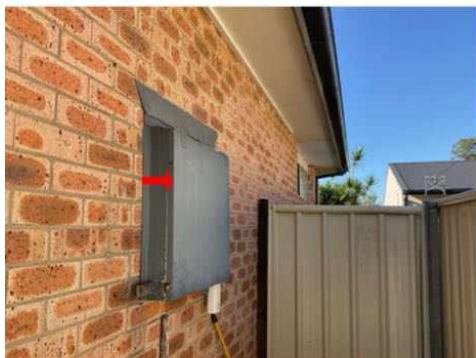
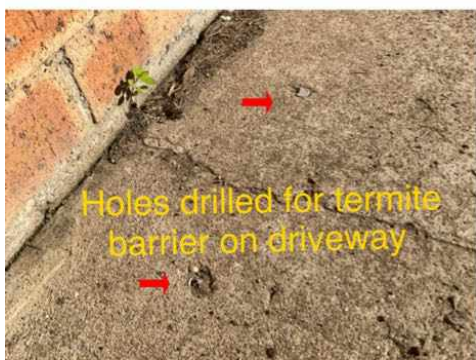
Finding 6.01

Building:	Building 1
Location:	Meter Box
Finding:	Termite Management System - no evidence of a chemical installation
Information:	The application of a post-construction chemical termite barrier is highly recommended for all properties. Such barriers are highly effective in preventing termite attack on any timber building elements throughout the property.

A durable notice should be placed in the switchboard unit to indicate current termite barriers. At the time of inspection, the durable notice was evident from condition. Additional durable notice stickers regarding the chemical termite management system has been installed should also be here.

The client may consider gaining further advice from the owner and/ or the pest controller that installed the last barrier. This 'chemical' application should be recharged immediately. It is recommended that obtaining such advice be a short-term high priority.

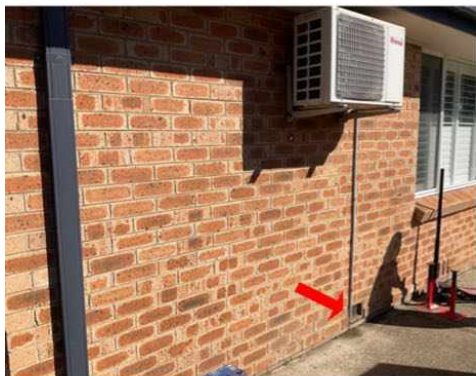
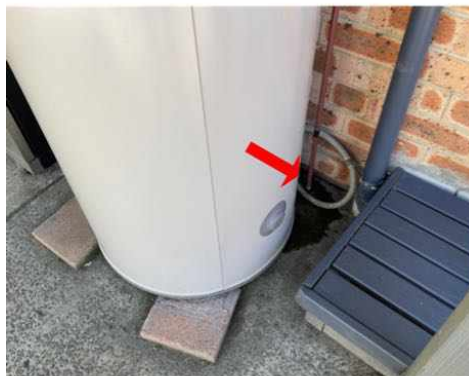
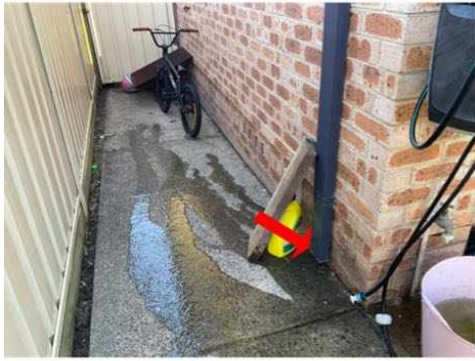
Building: Building 1
 Location: Pictured external wall areas
 Finding: Overflows - Not plumbed for drainage
 Information: The pictured overflow pipes are not plumbed or connected to suitable drainage, which has resulted in the surrounding area becoming excessively damp.

These damp conditions can lead to secondary defects such as rot, rust or corrosion of associated building elements, the formation of fungal decay, or even the creation of potential slip hazards. When coupled with poor site drainage, pooling of water may also attract termite activity to this area. It is highly recommended that a qualified plumber be appointed to install adequate drainage to these areas. These works will ensure that the area remains dry and free of any secondary defects.
