# Building and Timber Pest Inspection Report

Inspection Date: Fri, 20 Mar 2026

Property Address: 605/3 Jean Wailes Ave, Rhodes NSW 2138,  
Australia

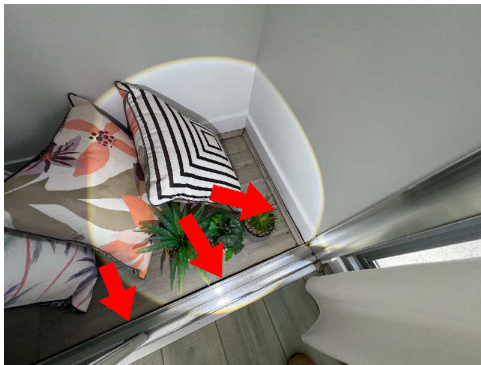
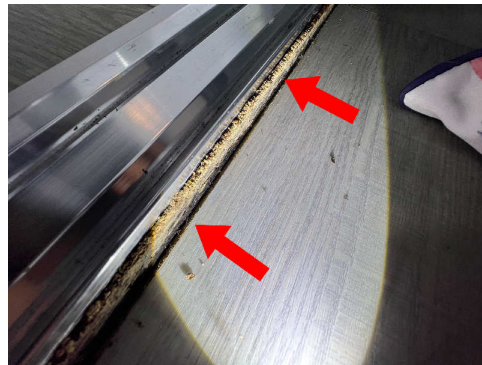
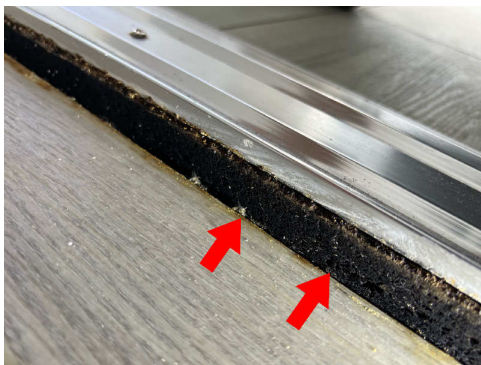
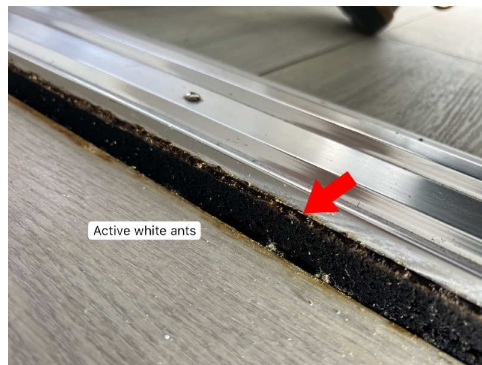
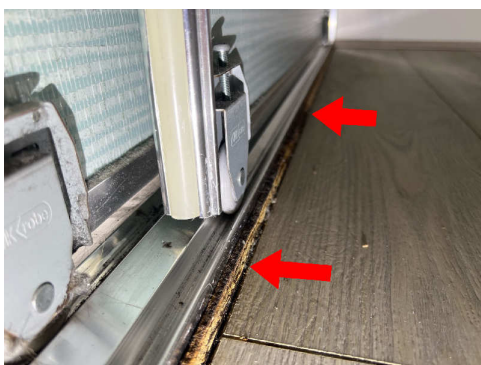
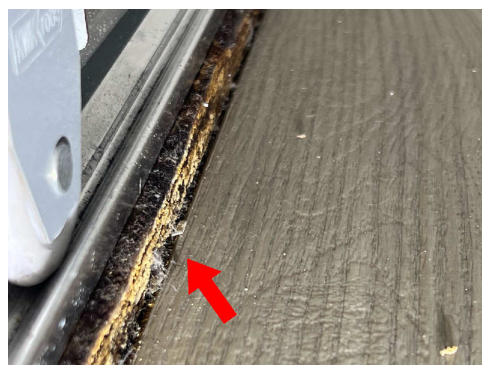
Finding: Moisture Ingress, Material Deterioration and Associated Insect Activity – Built-in Wardrobe Adjacent to Terrace

Information: Deterioration was observed to the base of the built-in wardrobe beneath the sliding door track, located adjacent to the external terrace area. The underlying board material appears moisture affected, with visible swelling, breakdown and friable condition consistent with prolonged moisture exposure. Associated with this condition, insect activity consistent with ants was noted within the damaged material. While no definitive evidence of termite activity was identified at the time of inspection, the presence of moisture-affected materials and concealed voids may provide conditions conducive to timber pest activity. The exact extent of damage could not be fully determined due to concealed construction.

Given the proximity to the terrace and the apparent waterproofing concerns externally, it is considered likely that moisture ingress from the adjoining external area has contributed to the deterioration observed. This condition is of concern as ongoing moisture ingress can result in further material degradation and may attract timber pests or other insects. It is recommended that the source of moisture ingress, including any waterproofing defects, be identified and rectified as a priority. Damaged materials should be repaired or replaced as required. An invasive inspection by a licensed timber pest controller is recommended to further assess concealed areas and confirm the absence of termite activity.

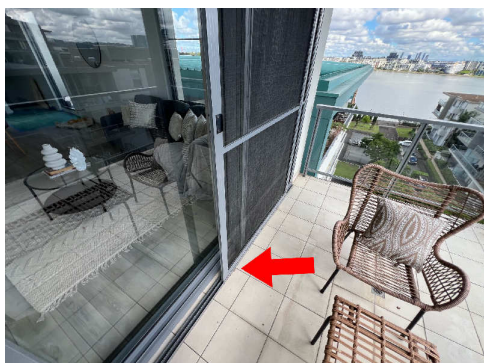
Information: The sliding screen door was found to be stiff and difficult to operate at the time of inspection. The door does not slide freely along its track, requiring increased force to open and close. This condition was observed at the balcony access point and appears likely due to debris build-up within the track, worn or misaligned rollers, or general lack of maintenance.

If left unaddressed, continued use may result in further wear to the rollers or track components, and may eventually lead to failure of the sliding mechanism. In some cases, excessive force can also cause damage to the door frame or track assembly. It is recommended that a suitably qualified handyman or door specialist assess the door, clean the track, and adjust or replace rollers as required to restore smooth operation.

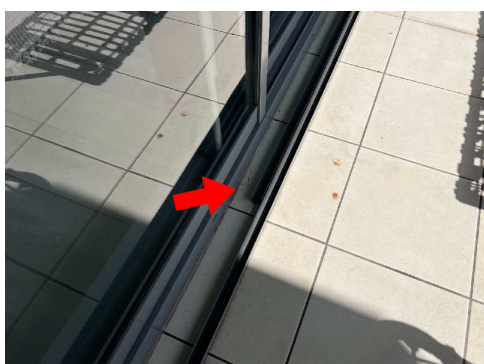
### Finding 3.02

Finding: Cracked Floor Tile – Balcony Sliding Door Threshold

Information: A floor tile adjacent to the sliding door threshold at the balcony was observed to be cracked. The cracking appears localised to a single tile and is likely due to impact damage, substrate movement, or stress at the doorway transition point where foot traffic is concentrated.

Cracked tiles can allow moisture ingress beneath the tiled surface, potentially leading to deterioration of the substrate or loosening of surrounding tiles over time. Additionally, the uneven surface may present a minor trip hazard if the damage worsens. It is recommended that a suitably qualified tiler assess and replace the affected tile and check surrounding tiles for any signs of movement or loss of adhesion.

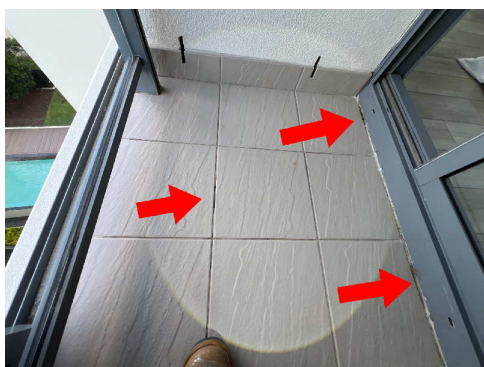
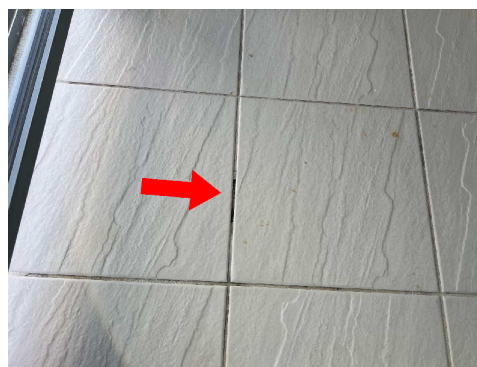
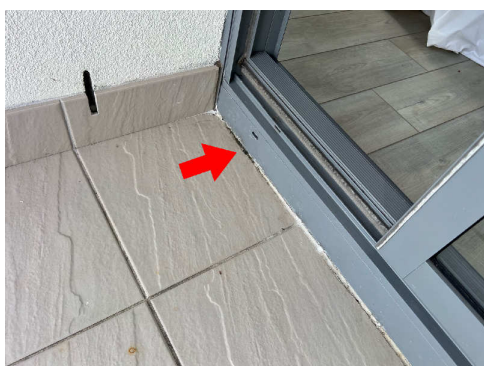
### Finding 3.03

Finding: Deteriorated Grout and Sealant – Balcony Tiling and Door Junction

Information: Grout between the balcony floor tiles and sealant along the junction of the sliding door frame were observed to be deteriorated and worn in sections. Localised gaps, cracking, and breakdown of sealant were noted, particularly along the door threshold and perimeter edges of the tiled surface.

Deterioration of grout and sealant can allow water to penetrate beneath the tiles and into adjoining building elements, potentially leading to moisture-related damage, tile loosening, or deterioration of the substrate over time. The door threshold area is particularly vulnerable due to exposure to weather and foot traffic. It is recommended that a suitably qualified tiler or sealant specialist remove and replace the affected grout and reapply appropriate flexible sealant to all junctions to maintain water resistance.

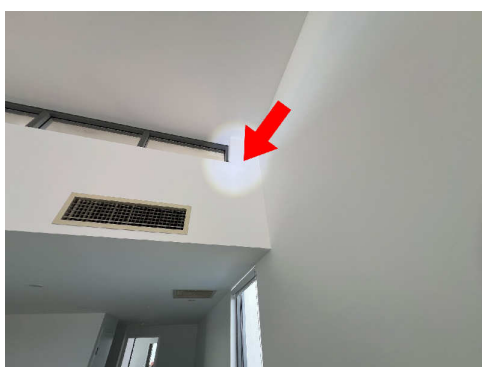
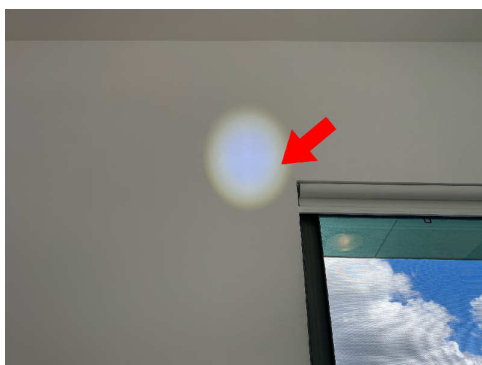
#### Finding 3.04

Finding: Minor Cracking to Internal Wall – Adjacent to Fixed Window Panels

Information: Minor cracking was observed to internal wall surfaces adjacent to fixed window panels, including above and beside the glazing. The cracks are fine and linear in nature and appear consistent with typical movement at junctions between the wall substrate and fixed window framing.

Cracking in these areas commonly occurs due to minor building movement, thermal expansion and contraction, or differential movement between dissimilar materials (e.g. plaster and aluminium window framing). While the cracks appear cosmetic at the time of inspection, they may worsen over time or allow minor moisture ingress if left unsealed. It is recommended that a suitably qualified painter or plasterer carry out patching and repainting as required, with ongoing monitoring to ensure the cracks do not increase in size.

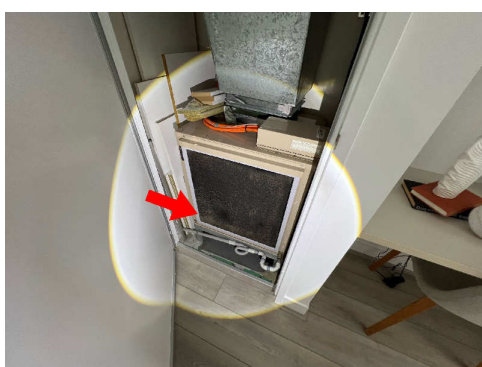
### Finding 3.05

Finding: Air Conditioning Unit – Dirty Filter and Internal Components

Information: The internal air conditioning unit located within the cupboard was observed to have a significant build-up of dust and debris on the return air filter and internal components. The level of contamination indicates the unit has not been cleaned or serviced for some time.

A dirty air conditioning system can restrict airflow, reduce efficiency, and place additional strain on the unit, potentially leading to premature wear or failure. It may also impact indoor air quality by circulating dust and contaminants throughout the dwelling. It is recommended that a suitably qualified HVAC technician carry out a full service, including cleaning or replacement of filters and inspection of internal components to ensure proper operation.

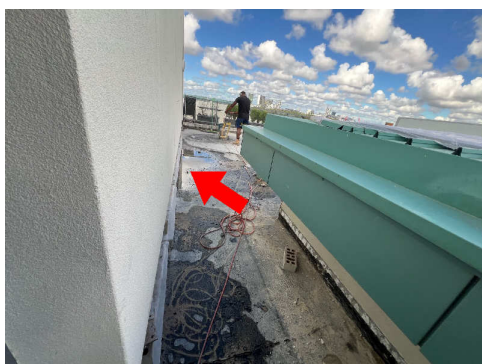
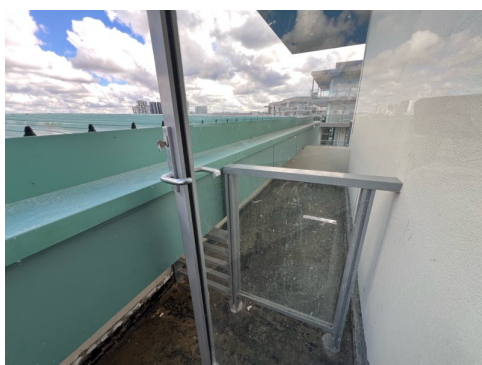
Finding: Conducive Conditions to Timber Pest Activity – Inaccessible Terrace Area

Information: The external terrace area adjacent to the bedroom was not accessible at the time of inspection due to the presence of workers. As a result, the condition of the terrace surface, drainage and waterproofing systems could not be assessed. Notwithstanding this limitation, the internal moisture-related deterioration and insect activity observed to the adjoining built-in wardrobe indicates that moisture ingress may be occurring from this external area.

Inaccessible external areas with potential waterproofing or drainage issues are considered conducive to timber pest activity, particularly where moisture may accumulate and affect adjacent building elements. It is recommended that the terrace area be inspected once access is available, with particular attention to waterproofing, drainage and any defects that may allow moisture ingress. Any identified issues should be rectified as required to reduce the risk of ongoing damage and potential timber pest activity.

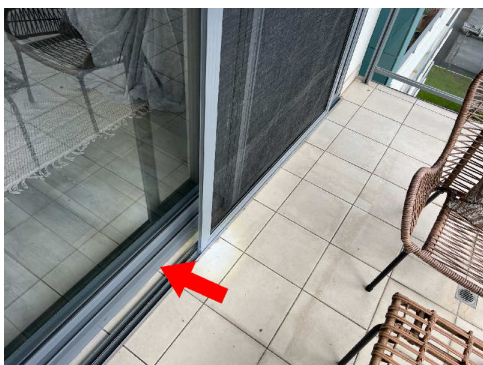
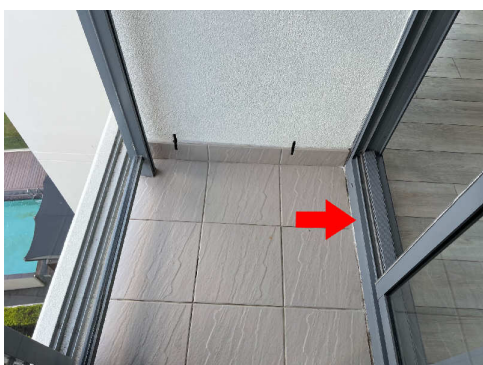
### Finding 6.02

It is important for internal flooring to be raised above adjacent external ground levels. Where external ground levels are above internal flooring water pooling and subsequent internal flooding is likely to occur which may attract termite activity to the internal area.

It is highly advised that a landscaper or paver be appointed to lower external grounds that are raised above adjacent internal flooring. Alternatively if external grounds and internal flooring is level installation of a raised door sill may be appropriate in preventing any water pooling in the area.

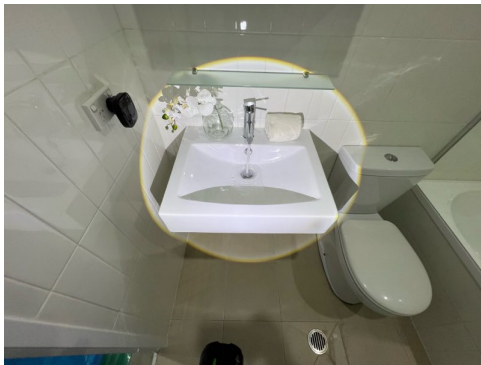
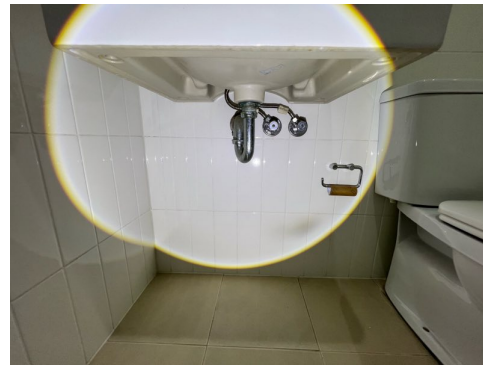
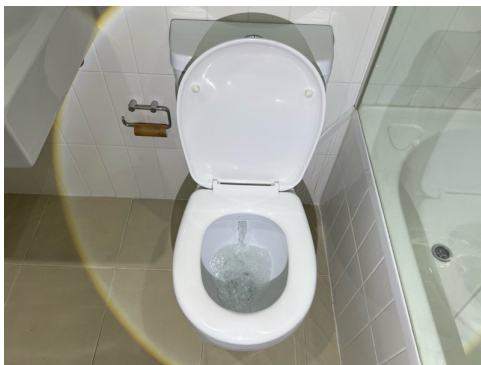
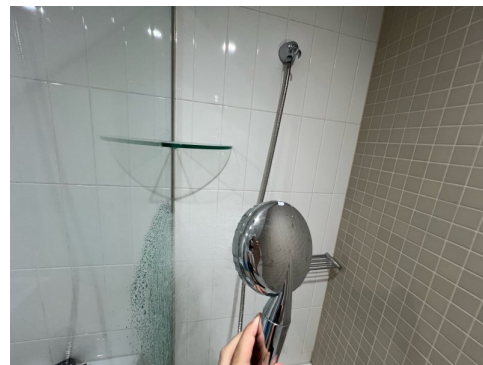
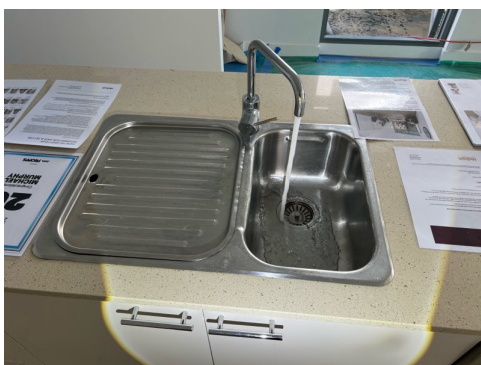
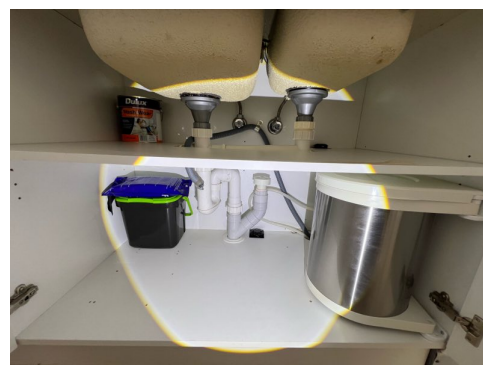
Information: All taps, mixers, and toilets were tested for correct operation, except where access was restricted. The shower recess waterproofing was assessed by conducting noninvasive moisture readings to the walls in and around the shower recess. No abnormal or significant moisture variations were detected within the areas tested. In addition, a visual inspection of the surrounding wall surfaces did not reveal any visible signs of recent or ongoing water damage where inspection was possible.

Based on the above observations, there is no conclusive evidence to suggest the presence of an active shower recess leak at the time of inspection, other than any issues already identified elsewhere in this report. It is therefore reasonable to assume that the shower waterproofing is currently performing as intended. However, it should be noted that if the shower has not been used for an extended period prior to the inspection, moisture readings may not accurately reflect underlying conditions and may result in misleading outcomes. As this inspection is limited to visual and noninvasive methods in accordance with pre-purchase inspection standards, it is not possible to definitively confirm the absence of leaks. If a higher level of certainty is required, a specialist invasive inspection is recommended.

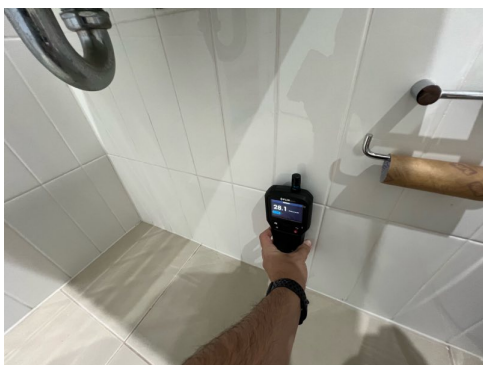
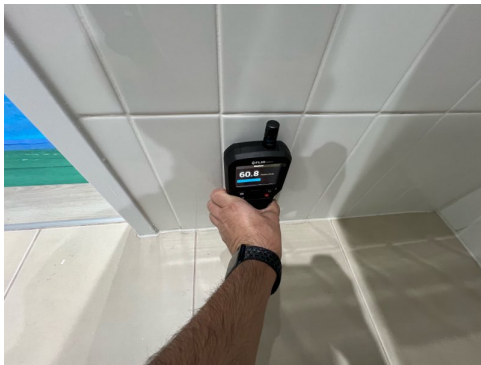
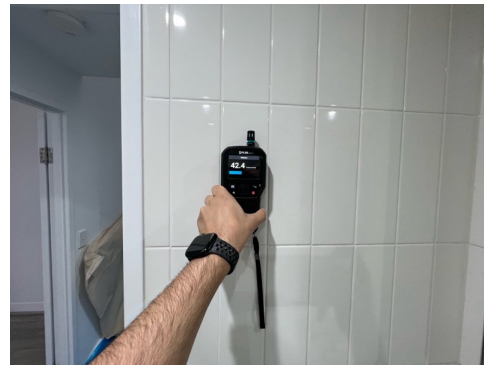
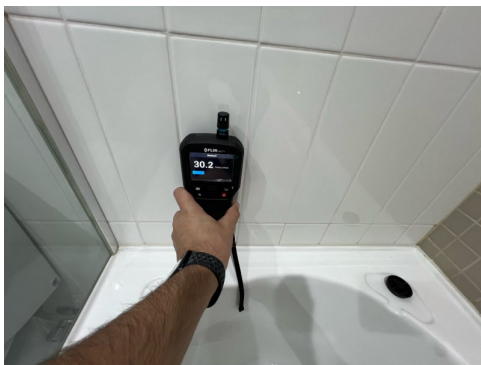
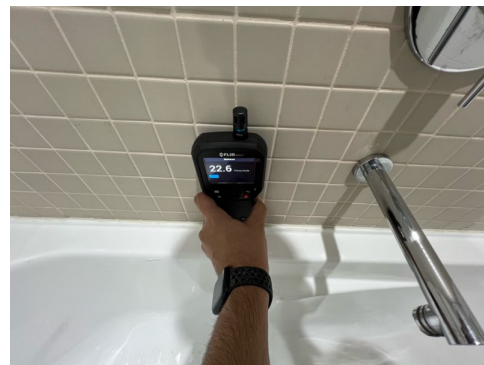
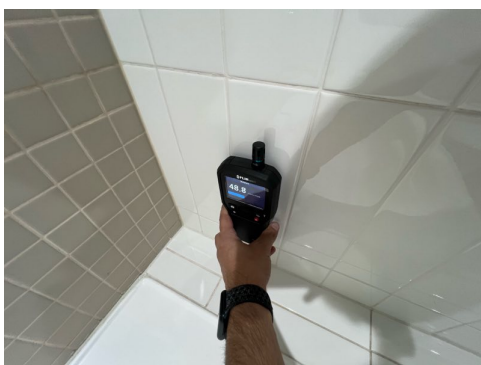
Finding: Moisture Meter Readings - For Information Only

Information: Moisture testing was undertaken to selected accessible internal surfaces using a noninvasive moisture meter at the time of inspection. Readings obtained provide an indicative assessment only and are intended as a guide to assist in identifying areas that may warrant further investigation.

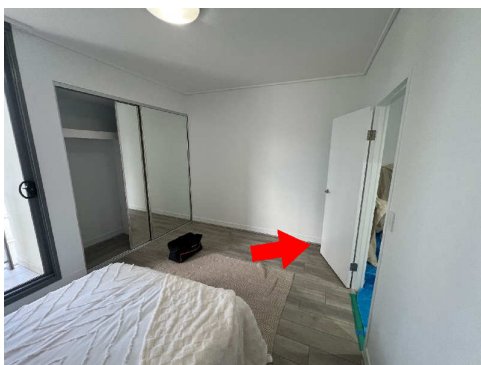
Finding: Door stop - Missing

Information: The door stop is missing stop the door handle from damaging the wall. Although some building elements may seem irrelevant or unnecessary, all building elements play a key role in the operation and function of the overall structure and its performance.

Re-installation or replacement of the door stop is advised as soon as possible to prevent any subsequent damage to the door or associated structures. A general handyman may be appointed to perform these works at client discretion.
