Building and Timber Pest Inspection Report

Inspection Date: Fri, 13 Mar 2026

Property Address: 5B Malcolm Ct, Mount Waverley VIC 3149,
Australia

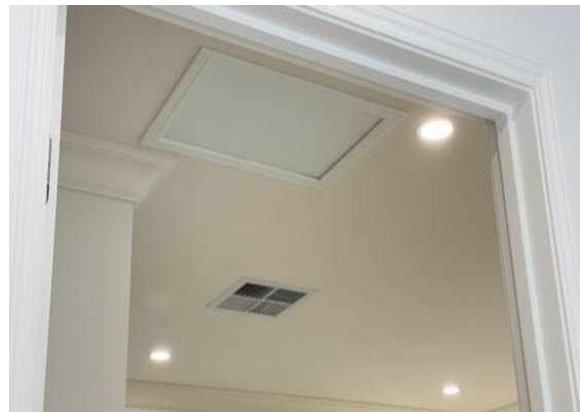
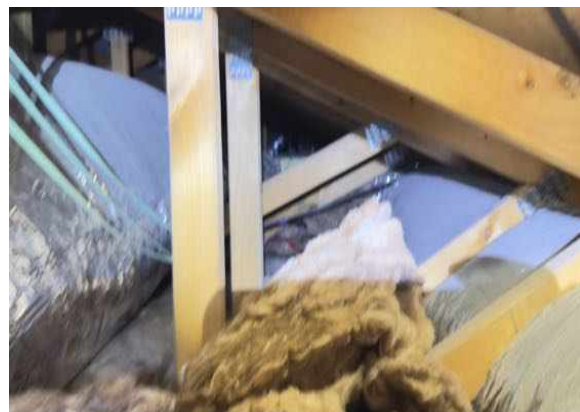
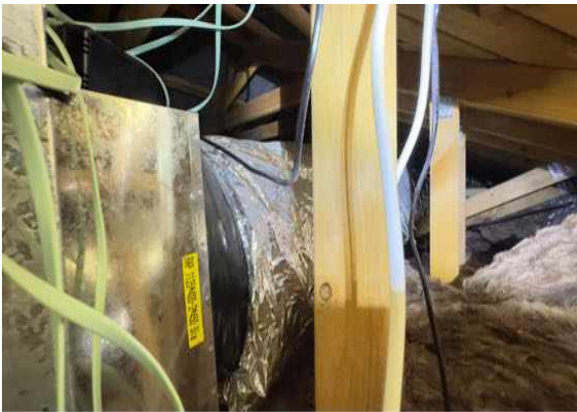
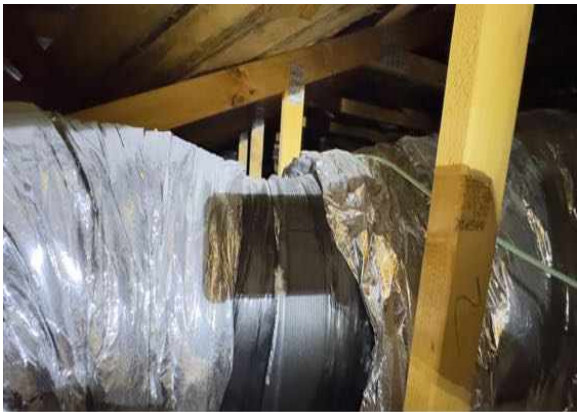
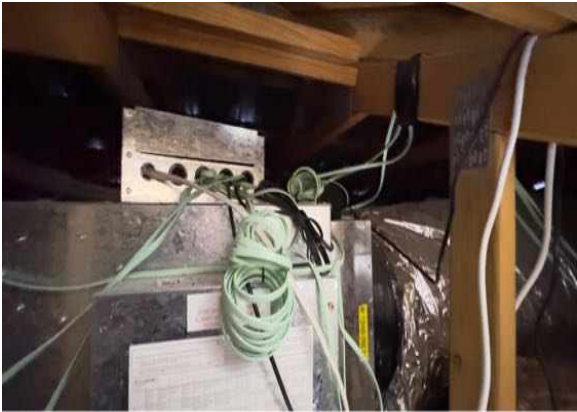
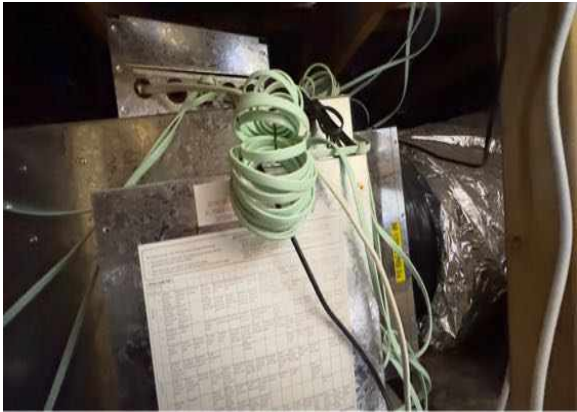
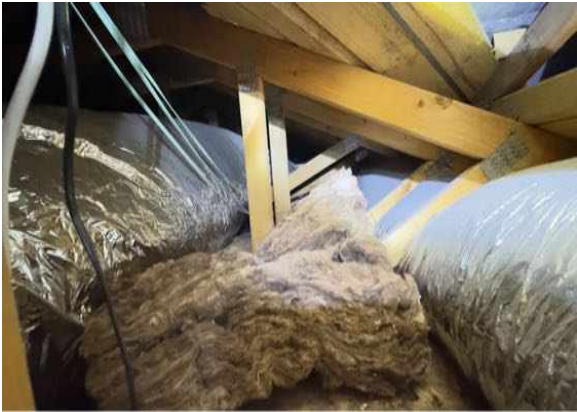
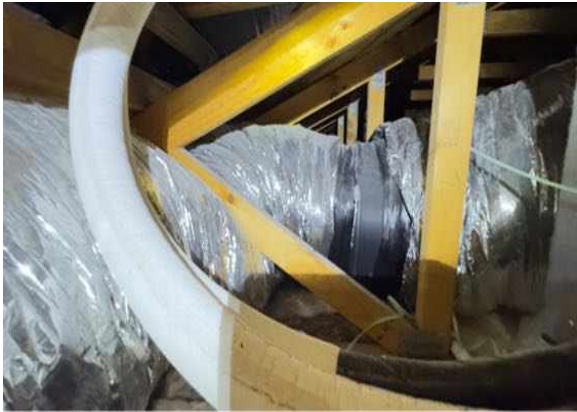
Information: Limited access to the roof void was present due to facts including but not limited to, limited access, insulation, Air condition Unit & ducting, obstructions or placement of insulation and or sarking, for this reason complete access to the roof void was not possible.

NOTE: Unless all insulation is removed from the roof space a full inspection is never possible, timber pest or termite activity and/or damage may not be visible.

A visual inspection was carried out from accessible areas only, recommend installing another access hatch in a more accessible area for a re-inspection.
