Building and Timber Pest Inspection Report

Inspection Date: Tue, 17 Feb 2026

Property Address: 36 Cimmaron Way, Kialla VIC 3631,
Australia

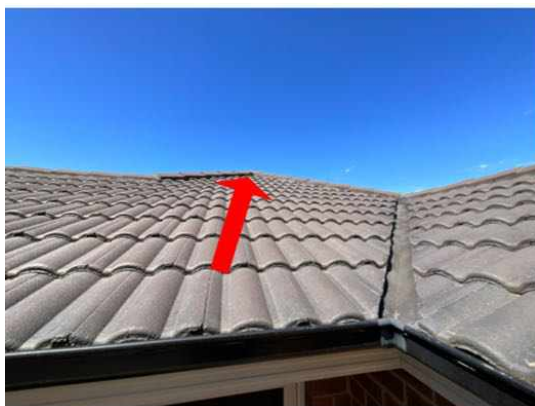
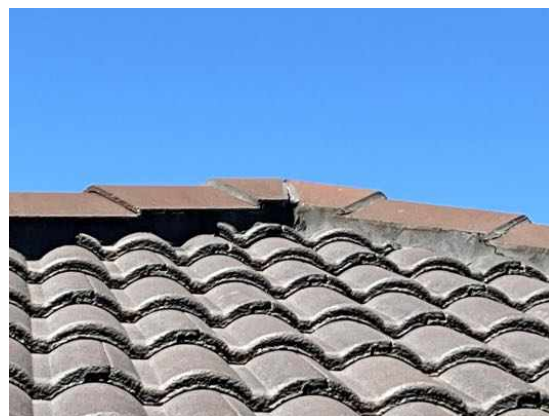
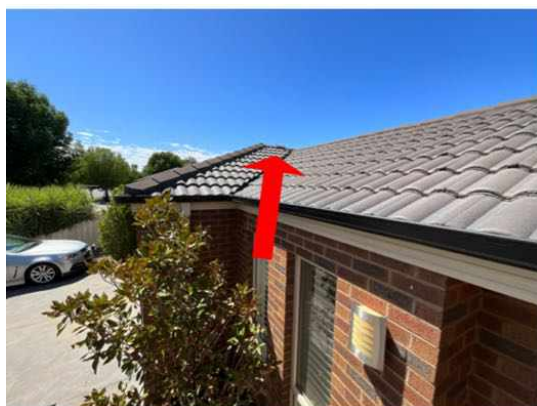
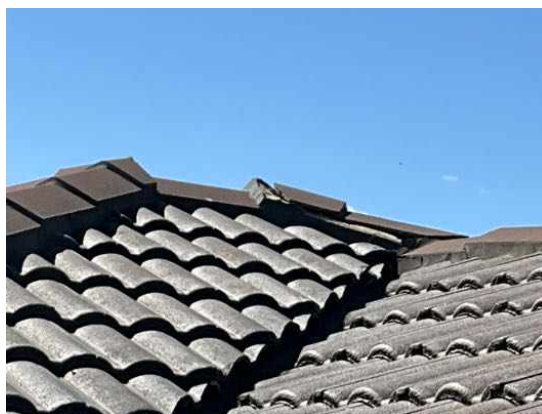
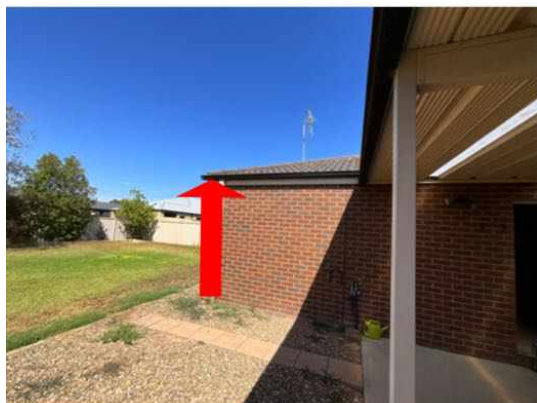
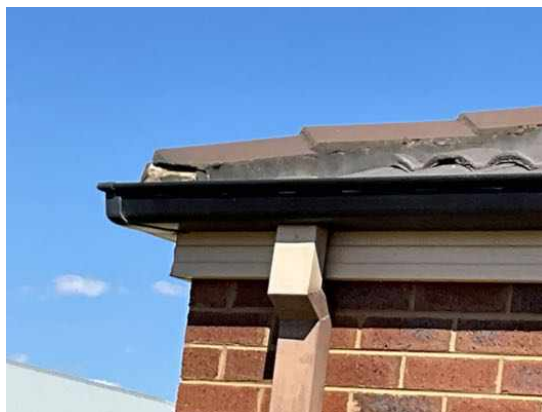
Finding 3.01

Building:	Building 1
Location:	Roof Exterior
Finding:	Mortar - Deterioration
Information:	Mortar, or 'bedding', is the material which fills joints and intersections between tiles and other building elements on the exterior roof covering, such as gable ends, hip capping and valleys. Upon inspection of the exterior roof, it was noted that sections of the mortar show varying levels of deterioration.

Mortar generally deteriorates as a result of frequent exposure to weather conditions over a prolonged period of time. Mortar that is deteriorating may allow water ingress into the roof void, putting associated building elements and roofing structures at risk of water damage. Deteriorated mortar also detracts from the functionality of roof tiles and other roofing elements, potentially decreasing weather tightness and roof drainage.

Mortar deterioration can be attended to by a handyperson where areas of deterioration are localised and easily accessible. Otherwise, consultation with a roofing contractor is advised where greater works are required.

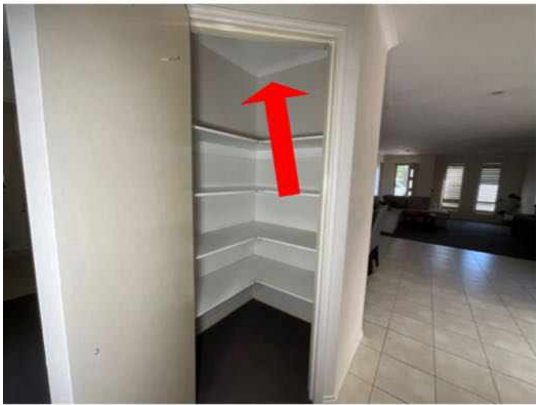
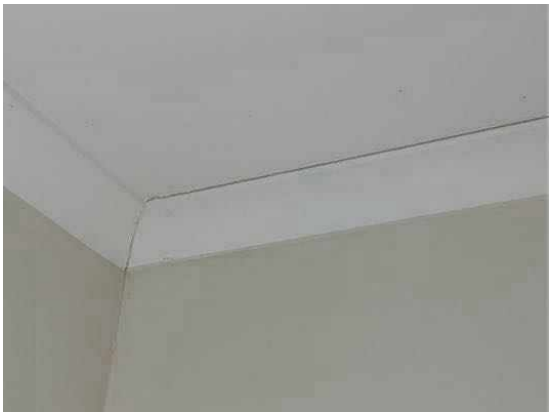
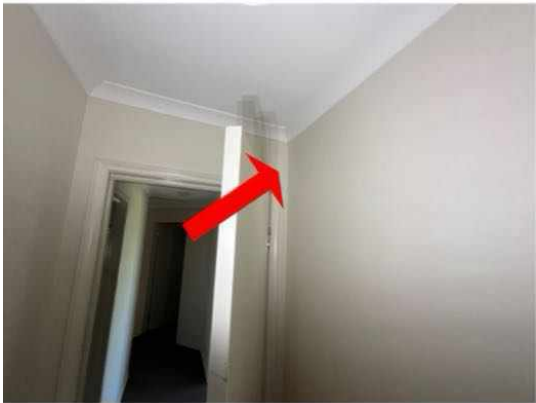
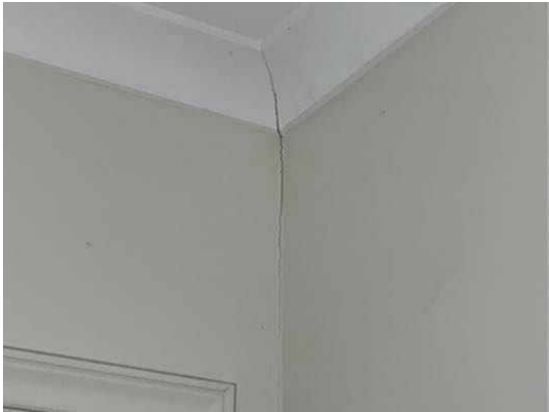
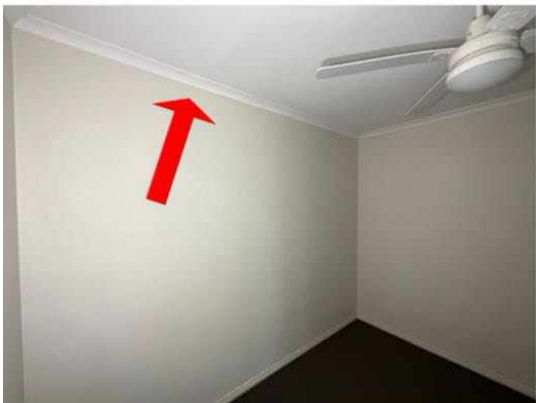
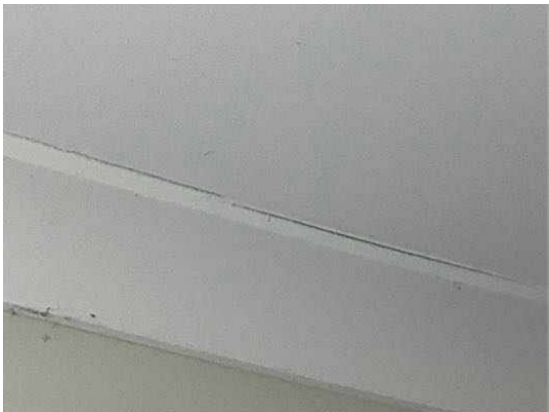
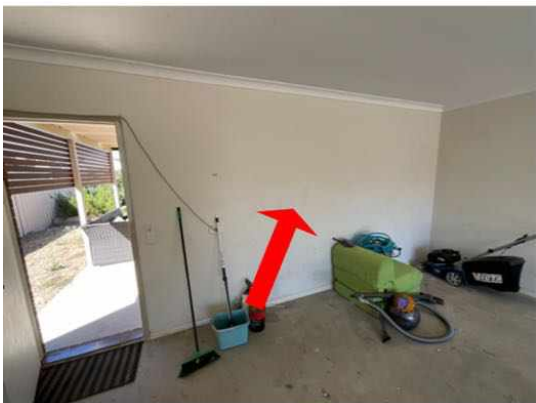
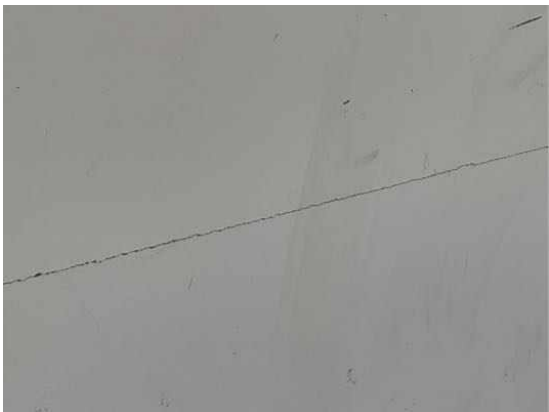
Finding 3.02

Building:	Building 1
Location:	Linen cupboard, Wc, bed 3, garage
Finding:	Cracking - Damage Category 1 - Fine (up to 1mm)
Information:	Although fine cracks are quite noticeable, they are often only considered to be an appearance defect, and usually do not indicate any structural damage. Generally, the cause of a fine crack is indicative of a separation between building materials and finishes (e.g. paint, plaster, etc.) along joins.

Cracking of this nature can generally be repaired with minor sanding, filling and/or repainting. Such works should be performed by a qualified painter or a general handyman.

Monitoring of all cracking should be conducted frequently. Always contact a building inspector should cracks widen, lengthen, or become more numerous.

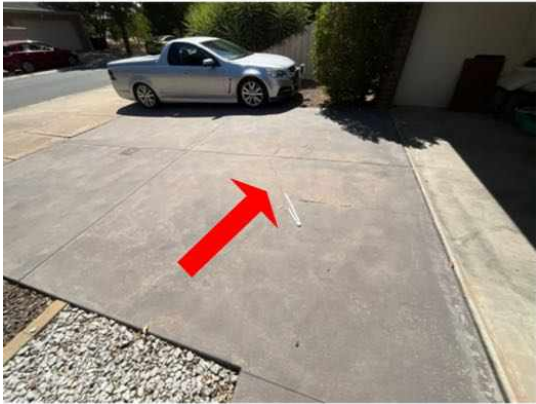
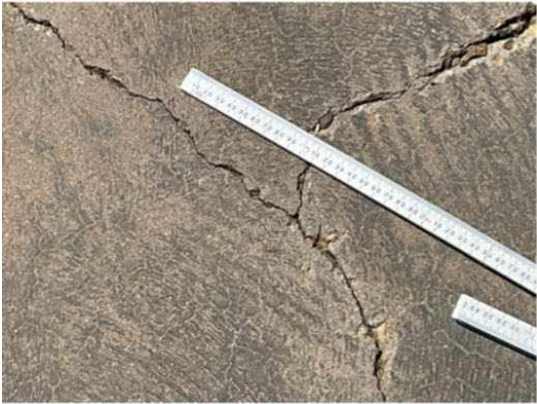
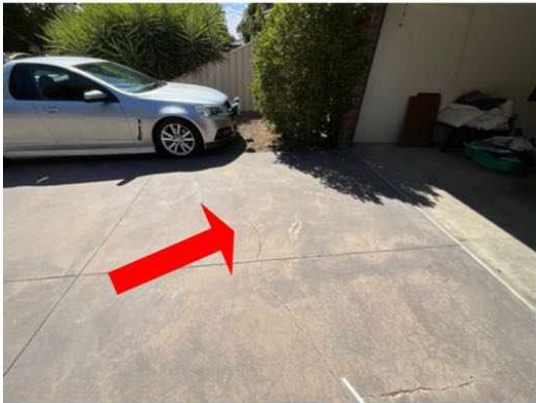
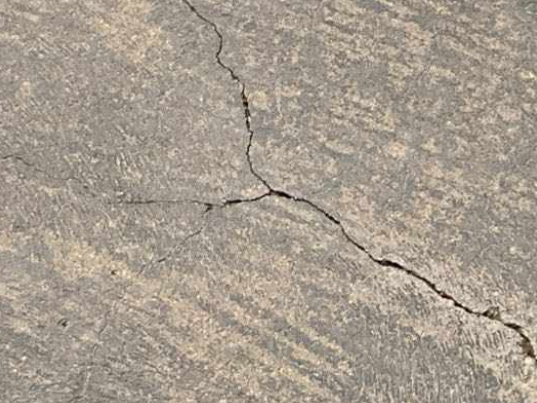
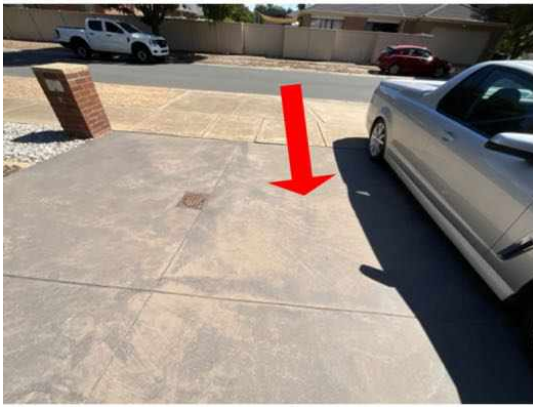
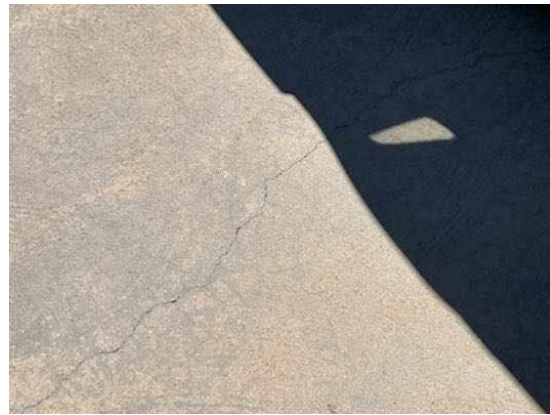
Finding 3.03

Building: Building 1
Location: Driveway
Finding: Cracking - External Concrete Paving Damage Category 3 - Wide Cracks (2mm - 4mm)
Information: Wide cracks were identified in external concrete paving Wide cracks are significant and are likely to lead to the development of safety hazards and secondary defects if left unmanaged.

General age and expected deterioration of the paved areas is a common cause of this type of cracking. However, expansion and contraction of the slab may also have occurred due to environmental factors. Such factors include variable moisture and weather conditions, the presence of trees and their roots having a settling or lifting affect on the soil, or the effect of load bearing, e.g. heavy vehicles over a sustained period of time.

Cracking to this degree may also be due to poor original installation of the concrete. Factors such as poor compaction of the sub surface and/or inadequate reinforcing of the slab may create cracking and other secondary defects. Wide cracks may also have a more significant structural cause, such as subsidence of soils.

Where the crack is located adjacent to structural elements of the building, the advice of a Structural Engineer is advisable before undertaking repairs. Significant repair and likely replacement of the concrete paving is probable.

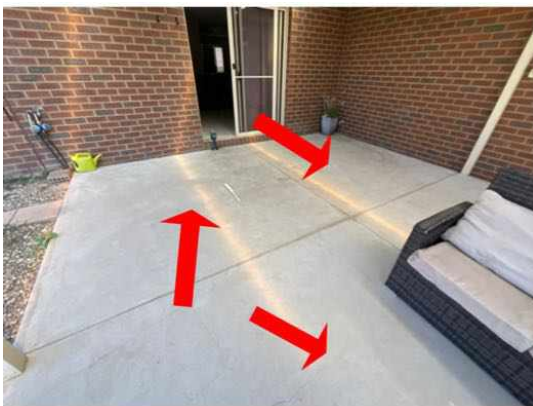
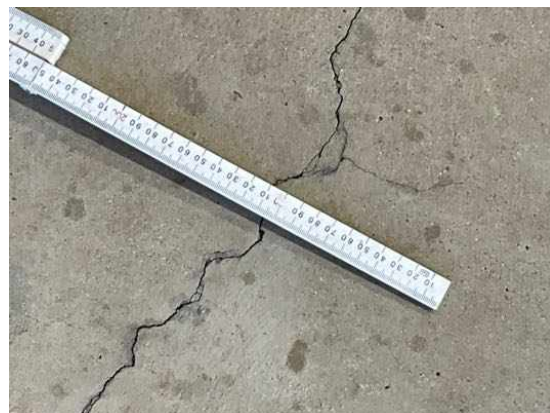
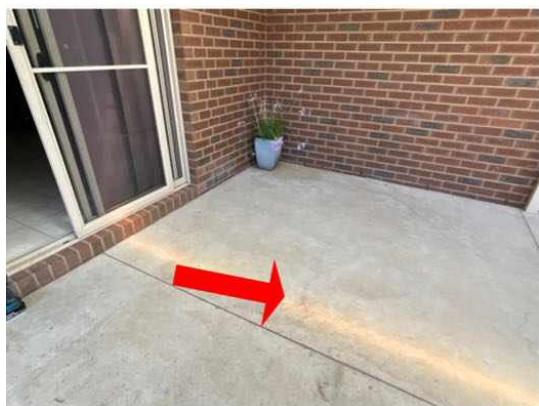
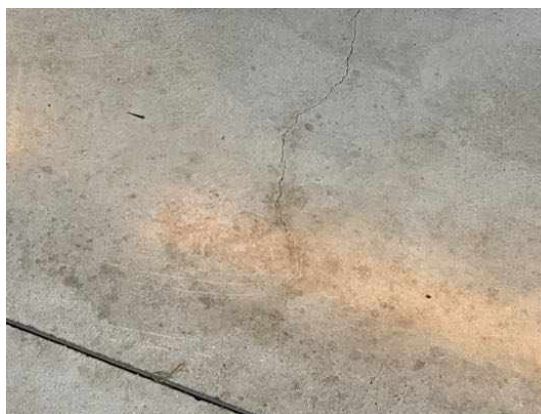
Finding 3.04

Building:	Building 1
Location:	Alfresco
Finding:	Cracking - External Concrete Paving Damage Category 1 - Fine (less than 2mm)
Information:	Fine cracks were identified in external concrete paving. Although fine cracks are quite noticeable, they are often only considered to be an appearance defect, and usually do not indicate any structural damage. To be considered a Category 1 or fine crack, the crack is found to be less than 2mm in width.

Generally the cause of a hairline crack in existing concrete paving such as driveways and pathways is indicative of the expansion and contraction of the concrete. Such causes are generally due to environmental factors, such as moisture levels, weather conditions, root systems of nearby trees or the soil types on which they are laid.

Fine cracks may also be due to poor original installation of the concrete. Factors such as poor compaction of the sub surface and/or inadequate reinforcing of the slab may create cracking and other secondary defects.

Monitoring of all cracking should be conducted frequently. Always contact a building inspector should cracks widen, lengthen, or become more numerous.

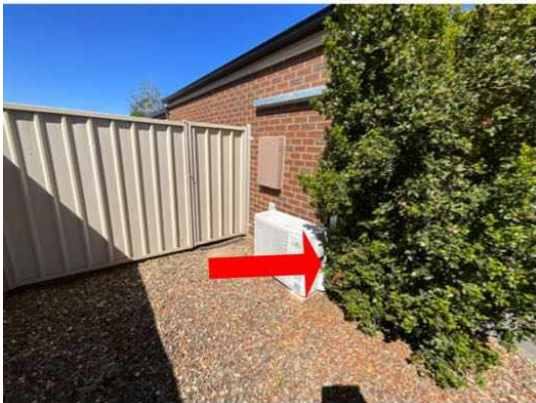
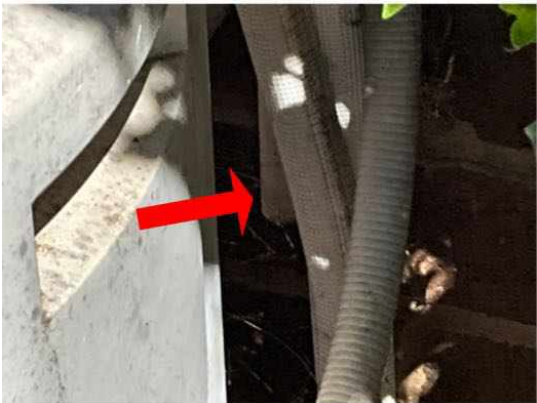
Finding 6.01

Building:	Building 1
Location:	Yard - Front
Finding:	Air conditioner - Disconnected overflow
Information:	The Air Conditioner (A/C) overflow was found to be disconnected from storm water drainage and is creating excessive moisture in the surrounding area.

Such leaking creates an environment which is conducive to an array of defects, including water damage to associated building elements and the attraction of termite or timber pest infestation.

It is highly recommended that a licensed plumber be appointed to connect the A/C overflow in order to prevent such an environment from being created. These minor works should be carried out as soon as possible.

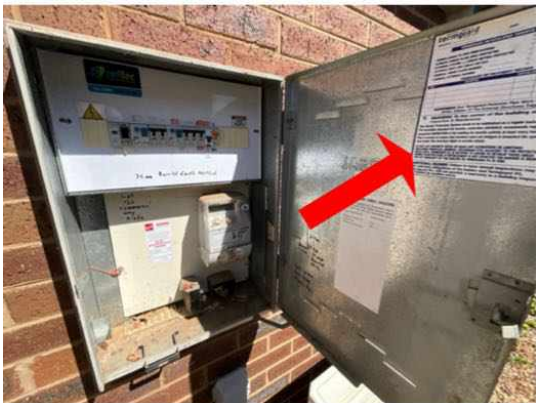
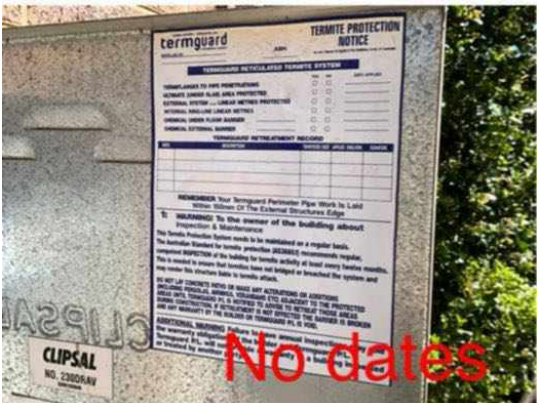
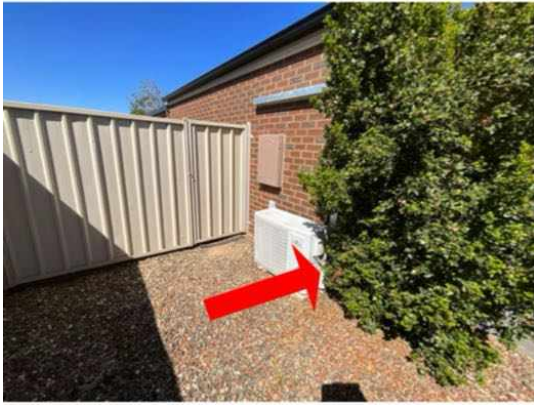
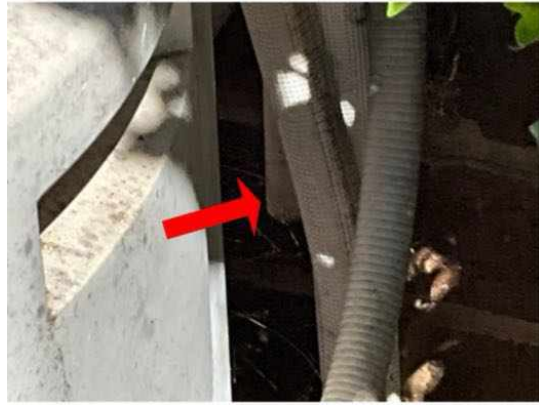
Finding 6.02

Building: Building 1
 Location: All External Areas
 Finding: Termite Management System - no evidence of a chemical installation
 Information: The application of a post-construction chemical termite barrier is highly recommended for all properties, particularly if live termite activity has been found on the site previously. Such barriers are highly effective in preventing termite attack on any timber building elements throughout the property.

A durable notice should be placed in the switchboard unit to indicate current termite barriers. At the time of inspection, it appeared as though no termite management system has been installed, with no evidence to suggest preventative works taking place.

The client may consider gaining further advice from a pest controller as to the costs and procedures involved with this application. It is recommended that obtaining such advice be a short-term priority.

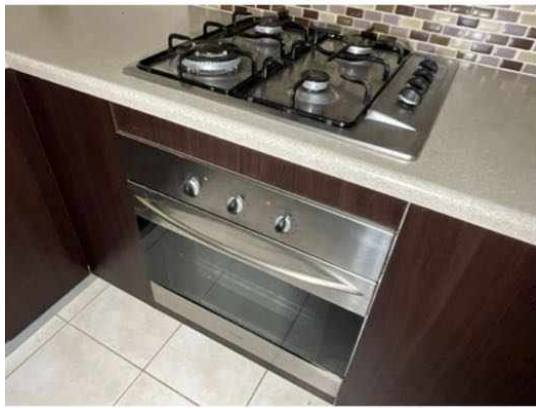
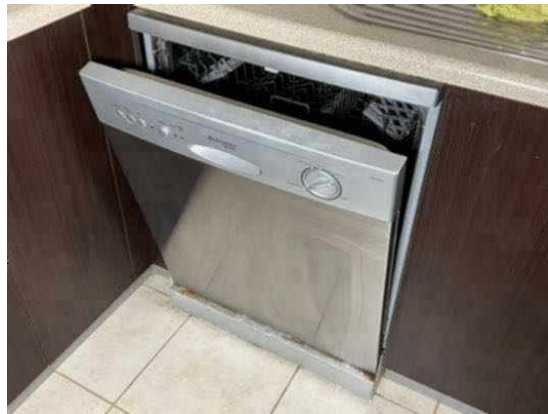
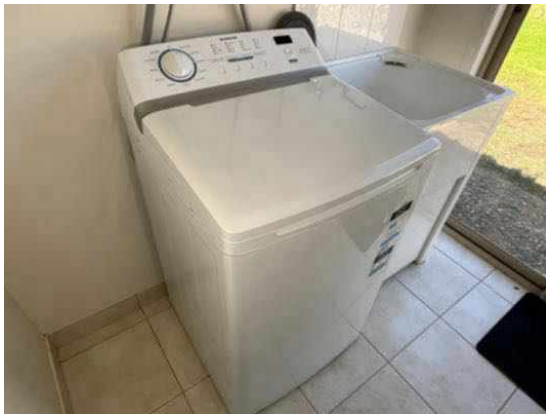
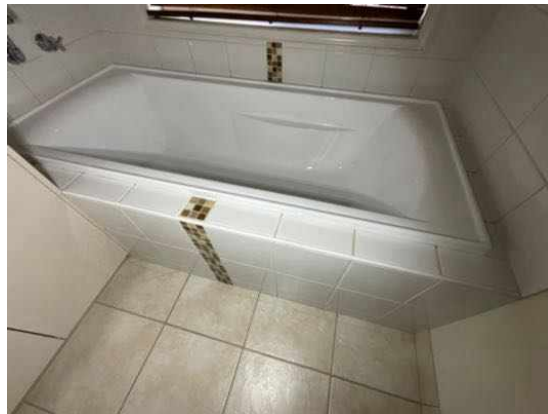
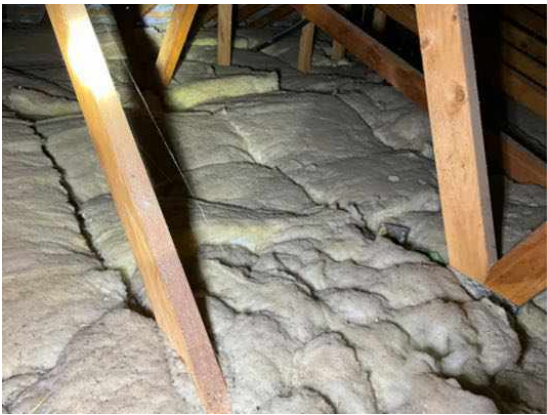
Noted Item

Building: Building 1
Location: All Areas
Finding: Additional Photos - Obstructions and Limitations
Information: These photographs are an indication of the obstructions and limitations which impeded full inspection of the property at the time of inspection. These obstructions can hide an array of defects and should be removed to allow full inspection to be carried out. A re-inspection is recommended once the areas are made accessible.
