Building and Timber Pest Inspection Report

Inspection Date: Thu, 9 Apr 2026

Property Address: 6/17-19 Norman St, Concord NSW 2137,
Australia

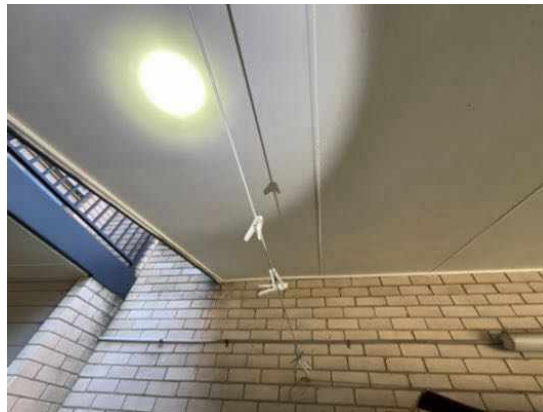
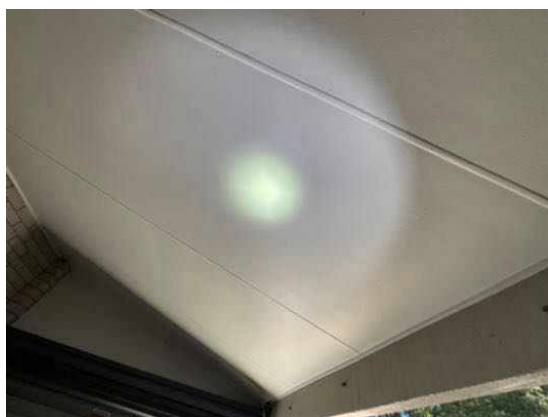
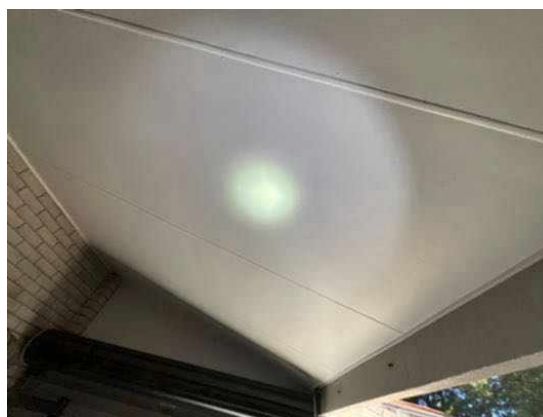
Finding: Additional Photos - Obstructions and Limitations

Information: These photographs are an indication of the obstructions and limitations which impeded full inspection of the property at the time of inspection. These obstructions can hide an array of defects and should be removed to allow full inspection to be carried out. A re-inspection is recommended once the areas are made accessible.

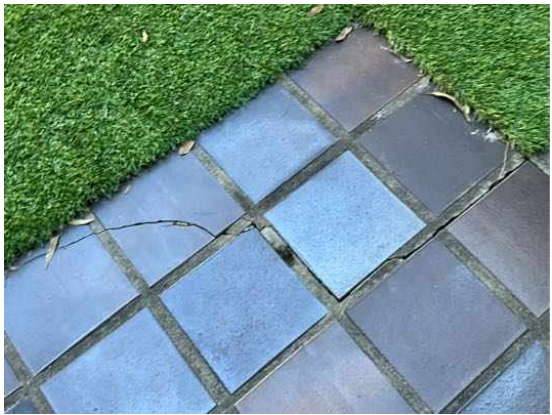
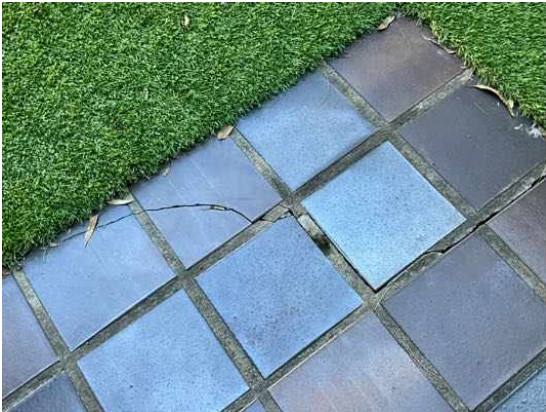
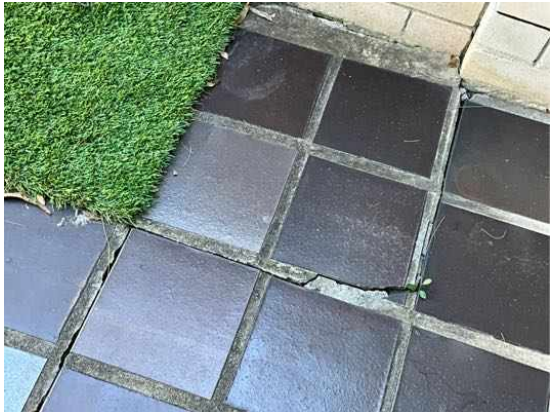
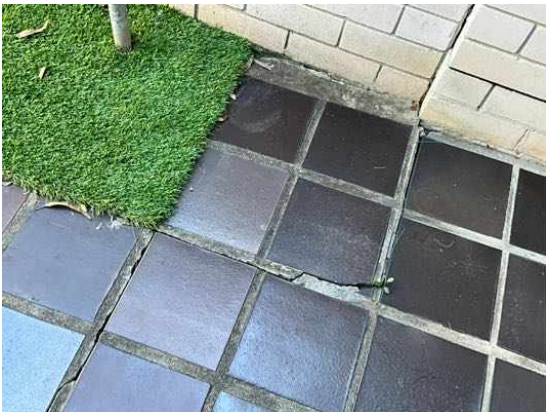
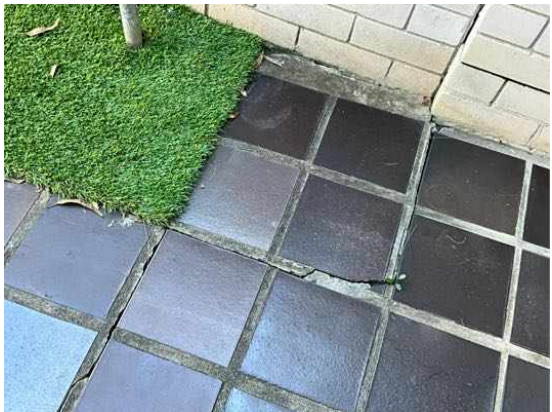
Building: Main Building
Location: Yard - Front
Finding: Tile - Floor Tile Damaged
Information: A floor tile is visibly damaged, showing a chipped/broken section on the surface.

The damaged tile presents a trip hazard, may lead to cuts if stepped on barefoot, and can allow moisture ingress into the substrate, which may cause further deterioration or loosening of adjacent tiles. It also affects the overall appearance of the floor.

Recommended Action / Who Can Fix It:

A licensed tiler should be engaged to remove the damaged tile and install a matching replacement. If spare tiles are unavailable, additional remedial work may be required to blend the repair with surrounding finishes.

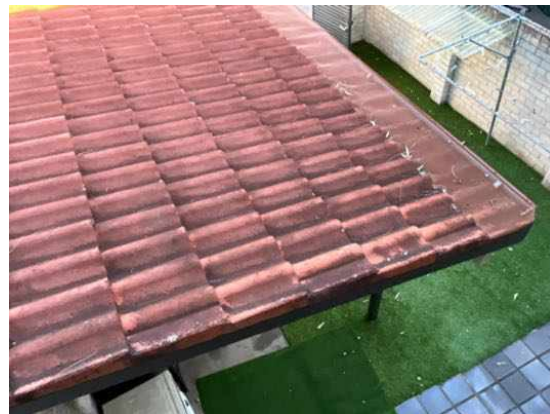
Information: Inspection of the roof revealed widespread weathering to the tiled roof surface. The tiles show loss of surface finish, colour fading, and age-related deterioration typical of older roof coverings. Although no significant cracking was noted, weathering can lead to increased porosity, reduced water-shedding capability, and a higher risk of future cracking or displacement during adverse weather conditions.

A licensed roofer should be engaged to undertake a closer inspection, carry out routine maintenance, and replace any tiles that may be compromised. Ongoing monitoring is recommended due to the age and condition of the roof covering.

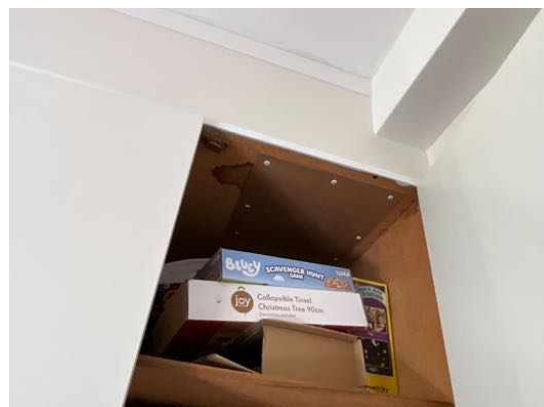
Building: Main Building
 Location: Wardrobe
 Finding: Water staining
 Information: Water staining was evident in this area at the time of inspection. Water staining indicates that surfaces have been exposed to excessive moisture over time. The minerals and other elements in the water lead to staining, which may graduate to corrosion and deterioration if left unmanaged.

While mostly an appearance defect, water staining can be indicative of more serious defects, which may be currently concealed by other building elements.

Where water staining is active, a licensed plumber must be consulted to identify the cause of the staining and to provide advice on any reparation works that may be required. Replacement of any broken or damaged structures is advised.

Conversely, where water staining is old and inactive, affected building materials may be repaired or replaced at client discretion. A qualified carpenter or registered builder may be appointed to perform these works.

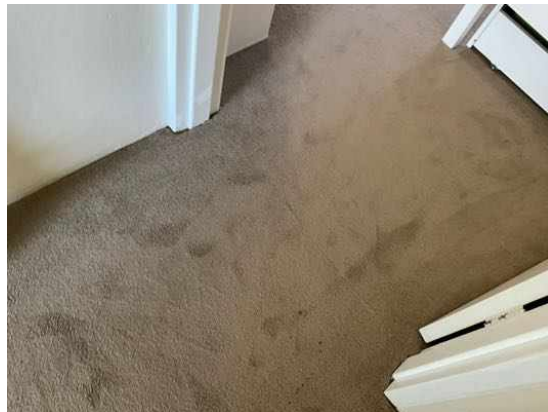
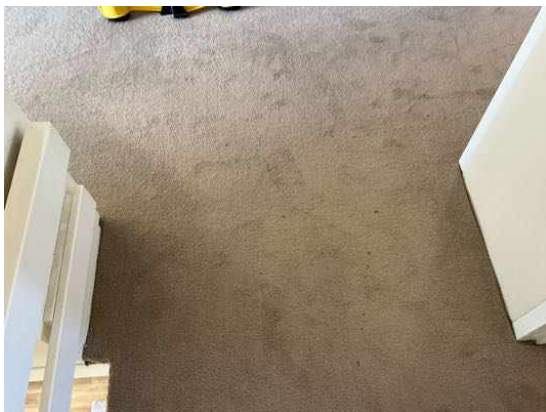
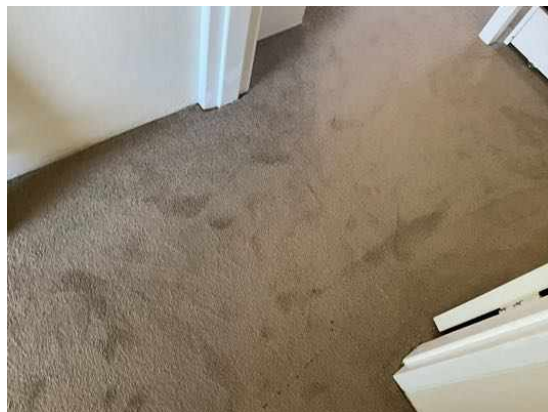
Finding 3.09

The risk associated with aging carpets includes diminished appearance, decreased comfort, potential tripping hazards due to frayed edges, and a negative impact on indoor air quality if fibers begin to degrade and release particles into the air.

Who can fix it:

Professional carpet cleaning and restoration services can address issues such as deep cleaning to rejuvenate colors, repairing frayed edges, and restoring fibers. Additionally, replacing the carpets entirely may be necessary in severe cases of aging or damage beyond repair.

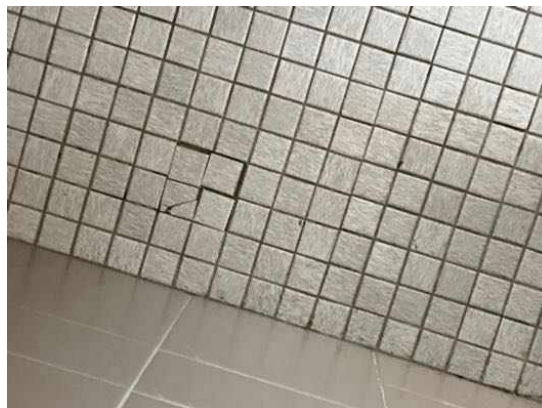
Finding 3.10

Finding: Tiles - Cracked or damaged

Information: Cracking was evident to the tiling in this area at the time of inspection. While the cracking appears to be minor, this area is frequently exposed to water, allowing potential for water penetration into adjoining sections of walls or flooring.

If left unmanaged, water penetration to these areas may lead to subsequent water damage, which is likely necessitate repair work to affected building elements.

A tiling contractor should be appointed to ensure that no further water damage

occurs. The re-application of silicone and grouting throughout remaining tile work is also advised, to further protect the area against water penetration.

Where water penetration has led to water damage, appointment of a relevant tradesperson may be required to repair damaged building elements.

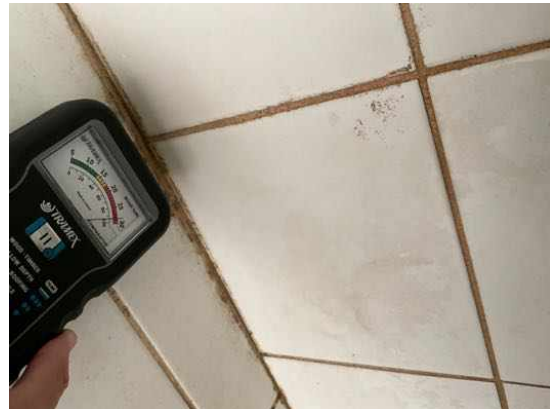
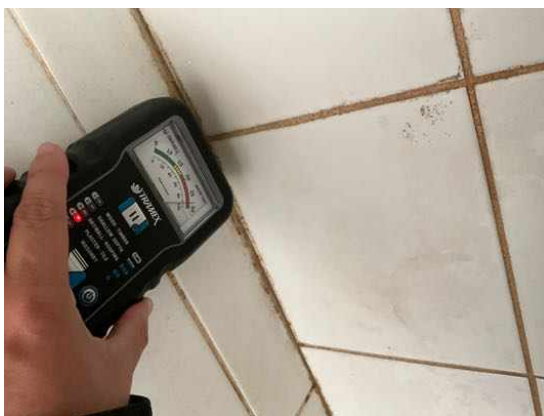
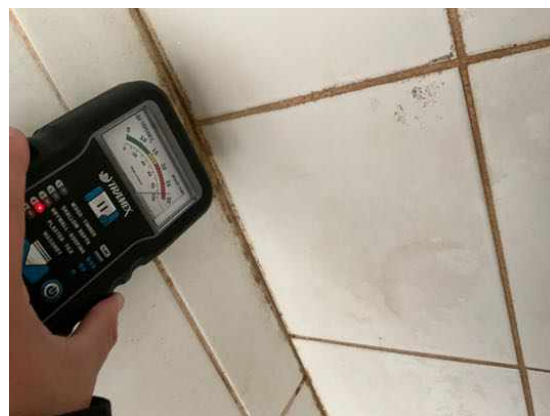
Finding 3.11

Building:	Main Building
Location:	Ensuite
Finding:	Shower - Damp
Information:	Damp is evident to the lower 300mm of wall to the shower alcove. This defect is quite common, and is suspected to have been caused by moisture permeating through the grouting in this area, which shows evidence of deterioration. Leaking pipes within the adjoining wall is also a possible cause.

Damp (or structural damp) refers to the presence of unwanted moisture in the structure of a building, either as the result of intrusion from outside, or condensation from within the structure. In the shower area, internal water leaks or other sources of excessive moisture are generally the cause of damp.

Unmanaged damp in the shower recess is likely to facilitate the formation and development of mould and fungi growth, decaying associated building materials and compromising their structural integrity. It is important to address damp conditions, as the World Health Organisation notes that excess moisture leads - on almost all indoor materials - to growth of microbes such as moulds, fungi and bacteria, which subsequently emit spores and other matter into the indoor air. Exposure to these contaminants is associated with a wide range of respiratory and other health-related problems.

Consultation with a qualified plumber or bathroom specialist is advised immediately to identify the cause of damp and to perform remedial works as required. Where excessive mould growth is present, further inspection by a specialist environmental health inspector should also be considered.

Always ensure that sealant and grout is in good condition to prevent any moisture issues occurring in the future.

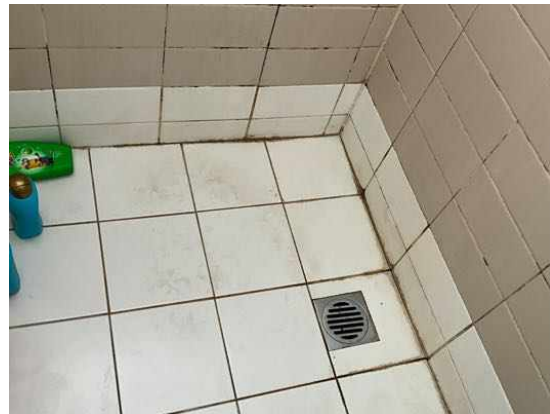
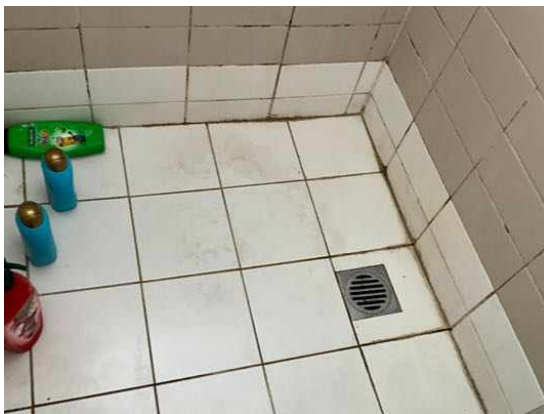
Finding 3.12

Building:	Main Building
Location:	Ensuite
Finding:	Sealant and grouting - Missing or damaged
Information:	It was noted on inspection that sealant or grout is degraded to the tiled shower alcove and or other areas of the bathroom.

Different materials and floor areas move at different rates, generally causing cracking

There appears to be excessive mould to the sealant and grout which will likely require scraping out and replacement.

Flexible and mould resistant materials should be applied to affected areas to prevent any subsequent water damage that is likely to occur. Regular maintenance and replacement of damage or missing or damaged sealant and grout is highly recommended to the wet areas, as this is a regular wear and tear defect. Sealant and grouting in areas that come into regular contact with water should be maintained for the long term care of your property.

A sealant specialist or tiling contractor should be appointed to complete these works as soon as possible

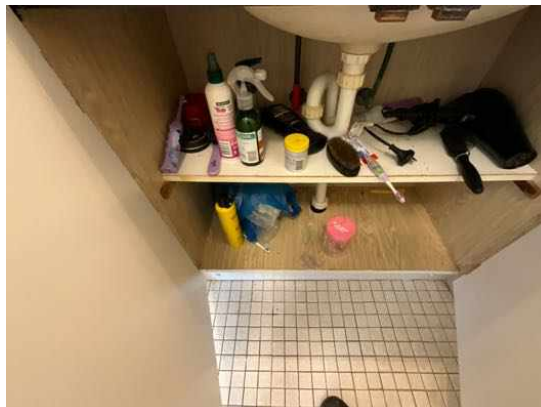
Finding 3.13

Building:	Main Building
Location:	Bathroom
Finding:	Water damage / Vanity
Information:	"The vanity in the shower area has sustained water damage, resulting in swelling and discoloration of the wood, as well as potential structural issues. This damage

1. **Carpenter or Woodworker:** They can assess and repair the damage to the vanity, potentially replacing any irreparable parts.
2. **Plumber:** If the water damage is due to plumbing issues, a plumber can fix leaks and ensure there are no further water-related problems.
3. **General Contractor:** If the damage is extensive and affects the surrounding area, a general contractor can coordinate the repair work, including both the vanity and any related structural or cosmetic repairs.

Make sure to obtain quotes from these professionals to determine the most cost-effective and efficient solution for your specific situation.

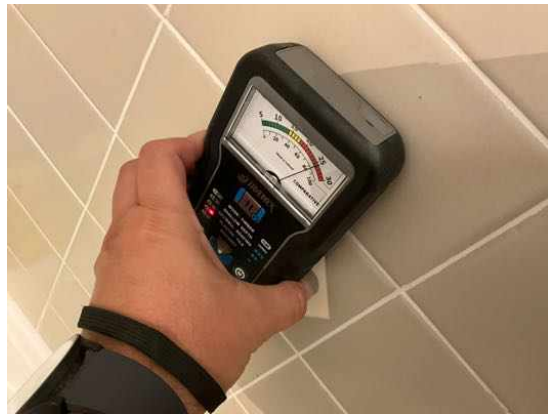
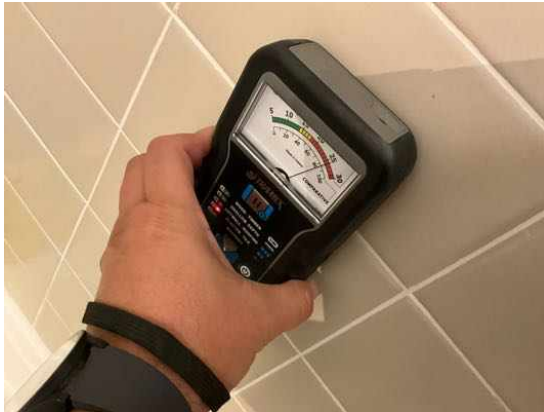
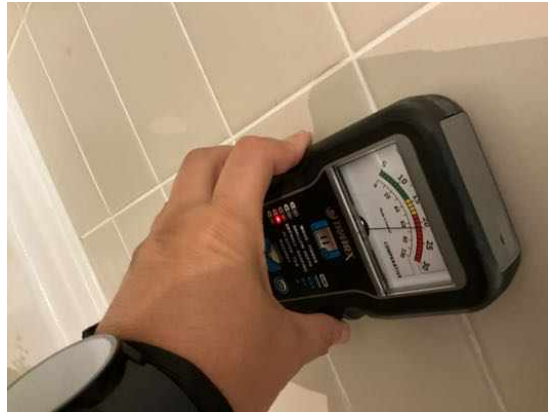
Finding 3.14

Building:	Main Building
Location:	Bathroom
Finding:	Evidence of excessive moisture was present at the time of inspection
Information:	Excessive moisture is present behind the bathroom tiles, indicating a potential water leakage issue within the wall.

The prolonged presence of moisture can lead to mold growth, deteriorate the structure, and create an environment conducive to health hazards. Additionally, it may compromise the adhesive holding the tiles, leading to their detachment.

A licensed plumber or a qualified contractor specializing in water damage remediation should investigate the source of the moisture, fix any leaks, and address the damage. Additionally, replacing affected tiles and ensuring proper waterproofing are crucial to preventing future issues.

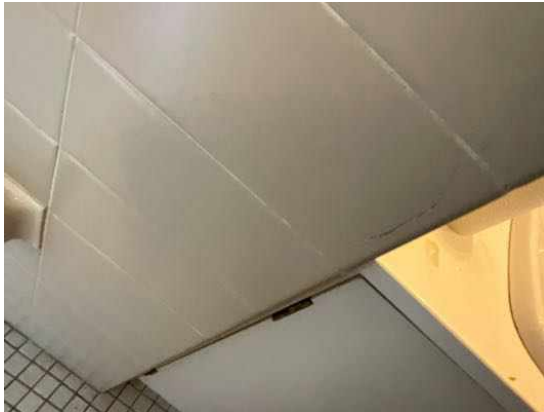
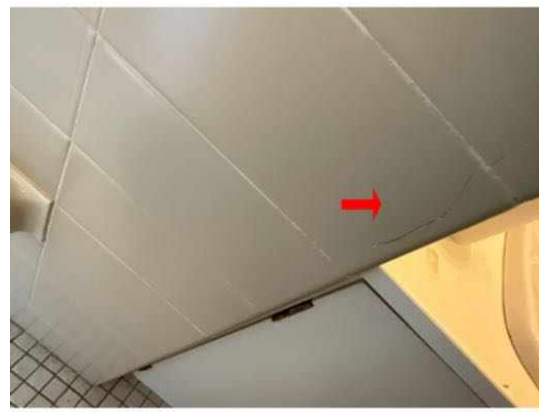
Finding 3.15

Finding: Tiles - Cracked or damaged

Information: Cracking was evident to the tiling in this area at the time of inspection. While the cracking appears to be minor, this area is frequently exposed to water, allowing potential for water penetration into adjoining sections of walls or flooring.

If left unmanaged, water penetration to these areas may lead to subsequent water damage, which is likely necessitate repair work to affected building elements.

A tiling contractor should be appointed to ensure that no further water damage

occurs. The re-application of silicone and grouting throughout remaining tile work is also advised, to further protect the area against water penetration.

Where water penetration has led to water damage, appointment of a relevant tradesperson may be required to repair damaged building elements.

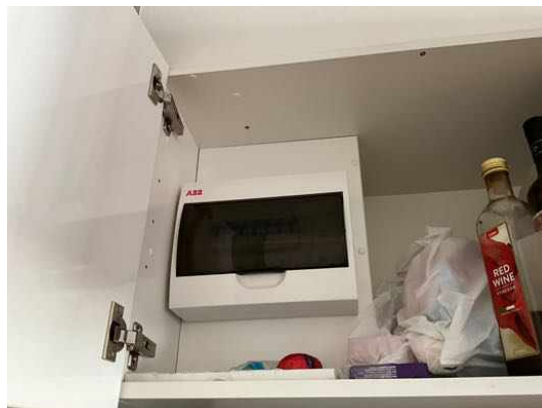
A durable notice was not placed in the switchboard unit to indicate current termite barriers is legible at the time of inspection.

Client must seek further information from the vendor or real estate agent if the conditions of termite management systems were maintained.

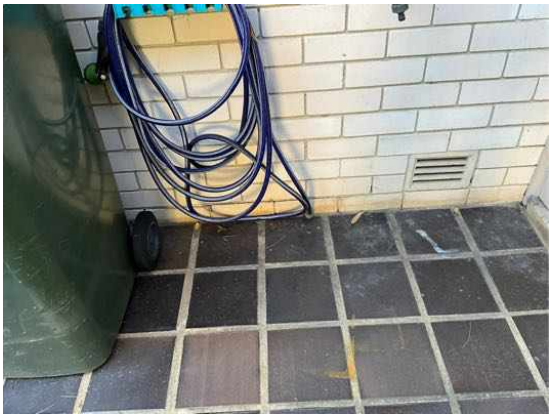
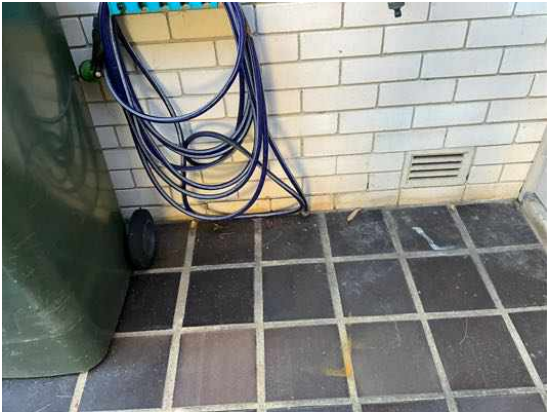
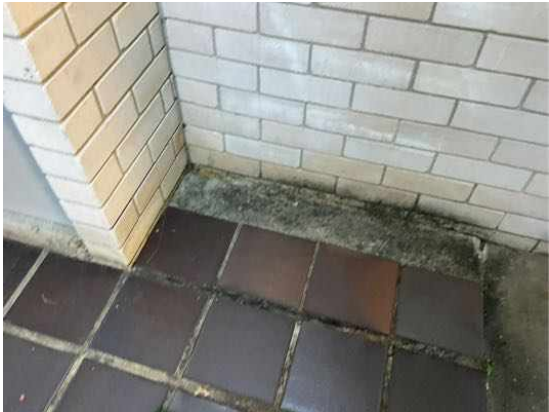
Finding 6.02

If the slab edge is not properly exposed there is a high risk of termite attack. Sometimes, in order to determine the type of slab, a suitably qualified person such as an architect or builder may be required to consult the construction plans.

Where the slab edge cannot be properly inspected, it is highly recommended that termite or timber pest inspections be carried out every 6-12 months to aid protection of the property against infestation.

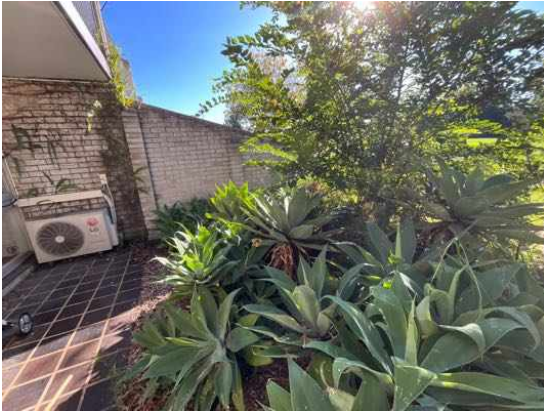
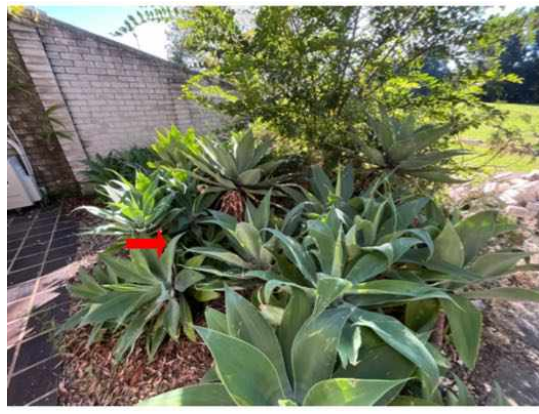
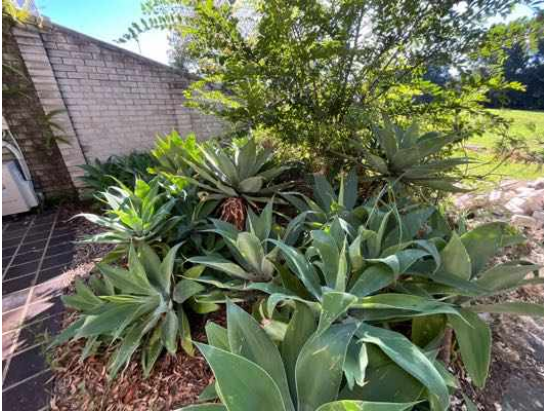
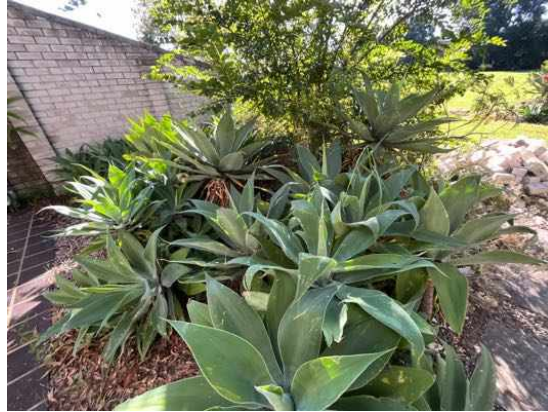
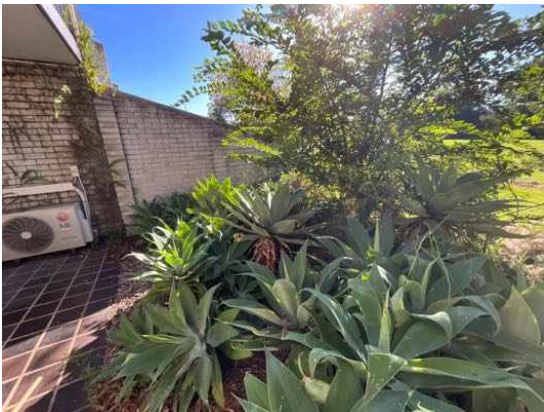
Finding 6.03

Building: Main Building
Location: All Areas
Finding: Dense vegetation around a property can increase the risk of termite infestation
Information: The presence of dense vegetation around a property can increase the risk of termite infestation, as it provides a conducive environment for them. To address this, consider maintaining a clear space between the vegetation and your home. If you suspect a termite issue, it's advisable to consult with a licensed pest control professional for inspection and treatment.

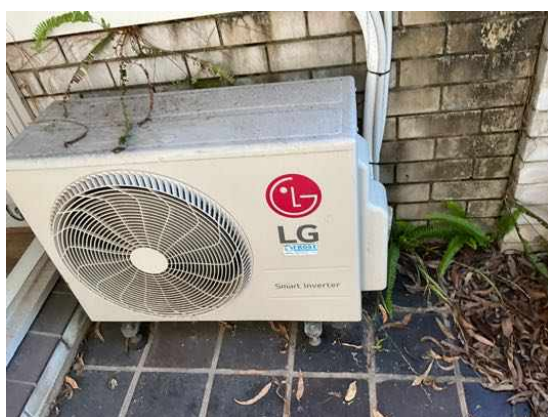
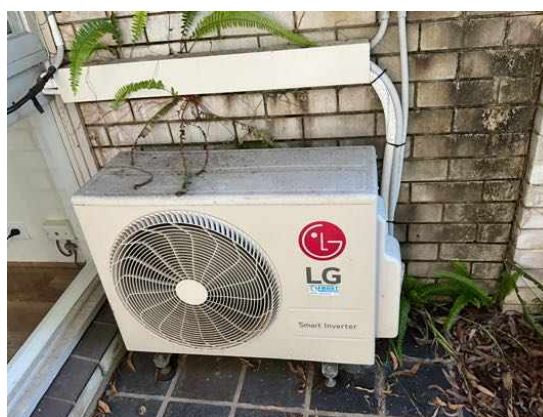
Finding 6.06

Building:	Main Building
Location:	Exterior walls - rear
Finding:	Bridging or Obstruction Conducive environment for Termites
Information:	Bridging of termite barriers occurs when termites bridge (usually by building a mud tunnel) a termite barrier or inspection inspection zone or where termites have a passage, allowing them to bridge the barrier.

Where bridging has occurred full inspection is prevented and termites may enter a property in a concealed or undetected manner.

Recommended moving obstructions away from the external walls for further and future inspections.

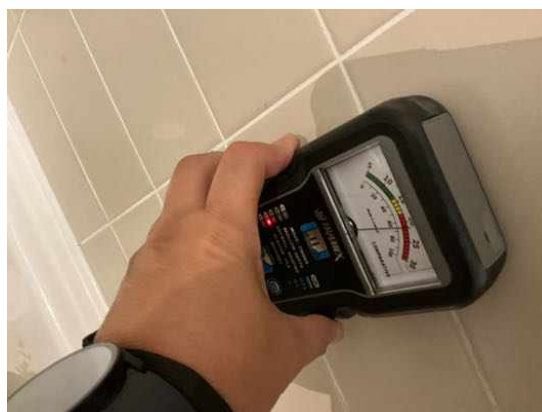
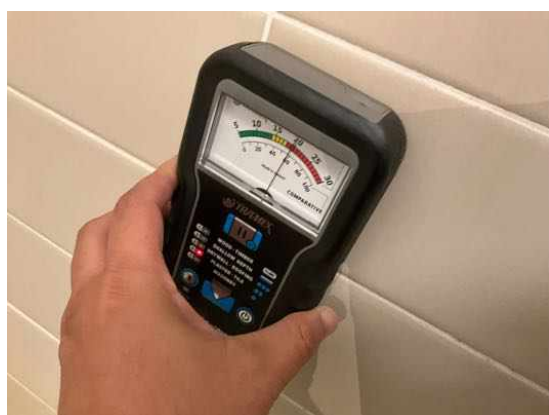
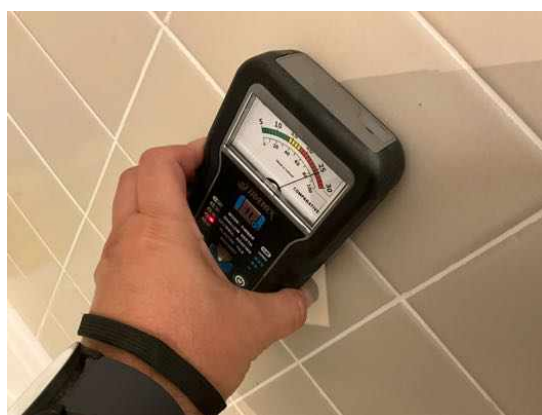
Finding 6.09

Building:	Main Building
Location:	Bathroom
Finding:	Excessive moisture - Conducive to Timber pest
Information:	Excessive moisture can attract termites and produce conditions that promote fungal growth and wood decay.

Prior to any remedial works being performed a qualified plumber should be appointed to further inspect the property and to identify the cause of the excessive moisture. Works to remove affected building elements may then be necessary and should be performed by an appropriate tradesperson.
