# Building and Timber Pest Inspection Report

Inspection Date: Tue, 17 Mar 2026

Property Address: 6A Ledger St, Goulburn NSW 2580,  
Australia

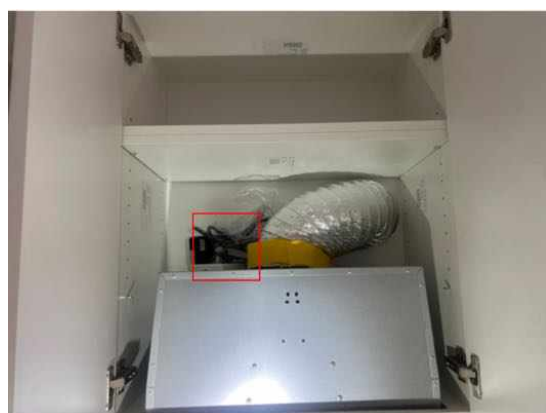
#### Finding 1.01

Building:	Main Building
Location:	Kitchen
Finding:	Electrical wires exposed
Information:	Exposed electrical wiring was identified. Exposed electrical wiring represents a potential safety hazard including for fire and personal contact. Contact a licensed electrician urgently for further inspection investigation and rectification.

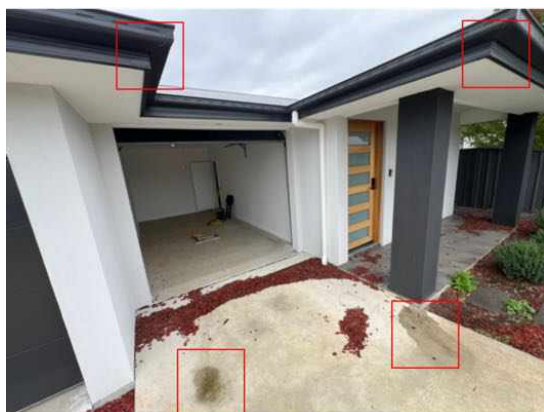
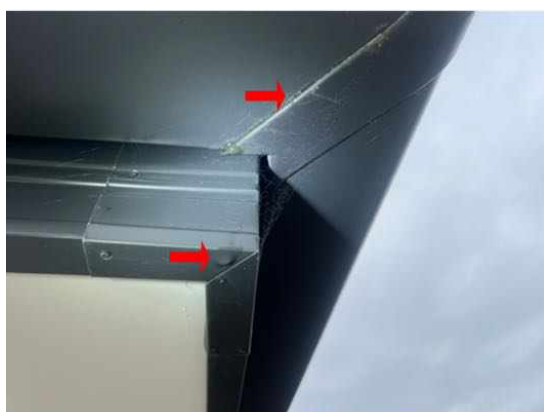
Building:	Main Building
Location:	Exterior walls - front
Finding:	Guttering - Active Leak
Information:	An active leak was identified in the guttering during the inspection. This issue is likely caused by damage, corrosion, or substandard installation. The leak allows water to escape improperly, increasing the risk of water pooling around the building's foundation. Prolonged moisture exposure can create conditions conducive to termite activity and may also lead to soil erosion, water ingress into lower areas, or damage to associated building elements.

A licensed roof plumber should assess the guttering to identify the exact cause of the leak and carry out necessary repairs or replacements as a priority to prevent further

damage and mitigate the risk of termite infestation.

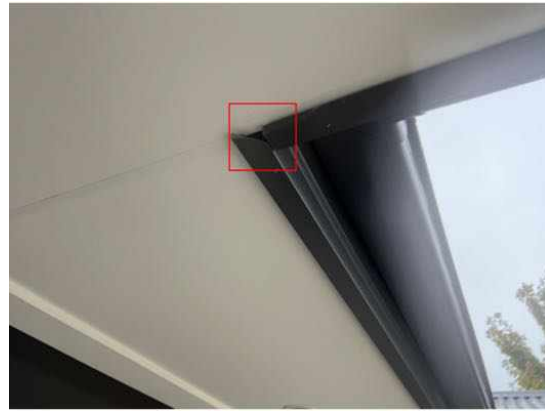
### Finding 3.02

Building:	Main Building
Location:	Garage
Finding:	Fascia internal corner/Installation - substandard or incomplete
Information:	The installation of this fascia corner appears to have been completed to a substandard level of workmanship or is incomplete. Generally substandard repairs or installation are related to poor workmanship, the use of inappropriate materials, or a failure to complete installation to a suitable standard.

Where installation is substandard and/or incomplete, the roof plumber should undertake rectification. Unfinished and substandard building works are likely to degrade more quickly and may create potential for secondary defects to associated building elements.

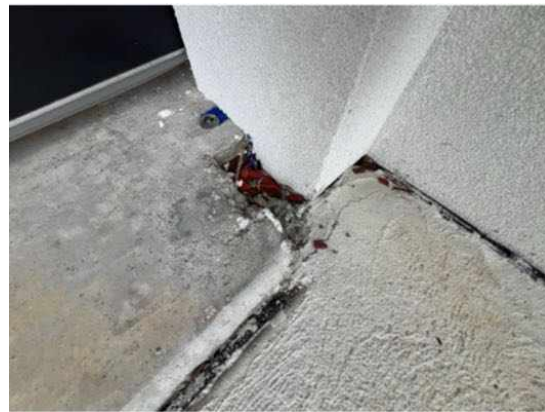
### Finding 3.03

Building:	Main Building
Location:	Garage, Alfresco
Finding:	Concrete finish/Installation - substandard or incomplete
Information:	The installation of concrete finish appears to have been completed to a substandard level of workmanship or is incomplete. Generally substandard repairs or installation are related to poor workmanship, the use of inappropriate materials, or a failure to complete installation to a suitable standard.

Where installation is substandard and/or incomplete, the concrete should undertake rectification. Unfinished and substandard building works are likely to degrade more quickly and may create potential for secondary defects to associated building elements.

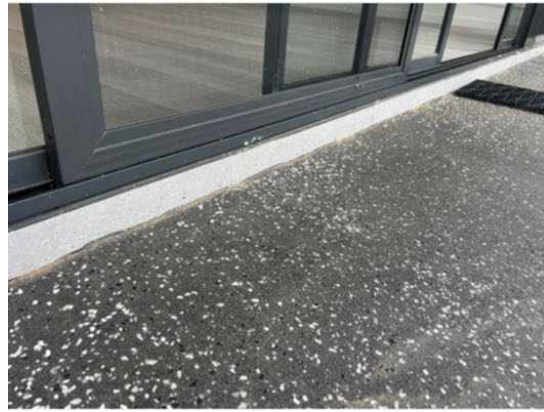
Information: Drummy tiled areas were identified at the time of inspection. The term 'drummy' refers to tiles that have become detached from their fixing, despite otherwise being in relatively good condition. Such defects are generally caused by physical or moisture damage to the area. Drummy tiled areas may also be a direct result of poor workmanship during the construction process.

Tiled areas may swell and shrink with changes in air humidity if the area has sustained moisture damage. Any exposure to moisture is capable of causing tiled areas to become drummy and/or cracked over a prolonged period of time. Drummy tiled areas generally require removal and replacement of affected tiles, with adequate sealant and grouting.

Specialist trades are available for these types of services. A registered builder may be required to undertake works if damage is extensive or if secondary building defects have resulted. Otherwise, it is advised that a tiling contractor be appointed to perform works as necessary. Immediate action is recommended to ensure that no further damage is sustained in the affected area.

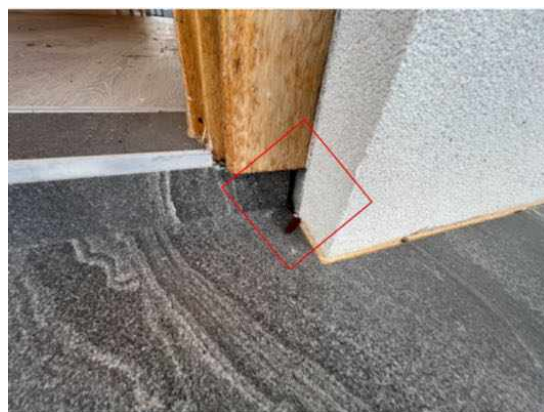
### Finding 3.07

Finding: Porch and Alfresco - Missing Sealant at Tile Junction

Information: It was noted that sealant was not installed along the junction at the porch floor tiles. Junctions between dissimilar materials such as tiles and wall surfaces require flexible sealant to accommodate normal movement and to prevent moisture entering beneath the tiles.

Without a suitable sealant, water may track below the tiled surface during rainfall, leading to drummy or detached tiles and deterioration of underlying materials. The absence of sealant at this junction increases the risk of moisture ingress and tile failure over time.

A flexible, exterior-grade sealant should be installed at the affected area to provide a watertight and durable finish. A tiling contractor or general handyperson should be appointed to carry out the necessary works.

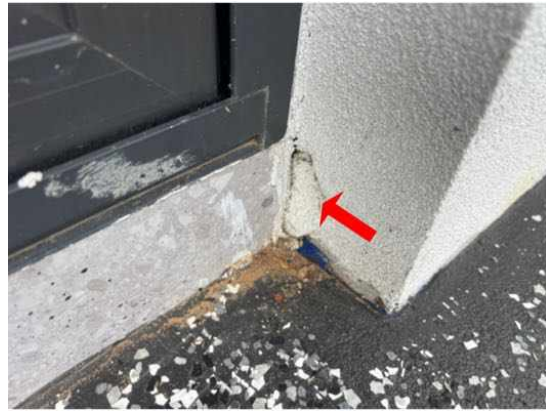
**Finding 3.08**

Building: Main Building  
Location: Porch, Alfresco  
Finding: Render - Damaged  
Information: Breakage occurs generally when the building materials have either aged and decayed, or as a result of damage (accidental or deliberate).

Repair and/or replacement of broken elements is advised to ensure that additional secondary defects do not arise as a consequence. Such works are necessary, as all building elements play a key role in the operation and function of the overall structure and its performance.

A renderer/plasterer should be appointed to repair or replace the affected building element prior to any subsequent damage being caused.

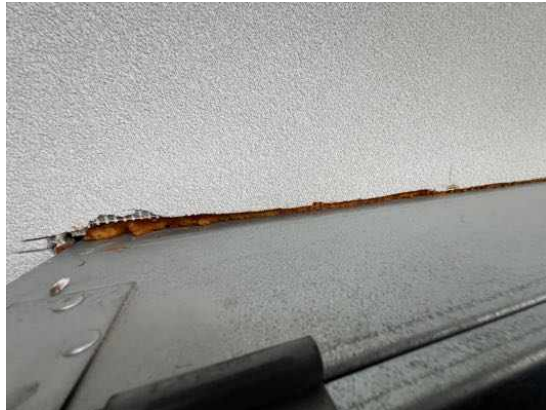
### Finding 3.09

Building: Main Building  
 Location: Meter Box  
 Finding: Meter Box - Unsealed Penetration  
 Information: A gap was observed around the meter box where it interfaces with the surrounding wall lining.

Open penetrations of this nature may allow moisture or water ingress into the wall structure, particularly during rainfall events. Ongoing exposure to moisture in these areas may contribute to deterioration of adjacent building materials over time.

It is recommended that the installation be assessed and the gap appropriately sealed to reduce the risk of moisture ingress into the wall system.

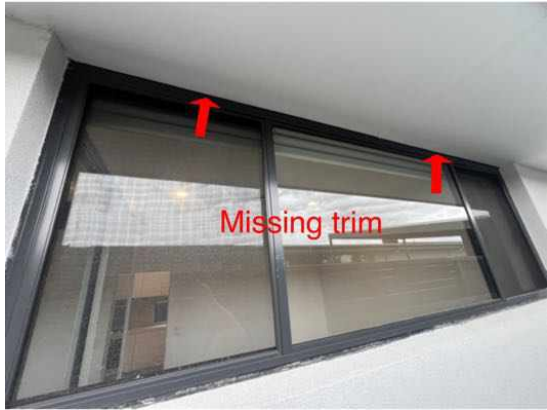
**Finding 3.10**

Building: Main Building  
Location: Exterior walls - right side  
Finding: Eave - Incomplete or substandard works  
Information: The works to this area appear to be incomplete or have been completed to a substandard level.

Works that have not been completed to a satisfactory level create potential for the development of building defects and may impede on the safety and integrity of the overall structure.

It is highly recommended that a carpenter be appointed to complete these works and ensure the safety of the area and the longevity of all associated building elements.

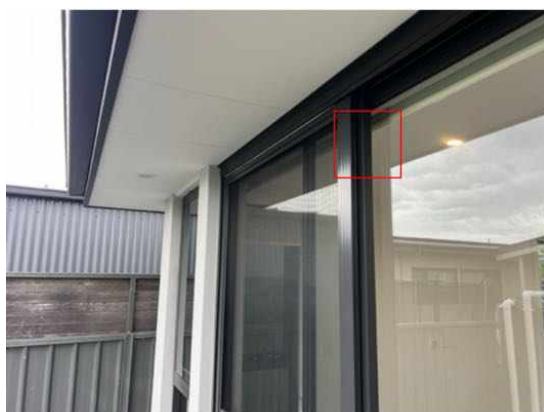
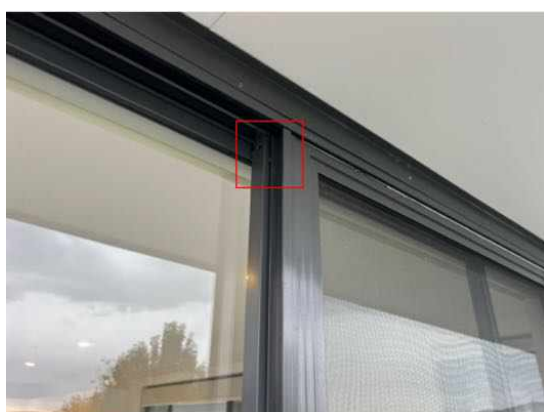
Building:	Main Building
Location:	Alfresco
Finding:	Additional Photos - Minor defects
Information:	Additional photographs have been included for general reference only. Where arrows or annotations are shown, these items may be discussed with the building inspector if

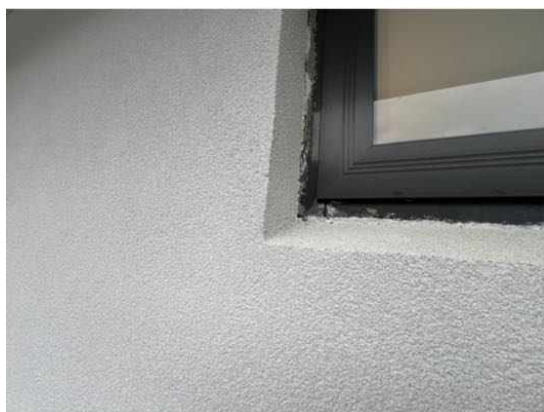
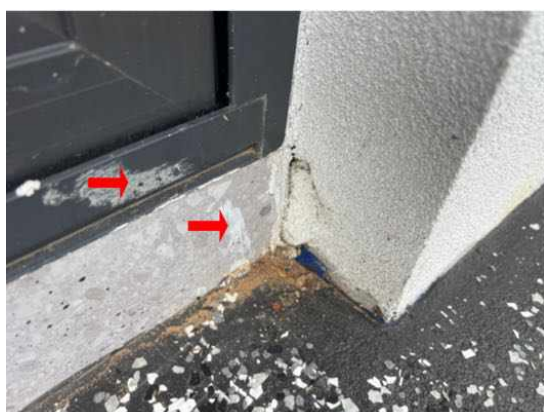
Building: Main Building  
Location: All External Areas  
Finding: Cleaning - Guide to Standards & Tolerances Part 19.8  
Information: During the inspection, it was observed that general cleaning of the building and site had not been completed to an acceptable presentation standard. The Guide to Standards & Tolerances Part 19.8 states that building works are defective where windows are not clean, floors are not swept, mopped or vacuumed, and fixtures such as tiles, sinks, basins, troughs, and cupboards are not ready for use. The client should consult with the builder to confirm how the cleaning will be completed to meet the minimum standard outlined in the Guide to Standards & Tolerances prior to handover.

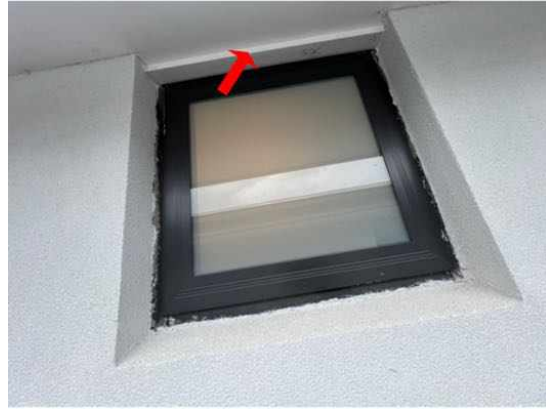
### Finding 3.15

Building:	Main Building
Location:	All External Areas
Finding:	Paint finish - Incomplete
Information:	The paint finish in this area was identified as being incomplete at the time of inspection.

Whilst incomplete or missing paint finish is generally an appearance defect, it can also lead to the development of secondary building defects over time. Incomplete areas of paint finish expose the area to moisture, potentially accelerating the deterioration of underlying building materials.

Incomplete paint finishes should be sanded back, filled, leveled and painted, as applicable. Where inadequate or missing paint protection has led to the deterioration of the associated building element, repair and/or replacement of this building element may be required.

A painting contractor should be appointed as soon as possible to perform necessary works to aid the appearance of the affected area and to ensure the area is protected against further deterioration. Alternatively, the homeowner following manufacturer instructions may perform these works.

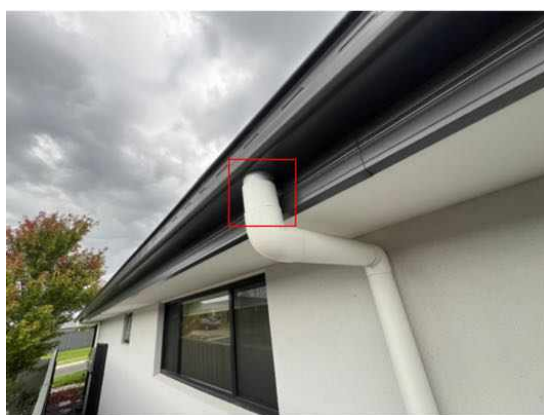
Building:	Main Building
Location:	All External Areas
Finding:	Downpipe - inadequately secured
Information:	The downpipe was noted to be not adequately secured to the adjoining gutter pop. Movement at the joint increases the likelihood of leakage or dislodgement during periods of heavy rainfall.

Inadequate downpipe connection may result in water discharging near the building foundation, increasing the risk of dampness, erosion, or concealed damage to surrounding elements. A licensed plumber should assess the downpipe and ensure it is properly fixed to maintain effective stormwater drainage from the property.

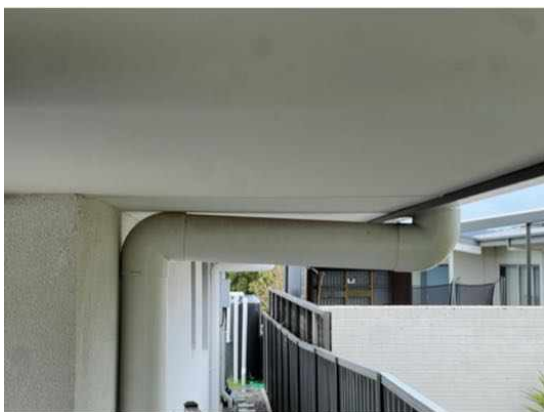
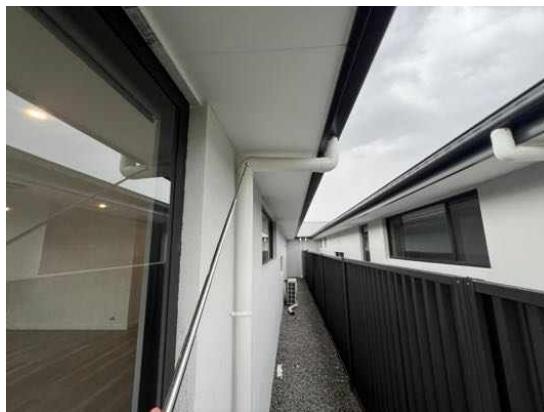
### Finding 3.19

Building:	Main Building
Location:	All External Areas
Finding:	Downpipe - Negative Fall
Information:	The downpipe connection from the gutter was observed to have a negative fall.

Poor drainage performance may lead to overflow at the gutter, increased moisture to surrounding building elements, and potential long-term deterioration if left unaddressed.

A licensed plumber should be appointed to assess the installation and confirm that adequate fall is provided to ensure proper stormwater discharge.

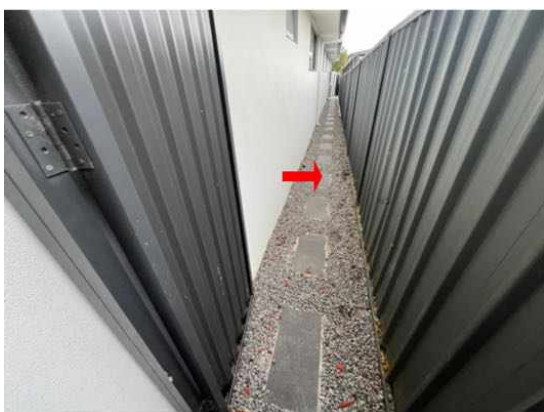
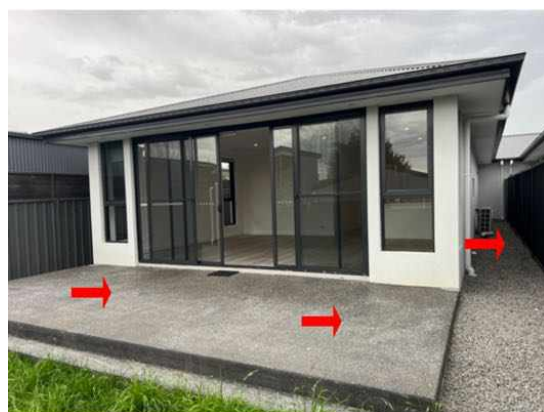
### Finding 3.20

Building:	Main Building
Location:	All External Areas
Finding:	Perimeter Paving - Insufficient Fall
Information:	The perimeter paving or ground levels were found to have an inadequate slope away from the adjoining building structure, creating potential for water pooling in this area.

Perimeter paving is required to fall from the building by a minimum of 25mm in the first metre and bare ground should fall away from the house by 50mm in the first meter. This standard ensures that excessive moisture does not pool around the base of building structures, which creates potential for water and structural damage, as well as making the area susceptible to termite and timber pest activity.

Where paving or ground levels do not have adequate fall, a licensed paving contractor should be appointed to install or remove and re-level pavement.

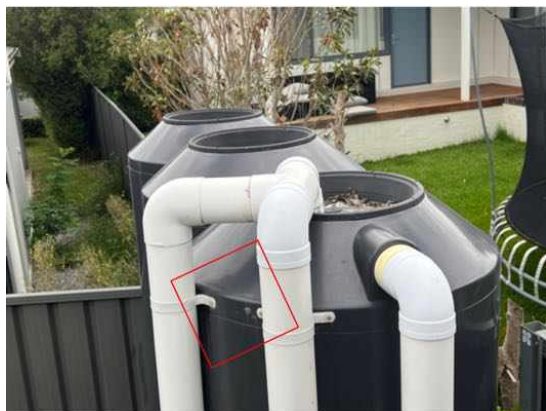
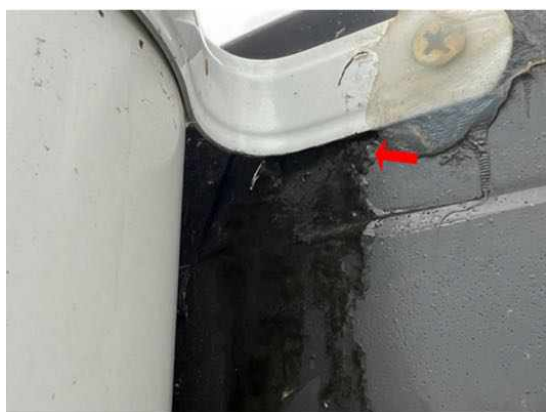
### Finding 3.21

Building: Yard  
 Location: Yard - Back  
 Finding: Water Tank Water leak - External  
 Information: Water leaks were found to be present to exterior plumbing work. Leaks are generally caused by deterioration of the plumbing elements over time, due to exposure to weather conditions, but may have also been caused by minor impact damage.

Such leaking creates damp conditions in the affected area, causing potential for water pooling and subsequent water damage if left unattended. These conditions may also attract termite attack, particularly if the area is subject to minimal levels of sun throughout daylight hours.

It is highly advised that a licensed plumber be appointed to rectify any water leaks that may be present. Areas of repair and replacement of plumbing fittings and fixtures may be required and, as such, a quotation should be sought.

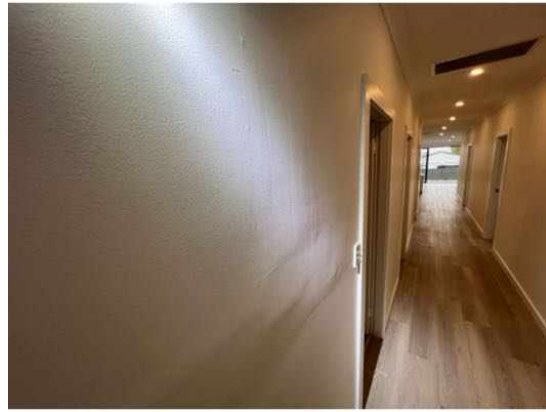
Works that have not been completed to a satisfactory level create potential for the development of building defects and may impede on the safety and integrity of the overall structure.

It is highly recommended that a licensed plasterboard contractor or painter should be appointed to finish the wall.

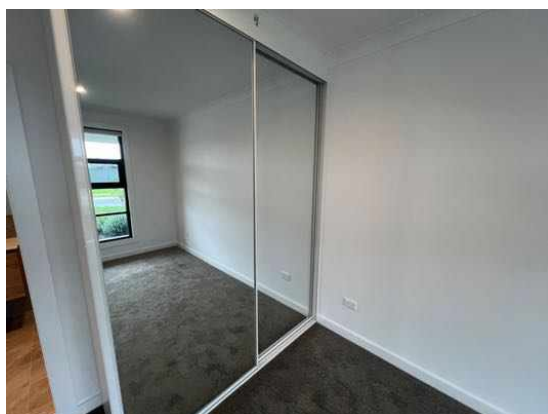
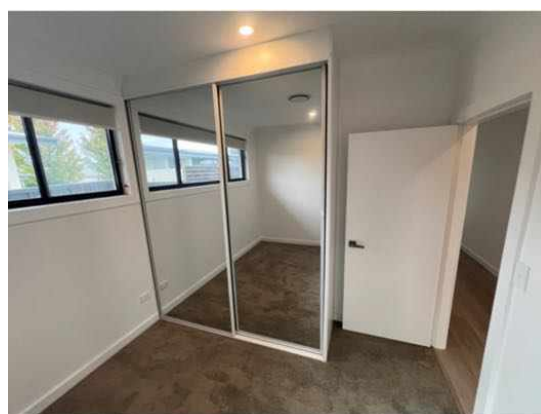
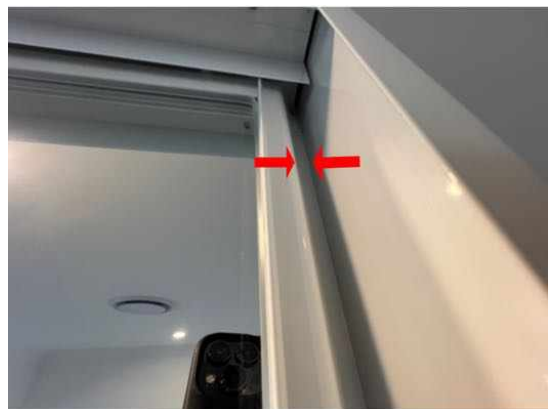
### Finding 3.29

Building:	Main Building
Location:	All Bedrooms
Finding:	Robe Sliding door - not plumb
Information:	The sliding robe doors are not plumb with the wall when closed, resulting in visible misalignment. This issue is generally caused by improper track installation, frame movement, or an out-of-square opening. Misaligned robe doors can affect operation, closing functionality, and the overall finish. The responsible carpenter or installer should assess the issue and undertake corrective work as required to ensure the doors align properly within the opening.

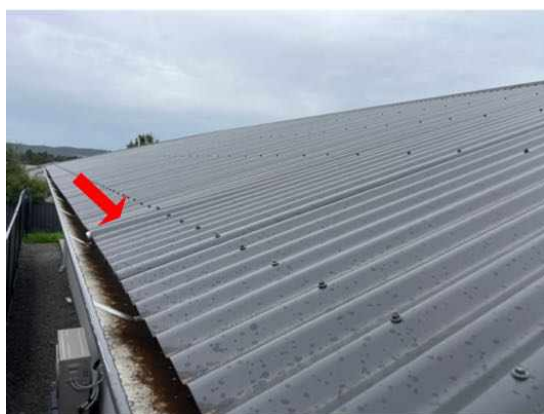
Finding 3.60

Building:	Main Building
Location:	Roof Exterior
Finding:	Roof Sheet - bulge to surface
Information:	A localised bulge was observed to the roof sheeting, likely caused by an air conditioning overflow pipe discharging directly beneath the sheet.

If left unmanaged, continued discharge may lead to further deformation and deterioration of the roof materials.

A licensed plumber or roofing contractor should be appointed to inspect the installation and undertake rectification as required.
