# Building and Timber Pest Inspection Report

Inspection Date: Thu, 29 Jan 2026

Property Address: 30 Yengo Ct, Holsworthy NSW 2173,  
Australia

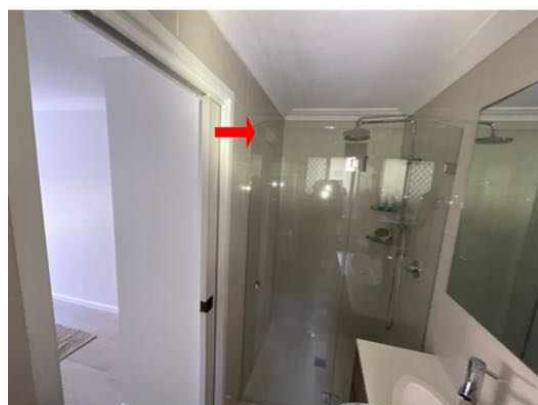
Binding and/or jamming of shower doors were evident during standard operation at the time of inspection. This defect is a potential safety hazard if the shower screen breaks due to impact or jamming force.

It appears this is due to poor initial installation of the shower components.

A licensed glazier is required immediately for repairs and to ensure the safety of the area.

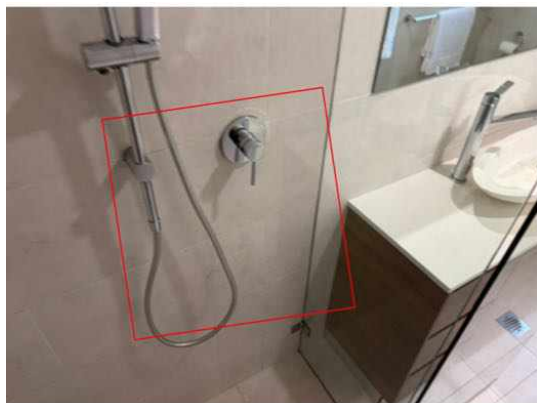
#### Finding 2.01

Building: Main Building  
 Location: Ensuite  
 Finding: Water leak - Suspected  
 Information:

A water leak is suspected in this area as excessive moisture was detected at the time of inspection. Another potential cause maybe moisture ingress behind the tiles from around the wall fittings and penetrations.

Internal water leaks can be detrimental to surrounding building elements; their potential causes include damage to plumbing fittings and fixtures, through to water damage and deterioration of associated building elements.

Attracting termites, corrosion, mould, decay and water damage are potential outcomes where a minor water leak is left unattended. More serious defects may also result, such as electrical hazards, or water damage to structural building elements.

In extreme cases, structural damage may develop due to a prolonged water leak. It is highly advised that internal water leaks be addressed by a licensed plumber as a matter of relative urgency.

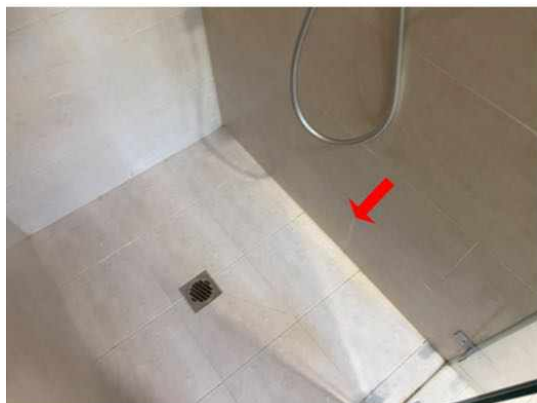
### Finding 3.01

Building:	Main Building
Location:	Bathroom
Finding:	Shower damp - Sealant and grout
Information:	Damp is evident to the lower 400mm of wall to the shower alcove. This defect is quite common, and is suspected to have been caused by moisture permeating or leaching through the grouting and sealant in this area, which shows evidence of deterioration. Leaking pipes within the wall is also a possible cause however this seems unlikely in this instance as there is no moisture build up around the taps or transferring to the other side of the wall. There appears to be no sealant around the tap spindles which may be a small contributing factor.

Damp (or structural damp) refers to the presence of unwanted moisture in the structure of a building, either as the result of intrusion from outside, or condensation from within the structure. In the shower area, internal water leaks, degraded materials or other sources of excessive moisture are generally the cause of damp.

Unmanaged damp in the shower recess is likely to facilitate the formation and development of mould and fungi growth, decaying associated building materials and compromising their structural integrity of associated elements. It is important to address damp conditions, as the World Health Organisation notes that excess moisture leads - on almost all indoor materials - to growth of microbes such as

moulds, fungi and bacteria, which subsequently emit spores and other matter into the indoor air. Exposure to these contaminants is associated with a wide range of respiratory and other health-related problems. Damp conditions also create a conducive environment for termite infestation.

Consultation with a bathroom sealant specialist is advised immediately to identify the cause of damp and to perform remedial works as required.

Always ensure that sealant and grout is in good condition to prevent any moisture issues occurring in the future.

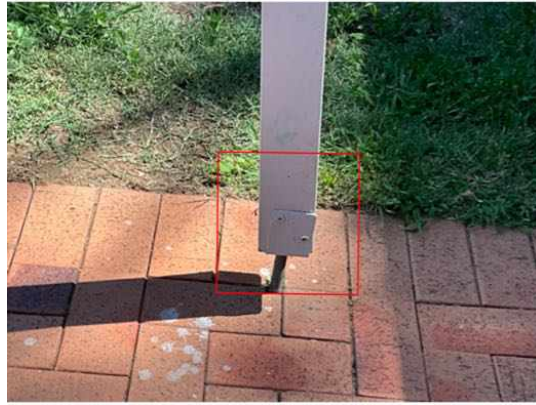
### Finding 3.02

Building:	Main Building
Location:	Alfresco
Finding:	Post anchor - Damaged
Information:	This post anchor in this area shows evidence of damage or movement at the time of inspection. This has likely occurred due to substandard workmanship at the time of construction or otherwise subsidence caused by weather elements.

The deteriorating condition is likely to worsen if not addressed in the short-term future.

A licensed builder should be appointed urgently for replacement or repair, ensuring the integrity of the structure is preserved.

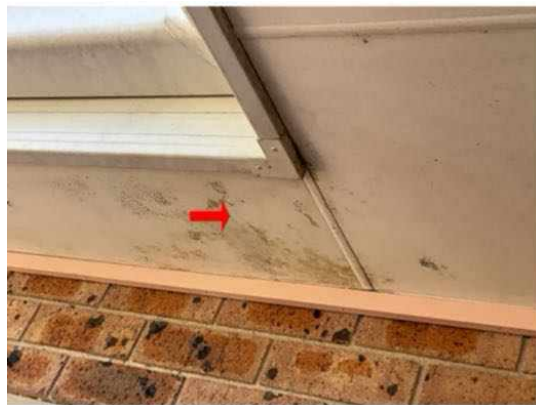
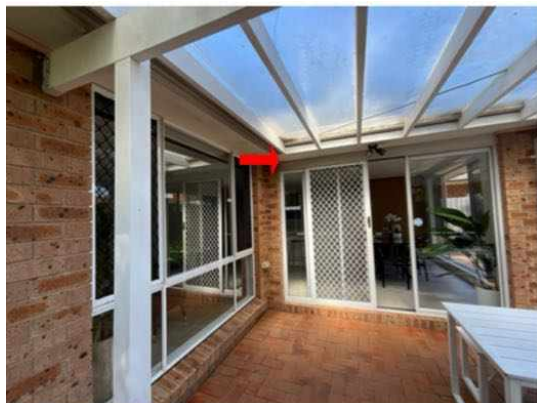
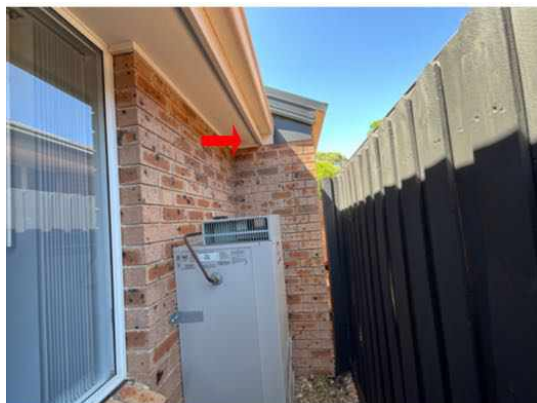
### Finding 3.03

Finding: Eaves/Roof plumbing -- water damages

Information: Water damage is generally an indication of excessive moisture being present, usually via a leak. It is suspected that gutter blockages causing stormwater to backflow into the eaves causing water damages. This is additionally conducive to termite activity due to the damp conditions.

Where water damage is evident, the primary requirement is to identify and rectify the source of the leak. Gutters must be kept clear of any blockages moving forward. A roofing plumber should be appointed for further assessment if the problem persists.

Once the leak is repaired, consultation with relevant tradespeople, including carpenters, plasterers and painters, is advised.

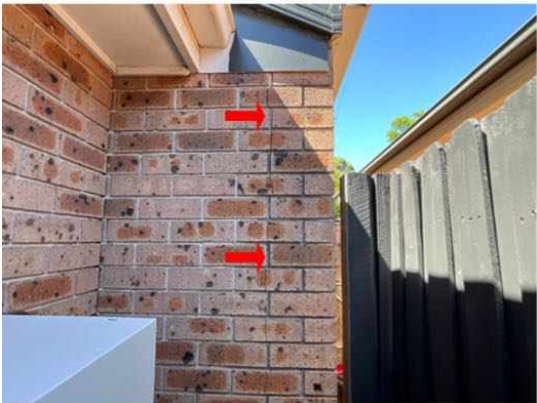
### Finding 3.04

Building:	Main Building
Location:	Behind garage
Finding:	Damage to Masonry Walls (Cracks)- Category 2
Information:	It has been observed that damage to masonry walls caused by movement of slabs, footings, or other causes, has occurred. The degree of damage falls within Category 2, described as noticeable cracks which are easily filled. Such cracking may cause doors and/or windows to stick slightly, and are generally less than 5mm in width.

Damage of this category is required to be monitored for a period of 12 months, after which time a crack rated at Category 2 or above is considered a defect requiring rectification, such as minor repairs and repointing. Always contact your building inspector should cracks widen, lengthen, or grow more numerous.

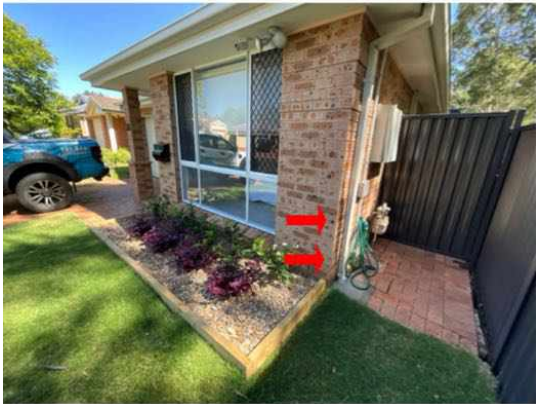
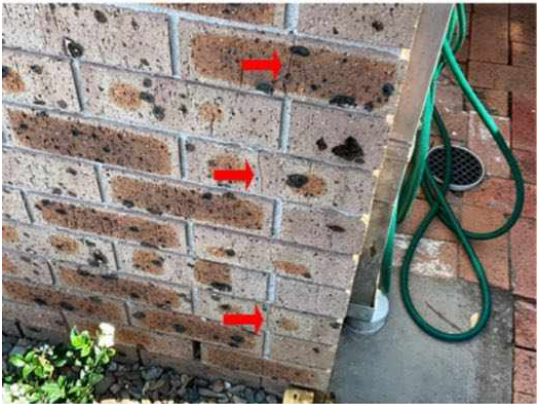
**Finding 3.05**

Building: Main Building  
Location: Multiple areas  
Finding: Damage to Masonry Walls (Cracks) - Category 0  
Information: It has been observed that damage to masonry walls caused by movement of slabs, footings, or other causes, has occurred. The degree of damage falls within Category 0, described as hairline cracks, which are less than 0.1mm in width limit.

Damage of this category is not considered a defect for rectification. Always contact your building ins

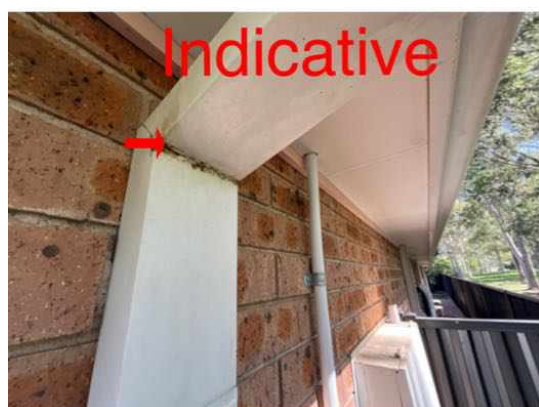
### Finding 3.06

Building:	Main Building
Location:	Multiple areas of roof plumbing
Finding:	Water leak - External
Information:	Water leaks were found to be present to exterior plumbing work. Leaks are generally caused by deterioration of the plumbing elements over time, due to exposure to weather conditions, but may have also been caused by minor impact damage.

Such leaking creates damp conditions in the affected area, causing potential for water pooling and subsequent water damage if left unattended. These conditions may also attract termite attack, particularly if the area is subject to minimal levels of sun throughout daylight hours.

It is highly advised that a licensed plumber be appointed to rectify any water leaks that may be present. Areas of repair and replacement of plumbing fittings and fixtures may be required and, as such, a quotation should be sought.

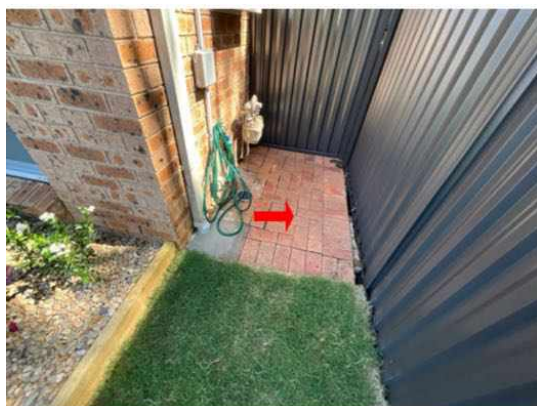
### Finding 3.07

Building:	Main Building
Location:	All Areas
Finding:	Paving — Uneven
Information:	Sections of the external paved area are uneven, which may develop into a trip hazard. It appears as though the area has been subject to rough installation, or that paving sections have lifted due to movements in the foundation.

Left unmanaged, the May develop into a safety hazard due to trip and fall.

Re-paving of the area is required to remedy this situation. Further consultation with a specialist concreter is advised.

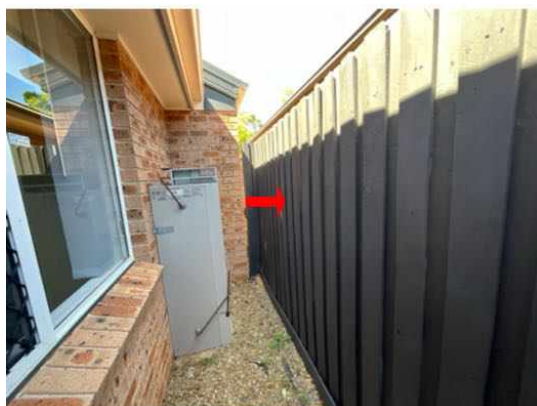
### Finding 3.08

Finding: Fencing - Deteriorated

Information: It was noted at the time of inspection that sections of the fencing in this area has deteriorated. Typically fencing deteriorates due to age and or wear, rot and or rust which is generally expected for a structure of this age, due to prolonged exposure to weather conditions. Sometimes inadequate installation or maintenance can be to blame.

If left unattended, it is likely that further damage will occur. It is suspected that repair of several elements of the fencing may be required however replacement may be a consideration of the client also.

A licensed fencing contractor should be appointed to provide further advice and perform rectification works as necessary.

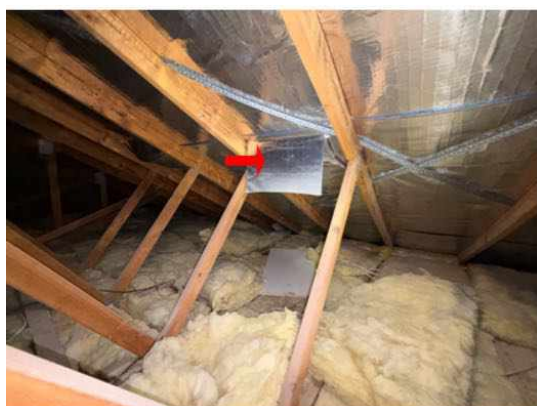
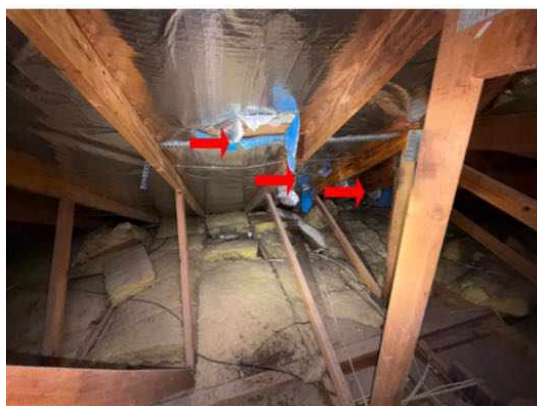
### Finding 3.09

Building:	Main Building
Location:	Roof Void
Finding:	Sarking - Damaged
Information:	Sarking, a laminated aluminium foil applied to the interior of the roof covering, assists in insulating the property and acting as a vapour-barrier to the roof void and, subsequently, to the household.

Where sarking is damaged, both insulation and moisture protection of the property are inhibited. This creates a loss of energy and thus negatively impacts the energy efficiency of the property, allowing potential for moisture ingress from condensation or leaking roof tiles.

It is important to repair any holes or damaged sections of sarking to ensure that the building material is fully functional. A registered builder or qualified carpenter should be consulted to provide further advice on this defect and to perform rectification works at client discretion.

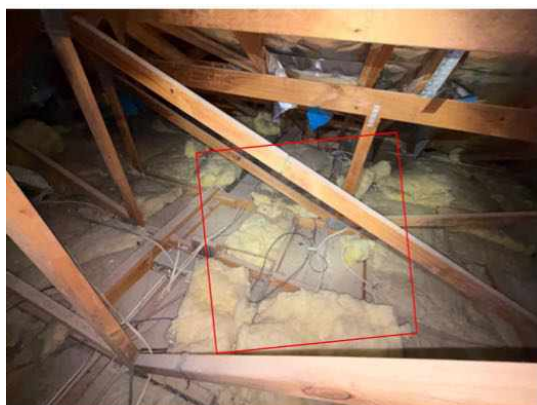
### Finding 3.10

Building:	Main Building
Location:	Roof Void
Finding:	Insulation - Inadequate
Information:	Upon inspection of the roof void it was noted that there is a lack of adequate insulation.

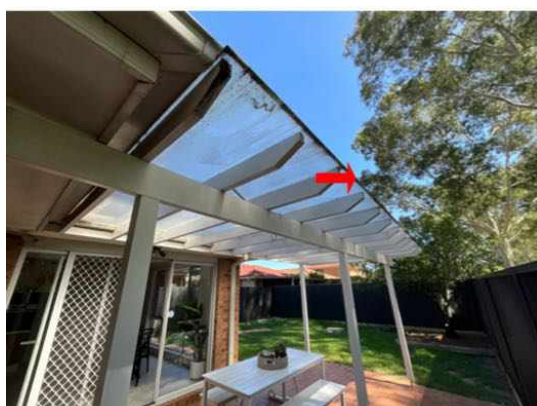
### Finding 3.11

Building:	Main Building
Location:	Alfresco
Finding:	Roof plumbing - Missing
Information:	Some sections of the roof are not adequately drained via gutters and downpipes. Gutters and downpipes that are not installed adequately are likely to result in excessively damp conditions against the exterior surfaces and around the base perimeter of the building.

Excessive moisture creates an environment which accelerates the deterioration of building elements in the area, as well as being conducive to termite and pest infestation. Such an environment is likely to necessitate repair and/or replacement of building elements, which are prone to sustaining wood rot, rust or corrosion.

A roofing plumber should be appointed as soon as possible to install relevant roof plumbing materials. Depending on the extent of the damage, repair and/or replacement of damaged building elements may be required.

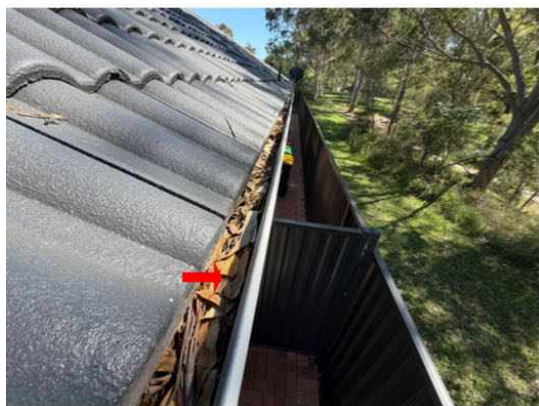
### Finding 3.12

Building:	Main Building
Location:	Gutters >
Finding:	Gutters - Debris
Information:	Roof plumbing structures, such as guttering and downpipes, should be free of all debris to prevent blockages. Blockages of the guttering and downpipes will lead to pooling and accumulated water overflows, which is likely to subsequently flood eaves and exterior walls.

Blocked gutters are likely to lead to high levels of moisture in the affected areas. Such moisture will not only cause rust and decay of the associated building materials, but

can also provide conditions that are conducive to termite and timber pest activity. Blockages in gutters should therefore be removed immediately to ensure dry conditions are maintained.

Consult a Licensed Plumber for further specific advice on remedial works that may be required. In the interim, it is highly advised that blocked gutters be removed by the homeowner or a general handyperson as a matter of urgency.

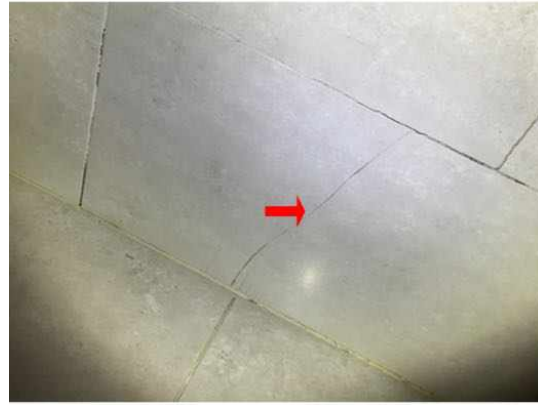
### Finding 3.13

Building:	Main Building
Location:	Ensuite
Finding:	Wet area tiles - Cracked or damaged
Information:	Cracking was evident to the tiling in this area at the time of inspection. While the cracking appears to be minor, this area is frequently exposed to water, allowing potential for water penetration into adjoining sections of walls or flooring.

If left unmanaged, water penetration to these areas may lead to subsequent water damage, which is likely necessitate repair work to affected building elements.

A bathroom specialist should be appointed to determine the integrity of the bathroom waterproofing membrane. If the membrane was found to be intact then relatively minor works to replace the cracked tiles should be carried out to ensure no further damage occurs. The re-application of silicone and grouting throughout remaining tile work is also advised, to further protect the area against water penetration.

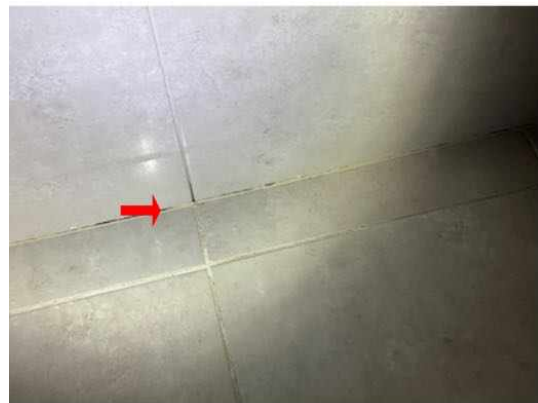
### Finding 3.14

Building:	Main Building
Location:	All Wet Areas
Finding:	Sealant and grouting - Missing or damaged
Information:

It was noted on inspection that sealant or grout is degraded to this area.

Different materials and floor areas move at different rates, generally causing cracking to grout or sealant at this point. A flexible sealant is required to allow for expected expansion and contraction, while keeping the joint water tight and protective of all associated building materials.

Flexible and mould resistant materials should be applied to affected areas to prevent any subsequent water damage that is likely to occur. Regular maintenance and replacement of damage or missing or damaged sealant and grout is highly recommended to the wet areas, as this is a regular wear and tear defect. Sealant and grouting in areas that come into regular contact with water should be maintained for the long term care of your property.

A sealant specialist should be appointed to complete these works as soon as possible.

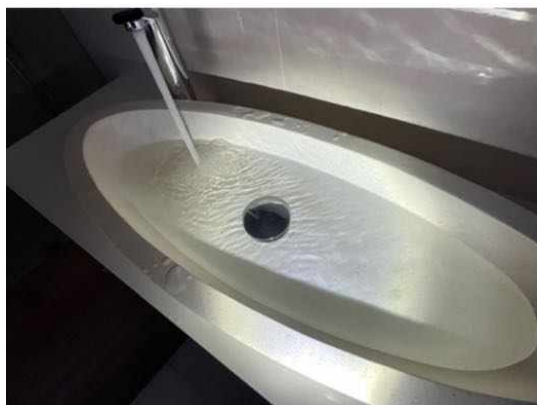
### Finding 3.15

The sink/basin drain appeared to be partially blocked at the time of inspection. Blockages here are usually caused by hair and other debris. If left unmanaged, a lack of general maintenance may lead to the development of more significant defects, such as water damage to surrounding building materials.

A licensed plumber should be appointed to remove the blockage at the client discretion.

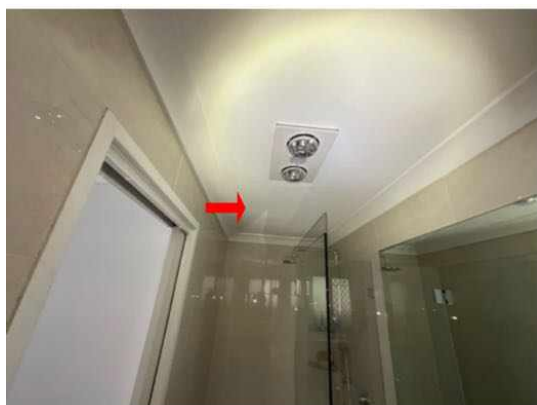
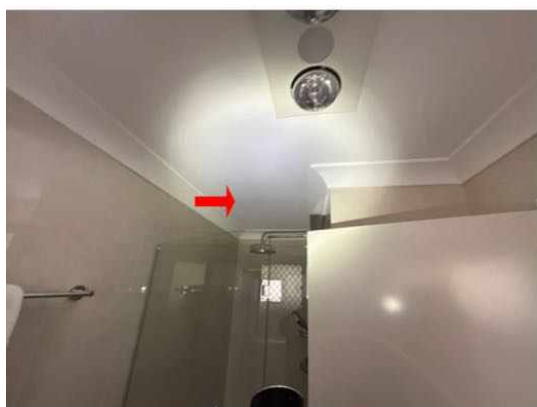
### Finding 3.16

Building: Main Building  
 Location: Ensuite, bathroom  
 Finding: Paint cracking and peeling  
 Information:

Cracking and ultimately flaking of paint can occur for a variety of reasons. Often these failures are due to the fact that the paint has inadequate adhesion and flexibility, both common problems with lower quality exterior flat paints.

When timber is involved, moisture intrusion results in swelling of the wood surface

followed by contraction as the wood dries. The expansion and contraction cycles, can result in cracking and subsequent paint failure by flaking and peeling.

Cracking and flaking can also result when paint is applied too thinly due to overspreading (higher-than-recommended spread rate) or excessive thinning. These practices tend to diminish the paint's final film thickness, so that it is more vulnerable to cracking and flaking.

Inadequate surface preparation can also cause these failures, especially when paint is applied to bare wood or a very porous surface without first applying a primer.

A qualified painter should be appointed to rectify the problem.

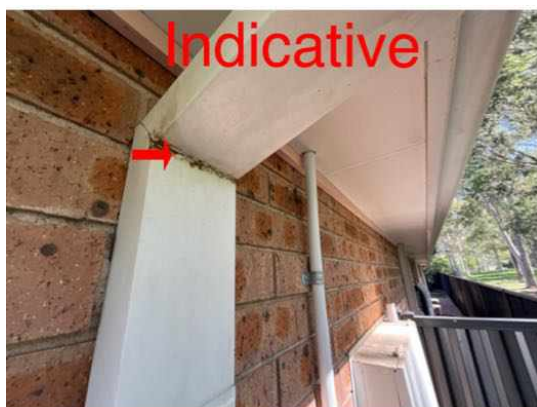
**Finding 6.03**

- Building: Main Building
- Location: Multiple areas of roof plumbing
- Finding: Water leak - External
- Information: Water leaks were found to be present to exterior plumbing work. Leaks are generally caused by deterioration of the plumbing elements over time, due to exposure to weather conditions, but may have also been caused by minor impact damage.

It is highly advised that a licensed plumber be appointed to rectify any water leaks that may be present. Areas of repair and replacement of plumbing fittings and fixtures may be required and, as such, a quotation should be sought.

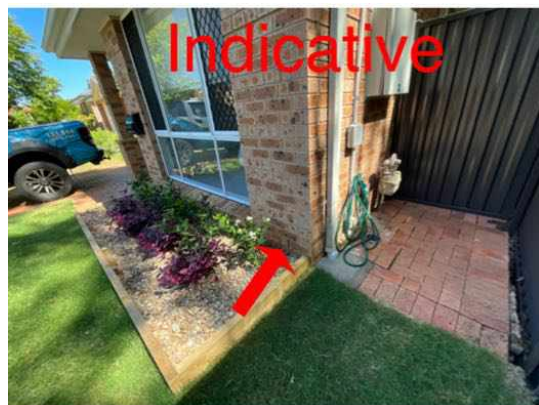
## Finding 6.05

Building:	Main Building
Location:	Perimeter
Finding:	Slab Edge - Exposure
Information:	Slab Edge Exposure: Where external concrete slab edges are not exposed there is a high risk of concealed termite entry. In some buildings built since July 1995 the edge of the slab forms part of the termite shield system. In these buildings an inspection zone of at least 75mm should be maintained to permit detection of termite entry. The concrete edge should not be concealed by render, tiles, cladding, flashings, adjoining structures, paving, soil, turf or landscaping etc. Where this is the case you should arrange to have the slab edge exposed for inspection. Concealed termite entry may already be taking place but could not be detected at the time of the inspection. This may have resulted in concealed timber damage. Does the slab edge inspection zone fully comply?

concealed termite ingress as the slab edge is concealed due to the construction design and cannot be exposed. The type of slab may only be determined by assessment of the construction plans by a qualified person e.g. Builder, Architect. Construction Plans may be obtainable by your local Council or Builder. Termite activity and or damage may be present in concealed timbers of the building. We strongly recommend frequent regular inspections in accordance with AS 3660.2. Where the slab edge is not fully exposed or the slab is an infill slab or the slab type cannot be determined then we strongly recommend inspections every 3 to 6 months in accordance with AS 3660.2 or AS 4349.3.

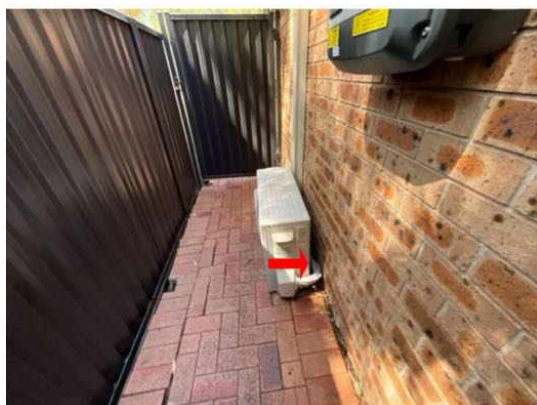
### Finding 6.06

Building:	Main Building
Location:	Slab penetrations
Finding:	Service penetrations
Information:	Services into home can allow for concealed termite entry without additional or adequate termite protection.

It is highly recommended that a licensed plumber be appointed to install adequate drainage to the overflow. These works will ensure that the area remains dry and free of any secondary defects.

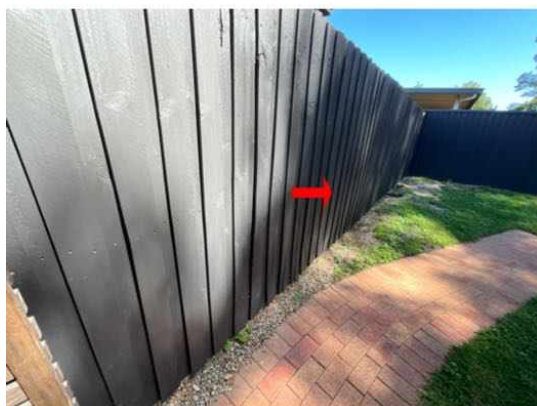
### Finding 6.08

Building:	Main Building
Location:	Alfresco
Finding:	Bridging of termite barrier
Information:	Bridging of termite barriers occurs when termites bridge (usually by building a mud tunnel) a termite barrier or inspection zone or where termites have a passage allowing them to bridge the barrier.

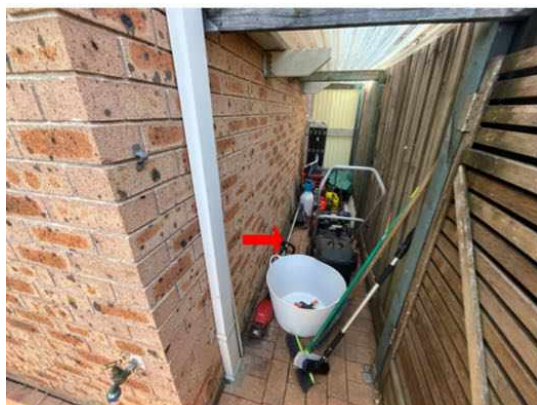
### Finding 6.10

Building:	Main Building
Location:	Yard
Finding:	Stored timbers - subfloor space or external area
Information:	The storing of timbers in the subfloor space or around the external property increases the risk of termite activity being present. As they are likely to come into contact with weather conditions or excessive moisture wood rot is likely to develop on timbers that are not treated.

It is highly recommended that any stored timbers be immediately removed from areas in which they may attract any termite / timber pest attack. Minimisation of risk / prevention of termite attack is far more adequate than dealing with the presence of termite activity.
