Building and Timber Pest Inspection Report

Inspection Date: Tue, 17 Feb 2026

Property Address: 24/6-8 Price St, Ryde NSW 2112, Australia

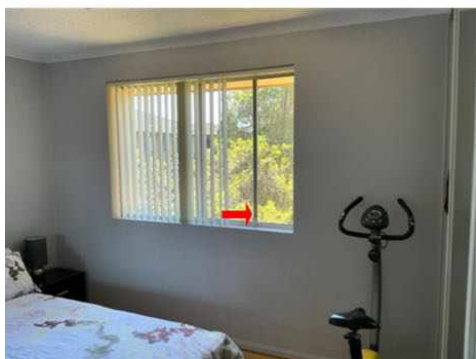
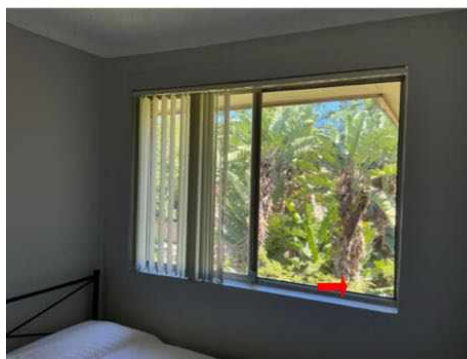
Building:	Main Building
Location:	All Areas
Finding:	Window Restrictors - Recommended
Information:	Upstairs windows did not have window restrictors installed. Although not a requirement at the time of construction, it is advisable to install window opening restrictors on all second storey windows with sill heights below 1.7 meter and potential fall of 2 meters or more.

If you live in a strata scheme, window safety devices must be installed on all applicable windows by 13 March 2018. Residents with safety devices installed can still fully open their windows but it's recommended that devices be engaged whenever children are present, to prevent falls.

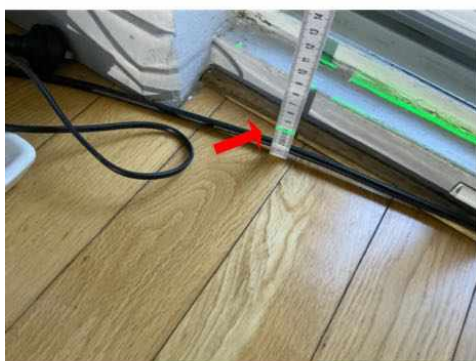
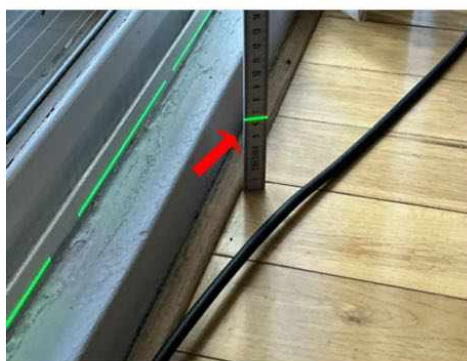
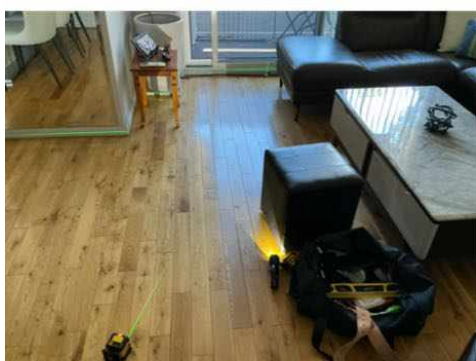
Building:	Main Building
Location:	Living Room
Finding:	Flooring Uneven - Apartment
Information:	The flooring was noted as uneven at the time of inspection. Uneven flooring, where the floor level varies, can be attributed to several factors. Firstly, the subfloor beneath the laminate might be uneven or improperly prepared before installation. This could include

issues such as dips, high spots, or general unevenness that wasn't addressed. Additionally, the laminate planks themselves may not have been acclimated to the room's temperature and humidity levels before installation, causing expansion or contraction after being laid down. Poor installation techniques, such as inadequate use of spacers or improper locking of the planks, can also result in an uneven surface.

Consider hiring a flooring specialist to address the issue at owner's discretion.

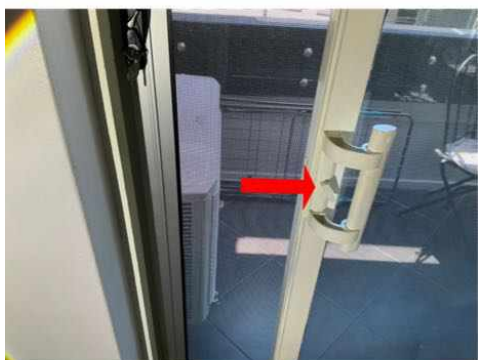
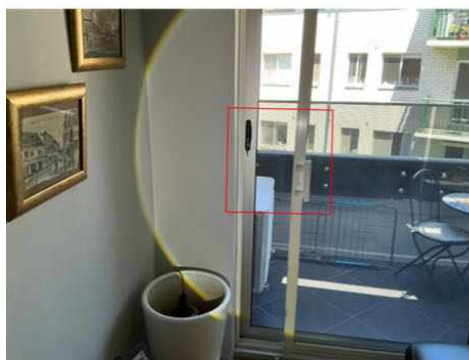
Finding 3.02

Building:	Main Building
Location:	Living Room
Finding:	Lock - Not working
Information:	The lock in this area was not operational at the time of inspection. Where locks have deteriorated to a point where they are no longer usable, the security of the property is immediately compromised.

Repair or replacement of the lock is highly recommended. Consultation with a locksmith or general handyman is required to gain further advice on any added security that may be available for the area.

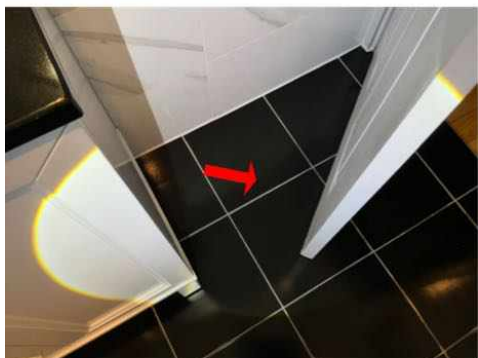
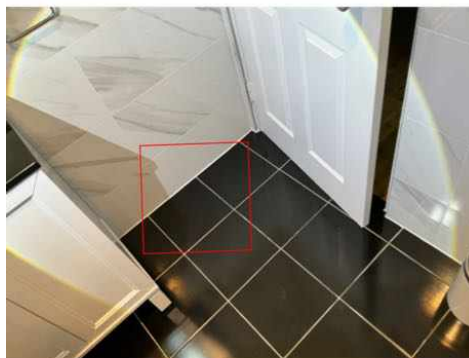
Finding 3.03

Building:	Main Building
Location:	Bathroom
Finding:	Door Stopper(s) - Missing
Information:	At the time of inspection, it was noted that a door stopper was missing in this area.

The absence of a door stopper can lead to potential damage to the door, wall, or surrounding finishes, as the door may swing open too far and impact the wall or adjacent objects. Over time, this can cause dents, scuffs, or even structural damage to the wall or door. It is recommended that a door stopper be installed to prevent further damage and ensure the protection of both the door and the surrounding area.

The client is advised to engage services of a handyman to install the door stopper.

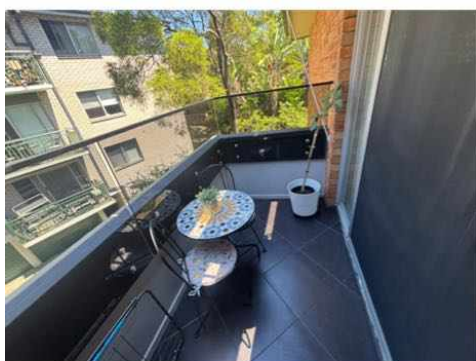
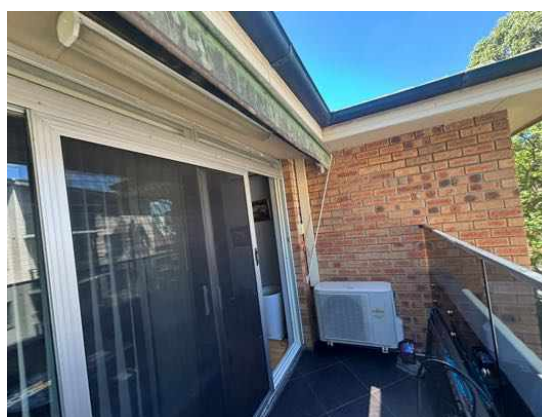
Building: Main Building
 Location: All External Areas
 Finding: Obstructions and Limitations - External Areas
 Information: The attached photographs provide a visual representation of the obstructions and limitations that impeded a full inspection of the external areas of the property at the time of assessment. These obstructions, which may include vegetation, stored items, debris, or other physical barriers, can obscure potential defects and prevent a thorough evaluation of the property's condition. Obstructions of this nature can conceal a wide range of issues, such as structural damage, water ingress, pest infestations, or deteriorating building materials, which may not be visible during the initial inspection.

It is essential that these obstructions be cleared to allow for a comprehensive inspection of the external areas. Removing these barriers will enable a more accurate assessment of the property's condition and allow any hidden defects to be identified and addressed promptly. Failure to do so could result in undetected issues worsening over time, potentially leading to more costly repairs in the future.

Therefore, it is strongly recommended that the obstructions be removed and a re-inspection be scheduled once the affected areas are made fully accessible. This will ensure a complete evaluation of the property's exterior and provide the client with a clear understanding of any potential issues that may have been concealed during the initial inspection.

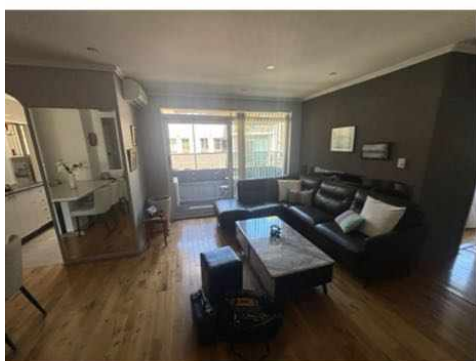
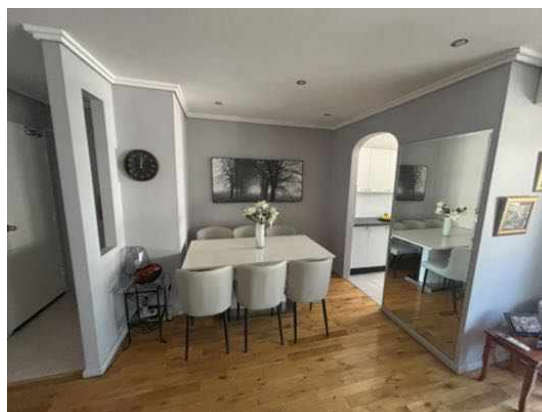
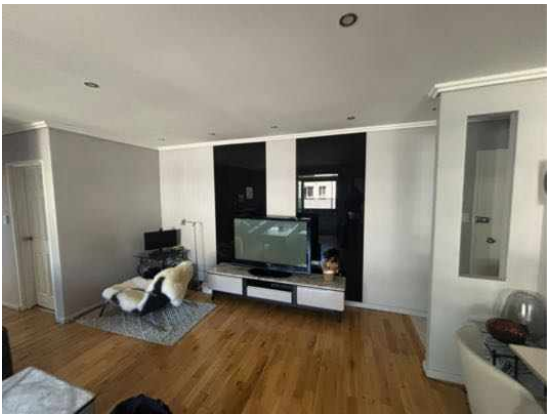
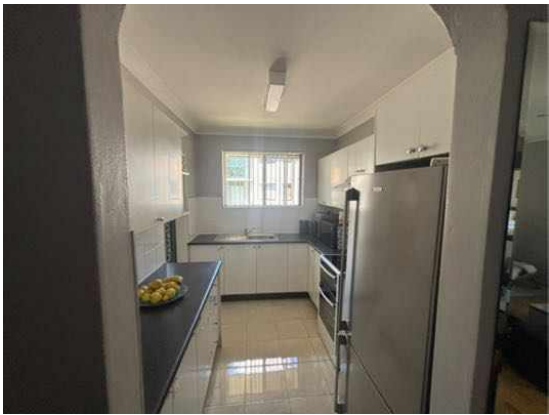
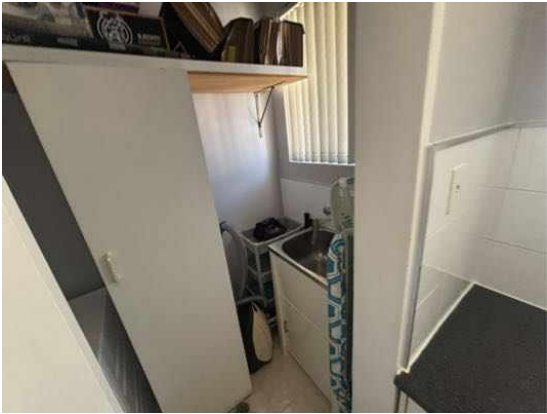
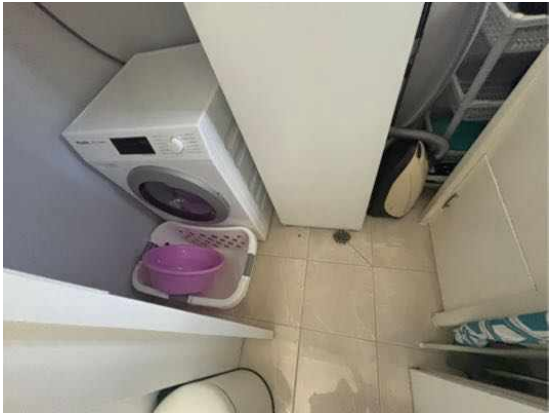
Information: The accompanying photographs provide clear evidence of the obstructions and limitations that restricted a comprehensive inspection of the internal areas of the property at the time of assessment. These obstructions, which may include furniture, personal belongings, stored items, or structural elements such as wall coverings and built-ins, significantly hindered the ability to thoroughly evaluate these areas. It is important to note that such obstructions can potentially conceal a wide array of defects, ranging from hidden structural damage, water leaks, pest infestations, or electrical issues, to deteriorating materials that may not be visible during the initial inspection.

The presence of these impediments means that critical areas of the property were not accessible, and therefore, any underlying defects that may affect the integrity and safety of the property could remain undetected. These hidden defects, if left unaddressed, could worsen over time and may result in costly repairs or pose potential safety hazards to the occupants.

It is highly recommended that all obstructions be cleared to facilitate a complete and thorough inspection of the internal areas. Once the obstructions have been removed and full access is available, a re-inspection should be carried out to ensure that any previously concealed issues can be properly identified and rectified. This follow-up inspection will provide a more accurate assessment of the property's internal condition and help the client make informed decisions about any necessary repairs or maintenance.

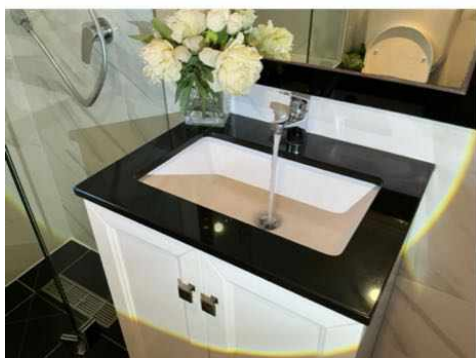
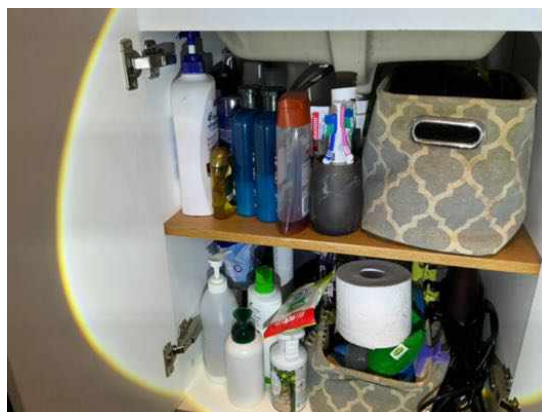
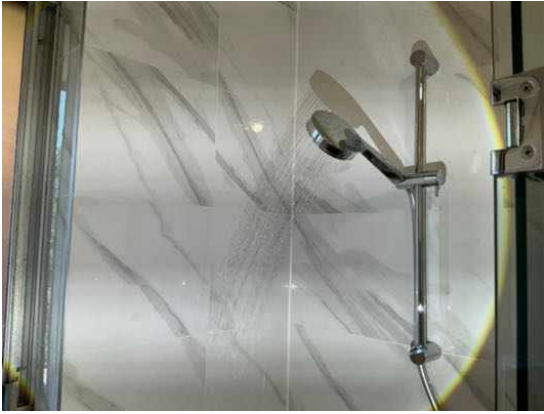
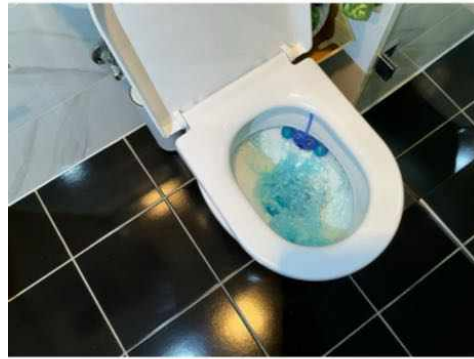
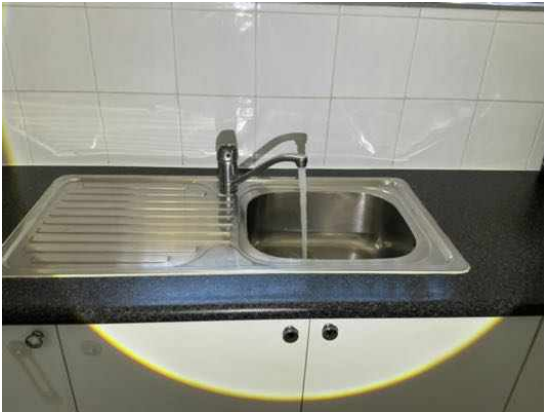
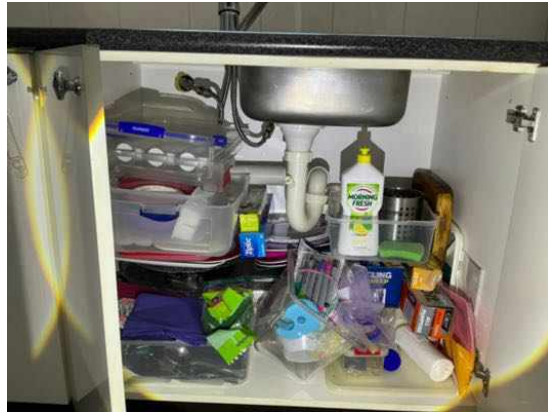
Building:	Main Building
Location:	All Areas
Finding:	FYI - Taps, Drainage & Toilets Tested and Cabinetry Obstructions
Information:	During the inspection, all accessible taps, drainage systems, and toilets were tested for water flow and drainage efficiency, and checked for any visible signs of leakage. At the time of the inspection, no issues were noted in these areas. Unless highlighted in a separate defect statement, no immediate remedial work appears necessary. Supporting images may be found in the additional photos section for reference.

It is important to note that while a visual inspection of cupboards and cabinetry beneath sinks and vanities was undertaken, stored personal items and fixtures presented obstructions that limited full visibility of the internal areas. As per standard inspection practices, inspectors are not permitted to move or disturb personal belongings during the inspection process. Therefore, only visible and accessible sections were inspected, and concealed water damage or plumbing defects may not have been detected.

Given this, a re-inspection is recommended after all obstructions have been cleared to allow for a comprehensive assessment of these areas. Regular maintenance and monitoring of plumbing and drainage systems is also advised to ensure ongoing functionality and early detection of potential issues.

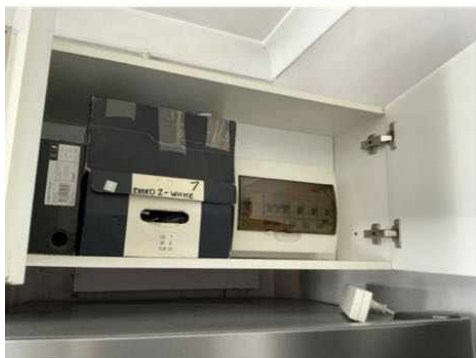
Building: Main Building
Location: Kitchen
Finding: Electrical Meter Box
Information: Electrical meter box is located in kitchen cabinets

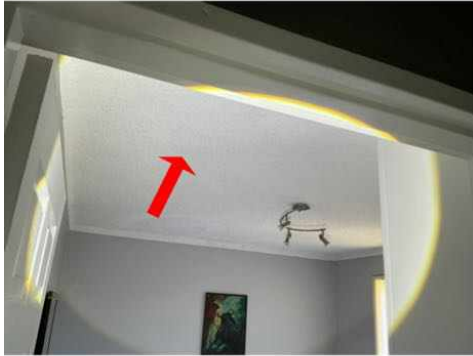
Building: Main Building
Location: All Areas
Finding: Asbestos - Suspected ACM Identified on Site
Information: Reporting on Asbestos is outside the Scope of this Report. This suspected defect is highlighted as a caution only. We suspect, based on our experience in the building industry, that there is a higher risk of the identified building element containing asbestos.

a separate Asbestos Inspection and Condition Audit, which can include the taking of samples for definitive confirmation of the presence of Asbestos.

In the interim, the client is advised to act with caution, especially when considering any damage to building materials general wear and tear renovations extensions demolition and general maintenance activities due to the suspected presence of Asbestos.
