Building and Timber Pest Inspection Report

Inspection Date: Wed, 11 Feb 2026

Property Address: 60 Park Rd, Sydenham NSW 2044, Australia

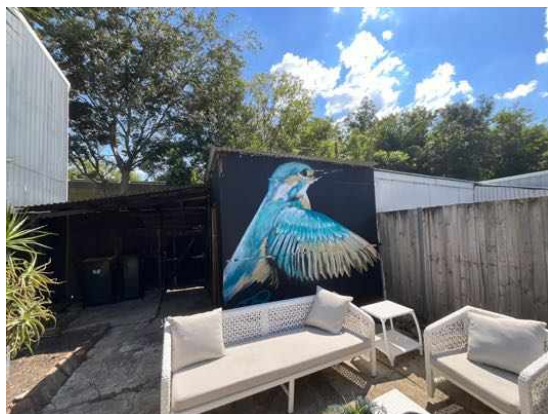
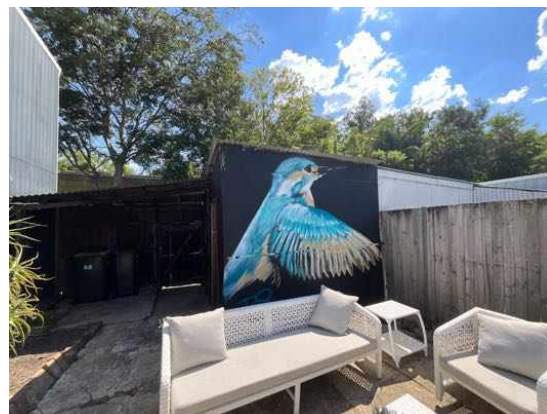
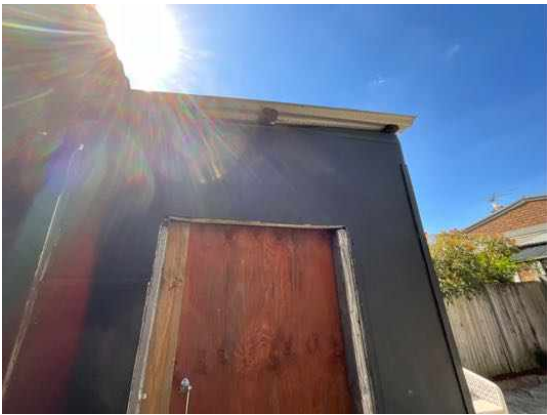
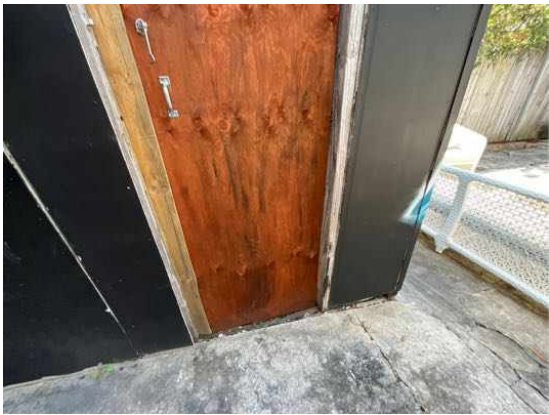
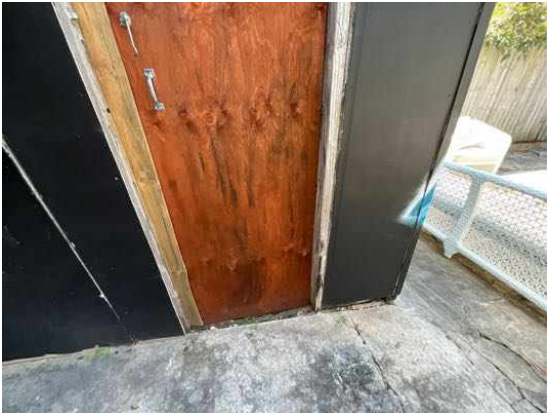
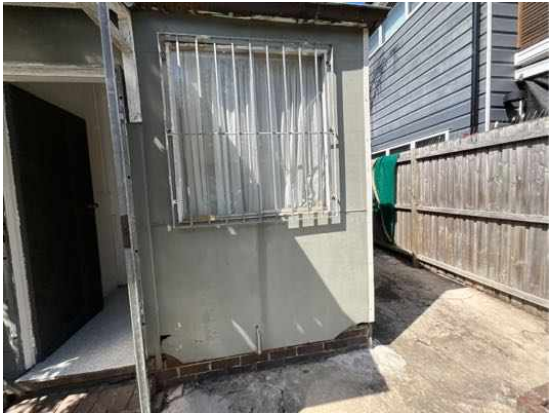
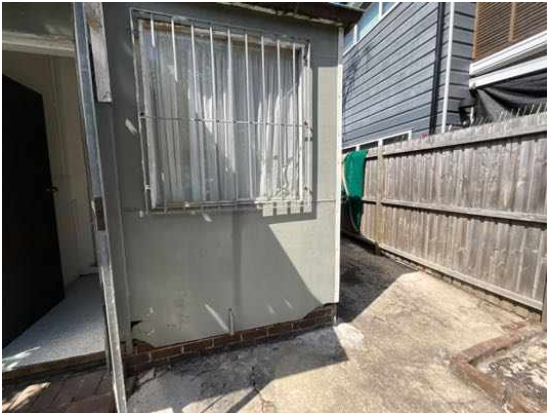
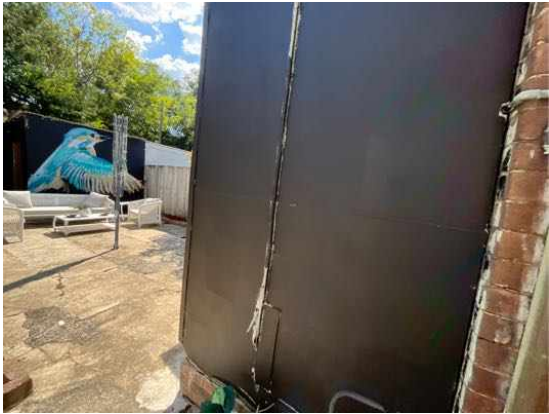
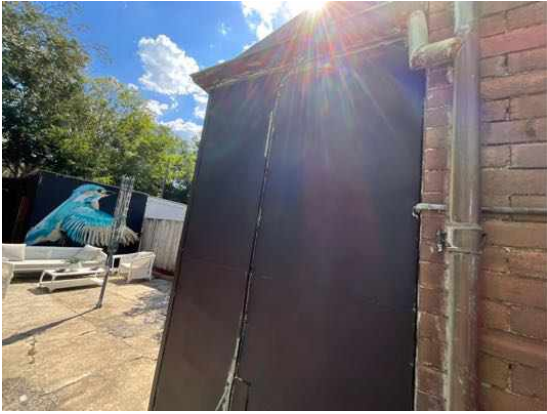
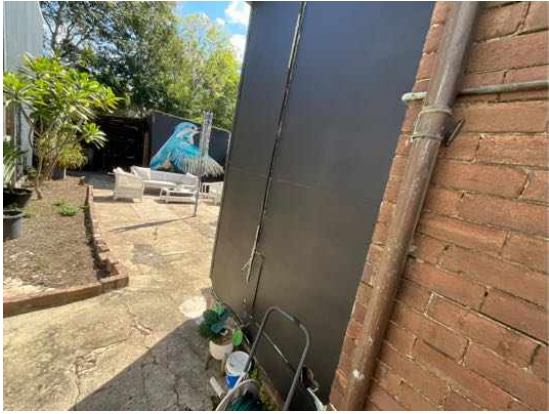
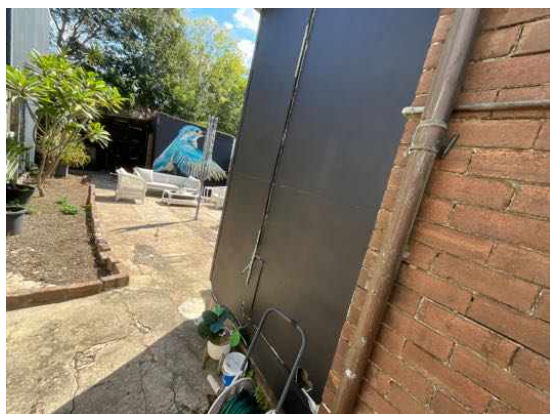
Information: Reporting on Asbestos is outside the Scope of this Report. This suspected defect is highlighted as a caution only. We suspect, based on our experience in the building industry, that there is a higher risk of the identified building element containing asbestos.

As Asbestos Reporting is outside the scope of this report, we advise that you consider a separate Asbestos Inspection and Condition Audit, which can include the taking of samples for definitive confirmation of the presence of Asbestos.

In the interim, the client is advised to act with caution, especially when considering any damage to building materials general wear and tear renovations extensions demolition and general maintenance activities due to the suspected presence of Asbestos.

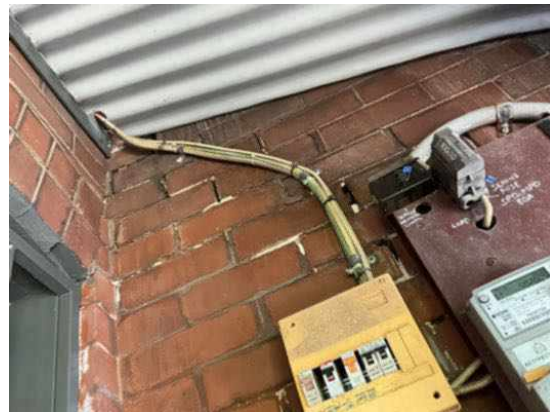
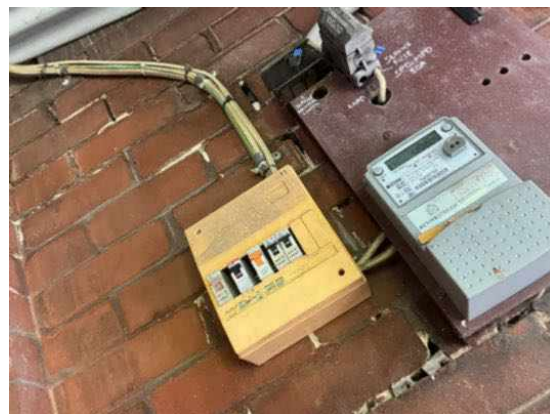
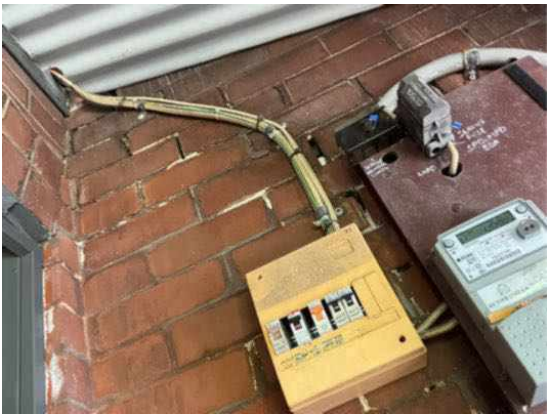
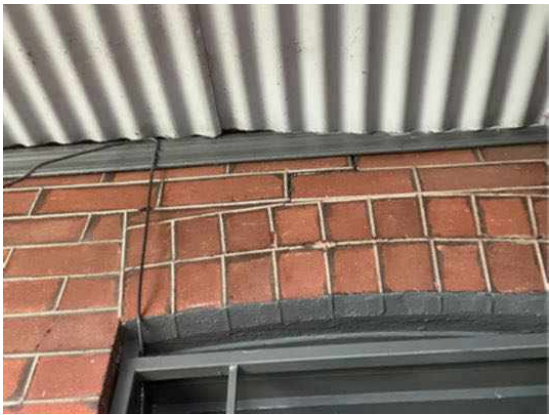
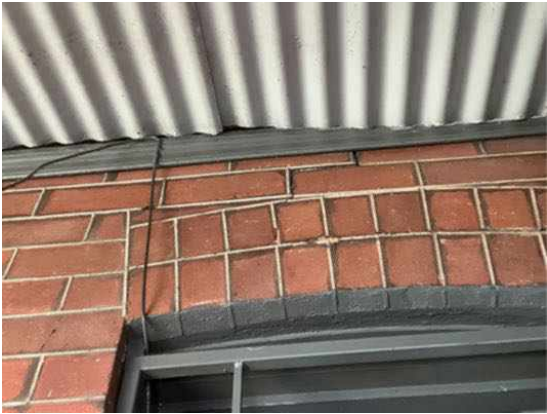
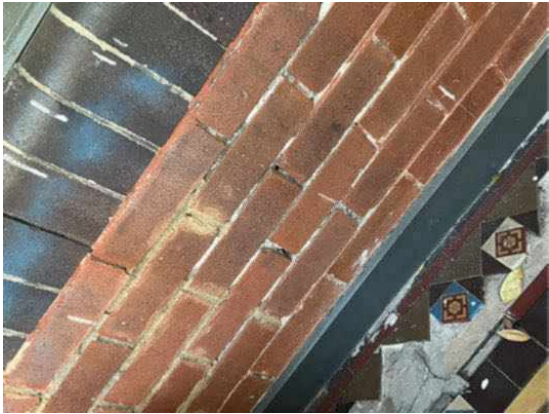
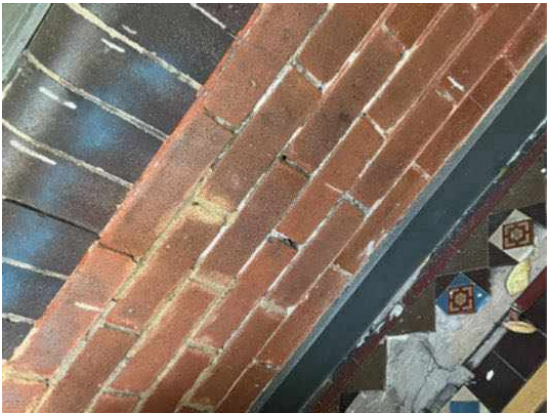
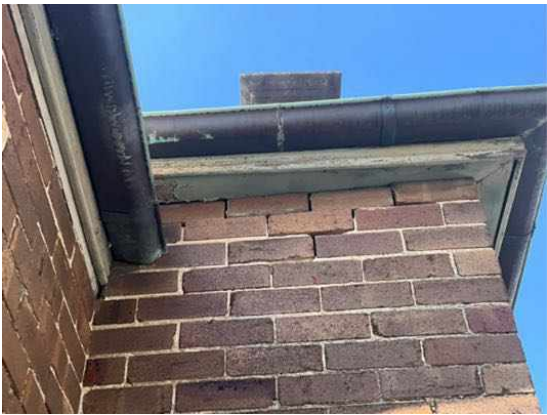
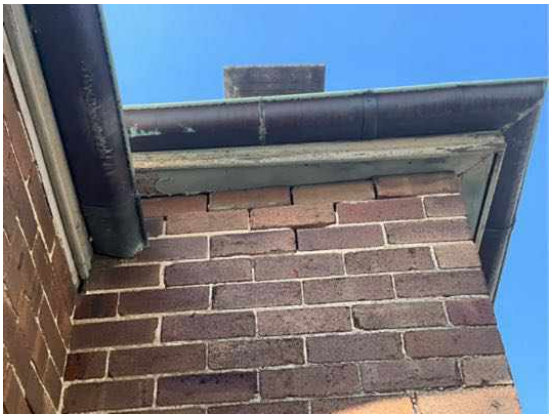
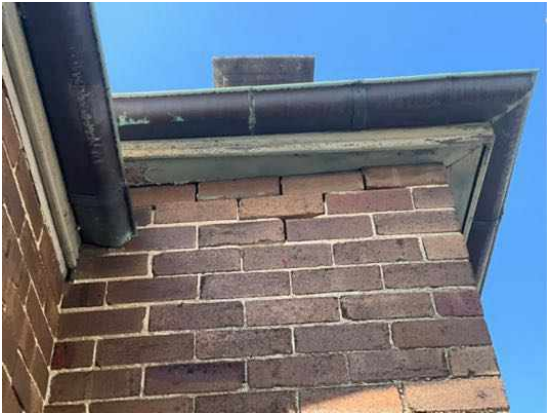
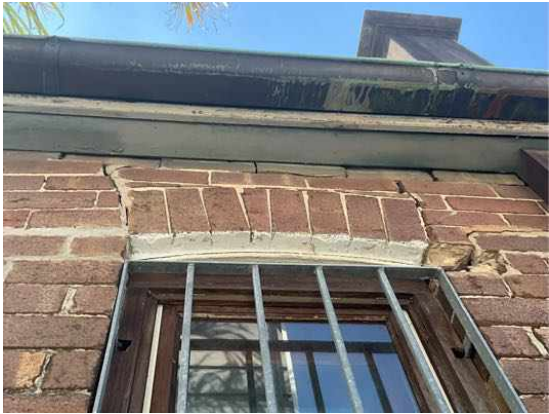
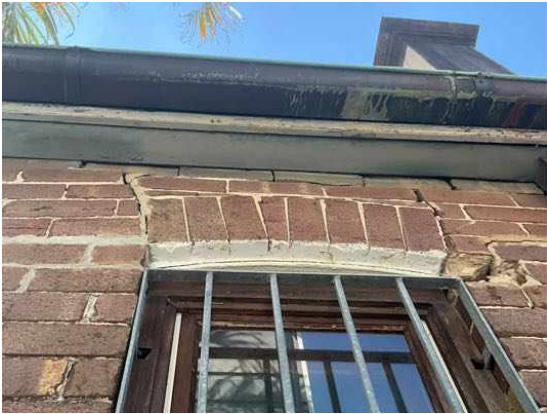
Finding 2.01

Building:	Main Building
Location:	All Areas
Finding:	Brickwork - Cracking in External Wall
Information:	The external wall displays several cracks, some of which follow a stepped pattern, indicative of movement within the structure. The cracks appear to vary in width, and some may be deep enough to compromise the weatherproofing of the wall, potentially allowing water ingress. These cracks suggest either settlement of the foundations, shrinkage, or thermal expansion/contraction of the building materials.

- **Structural Risk:** While the cracks may not indicate immediate danger of structural collapse, they pose a moderate risk by allowing further movement or deterioration over time. If left unattended, these cracks may widen, leading to more severe structural instability.
- **Water Ingress Risk:** There is a high risk of water ingress through the cracks, which could cause internal damage such as mold growth or moisture damage, especially during heavy rainfall.
- **Safety Risk:** If the cracks continue to propagate or are symptomatic of more significant underlying issues (e.g., foundation movement), there could be a moderate to high risk to the structural integrity of the building.

This defect could be classified as a major defect in accordance with Australian Standard AS4349 if the structural movement is confirmed and the cracks are found to be indicative of more severe underlying problems. If the cracks are cosmetic, it may be considered a minor defect but still requires prompt attention.

- **Engage a Structural Engineer:** A structural engineer should be consulted to assess the underlying cause of the cracks, particularly if there is suspicion of foundation movement or structural weakness.
- **Repair by a Licensed Builder:** Once the cause is identified, a licensed builder

experienced in masonry work should undertake the necessary repairs. This may involve crack stitching, mortar repair, or even foundation stabilization if required.

- Monitor for Further Movement: Ongoing monitoring of the area should be conducted to check for further cracking or movement.

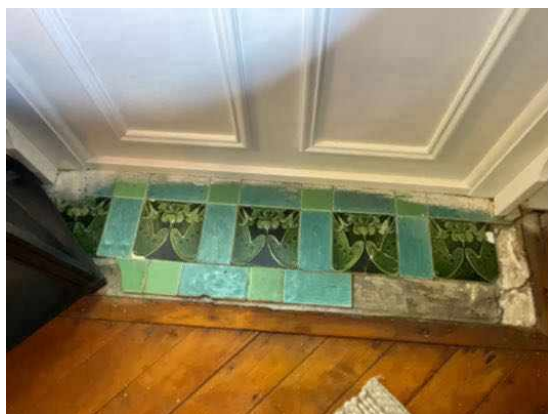
Finding 2.02

Building: Main Building
Location: All Areas
Finding: Uneven & damaged floor tiles
Information: Uneven & damaged floor tiles were observed on the tiled surface.

Uneven tiles present a trip hazard, particularly in high-traffic or outdoor areas, and can lead to personal injury. They may also contribute to water pooling and long-term deterioration of the tile adhesive or substrate.

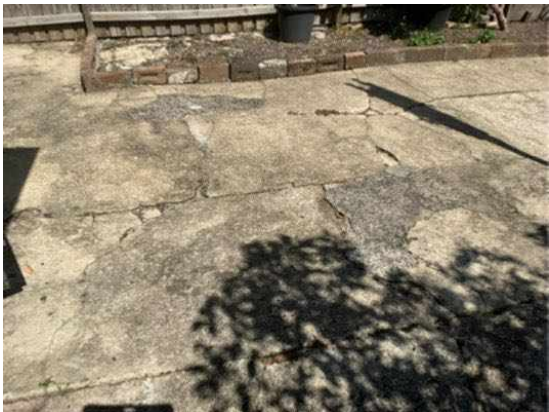
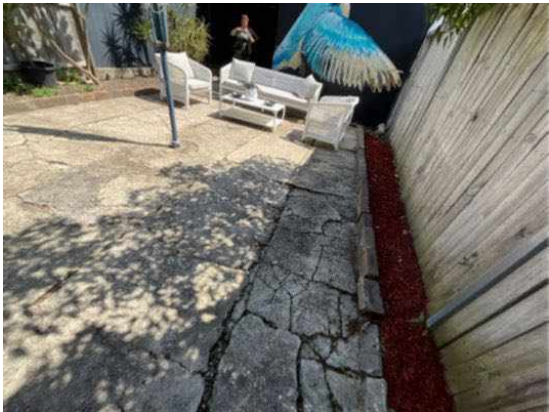
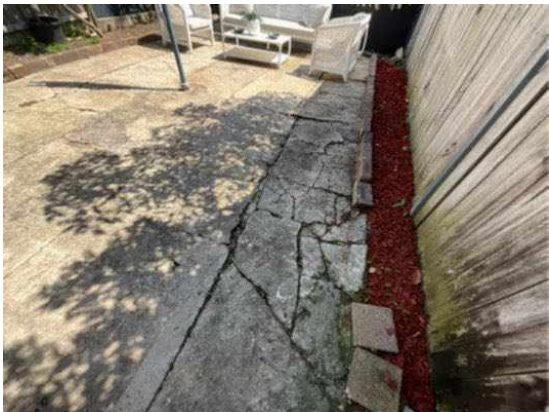
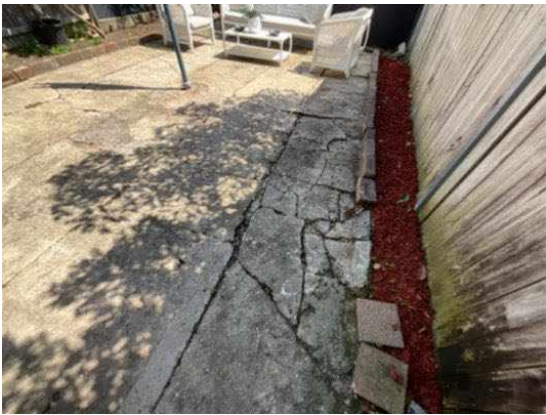
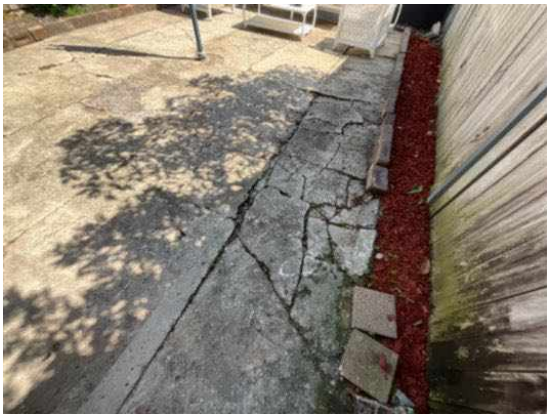
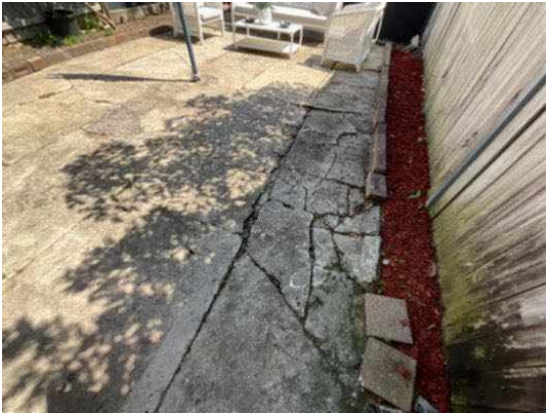
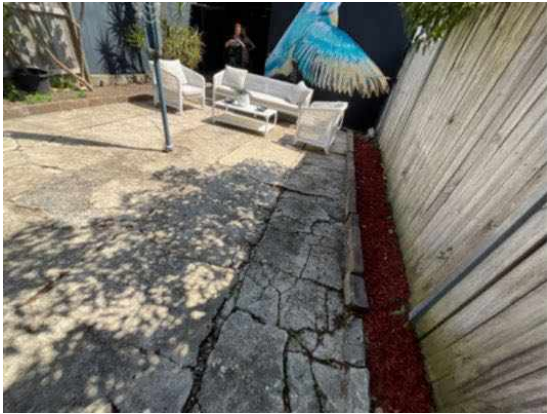
Finding 2.03

Building:	Main Building
Location:	All Areas
Finding:	Noticeable Cracking in Concrete Slab
Information:	Noticeable cracking has been observed in the concrete slab, failing to meet the required construction and quality standards.

- Cracks are visible on the surface and may extend through the depth of the slab.
- Evidence of improper curing or inadequate reinforcement leading to cracking.

- Compromised structural integrity of the slab, potentially leading to failure under load.
- Water ingress through cracks, causing corrosion of reinforcement and further weakening the structure.
- Potential trip hazards and aesthetic issues, reducing the overall value and safety of the property.
- Increased maintenance and repair costs due to ongoing deterioration.

- A structural engineer should be engaged to assess the extent of the cracking and recommend appropriate repair methods.
- A licensed contractor or concrete repair specialist should carry out the recommended repairs under the guidance of the structural engineer.

A detailed inspection should be conducted post-repair to confirm compliance with the required standards and to ensure that the structural integrity of the concrete slab has been restored.

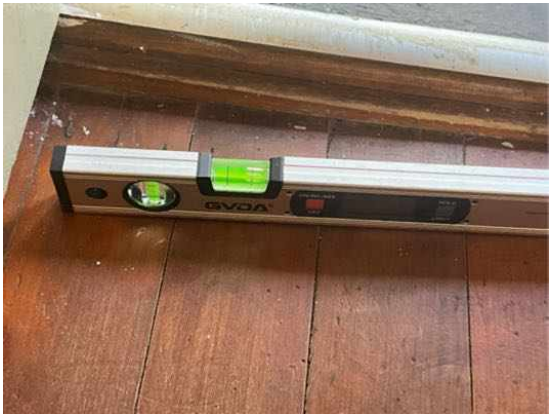
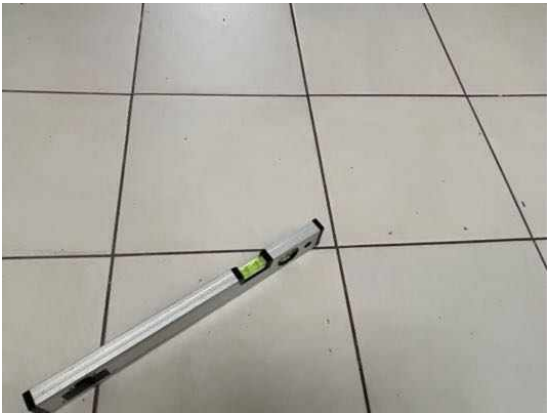
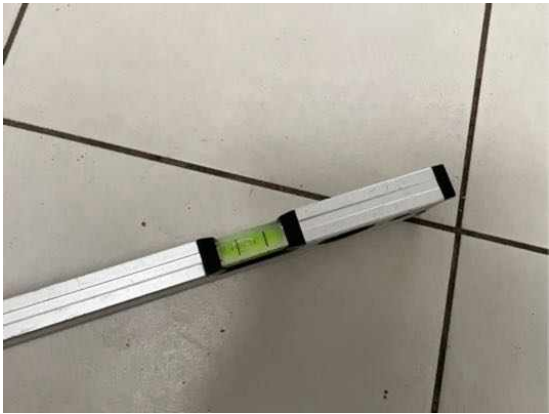
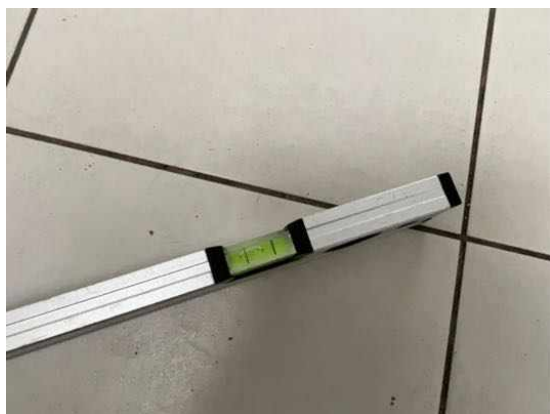
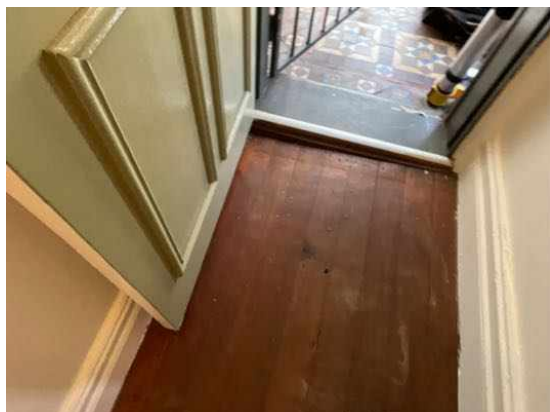
Finding 2.04

Building:	Main Building
Location:	All Areas
Finding:	Uneven / Out-of-Level Internal Flooring
Information:	The internal flooring within the inspected area was observed to be out of level and uneven underfoot. Variations in floor levels can indicate structural movement, which may be associated with foundation settlement, reactive soil movement, or deterioration and/or subsidence of supporting subfloor stumps and bearers.

Given the nature of this defect, a further invasive inspection of the subfloor area is strongly recommended to assess the condition of stumps, bearers, joists, and footings. Access limitations during a visual, non-invasive inspection may prevent full assessment of structural elements.

Repairs, if required, would typically involve re-levelling and/or re-stumping works and should be carried out by a suitably qualified and registered builder experienced in structural rectification works. In some cases, structural engineer assessment may also be required to determine the extent and cause of movement prior to rectification.

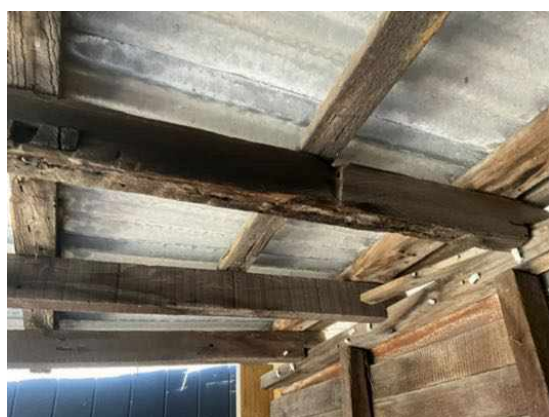
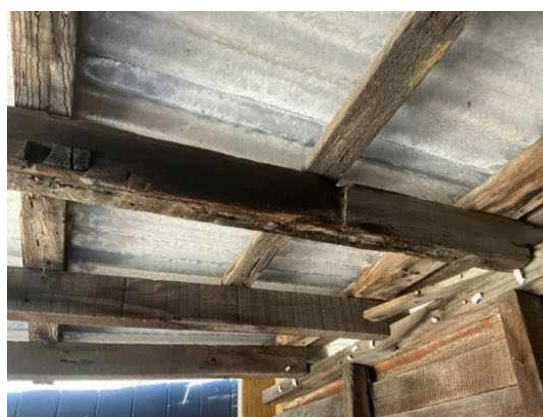
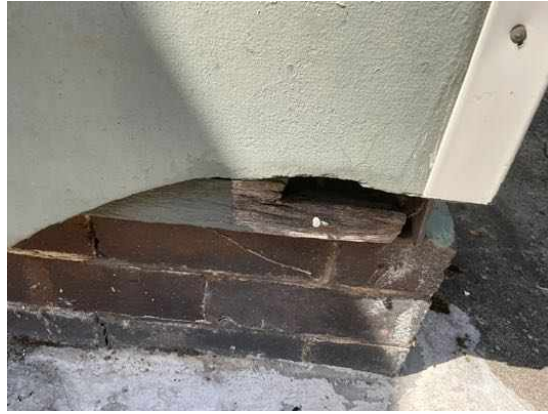
Building: Main Building
Location: All Areas
Finding: Rot weakening the timber structure
Information: Cracks and signs of wood rot have been observed, weakening the timber structure. The deterioration could be due to moisture exposure, aging, or insect infestation, compromising the structural integrity of the timber.

- ****Structural Instability:**** The cracks and wood rot can compromise the load-bearing capacity of the timber, potentially leading to structural failure or collapse, especially in

- **Safety Hazard:** Weakening of the timber structure increases the risk of accidents, such as falling debris or collapse, posing a danger to occupants.

- **Progressive Damage:** If left unaddressed, wood rot can spread, further degrading the timber and accelerating the risk of structural failure.

- **Pest Infestation:** Wood rot can attract pests such as termites, which may cause additional damage.

A structural engineer or professional carpenter should be contacted to assess the extent of the damage. Depending on the severity, repairs may involve replacing the affected timber sections, treating the wood with preservatives, or reinforcing the structure. If there is extensive rot, a specialist in wood restoration or pest control may also be required to prevent further decay or infestation.

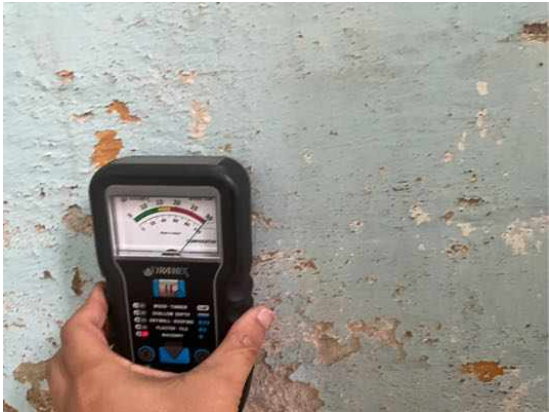
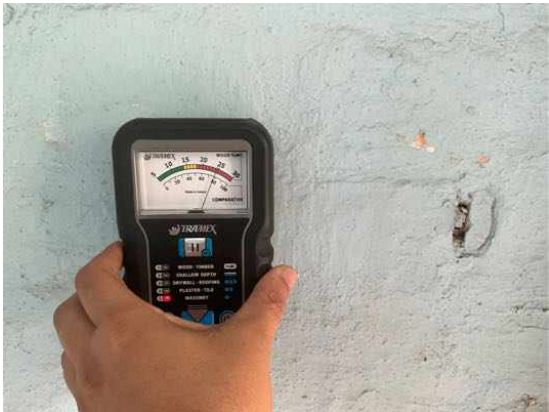
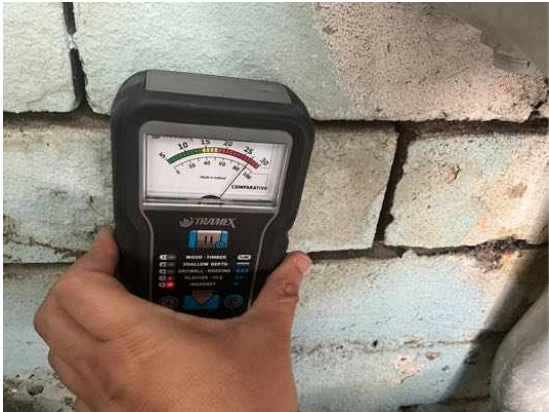
Finding 2.07

Building:	Main Building
Location:	Toilet (WC)
Finding:	Evidence of excessive moisture was present at the time of inspection
Information:	Excessive moisture is present behind the bathroom tiles, indicating a potential water leakage issue within the wall.

The prolonged presence of moisture can lead to mold growth, deteriorate the structure, and create an environment conducive to health hazards. Additionally, it may compromise the adhesive holding the tiles, leading to their detachment.

A licensed plumber or a qualified contractor specializing in water damage remediation

should investigate the source of the moisture, fix any leaks, and address the damage. Additionally, replacing affected tiles and ensuring proper waterproofing are crucial to preventing future issues.

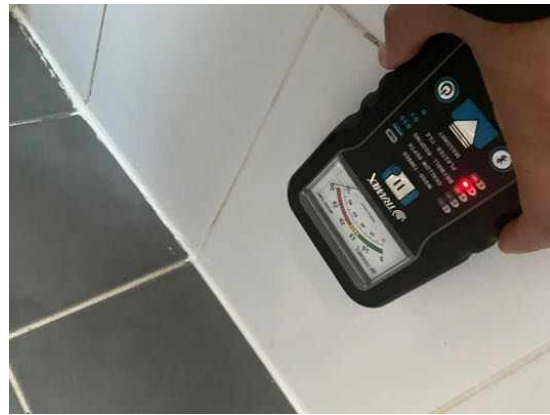
Building:	Main Building
Location:	Bathroom
Finding:	Evidence of excessive moisture was present at the time of inspection
Information:	Excessive moisture is present behind the bathroom tiles, indicating a potential water leakage issue within the wall.

The prolonged presence of moisture can lead to mold growth, deteriorate the structure, and create an environment conducive to health hazards. Additionally, it may compromise the adhesive holding the tiles, leading to their detachment.

A licensed plumber or a qualified contractor specializing in water damage remediation should investigate the source of the moisture, fix any leaks, and address the damage. Additionally, replacing affected tiles and ensuring proper waterproofing are crucial to preventing future issues.

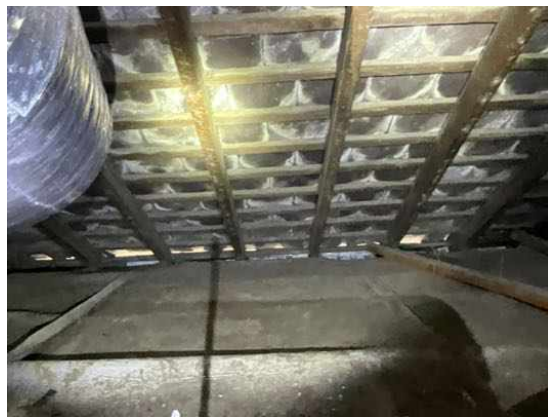
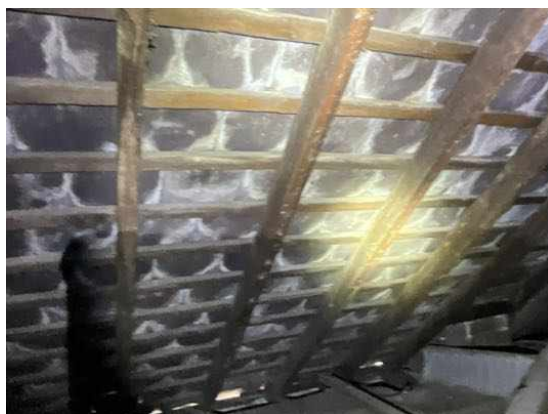
Finding 2.11

Building:	Main Building
Location:	Roof Void
Finding:	Roof void - Suspected water leak
Information:	Suspected water leak in the roof void, as evidenced by the presence of water stains, indicating potential gaps or holes.
Risk:	<ul style="list-style-type: none"> • Structural Damage: Continuous water leakage can weaken the structural integrity of the roof and ceiling, leading to potential collapse.

- Mold and Mildew: Persistent moisture can promote the growth of mold and mildew, posing health risks such as respiratory problems and allergic reactions.
- Electrical Hazard: Water intrusion near electrical wiring can create a risk of short circuits, fires, or electrical shocks.
- Insulation Damage: Prolonged exposure to moisture can damage insulation, reducing its effectiveness and increasing energy costs.

A licensed roofing contractor should be contacted immediately to inspect, diagnose, and repair the source of the leak to prevent further damage.

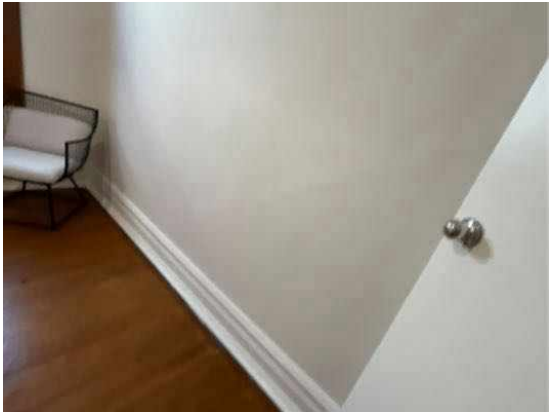
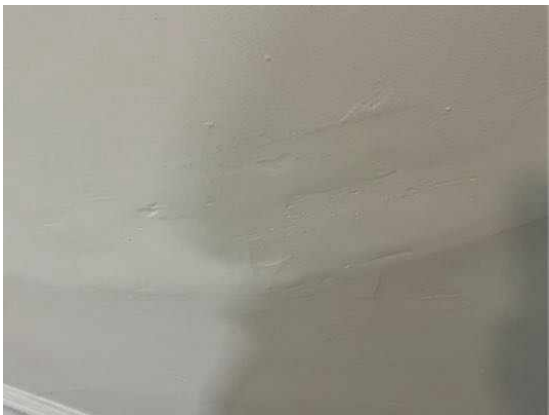
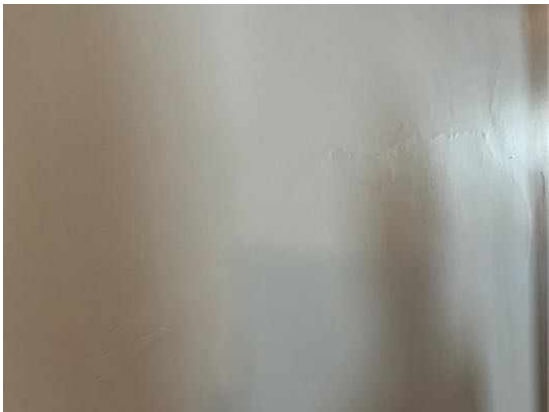
Risk: Poor workmanship poses a range of risks, including compromised structural integrity, potential safety hazards, and a decreased lifespan of the structure. It may also lead to aesthetic and functional issues.

Resolution: A qualified contractor or construction professional should be consulted to assess and address the poor workmanship. They can implement corrective measures to ensure structural soundness, safety, and overall quality of the construction.

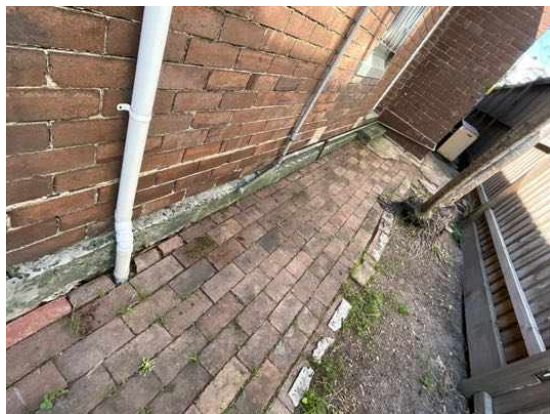
Finding 3.03

Information: The perimeter paving or ground levels were found to have an inadequate slope away from the adjoining building structure, creating potential for water pooling in this area.

Perimeter paving is required to fall from the building by a minimum of 25mm in the first metre and bare ground should fall away from the house by 50mm in the first meter. This standard ensures that excessive moisture does not pool around the base of building structures, which creates potential for water and structural damage, as well as making the area susceptible to termite and timber pest activity.

Where paving or ground levels do not have adequate fall, a licensed paving contractor should be appointed to install or remove and re-level pavement.

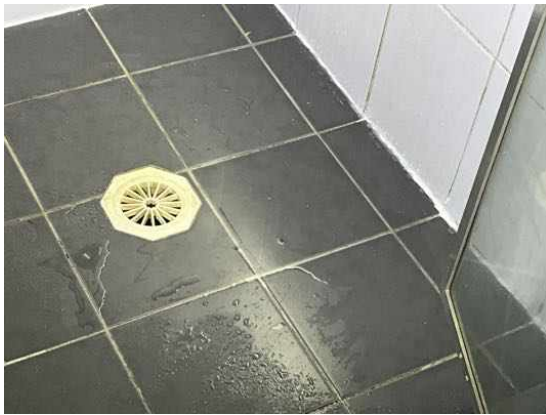
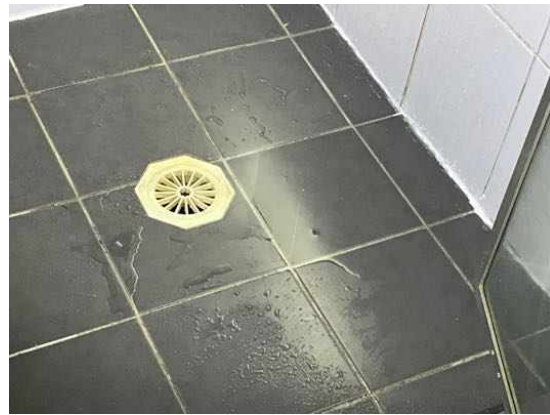
Finding 3.04

Building:	Main Building
Location:	Bathroom
Finding:	Shower base - Water pooling
Information:	Evidence of water pooling around the floor waste in the shower recess was noticed at the time of inspection. It is suspected that this excessive moisture is attributed to insufficient fall in the shower floor tiles.

This pooling is minor overall but is still considered unsatisfactory, as standard tiling practices would not permit this situation to occur. Pooling water around floor wastes can create a slip hazard in extreme cases and create conditions that are conducive to mould growth over time. Where left unmanaged, the degradation of sealant and grouting is also likely to occur, possibly necessitating further repair works.

Remedial works may involve some sections of tiling and flooring repair and replacement. A tiling contractor or bathroom specialist should be appointed to provide further advice on reparation options and to perform works as necessary.

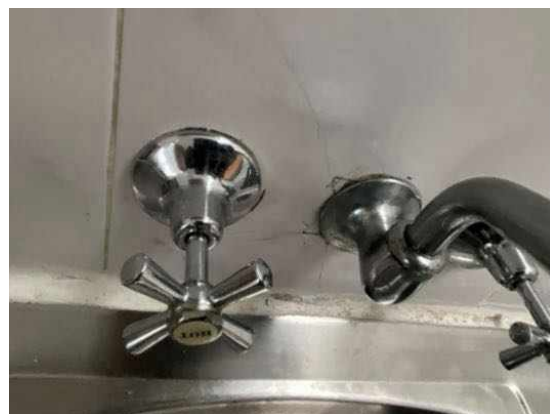
Finding 3.05

Finding: Tiles - Cracked or damaged

Information: Cracking was evident to the tiling in this area at the time of inspection. While the cracking appears to be minor, this area is frequently exposed to water, allowing potential for water penetration into adjoining sections of walls or flooring.

If left unmanaged, water penetration to these areas may lead to subsequent water damage, which is likely necessitate repair work to affected building elements.

A tiling contractor should be appointed to ensure that no further water damage occurs. The re-application of silicone and grouting throughout remaining tile work is also advised, to further protect the area against water penetration.

Where water penetration has led to water damage, appointment of a relevant tradesperson may be required to repair damaged building elements.

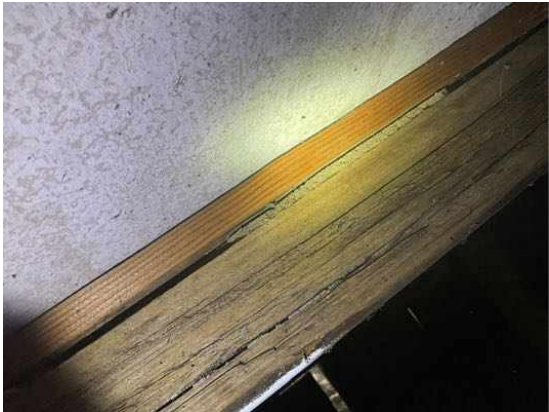
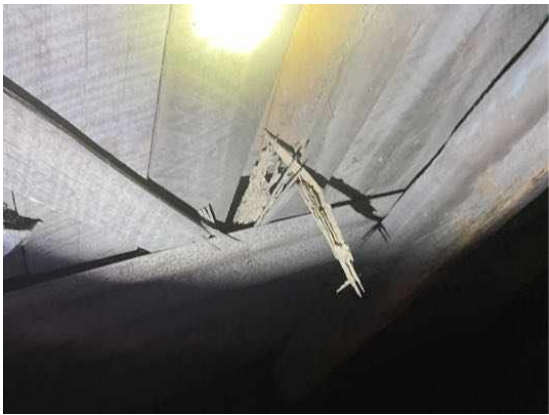
It is advised that the area be visually inspected frequently to ensure that the condition of affected building materials does not worsen.

A licensed pest controller must be appointed to provide a further invasive inspection.

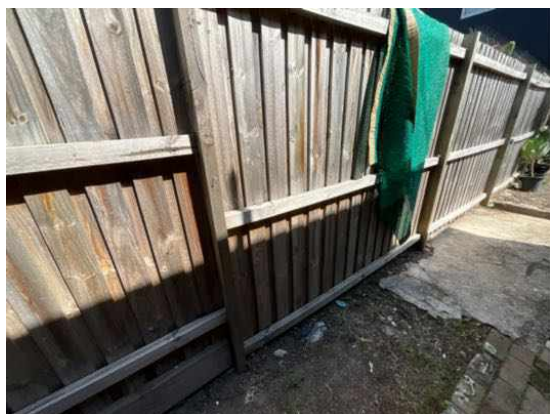
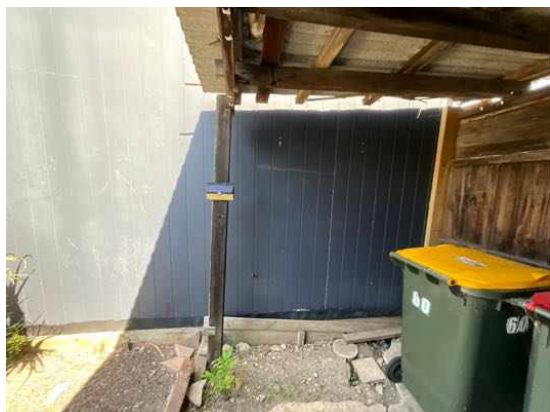
To prevent this, it's important to keep timber elevated and away from direct ground contact. Regular inspections and proper termite control measures are also essential to protect your wooden structures from termite damage.

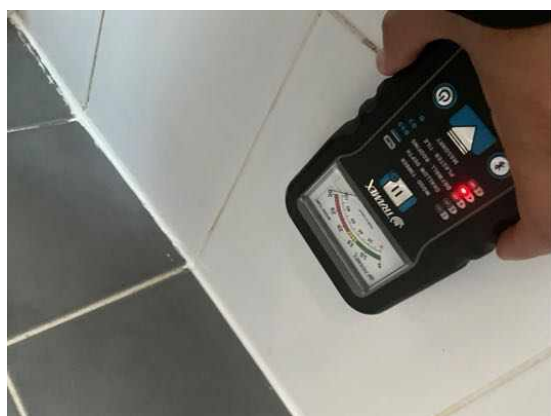
Finding 6.03

Building:	Main Building
Location:	Toilet (WC)
Finding:	Excessive moisture - Conducive to Timber pest
Information:	Excessive moisture can attract termites and produce conditions that promote fungal growth and wood decay.

Prior to any remedial works being performed a qualified plumber should be appointed to further inspect the property and to identify the cause of the excessive moisture. Works to remove affected building elements may then be necessary and should be performed by an appropriate tradesperson.

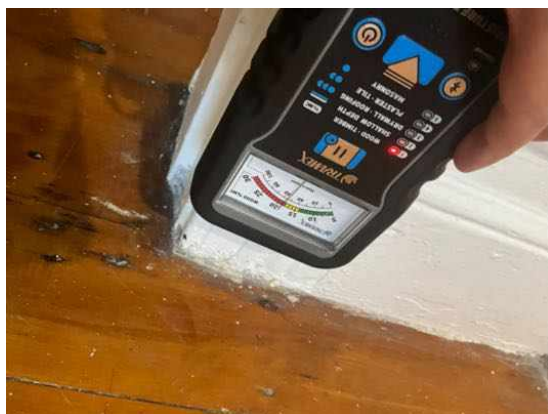
Finding 6.05

Building:	Main Building
Location:	Kitchen
Finding:	Excessive moisture - Conducive to Timber pest
Information:	Excessive moisture can attract termites and produce conditions that promote fungal growth and wood decay.

performed by an appropriate tradesperson.

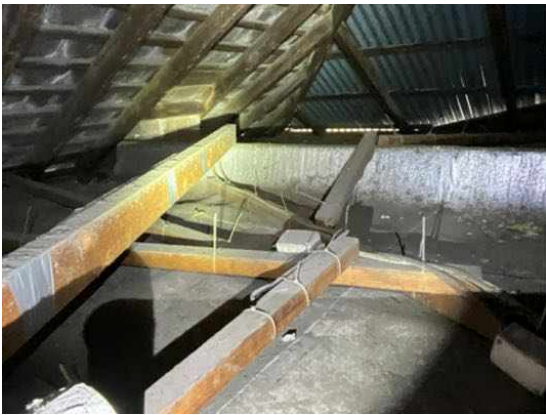
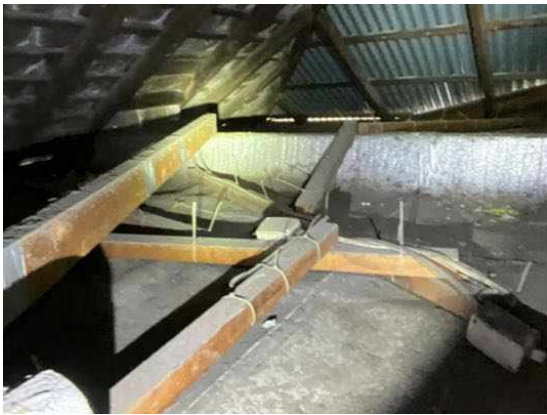
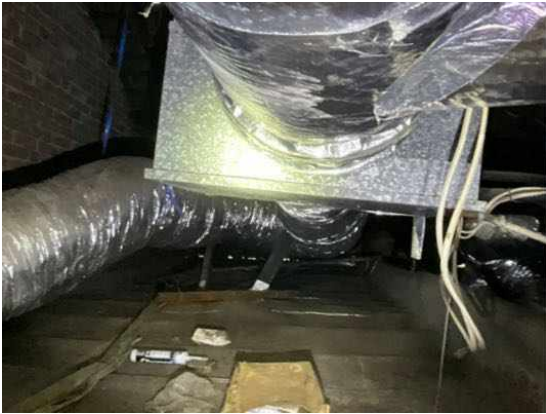
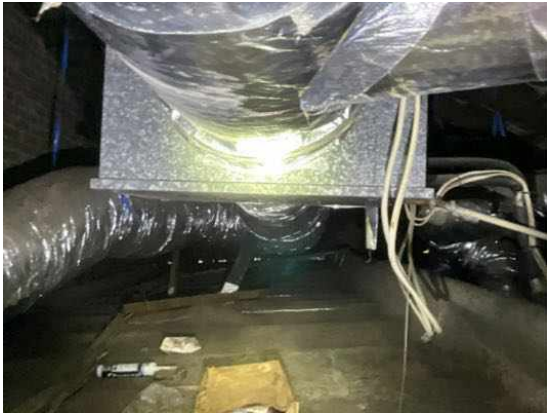
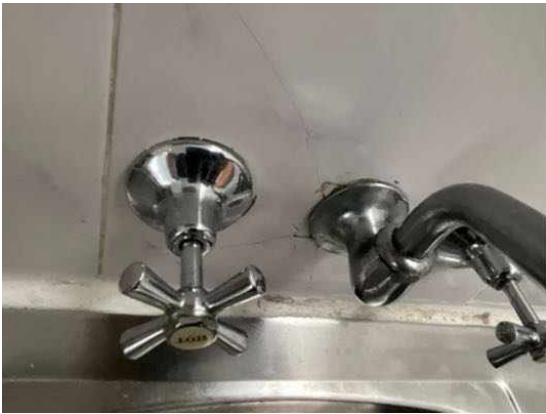
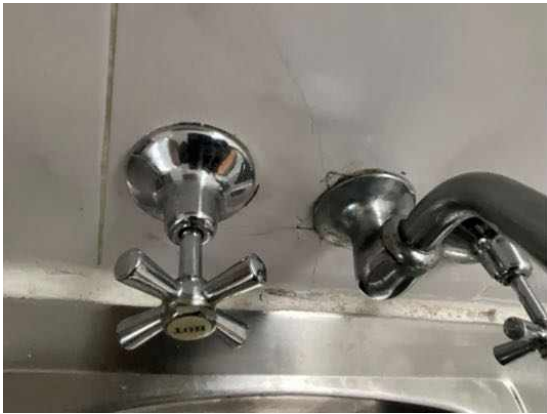
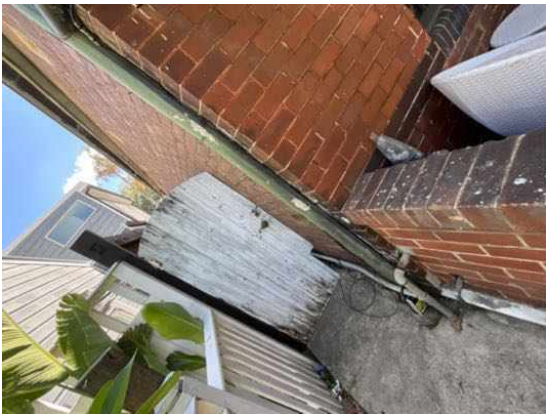
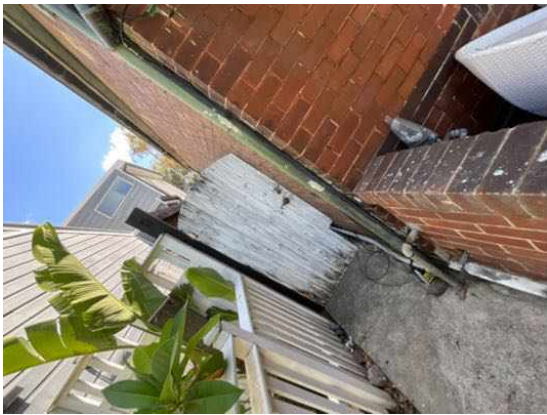
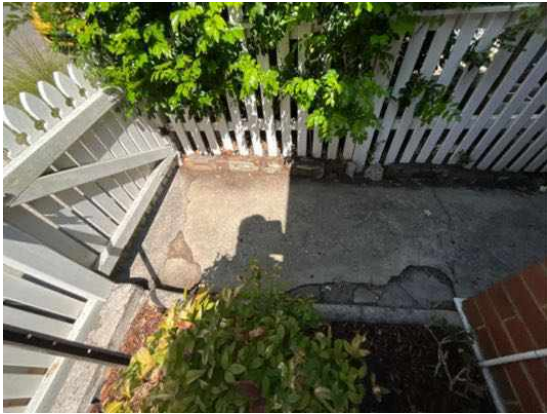
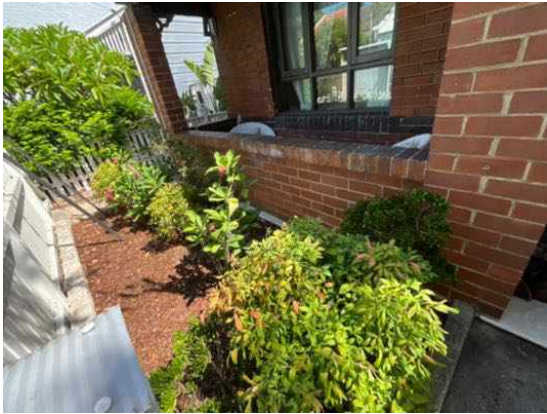
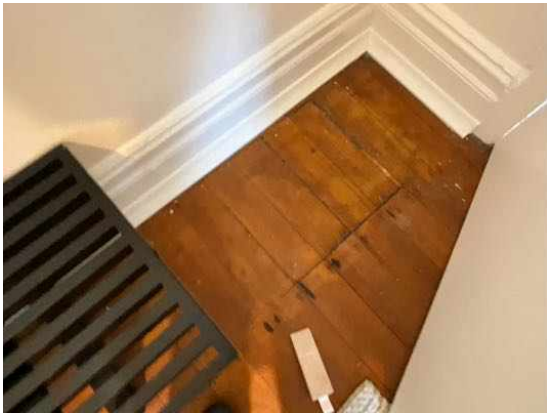
Building: Main Building
Location: All Areas
Finding: Additional Photos - Obstructions and Limitations
Information: These photographs are an indication of the obstructions and limitations which impeded full inspection of the property at the time of inspection. These obstructions can hide an array of defects and should be removed to allow full inspection to be carried out. A re-inspection is recommended once the areas are made accessible.
