Building and Timber Pest Inspection Report

Inspection Date: Wed, 25 Mar 2026

Property Address: 6 Kirkwood Cres, Colebee NSW 2761,
Australia

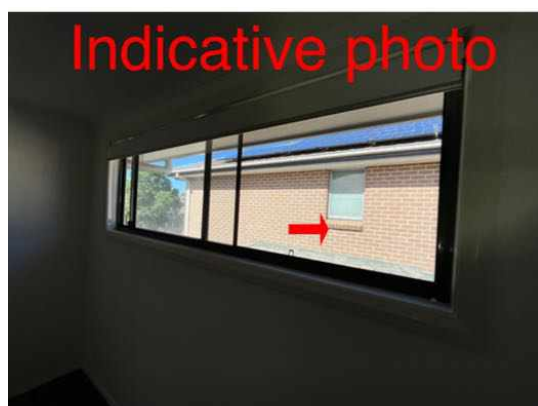
Building:	Main Building
Location:	Upstairs Windows
Finding:	Window restrictions - Missing
Information:	Window restrictors were found to be missing.

The National Construction Code (NCC) requirements apply to all openable bedroom windows in residential buildings, including hotels, motels and for all windows in early childhood centres.

Windows need to be locked at 12.5cm when the devices are engaged. The safety devices must be robust and child proof. The alternative is security screens such as bars or grills on the windows so long as they have gaps no bigger than 12.5cm. Flyscreens do not comply unless they are the reinforced security type and capable of resisting the very strong outward pressure which would prevent a child falling through. The laws apply to openable windows in a building within 1700mm of the internal floor and if the internal floor is more than 2m above the ground floor outside.

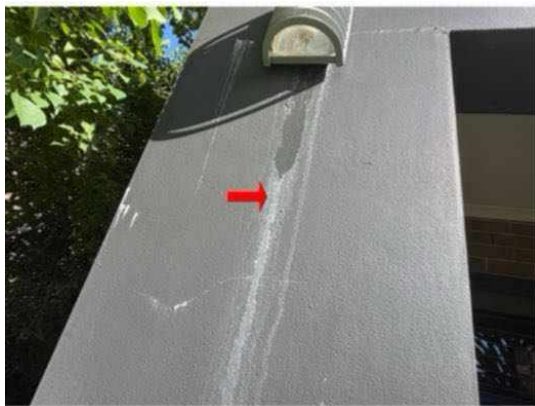
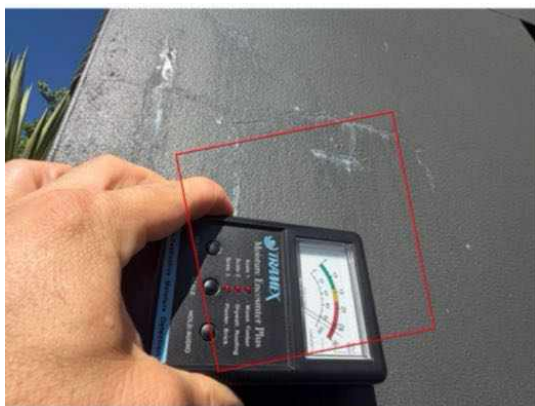
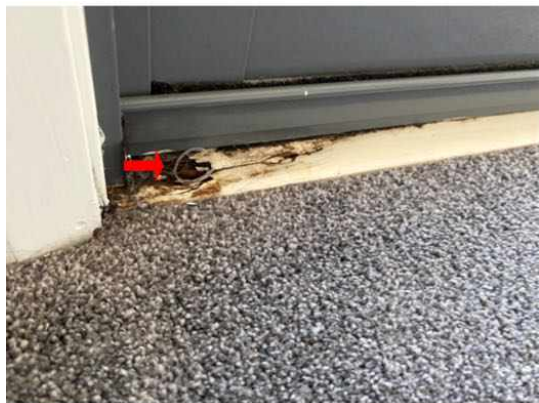
Finding 2.01

Building:	Main Building
Location:	Balcony
Finding:	Water leak - Internal
Information:	A water leak is expected in this area at the time of inspection due to the balcony floor waterproofing failure. Internal water leaks can be detrimental to surrounding building elements.

Rust, corrosion, decay and water damage are potential outcomes where a minor water leak is left unattended. More serious defects may also result, such as electrical hazards, or water damage to structural building elements.

In extreme cases, structural damage may develop due to a prolonged water leak. It is highly advised a licensed plumber be advised for further investigation. Major works should be expected and must be carried out by licensed builder.

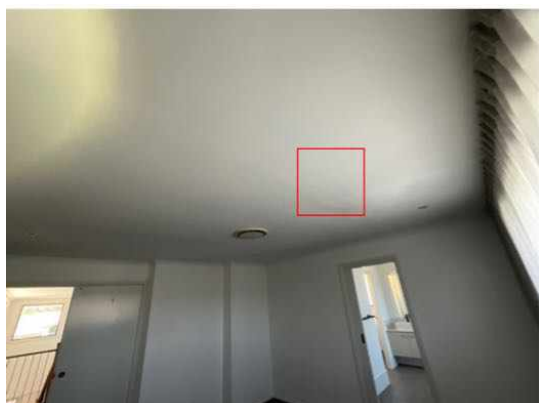
Finding 3.01

Building:	Main Building
Location:	Bedroom - Master
Finding:	Ceiling - Sagging
Information:	Sections of the ceiling were found to be sagging at the time of inspection. Sagging to the fixed ceiling structure generally indicates that the building materials have swollen, due to contact with water, or that fixings (e.g. nails or glue) have become loose and require reattachment.

Where minor sagging is evident, comparatively minor works, such as re-gluing of ceiling sheets, may be required. Such works may be performed by relevant tradespeople, such as plasterers and painters. Where excessive moisture has caused the roofing structure to swell and sag, the source of the water leak should primarily be identified prior to any remedial works being performed. A licensed roof plumber must be appointed for this work.

The appropriate action should be taken by the client as soon as possible to ensure that any potential further damage is limited.

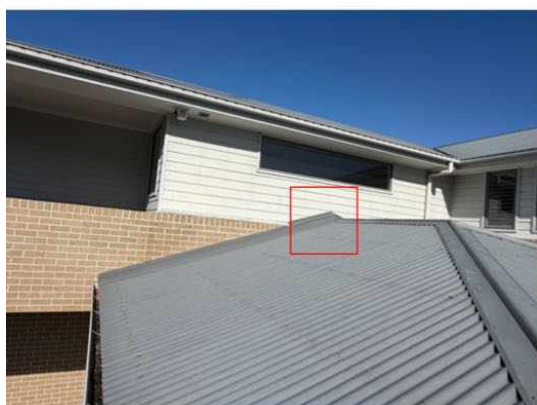
Finding 3.02

Building: Main Building
 Location: Garage
 Finding: Roof plumbing - Flashing inadequate
 Information: Some sections of the roof are missing or have inadequate roof flashings. Flashings are metal and other materials which are applied to seals and intersections between roof coverings and building elements. They are designed to aid in weatherproofing of roof joins.

Flashings that are not installed adequately or are missing are likely to result in water penetration to the interior of the property, as well as creating excessively damp conditions against the exterior surfaces and around the base perimeter of the building.

Premature ageing and secondary building defects are imminent where roof plumbing is missing or inadequately installed. Additionally, water pooling also creates an environment that is susceptible to termite and pest infestation.

A licensed roofing plumber should be appointed as soon as possible to install relevant roof plumbing materials, ensuring that no further damage is sustained.

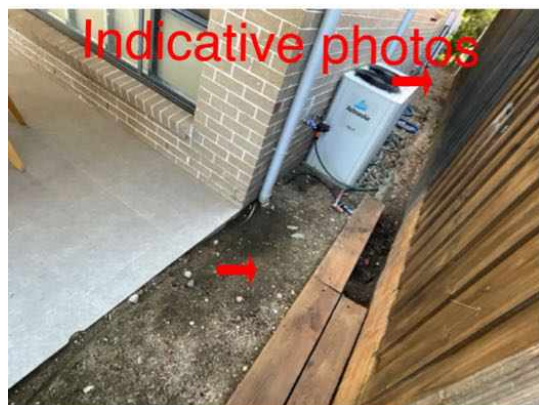
Finding 3.03

Building: Main Building
 Location: Yard
 Finding: Site drainage— Inadequate
 Information: The site drainage in this area was found to be inadequate at the time of inspection, creating potential for subsequent water damage to associated building elements. This is additionally conducive to termite activity.

Where site drainage is inadequate, installation of an Agricultural (Aggie) Drain may be required. A licensed plumber should be appointed to further inspect the property and perform any remedial works as necessary. Water damage and secondary defects are likely to occur if left unmanaged.

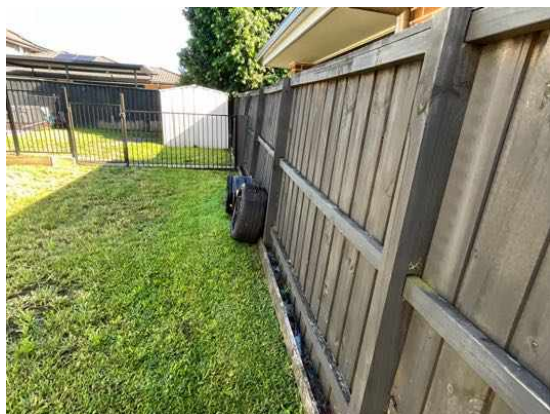
Finding 3.04

Finding: Fencing - Deteriorated

Information: It was noted at the time of inspection that sections of the fencing in this area has deteriorated. Typically fencing deteriorates due to age and or wear, rot and or rust which is generally expected for a structure of this age, due to prolonged exposure to weather conditions. Sometimes inadequate installation or maintenance can be to blame.

If left unattended, it is likely that further damage will occur. It is suspected that repair of several elements of the fencing may be required however replacement may be a consideration of the client also.

A licensed fencing contractor should be appointed to provide further advice and perform rectification works as necessary.

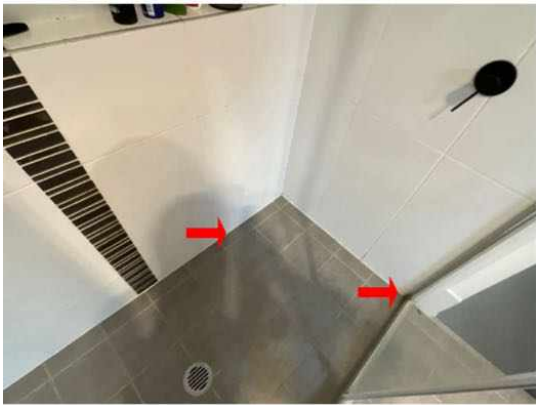
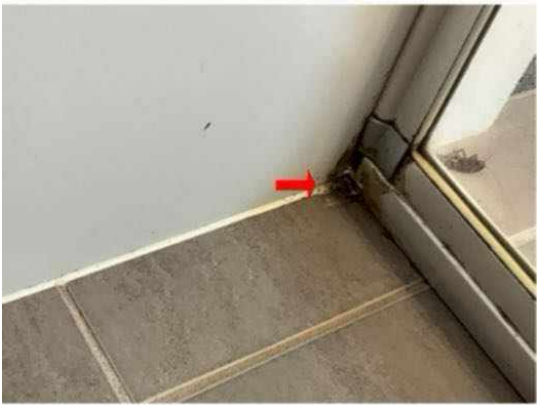
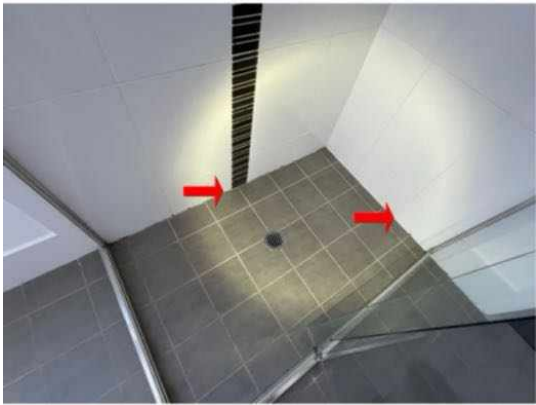
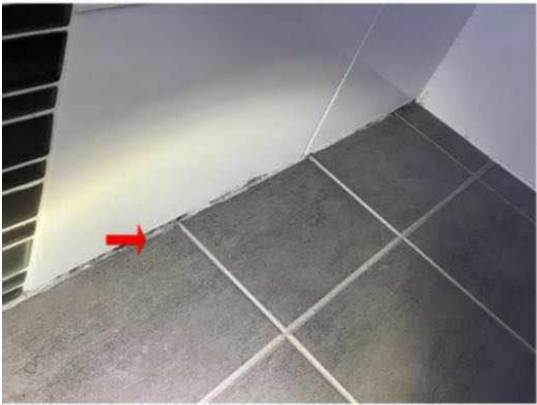
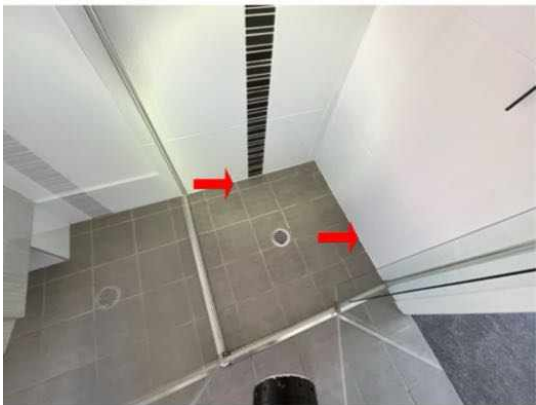
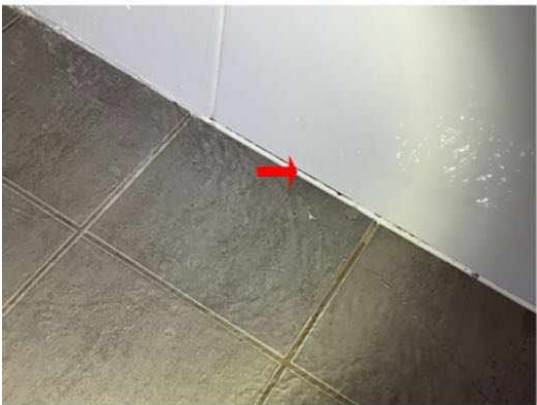
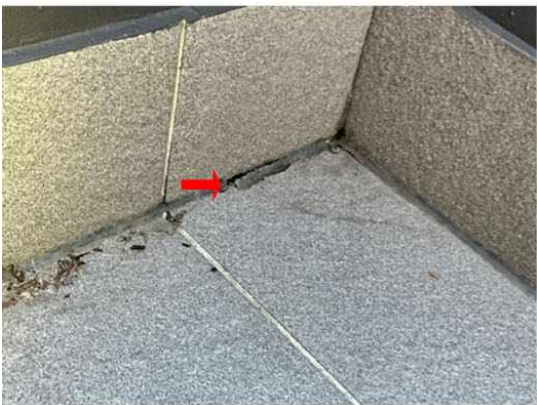
Finding 3.05

Building:	Main Building
Location:	All Wet Areas
Finding:	Sealant and grouting - Missing or damaged
Information:

It was noted on inspection that sealant or grout is degraded to this area.

Different materials and floor areas move at different rates, generally causing cracking to grout or sealant at this point. A flexible sealant is required to allow for expected expansion and contraction, while keeping the joint water tight and protective of all associated building materials.

Flexible and mould resistant materials should be applied to affected areas to prevent any subsequent water damage that is likely to occur. Regular maintenance and replacement of damage or missing or damaged sealant and grout is highly recommended to the wet areas, as this is a regular wear and tear defect. Sealant and grouting in areas that come into regular contact with water should be maintained for the long term care of your property.

A sealant specialist should be appointed to complete these works as soon as possible.

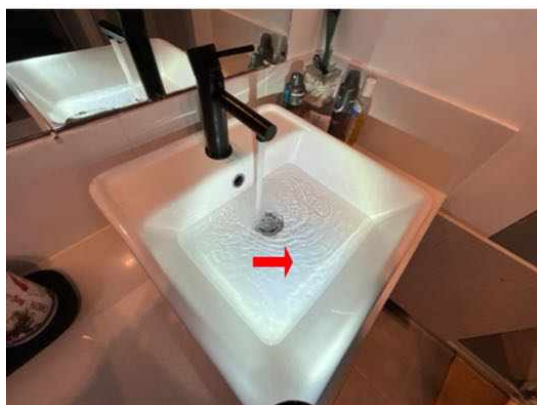
Finding 3.06

Building: Main Building
 Location: Ensuite 1 & 2
 Finding: Sink/basin - slow draining
 Information:

The sink/basin drain appeared to be partially blocked at the time of inspection. Blockages here are usually caused by hair and other debris. If left unmanaged, a lack of general maintenance may lead to the development of more significant defects, such as water damage to surrounding building materials.

A licensed plumber should be appointed to remove the blockage at the client discretion.

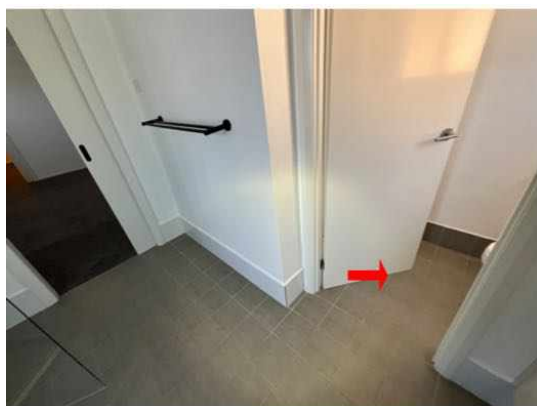
Finding 3.07

Building: Main Building
 Location: Ensuite 1
 Finding: Door - Binding/jamming
 Information:

Binding and/or jamming of this door is evident during standard operation. This defect inhibits the functionality of the affected door as well as creating potential for secondary defects to associated building elements, such as damage to the floor covering or adjacent frame.

A door that binds to flooring or to the associated door frame may have several causes, ranging from minor defects, such as poor installation of the door or deteriorated hinges.

A licensed carpenter should be appointed to perform minor rectification works at client discretion.

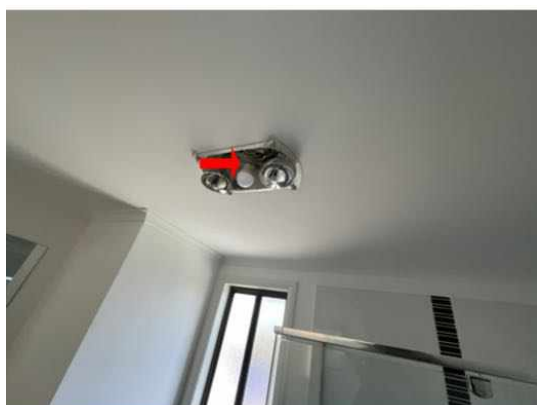
Finding 3.08

Building:	Main Building
Location:	Ensuite 1
Finding:	Light cover - Missing (Cosmetic)
Information:	The light cover in this area was found to be missing at the time of inspection. Breakage occurs generally when the building materials have aged and decayed, but may also be indicative of impact damage to the building element (accidental or deliberate). This is mainly a cosmetic defect which can be replaced by the home owner.

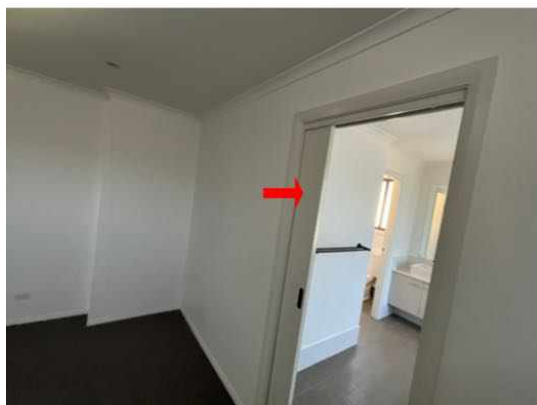
Finding 3.09

Building:	Main Building
Location:	Bedroom - Master
Finding:	Door - Stiff to slide
Information:	<p>The door in this area was jammed and difficult to slide along the associated tracks at the time of the inspection. Restricted function of the affected door may pose as a potential safety hazard if required for emergency egress from the building.</p> <p>Generally, factors such as general age of the building element and a lack of maintenance are the usual causes for this type of defect.</p>

Replacement of door hardware or tracks may be required, as well as minor repairs and cleaning. A registered builder will be required to repair the affected doors.

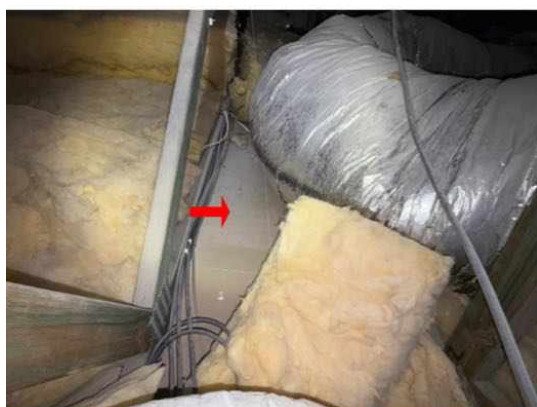
Finding 3.10

Building: Main Building
 Location: Roof Void
 Finding: Insulation - Moved
 Information:

Upon inspection of the roof void it was noted that some insulation is removed and or misplaced.

Insufficient insulation will result in a comparatively higher cost to heat and cool a property as there is a lack of Insulation (or uneven coverage of insulation) which works as a barrier to heat transfer. This helps to keep out unwanted heat in summer and preserves warmth inside your home in winter. It can also help soundproof your home from unwanted airborne noise transfer.

Installation of adequate insulation is required and should be conducted as soon as possible.

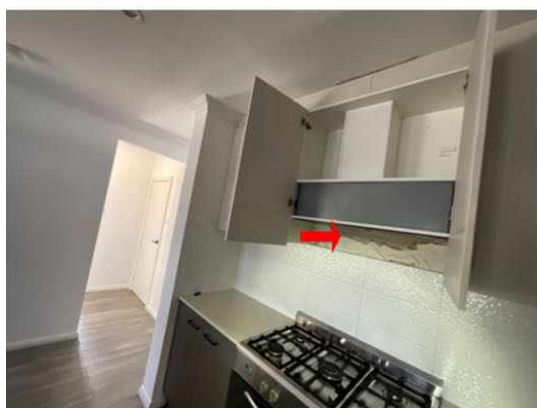
Finding 3.11

Building:	Main Building
Location:	Kitchen
Finding:	Tiles - Missing
Information:	Tiles were found to be missing in this tiled area. It appears as though broken tiles have been removed and not replaced, or have come loose from their original fixing through general deterioration.

Where tiles are missing, water penetration is likely to occur to exposed walls and flooring, creating potential for subsequent water damage.

Any tiles that are missing should be replaced immediately by a tiling contractor or general handyman. If left unmanaged over a prolonged period of time, water damage is likely to necessitate repair works to surrounding building elements.

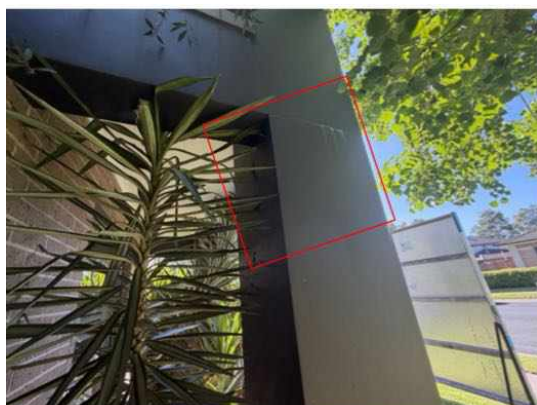
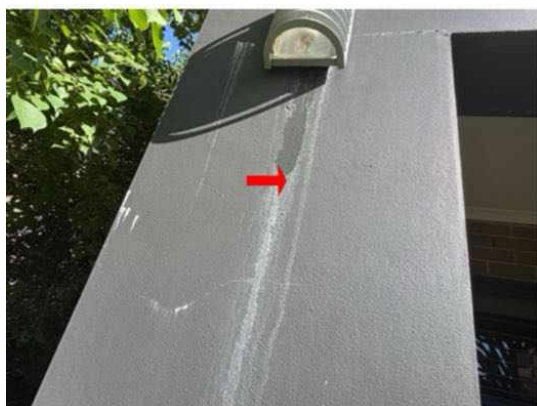
Building: Main Building
Location: Balcony
Finding: Water leak - Internal
Information: A water leak is expected in this area at the time of inspection due to the balcony floor waterproofing failure. Internal water leaks can be detrimental to surrounding building elements.

Rust, corrosion, decay and water damage are potential outcomes where a minor water leak is left unattended. More serious defects may also result, such as electrical hazards, or water damage to structural building elements.

In extreme cases, structural damage may develop due to a prolonged water leak. It is highly advised a licensed plumber be advised for further investigation. Major works should be expected and must be carried out by licensed builder.

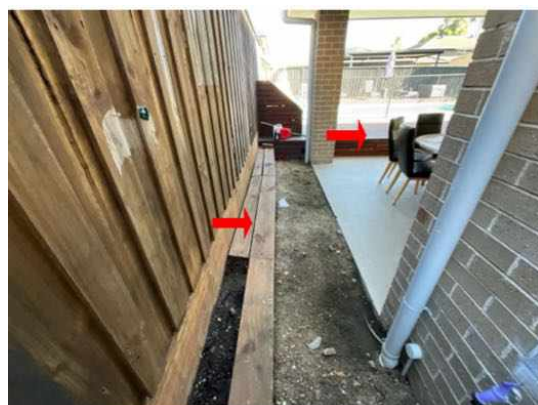
Building:	Main Building
Location:	Fencing & Landscaping
Finding:	Building materials in direct ground contact - conducive to termites
Information:	Where timber elements are in direct contact with the ground and consequently moisture or dampness they become conducive to termite activity. Whether timber is used as a building element part of a fencing structure or stored as an unused item they can provide an environment that is attractive to termite infestation.

When met with excessive moisture timber begins to decay and develop wood rot. Any timbers that are in direct contact with external grounds especially if left untreated or non-durable also provide ingress for subterranean termites into that particular element.

The removal of any such materials that may be conducive to termite activity should be removed as soon as possible to minimise the risk of termite attack.

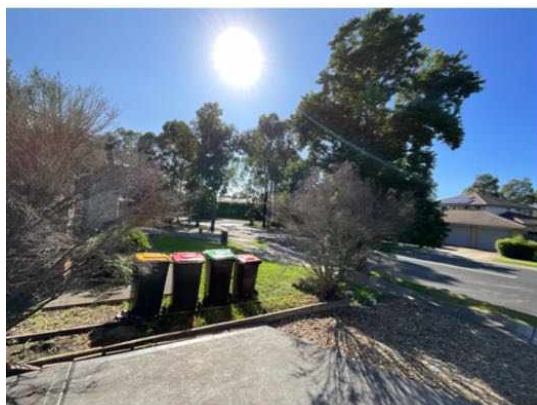
Finding 6.05

Building:	Main Building
Location:	
Finding:	Surrounding bushland - Conducive
Information:	Home and or building is situated in a high risk area for termite activity, due to close

proximity to surrounding bushland.

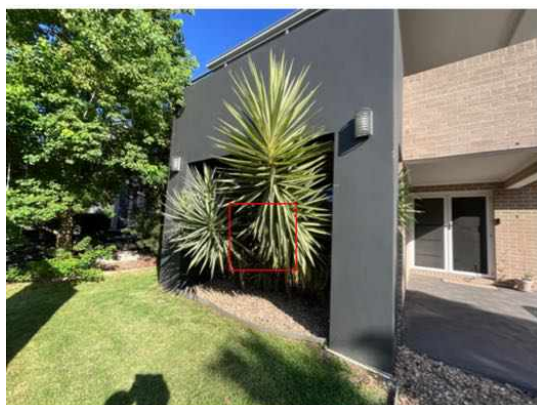
Finding 6.06

Building:	Main Building
Location:	Vegetation
Finding:	Vegetation - Abutting property
Information:	Vegetation against external wall may have an invasive root system. If there are weak points in the brick work or concrete slab, it is possible for the roots to gain entry into these areas. Once the roots have gained entry, it is possible for termites to gain concealed entry via these roots. It is recommended to remove the vegetation and root system where possible.

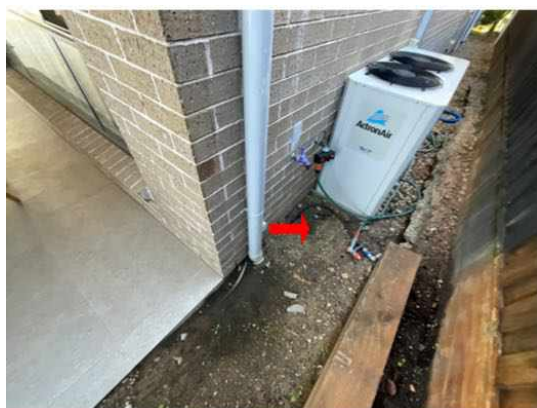
Finding 6.07

Building:	Main Building
Location:	External tap
Finding:	Tap - No drain
Information:	The external tap in this area was noted to have no drain at the time of inspection. This keeps the surrounding surfaces damp while using the tap, which becomes conducive to termite activity.

A licensed plumber must be appointed to ensure an appropriate drain is installed.
