# Building and Timber Pest Inspection Report

Inspection Date: Thu, 12 Feb 2026

Property Address: 125 Pound Creek Rd, Tumbarumba NSW  
2653, Australia

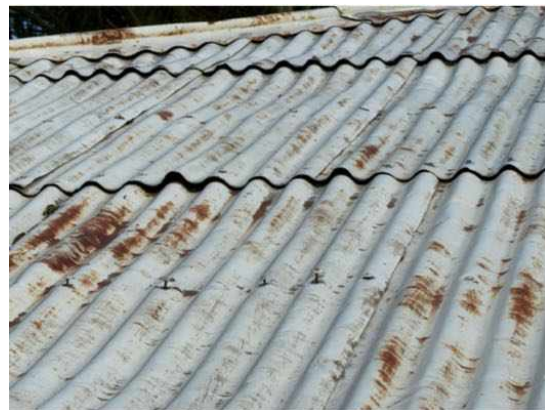
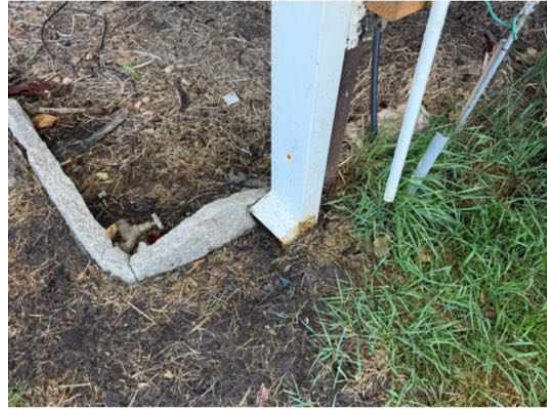
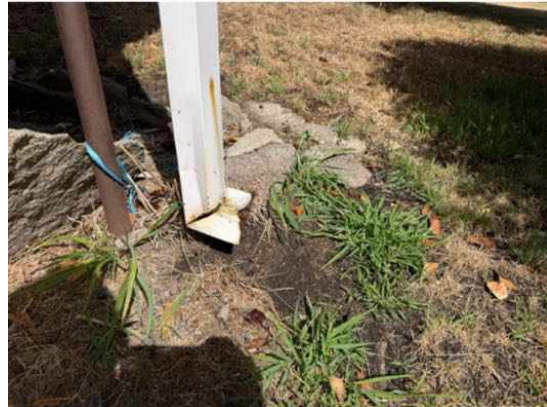
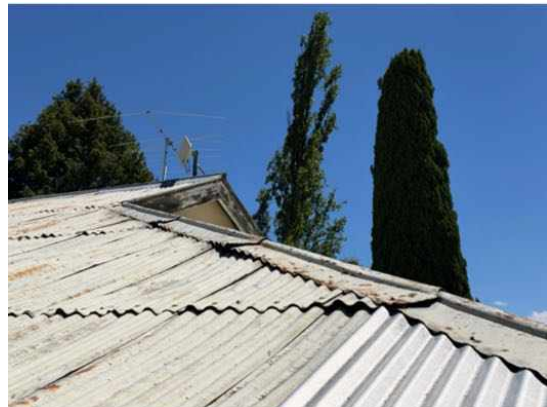
Building: Main Building  
Location: Gutters, Down-pipes, Roof Sheeting  
Finding: Roof plumbing & sheeting - Rusted, Loose, Disconnected  
Information: Several areas of rust were identified to the roof plumbing and roof sheeting, & several roof sheets were found to be loose. It appears the rust has lead to the development of holes at the bottom of the gutters and leaking of the downpipes. Some down-pipes were also found to be disconnected.

Consultation with a licensed roof plumber and roofing contractor is required promptly, to provide further advice on replacement works needed to prevent any potential further damage or deterioration that may occur.

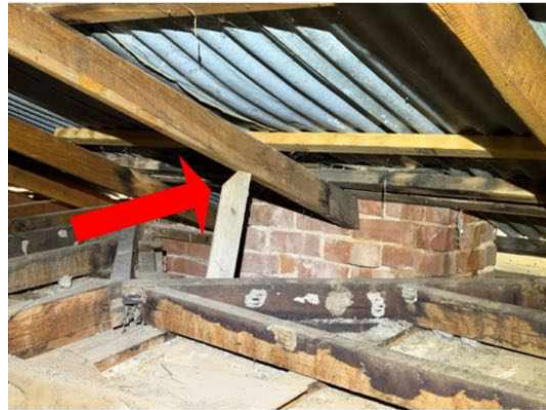
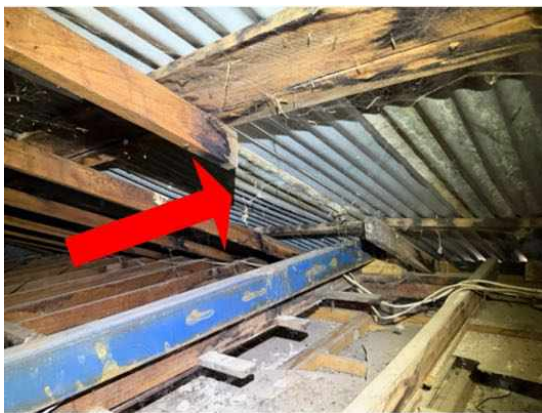
### Finding 3.01

Building:	Main Building
Location:	Roof Void
Finding:	Roof Framing - Additional Fixings / Support Required
Information:	It appears that a rafter in the roof void has been cut and requires additional support. A small strut also appears to require additional fixings, and an under-purlin was found to be slightly sagging.

Recommend engaging a licensed carpenter in the short term, to provide remedial works where necessary.

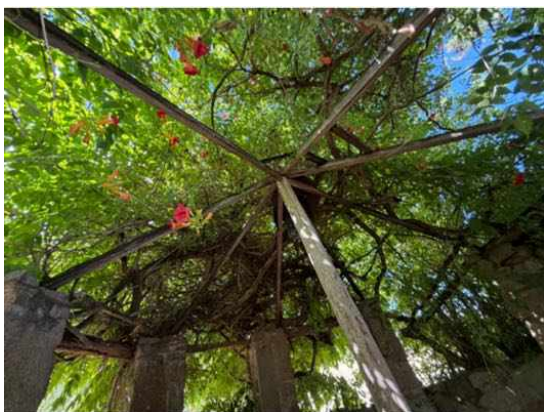
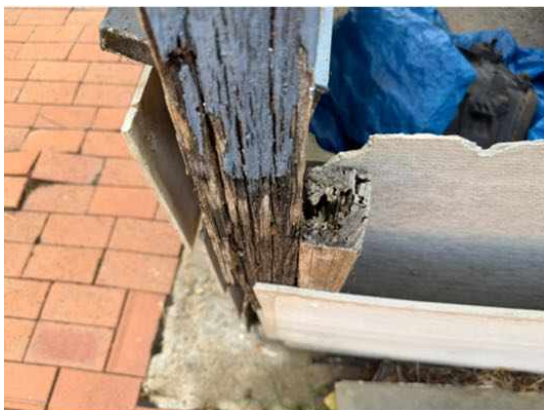
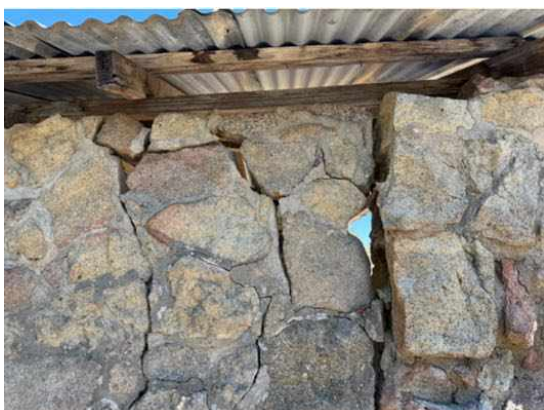
### Finding 3.02

Building:	Main Building
Location:	Sheds & Outbuildings
Finding:	Outbuildings & Sheds - Unstable & Deteriorated
Information:	It appears that areas of the outbuildings and sheds were unstable and deteriorated and evidence of movement was identified in the masonry. It is advised that the client engage a registered builder to either remove the structures or provide remedial works to ensure they are sufficiently reinforced and secure. Further movement & deterioration will occur if neglected.

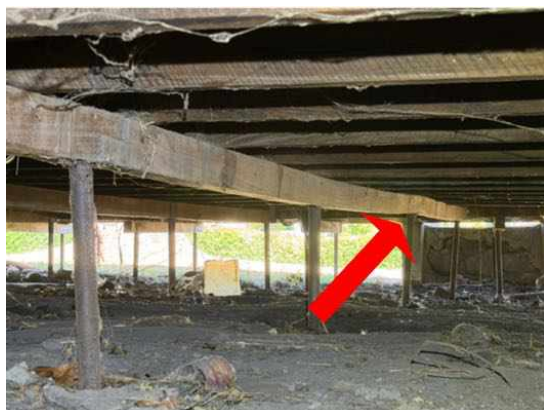
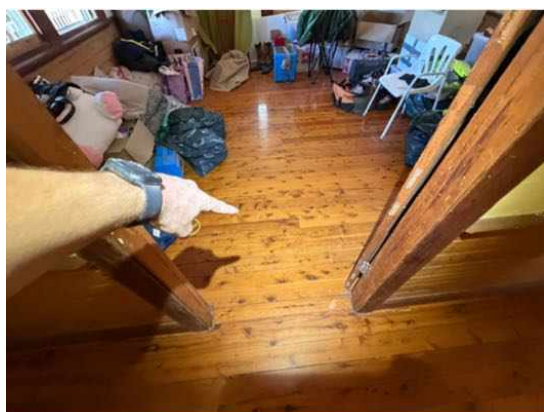
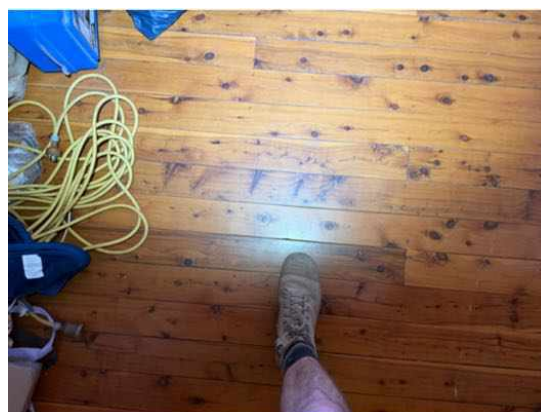
### Finding 3.03

Building:	Main Building
Location:	All Areas
Finding:	Flooring - Uneven
Information:	Some areas, of the flooring & bearers, throughout the building & subfloor appear to be uneven. It is advised that the client monitor the flooring to identify any further movement. Where flooring remains relatively unchanged for an extended period of time, it is likely that this defect has been caused by general movement of the foundations of the property.

However, where further movement and unevenness occurs, a structural engineer should be engaged promptly for further evaluation.

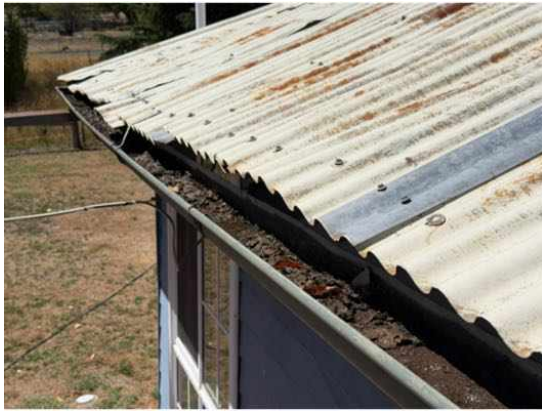
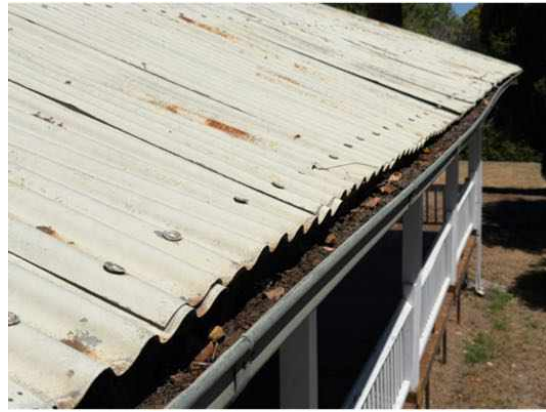
### Finding 3.04

Building:	Main Building
Location:	Gutters
Finding:	Gutters - Debris, Sagging & Water pooling
Information:	Water pooling and debris were noted in sections of the guttering at the time of inspection, and areas of sagging were identified. Water pooling can lead to deterioration of the roof plumbing over time, if neglected.

A licensed roof plumber should be engaged in the short term, to provide further advice & maintenance works to ensure adequate roof drainage is achieved. All debris should be cleared promptly to ensure proper drainage and prevent overflows.

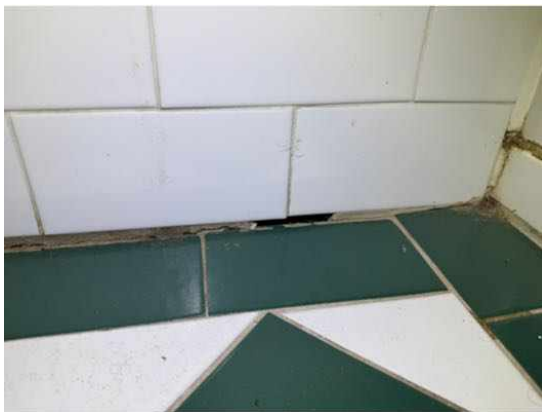
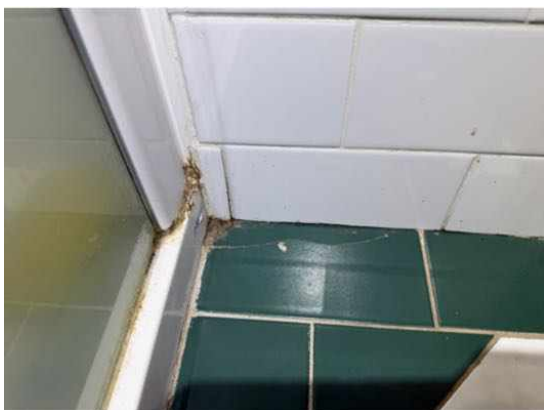
### Finding 3.05

Finding: Sealant / grouting - deteriorated or missing & Cracked Tiles

Information: It appears that the sealant and grout has deteriorated in some tiled areas, a common defect in buildings of a similar age. Areas of cracked & drummy tiles were also noted, which can allow for moisture ingress behind the tiles, if neglected.

Drummy

Sealant and grouting in areas that come into regular contact with water should be maintained for the long term care of your property.

Recommend engaging a licensed tiling contractor in the short term, to provide maintenance works where necessary.

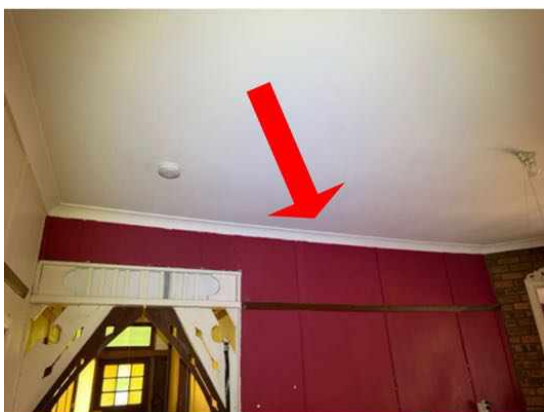
### Finding 3.06

Building:	Main Building
Location:	All Internal Areas
Finding:	Ceilings Sagging & Drummy / Loose Plaster
Information:	Sections of the ceilings throughout the building, appeared to be sagging at the time of inspection. Several plaster walls were also found to be loose and drummy. Causes of ceiling sagging & drummy plaster include fixings (e.g. nails or glue) that have become loose and require re-fixing, or movement of the building overtime.

Where sagging & drumminess has occurred, works such as re-gluing & re-fixings of plaster sheets, may be required. Such works may be performed by relevant tradespeople, such as plasterers or licensed carpenters.

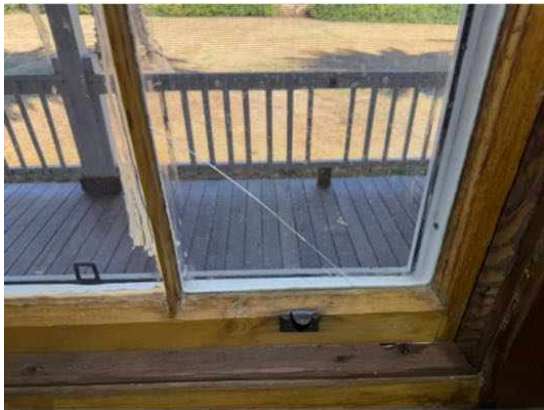
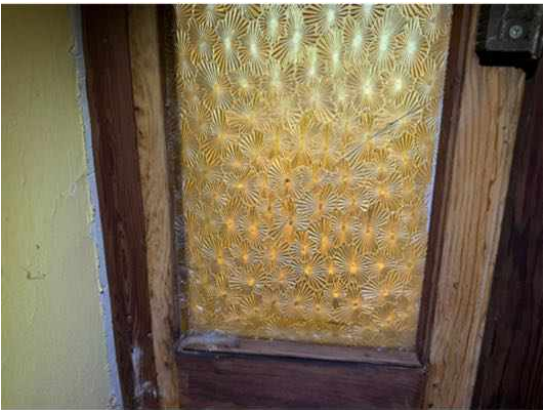
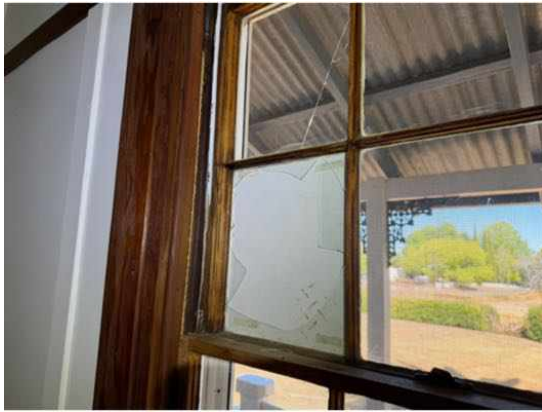
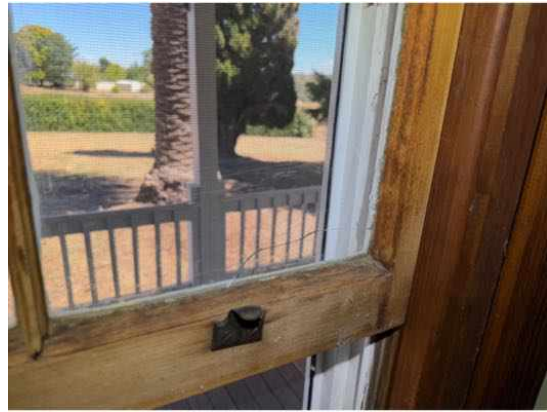
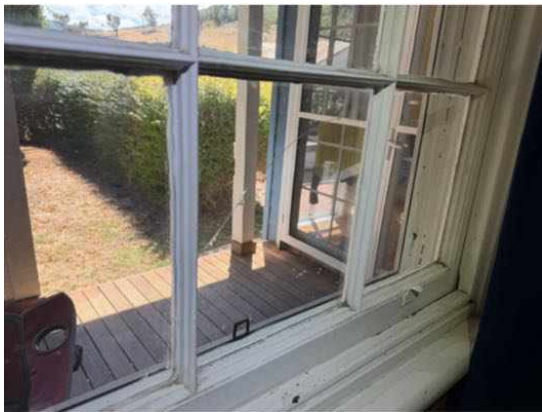
**Finding 3.07**

Building: Main Building  
Location: Bedrooms, Lounge Room, Hallway  
Finding: Windows - Cracked  
Information: Cracking was evident to several windows including but not limited to the bedrooms, hallway and lounge room. Any further impact may lead to additional cracking and/or shattering of the windows, creating a safety hazard in the area.

Recommend engaging a qualified glazier to replace the windows in the short term. Anyone coming into contact with the cracked windows should do so with due caution to avoid any personal injury that may ensue.

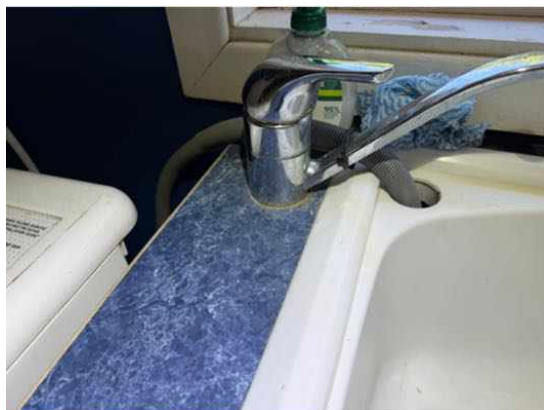
### Finding 3.09

Building: Main Building  
Location: Laundry  
Finding: Loose Tap  
Information: It was noted that the laundry tap appears to have become loose. A licensed plumber can be engaged at clients discretion to provide maintenance works where necessary.

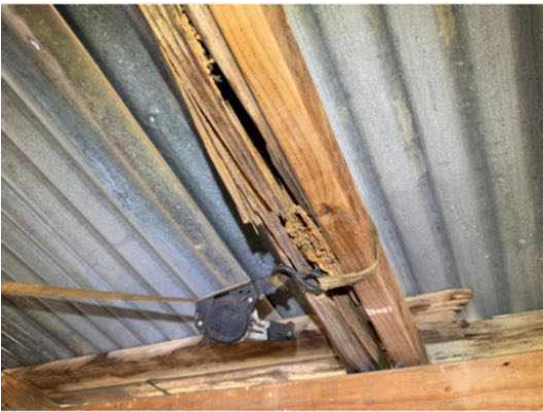
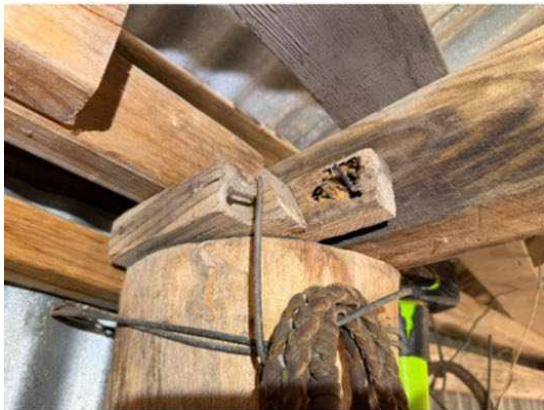
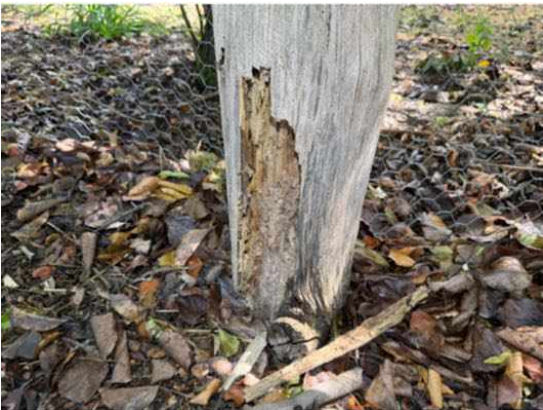
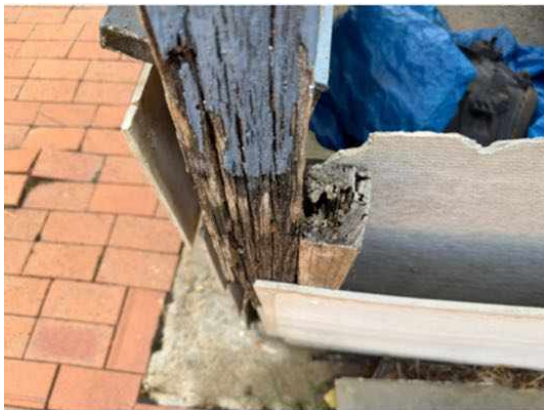
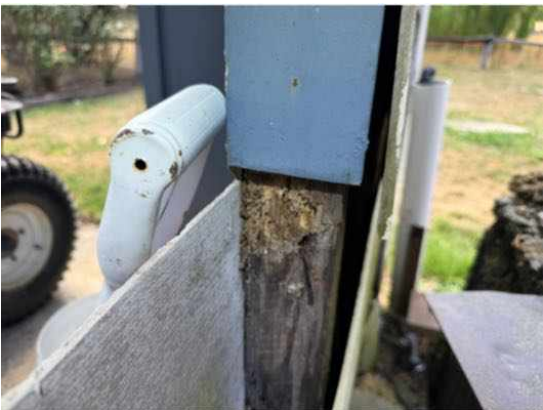
Building: Main Building  
Location: Shed Framing, Verandah Stair Post, Landscaping Timbers  
Finding: Evidence of termite workings & damage  
Information: Termite damage & workings were identified at, but not limited to, areas throughout the external shed framing, veranda stair posts, external timbers and trees.

The client should engage a licensed pest controller promptly to provide further advice regarding installation of a termite treatment.

6 monthly ongoing termite inspections, conducted by a qualified termite inspector, are also recommended

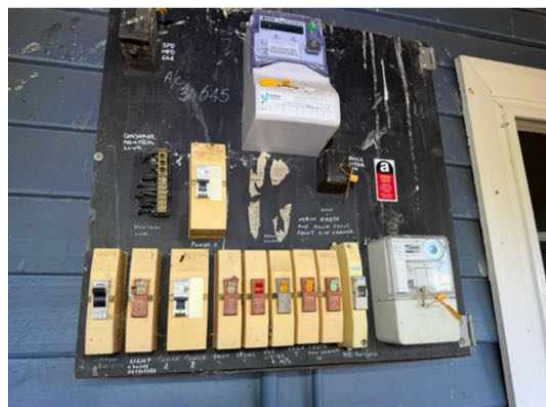
### Finding 6.01

Building:	Main Building
Location:	Switchboard
Finding:	Termite Management System - no evidence of a chemical installation
Information:	The application of a termite barrier is strongly recommended, as it appears no termite management system has been installed, with no evidence or durable notice to suggest works taking place. Generally, a durable notice is placed in the meter box to indicate current termite barriers.

Such barriers are highly effective in preventing termite attack on the building and therefore should be installed.

Recommend seeking further advice from a licensed pest controller.

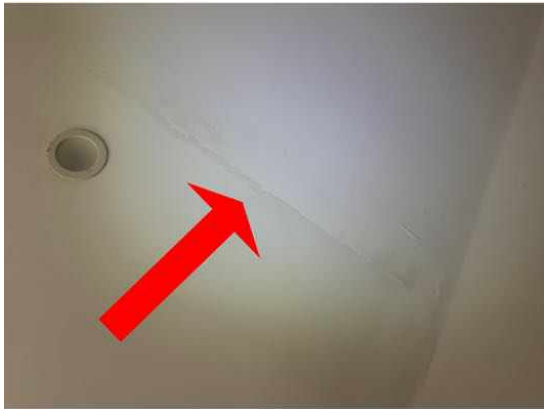
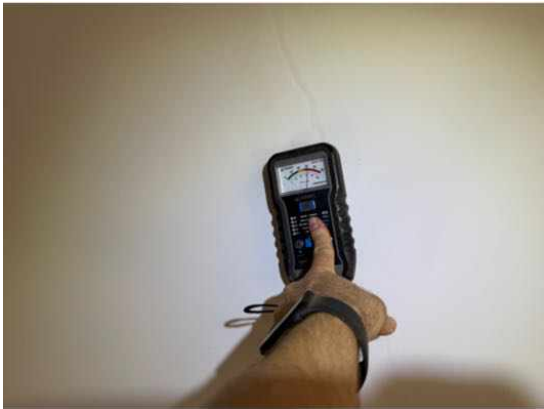
### Finding 6.02

Building:	Main Building
Location:	Dining Room Ceiling, Laundry Ceiling
Finding:	Ceiling Leaks
Information:	High moisture was identified at, but not limited to the dining room and laundry ceilings. Potential causes of leaking include damaged plumbing fittings and fixtures, or deterioration of the roof plumbing.

This creates an environment conducive to termite activity and water damage to surrounding materials.

Recommend engaging a licensed roof plumber or roofing contractor promptly to provide remedial works.

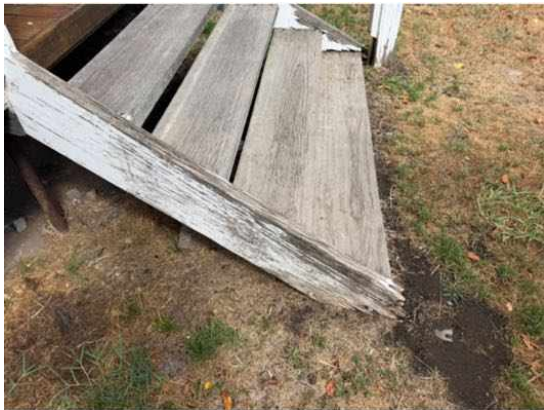
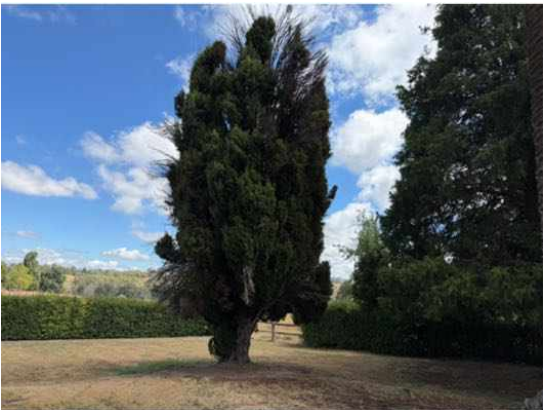
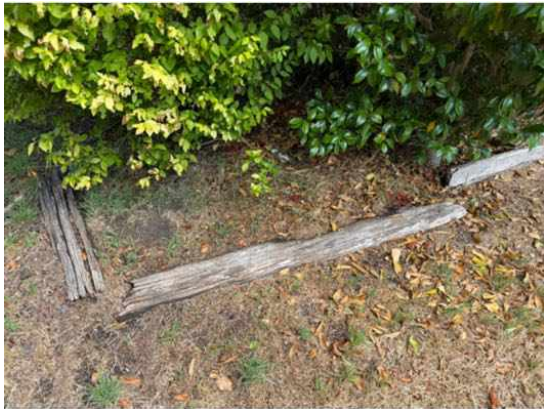
Building: Main Building  
Location: All External Areas  
Finding: Timber in direct ground contact & trees - conducive to termites  
Information: Where timber materials are in direct contact with the ground and consequently moisture, they become conducive to termite activity. The tree stumps, landscaping timbers, timber debris in the subfloor, and trees surrounding the building create an environment conducive to termite infestation.

Where feasible, any timbers in direct contact with the ground should be removed and any trees in close proximity to the building should be removed or test drilled (inspected) at least annually to reduce the risk of termite infestation & detect any early signs of termite activity.

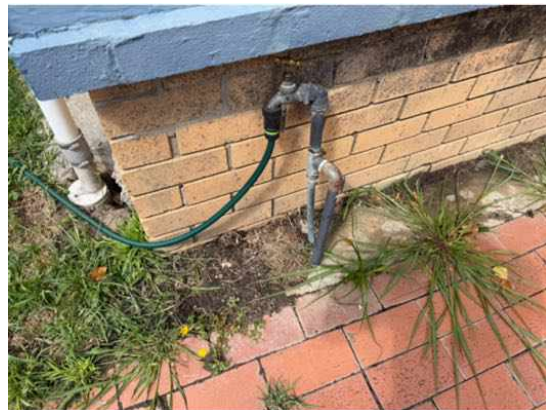
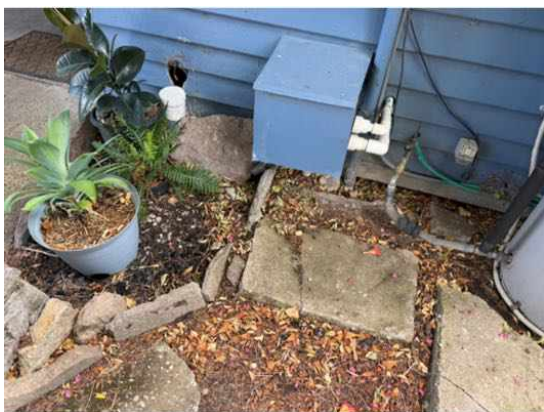
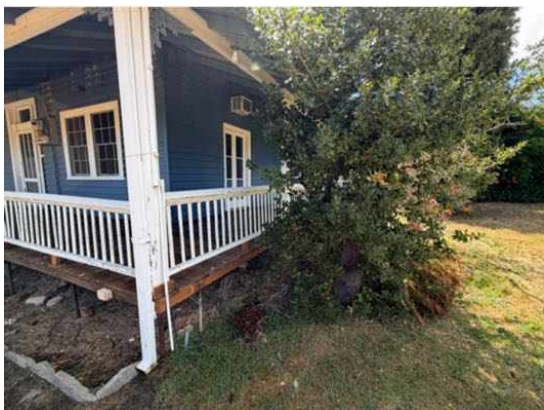
### Finding 6.05

Where insufficient drainage of taps, hot water system & aircon overflows, and garden beds against the house are present, water pooling is likely to occur, and can create areas conducive to timber pests and potential damage to the subfloor structure overtime, if neglected.

Recommend consulting with a licensed plumber in the short term to further assess and provide remedial advice.

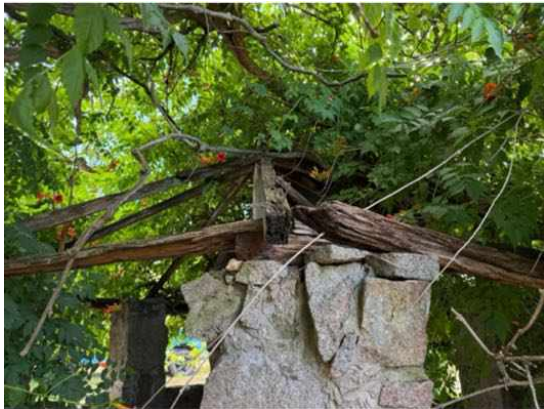
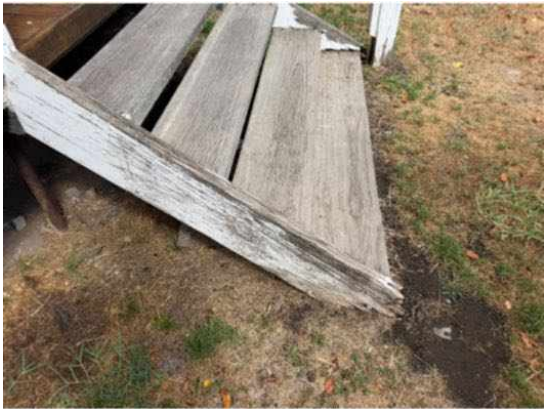
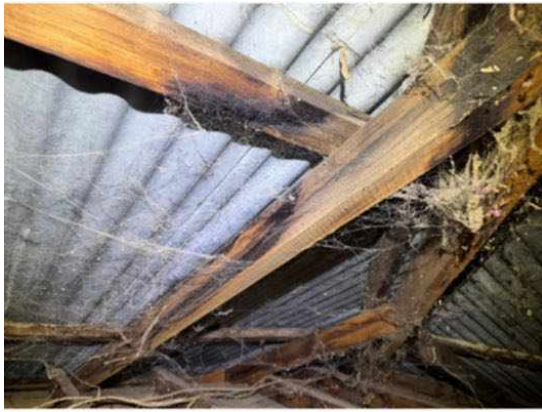
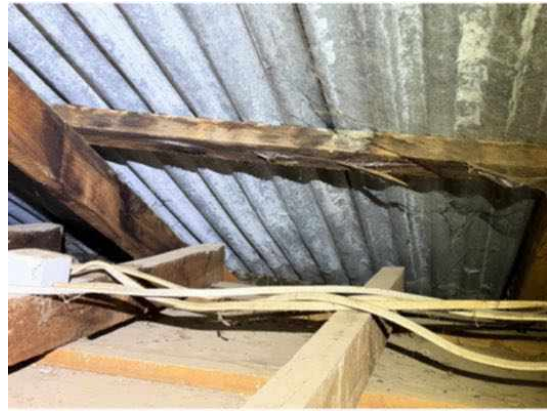
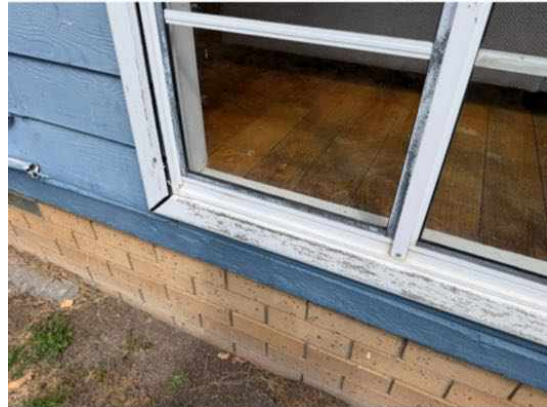
### Finding 7.01

Building:	Main Building
Location:	Roof Framing, Deck Framing, Balustrade, Fascias, Shed Framing, External Trims
Finding:	Fungal decay & weathering
Information:	Areas of fungal decay (wood rot) & weathering were identified at but not limited to some window frames, roof framing, deck framing, balustrade, fascias, shed framing & external trims.

For areas where structural timbers are affected by wood rot (deck, shed & roof framing) a registered builder should be engaged promptly to replace affected materials where necessary.

For areas where fungal decay is superficial, the client can engage a licensed carpenter at their discretion to replace affected materials.

For areas of general weathering, it is advised the client engage a licensed painter to apply protective sealant or coating to areas of weathered external timbers.

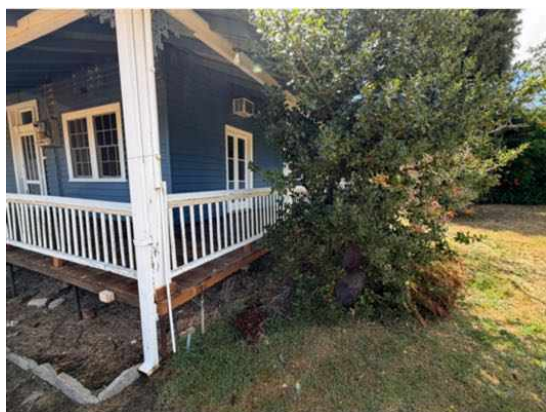
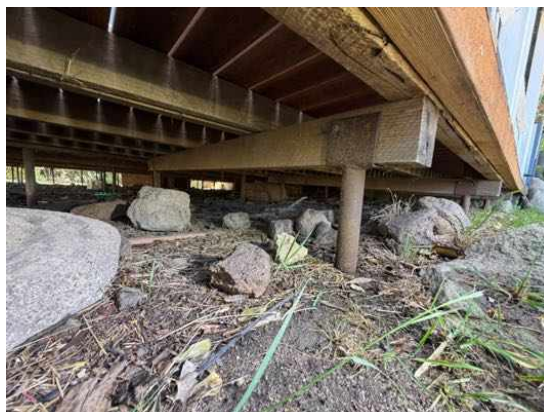
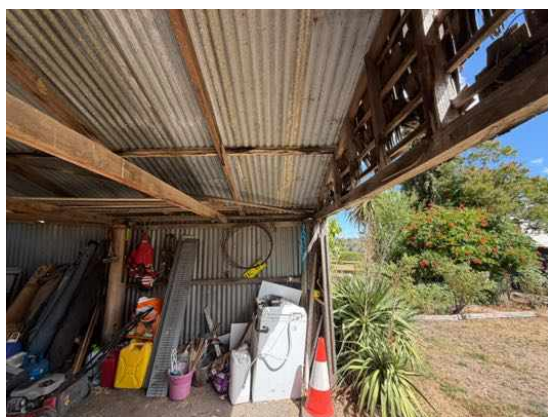
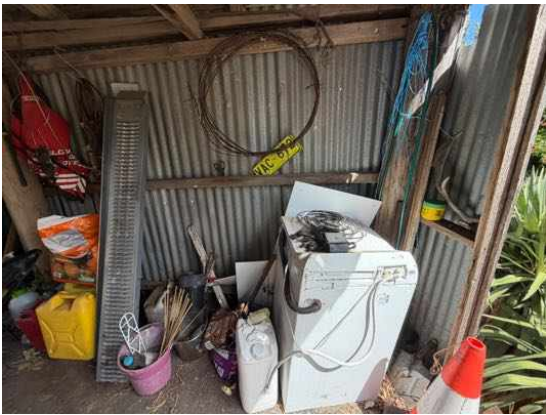
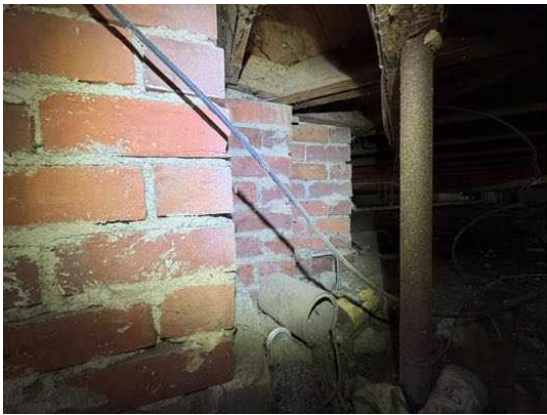
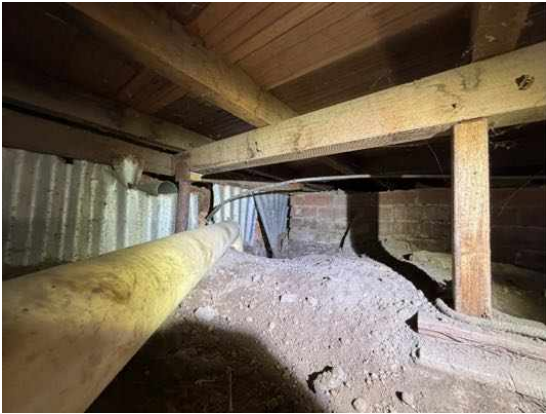
Building: Main Building  
Location: All Areas  
Finding: Additional Photos - Obstructions and Limitations  
Information: These photographs are an indication of the obstructions and limitations which impeded full inspection of the property at the time of inspection. These obstructions can hide an array of defects and should be removed to allow full inspection to be carried out. A re-inspection is recommended once the areas are made accessible.

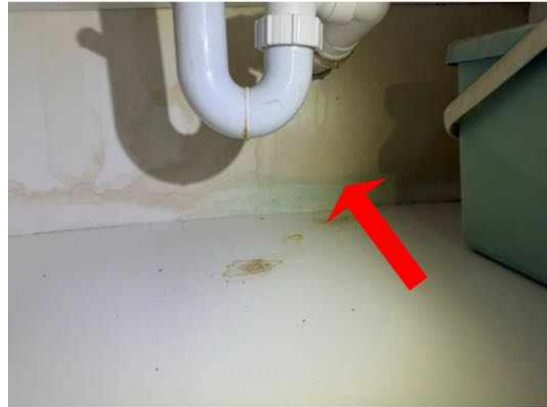
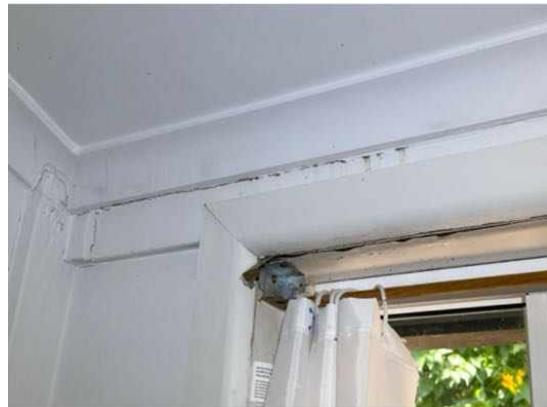
Building: Main Building  
Location: Kitchen ceiling, dining room window, laundry sink, bathroom window.  
Finding: Water Staining Present  
Information: It appears that water staining was present including but not limited to the Kitchen ceiling, dining room window, laundry sink, bathroom window. Potential causes of leaking include deteriorated roof cladding or damaged plumbing fittings and fixtures.

No high moisture was evident in these areas at the time of inspection.

Recommend that the client closely monitor these areas and engage a licensed plumber promptly, should the leak persist or return. A more invasive inspection may reveal secondary building defects.

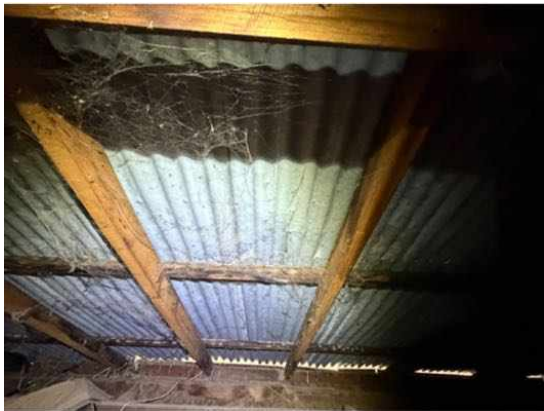
Building: Main Building  
Location: Roof Void  
Finding: Sarking - Not Present  
Information: It is noted for your information that sarking has not been installed on the roof. Sarking is a laminated aluminium foil applied to the interior of the roof covering, assists in insulating the property and acting as a vapour-barrier to the roof void.

The client can consult with a licensed roofing contractor at their discretion, to provide further advice.
