Building and Timber Pest Inspection Report

Inspection Date: Thu, 19 Feb 2026

Property Address: 5 Rosie Dr, Broadford VIC 3658, Australia

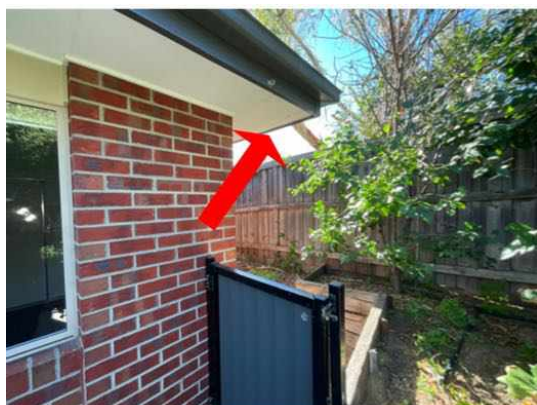
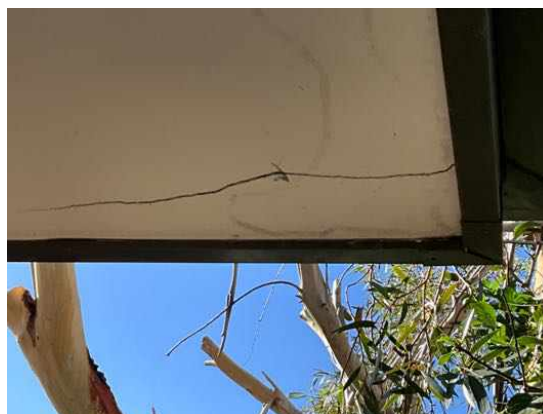
Finding 3.01

Building: Building 1
 Location: Eaves
 Finding: Eaves - Damaged
 Information: The eaves in this area were found to be in a visibly poor condition. The damage may have been sustained as a result of a number of possible causes, including poor roof drainage, leaking roof plumbing or minor impact damage.

The damage to the eave sheeting in this area detracts from the appearance of the structure, as well as potentially compromising the structural integrity of the roofing area.

Where eaves show moderate to severe damage, remedial works may be required. Where water damage is suspected as being the underlying cause, appointment of a licensed plumber is advised as a matter of urgency to identify the source of the water leak.

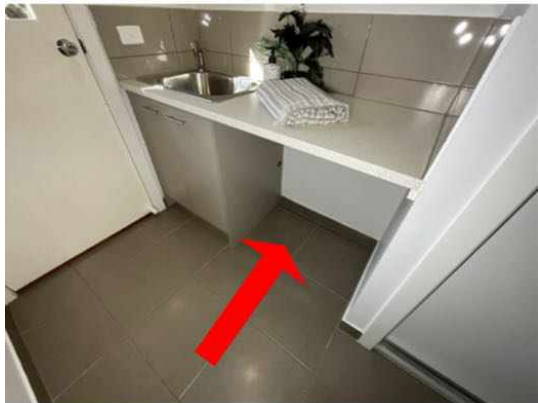
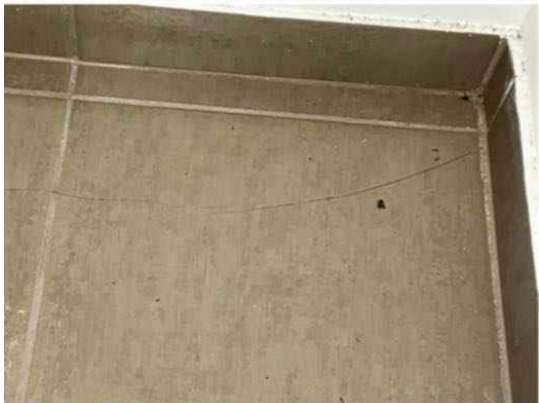
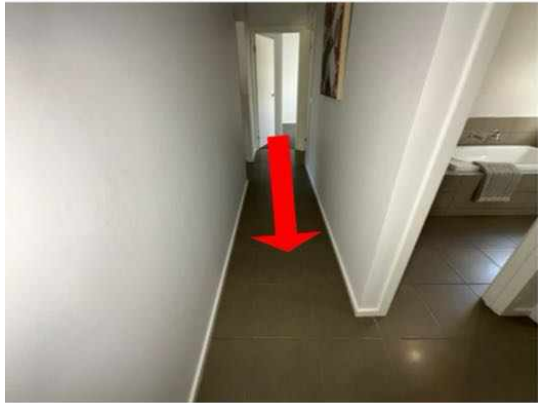
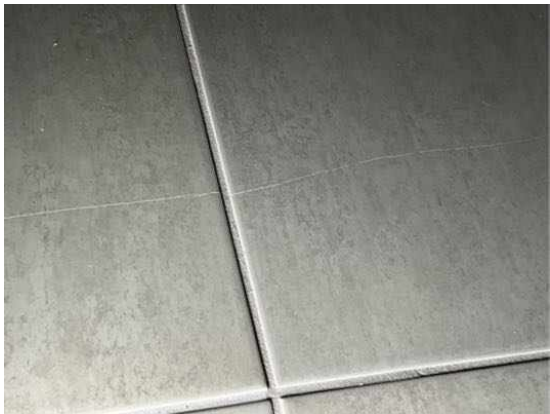
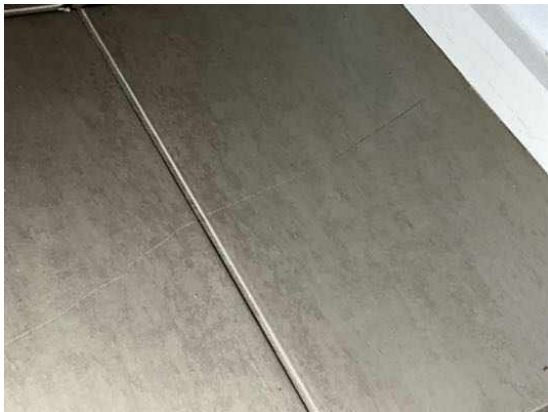
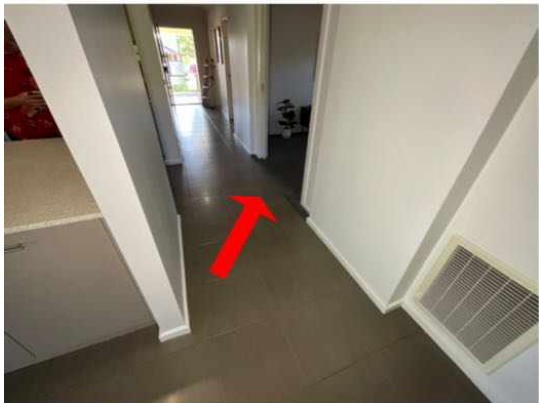
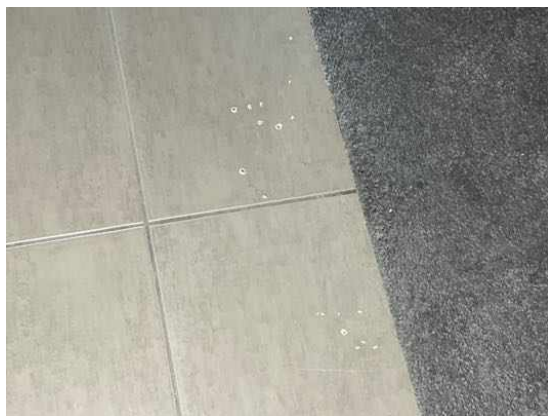
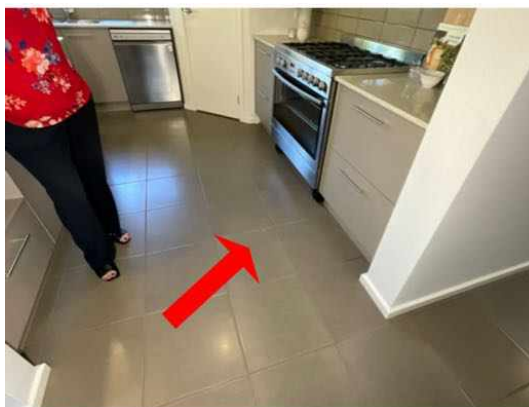
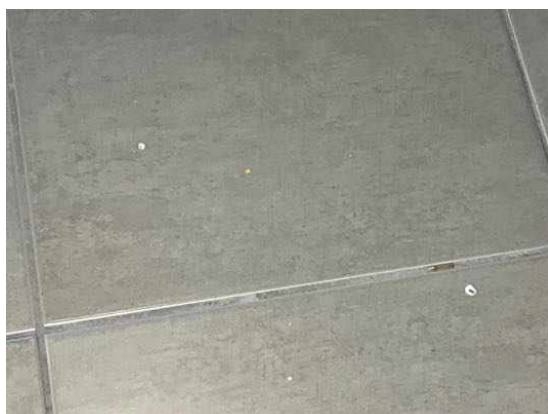
Finding 3.02

Building: Building 1
 Location: Laundry, hall, kitchen

Finding: Cracked floor tiles
Information: Cracking in the floor tiles was evident in this area at the time of inspection. It is suspected that this cracking has occurred as a result of minor settlement or impact damage.

Cracked tiles throughout the household detract from the overall appearance of the affected areas however it is unlikely to create or lead to any secondary defects.

While not considered a matter of urgency, replacement of cracked floor tiles is recommended at the clients discretion. A tiling contractor may be appointed to perform these works. Where cracks become more numerous, contact a licensed building inspector for further investigation.

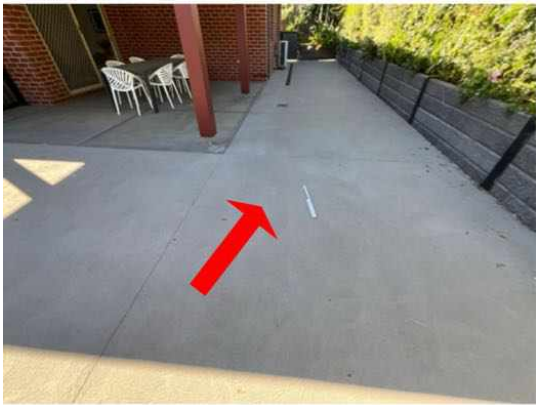
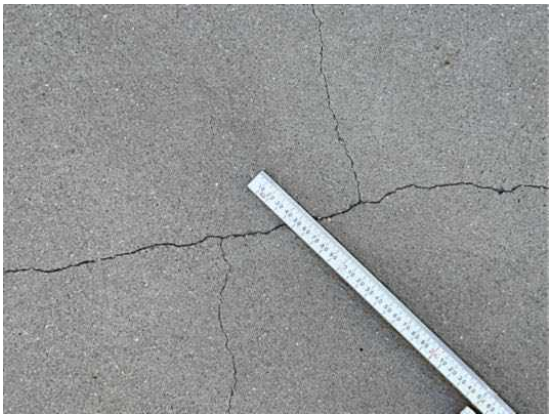
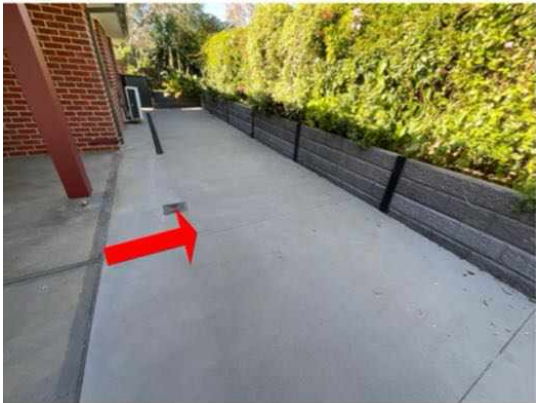
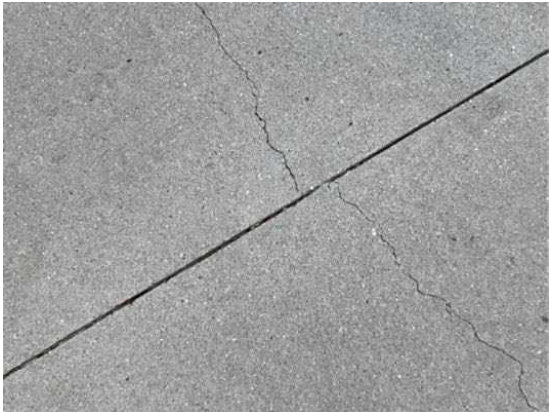
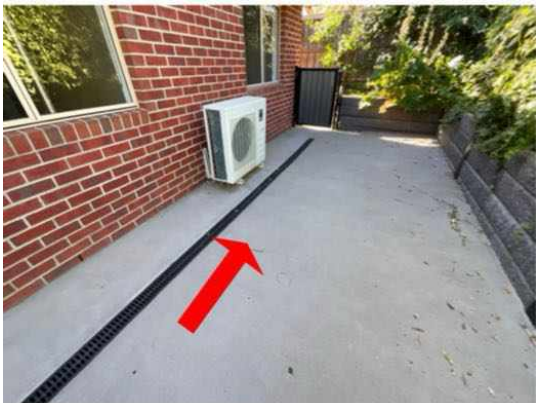
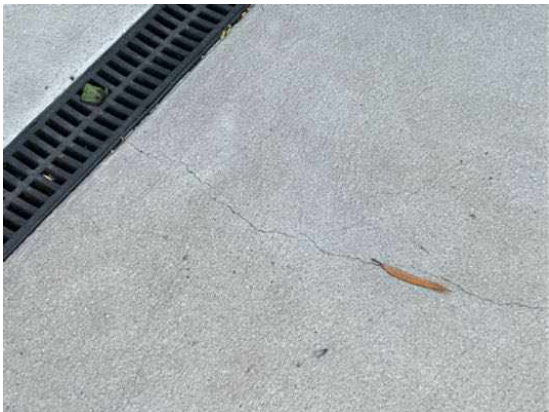
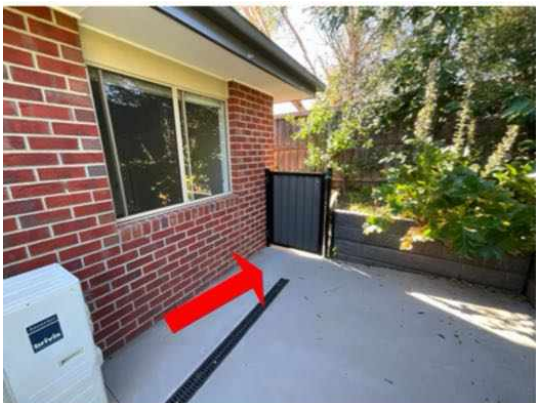
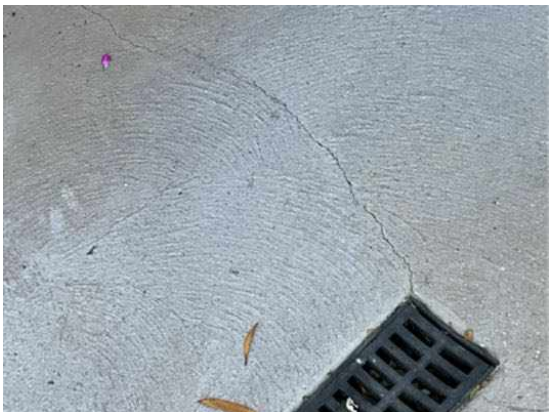
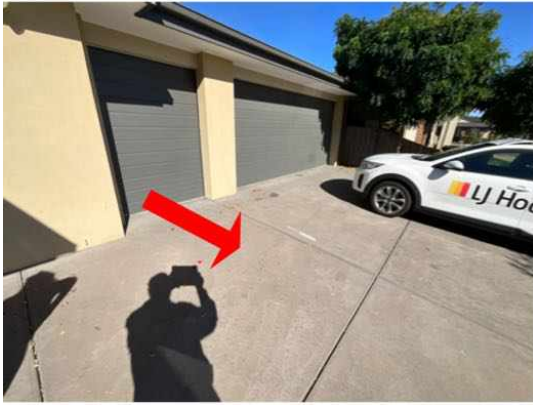
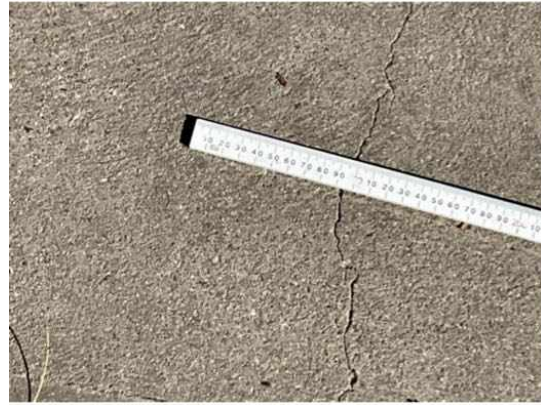
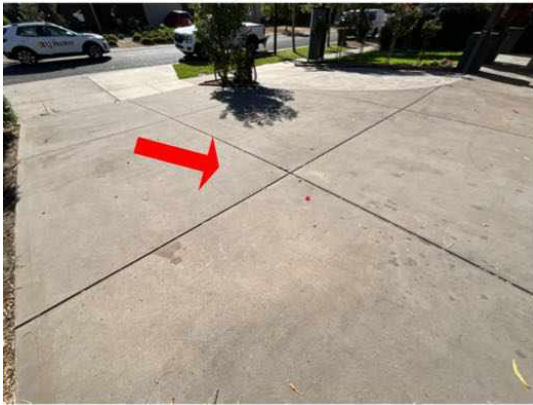
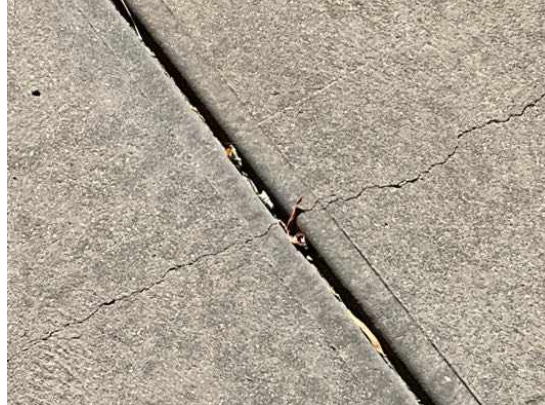
Finding 3.03

Building:	Building 1
Location:	Yard - Back, driveway
Finding:	Cracking - External Concrete Paving Damage Category 1 - Fine (less than 2mm)
Information:	Fine cracks were identified in external concrete paving. Although fine cracks are quite noticeable, they are often only considered to be an appearance defect, and usually do not indicate any structural damage. To be considered a Category 1 or fine crack, the crack is found to be less than 2mm in width.

Generally the cause of a hairline crack in existing concrete paving such as driveways and pathways is indicative of the expansion and contraction of the concrete. Such causes are generally due to environmental factors, such as moisture levels, weather conditions, root systems of nearby trees or the soil types on which they are laid.

Fine cracks may also be due to poor original installation of the concrete. Factors such as poor compaction of the sub surface and/or inadequate reinforcing of the slab may create cracking and other secondary defects.

Monitoring of all cracking should be conducted frequently. Always contact a building inspector should cracks widen, lengthen, or become more numerous.

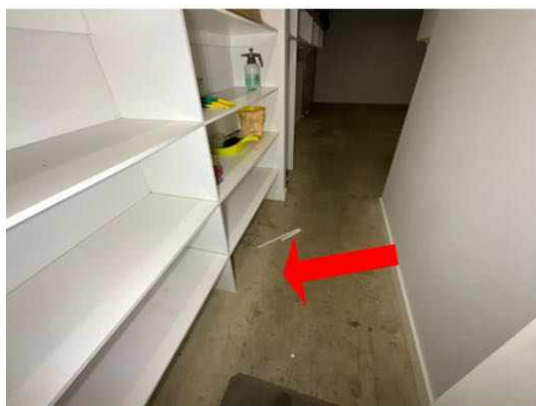
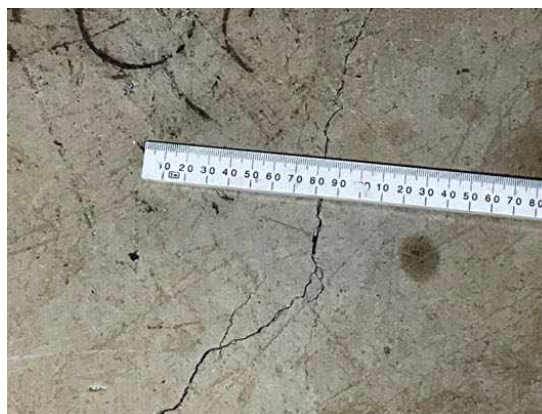
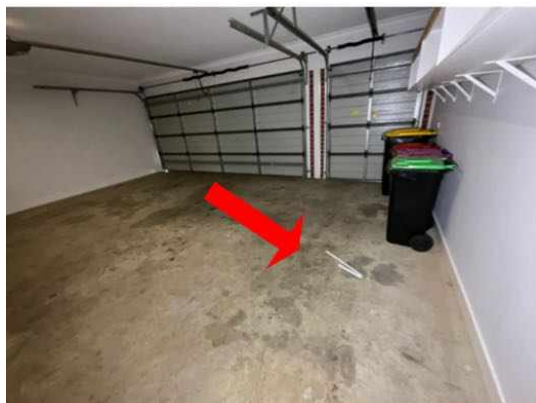
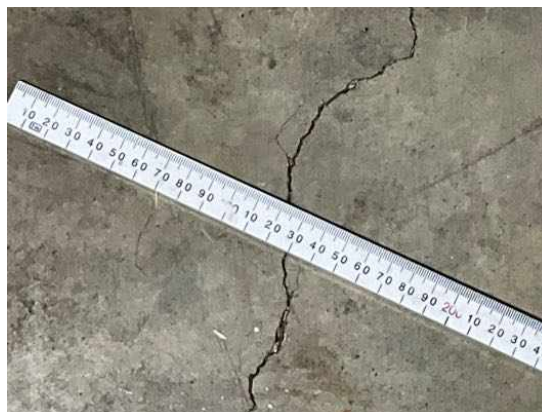
Finding 3.04

Building:	Building 1
Location:	Garage
Finding:	Crack in concrete slab - Category 1
Information:	A crack coded as Category 1 was identified in the slab. A Category 1 crack is described as a fine but noticeable crack, with the slab at an otherwise reasonable level.

To be considered Category 1, the approximate width of the crack is less than 1.0mm, or a less than 10mm change in offset when a 3m straight edge is placed over the defect.

Category 1 cracks should be monitored for a period of 12 months. At the end of the monitoring period, identified cracks that are rated greater than Category 2 are considered defects, and require rectification.

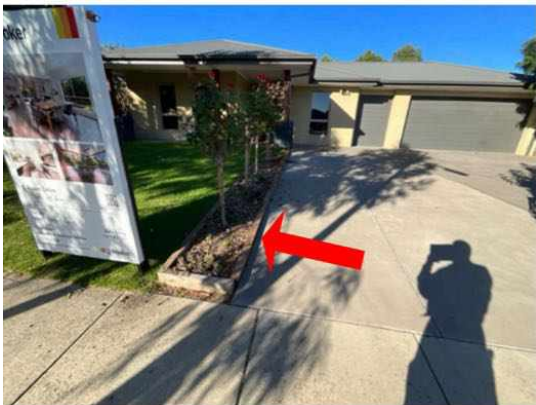
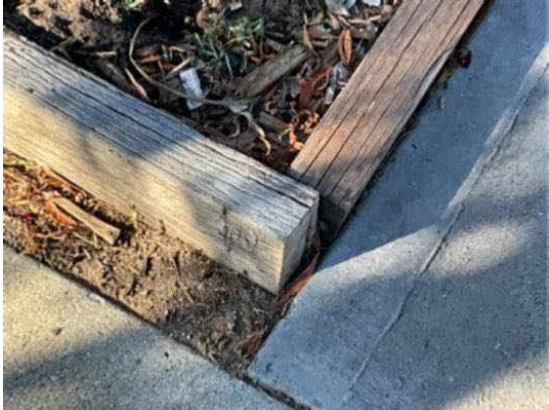
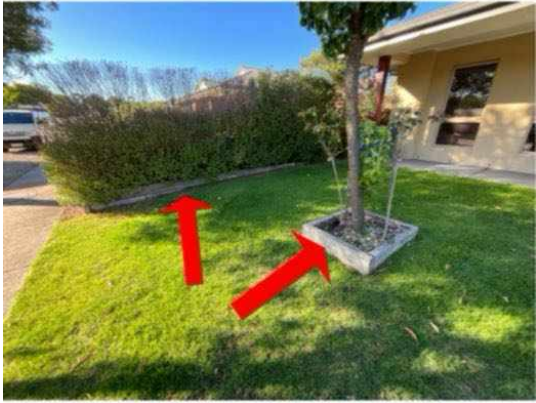
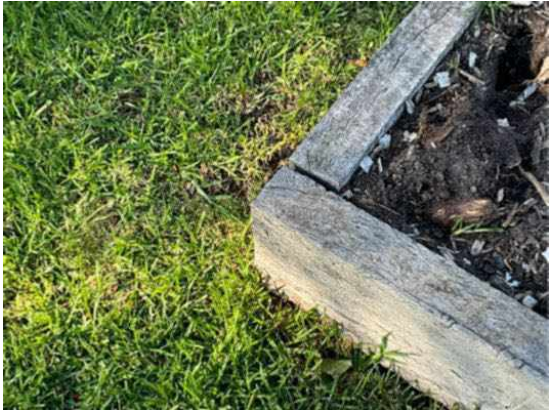
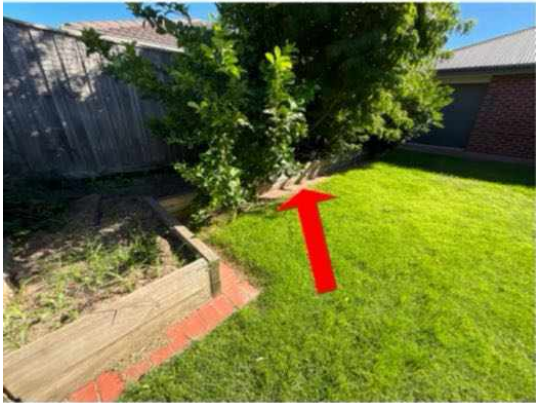
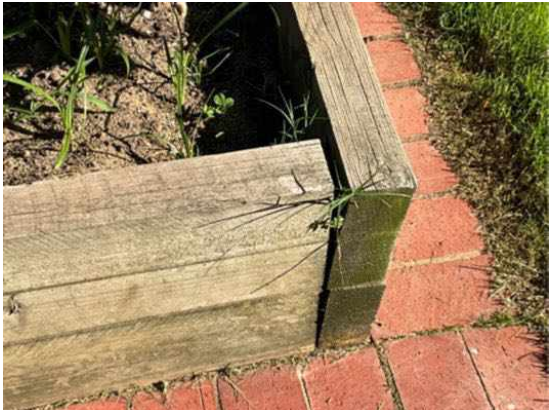
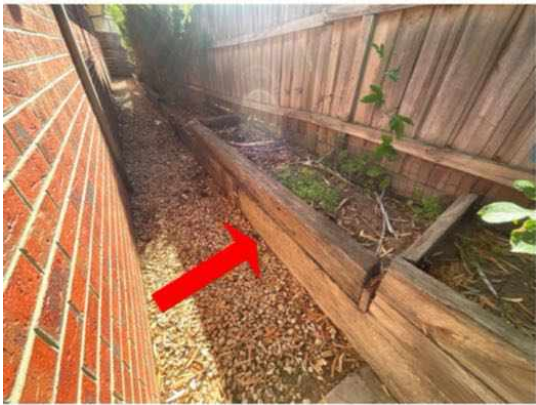
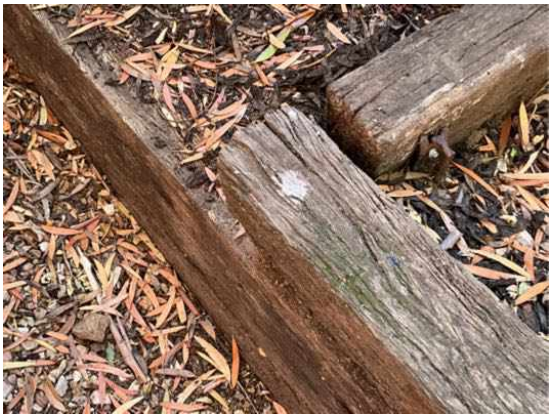
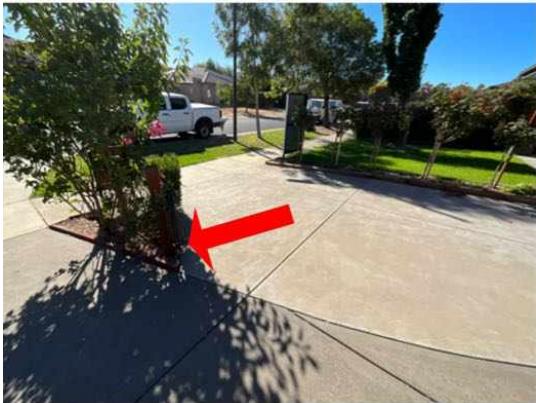
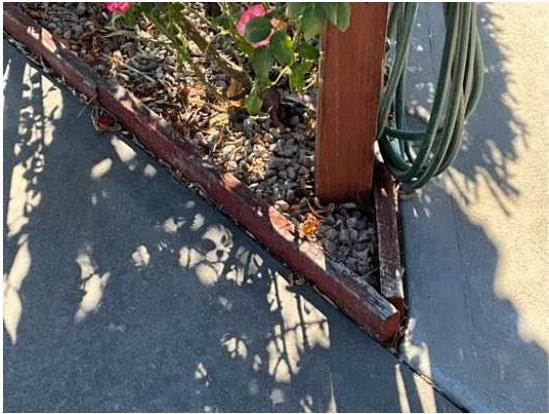
Finding 6.01

Building:	Building 1
Location:	Yard - Front, back, side
Finding:	Untreated or non-durable timbers in a hazardous environment
Information:	To reduce the risk of timber pest attack it is essential that timber used in a hazardous environment (e.g. in direct contact with the ground or frequently exposed to damp conditions) is of sufficient durability and/or is adequately preservative treated.

Untreated timbers in direct contact with the ground are likely to develop severe wood rot and/or fungal decay if left unattended creating attraction for subterranean termites to infest the timbers from surrounding areas.

If untreated or non-durable timbers are found to be in a hazardous environment it is highly advised that replacement of these building elements be performed as soon as possible to aid the protection of the property against termite / timber pest attack.

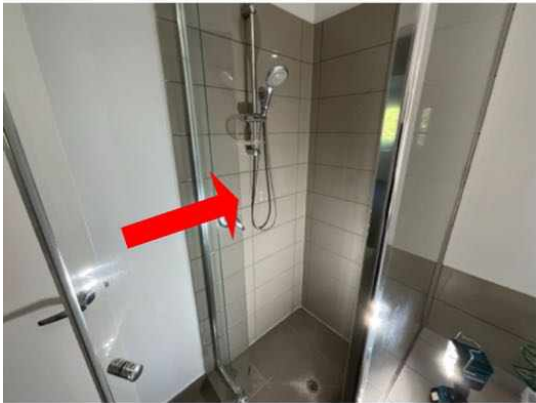
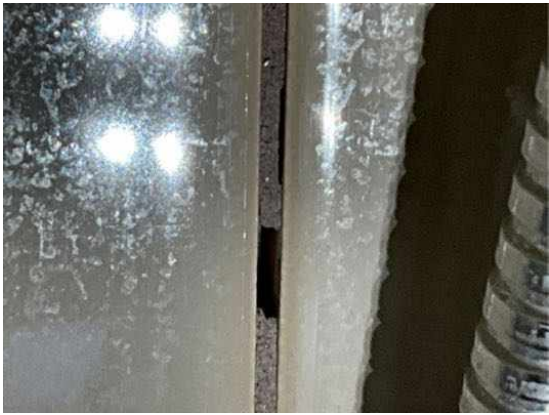
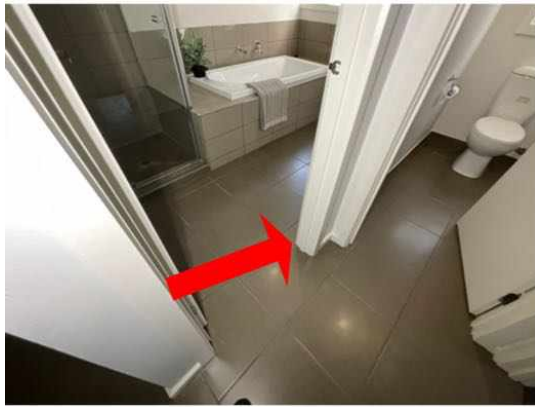
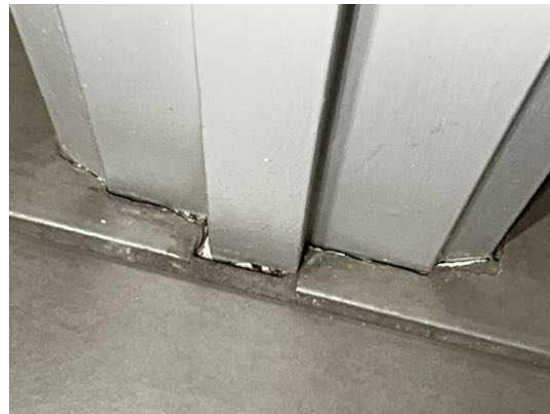
Finding 6.02

Building: Building 1
Location: Bathroom
Finding: Inadequate sealant or Grout
Information: This area has a lack of effective Sealant or Grout. This is allowing the ingress of water to the structure inside the wall.

The presence of water encourages Termite attack, Mould and Fungal Decay.

A Tiler or General Handy person must be contacted as soon as possible to effect repairs and prevent further deterioration.

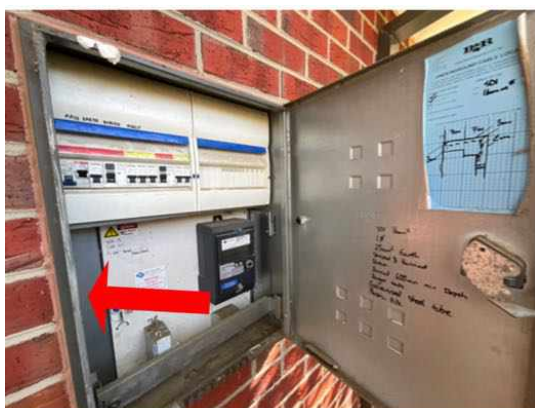
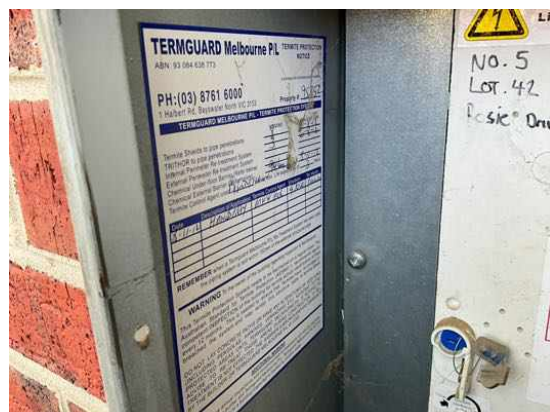
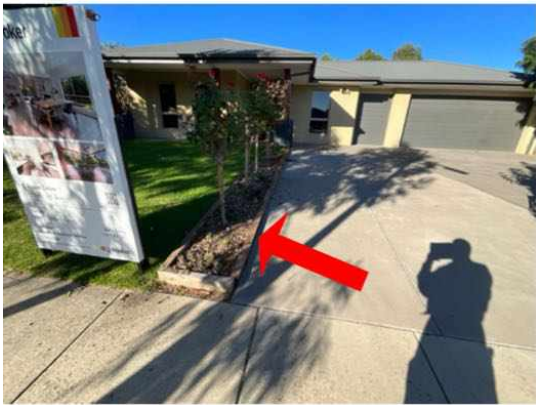
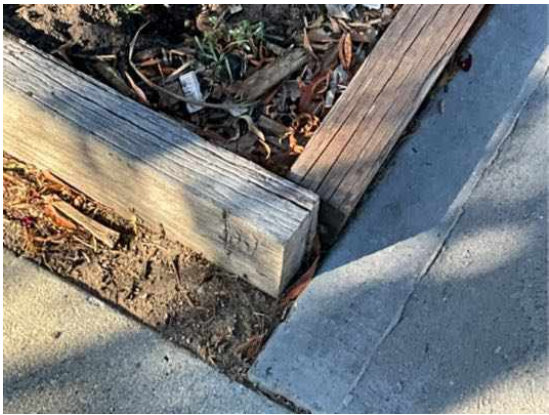
Finding 6.03

Building:	Building 1
Location:	All External Areas
Finding:	Termite Management System - no evidence of a chemical installation
Information:	The application of a post-construction chemical termite barrier is highly recommended for all properties, particularly if live termite activity has been found on the site previously. Such barriers are highly effective in preventing termite attack on any timber building elements throughout the property.

A durable notice should be placed in the switchboard unit to indicate current termite barriers. At the time of inspection, it appeared as though no termite management system has been installed, with no evidence to suggest preventative works taking place.

The client may consider gaining further advice from a pest controller as to the costs and procedures involved with this application. It is recommended that obtaining such advice be a short-term priority.

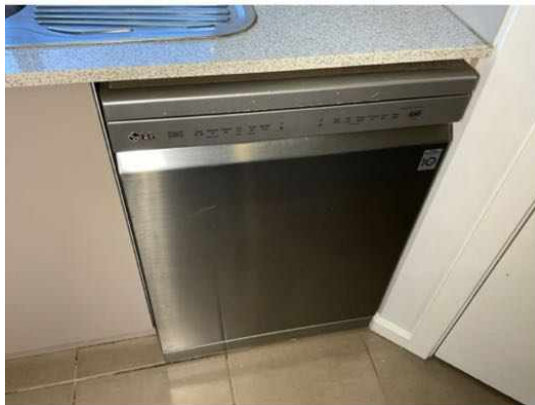
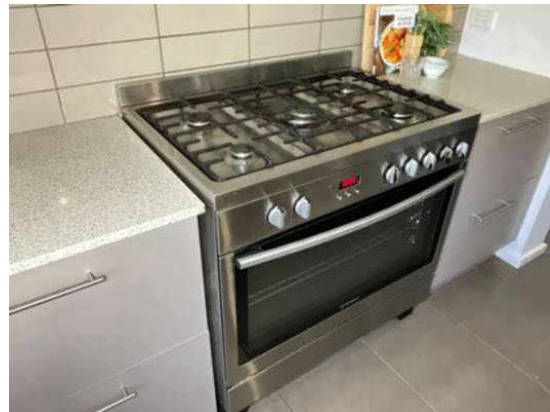
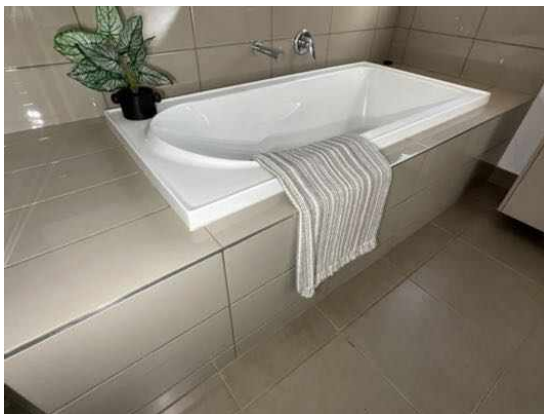
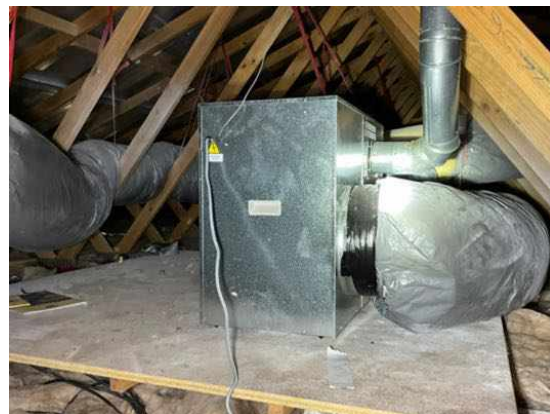
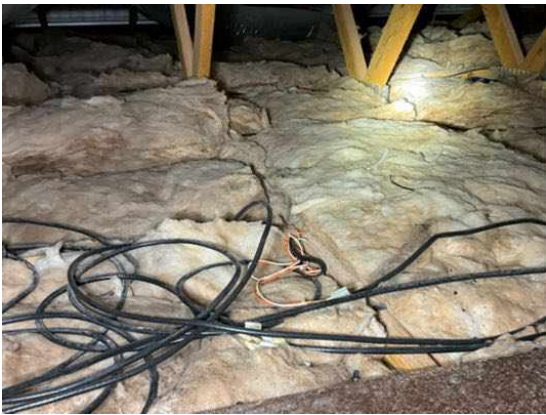
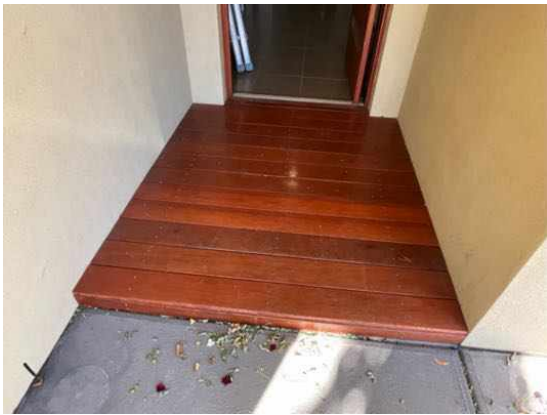
Building: Building 1
Location: All Areas
Finding: Additional Photos - Obstructions and Limitations
Information: These photographs are an indication of the obstructions and limitations which impeded full inspection of the property at the time of inspection. These obstructions can hide an array of defects and should be removed to allow full inspection to be carried out. A re-inspection is recommended once the areas are made accessible.
