Building and Timber Pest Inspection Report

Inspection Date: Mon, 9 Feb 2026

Property Address: 26 Olivedale St, Birdwood SA 5234,
Australia

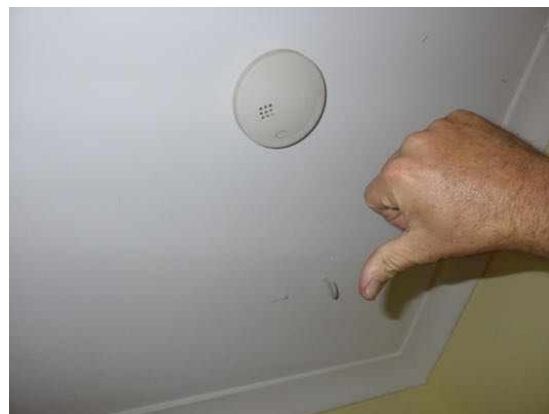
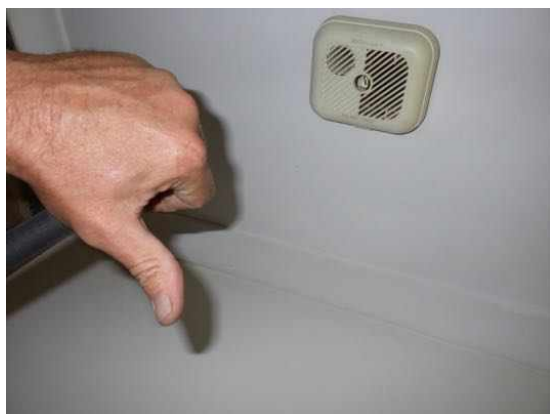
Please note that this defect is highlighted as a caution only. We suspect, based on our experience in the building industry, that the absence of smoke detectors, or their poor condition, should be addressed as a matter of urgency to improve occupant safety.

Always ensure sufficient working and suitable smoke detectors are installed prior to occupying any building. Additionally, it is advised that all smoke detectors be tested by the homeowner on a monthly basis.

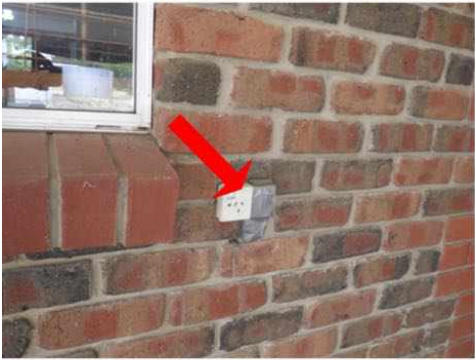
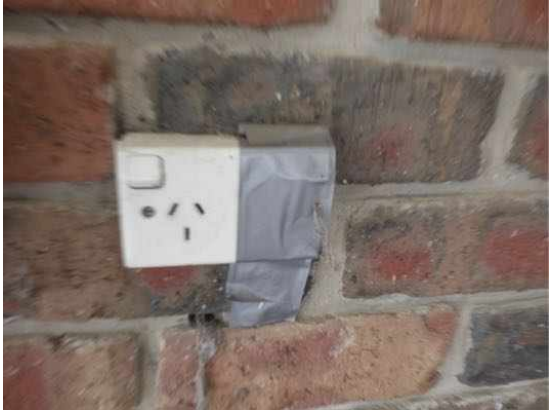
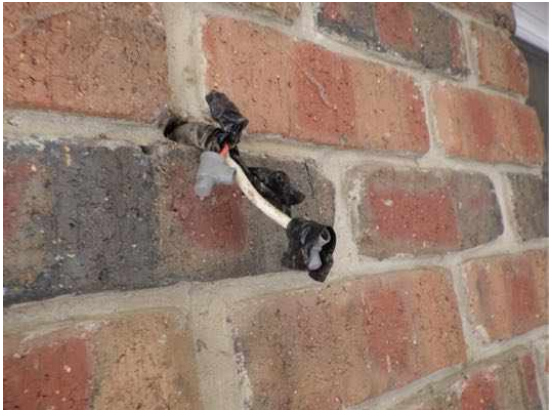
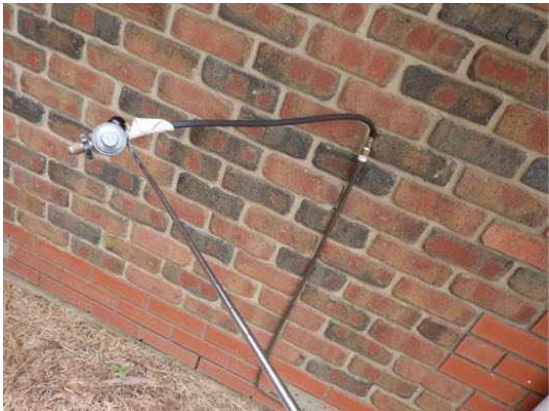
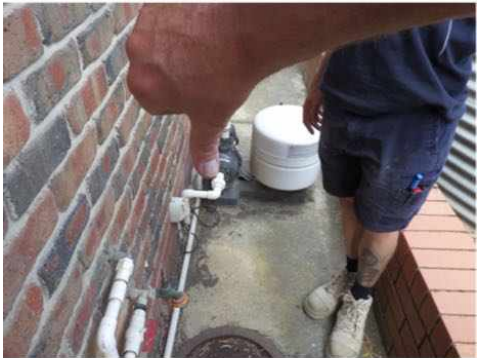
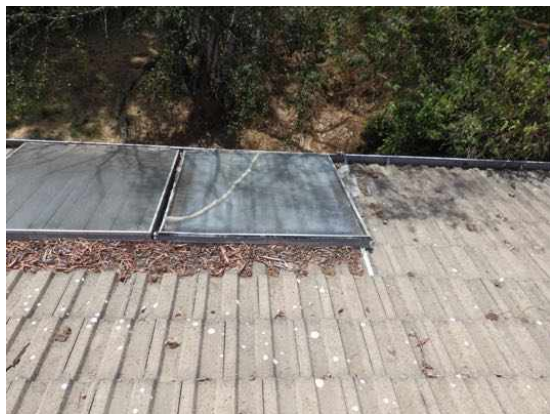
Finding 2.01

Building:	Building 1
Location:	All Areas
Finding:	Plumbing and electrical, aged / degraded
Information:	Commenting on plumbing and electrical issues is done to draw attention to potential issues throughout the dwelling. As we are not licensed plumbers or electricians follow-up advice is recommended.

Several issues were noted, including the pump Setup not switching off, damage to the solar hot water service on the roof, questionable gas bottle connection at the time of inspection.

Several issues were noted to the electrical including exposed blue points, a damaged power outlet at the time of inspection

These are common defects that is consistent with general ageing of the building element. However, it may be indicative of substandard plumbing or electrical workmanship in some cases.

While this defect only seems minor, if left unmanaged, it is likely to result in the development of rust, water damage, extensive water usage and safety hazards being created. .

It is advised that a licensed electricians and plumbers be appointed to perform remedial works on the affected areas.

Such works should be performed prior to the development of secondary defects to ensure adequate functionality of all associated building elements.

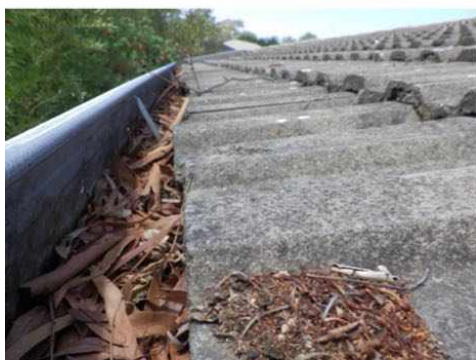
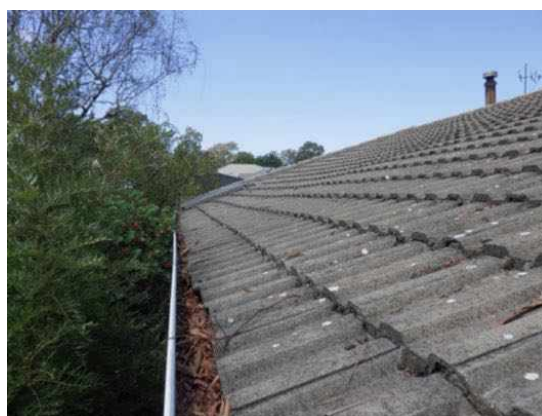
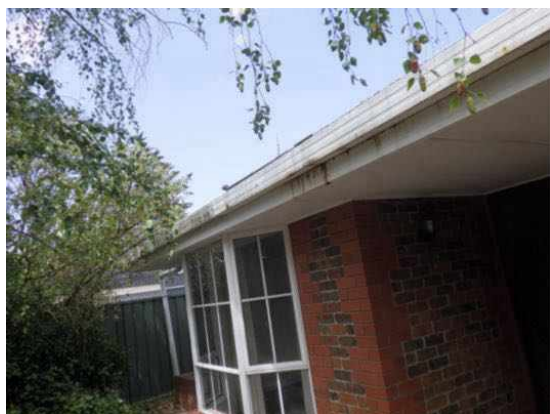
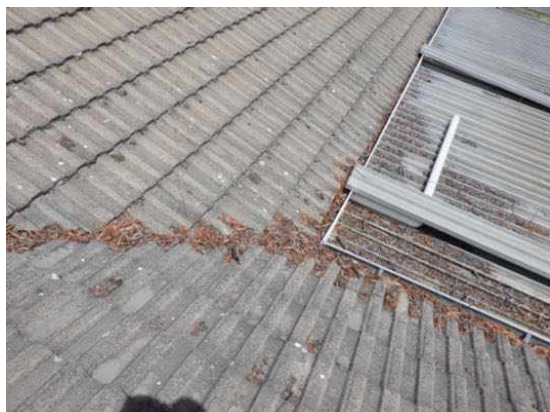
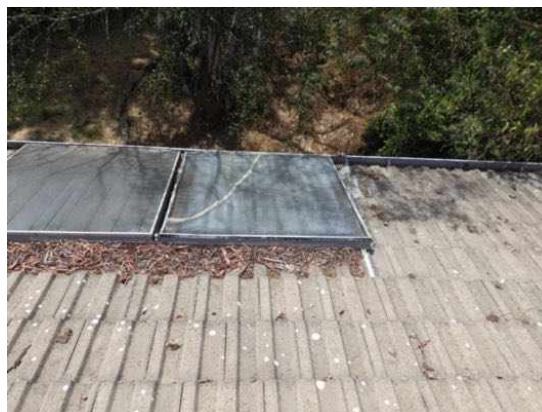
Finding 2.02

Building:	Building 1
Location:	Roof Exterior
Finding:	Gutters - Blocked
Information:	Roof plumbing structures, such as guttering and downpipes, should be free of all debris to prevent blockages. Blockages of the guttering and downpipes will lead to pooling and accumulated water overflows, which is likely to subsequently flood eaves and exterior walls.

Blocked gutters are likely to lead to high levels of moisture in the affected areas. Such moisture will not only cause rust and decay of the associated building materials, but can also provide conditions that are conducive to termite and timber pest activity. Blockages in gutters should therefore be removed immediately to ensure dry conditions are maintained.

Consult a Licensed Plumber for further specific advice on remedial works that may be required. In the interim, it is highly advised that blocked gutters be removed by the homeowner or a general handyperson as a matter of urgency.

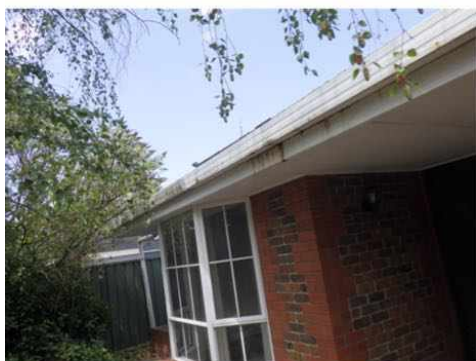
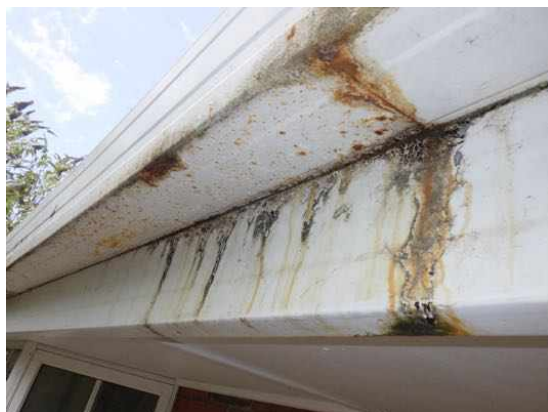
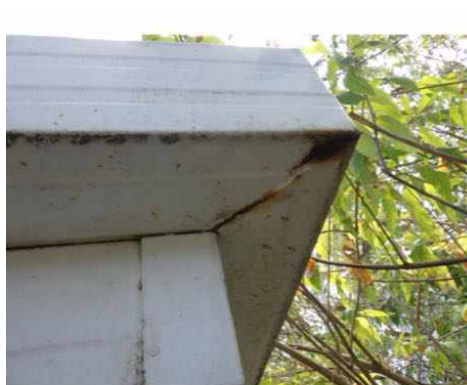
Finding 2.03

Building:	Building 1
Location:	Roof Exterior
Finding:	Roof plumbing - Rusted or corroded
Information:	The roof plumbing has areas of rust and corrosion. It is suspected that this has been caused by blockages, resulting in pooling or standing water, that have prematurely rusted elements of the roof plumbing.

Rusted roof plumbing will generally develop holes and leaks that can affect other building elements with poor drainage of storm water.

Poorly drained roof areas will also lead to damp conditions surrounding the base perimeter of the building which, if left unmanaged, can lead to a range of secondary building defects.

Repair and/or replacement of rusted roof plumbing is highly required in order to reinstate the roof drainage system to a fully operational level.

A licensed plumber or specialist roof restoration company should be appointed to undertake these works. It is advised that such works be completed as soon as

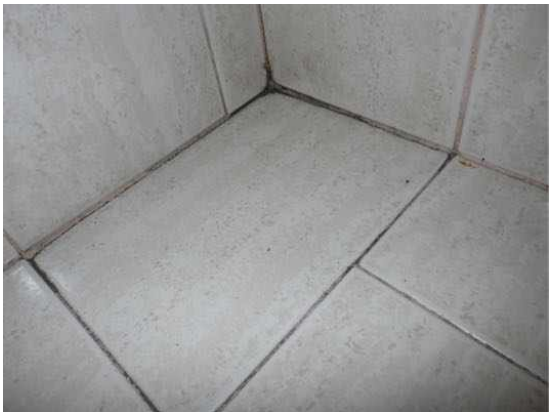
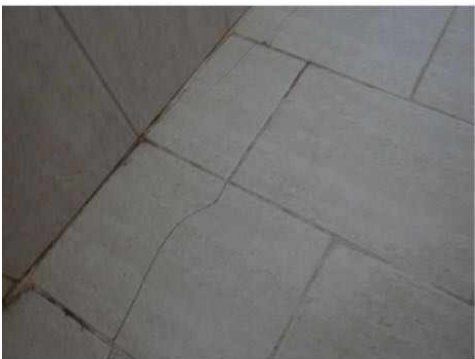
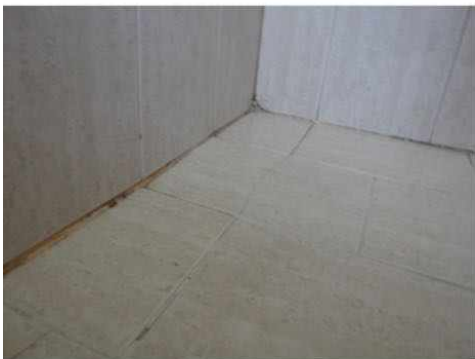
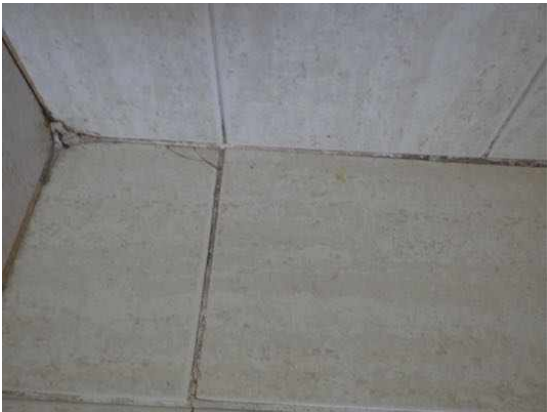
Finding 2.04

Building:	Building 1
Location:	Both bathrooms
Finding:	Deteriorated Tiling, sealant and grout
Information:	It was noted on inspection that tiling, sealant or grout to both bathrooms is showing signs of deterioration with cracked tiles and deteriorated grout throughout.

Flexible and mould resistant materials should be applied to any damaged areas to prevent any subsequent water damage that is likely to occur. Regular maintenance and replacement of damage or missing or damaged sealant and grout is highly recommended to the wet areas, as this is a regular wear and tear defect.

Deteriorated sealant and grouting in areas that come into regular contact with water should be maintained for the long term care of your property. A sealant specialist or tiling contractor should be appointed to complete these works as soon as possible. Full bathroom renovation will likely be required.

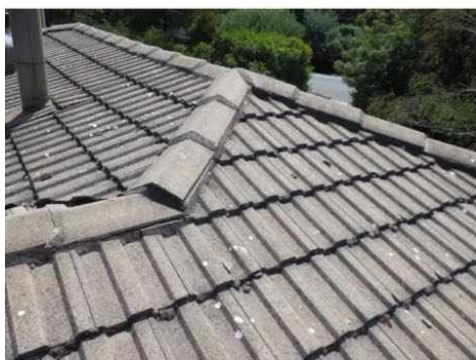
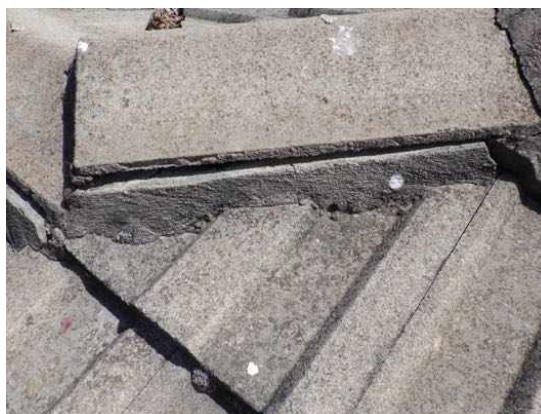
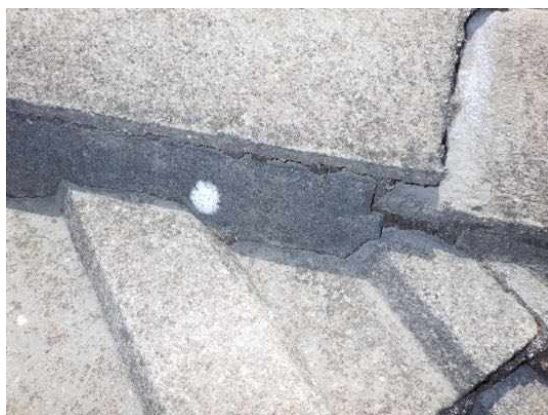
Finding 3.01

Building:	Building 1
Location:	Roof Exterior
Finding:	Mortar - Deterioration
Information:	Mortar, or 'bedding', is the material which fills joins and intersections between tiles and other building elements on the exterior roof covering, such as gable ends, hip capping and valleys. Upon inspection of the exterior roof, it was noted that sections of the mortar show varying levels of deterioration.

Mortar generally deteriorates as a result of frequent exposure to weather conditions over a prolonged period of time. Mortar that is deteriorating may allow water ingress into the roof void, putting associated building elements and roofing structures at risk of water damage.

Deteriorated mortar also detracts from the functionality of roof tiles and other roofing elements, potentially decreasing weather tightness and roof drainage.

Mortar deterioration can be attended to by a handyperson where areas of deterioration are localised and easily accessible. Otherwise, consultation with a roofing contractor is advised where greater works are required.

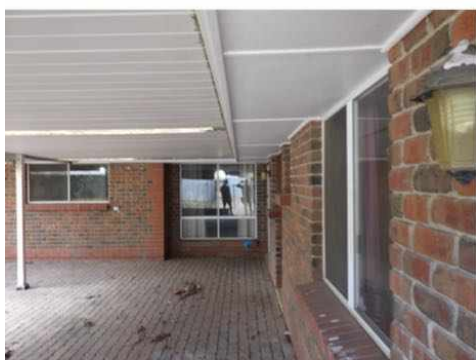
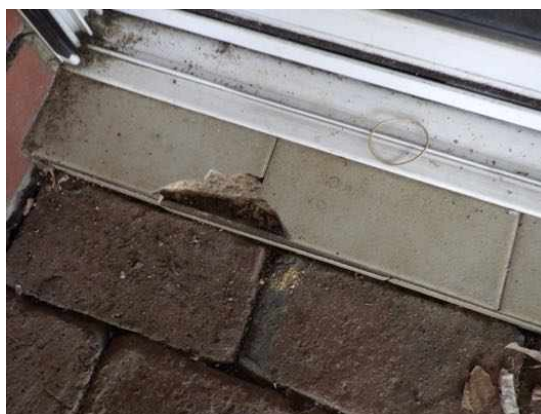
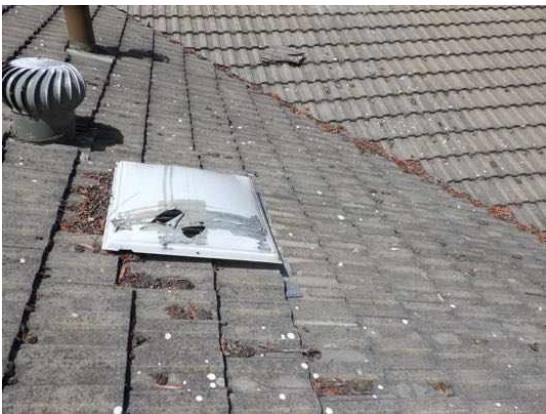
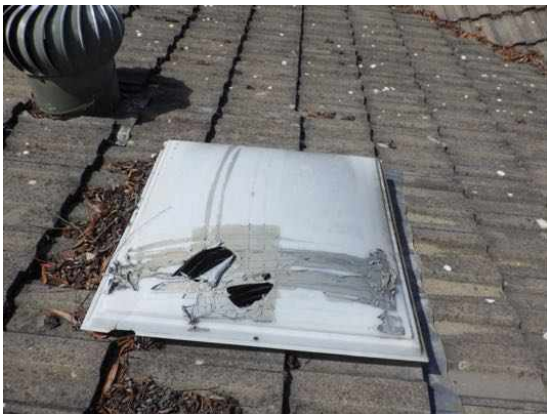
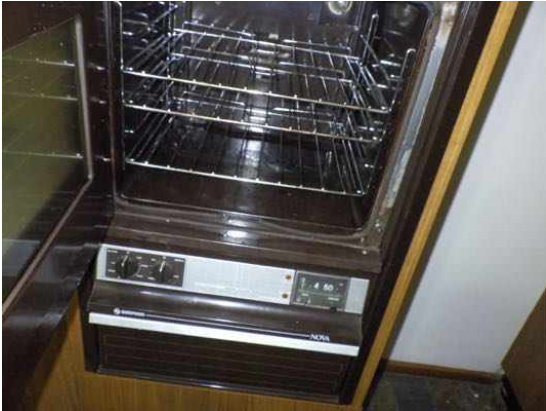
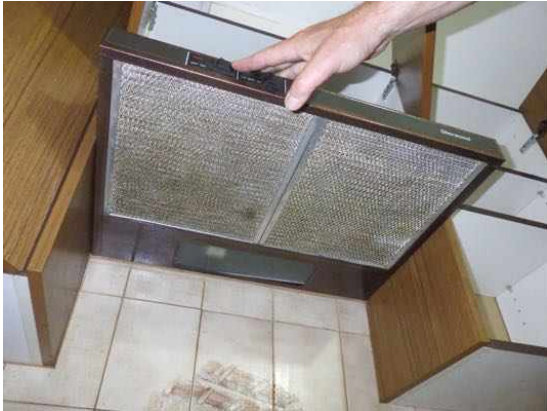
Building:	Building 1
Location:	All Areas
Finding:	Minor defects present
Information:	There were several age and maintenance related defects evident to the dwelling at the time of inspection. These defects include but are not limited to

- damage seal tiles to base of sliding doors
- Damage to plastic skylight on roof
- Appliances and Rangehood old and deteriorated
- Cracked or damaged tiles to living area
- Damaged shower screen
- Loose timber sill to bedroom three
- Air-conditioner requires service

Appropriate licensed trades people could be appointed to make repairs at the discretion of the client.

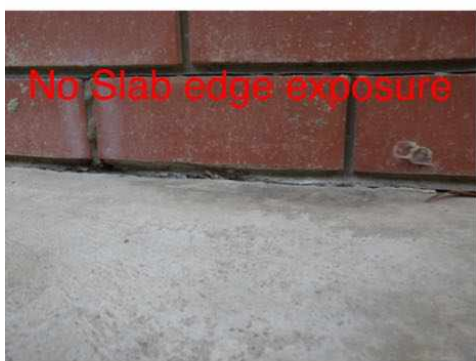
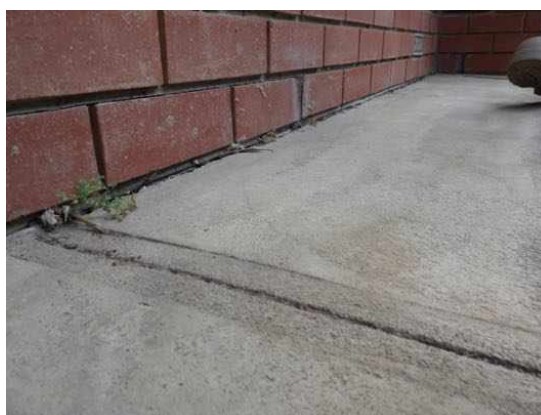
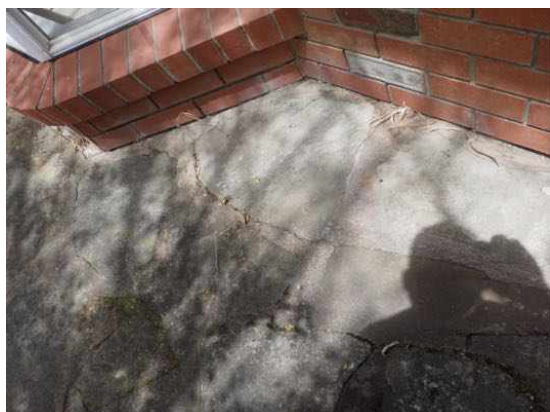
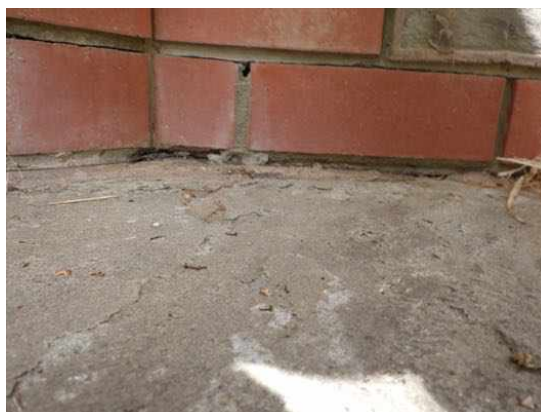
If the slab edge is not properly exposed there is a high risk of concealed termite attack which your inspector will likely not be able to see. Sometimes, in order to determine the type of slab, a suitably qualified person such as an architect or builder may be required to consult construction plans.

Where the slab edge cannot be properly inspected, it is highly recommended that termite or timber pest inspections be carried out every 6-12 months to aid protection of the property against infestation and termite treatment advice is followed closely.

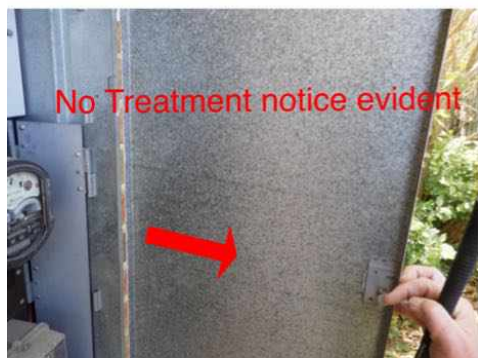
Building:	Building 1
Location:	All Areas
Finding:	Termite Management System - no evidence of a chemical installation
Information:	The application of a post-construction chemical termite barrier is highly recommended for all properties, particularly if live termite activity has been found on the site previously. Such barriers are highly effective in preventing termite attack on any timber building elements throughout the property.

The client may consider gaining further advice from a pest controller as to the costs

and procedures involved with this application. It is recommended that obtaining such advice be a short-term priority.
