Building Inspection Report

Inspection Date: Tue, 3 Mar 2026

Property Address: 39 Paragon Dr, Clyde North VIC 3978,
Australia

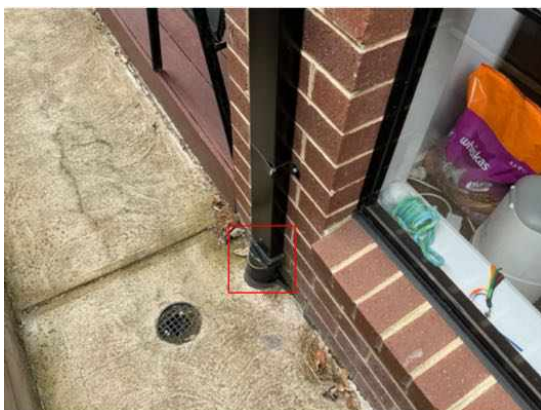
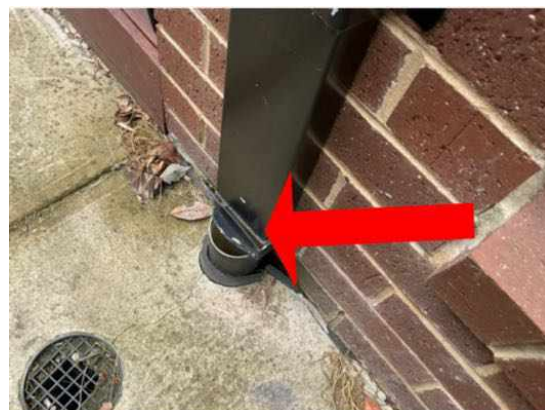
Defects 3.01

The rainwater downpipe at the inspected location was observed to terminate into an open stormwater entry point without a proper sealed connection at the base.

A condition of this nature may allow stormwater to escape around the base of the downpipe rather than being fully directed into the drainage system. Over time, this may result in localized water ponding or saturation adjacent to the wall and footing area, which may contribute to moisture-related deterioration or ground movement if left unrectified.

It is recommended that a licensed plumber be engaged to properly connect and seal the downpipe into the stormwater drainage system and confirm that roof water is being effectively discharged away from the dwelling.

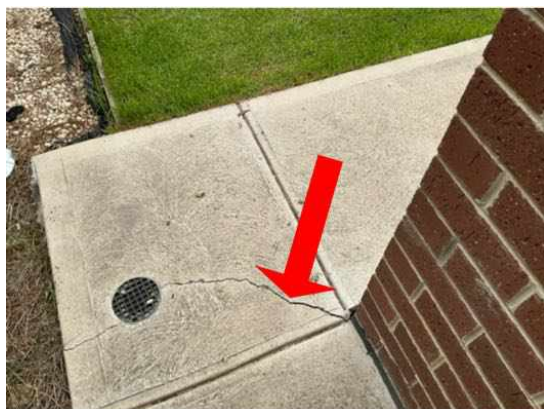
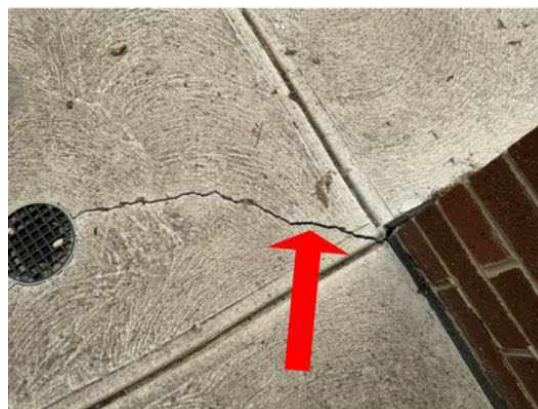
Defects 3.02

Location: Yard - Side
 Finding: Cracking - External Concrete Paving Damage Category 2 - Distinct (less than 3mm)
 Information: Distinct cracks were identified in external concrete paving. Distinct cracks are generally found in older concrete paving, and may also present as a trip hazard as consequence of an uneven or curved surface.

General age and expected deterioration of the paved areas is a common cause of this type of cracking. However, expansion and contraction of the slab may also have occurred due to environmental factors. Such factors include variable moisture and weather conditions, the presence of trees and their roots having a settling or lifting affect on the soil, or the effect of load bearing, e.g. heavy vehicles over a sustained period of time.

Cracking to this degree may also be due to poor original installation of the concrete. Factors such as poor compaction of the sub surface and/or inadequate reinforcing of the slab may create cracking and other secondary defects.

Repairs are likely to be required to prevent further cracking and to reduce hazards associated with cracking, such as tripping. Monitoring of all cracking should be conducted frequently. Always contact a building inspector should cracks widen, lengthen, or become more numerous.

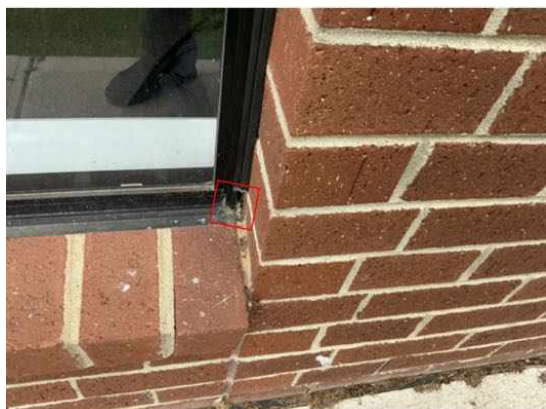
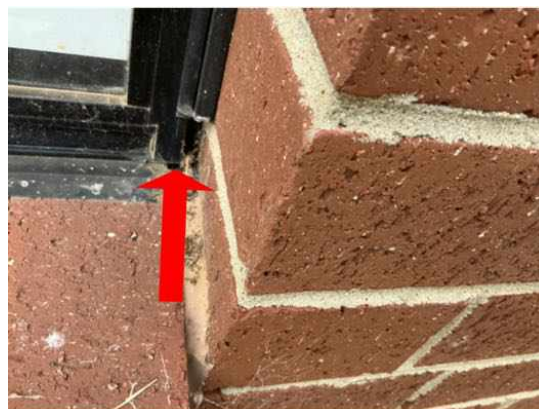
Defects 3.03

Building: Main Building
 Location: All External Areas
 Finding: Window seals - deteriorated
 Information: The window seals have deteriorated and are in a generally poor condition. Due to frequent exposure to weather conditions and subsequent moisture, deterioration of window seals is expected in a property of this condition and age.

Where window seals have deteriorated, the window is no longer weather-tight; rain penetration and subsequent water damage is therefore likely to ensue. Insulation of the area against external weather conditions will also be compromised.

It is recommended that all deteriorated window seals be replaced by a general handyman or sealant expert to prevent any further damage and to restore the window to a fully functional level.

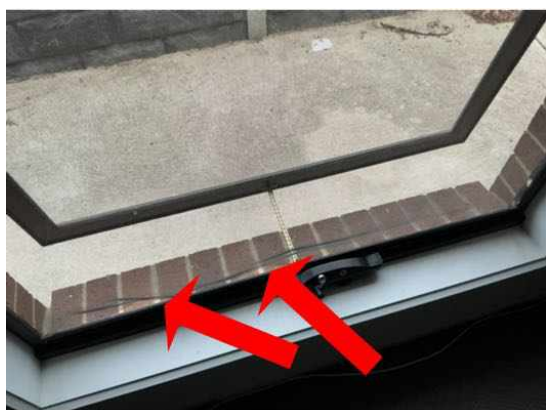
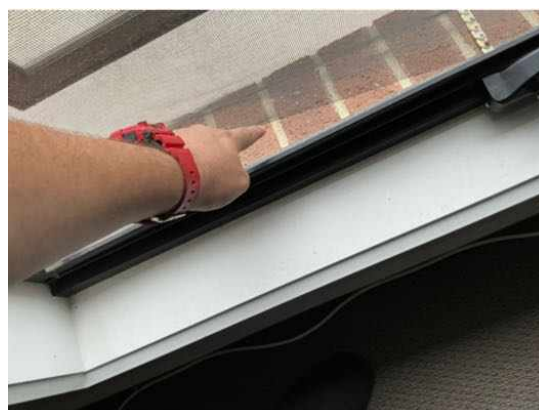
Defects 3.04

Building:	Main Building
Location:	Bedroom - Master
Finding:	Flyscreens - damaged
Information:	Upon visual inspection, we found that the flyscreen in the master bedroom is damaged. This condition could compromise insect protection and allow pests to enter through the open window, potentially affecting indoor comfort and hygiene. We recommend engaging a qualified tradesperson to repair or replace the damaged flyscreen at the earliest convenience to restore its functionality.

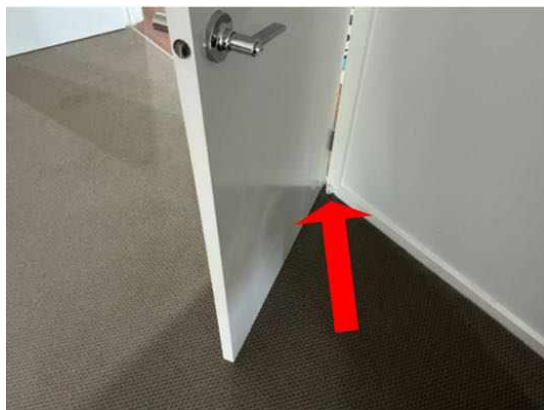
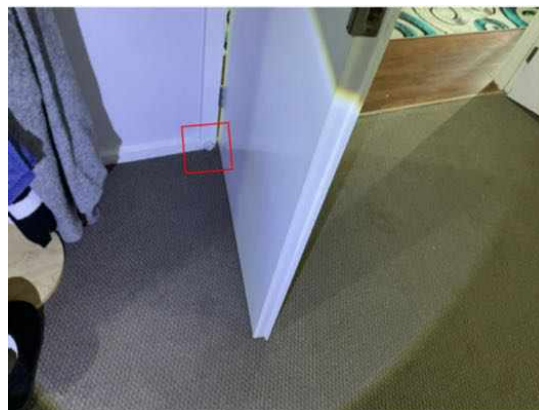
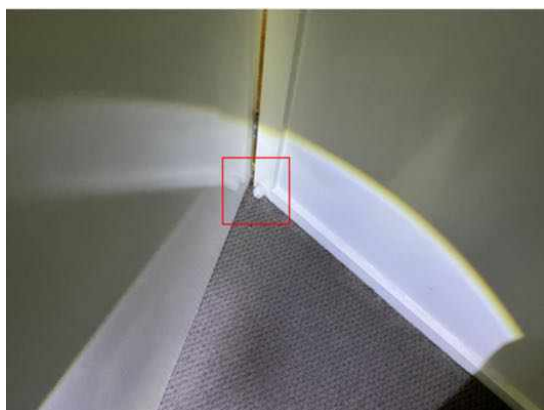
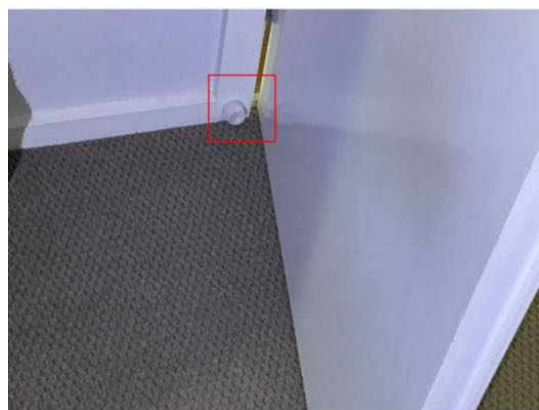
Defects 3.05

Building:	Main Building
Location:	Bedroom - Master
Finding:	Door stop - Missing
Information:	The door stop is missing or is inadequate to stop the door handle from damaging the wall. Although some building elements may seem irrelevant or unnecessary, all building elements play a key role in the operation and function of the overall structure

and its performance.

Re-installation or replacement of the door stop is advised as soon as possible to prevent any subsequent damage to the door or associated structures. A general handyman may be appointed to perform these works at client discretion.

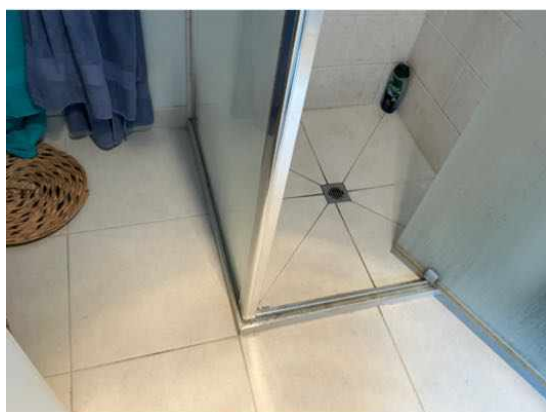
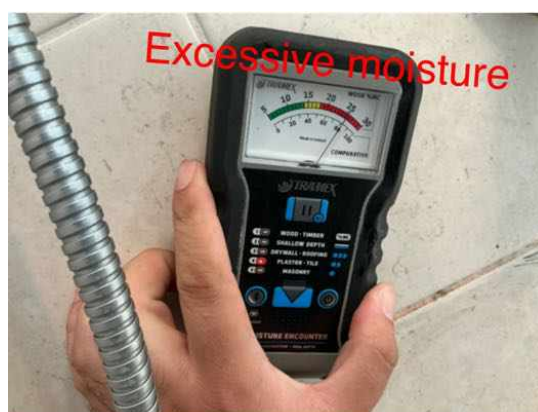
Defects 3.06

Building:	Main Building
Location:	Ensuite - Master
Finding:	Shower - Damp
Information:	Damp is evident to the lower 300mm of wall to the shower alcove. This defect is quite common, and is suspected to have been caused by moisture permeating through the grouting in this area, which shows evidence of deterioration. Leaking pipes within the adjoining wall is also a possible cause.

Damp (or structural damp) refers to the presence of unwanted moisture in the structure of a building, either as the result of intrusion from outside, or condensation from within the structure. In the shower area, internal water leaks or other sources of excessive moisture are generally the cause of damp.

Unmanaged damp in the shower recess is likely to facilitate the formation and development of mould and fungi growth, decaying associated building materials and

compromising their structural integrity. It is important to address damp conditions, as the World Health Organisation notes that excess moisture leads - on almost all indoor materials - to growth of microbes such as moulds, fungi and bacteria, which subsequently emit spores and other matter into the indoor air. Exposure to these contaminants is associated with a wide range of respiratory and other health-related problems.

Consultation with a qualified plumber or bathroom specialist is advised immediately to identify the cause of damp and to perform remedial works as required. Where excessive mould growth is present, further inspection by a specialist environmental health inspector should also be considered.

Always ensure that sealant and grout is in good condition to prevent any moisture issues occurring in the future.

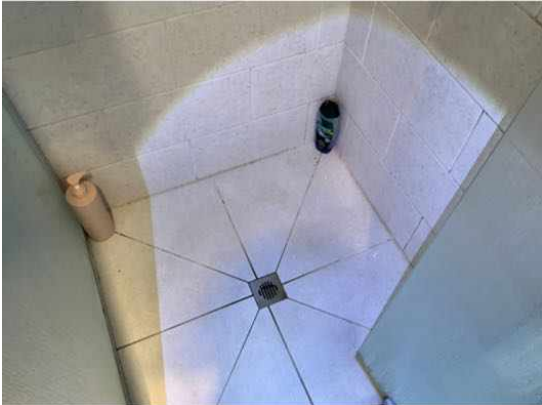
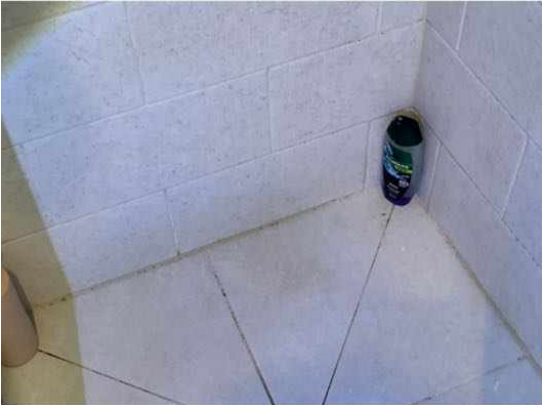
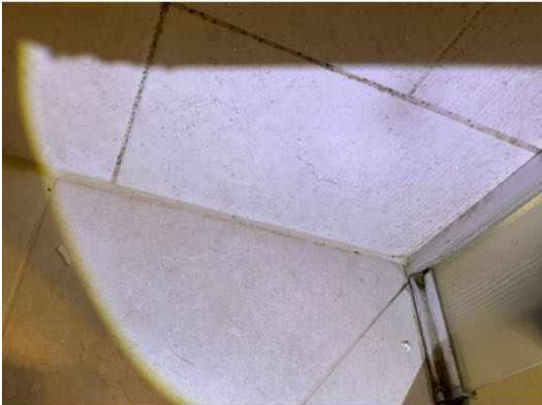
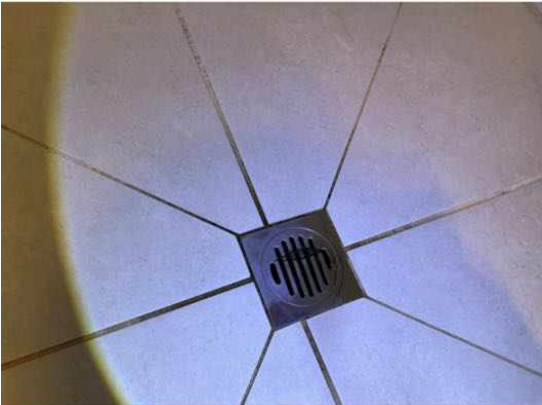
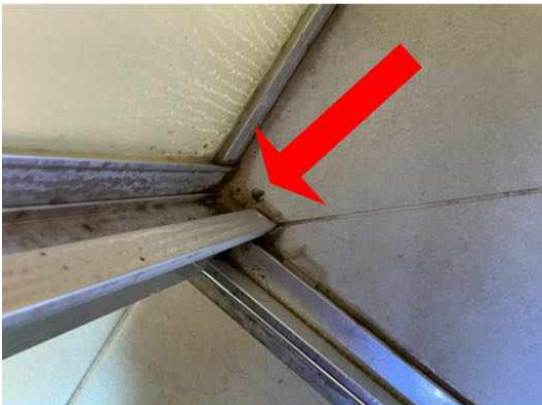
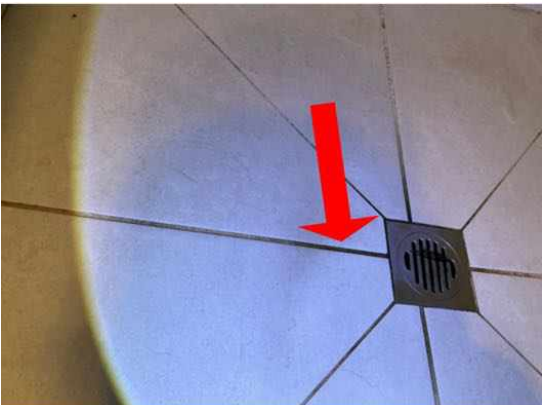
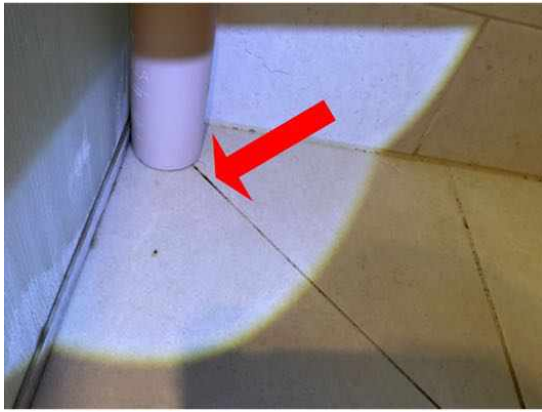
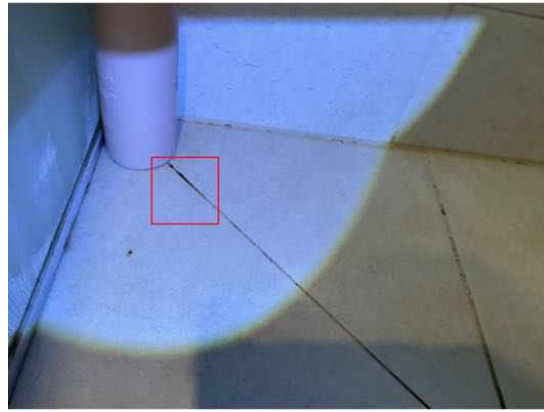
Defects 3.07

Building:	Main Building
Location:	Ensuite - Master
Finding:	Sealant and grouting - Deteriorated
Information:	It was noted on inspection that sealant or grout is degraded to the tiled shower alcove and or other areas of the bathroom.

Different materials and floor areas move at different rates, generally causing cracking to grout or sealant at this point. A flexible sealant is required to allow for expected expansion and contraction, while keeping the joint water tight and protective of all associated building materials.

There appears to be excessive mould to the sealant and grout which will likely require scraping out and replacement.

Flexible and mould resistant materials should be applied to affected areas to prevent any subsequent water damage that is likely to occur. Regular maintenance and replacement of damage or missing or damaged sealant and grout is highly recommended to the wet areas, as this is a regular wear and tear defect. Sealant and

grouting in areas that come into regular contact with water should be maintained for the long term care of your property.

A sealant specialist or tiling contractor should be appointed to complete these works as soon as possible

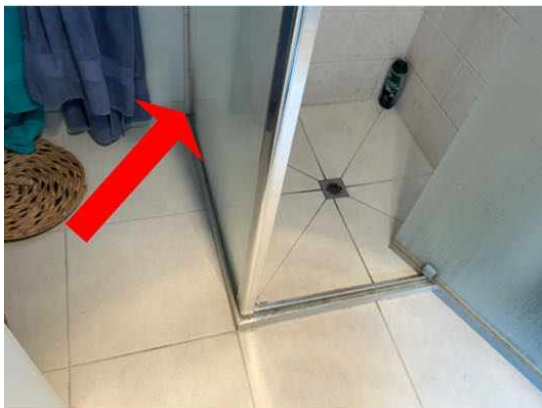
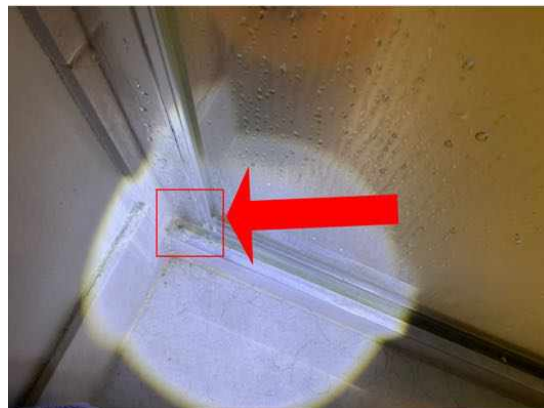
Defects 3.08

Building:	Main Building
Location:	Ensuite - Master
Finding:	Shower screen - Leaking
Information:	Leaking was evident to the ensuite's shower screen at the time of inspection. It is suspected that the leaking has occurred as a result of deteriorated or missing caulking to the shower or general ageing of the building elements.

Leaking from the shower where left unattended, is likely to lead to water damage to adjoining flooring and walls. Such damage can lead to water damage and necessitate extensive remedial works being required. Active water leaks may also create an environment that is susceptible to the formation and development of mould.

Appointment of a caulking contractor is required to repair or replace the caulking to the shower area. Such works should be performed as soon as possible to ensure that no further damage occurs.

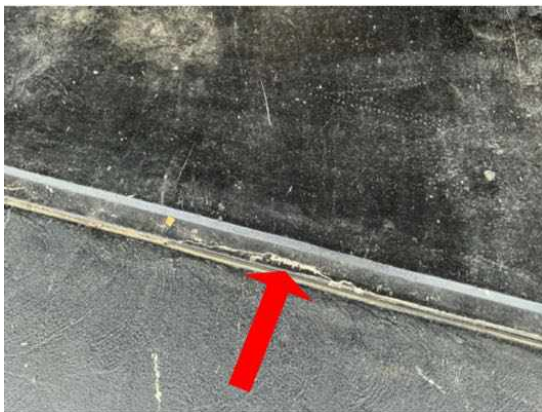
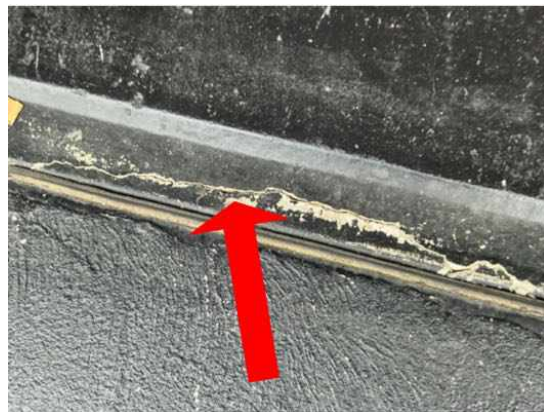
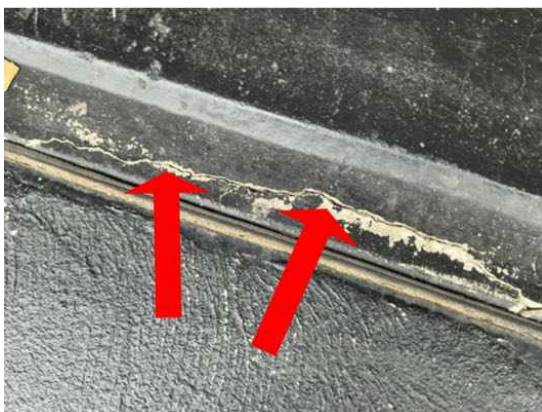
Defects 3.09

Building:	Main Building
Location:	Garage
Finding:	Cracking to Garage Concrete Slab Floor

Information: Cracking was observed to the concrete slab floor within the garage area at the time of inspection. The cracks appear to run along sections of the slab surface and are visible adjacent to the slab edge.

Concrete slab cracking can occur due to shrinkage, minor settlement, or natural movement of the concrete over time. In most cases, cracks of this nature are relatively common in concrete slabs; however, if they widen or allow moisture ingress, they may contribute to gradual deterioration of the slab surface.

It is recommended that the cracks be monitored for any signs of progression. If the cracks widen or show signs of ongoing movement, a qualified concreter should be consulted to assess the slab and carry out appropriate repairs, which may include cleaning and sealing the cracks to minimise moisture penetration and further deterioration.

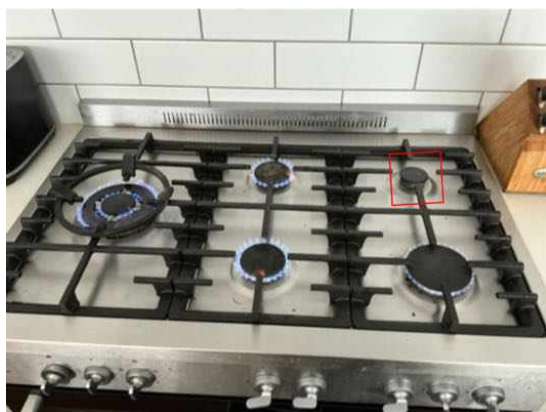
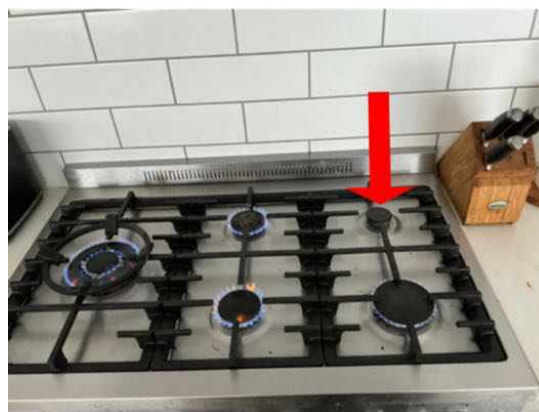
Defects 3.10

Building: Main Building
 Location: Kitchen
 Finding: One Stove Burner Not Operating
 Information:

At the time of the inspection, one of the stove burners was found to be not operating when tested.

A non-functioning burner may indicate a fault with the burner component, ignition system, gas supply to that burner, or a blockage within the burner assembly. Malfunctioning cooking appliances can affect the usability of the appliance and may require servicing to restore proper operation.

It is recommended that a licensed gas fitter or appliance technician be engaged to inspect the stove, diagnose the issue with the affected burner, and carry out the necessary repairs or servicing as required.

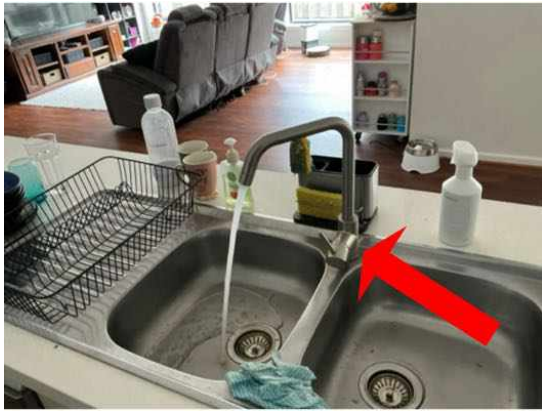
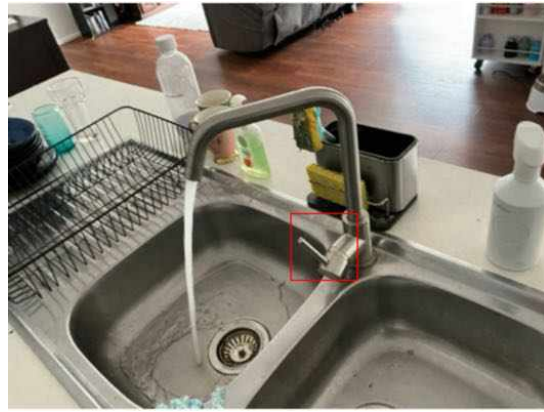
Defects 3.11

Building:	Main Building
Location:	Kitchen
Finding:	Tap - Water hammer
Information:	The kitchen sink tap shows evidence of water hammer being present. Water hammer, a pressure surge resulting when a fluid is forced to suddenly change direction, is a common defect in plumbing fittings, particularly those that are aged and not frequently maintained. Water hammer is generally caused by factors that create high water pressure in the affected plumbing fixture, usually evidenced by a faint banging noise during operation of the affected tap.

Although water hammer is generally considered to be a minor defect, subsequent damage such as erosion of tap hardware and/or water damage to associated building elements is likely to occur if left unmanaged.

A licensed plumber should be appointed as soon as possible to replace any affected tap hardware and perform any remedial works as necessary. Please be advised that the appointment of a cabinet maker or qualified carpenter may be necessary if water damage to associated building elements has occurred.

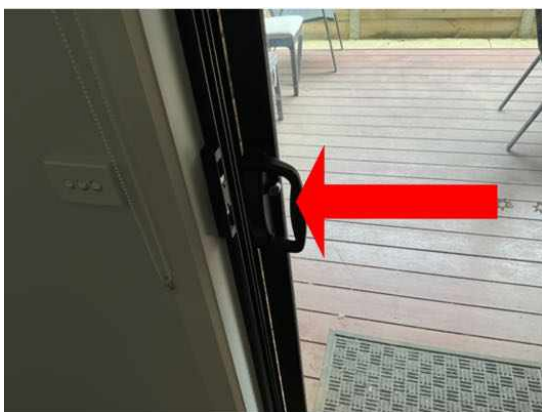
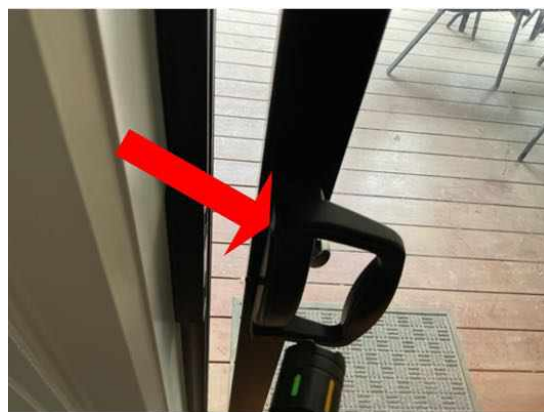
Defects 3.12

Building: Main Building
 Location: Alfresco
 Finding: Defective Sliding Door Lock – Dining Room to alfresco
 Information: The sliding door leading from the dining room to the alfresco area does not latch securely, preventing it from locking properly. The locking mechanism requires excessive force to engage, indicating potential misalignment, internal wear, or damage to the latch or strike plate.

A faulty lock compromises security, making it easier for unauthorised access and increasing the risk of damage to the door hardware due to repeated forceful operation. Continued use in this condition may lead to further deterioration, potentially rendering the lock completely inoperative.

It is recommended that a qualified tradesperson inspect and rectify the issue by adjusting the alignment of the door and strike plate, lubricating or replacing the locking mechanism as necessary, and ensuring smooth and secure operation.

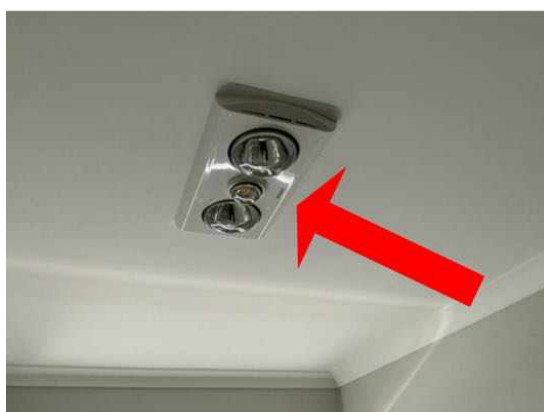
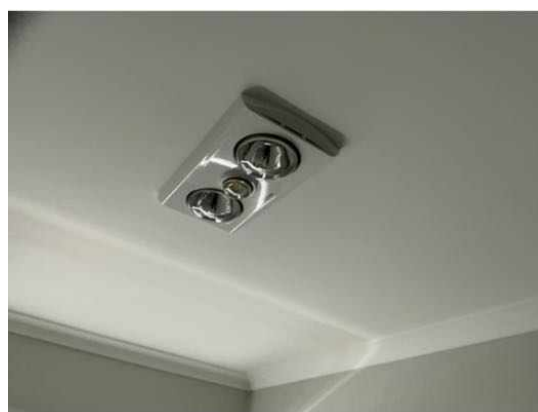
Defects 3.13

Building: Main Building
 Location: Bathroom 2

This issue may reduce the efficiency of the exhaust fan, leading to inadequate ventilation in the en-suite, which could contribute to moisture buildup and potential issues such as mold or mildew growth. A noisy fan is also generally less effective at expelling humid air, which could affect the overall air quality and comfort of the space.

It is recommended that a qualified technician inspect and service the exhaust fan to determine the cause of the noise. If necessary, the fan should be repaired or replaced to restore proper ventilation and ensure the en-suite remains well-ventilated and free of excess moisture.

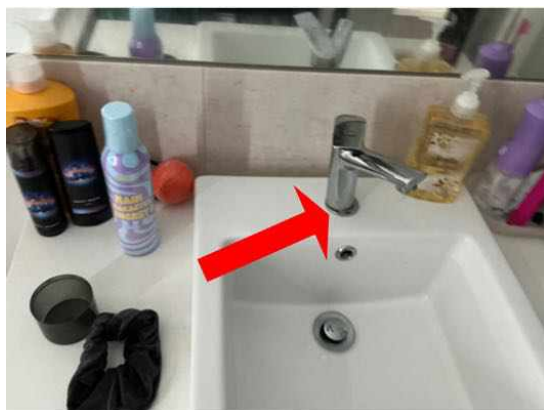
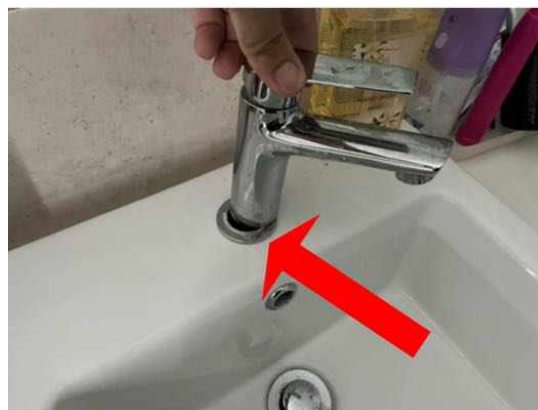
Defects 3.14

Finding: Tap - Loose

Information: The vanity sink tap has not been installed correctly, or has deteriorated with age, and is consequently loose. This tap being loose creates potential for water leaks and subsequent water damage to the surrounding area.

Where taps or spouts are loose, a qualified plumber should be appointed to re-fix the plumbing fitting.

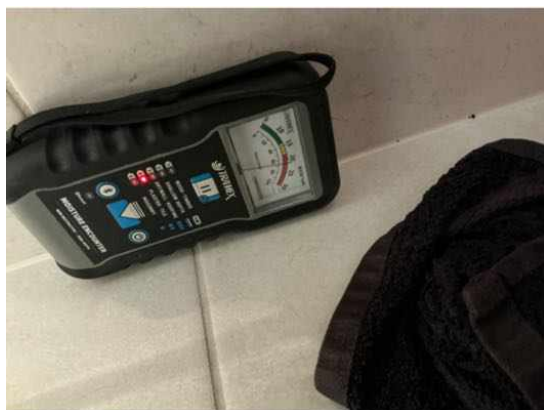
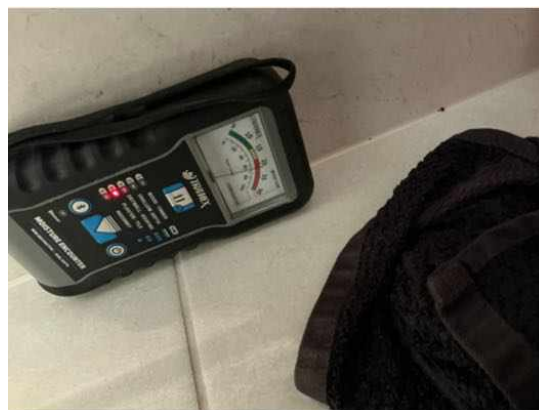
Defects 3.15

Building:	Main Building
Location:	Bathroom 2
Finding:	Shower - Damp
Information:	Damp is evident to the lower 300mm of wall to the shower alcove. This defect is quite common, and is suspected to have been caused by moisture permeating through the grouting in this area, which shows evidence of deterioration. Leaking pipes within the adjoining wall is also a possible cause.

Damp (or structural damp) refers to the presence of unwanted moisture in the structure of a building, either as the result of intrusion from outside, or condensation from within the structure. In the shower area, internal water leaks or other sources of excessive moisture are generally the cause of damp.

Unmanaged damp in the shower recess is likely to facilitate the formation and development of mould and fungi growth, decaying associated building materials and compromising their structural integrity. It is important to address damp conditions, as the World Health Organisation notes that excess moisture leads - on almost all indoor materials - to growth of microbes such as moulds, fungi and bacteria, which subsequently emit spores and other matter into the indoor air. Exposure to these contaminants is associated with a wide range of respiratory and other health-related problems.

Consultation with a qualified plumber or bathroom specialist is advised immediately to identify the cause of damp and to perform remedial works as required. Where excessive mould growth is present, further inspection by a specialist environmental health inspector should also be considered.

Always ensure that sealant and grout is in good condition to prevent any moisture issues occurring in the future.

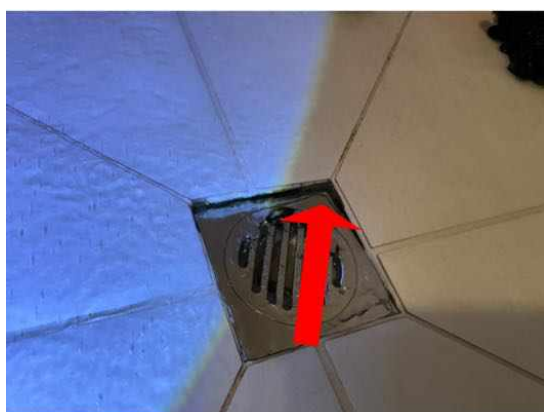
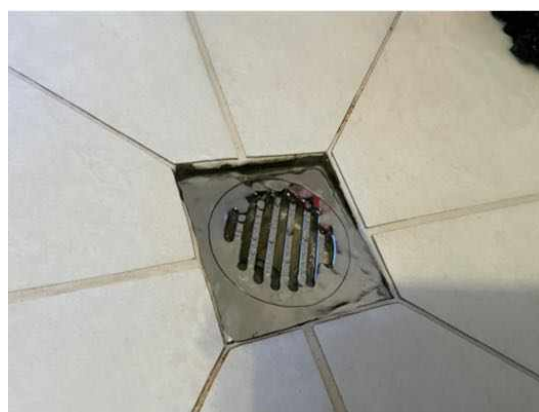
Defects 3.16

Building: Main Building
 Location: Bathroom 2
 Finding: Shower Floor Waste Recessed Below Tile Level and Not Properly Supported
 Information:

The shower floor waste was observed to be recessed below the surrounding tile surface at the time of inspection. The drain fitting appears to have dropped within the waste opening rather than sitting flush with the finished tile surface. The sealant around the waste also appears deteriorated and uneven.

A floor waste should be properly supported and installed so that the flange sits flush with the surrounding tiles to allow an effective waterproof seal. When the waste becomes recessed below tile level, it becomes difficult to maintain a watertight seal around the drain and water may accumulate around the perimeter. Over time, this condition may allow moisture to penetrate beneath the tiled surface and contribute to deterioration of the underlying substrate if not rectified.

It is recommended that a licensed plumber be engaged to inspect the shower waste assembly and determine why the fitting has dropped below the tile level. Rectification may involve resetting or replacing the waste fitting so that it sits flush with the surrounding tiles, followed by proper sealing with an appropriate sanitary-grade sealant to restore the watertight integrity of the shower floor.

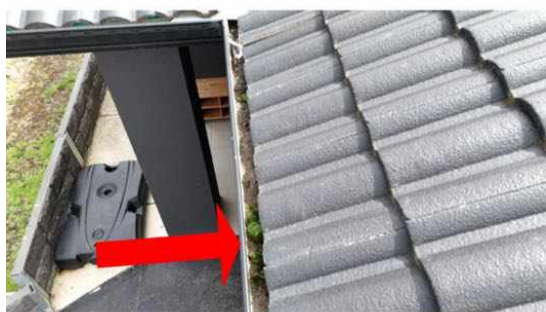
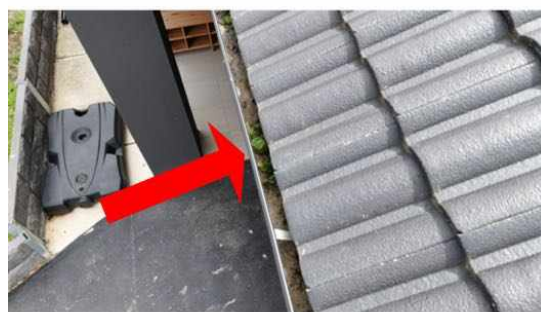
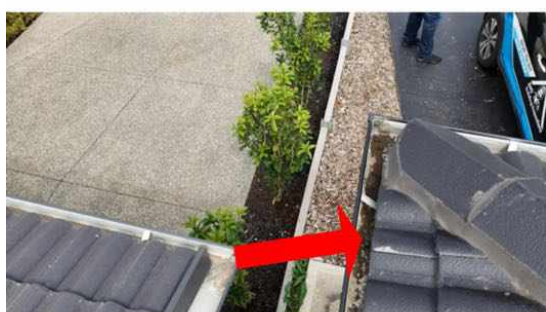
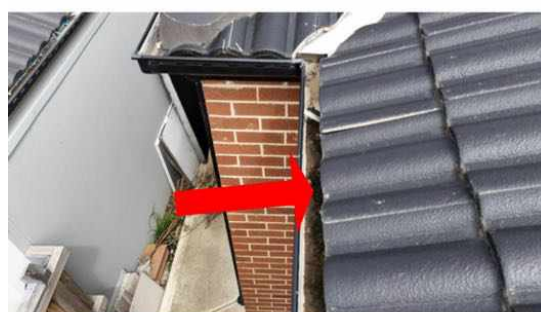
Defects 3.17

Building: Main Building
Location: Gutters
Finding: Gutters - Partially Blocked
Information: Sections of the external gutters were partially blocked with debris, soil and leaves. Roof plumbing structures, such as guttering and downpipes, should be free of all debris to prevent blockages. Blockages of the guttering and downpipes will lead to pooling and accumulated water overflows, which is likely to subsequently flood eaves and exterior walls.

Blocked gutters are likely to lead to high levels of moisture in the affected areas. Such moisture will not only cause rust and decay of the associated building materials, but can also provide conditions that are conducive to termite and timber pest activity. Blockages in gutters should therefore be removed immediately to ensure dry conditions are maintained.

Consult a Licensed Plumber for further specific advice on remedial works that may be required. In the interim, it is highly advised that blocked gutters be removed by the homeowner or a general handyperson as a matter of urgency.

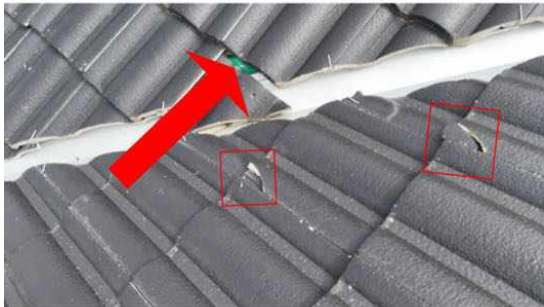
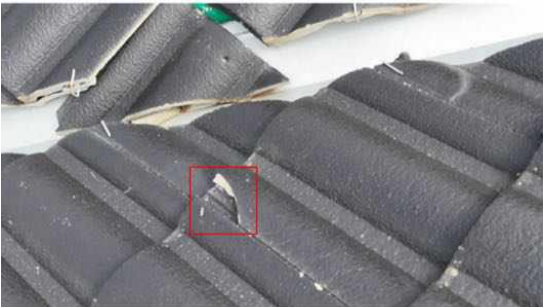
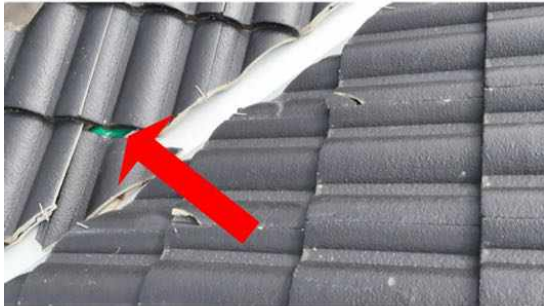
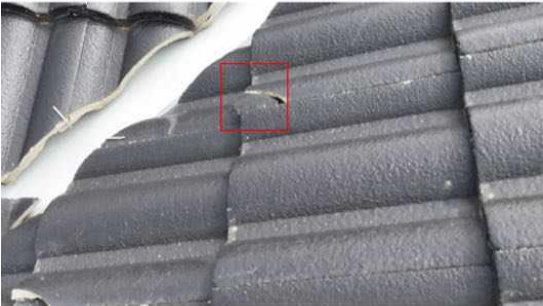
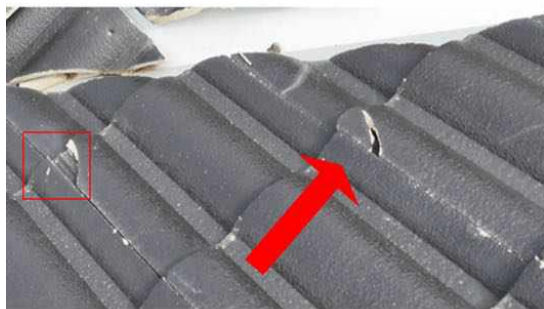
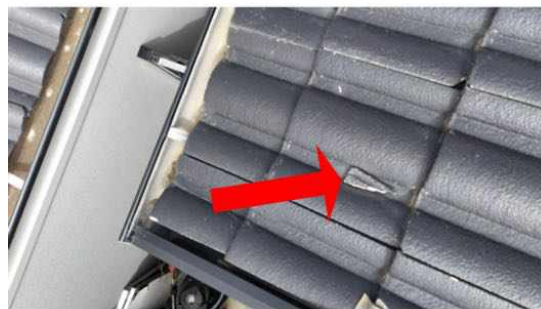
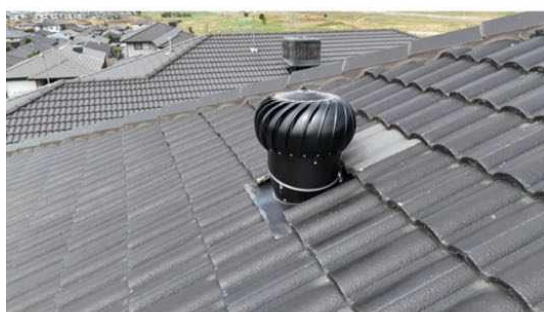
Defects 3.18

Building: Main Building
Location: Roof Exterior
Finding: Multiple Broken and Dislodged Roof Tiles Presenting Risk of Water Ingress
Information:

Multiple roof tiles were observed to be broken, chipped, or displaced at the time of inspection. In addition, several areas of the tiled roof covering were noted where the tiles were not sitting flush with one another, resulting in visible gaps between the tiles.

Broken or misaligned roof tiles can compromise the roof’s ability to effectively shed rainwater and may allow water ingress into the roof space during wet weather conditions. If left unrectified, this condition may contribute to moisture penetration, deterioration of roof timbers, and potential internal ceiling damage over time.

It is recommended that a licensed roofing contractor be engaged as a matter of priority to carry out a comprehensive inspection of the entire roof covering. Any broken or chipped tiles should be replaced, and all displaced or misaligned tiles should be properly repositioned and secured to ensure the roof covering remains weatherproof and functioning as intended.

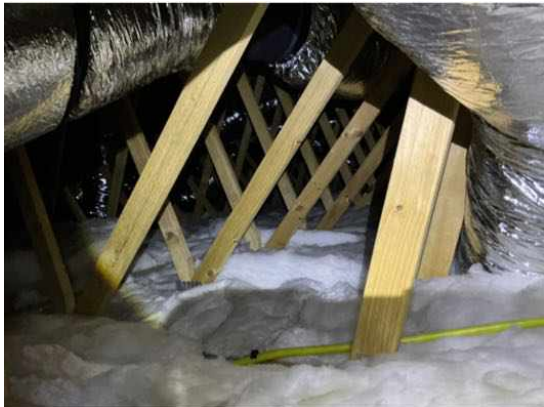
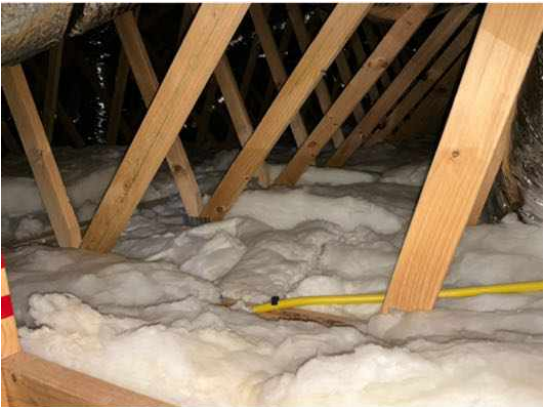
Defects 3.19

Building:	Main Building
Location:	Roof Void
Finding:	Bathroom Exhaust Fans Not Ducted to External Atmosphere
Information:	The exhaust fans installed in the bathrooms were observed to be discharging directly into the roof cavity rather than being ducted to the external atmosphere. This configuration does not comply with best practice ventilation standards, as it allows moist air to accumulate within the roof space.

Prolonged moisture build-up in the roof cavity can lead to elevated humidity levels, which may contribute to mould growth, timber decay, and potential damage to insulation or other roof components over time.

It is recommended that a licensed ventilation specialist or electrician be engaged to install compliant ducting that vents the exhaust air to the outside of the building, in accordance with current building regulations and ventilation standards.

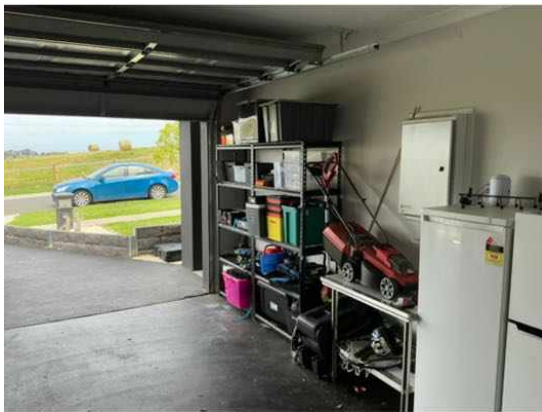
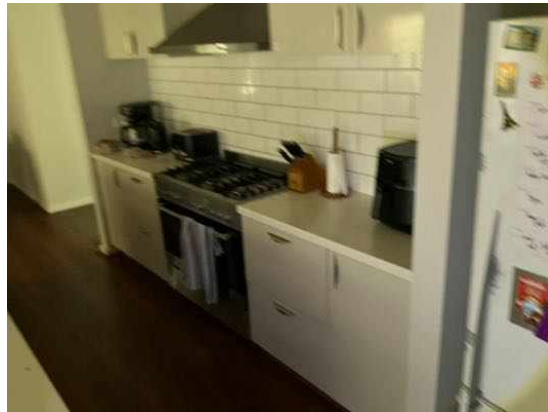
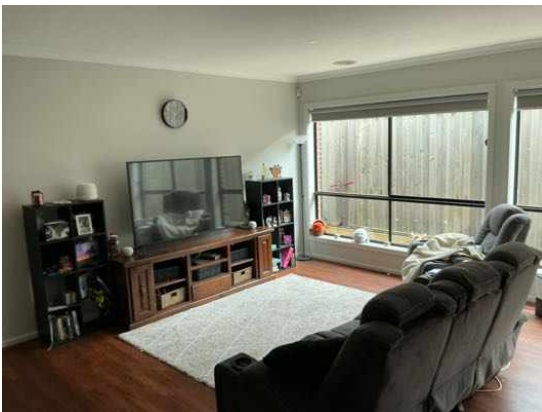
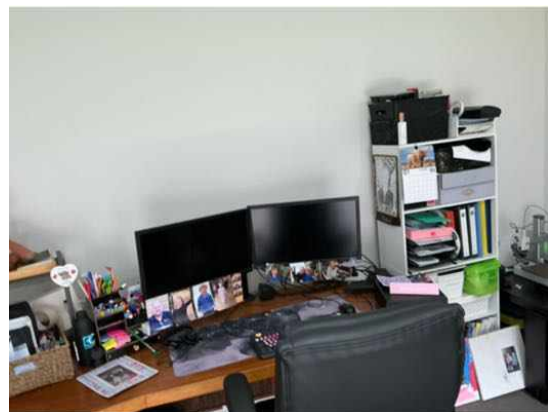
Noted Item

Building: Main Building
 Location: All Areas
 Finding: Obstructions and Limitations - Interior
 Information: These photographs are an indication of the obstructions and limitations which impeded the inspection of the internal areas of the property at the time of inspection. These obstructions can hide an array of defects and should be removed to allow full inspection to be carried out. A re-inspection is recommended once the areas are made accessible.

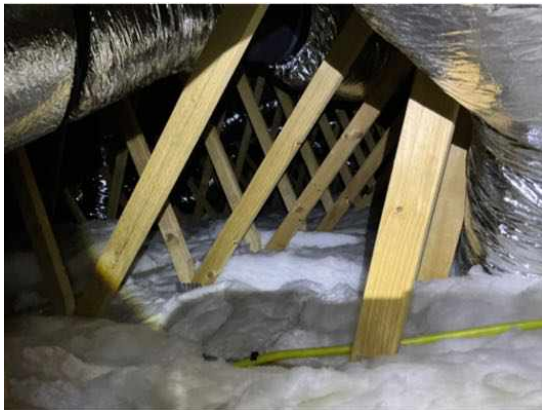
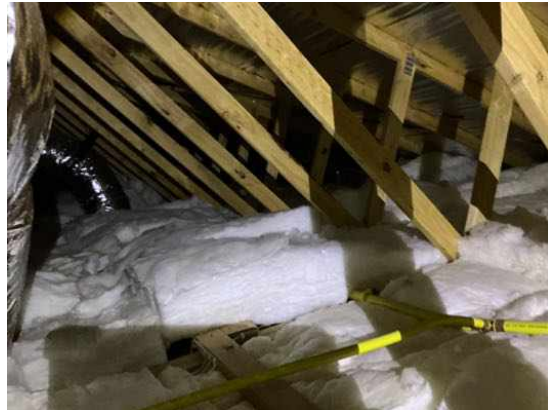
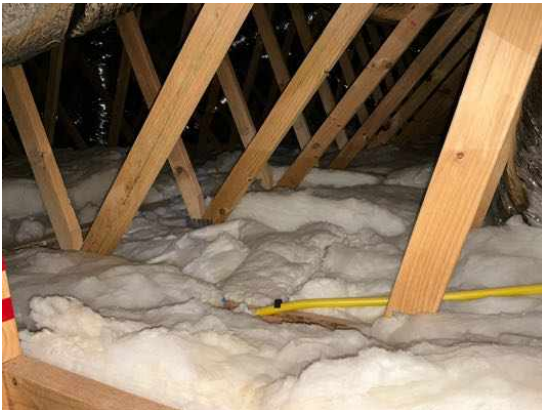
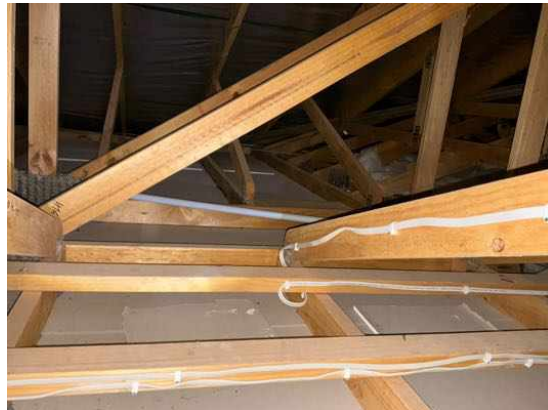
Noted Item

Building: Main Building
 Location: Roof Void
 Finding: Obstructions and Limitations - roof cavity
 Information: These photographs are an indication of the obstructions and limitations which impeded the inspection of the roof cavity area of the property at the time of inspection.

These obstructions can hide an array of defects and should be removed to allow full inspection to be carried out. A re-inspection is recommended once the areas are made accessible.

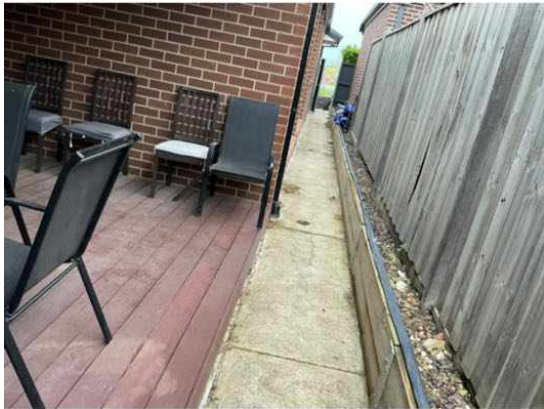
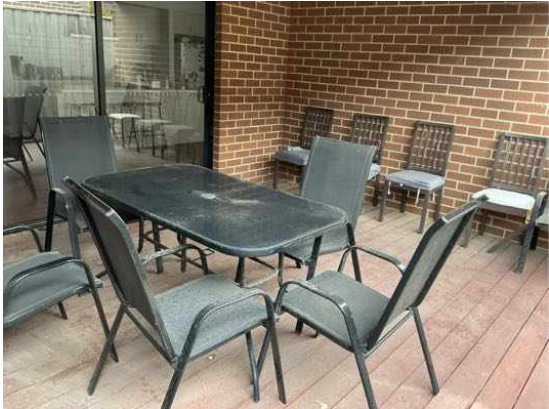
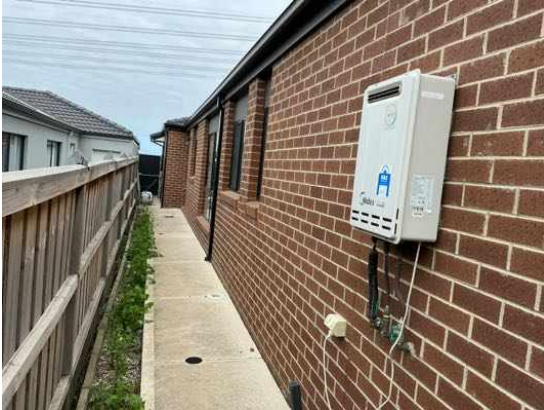
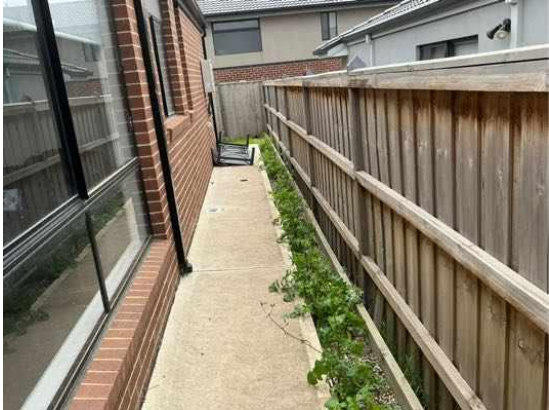
Noted Item

Building:	Main Building
Location:	All External Areas
Finding:	Obstructions and Limitations - Exterior
Information:	These photographs are an indication of the obstructions and limitations which impeded the inspection of the external areas of the property at the time of inspection. These obstructions can hide an array of defects and should be removed to allow full inspection to be carried out. A re-inspection is recommended once the areas are made accessible.
