# Building and Timber Pest Inspection Report

Inspection Date: Wed, 28 Jan 2026

Property Address: 26 Banksia St, Grafton NSW 2460, Australia

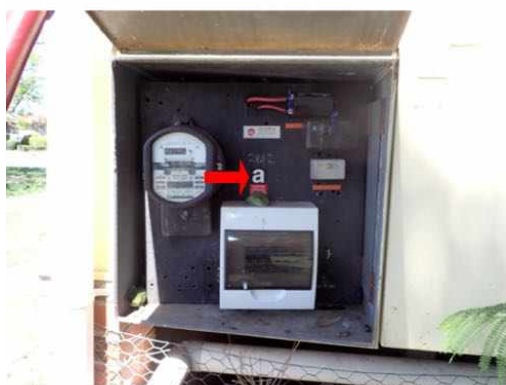
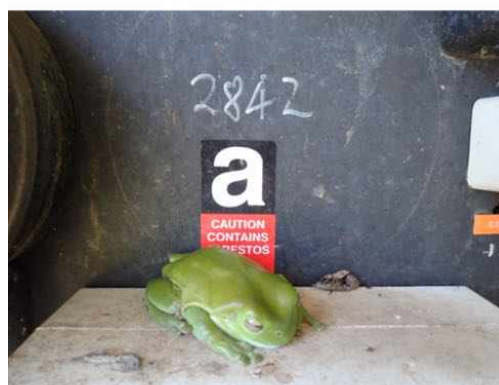
#### Finding 1.01

Building:	Main Building
Location:	Electrical meter box
Finding:	Asbestos Warning Sticker – Electrical Meter Box
Information:	An asbestos warning sticker was observed affixed to the electrical meter box. This sticker is intended to alert occupants and trades that asbestos-containing materials may be present within the building generally. No testing or confirmation of asbestos content was undertaken, as this is outside the scope of this inspection. Any future works that may disturb building materials should be approached with caution and, where required, further assessment by a licensed asbestos assessor is recommended. Any removal or disturbance works should be carried out by a licensed asbestos contractor.

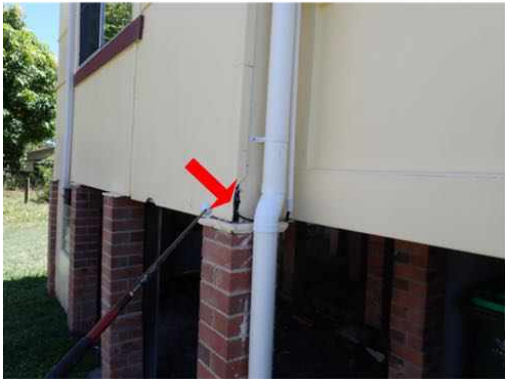
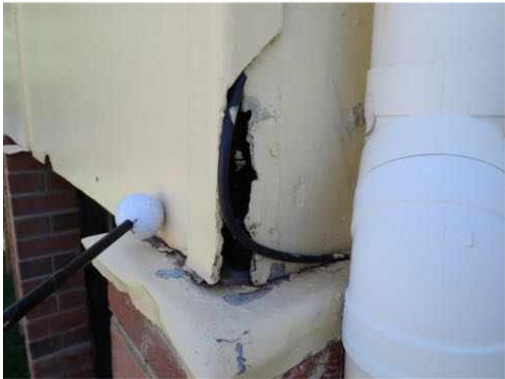
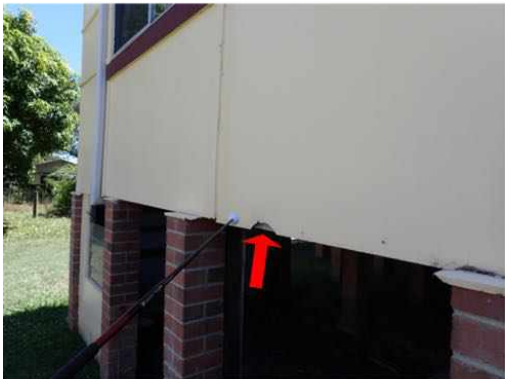
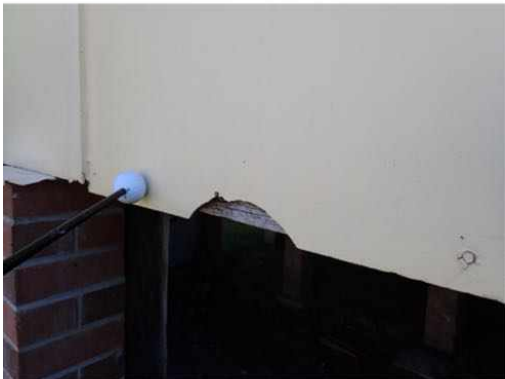
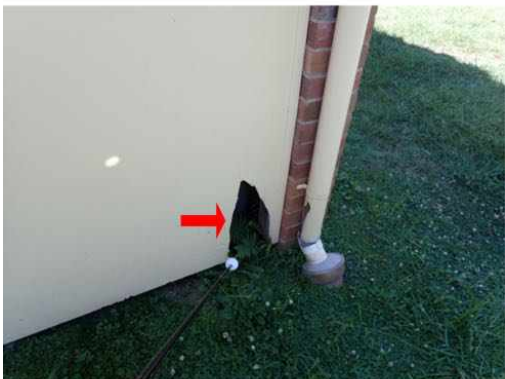
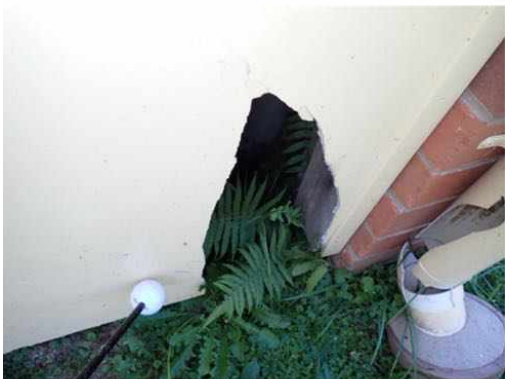
#### Finding 1.02

Building:	Main Building
Location:	External cladding
Finding:	External Cladding – Damage (Possible Asbestos-Containing Material)
Information:	Damage was identified to sections of the external cladding, which may contain asbestos-containing material due to the age of the building. No testing or confirmation of asbestos content was carried out, as this is outside the scope of this inspection. Disturbance of the affected areas may pose a health risk. Further assessment is recommended prior to any repair or removal works. Any required works should be undertaken by a licensed asbestos contractor, with repairs completed by a suitably qualified builder as required.

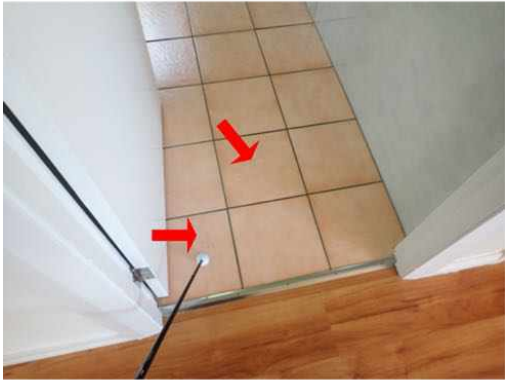
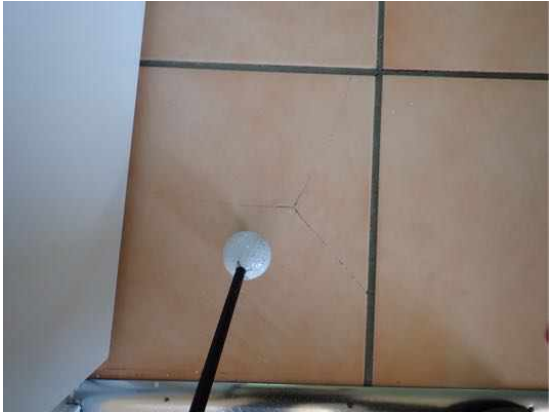
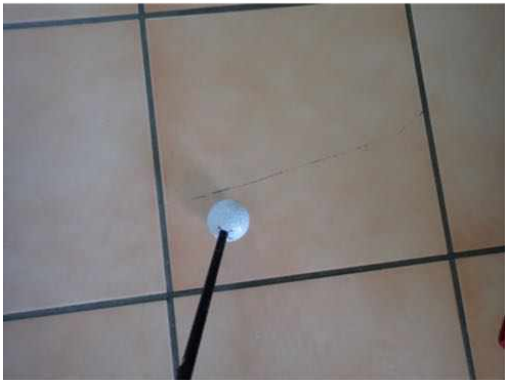
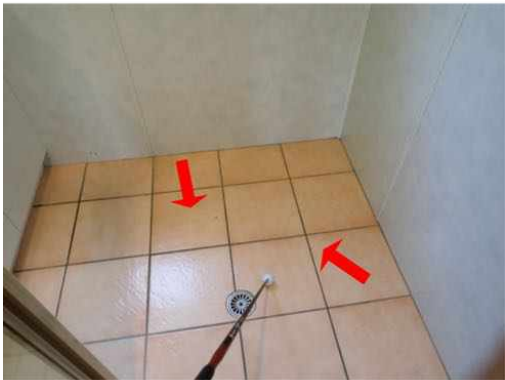
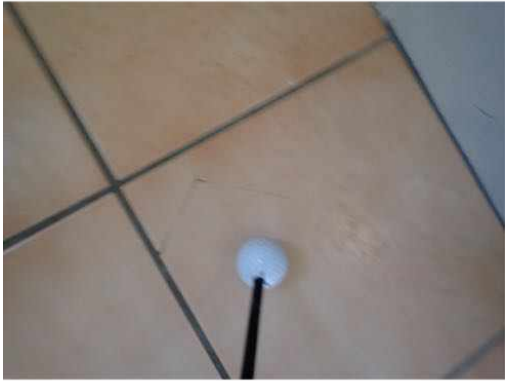
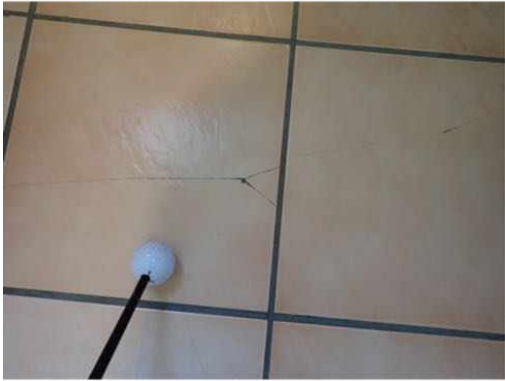
**Finding 2.01**

Building:	Main Building
Location:	All Areas
Finding:	Bathroom Floor Tiles – Cracking
Information:	Several cracked floor tiles were identified within the bathroom. This condition may be associated with movement, impact, or deterioration of the underlying substrate and can allow moisture penetration if left unaddressed. Further deterioration may occur over time. Repair or replacement of the affected tiles is recommended as required.

Works should be carried out by a licensed tiler.

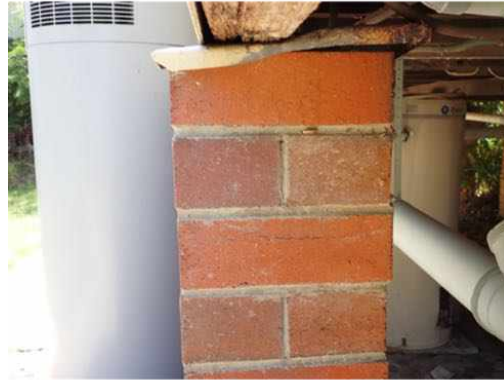
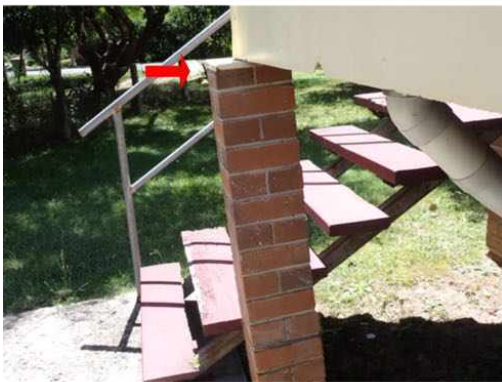
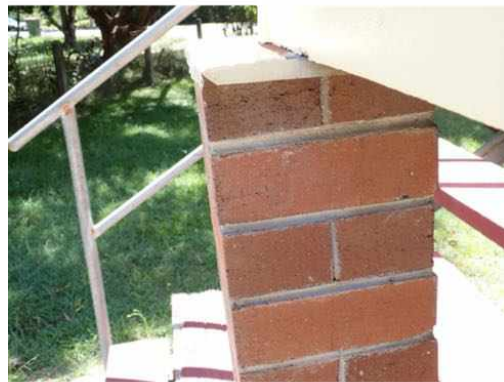
**Finding 2.02**

Building: Main Building  
Location: Subfloor  
Finding: Brick Piers – Out of Level  
Information: Several brick piers were observed to be leaning and out of level. This condition is a common defect, often associated with ground movement, footing settlement, or age-related deterioration. While the extent noted at the time of inspection may not be critical, further movement may occur if left unaddressed. Ongoing monitoring and further assessment as required is recommended. Rectification works should be

carried out by a licensed builder or structural engineer.

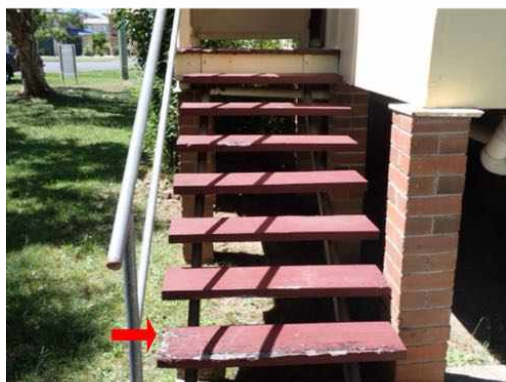
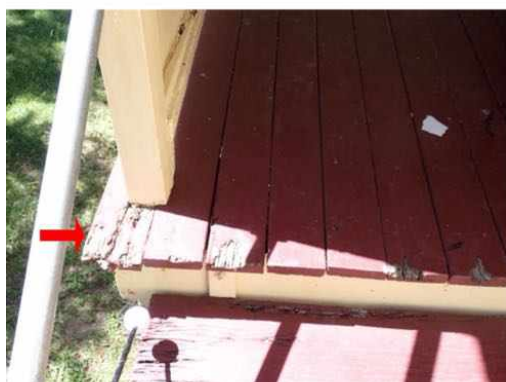
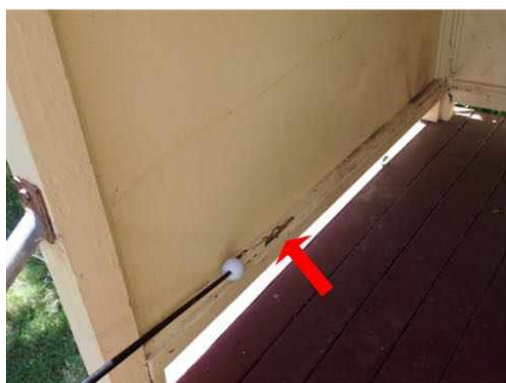
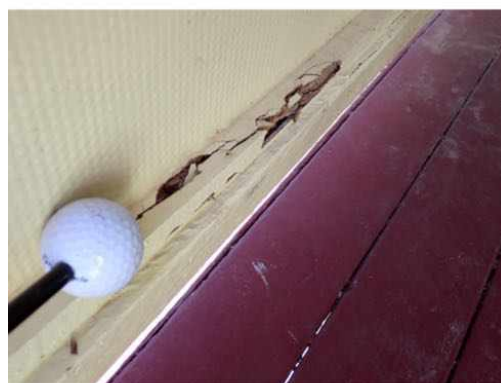
### Finding 2.03

Building:	Main Building
Location:	Entry stairs and porch
Finding:	Entry Stairs and Porch – Wood Rot
Information:	Wood rot was identified to the entry stairs and porch decking and associated framing. This condition is typically caused by prolonged moisture exposure and, if left unaddressed, may worsen and affect the durability and safety of these elements. Repair or replacement of affected timbers is recommended to prevent further deterioration. Works should be carried out by a suitably qualified carpenter or licensed builder.

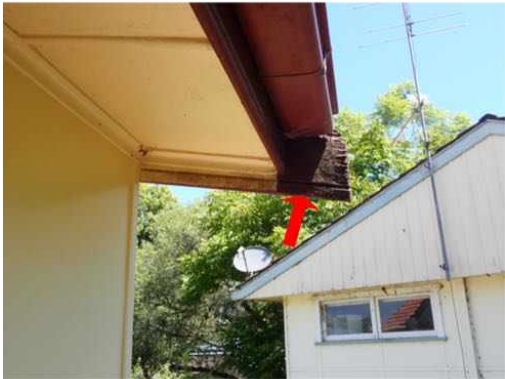
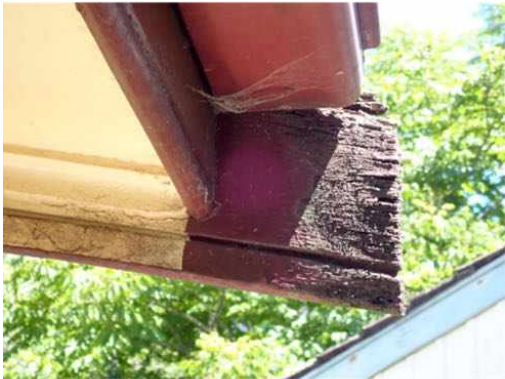
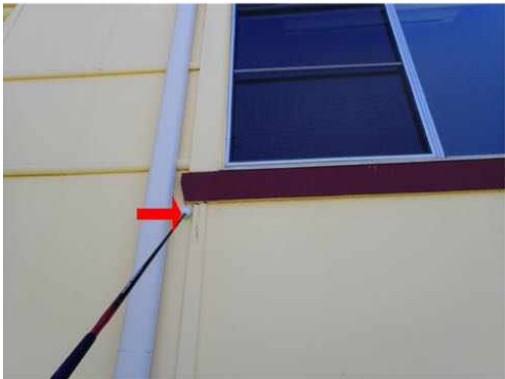
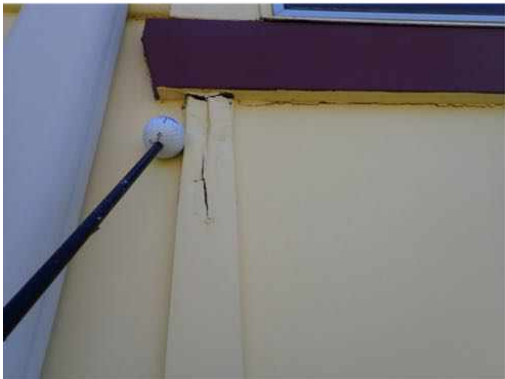
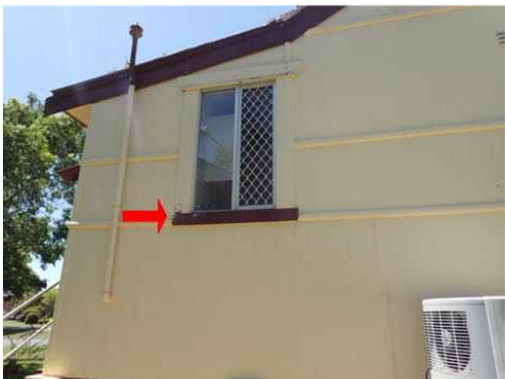
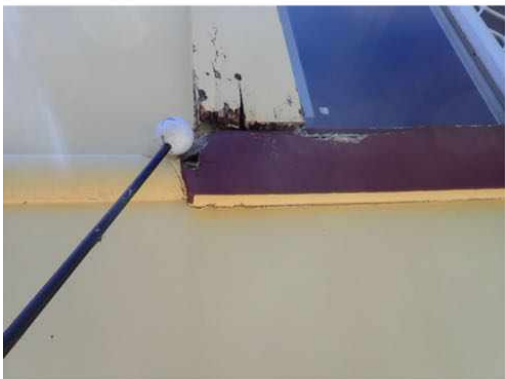
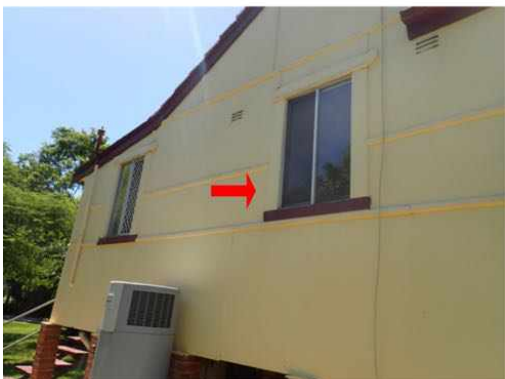
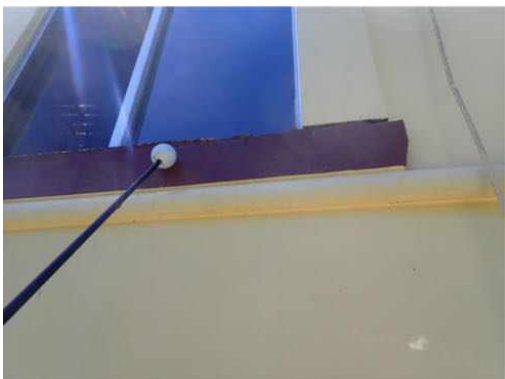
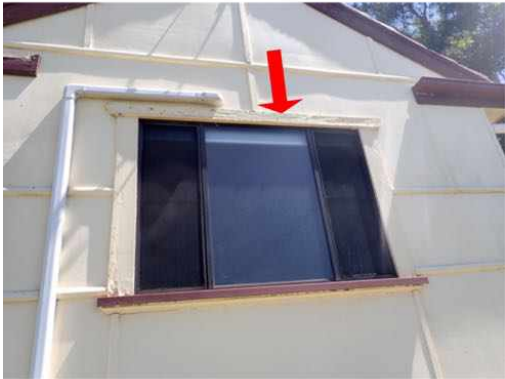
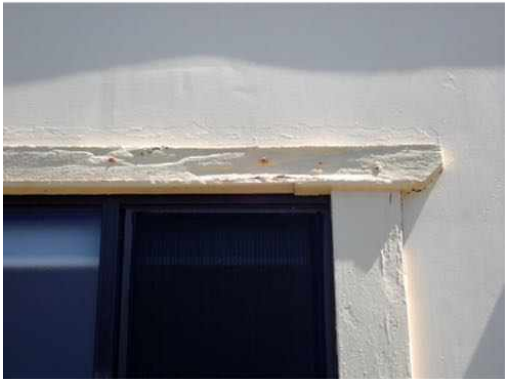
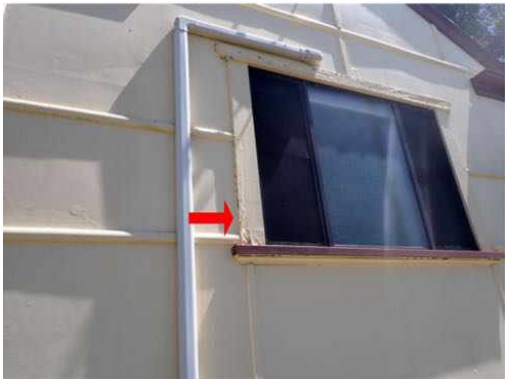
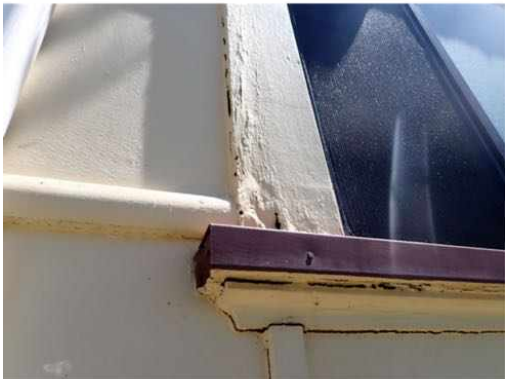
### Finding 2.04

Building:	Main Building
Location:	External walls
Finding:	Timber Windows, Trims and Fascia – Wood Rot
Information:	Wood rot was identified to timber windows, external timber trims, and fascia boards at multiple locations. This condition is commonly associated with prolonged moisture exposure and deferred maintenance. If left unaddressed, further deterioration of the affected timbers may occur. Repair or replacement of damaged timber and appropriate maintenance is recommended. Works should be carried out by a suitably qualified carpenter or licensed builder.

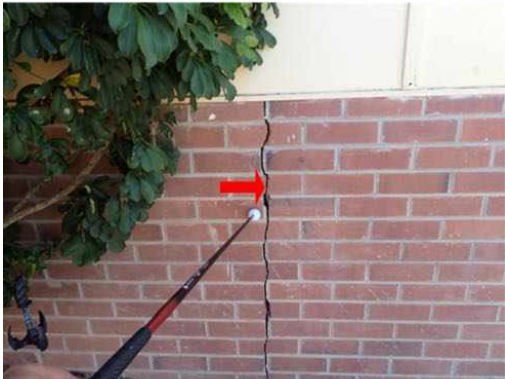
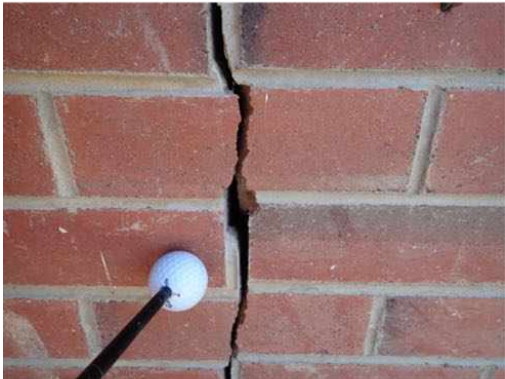
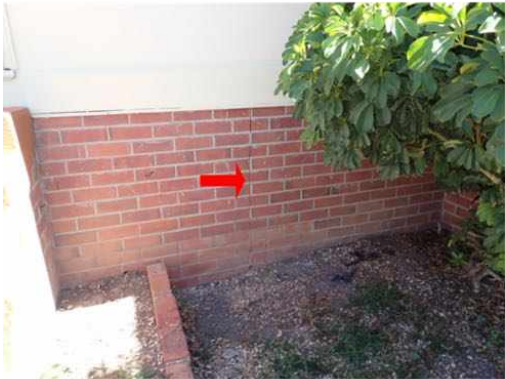
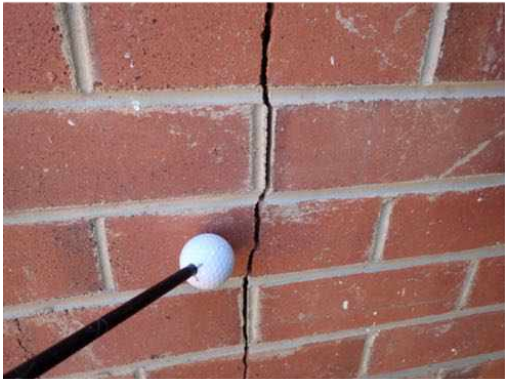
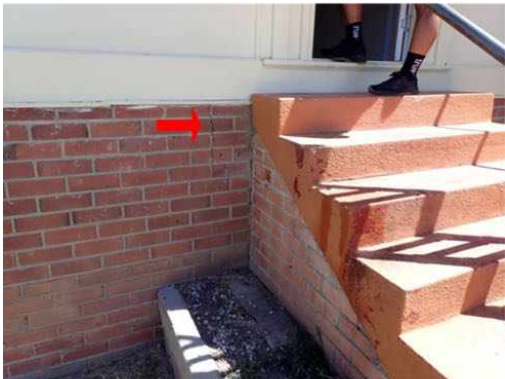
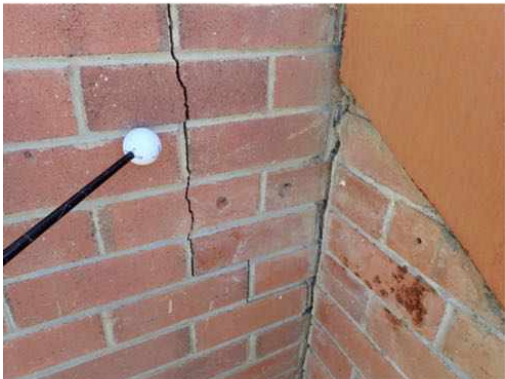
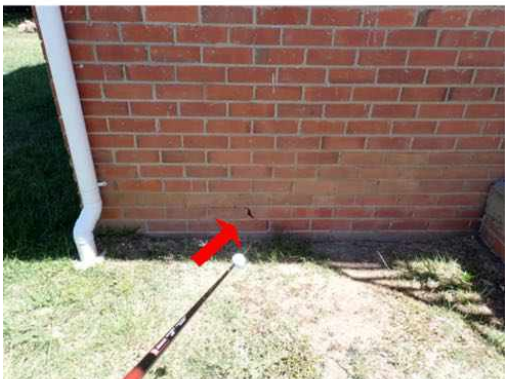
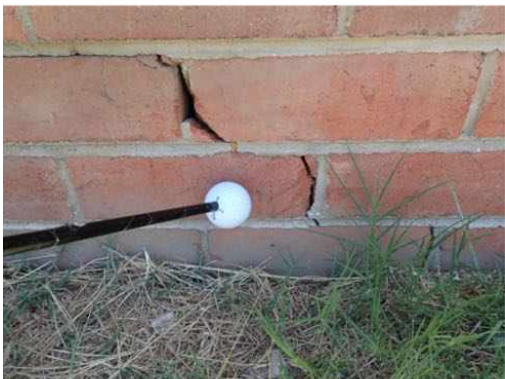
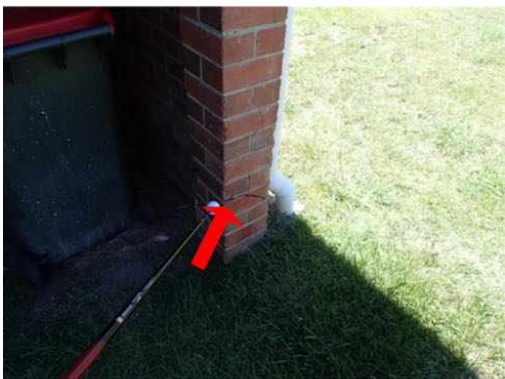
**Finding 2.05**

Building: Main Building  
Location: Base brick work wall  
Finding: Base Brickwork – Large Cracking  
Information: Several large cracks were identified in the base brickwork. This condition may be associated with ground movement, footing settlement, or age-related deterioration. Ongoing monitoring and further assessment are recommended, and rectification works should be carried out as required by a licensed builder or bricklayer in consultation with a structural engineer.

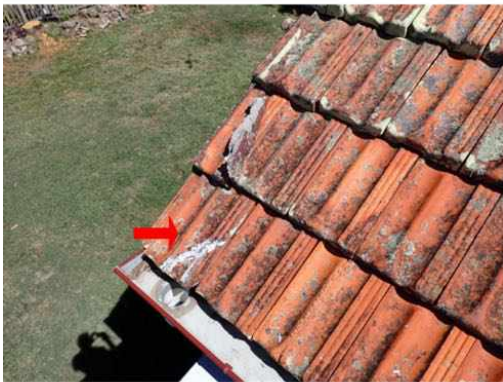
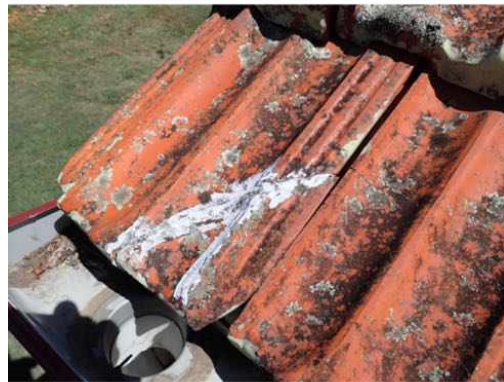
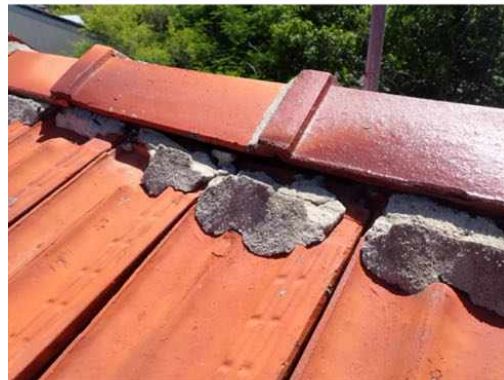
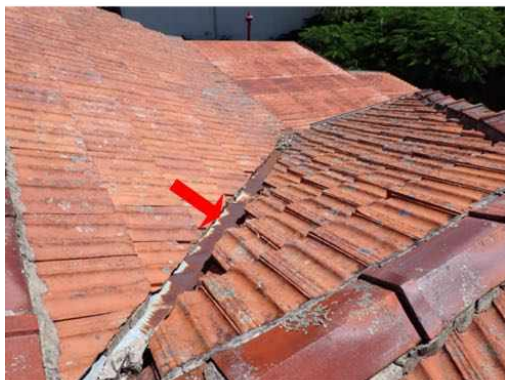
Finding 2.06

Building: Main Building  
Location: Roof  
Finding: Roof Tiles – Poor Condition  
Information: Roof Tiles – Poor Condition

The roof tiles were observed to be in poor condition, with several cracked tiles, missing or deteriorated bedding, misaligned tiles, and lichen growth identified. Surface rust was also noted to the metal roof valleys. These defects may compromise the roof's weatherproof performance and increase the risk of water ingress if left unaddressed. Repair or replacement of affected tiles, bedding, and corroded metal components, along with cleaning of lichen growth, is recommended. Works should be carried out by a licensed roofing contractor or suitably qualified roof tiler.

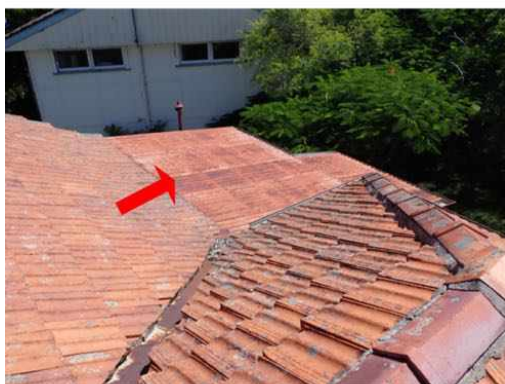
### Finding 2.07

Building:	Main Building
Location:	Roof
Finding:	Entry Tin Roof – Rusting
Information:	Rust was identified to the entry tin roof. This condition is typically associated with age and weather exposure and may worsen over time, potentially leading to corrosion-related perforation and water ingress if left unaddressed. Maintenance, including rust treatment, protective coating, or replacement of affected sheets as required, is recommended. Works should be carried out by a licensed roofing contractor or suitably qualified roof plumber.

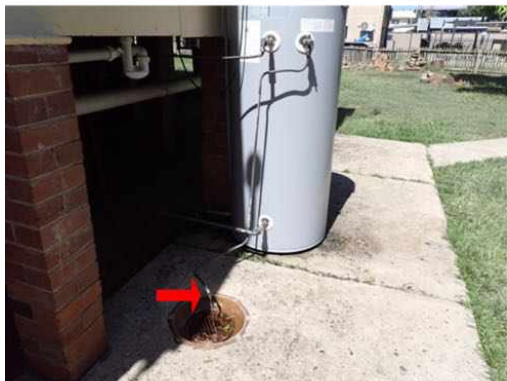
### Finding 2.08

Building:	Main Building
Location:	Right hand side of building
Finding:	Hot Water Unit – Overflow Pipe Constantly Discharging
Information:	The overflow pipe to the hot water unit was observed to be constantly running at the time of inspection. This condition may indicate a faulty pressure relief valve, excessive system pressure, or a defect with the hot water unit. Ongoing discharge can lead to increased water usage and potential damage to surrounding areas if left unaddressed. Further investigation and rectification are recommended. Works should be carried out by a licensed plumber.

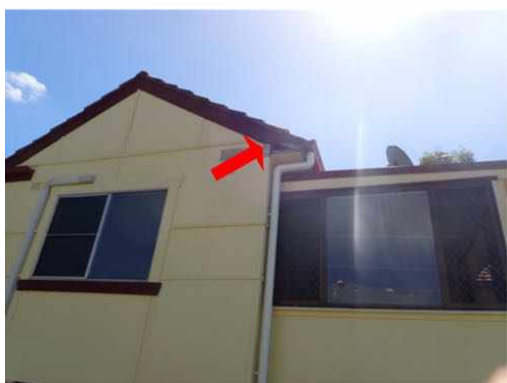
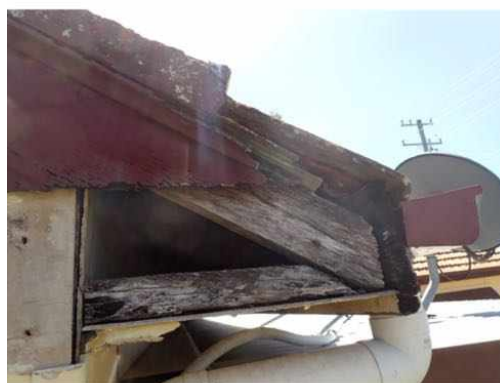
### Finding 2.09

Building:	Main Building
Location:	Rear of building
Finding:	Eaves and Fascia – Wood Rot from Exposed Timber
Information:	Wood rot was identified to the timber eave framing and fascia boards at this location. The deterioration appears to be associated with damaged cladding that has exposed the timber to ongoing moisture. If left unaddressed, further decay may occur. Repair or replacement of affected timbers and rectification of the damaged cladding is recommended to prevent further deterioration. Works should be carried out by a suitably qualified carpenter or licensed builder.

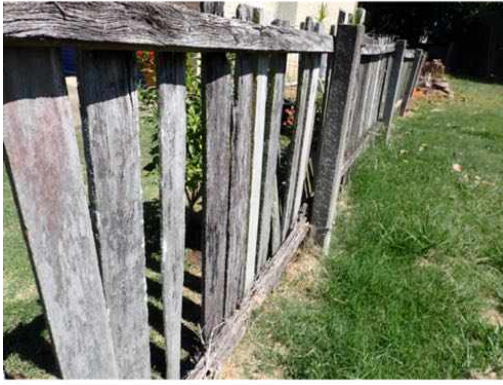
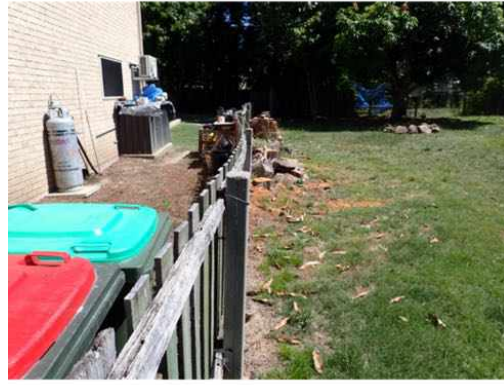
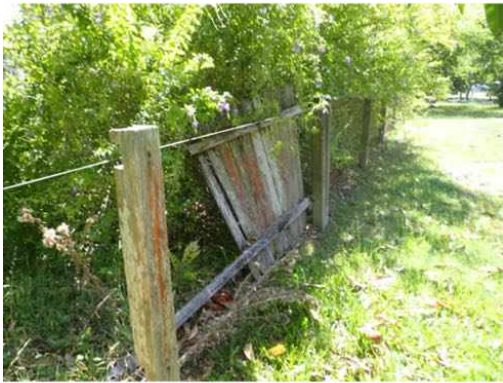
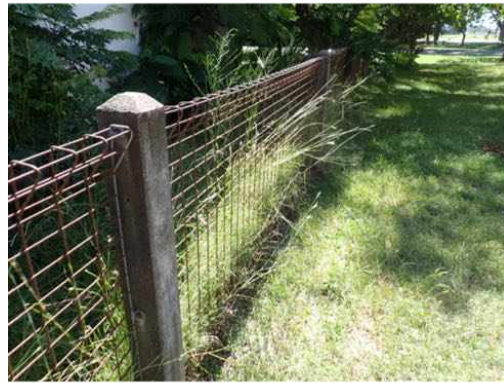
### Finding 2.10

Building:	Main Building
Location:	Fences
Finding:	Fences – Poor Condition
Information:	The fences were observed to be in poor condition overall. This condition is consistent with age and weather exposure and may worsen over time if left unaddressed. Repair or replacement of affected sections is recommended as required. Works should be carried out by a fencing contractor or suitably qualified tradesperson.

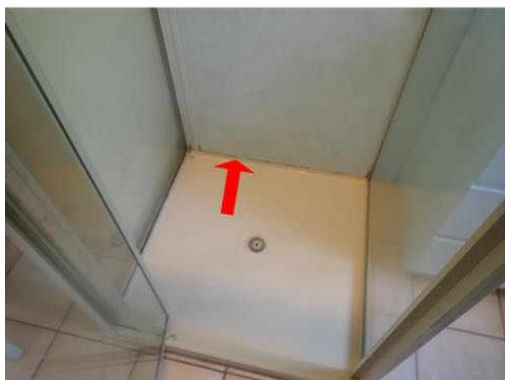
Finding 3.02

Building:	Main Building
Location:	Bathroom
Finding:	Bathroom – Deteriorated Silicone
Information:	Deteriorated silicone sealant was identified within the bathroom. This condition may allow moisture to penetrate behind tiled surfaces, increasing the risk of damage to underlying materials over time. Removal and replacement of failed silicone is recommended to maintain adequate water resistance. Works should be carried out by a licensed tiler or suitably qualified tradesperson.

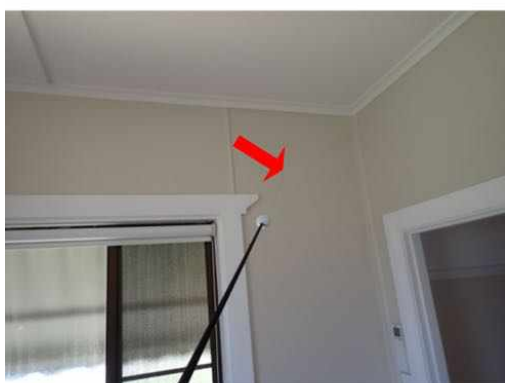
### Finding 3.03

Building:	Main Building
Location:	Bedroom
Finding:	Internal Wall Cladding – Bedroom Cracking
Information:	Cracking was identified in the internal wall cladding within the bedroom. This appears to be a minor defect, commonly associated with shrinkage, age-related wear, or possible structural movement. Cracks may worsen over time if left unaddressed. Monitoring and repair as required is recommended. Works can be carried out by a carpenter or suitably qualified tradesperson.

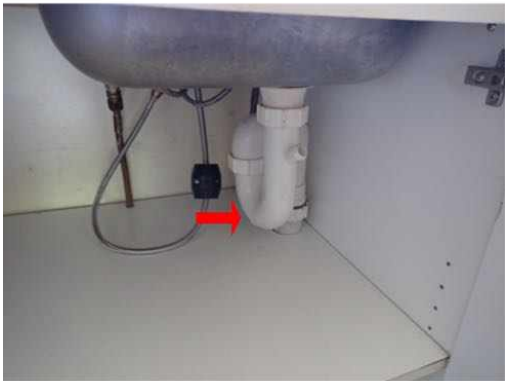
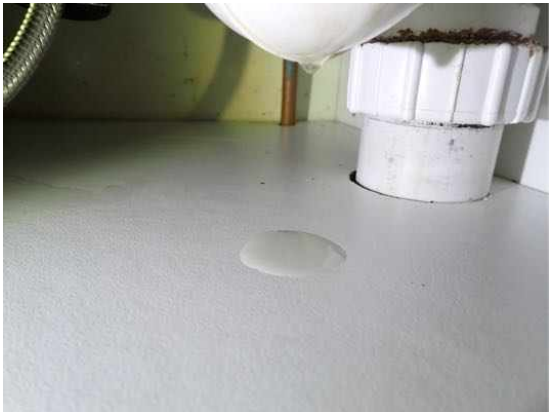
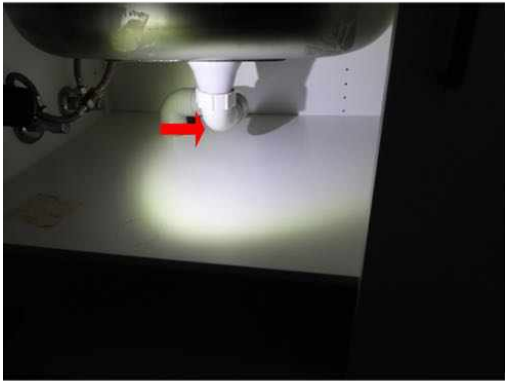
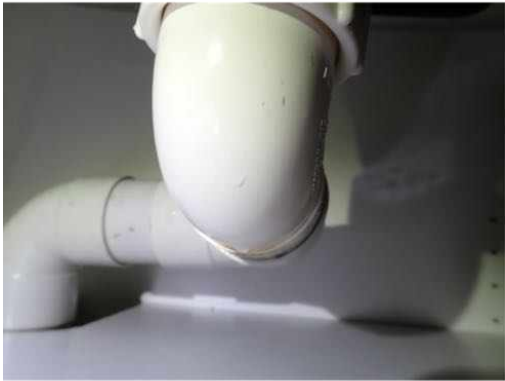
**Finding 3.04**

Building: Main Building  
Location: Kitchen and laundry  
Finding: Kitchen and Laundry Waste Pipes – Minor Leaks  
Information: Minor leaks were identified to the kitchen and laundry waste pipes at the time of inspection. While limited in extent, ongoing leakage may lead to moisture damage to surrounding materials and promote mould growth if left unaddressed. Further investigation and repair of the affected pipework is recommended. Works should be carried out by a licensed plumber.

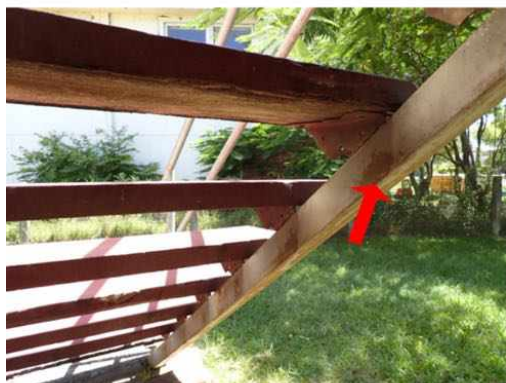
**Finding 3.05**

Building:	Main Building
Location:	Front entry stairs
Finding:	Entry Stairs – Surface Rust to Steel Stringers
Information:	Surface rust was identified to the steel stringers of the entry stairs. This condition is typically associated with weather exposure and age. While minor at the time of inspection, ongoing corrosion may occur if left untreated. Cleaning, rust treatment, and protective coating are recommended to help prevent further deterioration. Works should be carried out by a suitably qualified metal tradesperson or general handyman.

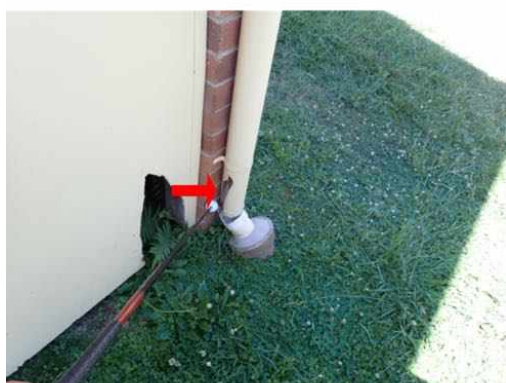
### Finding 3.06

Building:	Main Building
Location:	Back right hand corner
Finding:	Downpipe – Back Right-Hand Corner Damage
Information:	Damage was identified to the downpipe located at the back right-hand corner of the building. This condition may affect effective stormwater discharge and could lead to water overflow and moisture issues to adjacent building elements if left unaddressed. Repair or replacement of the damaged downpipe is recommended. Works should be carried out by a licensed plumber or suitably qualified handyman.

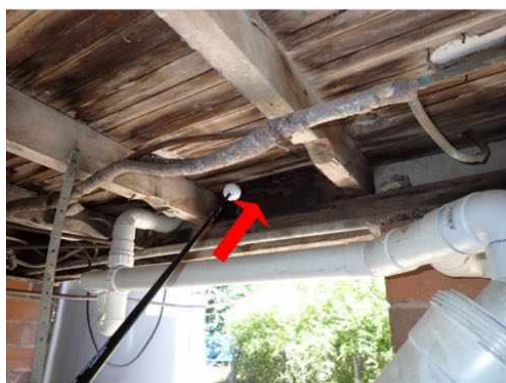
### Finding 7.01

Building:	Main Building
Location:	Subfloor
Finding:	Subfloor Timbers – Minor Wood Rot
Information:	Minor wood rot was identified to subfloor timbers at several locations. This condition is commonly associated with properties of this age and is typically related to prolonged moisture exposure or inadequate ventilation. While minor at the time of inspection, ongoing deterioration may occur if moisture issues persist. Monitoring and repair or replacement of affected timbers as required is recommended. Works should be carried out by a suitably qualified carpenter or licensed builder.

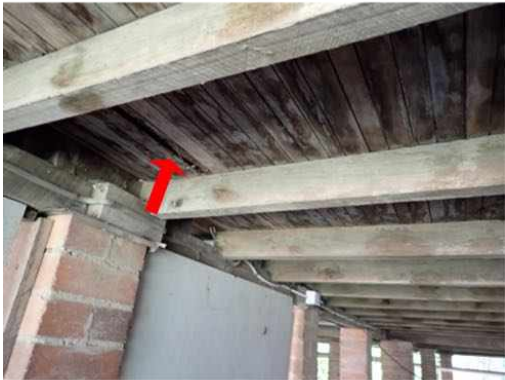
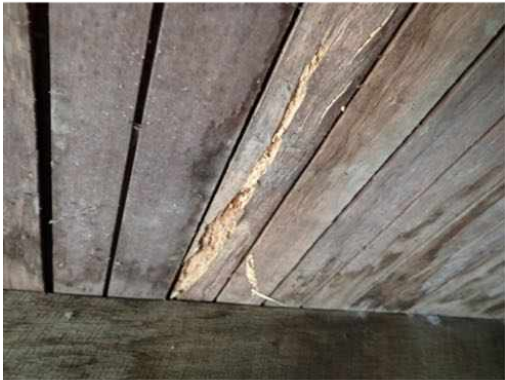
**Finding 8.01**

Building: Main Building  
Location: Subfloor  
Finding: Flooring – Isolated Borer Damage  
Information: Borer damage was identified to the flooring at several isolated locations. This indicates timber pest activity, which may affect the condition and durability of the timber if ongoing. While the damage appeared limited at the time of inspection, further activity cannot be ruled out. Monitoring and assessment are recommended, with treatment or repairs carried out as required. Works should be undertaken by a licensed timber pest technician and/or suitably qualified carpenter.

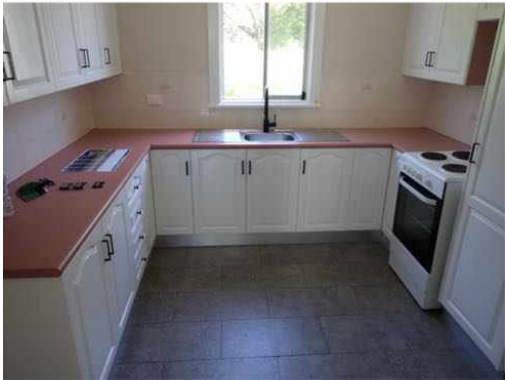
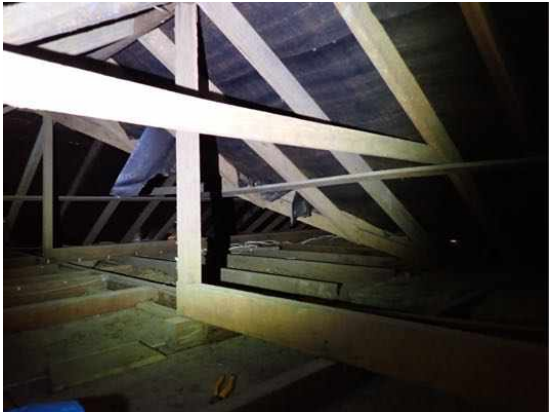
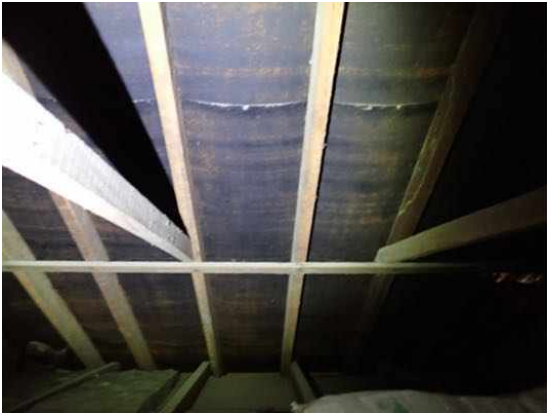
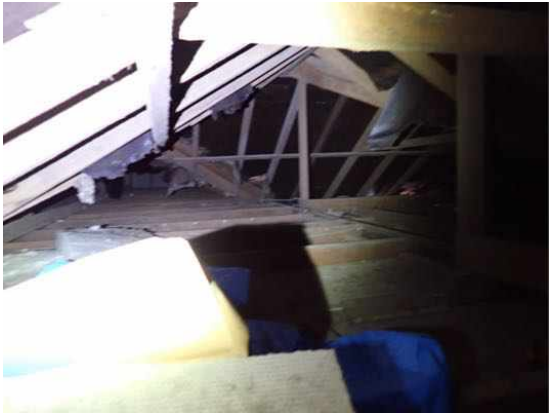
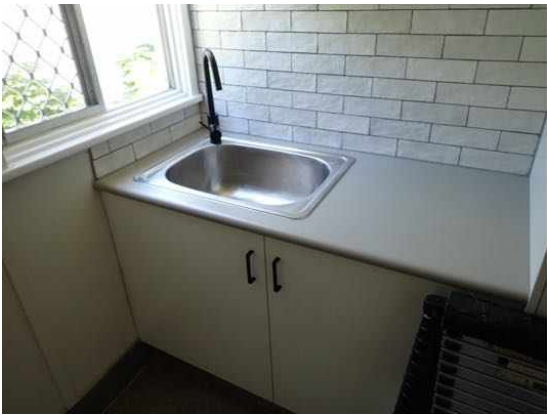
#### Noted Item

Building: Main Building  
Location: All Areas  
Finding: Additional Photos - Obstructions and Limitations  
Information: These photographs are an indication of the obstructions and limitations which impeded full inspection of the area at the time of inspection. These obstructions can hide an array of defects and should be removed to allow full inspection to be carried out. A re-inspection is recommended once the areas are made accessible.
