# Building and Timber Pest Inspection Report

Inspection Date: Wed, 25 Feb 2026

Property Address: 8 Barbarrosa Rd, Edmondson Park NSW  
2174, Australia

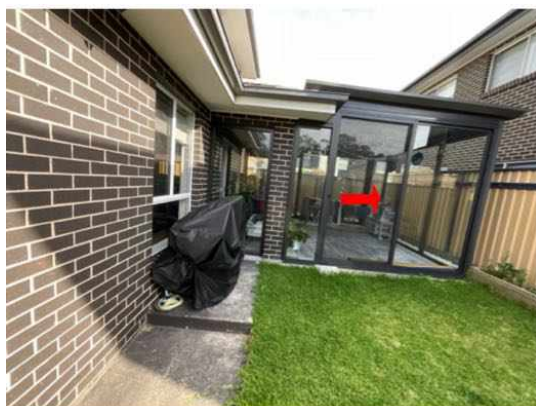
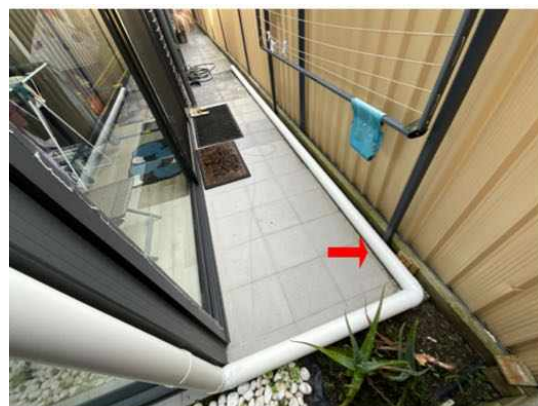
#### Finding 3.01

While the structure does not currently appear to be unsafe, compliance with such standards ensures the structural integrity. As building standards have not been followed, this area provides a heightened risk of the development of building defects. The structural integrity of these areas may have been compromised, which creates potential for the development or presence of major safety issues.

It is highly recommended that any planned repair, remodelling or demolition works be carried out by licensed builders. A structural engineer should be appointed for consultation and any rectification required.

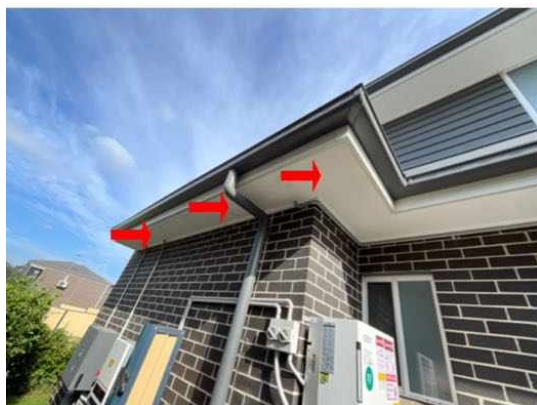
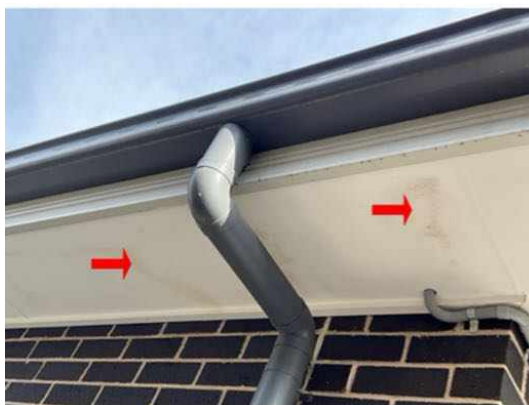
#### Finding 3.02

Building:	Main Building
Location:	Eaves LHS
Finding:	Ceiling - Water damaged
Information:	Water damage to the ceiling lining is generally an indication of excessive moisture being present in the roof void, usually via a leak to the roof covering.

Where water damage is evident to the ceiling, the primary requirement is to identify and rectify the source of the leak. A roofing plumber should be appointed as soon as possible to identify the leak and perform rectification works as necessary, ensuring the water damage is restricted.

Once the leak is repaired, consultation with relevant tradespeople, including plasterers and painters, is advised. Rectification works may include replacement of ceiling lining or minor repainting, depending on the extent of the damage.

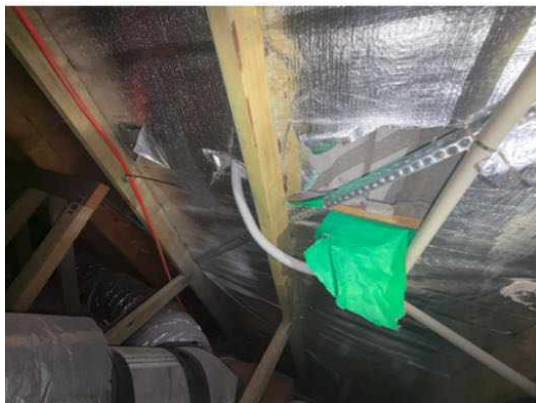
### Finding 3.03

Building:	Main Building
Location:	Roof Void
Finding:	Sarking - Damaged
Information:	Sarking, a laminated aluminium foil applied to the interior of the roof covering, assists in insulating the property and acting as a vapour-barrier to the roof void and, subsequently, to the household.

Where sarking is damaged, both insulation and moisture protection of the property are inhibited. This creates a loss of energy and thus negatively impacts the energy efficiency of the property, allowing potential for moisture ingress from condensation or leaking roof tiles.

It is important to repair any holes or damaged sections of sarking to ensure that the building material is fully functional. A registered builder or qualified carpenter should be consulted to provide further advice on this defect and to perform rectification works at client discretion.

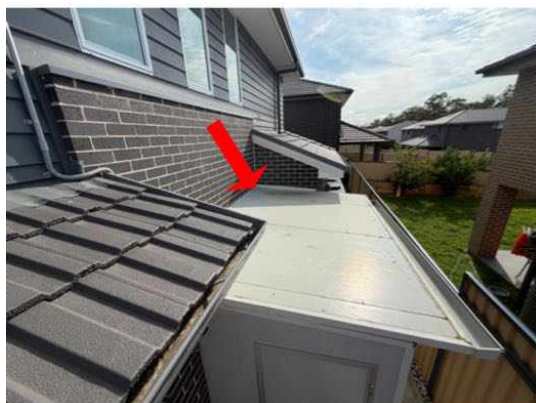
### Finding 3.04

Building: Main Building  
 Location: Shed  
 Finding: Roof flashing (acceptable) - Non-standard  
 Information:

The roof flashing that has been installed does not appear to comply with current building practice. However the flashing appears to be in an acceptable condition and is fulfilling its purpose in ensuring the roof covering is weather-tight.

Whilst retrospective fixing is not required if flashing begins to come loose from its fixing or deteriorates as evidenced by roof leaks a licensed roofing plumber should be appointed immediately to replace the building element.

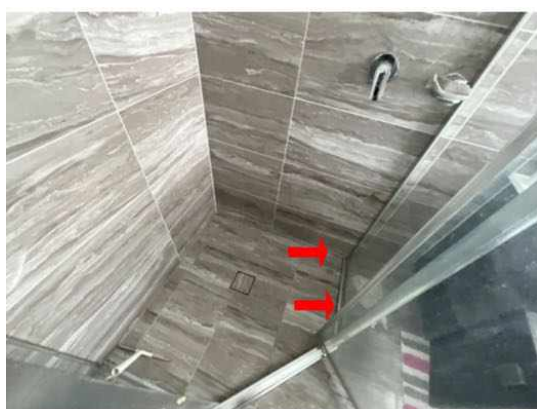
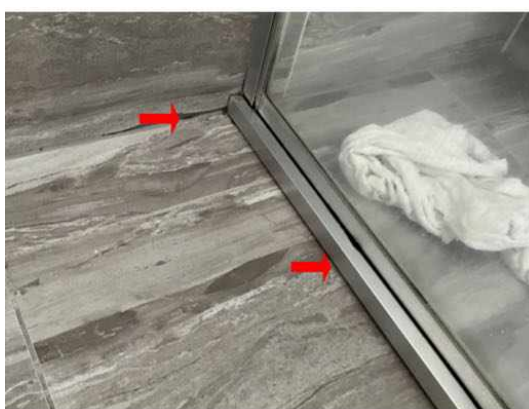
### Finding 3.05

Building: Main Building  
 Location: All Wet Areas  
 Finding: Sealant and grouting - Missing or damaged  
 Information:

It was noted on inspection that sealant or grout is degraded to this area.

Different materials and floor areas move at different rates, generally causing cracking

Flexible and mould resistant materials should be applied to affected areas to prevent any subsequent water damage that is likely to occur. Regular maintenance and replacement of damage or missing or damaged sealant and grout is highly recommended to the wet areas, as this is a regular wear and tear defect. Sealant and grouting in areas that come into regular contact with water should be maintained for the long term care of your property.

A sealant specialist should be appointed to complete these works as soon as possible.

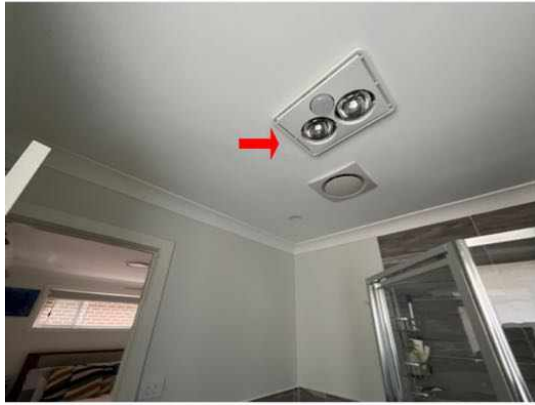
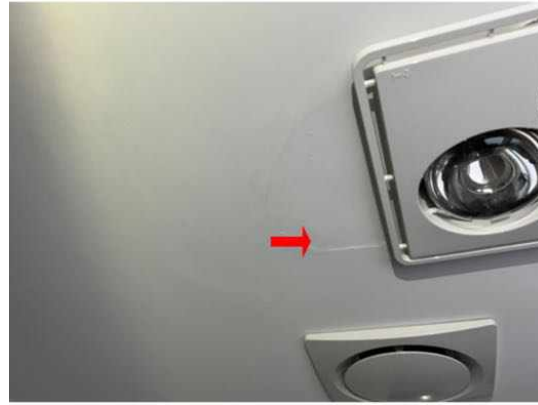
### Finding 3.06

Building:	Main Building
Location:	Ensuite
Finding:	Incomplete or substandard works
Information:	The works to this area appear to be incomplete or have been completed to a substandard level.

Works that have not been completed to a satisfactory level create potential for the development of building defects and may impede on the safety and integrity of the overall structure.

It is highly recommended that the relevant trades be appointed to complete these works and ensure the safety of the area and the longevity of all associated building elements.

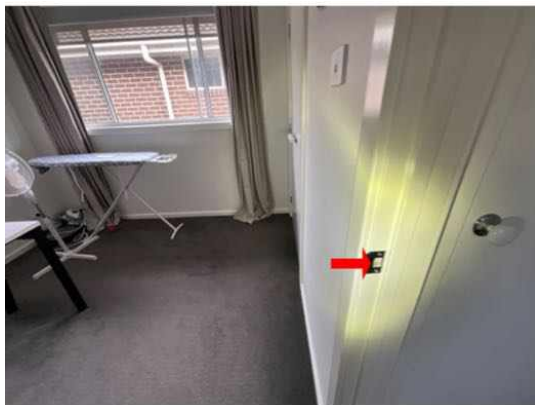
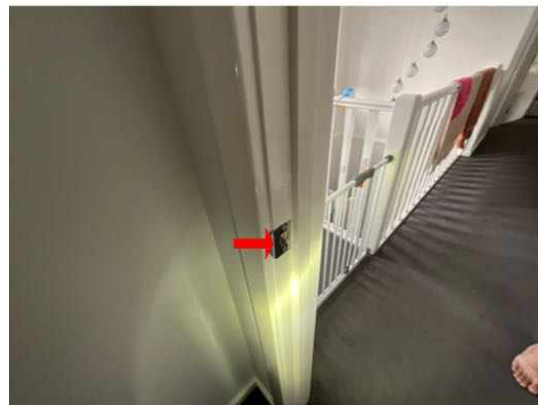
### Finding 3.07

Building:	Main Building
Location:	Multiple areas
Finding:	Door - Striker plate misaligned
Information:	The striker plate to this door appears to have become misaligned and has consequently resulted in the door's operation being compromised.

This is a common defect and is expected in a property of this age, whether being due to substandard installation or general deterioration of the door hardware.

Readjustment of the striker plate is recommended at client discretion. Works such as these can be completed by a general handyman or qualified carpenter.

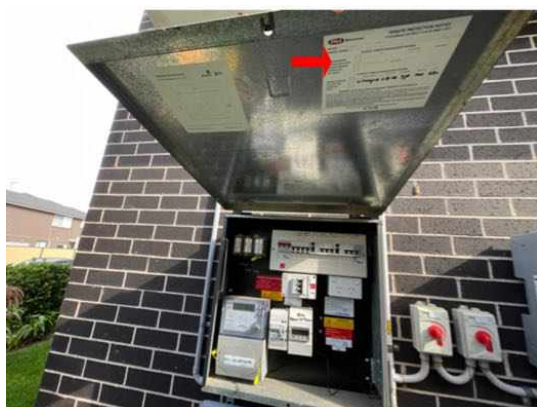
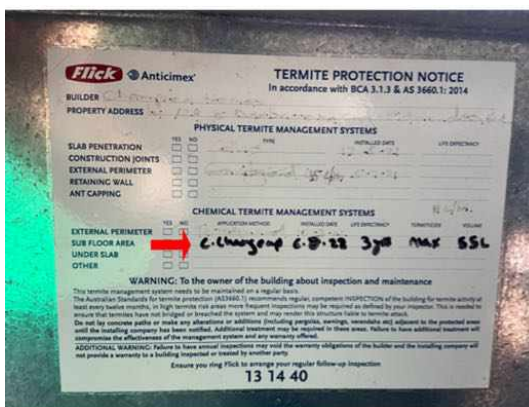
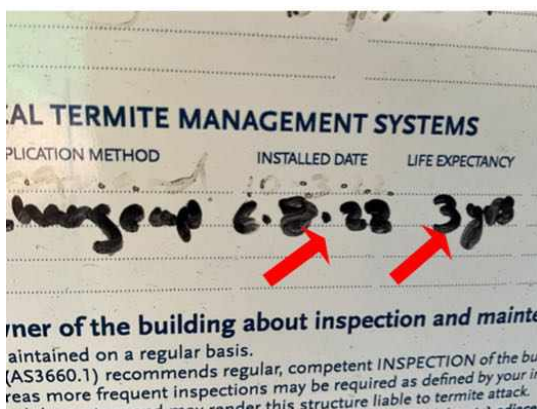
Building: Main Building  
 Location: All Areas  
 Finding: Re-application of chemical termite barrier - required  
 Information: Chemical treated barriers deteriorate over time necessitating the need for re-application of a barrier every 6-10 years depending on the product type environment etc. Due to this deterioration chemical barriers decline in their effectiveness exponentially if not replenished.

Consult the record of installation to identify the type of chemical and date of application. It is then advised to consult a licensed pest controller regarding reapplication intervals. Annual inspections are almost always required for all system types.

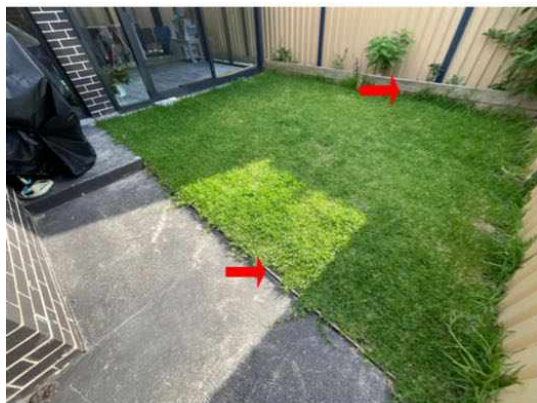
### Finding 6.02

Building: Main Building  
 Location: Fencing & Landscaping  
 Finding: Building materials in direct ground contact - conducive to termites  
 Information: Where timber elements are in direct contact with the ground and consequently

moisture or dampness they become conducive to termite activity. Whether timber is used as a building element part of a fencing structure or stored as an unused item they can provide an environment that is attractive to termite infestation.

When met with excessive moisture timber begins to decay and develop wood rot. Any timbers that are in direct contact with external grounds especially if left untreated or non-durable also provide ingress for subterranean termites into that particular element.

The removal of any such materials that may be conducive to termite activity should be removed as soon as possible to minimise the risk of termite attack.

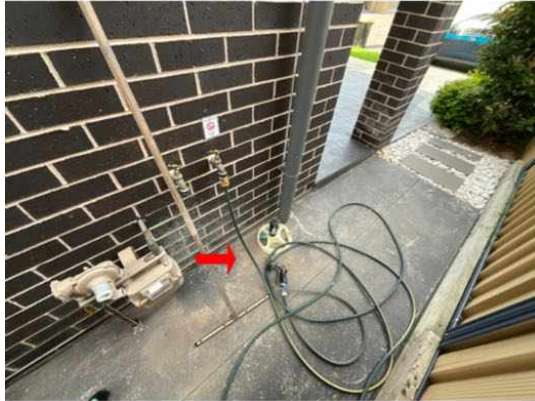
Finding: Tap - No drain  
Information: The external tap in this area was noted to have no drain at the time of inspection.

This keeps the surrounding surfaces damp while using the tap, which becomes conducive to termite activity.

A licensed plumber must be appointed to ensure an appropriate drain is installed.
