Building and Timber Pest Inspection Report

Inspection Date: Thu, 9 Apr 2026

Property Address: 4104/31 Bourton Rd, Merrimac QLD 4226,
Australia

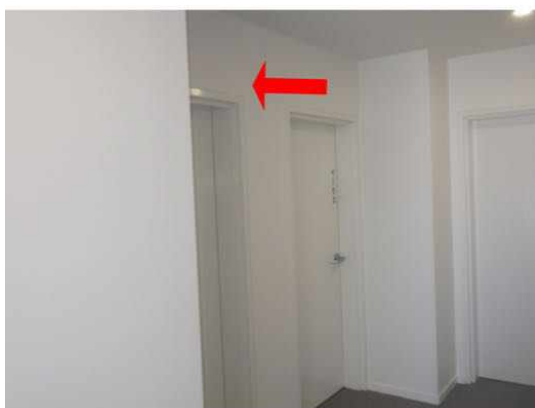
Finding 3.01

Building: Main Building
Location: Entry > Front Right
Finding: Cracking - Wall
Information: There is fine cracking to an area of the exterior wall in the entry area.

The cracking appears minor in nature and is generally only ever an appearance defect. While such cracking may be noticeable in some cases, it is quite common and does not indicate any structural damage.

Cracking of this nature can generally be repaired with minor sanding, filling and/or repainting. Such works should be performed by a qualified painter or a general handyman.

Note - External area wall repairs and/or maintenance will likely be the responsibility of the buildings body corporate managers.

Monitoring of all cracking should be conducted frequently. Always contact a building inspector should cracks widen, lengthen, or become more numerous.

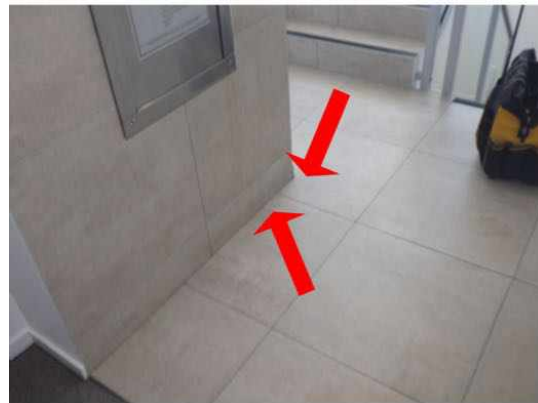
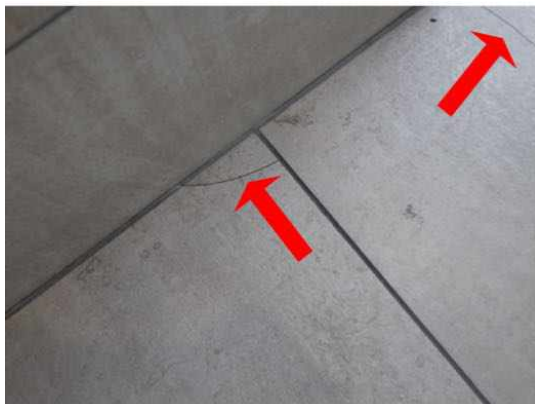
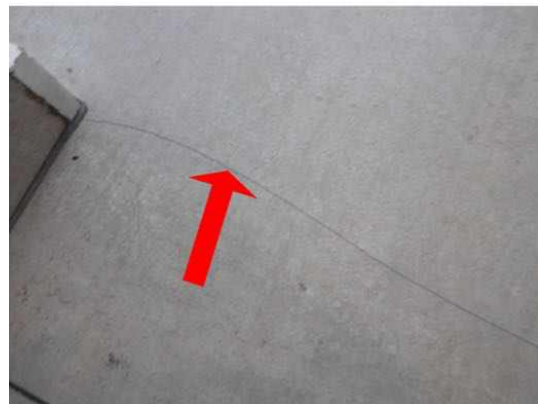
Finding 3.02

Building: Main Building
 Location: Entry > Centre Right
 Finding: Tile - Cracked
 Information: Cracked tiles to the entry area floor were identified at the time of inspection. Such defects are generally caused by impact. Cracked or broken tiled areas may also be a direct result of poor workmanship during the construction process.

A tiling contractor could be appointed to perform repair works at the clients discretion.

Note - External area floor repairs and/or maintenance will likely be the responsibility of the buildings body corporate managers.

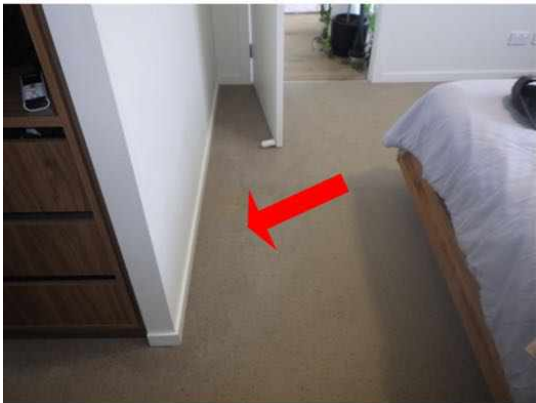
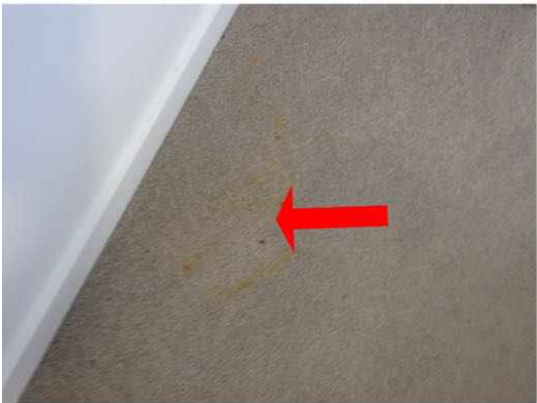
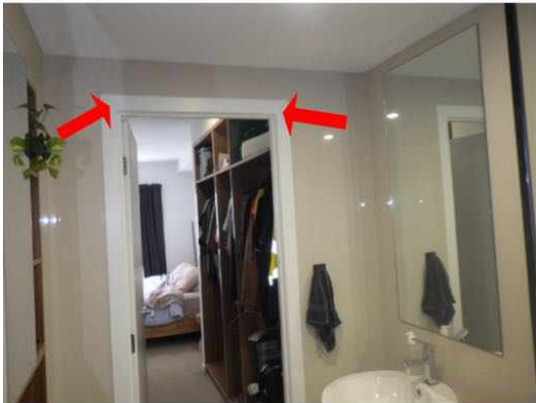
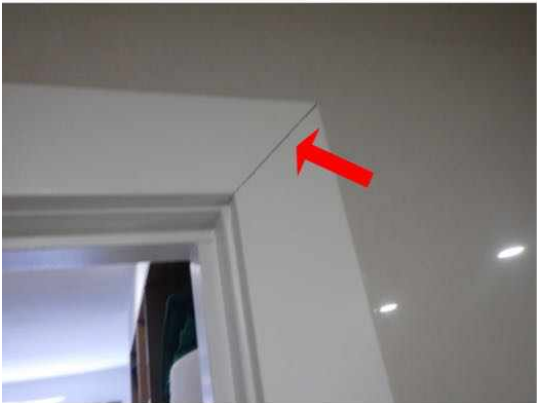
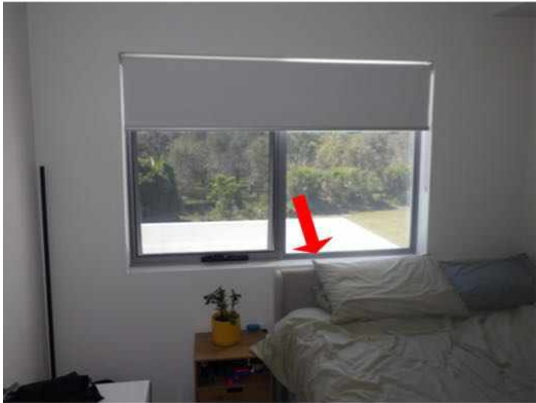
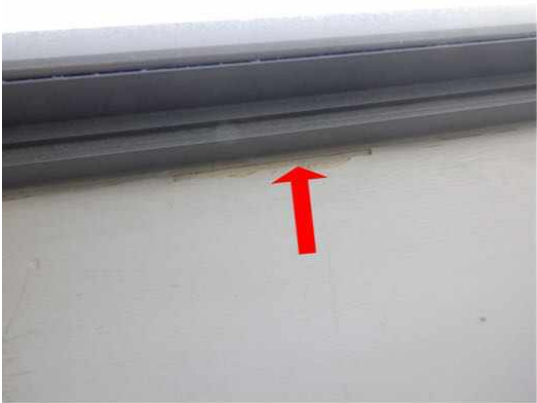
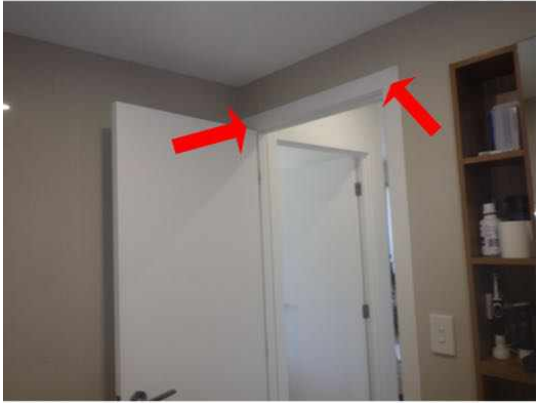
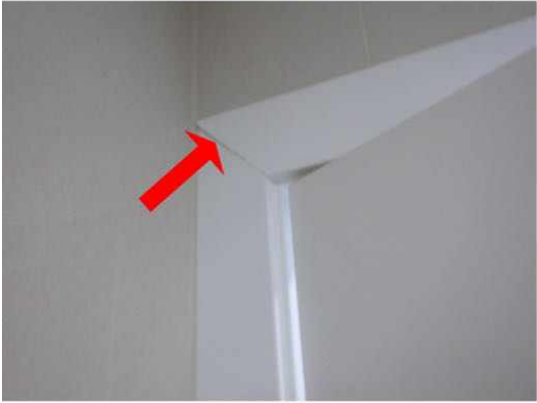
Finding 3.03

Building: Main Building
 Location: Internal Areas > Existing
 Finding: Wear and Tear
 Information: At the time of inspection the building interior showed signs of minor cracking and/or scuffing to floors, walls and timber trims (as per example photos).

The level of damage appears consistent with general deterioration and/or wear and tear.

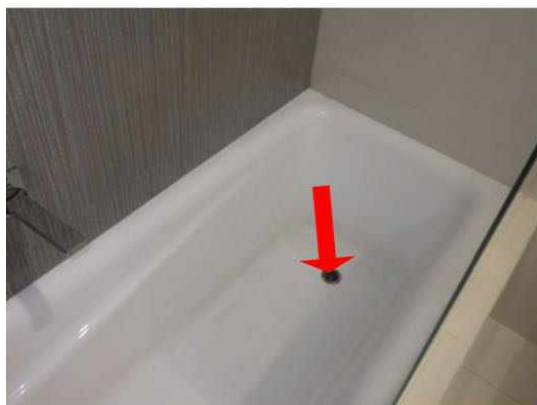
Finding 3.04

Building: Main Building
 Location: Bathroom > Rear Left
 Finding: Surface Rust
 Information: At the time of inspection the bath drain grate in the bathroom showed evidence of surface rust.

As surface rust provides no protection to the underlying iron, the deteriorating condition is likely to worsen if not addressed.

Rust formation can be controlled with coatings, such as paint, that isolate the iron from the environment.

Alternatively a qualified plumber could be engaged to replace the bath drain grate at the clients discretion.

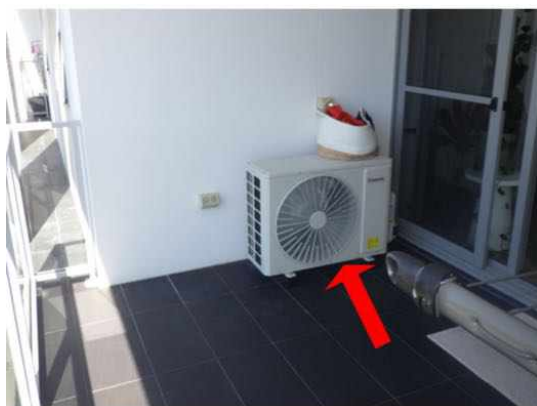
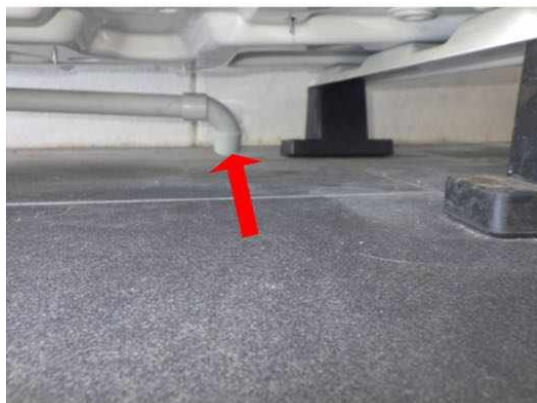
Finding 3.05

Building: Main Building
 Location: Balcony > Centre Right
 Finding: Overflow - Not plumbed for drainage
 Information: The air conditioning unit overflow is not plumbed or connected to suitable drainage, which can result in the surrounding area becoming excessively damp. These damp conditions can lead to secondary defects such as rot, rust or corrosion of associated building elements, the formation of fungal decay, or even the creation of potential slip hazards. When coupled with poor site drainage, pooling of water may also attract termite activity to this area. It is highly recommended that a qualified plumber or general handyman be appointed to extend the overflow pipe to the drainage grate provided. These works will ensure that the area remains dry and free of any secondary defects.

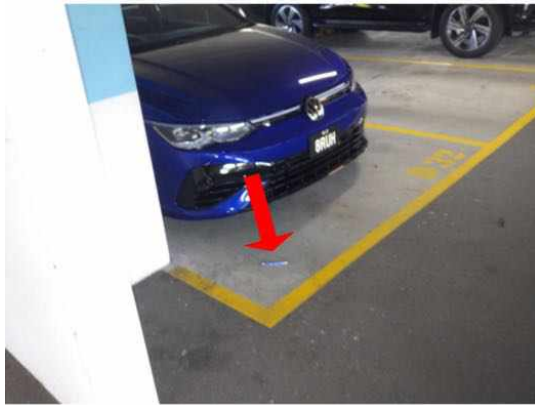
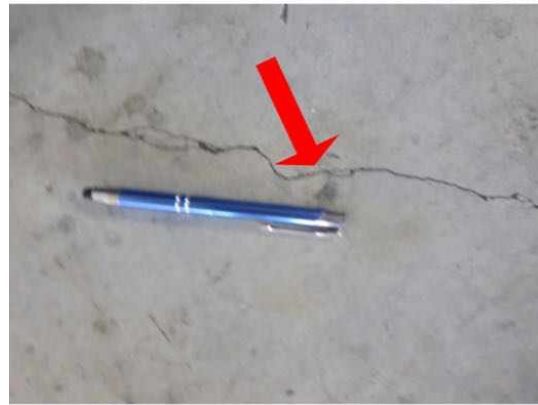
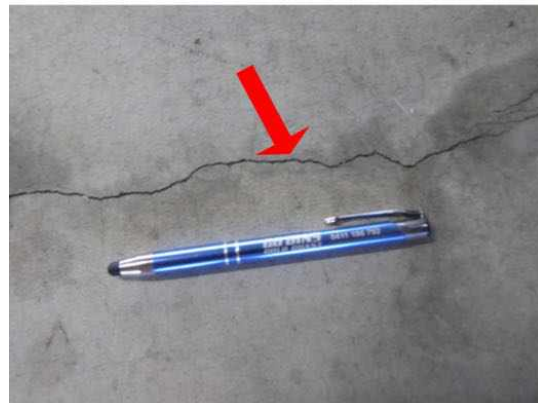
Finding 3.06

| Finding: | Cracking in concrete slab - Category 1 |
| Information: | Cracking coded as Category 1 was identified in the vehicle parking space area concrete slab (as per example photos). A Category 1 crack is described as a fine but noticeable crack, with the slab at an otherwise reasonable level. |

To be considered Category 1, the approximate width of the crack is less than 1.0mm, or a less than 10mm change in offset when a 3m straight edge is placed over the defect.

Category 1 cracks should be monitored for a period of 12 months. At the end of the monitoring period, identified cracks that are rated greater than Category 2 are considered defects, and require rectification.

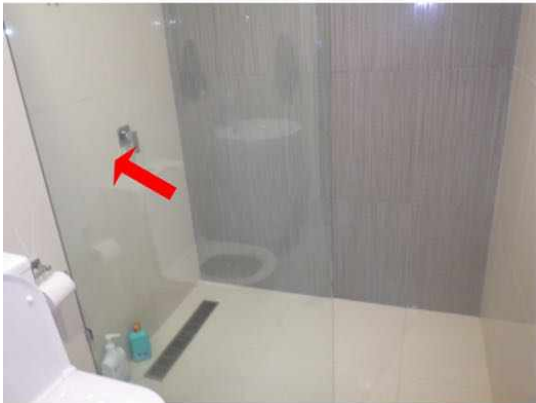
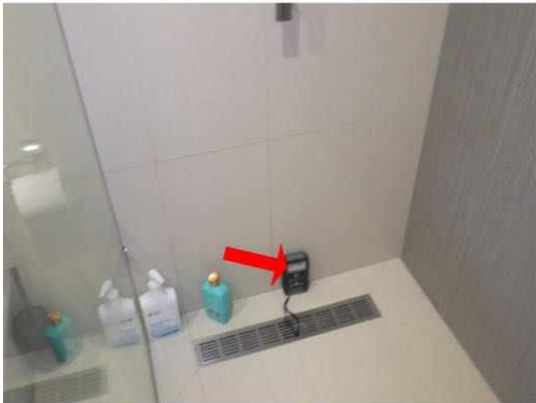
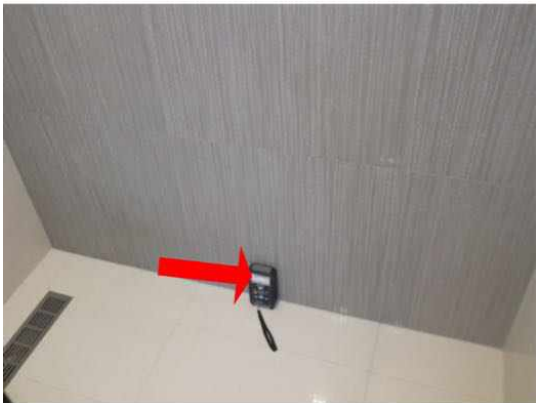
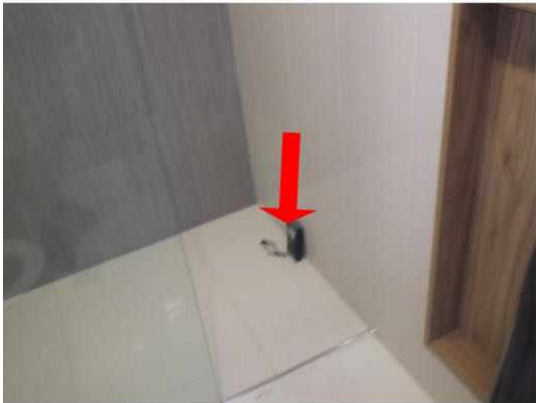
Building: Main Building
Location: Ensuite > Rear
Finding: Moisture Level Readings
Information: At the time of inspection the ensuite shower cubicle areas checked with the Tramex Moisture Meter returned low moisture level readings.

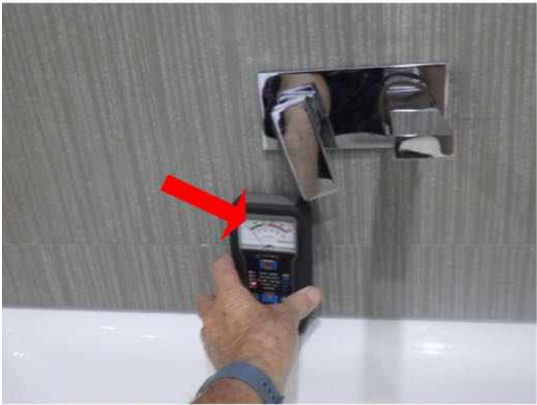
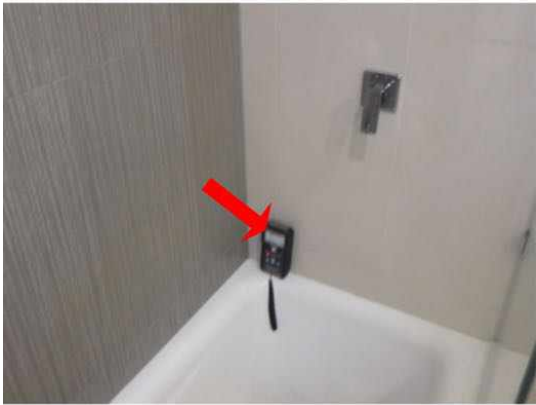
Building: Main Building
Location: Bathroom > Centre Left
Finding: Moisture Level Readings
Information: At the time of inspection the bathroom shower cubicle areas checked with the Tramex Moisture Meter returned low moisture level readings.

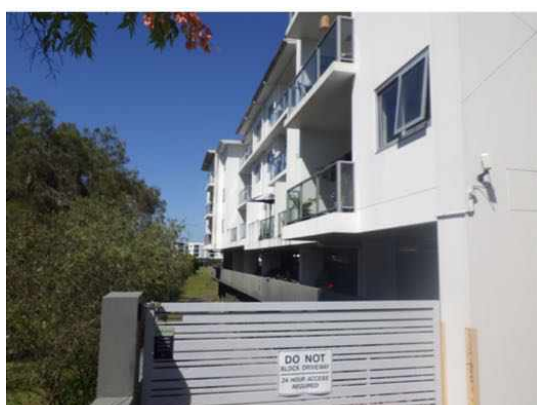
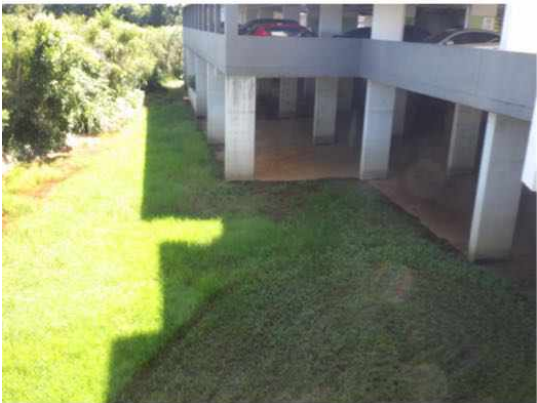
| Finding: | Evidence of a previous termite management system was identified |
| Information: | There are a number of factors which indicate the presence of a previously installed or applied termite barrier. The most common are a durable notice (to the inside of your meter box) observable physical barriers installed to building perimeter and in ground reticulation systems. |

In this instance a visual inspection zone was observed. This system requires regular annual inspections.

Note - The buildings body corporate managers may have information regarding any current timber termite management system and/or regular inspections documentation for the property.
