Building and Timber Pest Inspection Report

Inspection Date: Tue, 20 Jan 2026

Property Address: 64 Andrew Lloyd Dr, Doonside NSW 2767,
Australia

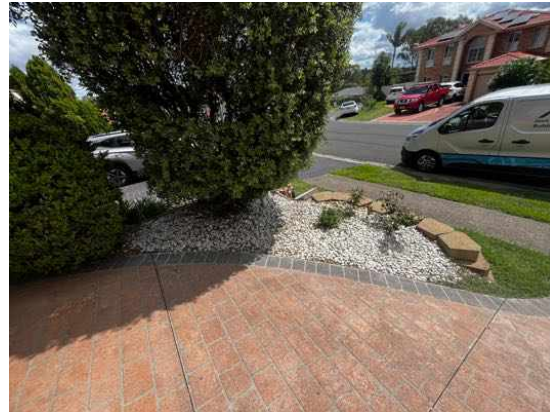
Finding 3.01

Building: Main Building
Location: Driveway
Finding: Crack in concrete slab - Category 1
Information: A crack coded as Category 1 was identified in the slab. A Category 1 crack is described as a fine but noticeable crack, with the slab at an otherwise reasonable level.

To be considered Category 1, the approximate width of the crack is less than 1.0mm, or a less than 10mm change in offset when a 3m straight edge is placed over the defect.

Category 1 cracks should be monitored for a period of 12 months. At the end of the monitoring period, identified cracks that are rated greater than Category 2 are considered defects, and require rectification.

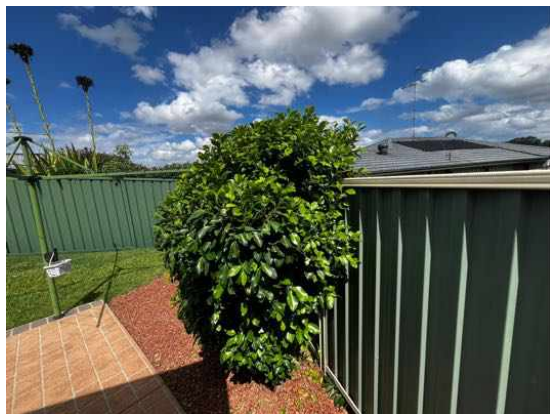
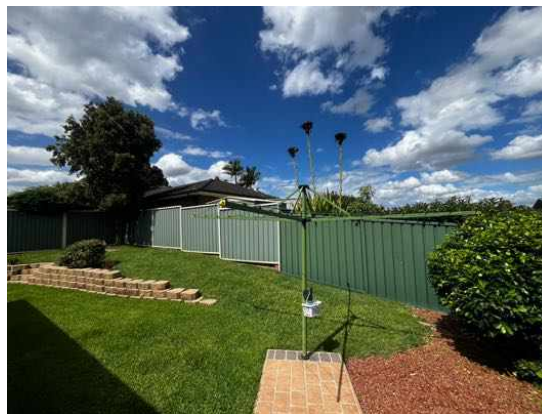
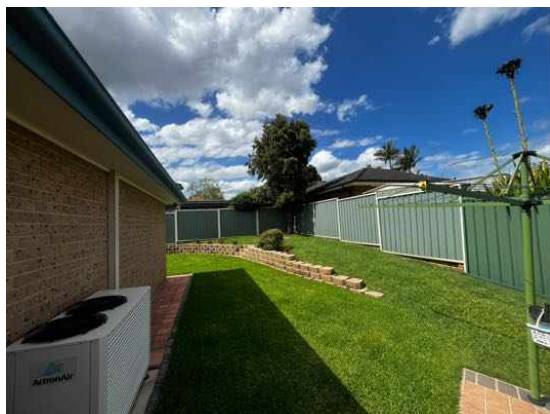
Finding 3.02

Building: Main Building
 Location: Yard
 Finding: Fencing - Deteriorated
 Information:

It was noted at the time of inspection that sections of the fencing throughout the property have deteriorated. Typically fencing deteriorates due to age and or wear, rot and or rust which is generally expected for a structure of this age, due to prolonged exposure to weather conditions. Sometimes inadequate installation or maintenance can be to blame.

If left unattended, it is likely that further damage will occur. It is suspected that repair of several elements of the fencing may be required however replacement may be a

A licensed fencing contractor should be appointed to provide further advice and perform rectification works as necessary.

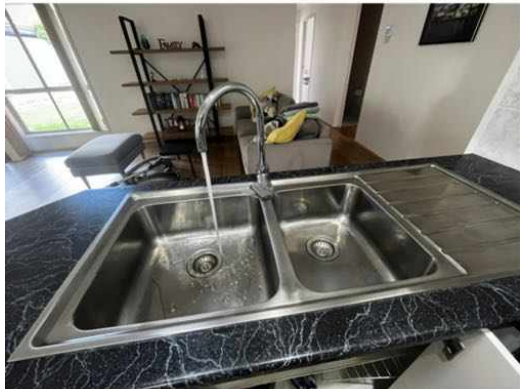
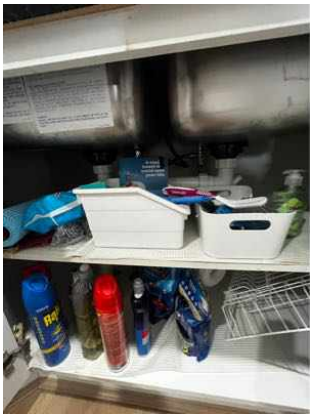
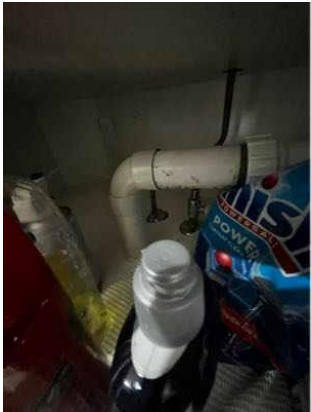
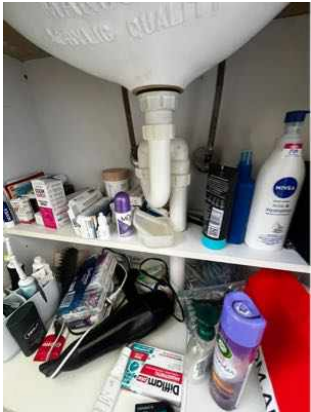
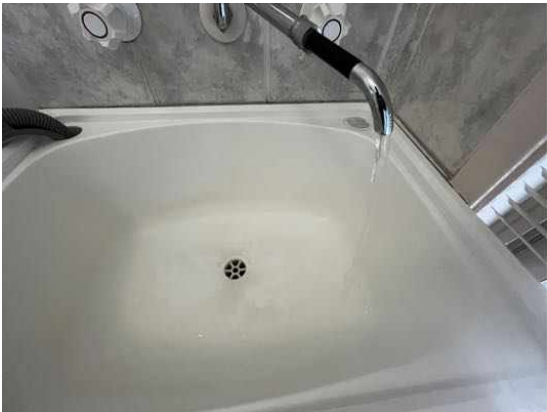
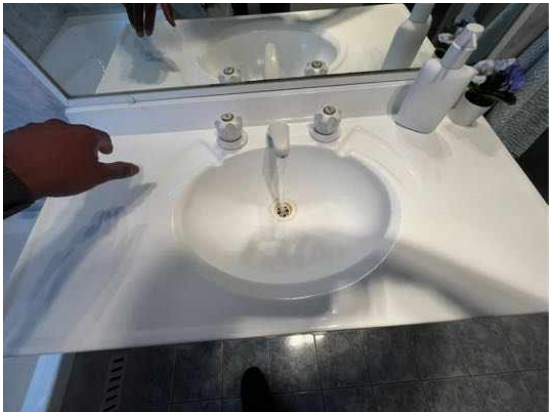
Finding 3.03

Building:	Main Building
Location:	Kitchen/ Laundry Bathroom/Ensuite
Finding:	Cabinetry Plumbing - Kitchen/ Laundry/Bathroom
Information:	All cupboards where sinks and basins with drainage plumbing were inspected and no evidence of leaks were present at the time of inspection.

If damp or wet conditions do occur there are many consequences including the development of fungal decay and/or wood rot, swelling or water damage to building materials.

For your information only no remedial works are required at the time of inspection.

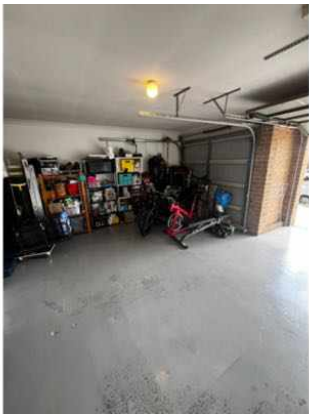
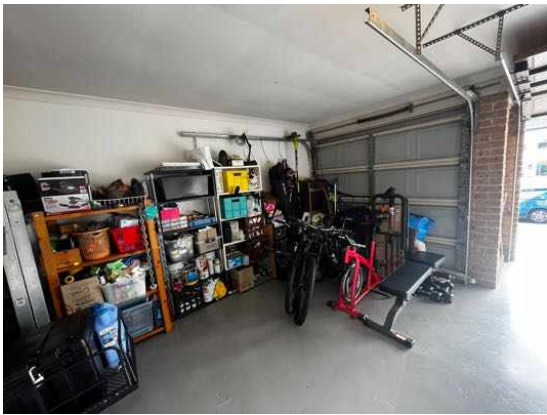
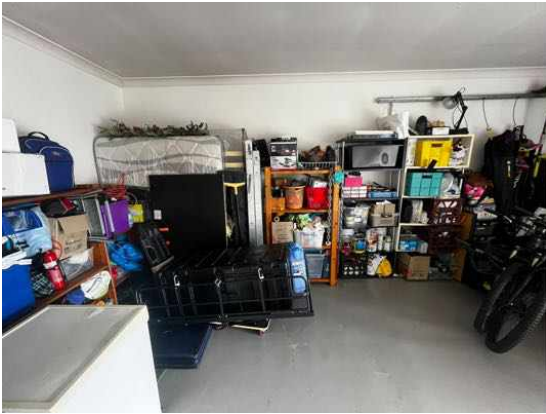
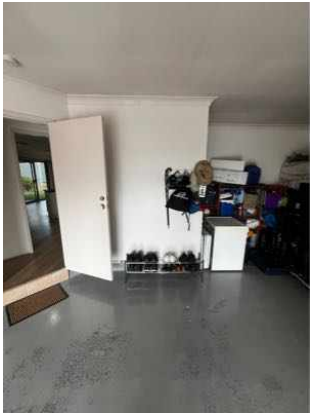
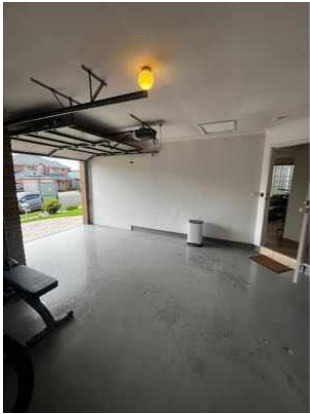
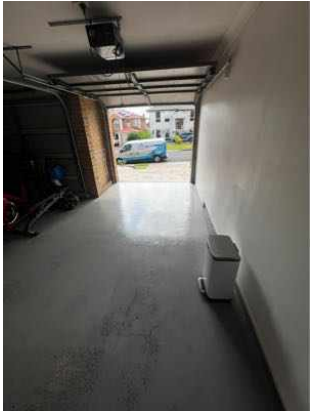
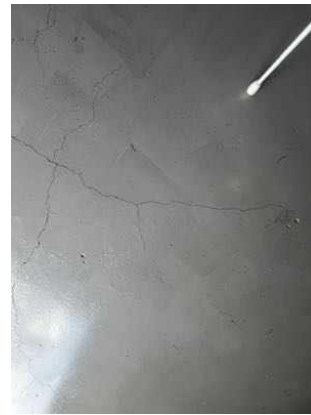
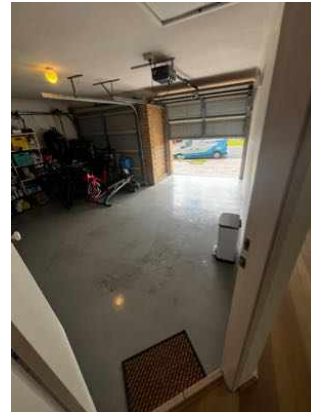
Finding 3.04

In inspection of the Floor there were fine cracks found during the inspection noted.

A crack coded as Category 1 was identified in the slab. A Category 1 crack is described as a fine but noticeable crack, with the slab at an otherwise reasonable level.

To be considered Category 1, the approximate width of the crack is less than 1.0mm, or a less than 10mm change in offset when a 3m straight edge is placed over the defect.

A re-inspection is recommended once the areas are made accessible.

Category 1 cracks should be monitored for a period of 12 months. At the end of the monitoring period, identified cracks that are rated greater than Category 2 are considered defects, and require rectification.

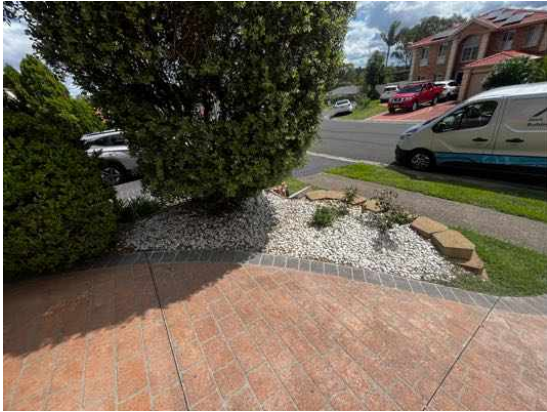
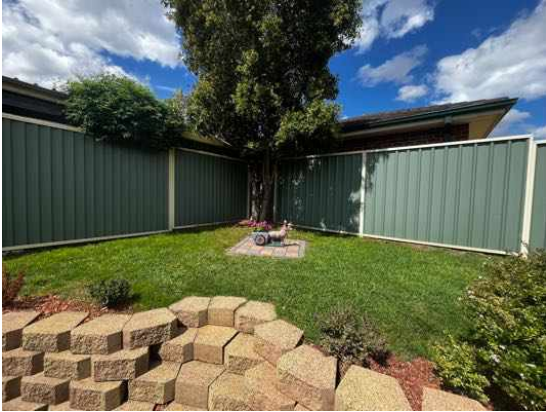
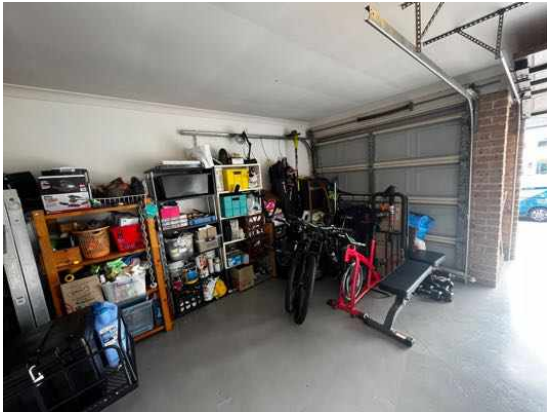
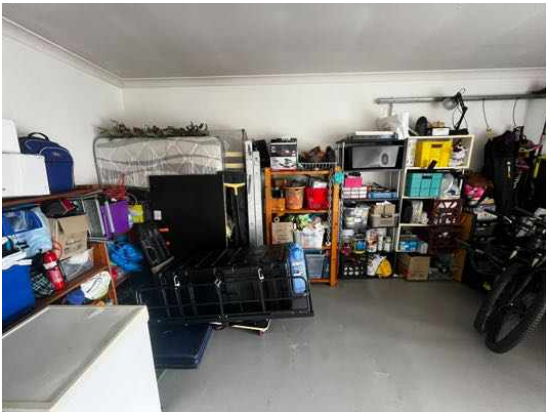
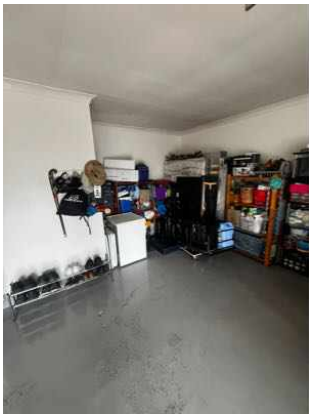
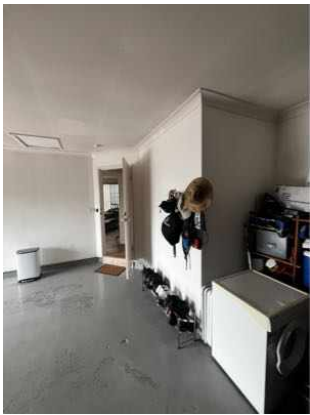
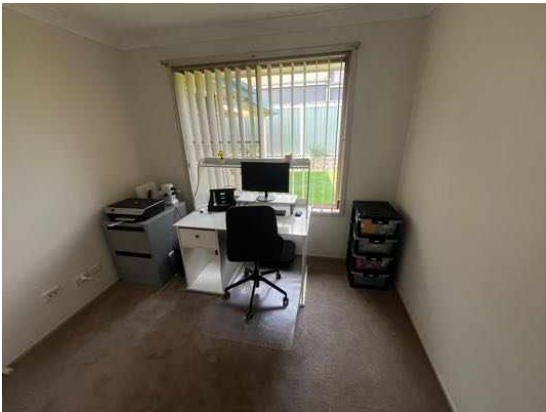
Finding: Additional Photos - Obstructions and Limitations

Information: These photographs are an indication of the obstructions and limitations which impeded full inspection of the property at the time of inspection. These obstructions can hide an array of defects and should be removed to allow full inspection to be carried out. A re-inspection is recommended once the areas are made accessible.

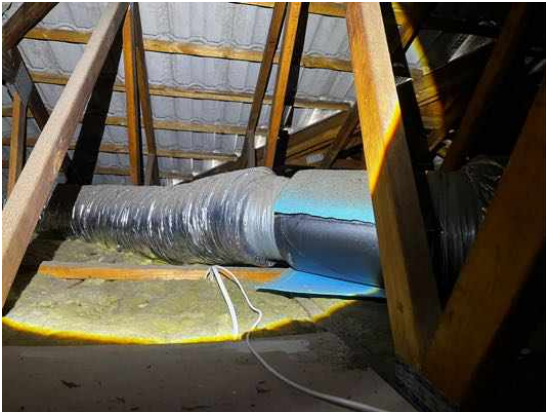
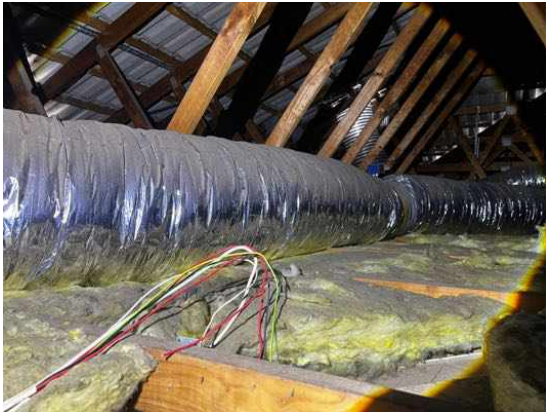
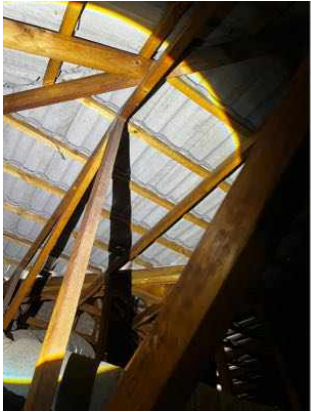
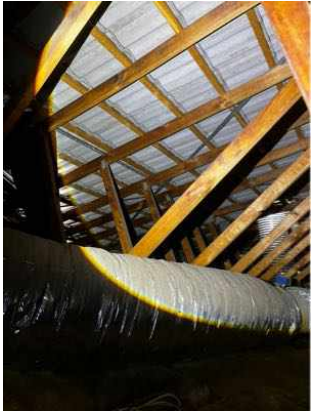
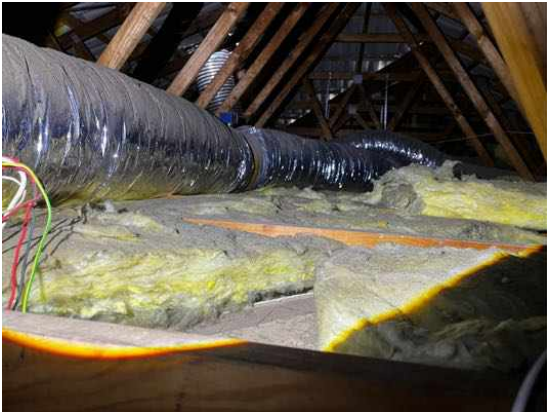
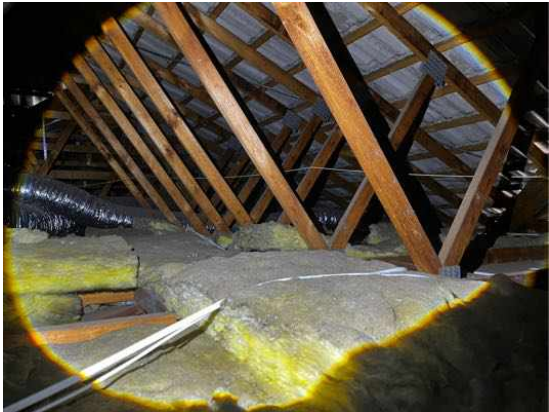
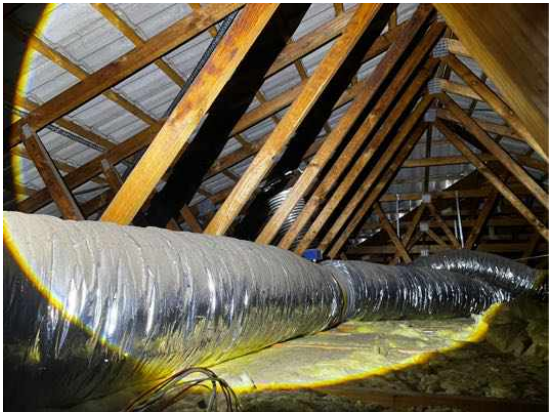
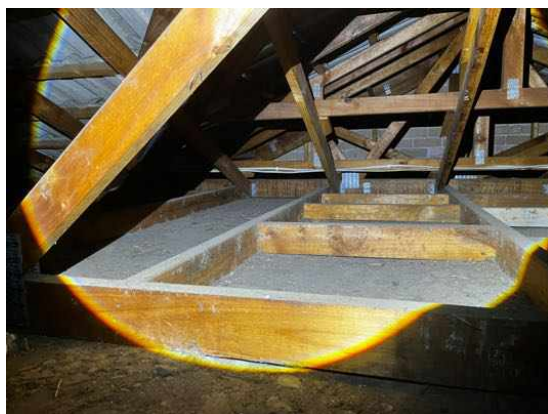
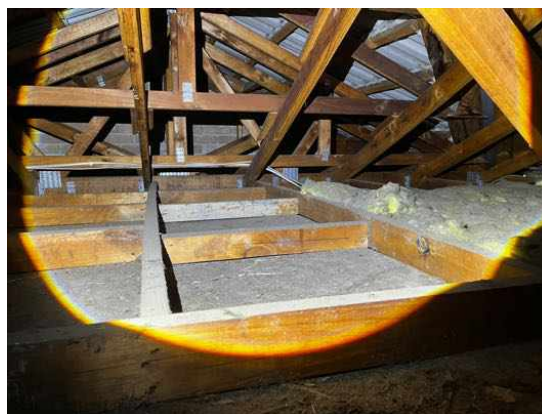
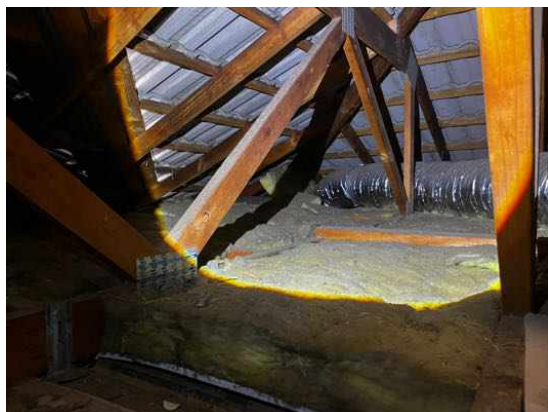
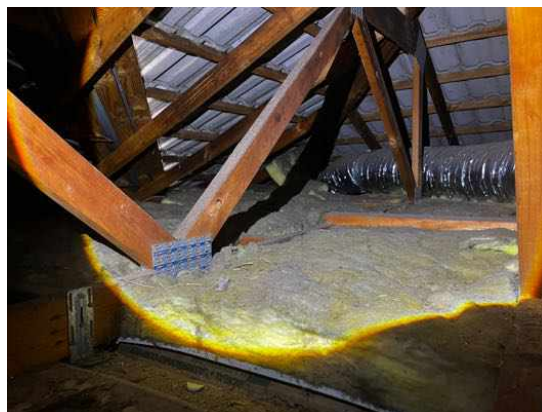
Building:	Main Building
Location:	Roof Void
Finding:	Obstructions and Limitations - Roof space
Information:	<p>The Roof Void was inspected up to the safe point of access possible - These photographs are an indication of the obstructions and limitations which impeded full inspection of the Roof Space/Void at the time of inspection such as Stored items, Ducting, Aircon ducting, Skylight tubes, Electrical wires, insulation and cross beams, rafters, low clearance as of the pitch in the roof. These obstructions can hide an array of defects and should be removed to allow full inspection to be carried out.</p>

A re-inspection is recommended once the areas are made accessible.

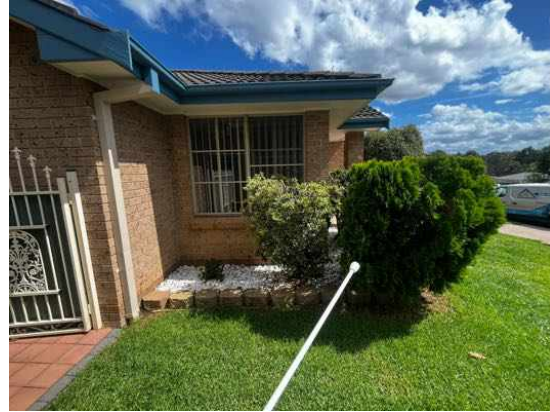
Finding 6.03

Building:	Main Building
Location:	All Areas
Finding:	Building materials in direct ground contact - conducive to termites
Information:	Where timber elements are in direct contact with the ground and consequently moisture or dampness they become conducive to termite activity. Whether timber is used as a building element part of a fencing structure or stored as an unused item they can provide an environment that is attractive to termite infestation.

When met with excessive moisture timber begins to decay and develop wood rot. Any timbers that are in direct contact with external grounds especially if left untreated or non-durable also provide ingress for subterranean termites into that particular element.

The removal of any such materials that may be conducive to termite activity should be removed as soon as possible to minimise the risk of termite attack.

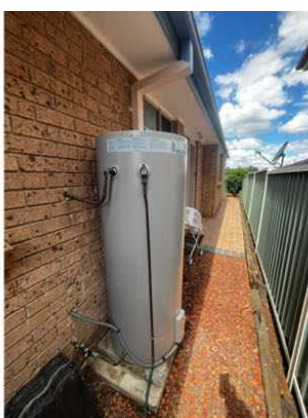
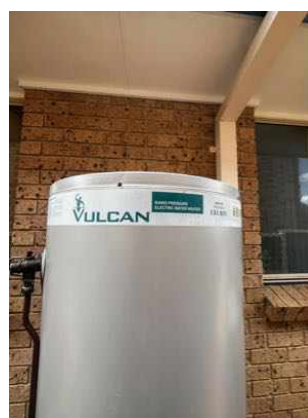
Building: Main Building
 Location: Yard
 Finding: Hot Water Unit
 Information: The Electric HWS appeared to be in good condition at the time of inspection.

Water pressure appears to be normal, however, this is not an opinion of a licensed plumber.

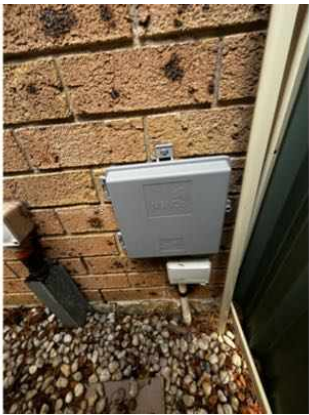
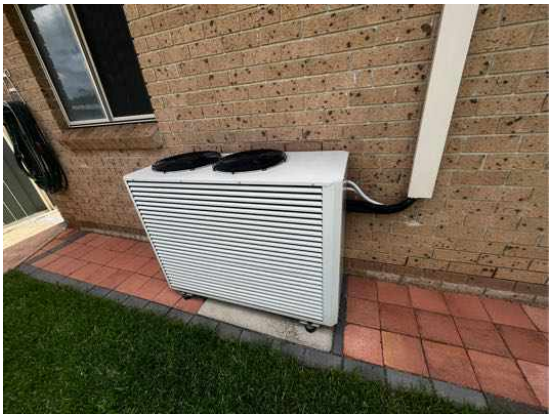
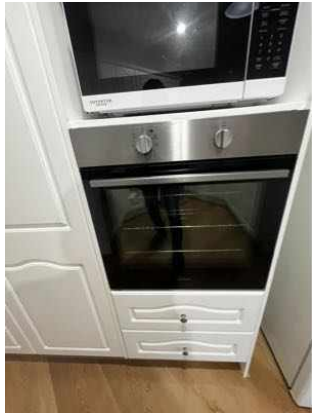
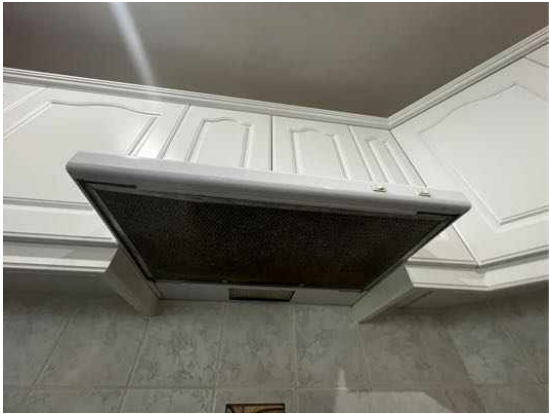
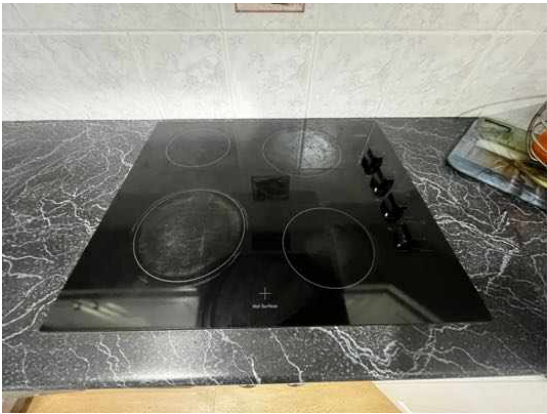
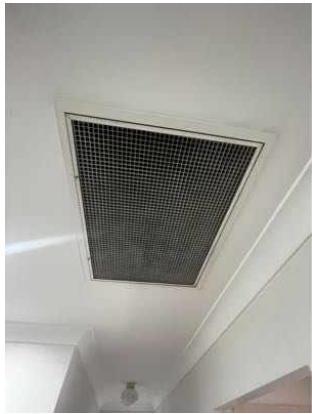
Building: Main Building
 Location: All Areas
 Finding: Plumbing/electrical/gas/aircon/appliances/pool equipment/fire safety etc
 Information: Plumbing and electrical inspections are outside the scope of the building inspection and must be conducted by a Licensed and registered Trades person.

It is highly recommended that the client makes immediate arrangements to have the gas appliances checked by a licensed gas plumber to ensure that the appliances are working safely and efficiently.

We recommend all other installations be checked also.

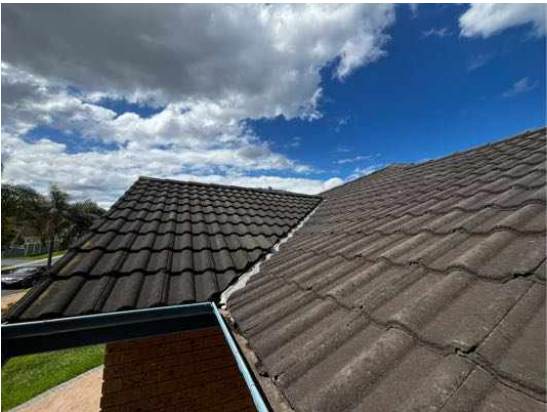
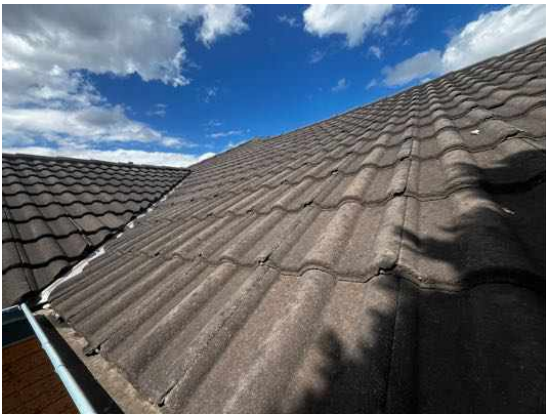
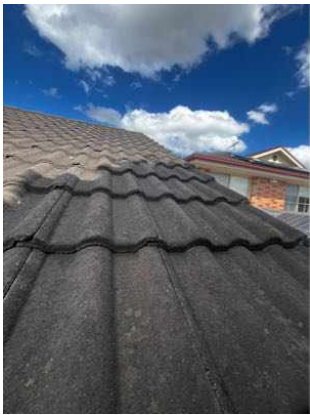
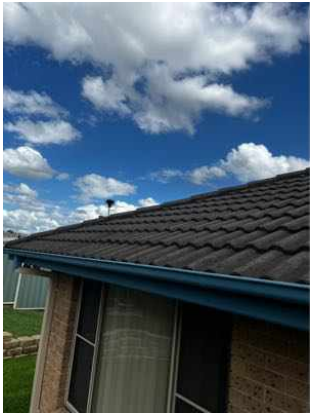
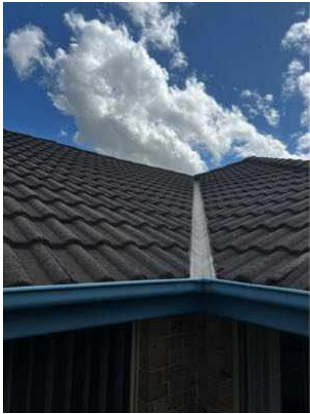
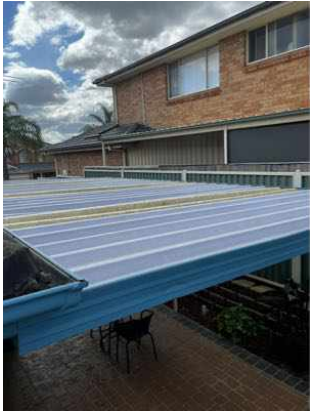
Building: Main Building
Location: Roof Exterior
Finding: Roof tiles - Weathered
Information: Upon inspection of the exterior roofing, the majority of roof tiles were considered to be in a fair condition. While weathering of the tiles is consistent with the age of the property, maintenance works are required.

Where left unmanaged, deteriorating roof tiles are likely to lead to a number of secondary defects, including minor water leaks and weather exposure to internal roofing structures.

Consultation with a roofing contractor is highly advised to gain advice on cost of remedial works that may be required in the short to medium term. Remedial works are likely to increase the longevity of the exterior roofing structure.

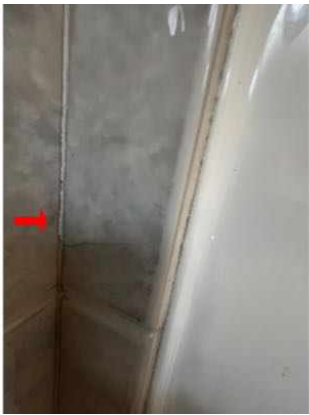
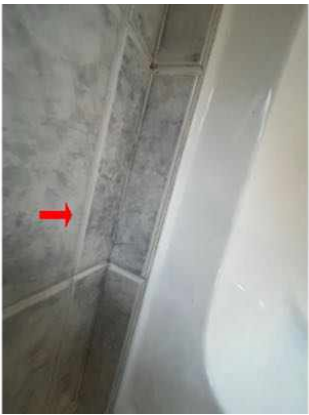
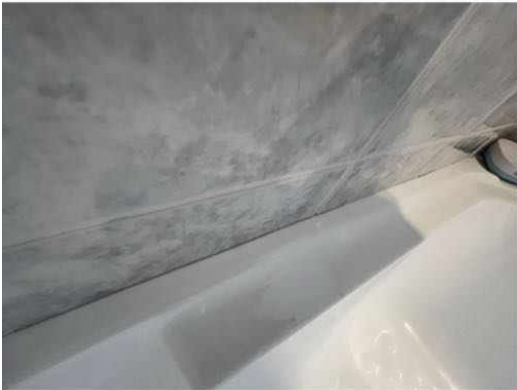
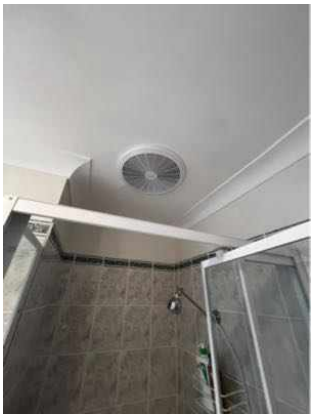
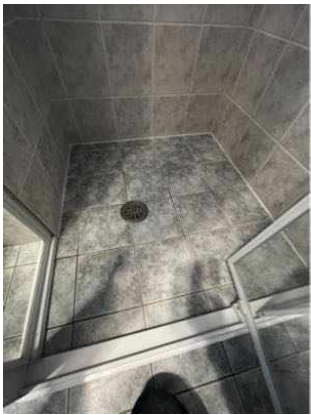
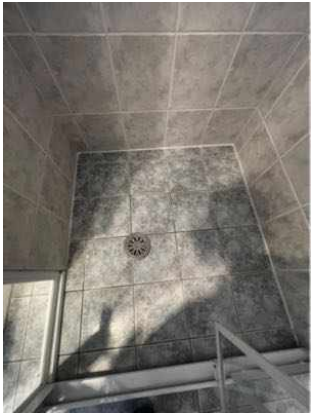
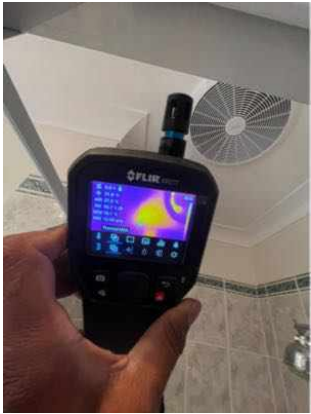
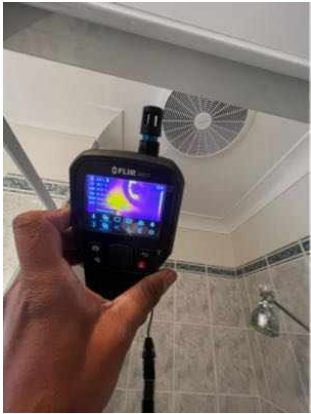
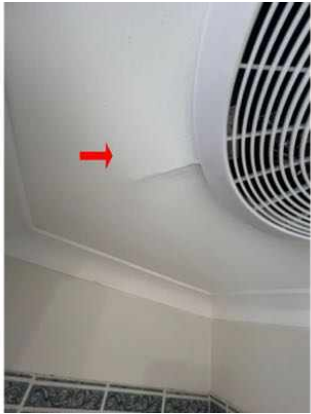
Building:	Main Building
Location:	Main Bathroom
Finding:	Sealant and grouting - Missing or damaged
Information:	It was noted on inspection that sealant or grout is degraded to the tiled shower alcove and or other areas of the bathroom.

Different materials and floor areas move at different rates, generally causing cracking to grout or sealant at this point. A flexible sealant is required to allow for expected expansion and contraction, while keeping the joint water tight and protective of all associated building materials.

There appears to be excessive mould to the sealant and grout which will likely require scraping out and replacement.

Flexible and mould resistant materials should be applied to affected areas to prevent any subsequent water damage that is likely to occur. Regular maintenance and replacement of damage or missing or damaged sealant and grout is highly recommended to the wet areas, as this is a regular wear and tear defect. Sealant and grouting in areas that come into regular contact with water should be maintained for the long term care of your property.

A sealant specialist or tiling contractor should be appointed to complete these works as soon as possible

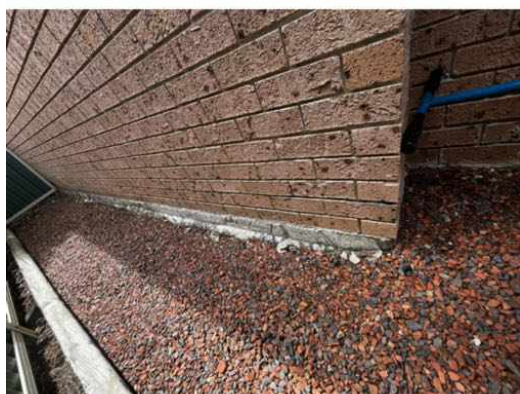
Building: Main Building
 Location: All External Areas
 Finding: Slab Edge - Exposure
 Information: An inspection zone of at least 75mm in relation to the exposed slab edge, between the bottom brick and the perimeter pavement, is required. This inspection zone should be maintained in order to force termites into the open where they can be detected more readily during regular inspections. The slab edge should not be concealed by anything that may prevent inspection of the area, including render, landscaping, soil, turf, paving, concrete cladding or other structures.

If the slab edge is not properly exposed there is a high risk of termite attack. Sometimes, in order to determine the type of slab, a suitably qualified person such as an architect or builder may be required to consult the construction plans.

Where the slab edge cannot be properly inspected, it is highly recommended that termite or timber pest inspections be carried out every 6-12 months to aid protection of the property against infestation.

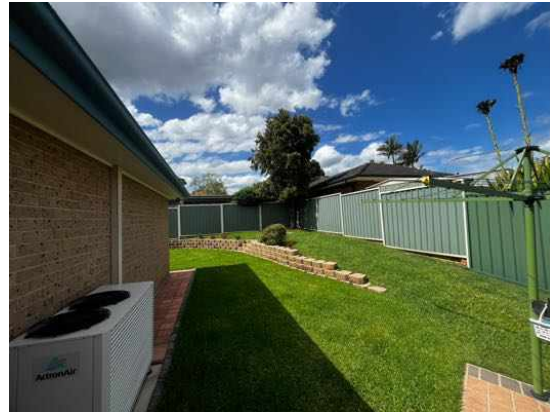
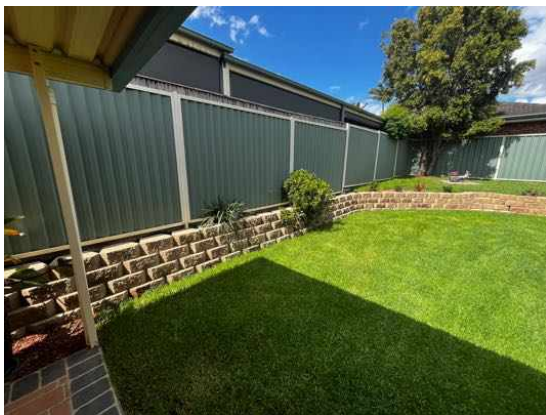
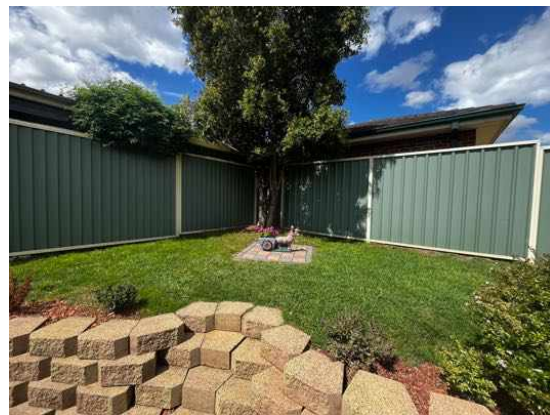
Building: Main Building
 Location: All Areas
 Finding: Site drainage - For your Information
 Information: Site Drainage appears to be acceptable at the time of inspection, however, the site/ Yard should be monitored during heavy rain to determine whether the existing drains cope. If it appears that they cannot cope, then additional drains may be required.

at the time of inspection. It is recommended that a smoke test be obtained to determine any illegal connections, blocked or broken drains.

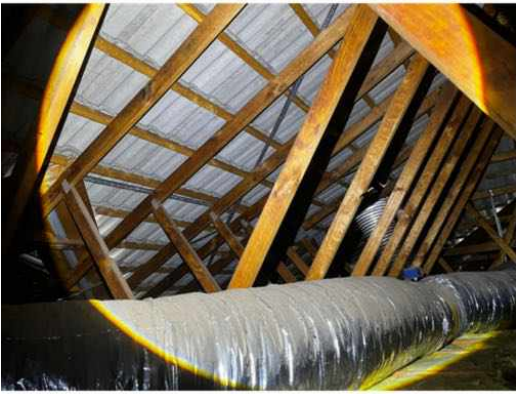
Building:	Main Building
Location:	Roof Void
Finding:	Sarking - Missing
Information:	Sarking is missing under the roof sheeting. Sarking acts as an insulator that helps with noise reduction and protects against water penetration. Sarking plays a key role in the operation and function of the overall roofing structure and its performance.

Although not a requirement at the time of construction, replacement of any missing building element is advisable (although this can be quite expensive to do after the time of construction). Where sarking is missing, regular inspections of the roof tiles for cracking and potential moisture penetration is required.

Sarking may be retrospectively fitted by a registered builder at the discretion of the client.
