# Building and Timber Pest Inspection Report

Inspection Date: Tue, 3 Feb 2026

Property Address: 6/3 Parkside Parade, Toronto NSW 2283,  
Australia

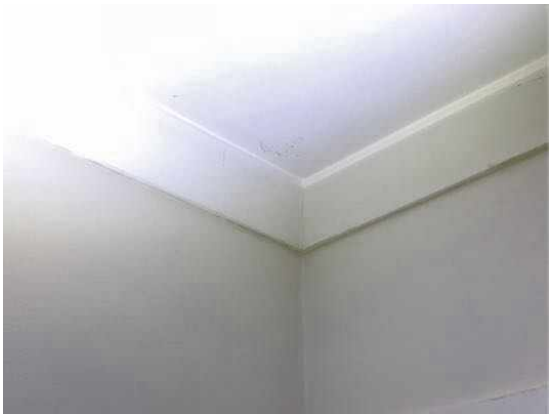
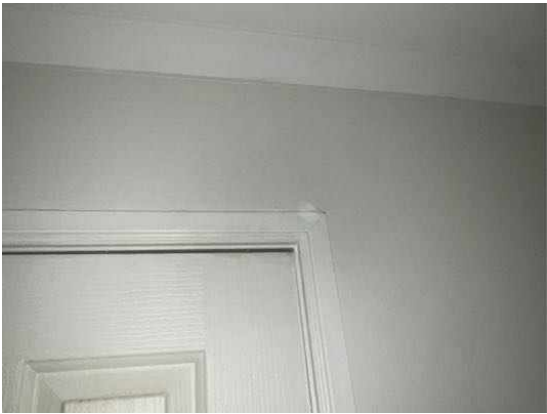
Building:	Main Building
Location:	All Internal Areas > All Areas
Finding:	Cracking - Damage Category 1 - Fine (up to 1mm)
Information:	Cracks were evident to the plasterboard above several doors and to the corner of some of the cornice. Although fine cracks are quite noticeable, they are often only considered to be an appearance defect, and usually do not indicate any structural damage. Generally, the cause of a fine crack is indicative of a separation between building materials and finishes (e.g. paint, plaster, etc.) along joins.

Cracking of this nature can generally be repaired with minor sanding, filling and/or repainting. Such works should be performed by a qualified painter or a general

Monitoring of all cracking should be conducted frequently. Always contact a building inspector should cracks widen, lengthen, or become more numerous.

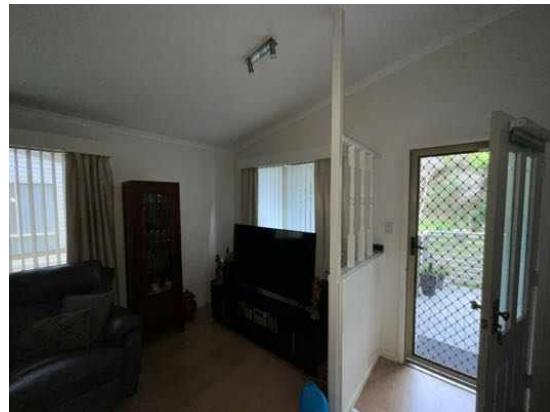
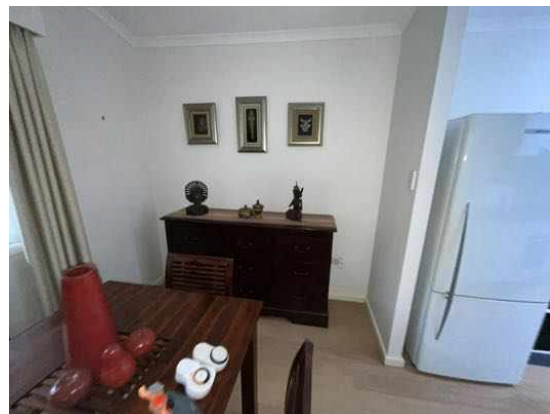
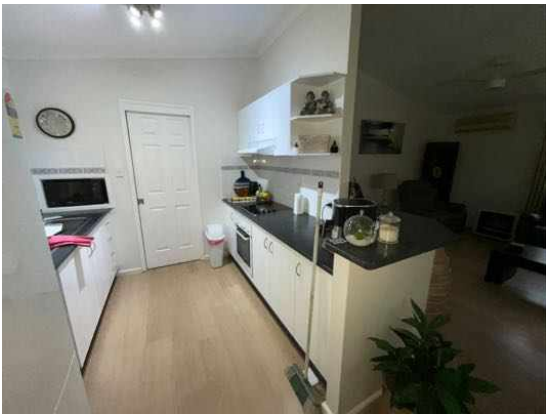
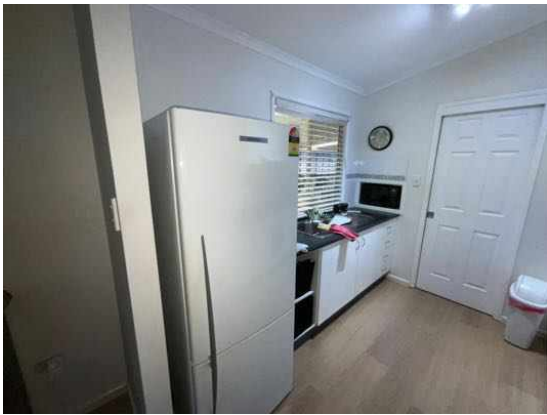
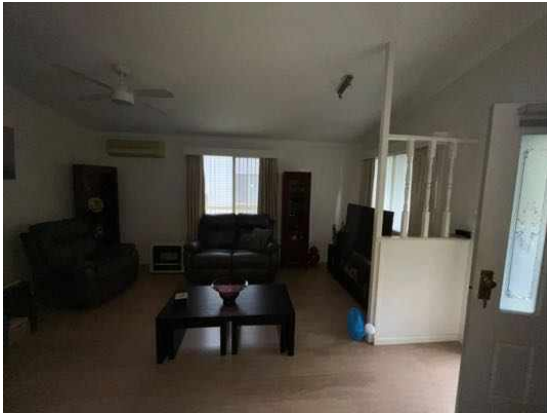
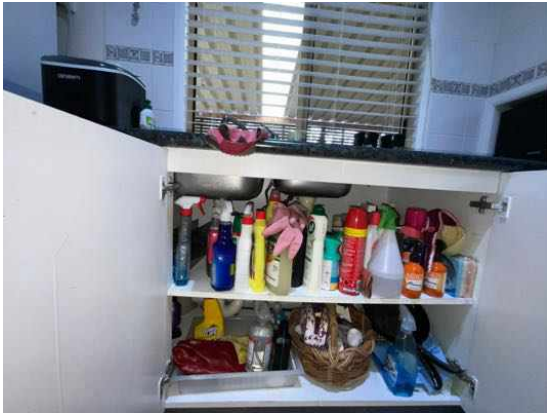
#### Noted Item

Building: Main Building  
Location: All Areas > All Areas  
Finding: Additional Photos - Obstructions and Limitations - Interior Areas  
Information: These photographs are an indication of the obstructions and limitations which impeded full inspection of the property at the time of inspection. These obstructions can hide an array of defects and should be removed to allow full inspection to be carried out. A re-inspection is recommended once the areas are made accessible.

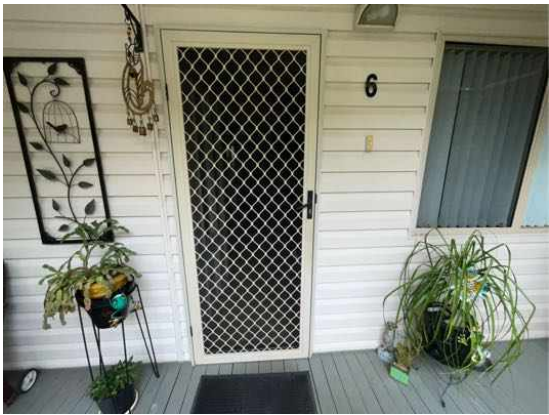
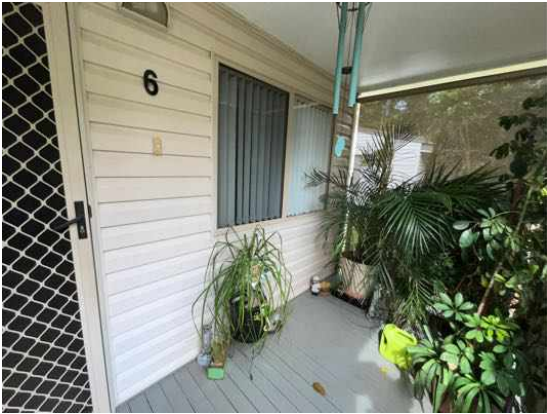
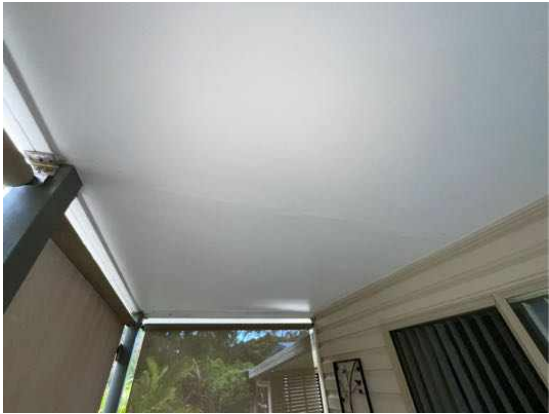
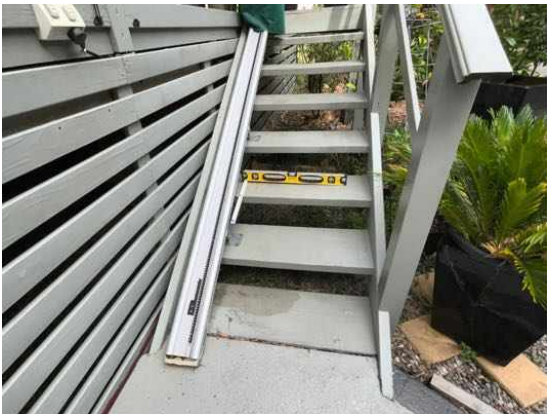
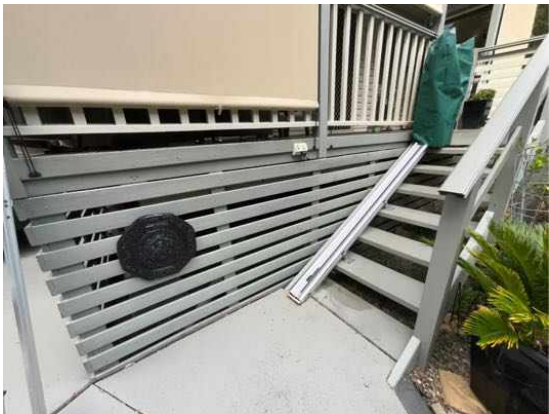
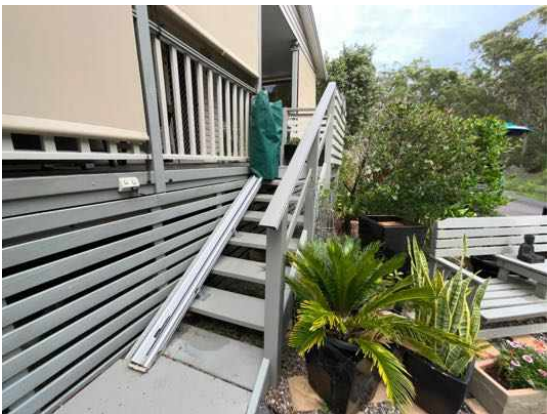
### Noted Item

Building: Main Building  
 Location: All External Areas > All Areas  
 Finding: Additional Photos - Obstructions and Limitations - External Areas  
 Information: These photographs are an indication of the obstructions and limitations which impeded full inspection of the property at the time of inspection. These obstructions can hide an array of defects and should be removed to allow full inspection to be carried out. A re-inspection is recommended once the areas are made accessible.

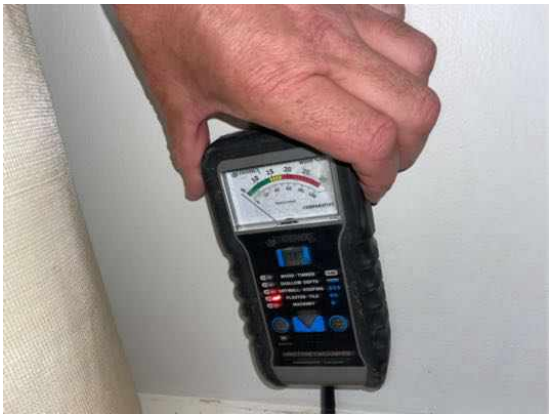
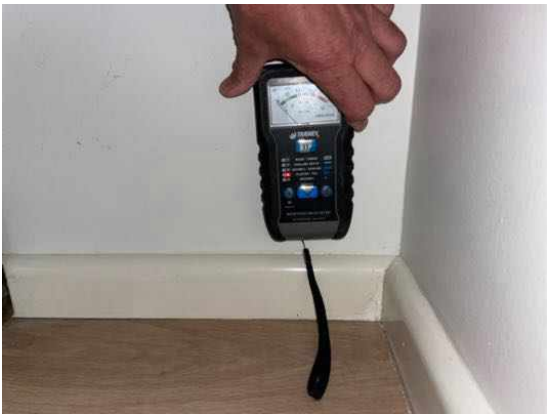
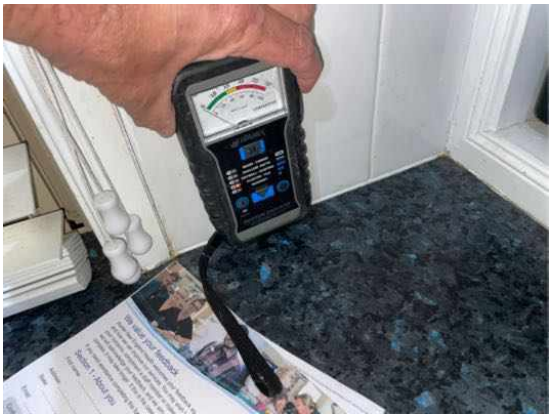
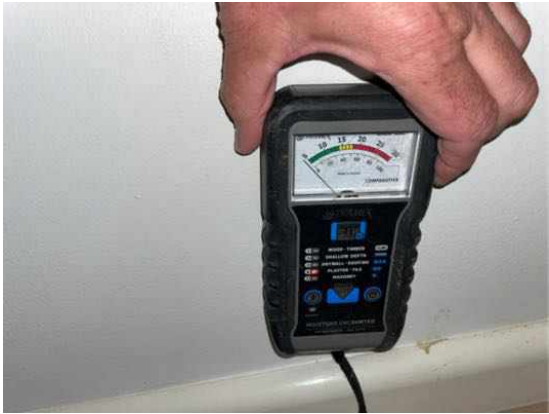
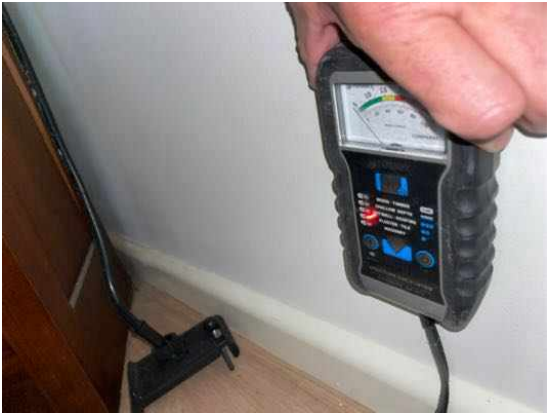
**Noted Item**

Building: Main Building  
 Location: All Areas > All Areas  
 Finding: Moisture Readings  
 Information: Moisture readings were taken to the wet areas and below and beside windows. There was elevated moisture levels located to the Walk in Robe and beside the shower.

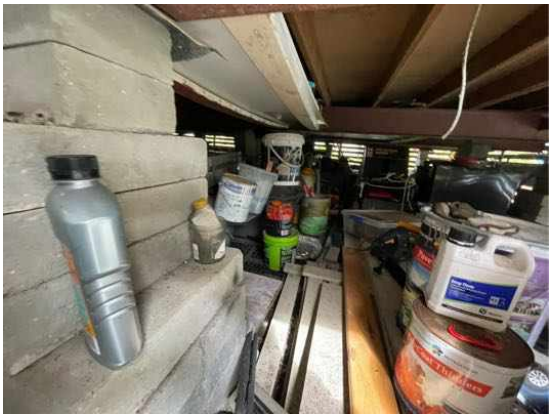
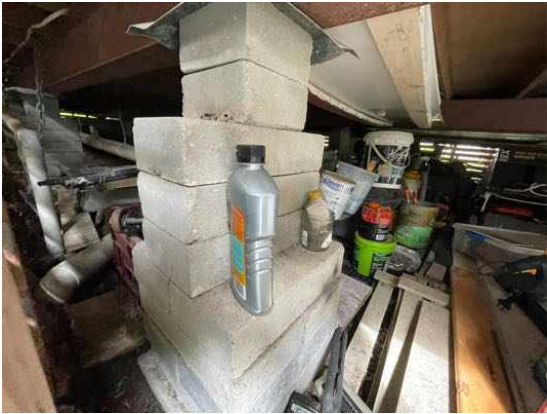
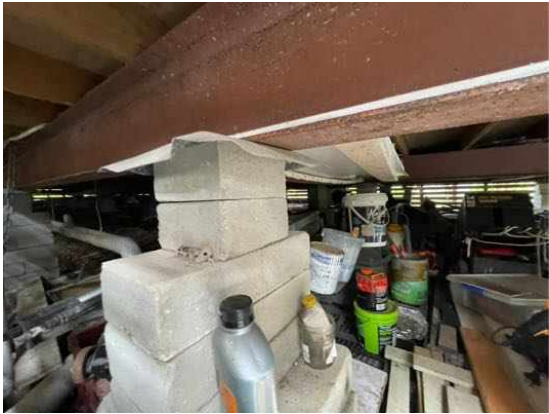
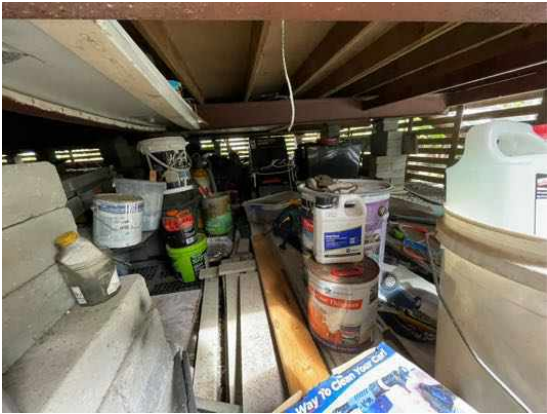
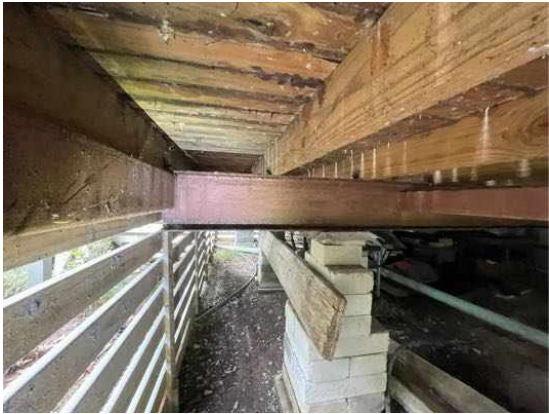
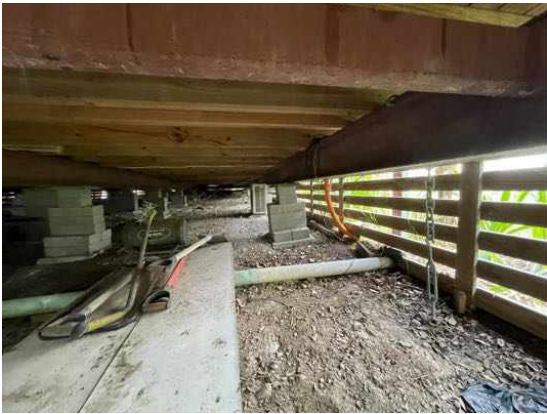
### Noted Item

Building:	Main Building
Location:	Subfloor > All Areas
Finding:	Obstructions and Limitations Subfloor
Information:	These photographs are an indication of the obstructions and limitations which impeded full inspection of the Subfloor at the time of inspection. These obstructions can hide an array of defects and should be removed to allow full inspection to be carried out. A re-inspection is recommended once the areas are made accessible.
