Building and Timber Pest Inspection Report

Inspection Date: Thu, 9 Apr 2026

Property Address: 36 Moss St, Numurkah VIC 3636, Australia

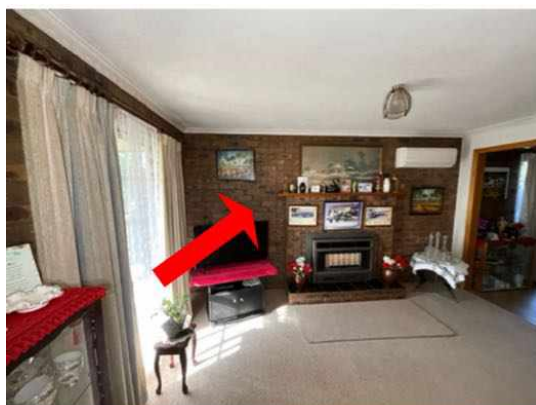
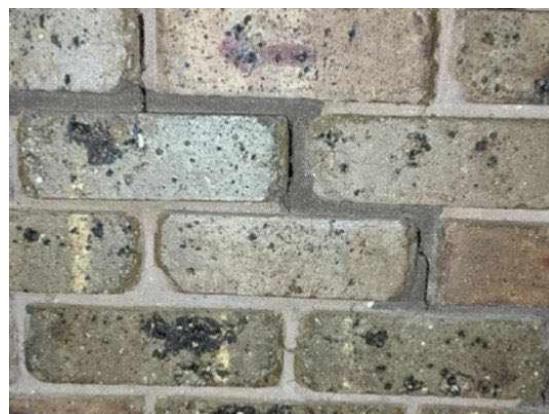
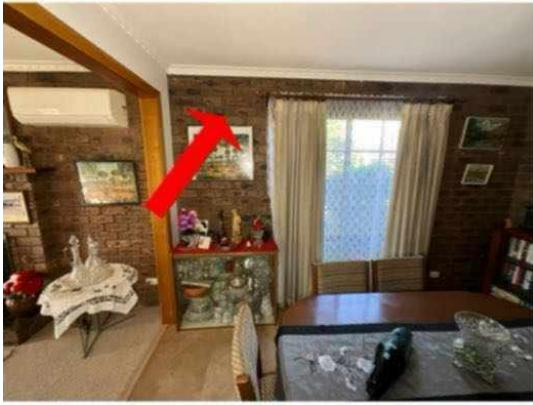
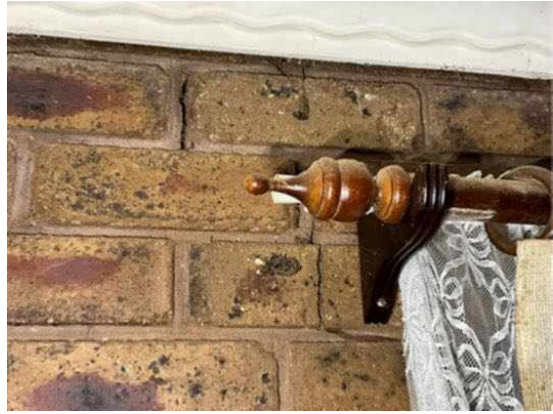
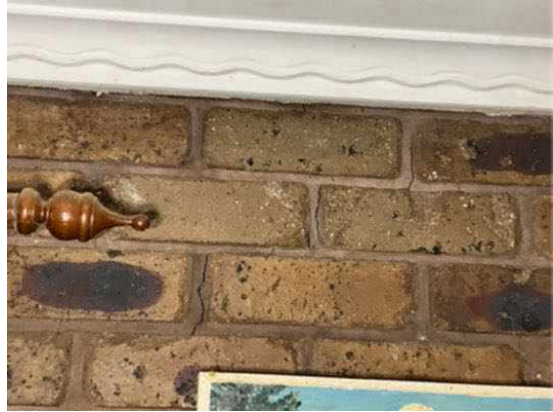
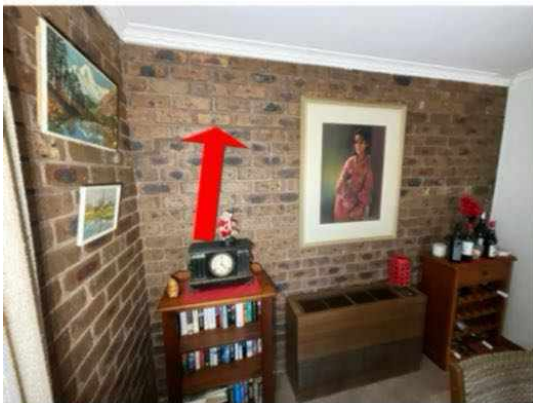
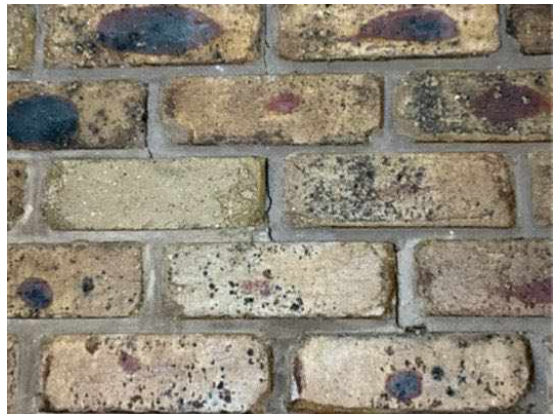
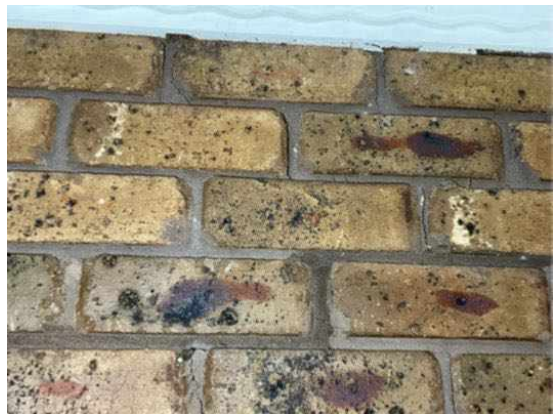
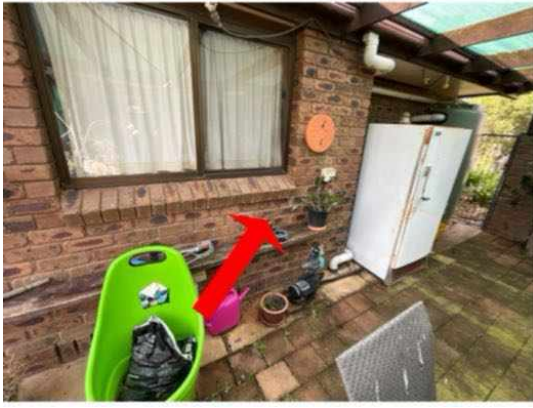
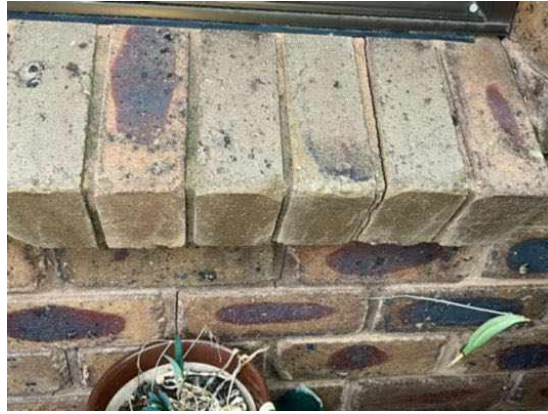
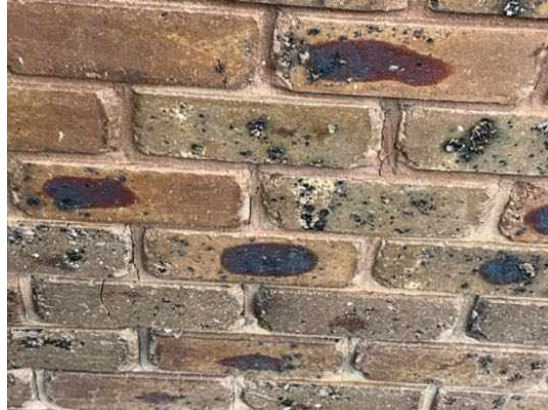
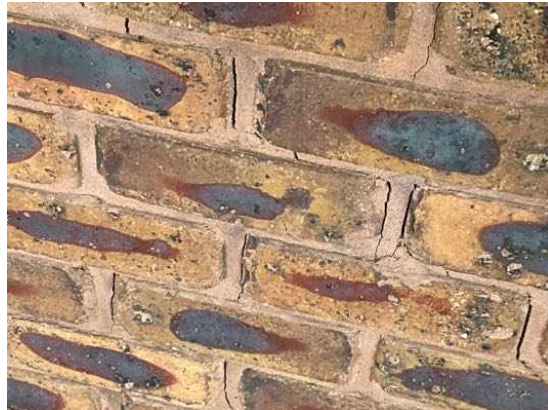
Finding 3.01

Building: Building 1
Location: Living Room, dining, alfresco, end and front wall
Finding: Brickwork - Step cracking
Information: Step cracking was identified to the brickwork in this area at the time of inspection. Step cracking, which is similar to other forms of cracking, has a variety of possible causes. However, the most common is the subsidence of adjacent footings.

Step cracking is a relatively common defect, and is most likely to occur adjacent to windows, doors and other openings. Mortar failure in the gaps between affected bricks indicates the stresses and tensions affecting the wall.

Where step cracking is extensive or severe, the client is advised to consult a structural engineer. Minor step cracking can be used as a warning sign to address factors causing stress to the wall, which can include the effect of surrounding trees, water leaks, soil erosion, or even the presence of reactive soils in the surrounding area.

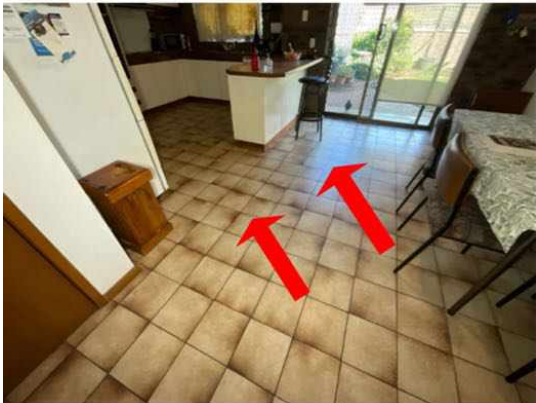
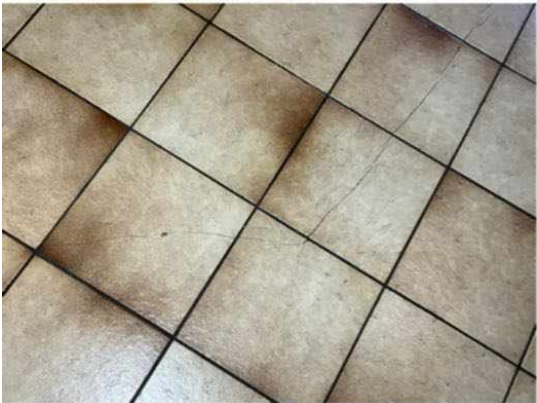
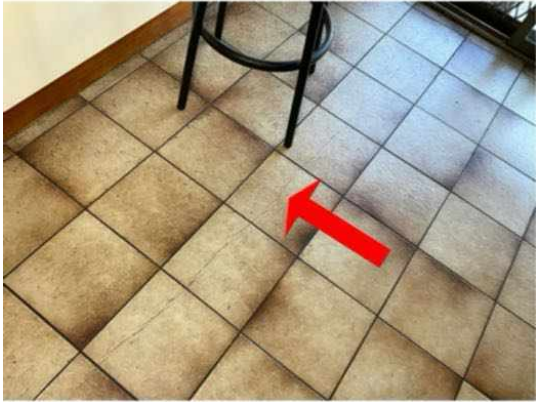
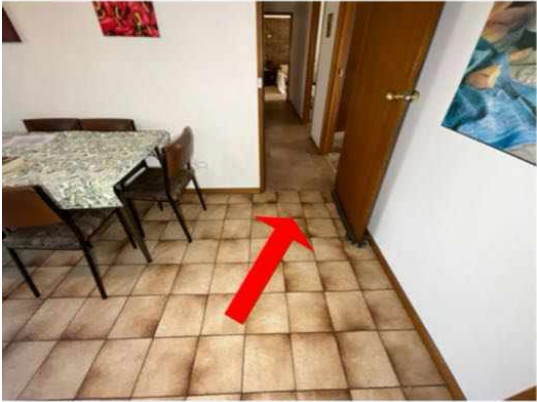
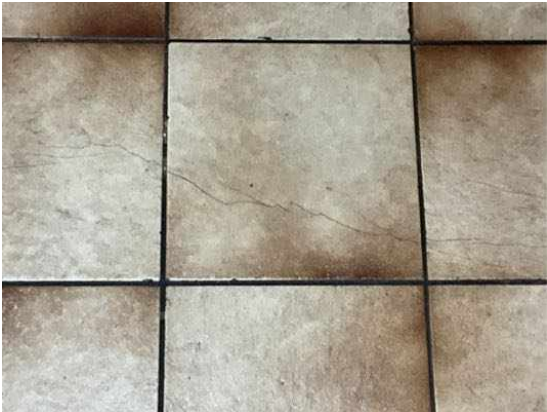
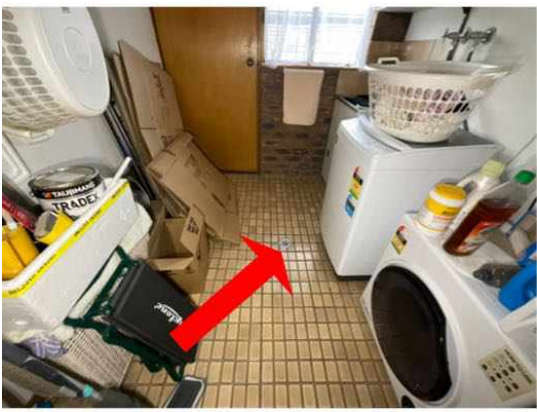
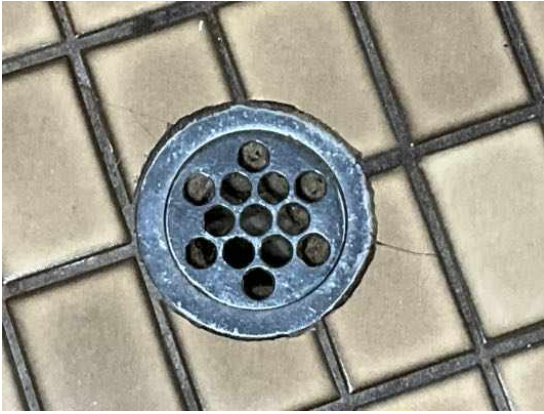
Finding 3.02

Building:	Building 1
Location:	Dining Room, laundry
Finding:	Cracked floor tiles
Information:	Cracking in the floor tiles was evident in this area at the time of inspection. It is suspected that this cracking has occurred as a result of minor settlement or impact damage.

Cracked tiles throughout the household detract from the overall appearance of the affected areas however it is unlikely to create or lead to any secondary defects.

While not considered a matter of urgency, replacement of cracked floor tiles is

recommended at the clients discretion. A tiling contractor may be appointed to perform these works. Where cracks become more numerous, contact a licensed building inspector for further investigation.

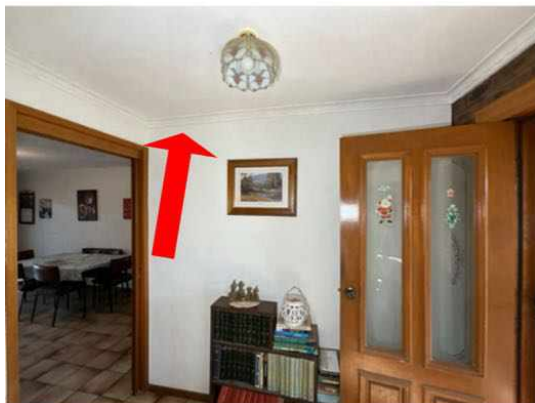
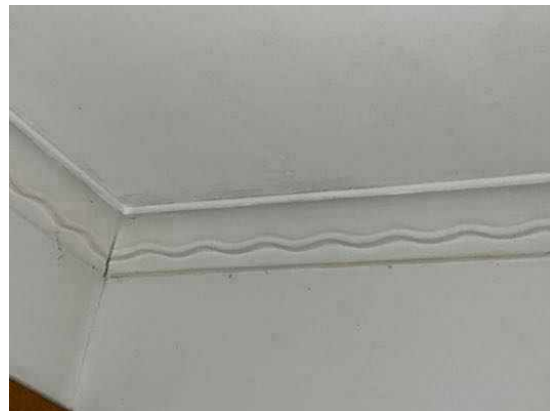
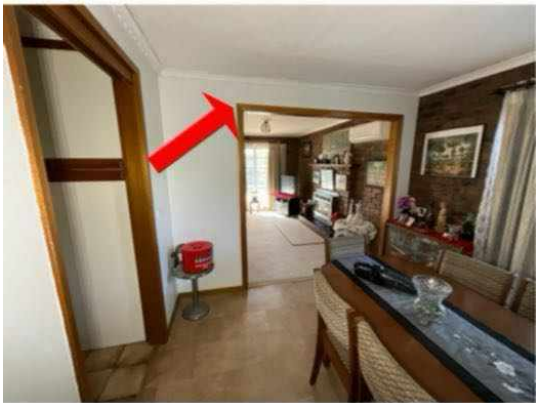
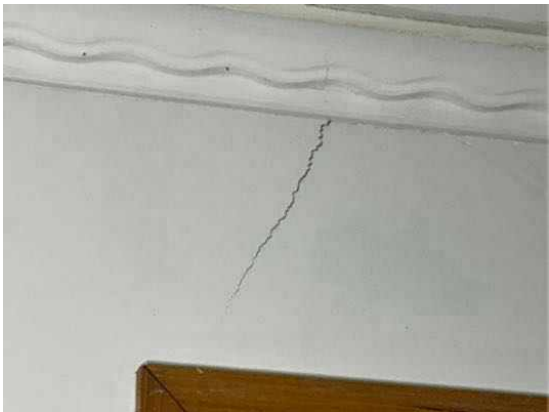
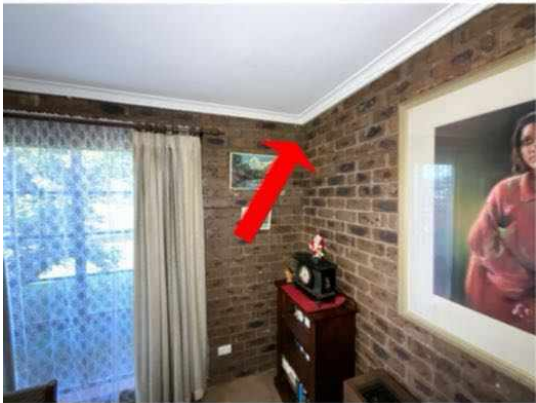
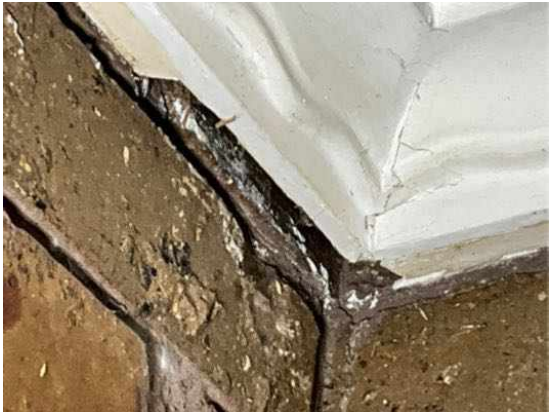
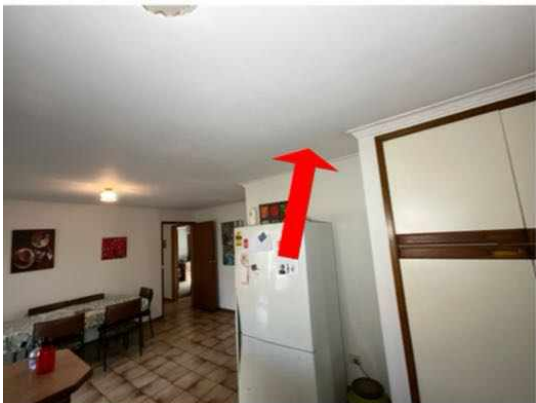
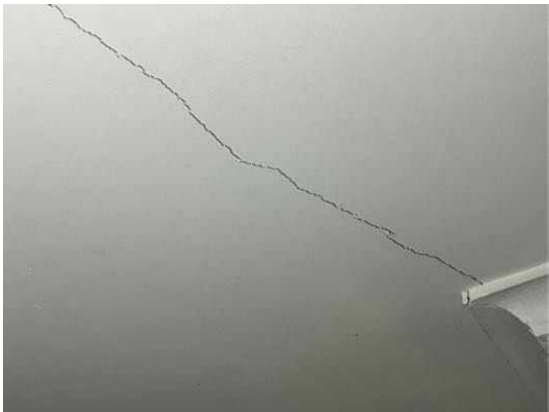
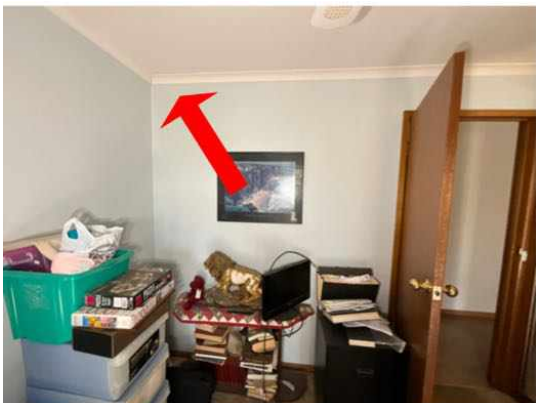
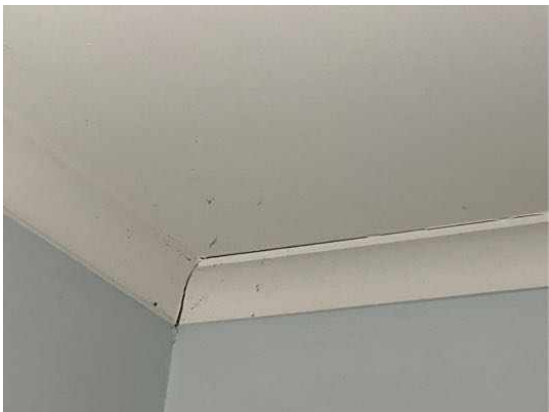
Finding 3.03

Building:	Building 1
Location:	Entry, dining, kitchen, bed 3
Finding:	Cracking - Damage Category 1 - Fine (up to 1mm)
Information:	Although fine cracks are quite noticeable, they are often only considered to be an appearance defect, and usually do not indicate any structural damage. Generally, the cause of a fine crack is indicative of a separation between building materials and finishes (e.g. paint, plaster, etc.) along joints.

Cracking of this nature can generally be repaired with minor sanding, filling and/or repainting. Such works should be performed by a qualified painter or a general handyman.

Monitoring of all cracking should be conducted frequently. Always contact a building inspector should cracks widen, lengthen, or become more numerous.

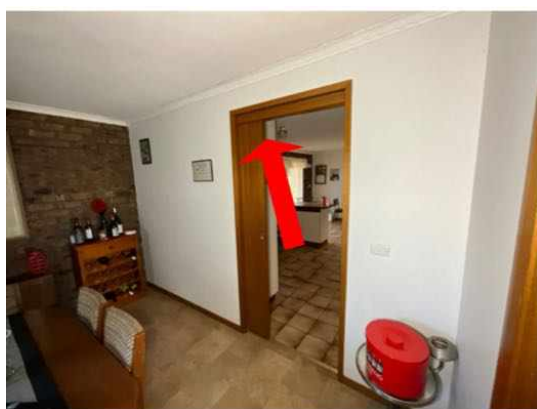
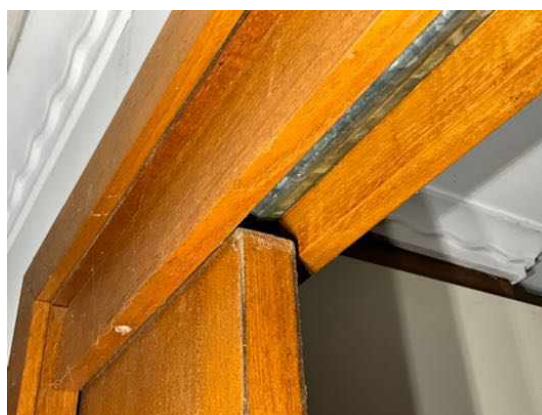
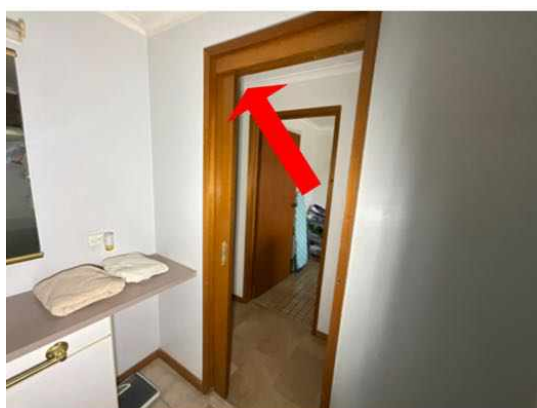
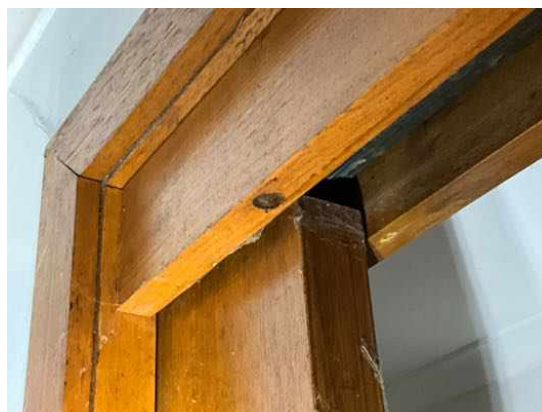
Finding 3.04

Building: Building 1
 Location: Dining Room, bathroom
 Finding: Door- Stiff to slide
 Information: The door in this area was jammed and difficult to slide along the associated tracks at the time of the inspection. Restricted function of the affected door may pose as a potential safety hazard if required for emergency egress from the building.

Generally, factors such as general age of the building element and a lack of maintenance are the usual causes for this type of defect.

Replacement of door hardware or tracks may be required, as well as minor repairs and cleaning. A registered builder or general handy person will be required to repair the affected doors.

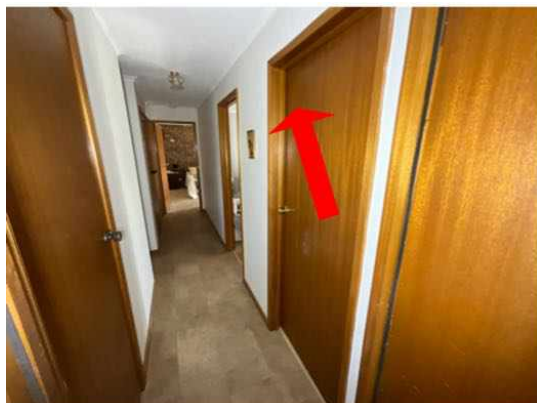
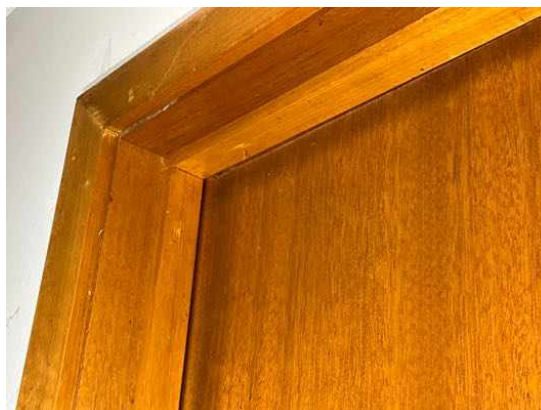
Finding 3.05

Building: Building 1
 Location: Bedroom 3
 Finding: Door- Binding/jamming
 Information: Binding and/or jamming of this door is evident during standard operation. This defect inhibits the functionality of the affected door as well as creating potential for secondary defects to associated building elements, such as damage to the floor covering.

A door that binds to flooring or to the associated door frame may have several causes, ranging from minor defects, such as poor installation of the door or deteriorated hinges, through to major structural issues, such as damage to subfloor structures.

A qualified carpenter or general handyperson should be appointed to perform minor rectification works at client discretion.

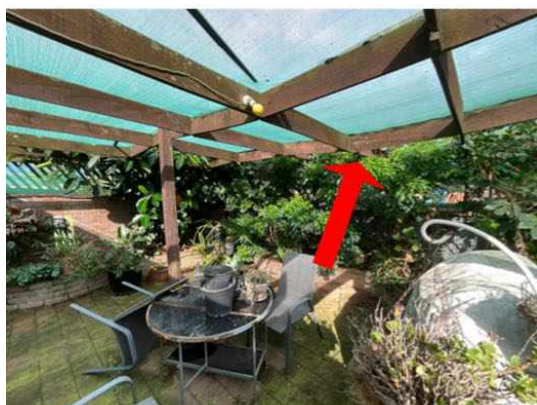
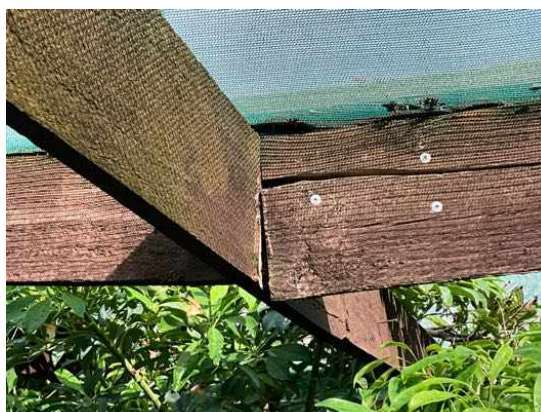
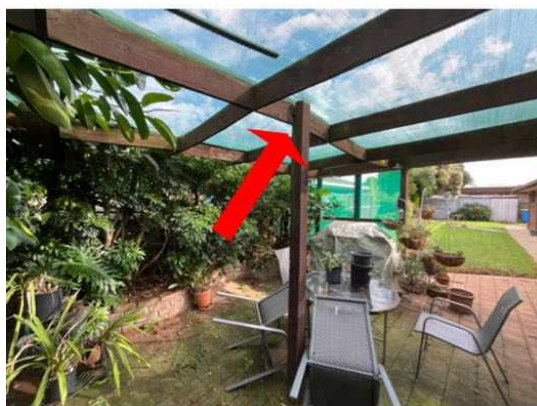
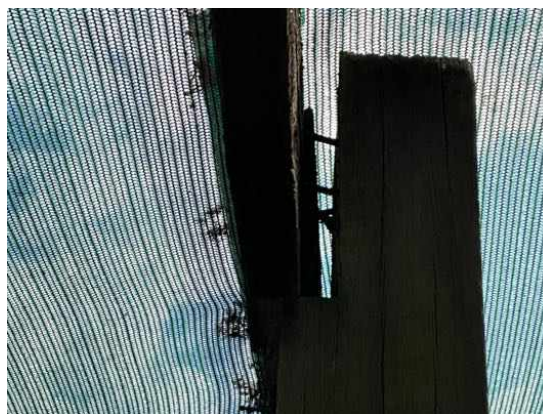
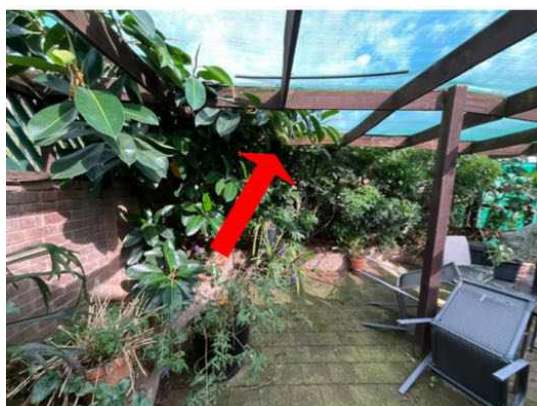
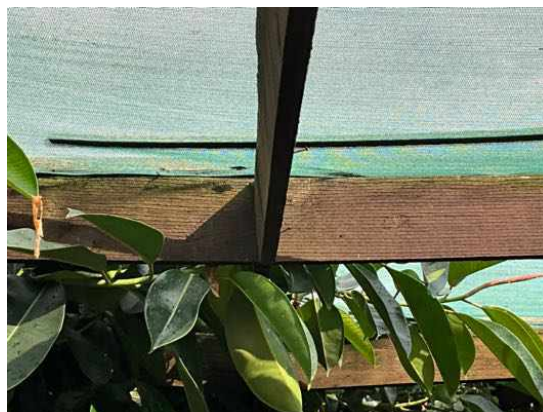
Finding 3.06

Building: Building 1
 Location: Alfresco
 Finding: Structure - Old, sagging
 Information: This structure, whilst appearing to provide adequate structural support, does not comply with contemporary building practices and current Australian Standards.

Although this is not a requirement in older homes, the client should be aware of the age of the structure when planning any repairs or remodelling.

It is a garden feature, rather than part of the main building. A builder or carpenter should be contacted, at client discretion, to make any needed improvements.

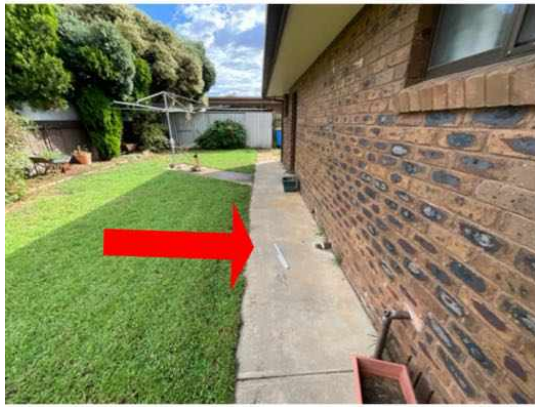
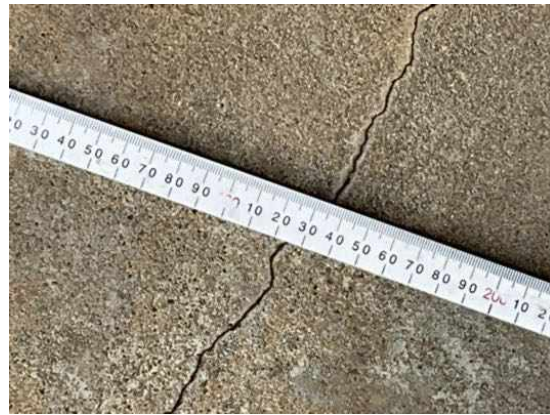
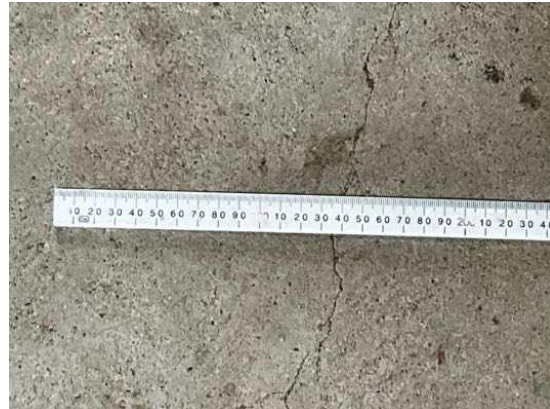
Finding 3.07

Building:	Building 1
Location:	Yard - Back, garage
Finding:	Cracking - External Concrete Paving Damage Category 1 - Fine (less than 2mm)
Information:	Fine cracks were identified in external concrete paving. Although fine cracks are quite noticeable, they are often only considered to be an appearance defect, and usually do not indicate any structural damage. To be considered a Category 1 or fine crack, the crack is found to be less than 2mm in width.

Generally the cause of a hairline crack in existing concrete paving such as driveways and pathways is indicative of the expansion and contraction of the concrete. Such causes are generally due to environmental factors, such as moisture levels, weather conditions, root systems of nearby trees or the soil types on which they are laid.

Fine cracks may also be due to poor original installation of the concrete. Factors such as poor compaction of the sub surface and/or inadequate reinforcing of the slab may create cracking and other secondary defects.

Monitoring of all cracking should be conducted frequently. Always contact a building inspector should cracks widen, lengthen, or become more numerous.

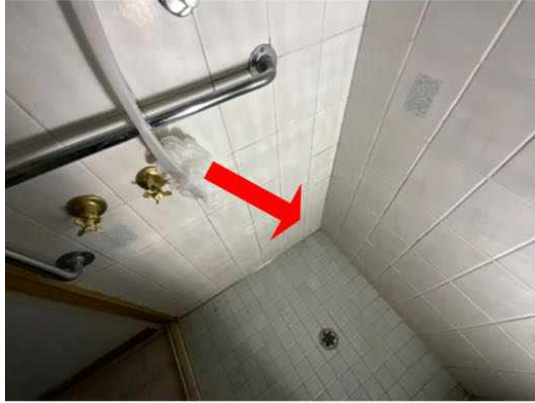
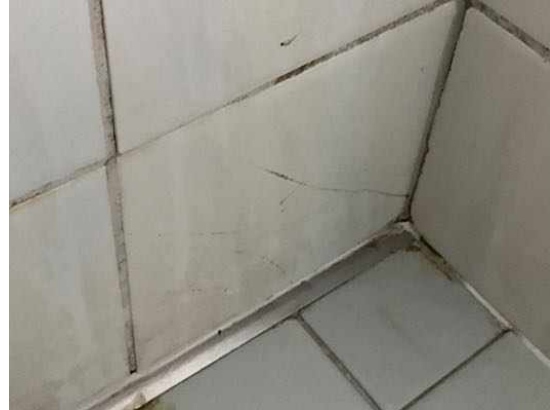
Finding 6.01

Building: Building 1
 Location: Bathroom
 Finding: Wall Tiles- Cracked
 Information: Cracked tiles within the household detract from the overall appearance of the affected areas, as well as creating potential for water penetration to adjoining building elements. If left unmanaged, water damage may occur as a result of constant water penetration over a prolonged period of time.

While not considered a matter of urgency, replacement of tiles is advised as a solution. A Tiling Contractor may be appointed to perform these works at client discretion.

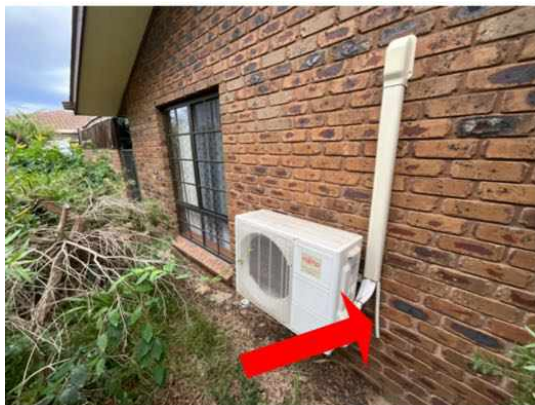
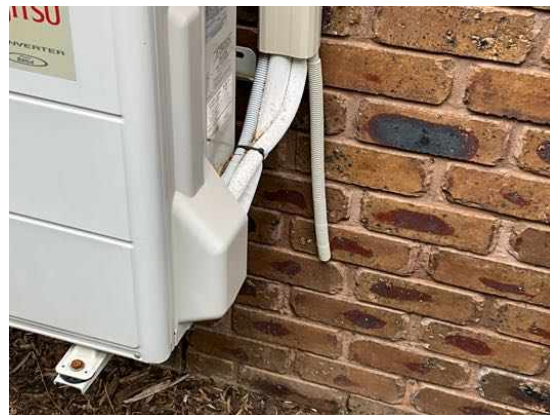
Finding 6.02

Building:	Building 1
Location:	Yard - Front
Finding:	Air conditioner - Disconnected overflow
Information:	The Air Conditioner (A/C) overflow was found to be disconnected from storm water drainage and is creating excessive moisture in the surrounding area.

Such leaking creates an environment which is conducive to an array of defects, including water damage to associated building elements and the attraction of termite or timber pest infestation.

It is highly recommended that a licensed plumber be appointed to connect the A/C overflow in order to prevent such an environment from being created. These minor works should be carried out as soon as possible.

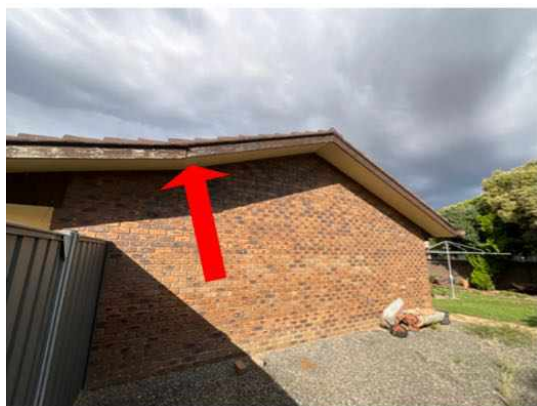
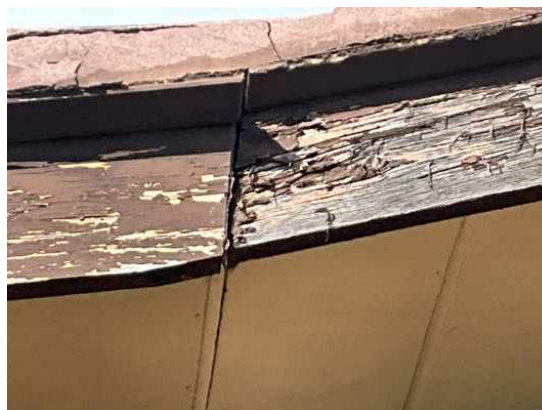
Finding 6.03

Building:	Building 1
Location:	External timber
Finding:	Timber - exposed to weather
Information:	External timbers that are frequently exposed to harsh weather conditions require

adequate protection in order to maintain their condition. Where timbers have not been painted or treated adequately, general deterioration is likely to occur at an accelerated rate.

If left unattended, replacement of these timbers is likely to be necessary in the short-term future. Adequate treatment of these timbers is required as soon as possible by a painting contractor or general handyman.

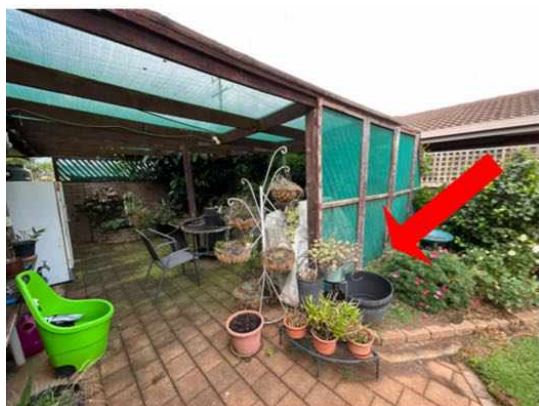
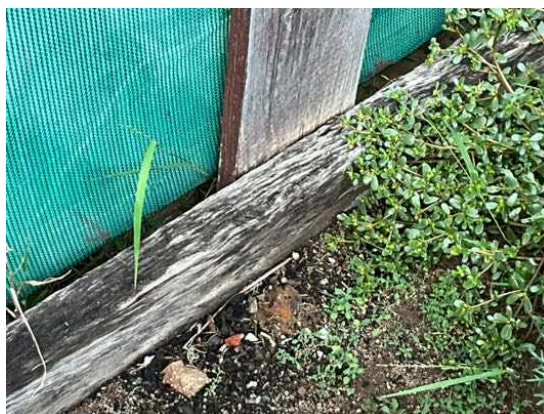
Finding 6.04

Building:	Building 1
Location:	Alfresco
Finding:	Untreated or non-durable timbers in a hazardous environment
Information:	To reduce the risk of timber pest attack it is essential that timber used in a hazardous environment (e.g. in direct contact with the ground or frequently exposed to damp conditions) is of sufficient durability and/or is adequately preservative treated.

Untreated timbers in direct contact with the ground are likely to develop severe wood rot and/or fungal decay if left unattended creating attraction for subterranean termites to infest the timbers from surrounding areas.

If untreated or non-durable timbers are found to be in a hazardous environment it is highly advised that replacement of these building elements be performed as soon as possible to aid the protection of the property against termite / timber pest attack.

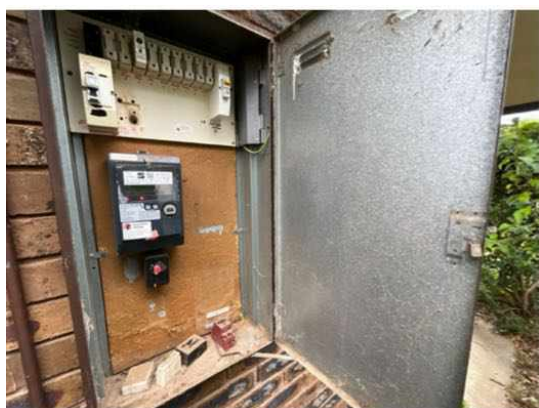
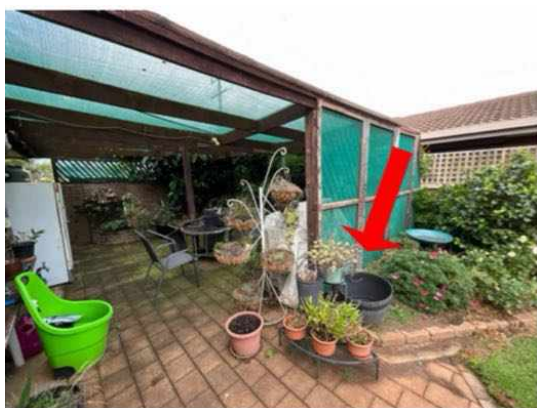
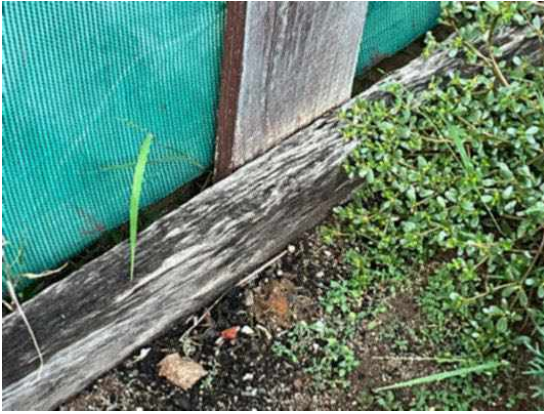
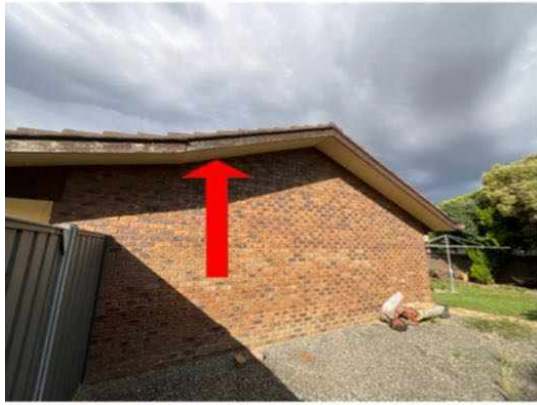
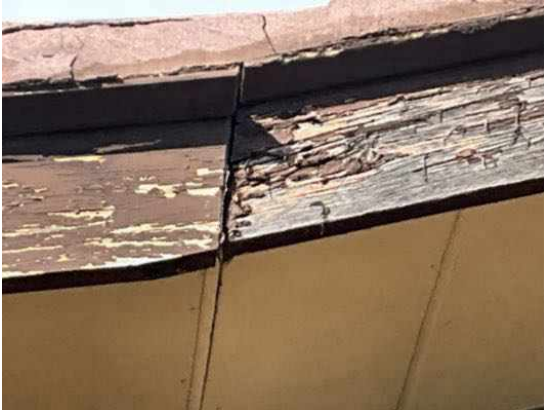
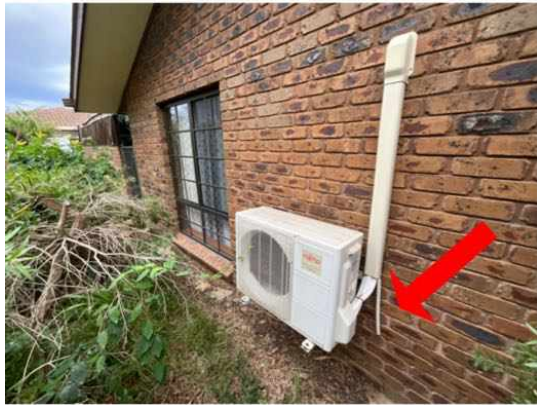
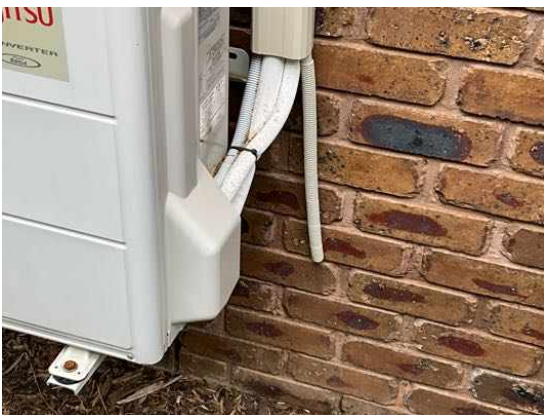
Finding 6.05

Building:	Building 1
Location:	All External Areas
Finding:	Termite Management System - no evidence of a chemical installation
Information:	The application of a post-construction chemical termite barrier is highly recommended for all properties, particularly if live termite activity has been found on the site previously. Such barriers are highly effective in preventing termite attack on any timber building elements throughout the property.

A durable notice should be placed in the switchboard unit to indicate current termite barriers. At the time of inspection, it appeared as though no termite management system has been installed, with no evidence to suggest preventative works taking place.

The client may consider gaining further advice from a pest controller as to the costs and procedures involved with this application. It is recommended that obtaining such advice be a short-term priority.

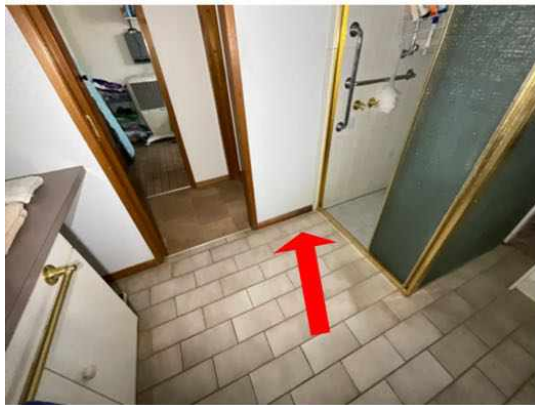
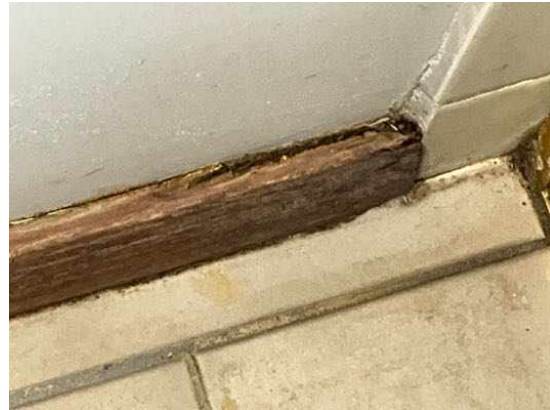
Finding 7.01

Building:	Building 1
Location:	Bathroom
Finding:	Fungal decay - present (localised)
Information:	Fungal decay also known as wood decay or wood rot generally refers to the deterioration of timber elements when in contact with excessive levels of moisture for a prolonged period of time.

The development of fungal decay is accelerated by temperatures in the range of 5degreeC to 40degreeC as well as the presence of oxygen. Generally fungal decay develops on timber elements that are in use in an external environment which are exposed to rain penetration.

In this case although the affected timber element is in a decaying state the extent of any visible damage appears to be localised to a specific area and is yet to spread to other parts of the building element or affect adjoining structures. The fungal decay is therefore likely to be of a relatively superficial nature with minimal impact on the structural integrity or tensile strength of the timber element.

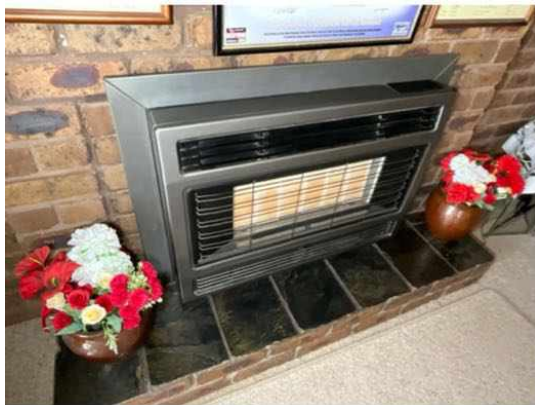
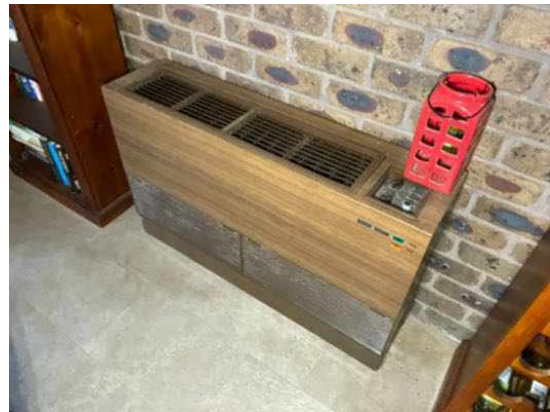
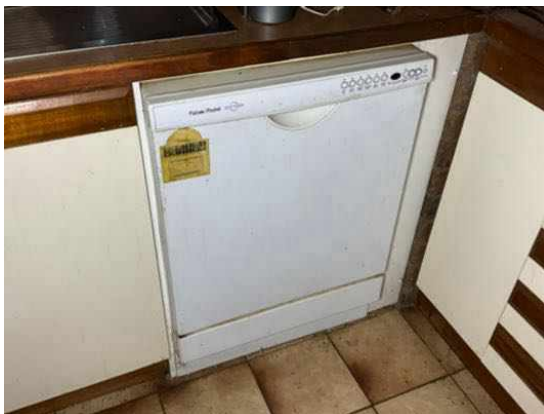
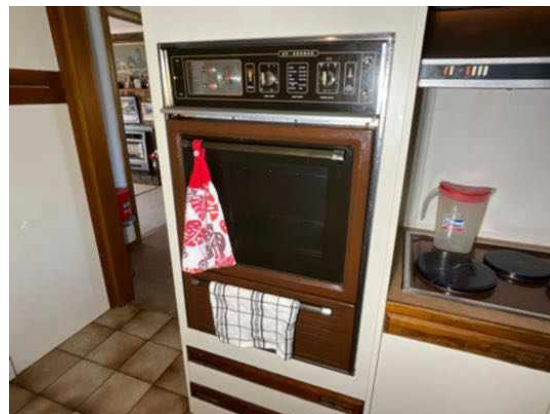
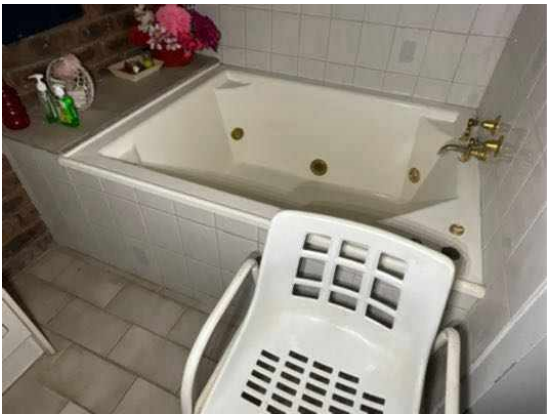
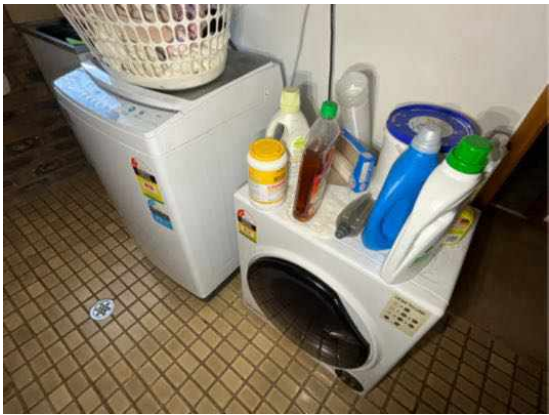
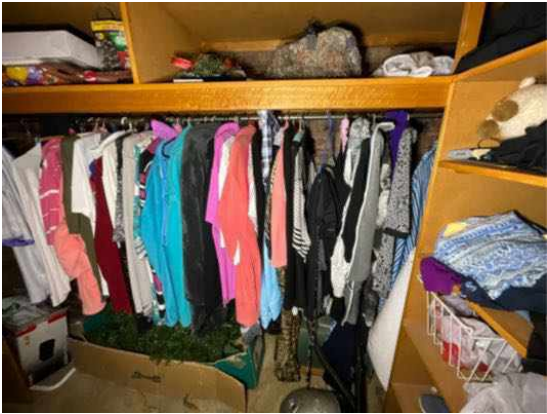
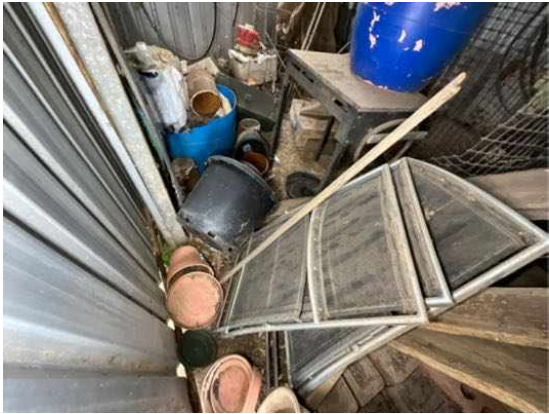
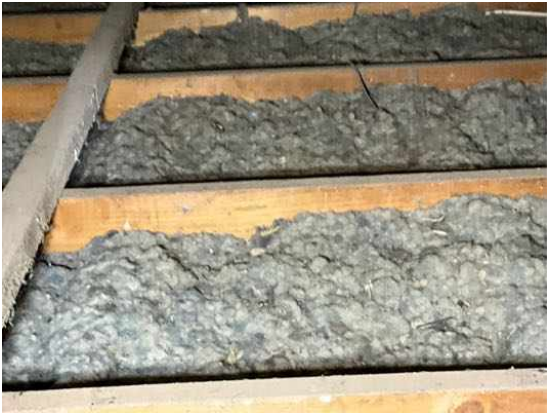
Noted Item

Building: Building 1
Location: All Areas
Finding: Additional Photos - Obstructions and Limitations
Information: These photographs are an indication of the obstructions and limitations which impeded full inspection of the property at the time of inspection. These obstructions can hide an array of defects and should be removed to allow full inspection to be carried out. A re-inspection is recommended once the areas are made accessible.
