Building and Timber Pest Inspection Report

Inspection Date: Wed, 11 Feb 2026

Property Address: 9/133 Bringelly Road, Kingswood NSW
2747

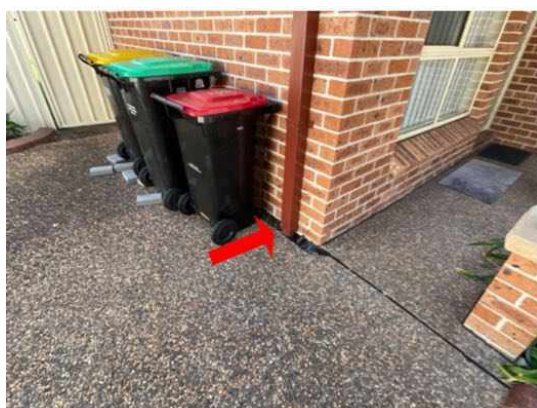
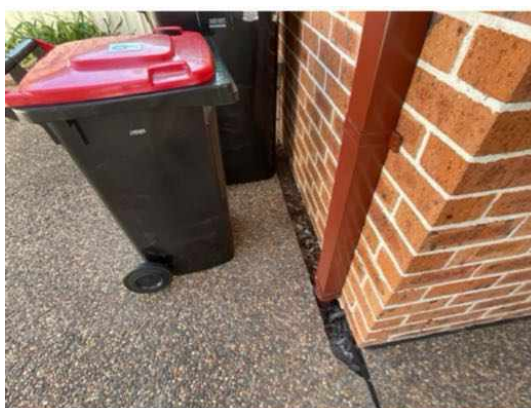
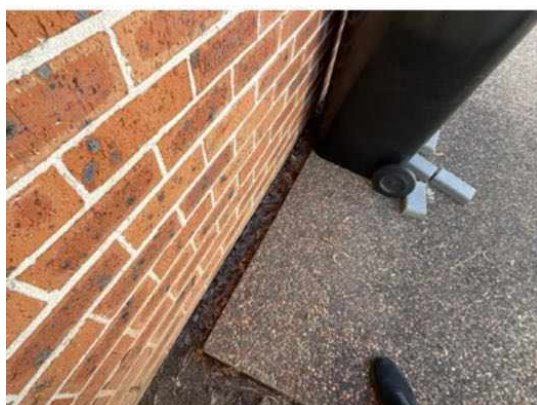
Building:	Main Building
Location:	Exterior walls - left side
Finding:	Site/Yard drainage - Inadequate.
Information:	Observation – Site Drainage

Poor surface drainage can lead to moisture ingress and deterioration of materials at the base of walls, slab edge dampness, or foundation movement. Prolonged exposure to standing water may cause rising damp, efflorescence, or corrosion of embedded steel components. These conditions can lead to secondary structural or moisture-related defects if not draining effectively.

- Provide a minimum 50 mm clearance between finished ground level and the bottom of cladding or wall weep holes (minimum 75 mm where paved and 100 mm where unpaved).
- Be graded to achieve a minimum fall of 1:20 (50 mm over 1 m) away from the building for at least 1 m.

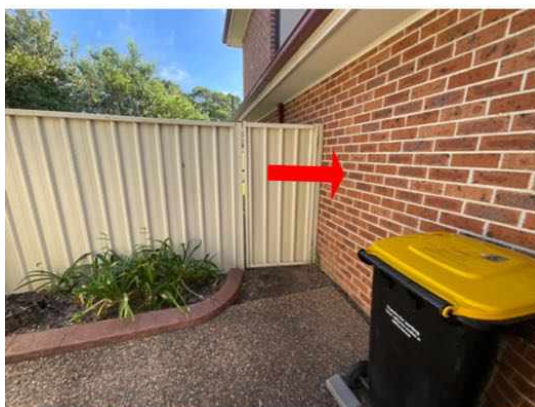
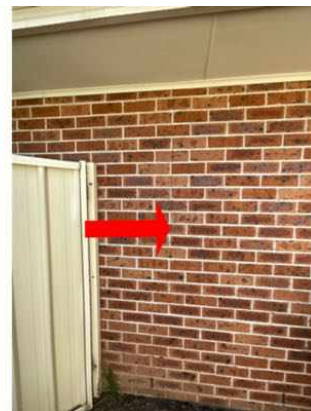
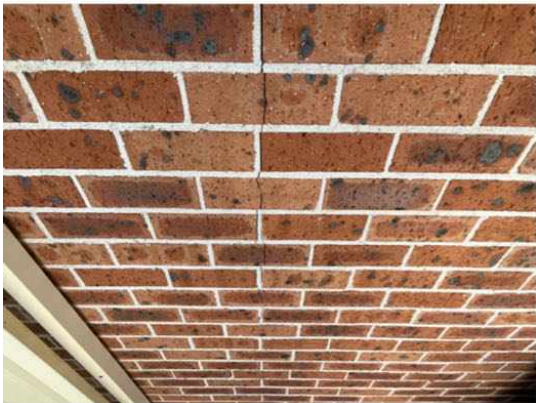
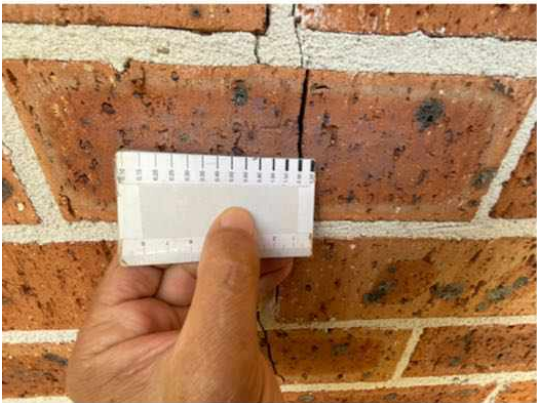
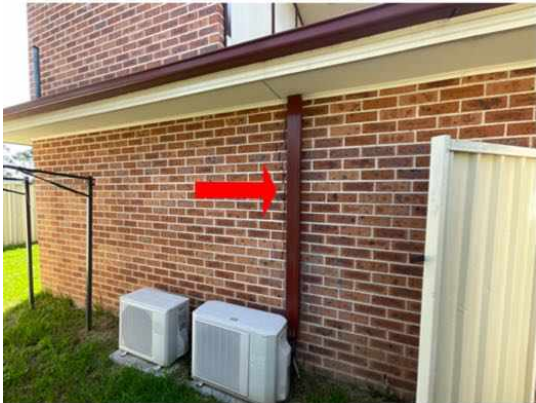
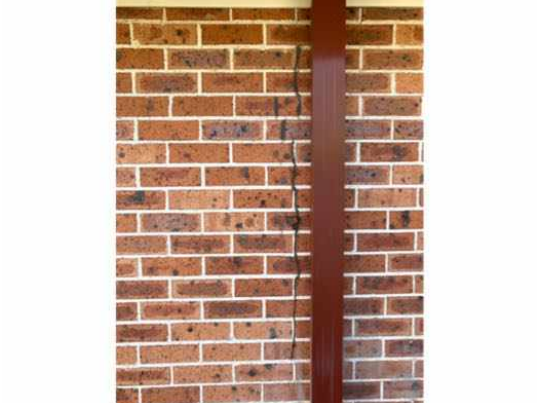
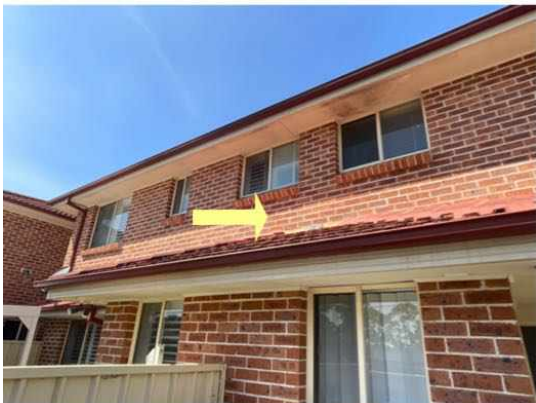
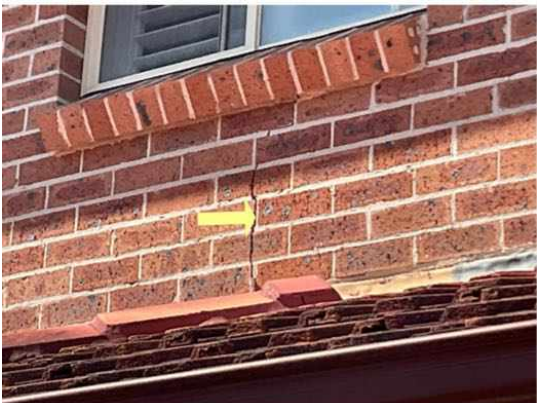
Finding 3.02

Building:	Main Building
Location:	Exterior walls - left side
Finding:	Brickwork - Cracking Moderate. (Vertical)
Information:	Observation:

Cracking was noted in the external brickwork and appeared to be moderate at the time of inspection.

Vertical cracking may indicate thermal movement, while other patterns could suggest more localised stress within the wall.

- Cracks of this nature may progress or widen if underlying movement continues
- There is potential for remedial works or brickwork replacement in the future
- Moisture ingress may also occur through open cracks, leading to deterioration of internal elements if not addressed

- Although cracking appears moderate and non-structural at this stage, it is recommended that the area be monitored
- For a more detailed assessment, consultation with a qualified Structural Engineer is advised to determine if movement is ongoing and whether any remedial action is necessary

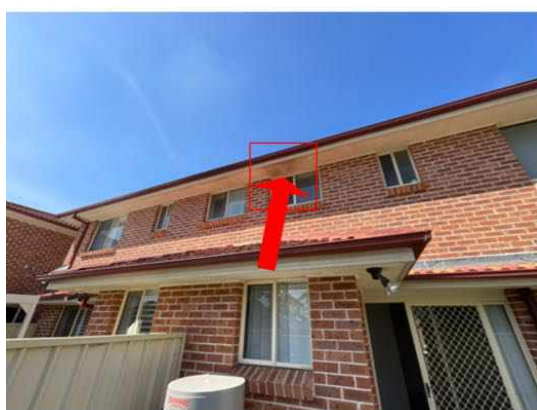
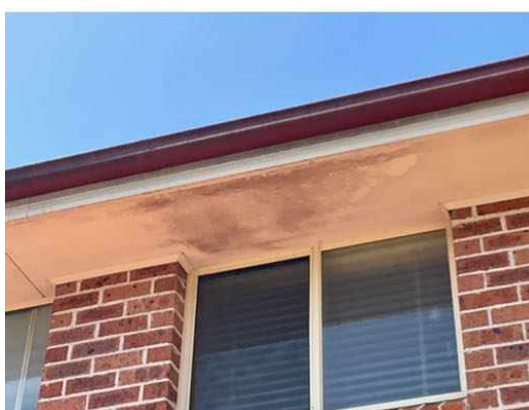
Finding 3.03

Building: Main Building
 Location: Exterior walls - left side
 Finding: Eaves - Mould present.
 Information: Defect Type: Mould growth and staining
 Severity: Minor
 Condition: Unsightly, potential moisture ingress
 Observation:

Mould growth and associated staining were observed on the eave linings in this area. This is typically caused by elevated moisture levels, which may result from a roof or gutter leak, or in some cases, excessive condensation within the roof space.

The source of moisture should be identified and rectified as necessary to prevent further mould development and potential damage. This may involve inspection of the roof covering, flashings, or guttering in the affected area.

Cleaning and/or repainting the eaves to restore appearance is at the client's discretion. A licensed painting contractor may be appointed to carry out such cosmetic works once the underlying cause has been addressed.

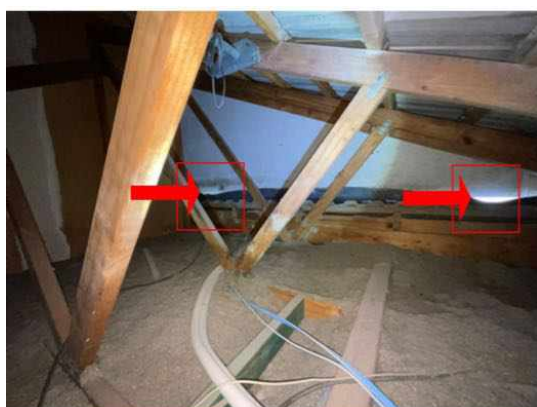
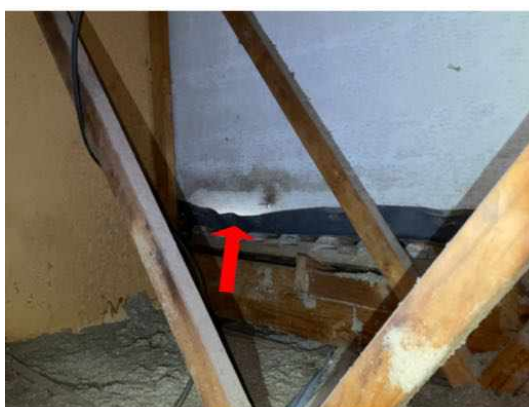
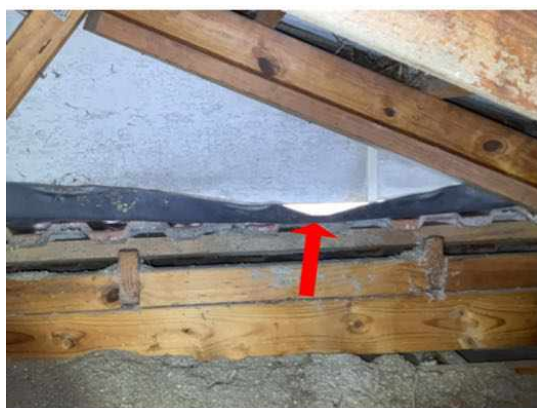
Finding 3.04

Building:	Main Building
Location:	Roof Exterior
Finding:	Roof flashing - Deteriorated (roof void).
Information:	Observation:

The roof flashings associated with the Dutch gable were observed to be deteriorated and in poor condition at the time of inspection. This condition was noted from within the roof space, where corrosion, ageing, and general degradation of the flashing materials were evident. Roof flashings are critical components of the roof system and are typically constructed from lead, metal, or other waterproof materials. They are installed at junctions where the roof covering meets adjoining elements, such as walls or gable ends, to form a weatherproof seal and prevent water ingress.

Where roof flashings have deteriorated, failed, or become damaged, their ability to provide effective weatherproofing is significantly reduced. This increases the risk of water penetration into the roof space and internal areas of the dwelling, particularly during periods of heavy rainfall or wind-driven rain. Ongoing moisture ingress can

contribute to premature deterioration of roof framing and other building materials, and may lead to secondary defects such as internal water staining, mould growth, decay of timber elements, and potential structural issues if left unaddressed.

It is recommended that a licensed roofing plumber or suitably qualified roofing contractor be engaged as soon as practicable to carry out a detailed assessment of the Dutch gable flashings. Any deteriorated or defective flashing materials should be repaired or replaced as necessary to restore effective weatherproofing. Prompt remedial action is advised to minimise the risk of ongoing water ingress and to prevent the development of further internal damage or consequential defects.

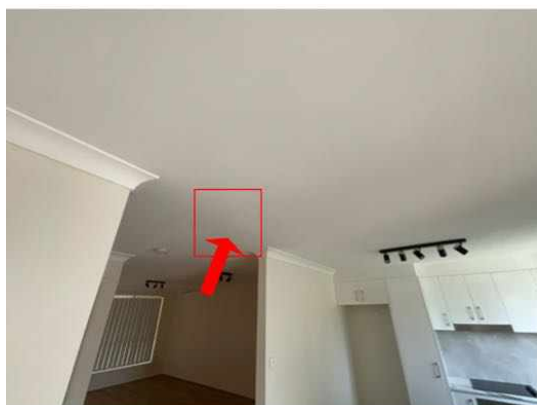
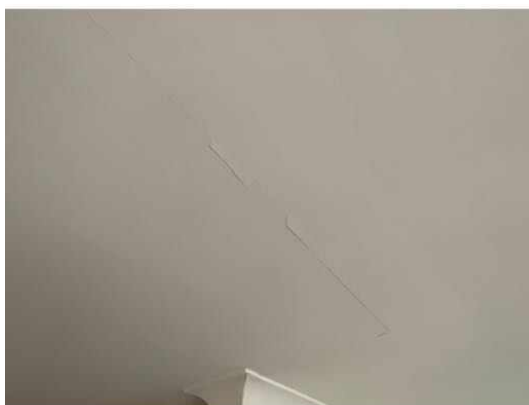
Finding 3.05

Building: Main Building
 Location: Dining Room
 Finding: Ceiling Cracking – Non-Structural Movement.
 Information: Observation:

- Cracking was noted in the ceiling at this location(s). This is a common occurrence in buildings of similar age and construction, typically caused by:
- Minor separation of building materials due to seasonal moisture fluctuations

- The observed cracking appears to be fine and cosmetic in nature at the time of inspection.
- These cracks are typically considered appearance defects and are not believed to impact the structural integrity of the building.
- However, should further evidence arise during a more detailed or invasive inspection, it may suggest underlying structural issues that require further assessment.

- Cracks of this nature can generally be repaired with standard cosmetic maintenance, including:
 - Filling, sanding, and repainting of affected areas
 - Installing a ceiling expansion joint to accommodate future movement and reduce the likelihood of recurrence
 - These works may be carried out at the client's discretion by a qualified plasterer, painter, or handyman.

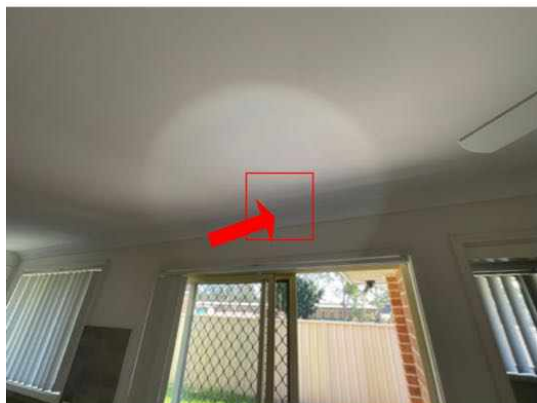
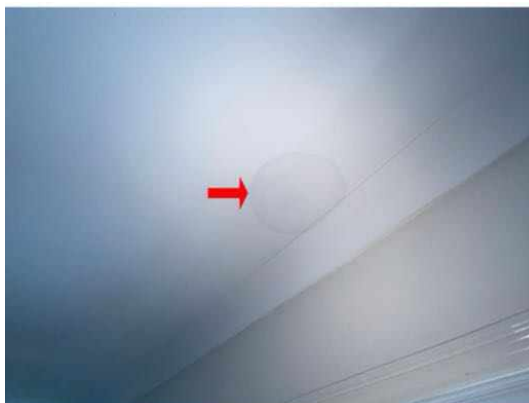
Finding 3.06

Building:	Main Building
Location:	Dining Room
Finding:	Ceiling - Water stained.
Information:	Observation:

Water staining was noted to ceiling linings in the inspected area(s) at the time of the

inspection. These stains present as discoloured or patchy areas and may suggest a history of moisture ingress, most commonly associated with roof leaks or plumbing issues.

Water staining is typically the result of prolonged exposure to moisture, which allows minerals and other contaminants carried by the water to accumulate on surfaces, leaving visible marks. If ongoing or left untreated, moisture ingress can lead to more serious issues such as:

Where the staining is still active (i.e., the leak continues during rainfall), this may indicate a current and unresolved roofing issue. In such cases, prompt attention is required to prevent further internal damage.

- Where the staining is active or suspected to be active during wet weather, a qualified roofing specialist should be engaged to conduct a more detailed inspection. Their investigation should focus on identifying the exact source of moisture ingress and advising on necessary repairs to the roof coverings, flashings, penetrations, or associated components.
- Where the staining appears to be historical (i.e., dry and showing no recent progression), reparation of affected ceiling materials (such as repainting or patching) may be carried out at the client's discretion, subject to confirmation that the source of the leak has been effectively addressed.

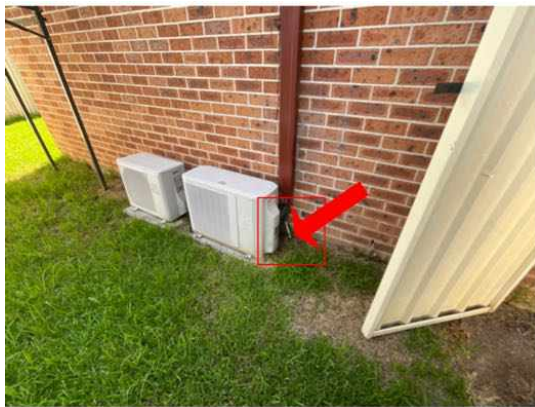
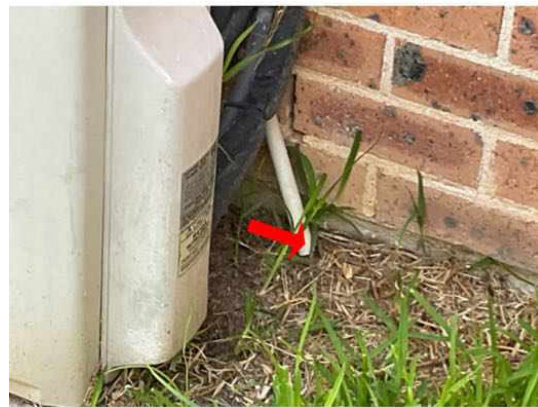
Building:	Main Building
Location:	All External Areas
Finding:	Overflow Management – Risk of Termite Activity..
Information:	Observation: Water Pooling from HWS and Air Conditioning Overflows

Water discharge from the Hot Water System (HWS) pressure relief valve and air conditioning unit overflows was observed discharging close to the base of the structure, contributing to water pooling around the building perimeter.

Persistent moisture near the foundation or subfloor area significantly increases the likelihood of termite activity. Termites are highly attracted to damp environments, and stagnant water near structural elements provides ideal conditions for foraging and infestation.

It is highly recommended that all overflows from the HWS and air conditioning units be redirected away from the building, preferably via fixed drainage or extension piping, to prevent water accumulation near the structure.

These minor corrective works should be undertaken promptly to minimise the risk of both termite ingress and potential structural damage due to ongoing moisture exposure.

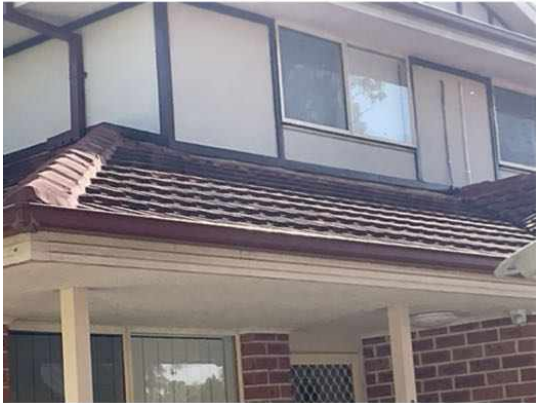
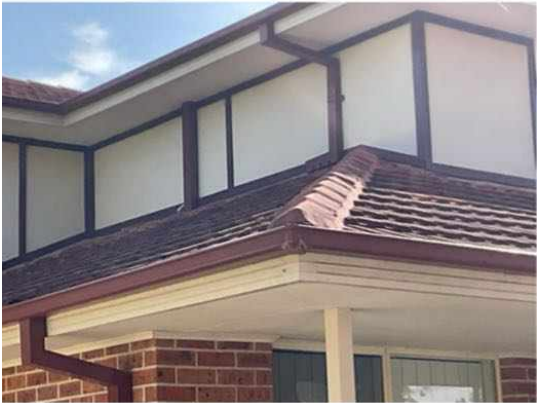
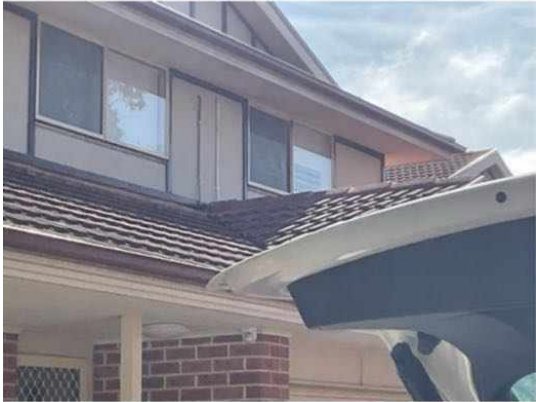
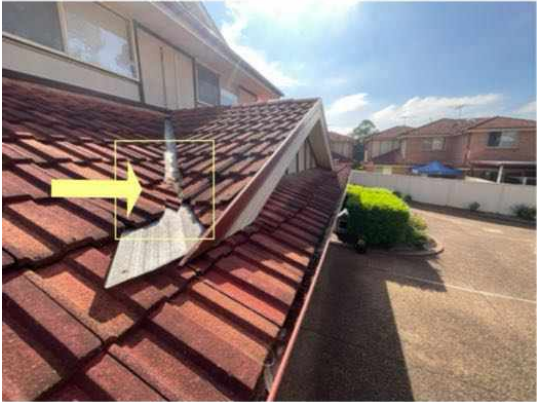
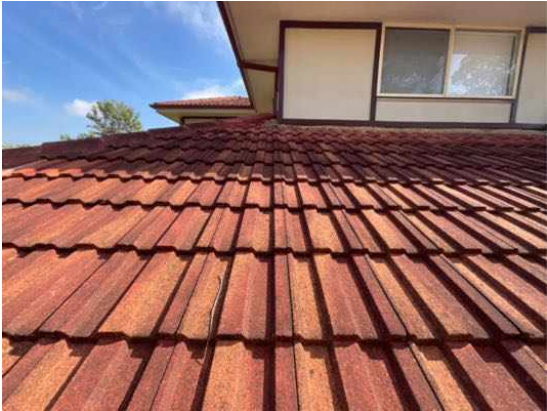
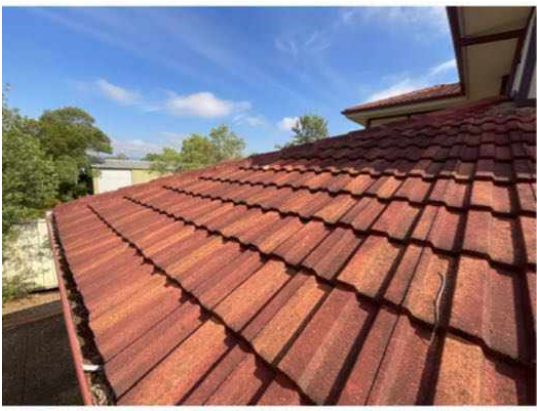
Building: Main Building
 Location: Roof Exterior
 Finding: Roof Inspection Summary

Loose flashing was observed from within the roof void.

The concrete tiled roof was observed to be in generally sound condition at the time of inspection; however, minor leakage evidence and loose flashing were identified. Access was restricted due to height and safety considerations, and not all roof areas were physically inspected.

Regular maintenance, including inspection of ridge pointing, cleaning of gutters and valleys, and timely repair of loose flashing, is recommended to minimise the risk of future water ingress.

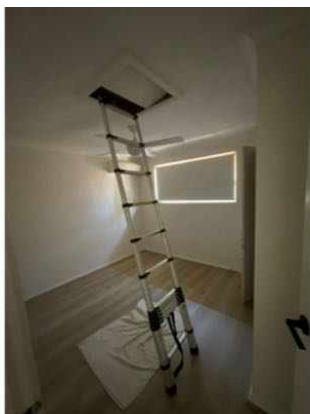
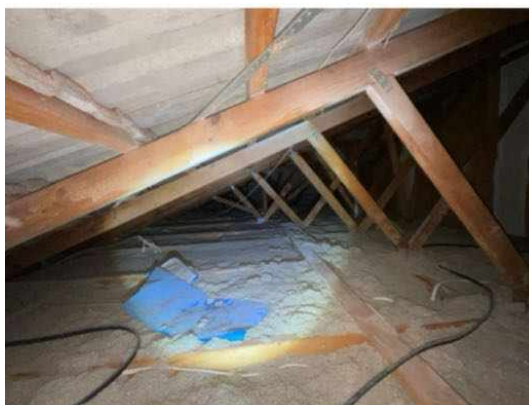
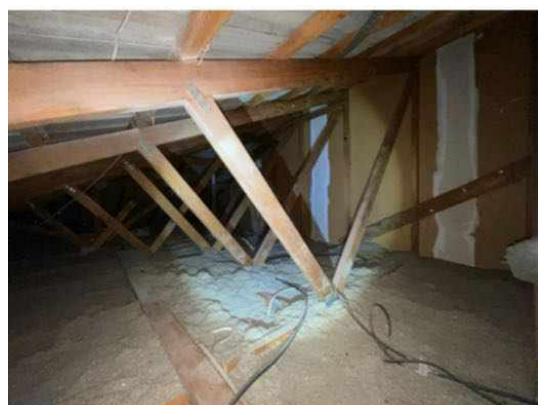
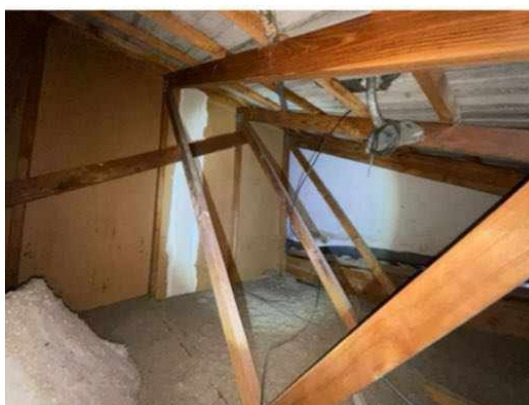
Building: Main Building
Location: Roof Void
Finding: Roof Void – Limited Accessibility..
Information: Observation:

Installation of an additional manhole is recommended to facilitate a re-inspection and enable a more thorough assessment of the roof void in the future. This will help ensure that all structural elements and concealed areas are properly evaluated.
