Building Inspection Report

Inspection Date: Thu, 12 Mar 2026

Property Address: 2/120 Passendale Road, Edmondson Park,
NSW 2174

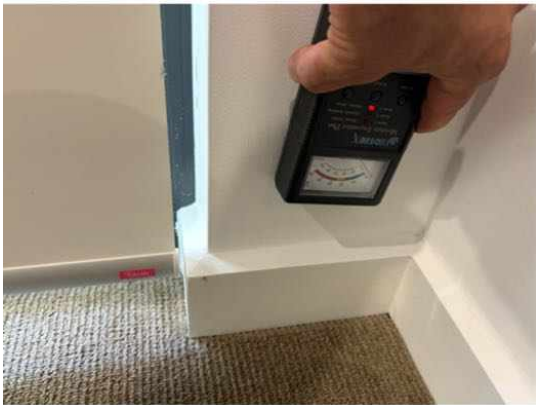
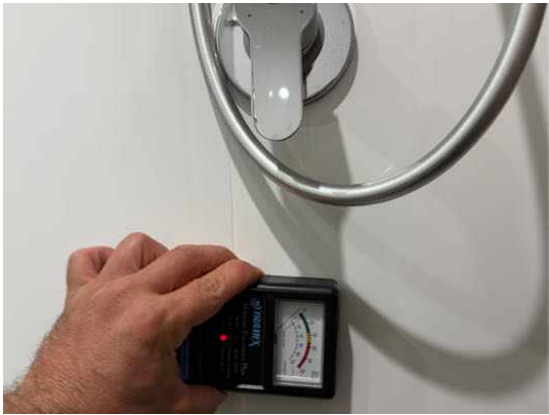
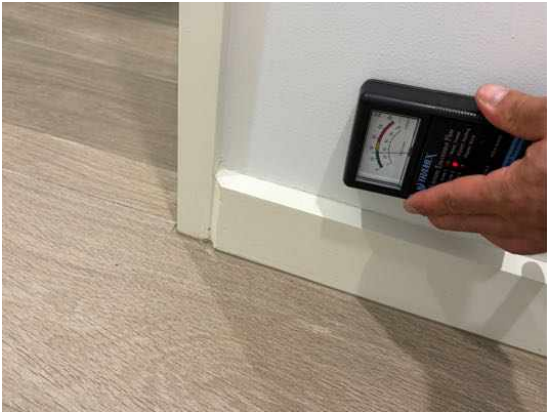
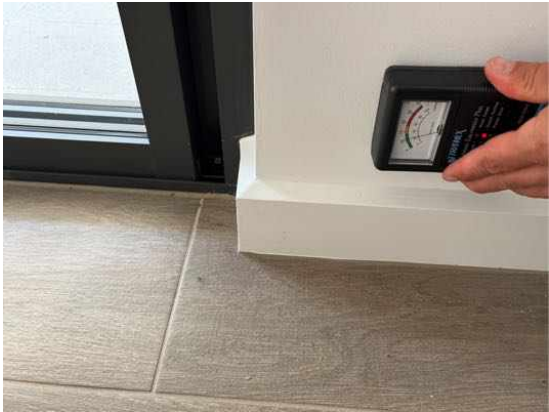
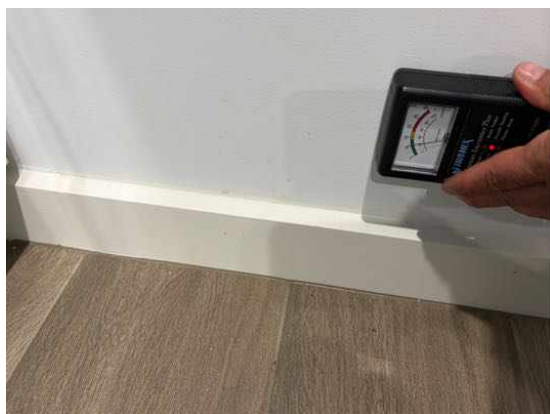
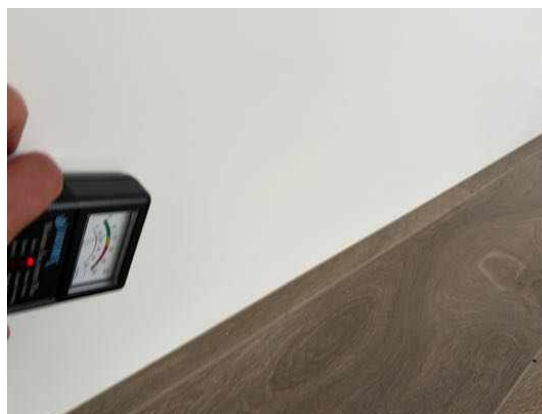
Building: Main Building
Location: All Areas
Finding: Moisture metre
Information: During the inspection the property was checked for moisture using a moisture metre.

This is for information only.

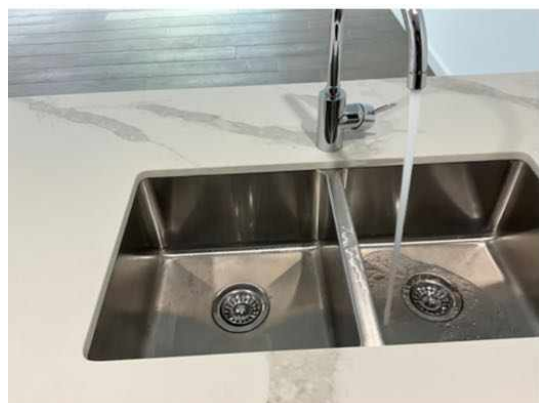
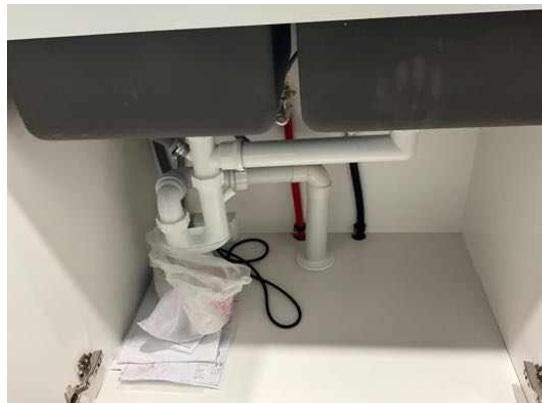
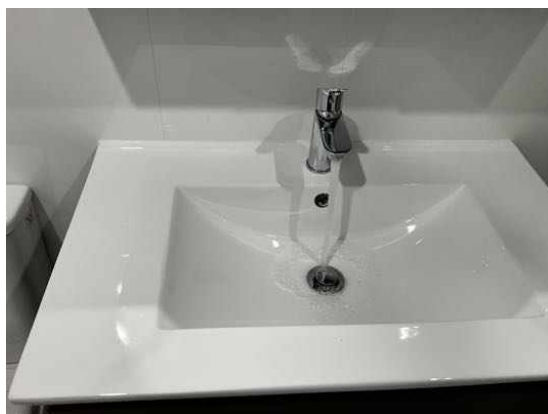
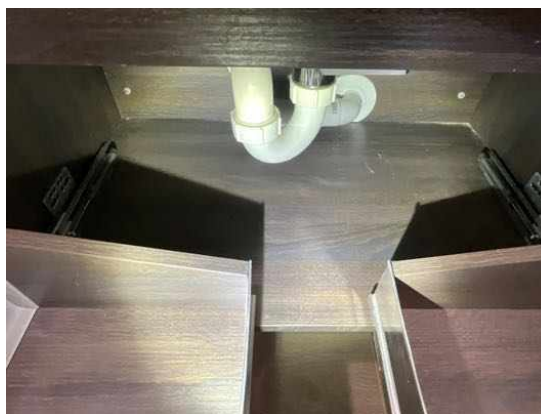
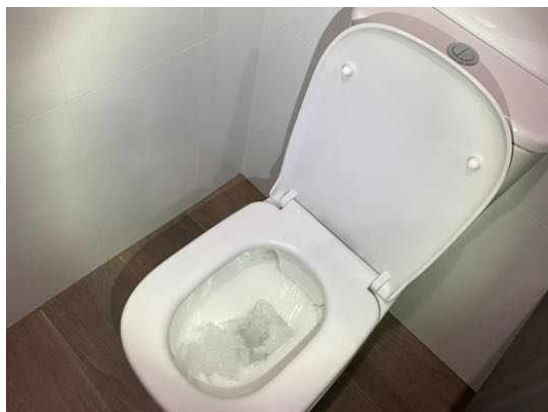
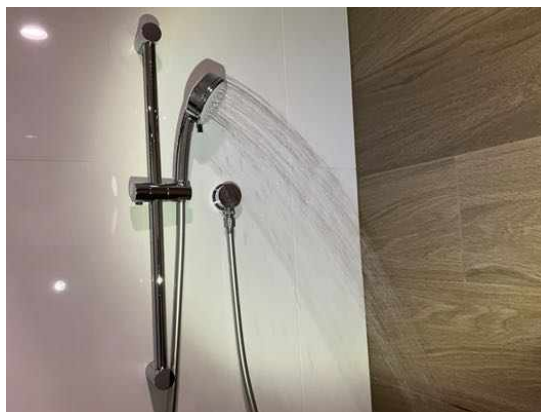
All taps, mixers and toilets were tested for operation, except for those obstructed. The waterproofing to the shower recess was assessed by checking the walls in and around the shower recess for varying moisture content. There were no significant variations across the tested areas. No sign of recent water damage was evident upon a visual inspection of the surrounding walls, where the visual nature of the inspection was possible.

Consequently, there is no conclusive evidence of any current shower recess leakage other than those which may have already been mentioned earlier in this report. It is reasonable to assume the shower waterproofing is sound. Note that if the shower is not used, or has not been used for some time, moisture readings would not vary significantly and this can lead to erroneous results. It is not possible under the visual inspection criteria (under which a prepurchase inspection is carried out) to categorically determine if there are leaks. If a more accurate assessment is required, a special purpose inspection should be requested. Alternatively, the assumption should be made that the shower may leak.

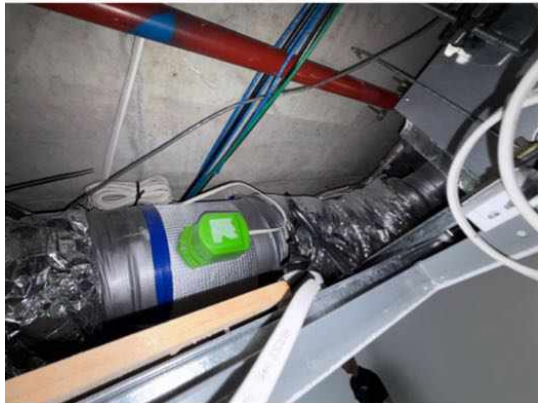
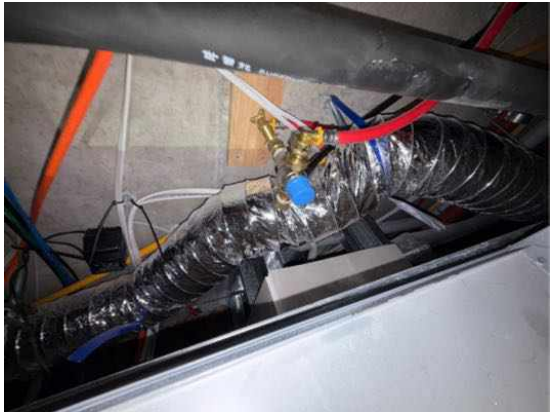
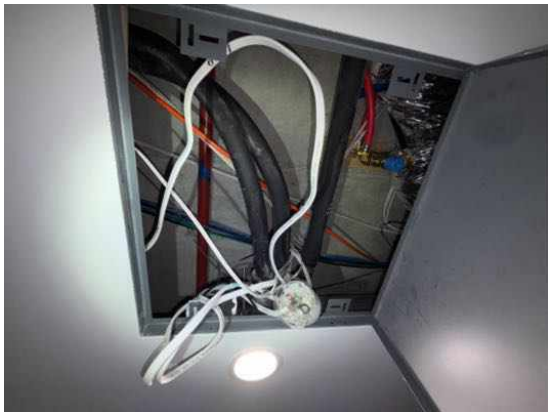
Building: Main Building
 Location: Ceiling cavity
 Finding: Additional Photos- ceiling cavity
 Information: Additional photos are provided for your general reference. Arrows may have been included to highlight areas of importance. Please discuss these photos with your building consultant for clarification.

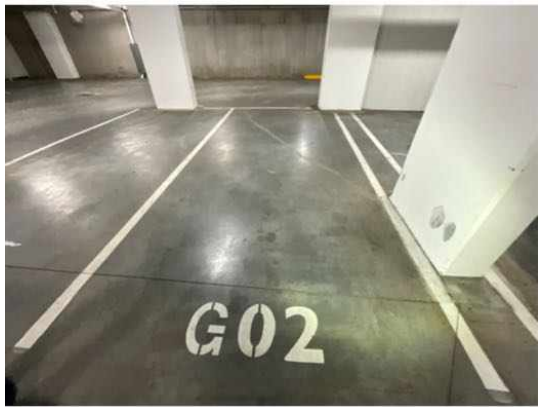
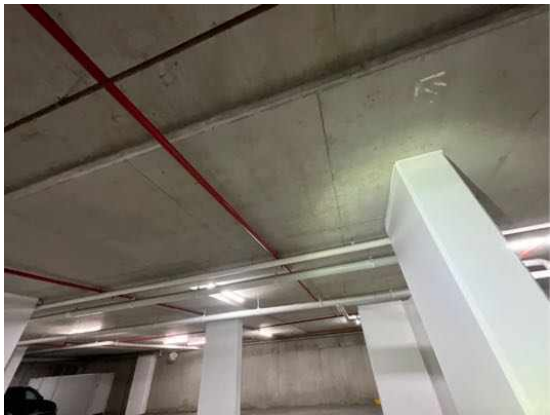
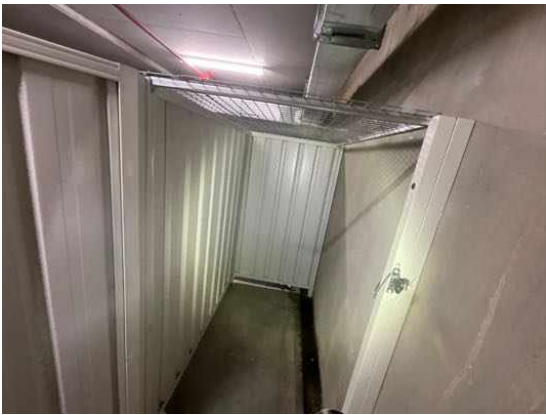
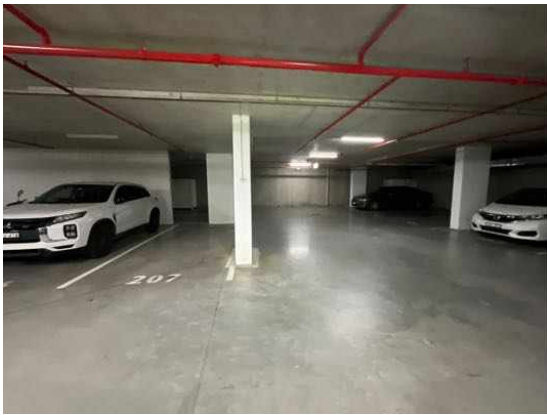
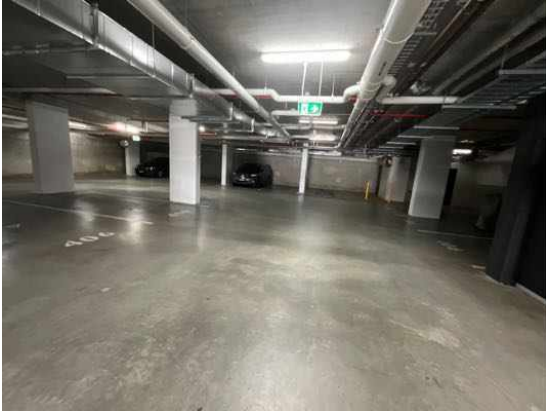
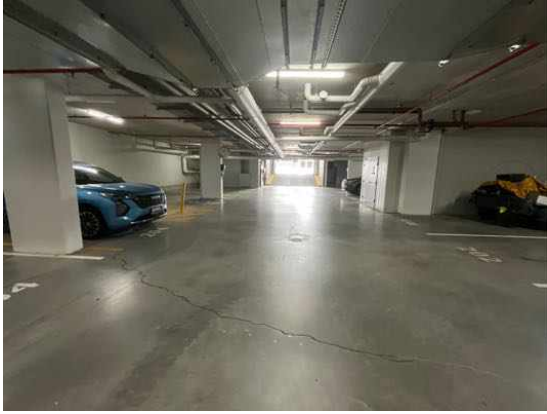
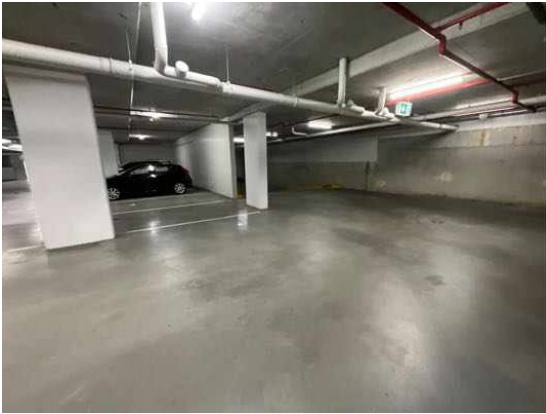
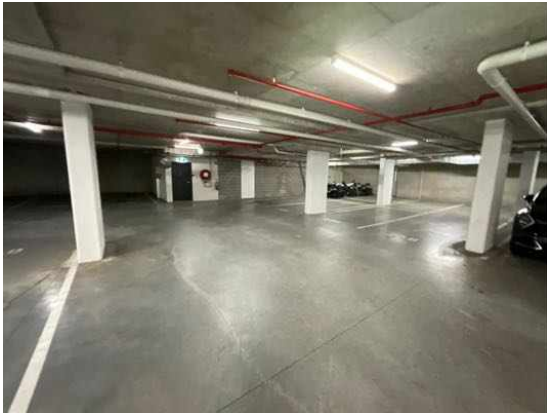
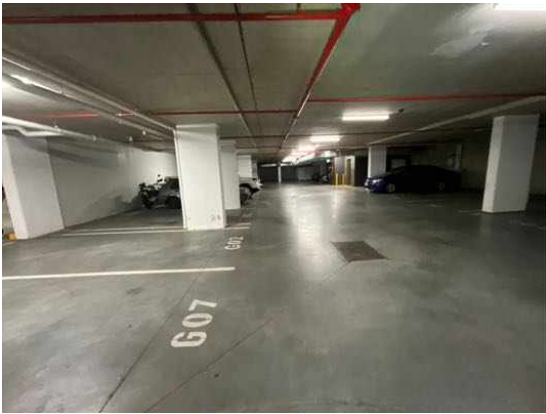
Building: Main Building
Location: Garage
Finding: Additional Photos- Garage
Information: Additional photos are provided for your general reference. Arrows may have been included to highlight areas of importance. Please discuss these photos with your building consultant for clarification.

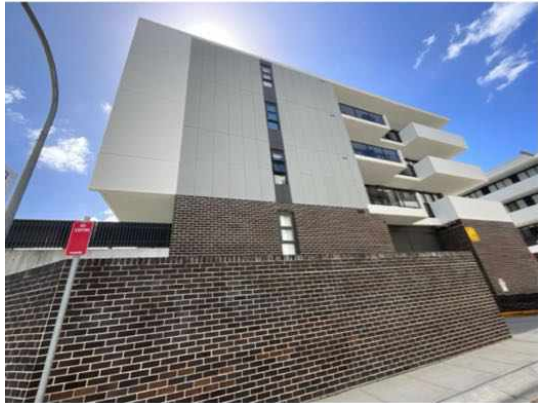
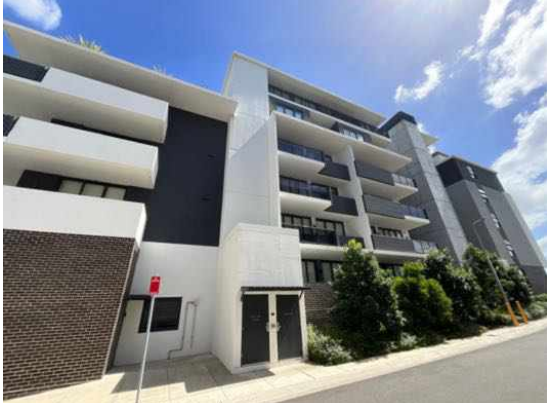
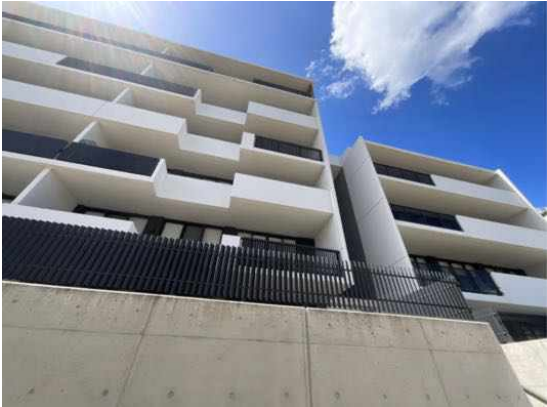
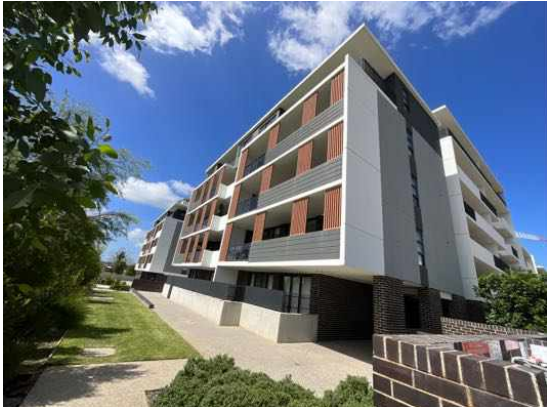
Building: Main Building
Location: Exterior
Finding: Additional Photos
Information:

Additional photos are provided for your general reference.

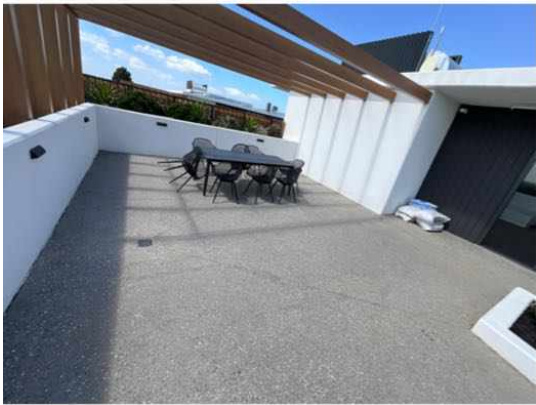
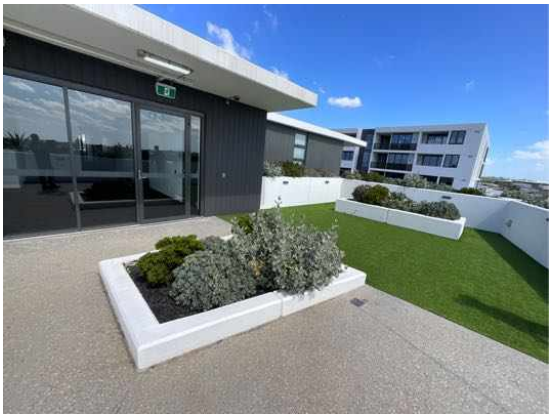
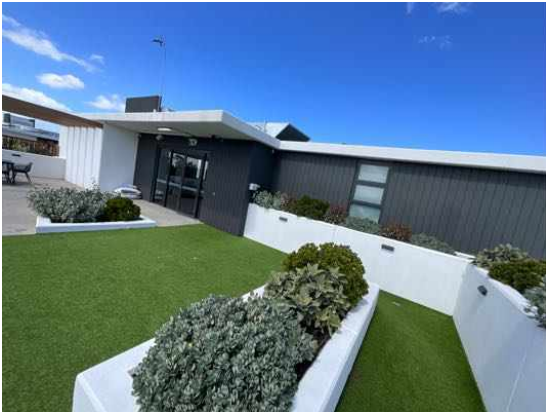
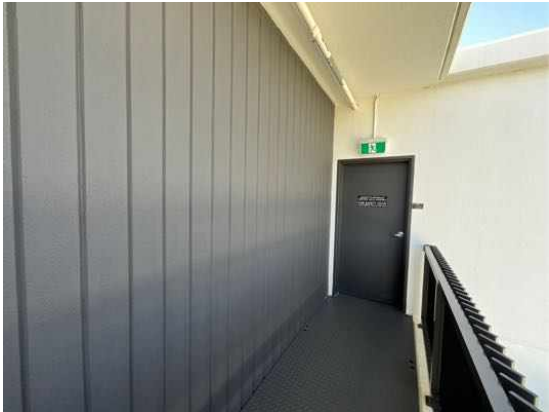
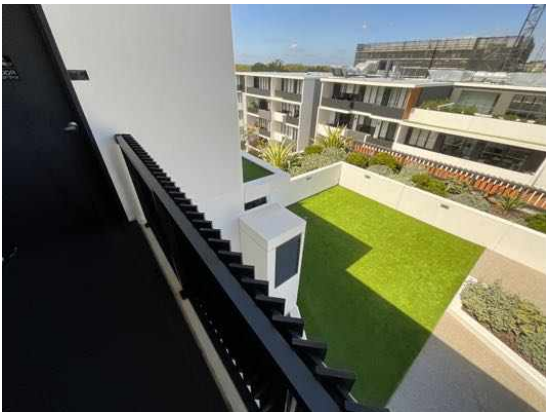
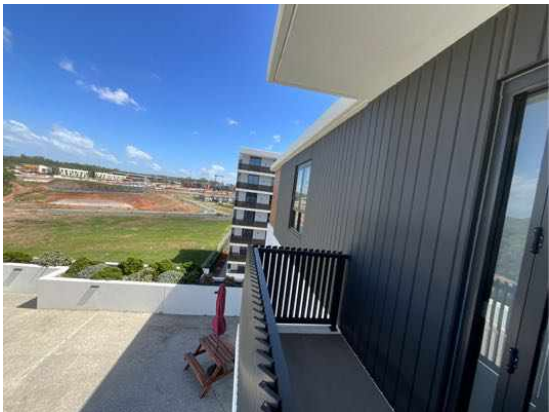
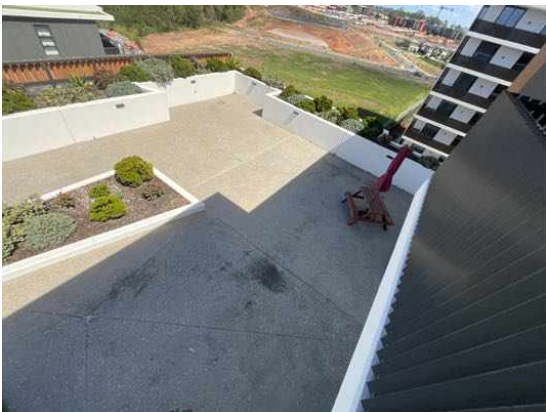
Building: Main Building
Location: Rooftop
Finding: Additional Photos
Information:

Additional photos are provided for your general reference.

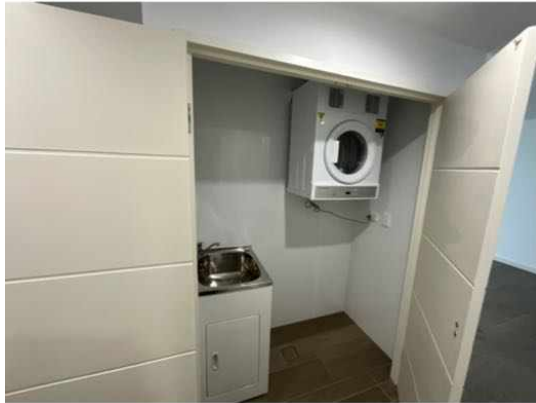
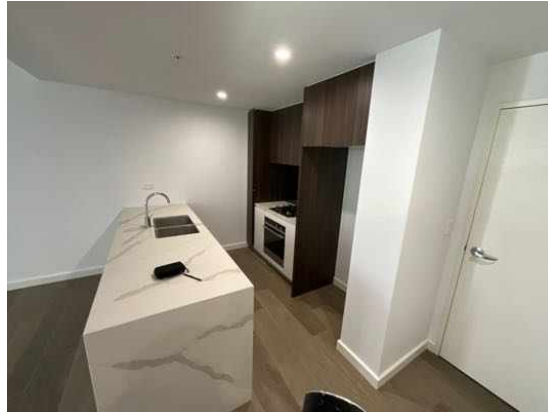
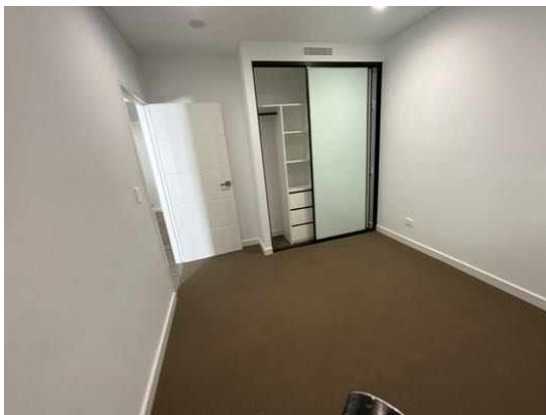
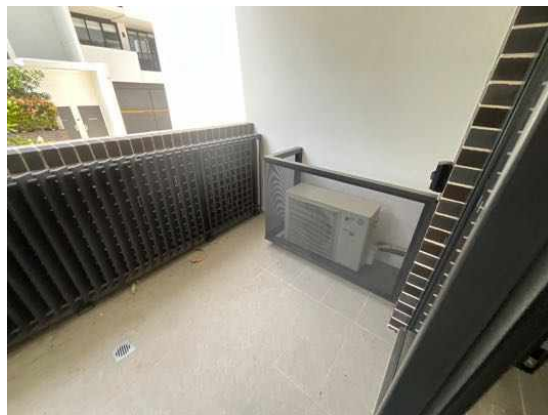
Building: Main Building
Location: All Areas
Finding: Additional Photos - Obstructions and Limitations
Information:

These photographs are an indication of the obstructions and limitations which impeded full inspection of the property at the time of inspection. These obstructions can hide an array of defects and should be removed to allow full inspection to be carried out. A re-inspection is recommended once the areas are made accessible.
