Building and Timber Pest Inspection Report

Inspection Date: Wed, 18 Mar 2026

Property Address: 14 Burge Pl, Warilla NSW 2528, Australia

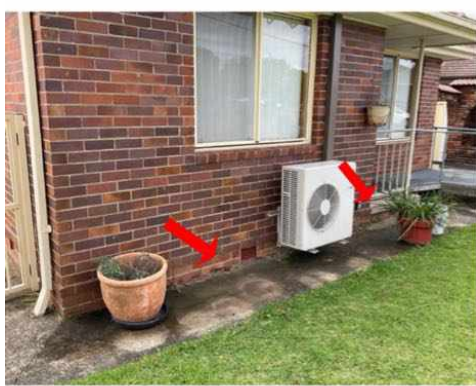
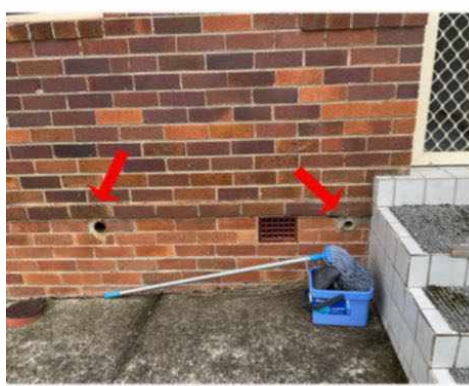
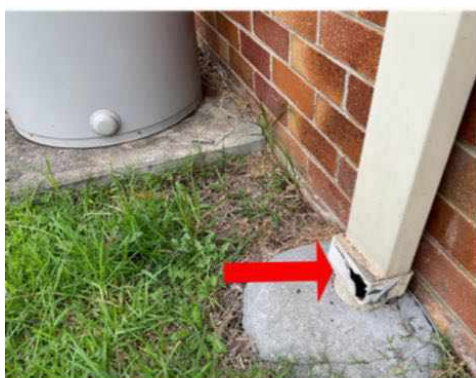
Building:	Building 1
Location:	External walls
Finding:	Site drainage - Inadequate
Information:	The site drainage in these areas was found to be inadequate at the time of inspection, creating potential for subsequent water damage to associated building elements.

No drainage was evident to the front wall. Water appears to be entering the front subfloor during high rain events. This can often damage subfloor walls and piers.

The hot water system, bathroom and laundry overflows also run against the house walls and the rear downpipe is damaged.

It is important that water does not lie against the base of walls; surrounding paths and ground levels should be sloped to drain water away from walls. Downpipes should not discharge stormwater onto lower walls or plinths. Stormwater should be carried away by large, regularly cleaned drains. Ground levels may need to be lowered to expose a buried DPC.

Where site drainage is inadequate, installation of an Agricultural (Aggie) Drain may be required. A qualified plumber should be appointed to further inspect the property and perform any remedial works as necessary. Secondary defects are likely to occur if left unmanaged.

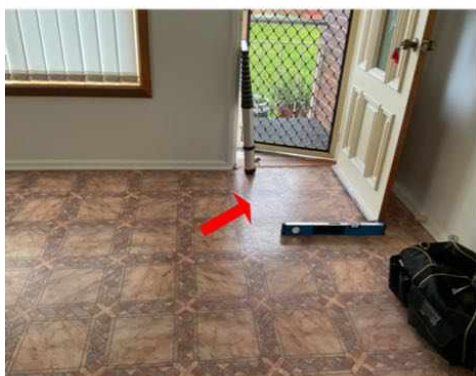
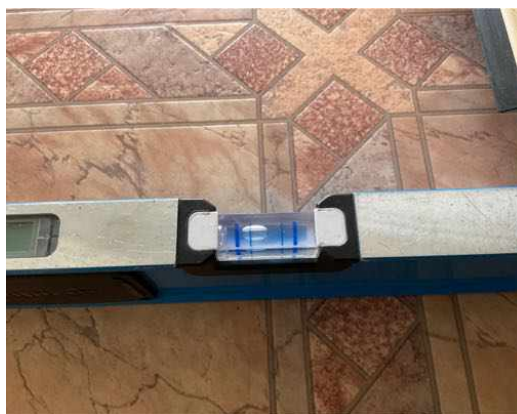
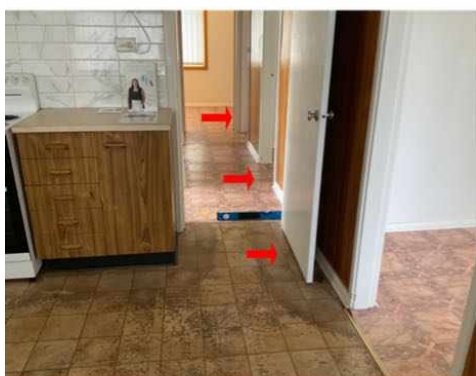
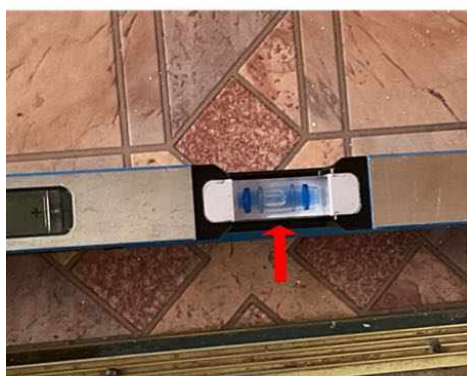
Finding 3.02

Building:	Building 1
Location:	Pictured areas
Finding:	Flooring - Uneven
Information:	The internal flooring in many areas is out of level and uneven. Uneven flooring is likely to indicate minor defects such as expected movement of the foundations of the property, but may also indicate subsidence of the associated subfloor stumps.

It is advised that the flooring be closely monitored to identify any further movement. Where flooring remains relatively unchanged for an extended period of time (i.e. several months), it is likely that this defect has been caused by expected movement of the foundations of the property.

However, where flooring is uneven further, potentially invasive inspection of the subfloor structures and stumps in this area is required. In this case, works to repair are likely to be required, and would be carried out by a registered builder specialising in re-stumping. Installing front drainage will also assist in stopping subfloor movement.

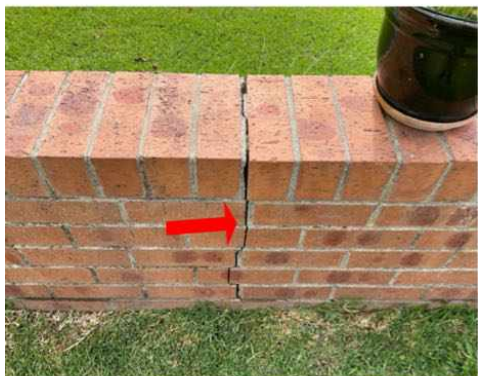
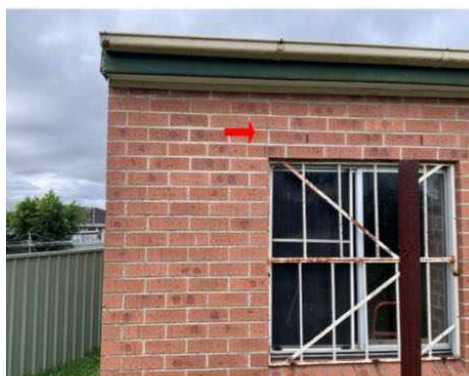
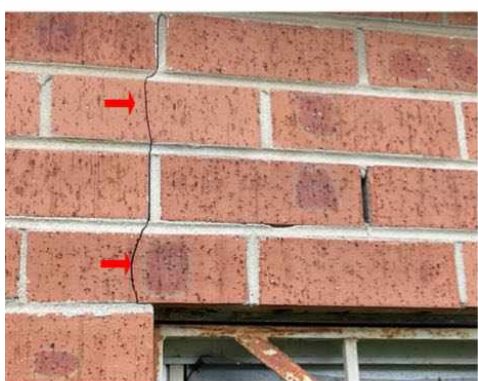
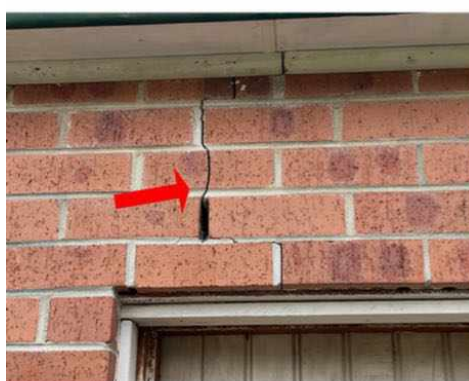
Finding 3.03

Building:	Building 2
Location:	Garage wall & fence
Finding:	Step cracking to brickwork (minor)
Information:	Minor step cracking was identified to the brickwork in this area at the time of inspection. Step cracking, which is similar to other forms of cracking, has a variety of possible causes. However, the most common is the subsidence of adjacent footings.

Step cracking is a relatively common defect, and is most likely to occur adjacent to windows, doors and other openings. Mortar failure in the gaps between affected bricks indicates the stresses and tensions affecting the wall.

Where step cracking is extensive or severe, the client is advised to consult a structural engineer. This minor step cracking can be used as a warning sign to address factors causing stress to the wall, which can include the effect of surrounding trees, water leaks, soil erosion, or even the presence of reactive soils in the surrounding area.

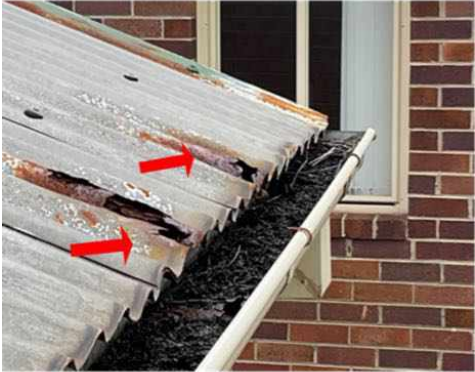
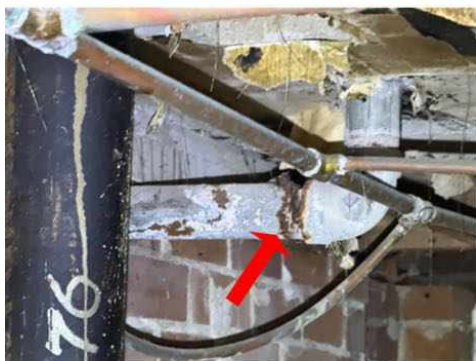
Finding 3.04

Building:	Building 1
Location:	Pictured areas of both buildings
Finding:	Building elements - Rusted or corroded
Information:	This areas of both buildings shows evidence of rusting and corrosion, which is likely to have developed as a result of excessive exposure to moisture and or inadequate

As surface rust provides no protection to the underlying iron, the deteriorating condition is likely to worsen if not addressed in the short-term future.

Where possible, the use of galvanized (treated) metals or aluminium coated metals aid in rust prevention, as does regular general maintenance. Rust formation can be controlled with coatings, such as paint, that isolate the iron from the environment.

Rusting and corrosion should be managed by ideally removing or limiting the affected surface from exposure to moisture. A registered builder may be appointed to replace any building elements that have been severely affected by rust or water damage.

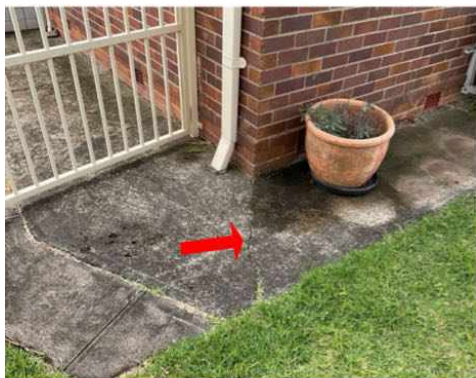
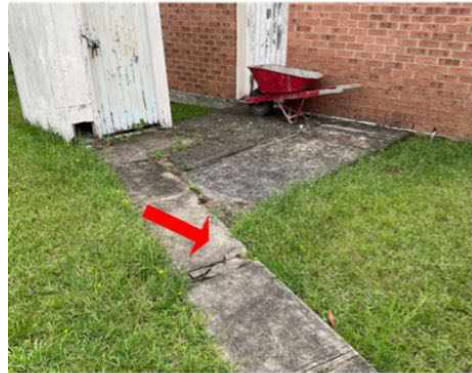
Finding 3.05

Building:	Building 1
Location:	Driveway & garage
Finding:	Crack in concrete slabs - Category 1
Information:	Cracks coded as Category 1 was identified in these pictured slabs. A Category 1 crack is described as a fine but noticeable crack, with the slab at an otherwise reasonable level. To be considered Category 1, the approximate width of the crack is less than 1.0mm, or a less than 10mm change in offset when a 3m straight edge is placed over the defect.

Category 1 cracks should be monitored for a period of 12 months. At the end of the monitoring period, identified cracks that are rated greater than Category 2 are considered defects, and require rectification.

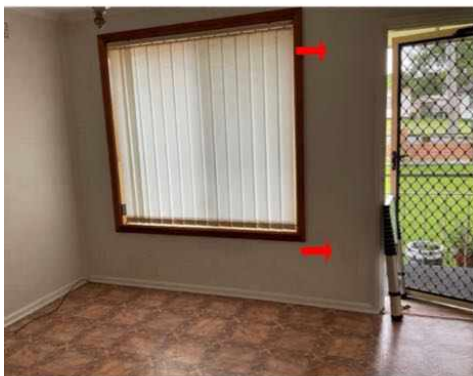
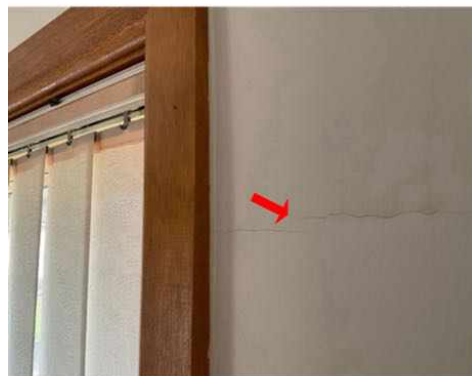
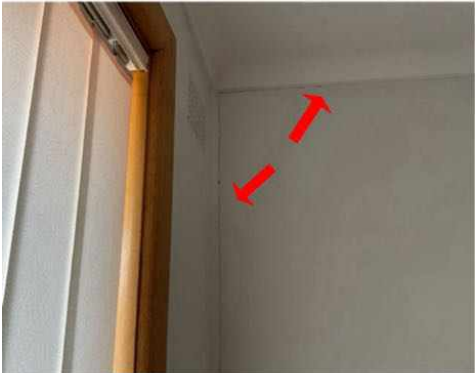
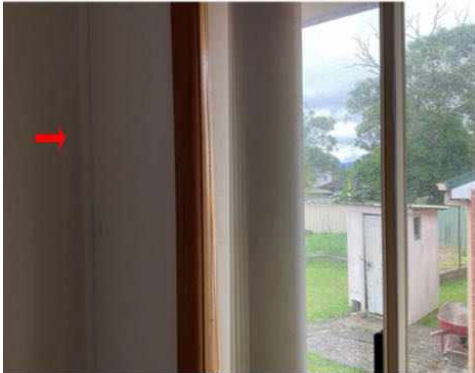
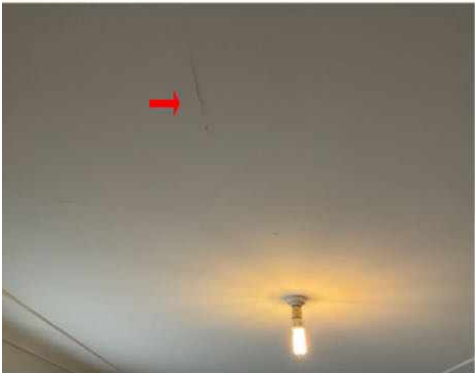
Finding 3.06

Building:	Building 1
Location:	Some rooms
Finding:	Cracking - Damage Category 1 - Fine (up to 1mm)
Information:	Although fine cracks are quite noticeable, they are often only considered to be an appearance defect, and usually do not indicate any structural damage. Generally, the cause of a fine crack is indicative of a separation between building materials and finishes (e.g. paint, plaster, etc.) along joints. Some of these appear to just be paint cracks.

Cracking of this nature can generally be repaired with minor sanding, filling and/or repainting. Such works should be performed by a qualified painter or a general handyman.

Monitoring of all cracking should be conducted frequently. Always contact a building inspector should cracks widen, lengthen, or become more numerous.

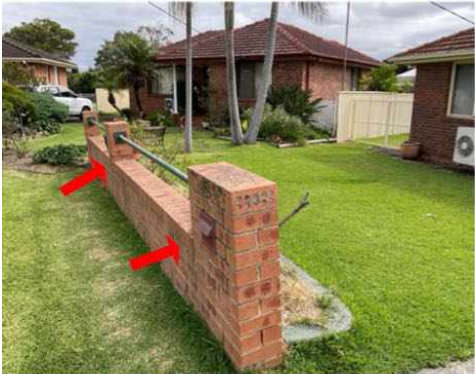
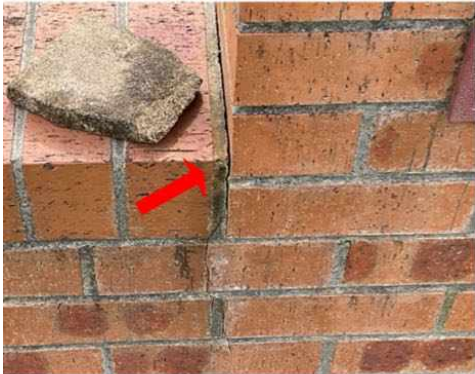
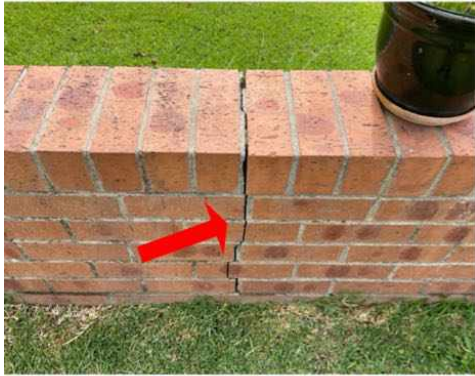
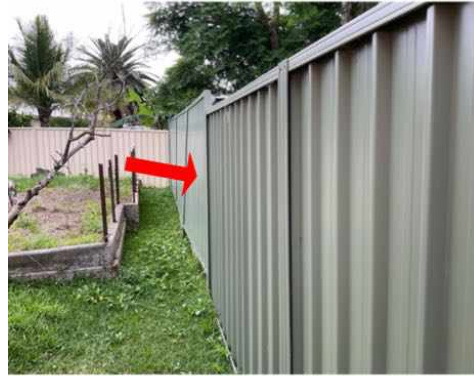
Finding 3.07

Building: Building 1
Location: Pictured fences
Finding: Fences damaged - leaning
Information: Evidence of damage to the pictured front and rear fences was identified at the time of the inspection. The likely cause of these fences leaning is not enough concrete used in the post footings. The front fence also has small cracks evident. If left unmanaged these fences may deteriorate further.

It is suggest a fencing contractor be engaged for rectification when convenient.

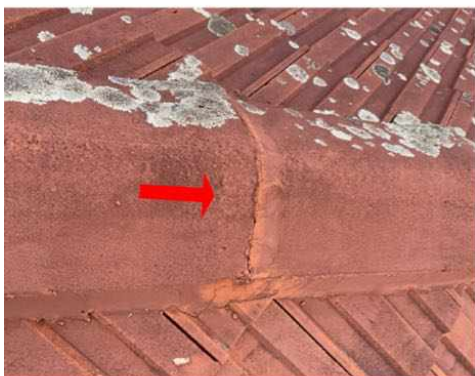
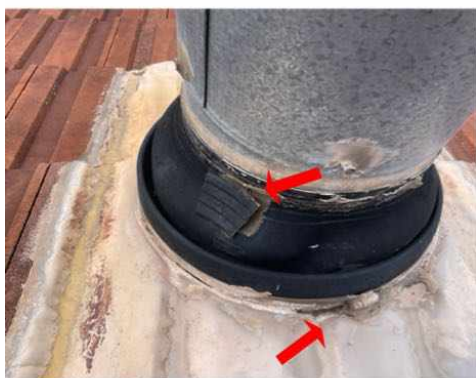
Finding 3.08

Building:	Building 1
Location:	Roof Exterior
Finding:	Roof areas (tiles, mortar, sealant)- weathered
Information:	Upon inspection of the exterior roofing, the majority of roof tiles and mortar were considered to be in a good condition. While weathering of the roofing areas is consistent with the age of the property, maintenance works are required.

Isolated areas of mortar and tiles show minor cracking is present. Re-pointing and re-sealing the may be considered as an interim solution by the client to help preserve and extend the life span of the tiles. Where left unmanaged, deteriorating roof mortar and tiles are likely to lead to a number of secondary defects, including minor water leaks and weather exposure to internal roofing structures.

Consultation with a roofing contractor is highly advised to gain advice on cost of remedial works that may be required in the short to medium term. Remedial works are likely to increase the longevity of the exterior roofing structure.

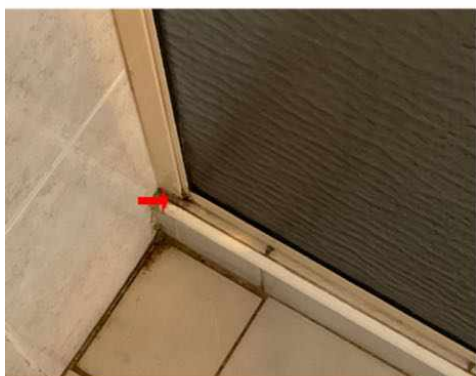
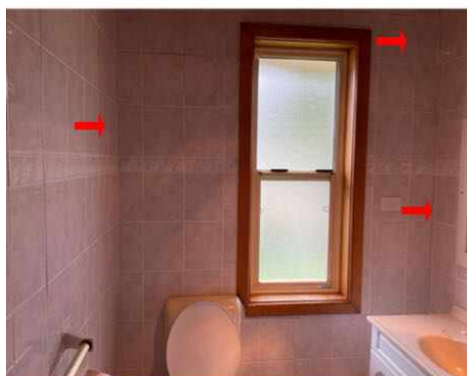
Finding 3.09

Building:	Building 1
Location:	Bathroom
Finding:	Sealant and grouting - Missing or damaged
Information:	It was noted on inspection that sealant or grout is degraded to these pictured areas.

Different materials and floor areas move at different rates, generally causing cracking to grout or sealant at this point. A flexible sealant is required to allow for expected expansion and contraction, while keeping the joint water tight and protective of all associated building materials.

Flexible and mould resistant materials should be applied to affected areas to prevent any subsequent water damage that is likely to occur. Regular maintenance and replacement of damage or missing or damaged sealant and grout is highly recommended to the wet areas, as this is a regular wear and tear defect. Sealant and grouting in areas that come into regular contact with water should be maintained for the long term care of your property.

A sealant specialist or tiling contractor should be appointed to complete these works as soon as possible

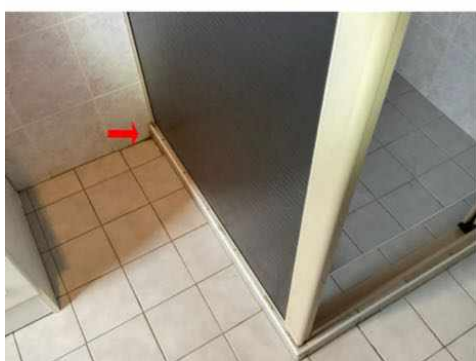
Finding 3.10

Building:	Building 1
Location:	Bathroom
Finding:	Shower screen - Leaking
Information:	Leaking was evident to the shower screening at the time of inspection. It is suspected that the leaking has occurred as a result missing sealant. Leaking from the shower , where left unattended, is likely to lead to water damage to adjoining flooring and walls. Such damage can lead to water damage and necessitate extensive remedial works being required. Active water leaks may also create an environment that is susceptible to the formation and development of mould.

Appointment of a sealant expert is required to repair or replace this missing sealant. Such works should be performed as soon as possible to ensure that no further damage occurs.

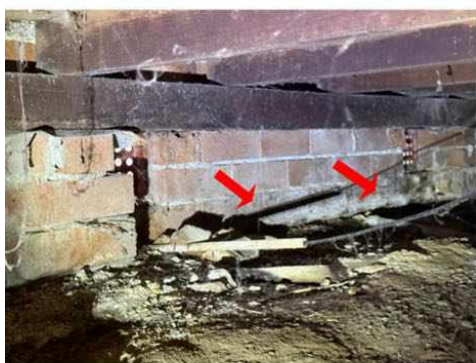
Rising damp is generally managed by the installation of a damp proof course during construction. A Damp Proof Course (DPC) is an impermeable barrier at the base of the wall above ground level. However, many 19th Century buildings have no damp course installed, or the materials have failed. The DPC may have been omitted as a consequence of poor workmanship, or it may have been bridged where materials built up against the side of the house allow moisture ingress above the DPC level.

The first step in addressing rising damp is to diagnose the cause. The identified cause should be addressed first before addressing the appearance and other defects which have resulted from the rising damp. If the original cause is not resolved, further cases of damp are likely to ensue, resulting in secondary defects.

Consultation with a qualified plumber is advised immediately to identify the cause of the damp and perform remedial works as required.

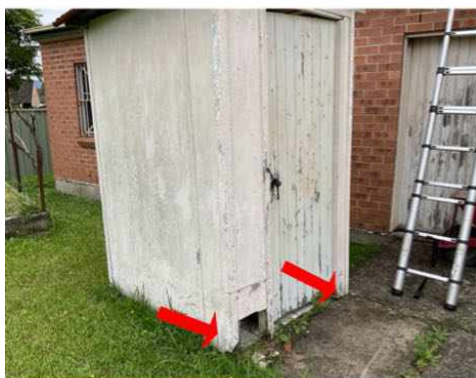
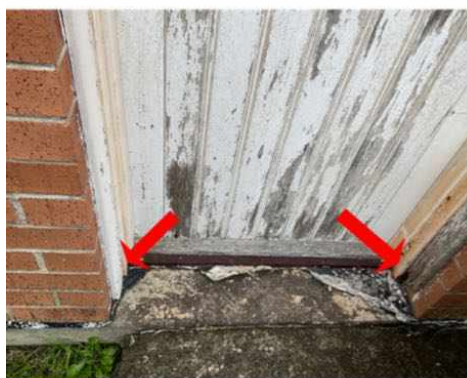
Finding 3.14

Building:	Building 1
Location:	Toilet & garage door
Finding:	Wood rot
Information:	These pictured areas show evidence of wood rot. Wood rot, also known as Fungal

Decay, occurs when timbers and other cellulose building materials are exposed to damp conditions on an ongoing basis. This could be the result of exposure to weathering over a prolonged period of time, or the attraction of excessive moisture from other abutting building materials. Replacement of affected timbers may then be a necessary step in protecting surrounding building elements from such deterioration.

A qualified carpenter or registered builder may also be required to replace affected timber. These walls may be asbestos. If testing is required contact this inspector.

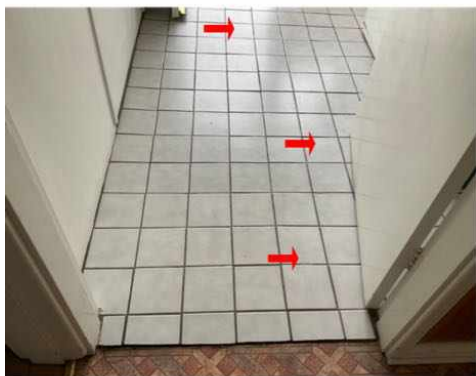
Finding 3.15

Building:	Building 1
Location:	Laundry
Finding:	Tiles - Drummy
Information:	Drummy tiled areas were identified at the time of inspection. The term 'drummy' refers to tiles that have become detached from their fixing, despite otherwise being in relatively good condition. Such defects are generally caused by physical or moisture damage to the area. Drummy tiled areas may also be a direct result of poor workmanship during the construction process.

Tiled areas may swell and shrink with changes in air humidity if the area has sustained moisture damage. Any exposure to moisture is capable of causing tiled areas to become drummy and/or cracked over a prolonged period of time. Drummy tiled areas generally require removal and replacement of affected tiles, with adequate sealant and grouting.

Specialist trades are available for these types of services. A registered builder may be required to undertake works if damage is extensive or if secondary building defects have resulted. Otherwise, it is advised that a tiling contractor be appointed to perform works as necessary. Immediate action is recommended to ensure that no further damage is sustained in the affected area.

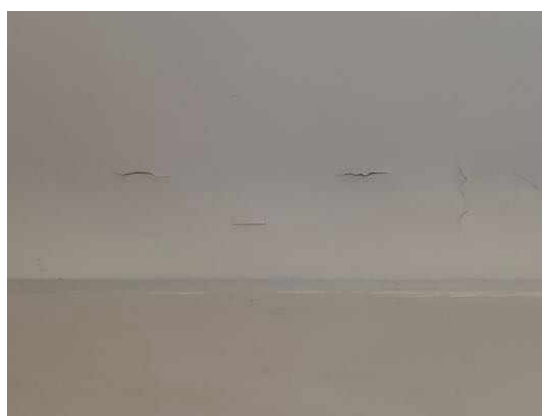
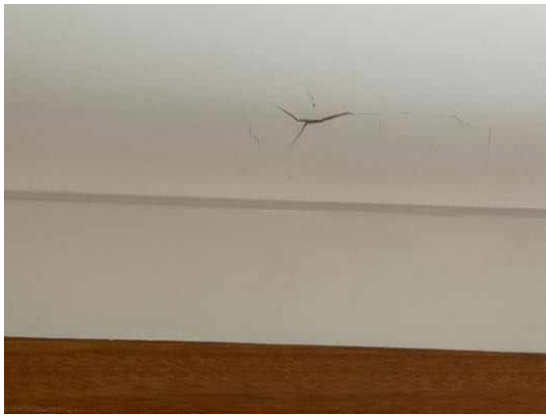
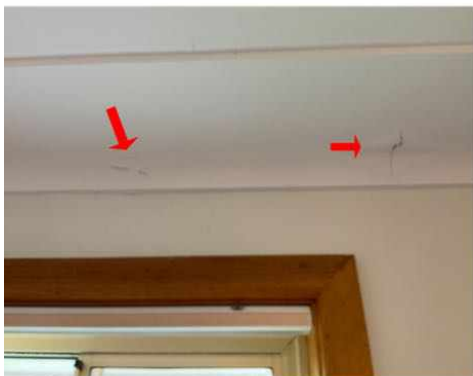
Finding 3.16

Finding: Paint damaged

Information: The paint finish throughout the house was found to be damaged. Damaged painting is generally classified as an appearance defect. However, the appearance may also be indicative of poor surface preparation and substandard workmanship. Damaged paint finishes in areas exposed to moisture,

e.g. external areas or wet areas, could lead to deterioration of underlying building materials. Damaged paint finishes should be sanded back, filled, leveled and repainted, as applicable.

A painting contractor should be appointed as soon as possible to perform necessary works to aid the appearance of the affected area and to ensure that the area is protected against further deterioration. Alternatively, the homeowner following manufacturer instructions may be able to provide this service.

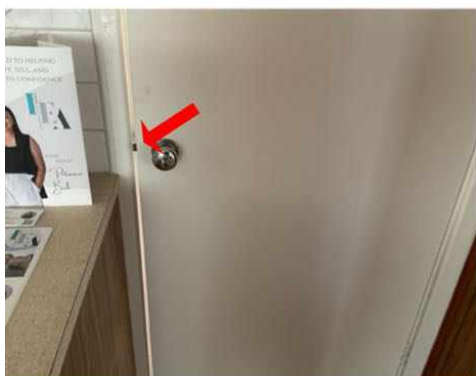
Finding 3.17

Building:	Building 1
Location:	Kitchen
Finding:	Door handle - Not latching
Information:	It was noted that the door was not latching during operation at the time of inspection. It is suspected that this defect has occurred due to minor issues with the associated hinges. Such damage is identified as general wear and tear, which is expected for building elements of this age.

A qualified carpenter or general handyperson may be appointed to perform rectification works as necessary, at client discretion. If left unattended, further functional impairment is likely to occur.

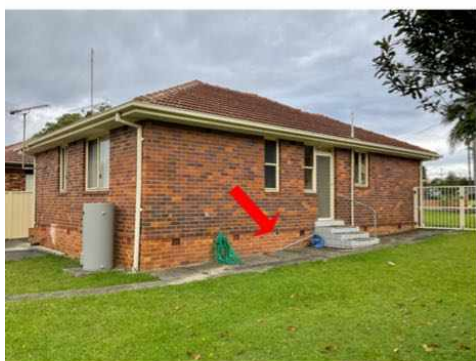
These damp conditions can lead to secondary defects such as rot, rust or corrosion of associated building elements, the formation of fungal decay, or even the creation of potential slip hazards. When coupled with poor site drainage, pooling of water may also attract termite activity to this area. It is highly recommended that a qualified plumber be appointed to install adequate drainage to these areas. These works will ensure that the area remains dry and free of any secondary defects.

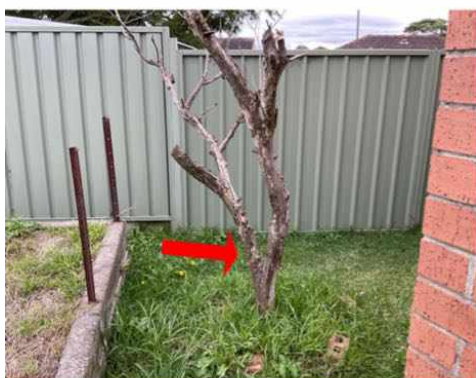
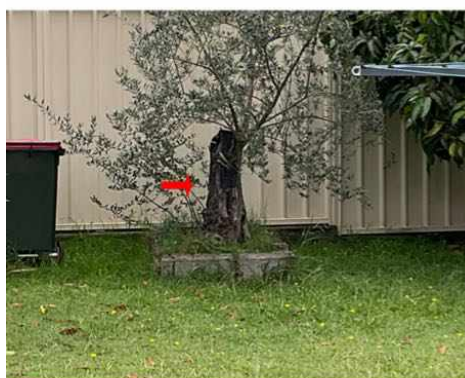
Finding 6.06

Building:	Building 1
Location:	Pictured rear yard areas
Finding:	Tree stumps - left in ground
Information:	Tree stumps left in ground provide opportunity for termite attack as they are likely to be subject to rot and decay providing an attractive food source. Treatment and/or Removal of the stump is highly recommended. A pest controller and tree removalist should be engaged to perform such works.

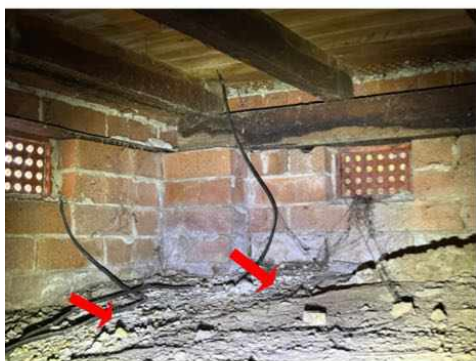
Finding 6.07

Building:	Building 1
Location:	Subfloor Areas
Finding:	Mould - Present in subfloor
Information:	Where evidence of mould growth was noted, there may be environmental, biological or health issues associated with the report. A specialist inspection by a suitably qualified environmental health inspector is warranted, where mould is extensive or where any queries regarding air quality spores or other related issues apply.

Subfloor mould is generally caused by moisture ingress, lack of external drainage, lack of adequate ventilation and subfloor debris present. These issues need rectification

Generally, the client is advised to ensure that the general environment is free of moisture and humidity to aid in the prevention of mould formation and development.

to stop mould development. Any mould found during the inspection should be cleaned immediately by a cleaning contractor or the homeowner as applicable.

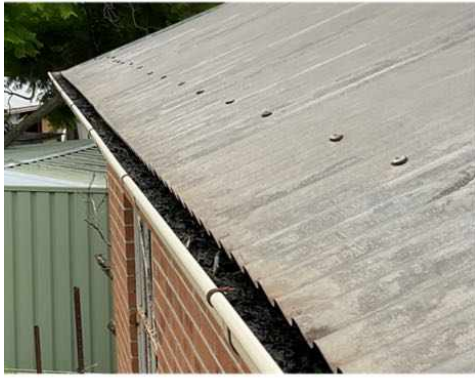
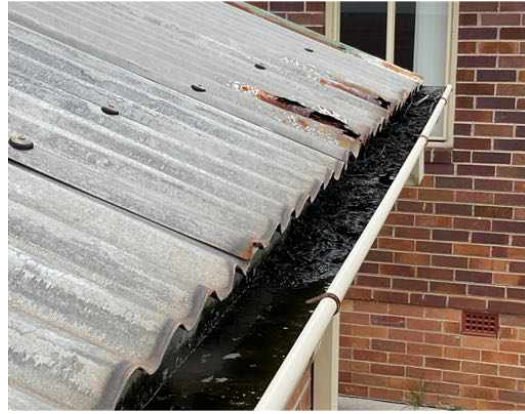
Finding 6.08

Building: Building 2
Location: Garage
Finding: Gutters - Full and blocked
Information: The guttering on around the roof was found to be blocked at the time of the inspection. Roof plumbing structures, such as guttering and downpipes, should be free of all debris to prevent blockages. Blockages of the guttering and downpipes will lead to pooling and accumulated water overflows, which is likely to subsequently flood eaves and exterior walls.

It is highly advised that gutters be cleaned by the homeowner or a general handyperson as a matter of urgency.

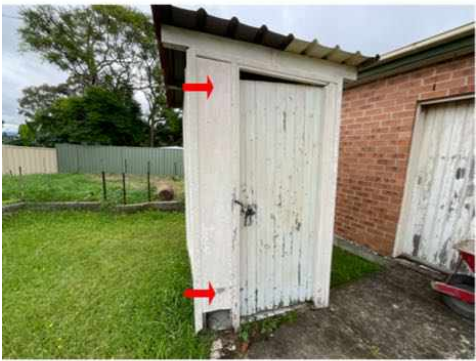
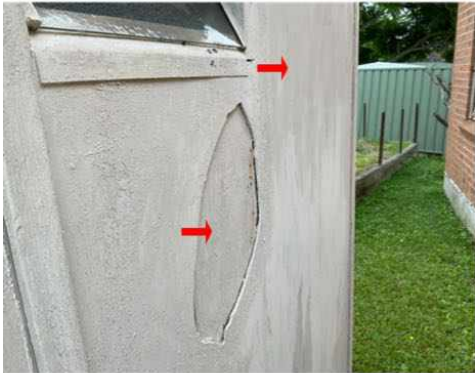
Noted Item

Building:	Building 1
Location:	Yard areas
Finding:	Asbestos - Suspected ACM Identified on Site
Information:	Reporting on Asbestos is outside the Scope of this Report. This suspected defect is highlighted as a caution only. We suspect, based on our experience in the building industry, that there is a higher risk of the identified building element containing asbestos.

In the interim, the client is advised to act with caution, especially when considering any damage to building materials general wear and tear renovations extensions demolition and general maintenance activities due to the suspected presence of Asbestos.
