## Building Inspection Report

Inspection Date: Mon, 12 Jan 2026

Property Address: 46 Bonogin Rd, Mudgeeraba QLD 4213,  
Australia

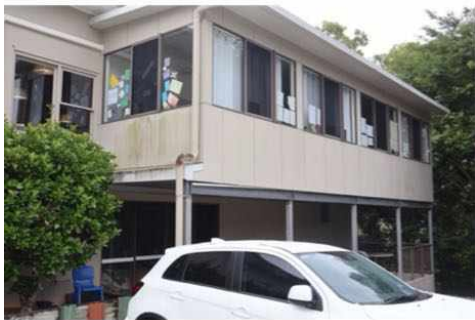
#### Defects 1.01

Information: Where evidence of mould growth was noted, there may be environmental, biological or health issues associated with the report. A specialist inspection by a suitably qualified environmental health inspector is warranted, where mould is extensive or where any queries regarding air quality spores or other related issues apply.

Generally, the client is advised to ensure that the general environment is free of moisture and humidity to aid in the prevention of mould formation and development. Any mould found during the inspection should be cleaned immediately by a cleaning contractor or the homeowner as applicable.

Please note that severely affected building elements may require replacement by a registered builder or qualified carpenter.

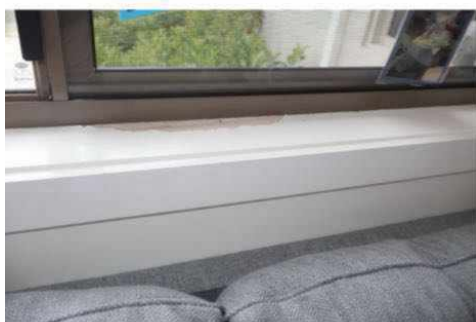
### Defects 3.01

Building:	Main Building
Location:	Quite room > Rear
Finding:	Painted surface - Bubbling
Information:	Sections of paint in this area was found to have bubbled and deteriorated. Paint bubbling is generally an indication of excessive moisture in the area, that is currently hidden by the painted surface.

The presence of excessive moisture can have major implications on associated building elements if left unattended. While only seemingly minor at this stage, the damage cannot be determined due to the paint obstructing any further inspection of the damage.

It is highly advised that the affected paint be cleaned to allow a further, more invasive inspection by a licensed plumber. Failure to act on this defect may necessitate major works in the future.

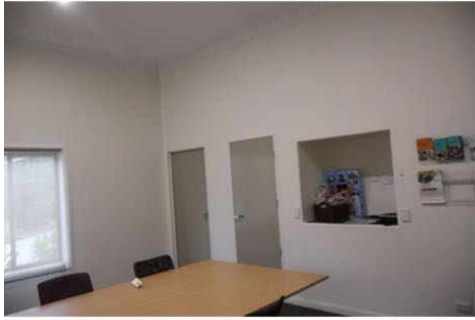
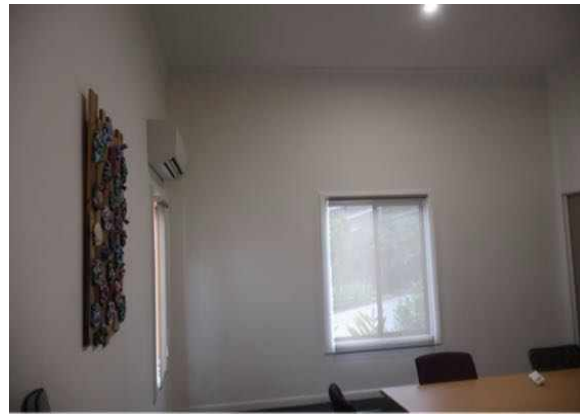
## Defects 3.04

Building: Main Building  
Location: Meeting Room > Rear  
Finding: Cracks to external render - Category 2  
Information: It has been observed that cracking to external rendered surfaces has occurred. The degree of damage falls within Category 2, described as noticeable cracks which are easily filled. Cracking of this size are generally less than 5mm in width.

Category 2 damage is required to be monitored for a period of 12 months. After the monitoring period, a crack rated at Category 2 or above is considered a defect requiring rectification.

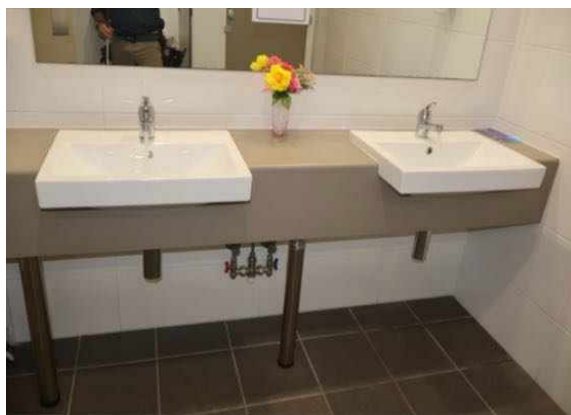
### Defects 3.07

Building:	Main Building
Location:	Ladies toilets > Rear
Finding:	Cracks to internal plaster- Category 2
Information:	It has been observed that cracking to internal plaster surfaces has occurred. The degree of damage falls within Category 2, described as noticeable cracks which are easily filled. Cracking of this size are generally less than 5mm in width.

Category 2 damage is required to be monitored for a period of 12 months. After the monitoring period, a crack rated at Category 2 or above is considered a defect

requiring rectification.

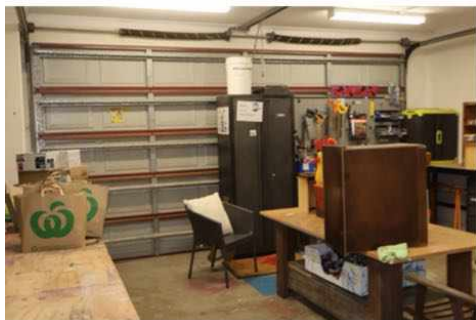
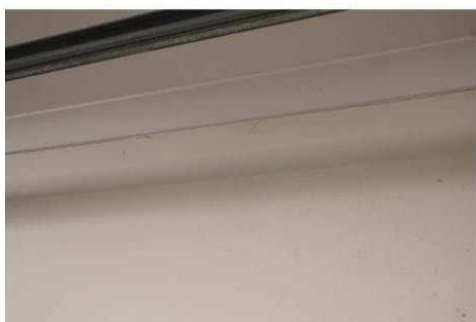
### Defects 3.10

Building:	Main Building
Location:	Workshop/garage > Rear Left
Finding:	Beading - gap
Information:	Beading acts (like cornice or skirtings) to cover the intersection or joins of building materials. It was noted at the time of inspection that beading in this area has minor gaps. This deterioration is suspected to have been caused by general ageing, which is expected in a building of this age and condition.

Beading is important in weatherproofing the surrounding building elements and preventing termite or pest ingress. Furthermore, beading works to protect the joins of building materials, which are more susceptible to deterioration and decay.

Repair or replacement of the beading is advised to ensure the protection and longevity of any associated building elements. Such works may be performed by a general handyperson or qualified carpenter.

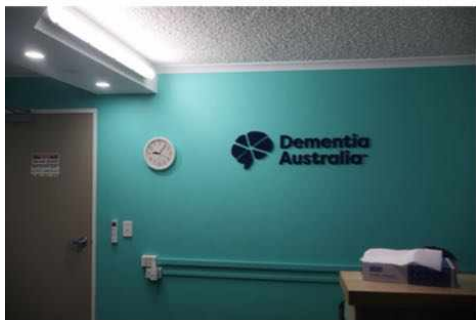
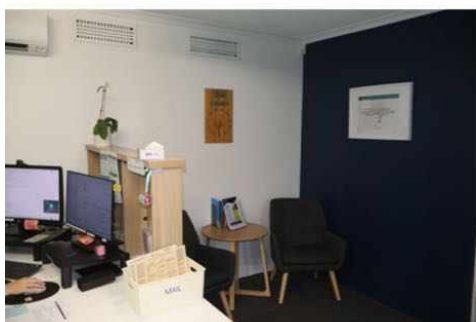
### Defects 3.11

Building:	Main Building
Location:	Reception > Rear Right
Finding:	Brickwork - Step cracking
Information:	Step cracking was identified to the brickwork in this area at the time of inspection. Step cracking, which is similar to other forms of cracking, has a variety of possible causes. However, the most common is the subsidence of adjacent footings.

Step cracking is a relatively common defect, and is most likely to occur adjacent to windows, doors and other openings. Mortar failure in the gaps between affected bricks indicates the stresses and tensions affecting the wall.

Where step cracking is extensive or severe, the client is advised to consult a structural engineer. Minor step cracking can be used as a warning sign to address factors causing stress to the wall, which can include the effect of surrounding trees, water leaks, soil erosion, or even the presence of reactive soils in the surrounding area.

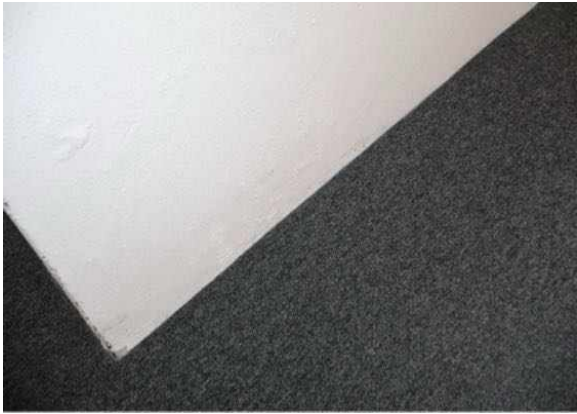
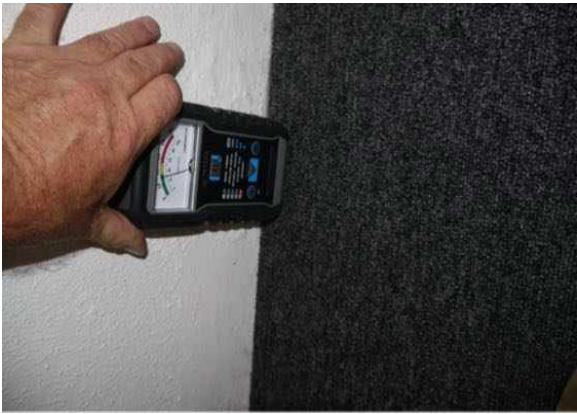
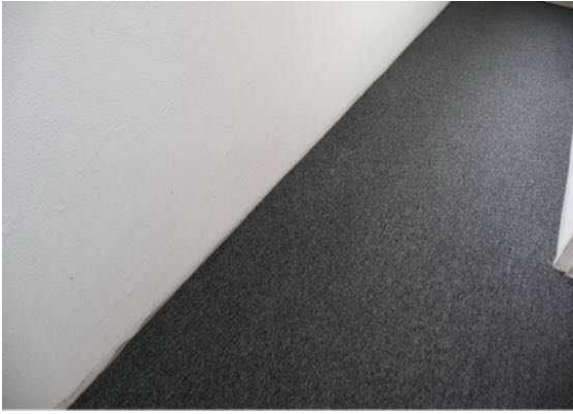
### Defects 3.12

Building:	Main Building
Location:	Hallway > Centre Left
Finding:	Render - Drummy
Information:	<p>Drummy rendered areas were identified at the time of inspection. The term 'drummy' refers to render that has become detached from its fixing, despite it still being solid. Such defects are generally caused by physical or moisture damage to the area. Drummy render may also be a direct result of poor workmanship during the construction process.</p>

Render may swell and shrink with changes in air humidity if the area has sustained moisture damage. Any exposure to moisture is capable of causing rendered areas to become drummy and/or cracked over a prolonged period of time. Drummy render generally requires chipping off and re-rendering or painting.

Specialist trades are available for these types of services. A registered builder may be required to undertake works if damage is extensive, or if secondary building defects have resulted. Immediate action is recommended to ensure that no further damage is sustained in the affected area.

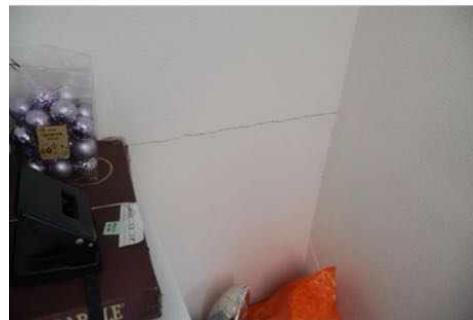
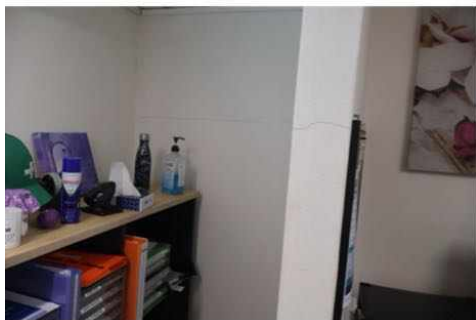
### Defects 3.13

Building: Main Building  
 Location: Office 4 > Rear  
 Finding: Cracks to internal render - Category 2  
 Information: It has been observed that cracking to internal rendered surfaces has occurred. The degree of damage falls within Category 2, described as noticeable cracks which are easily filled. Cracking of this size are generally less than 5mm in width.

Category 2 damage is required to be monitored for a period of 12 months. After the monitoring period, a crack rated at Category 2 or above is considered a defect requiring rectification.

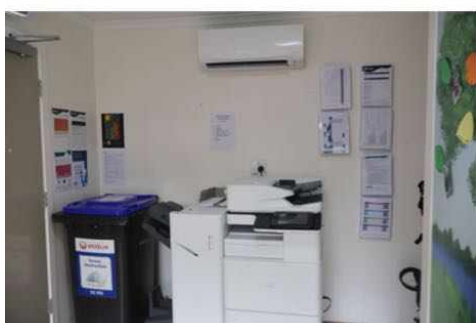
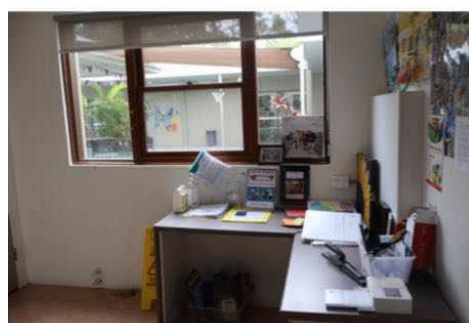
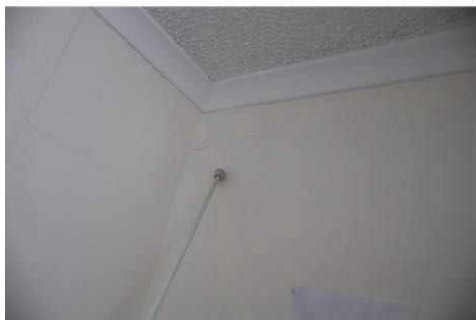
### Defects 3.14

Building:	Main Building
Location:	Stationary > Rear
Finding:	Brickwork - Step cracking
Information:	Step cracking was identified to the brickwork in this area at the time of inspection. Step cracking, which is similar to other forms of cracking, has a variety of possible causes. However, the most common is the subsidence of adjacent footings.

Step cracking is a relatively common defect, and is most likely to occur adjacent to windows, doors and other openings. Mortar failure in the gaps between affected bricks indicates the stresses and tensions affecting the wall.

Where step cracking is extensive or severe, the client is advised to consult a structural engineer. Minor step cracking can be used as a warning sign to address factors causing stress to the wall, which can include the effect of surrounding trees, water leaks, soil erosion, or even the presence of reactive soils in the surrounding area.

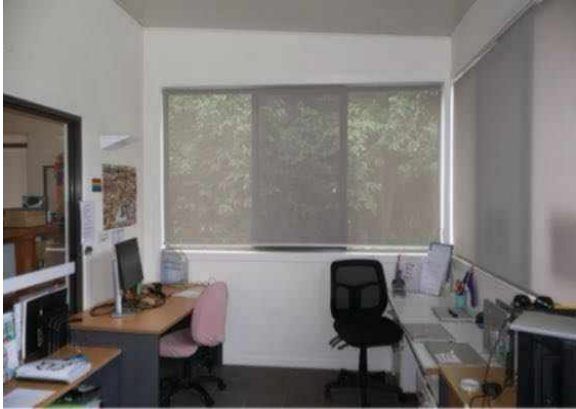
Building: Main Building  
 Location: Staff office > Rear Left  
 Finding: Water staining  
 Information: Water staining was evident in this area at the time of inspection. Water staining indicates that surfaces have been exposed to excessive moisture over time. The minerals and other elements in the water lead to staining, which may graduate to corrosion and deterioration if left unmanaged.

Conversely, where water staining is old and inactive, affected building materials may be repaired or replaced at client discretion. A qualified carpenter or registered builder may be appointed to perform these works.

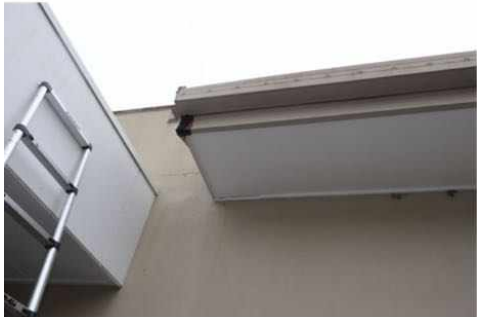
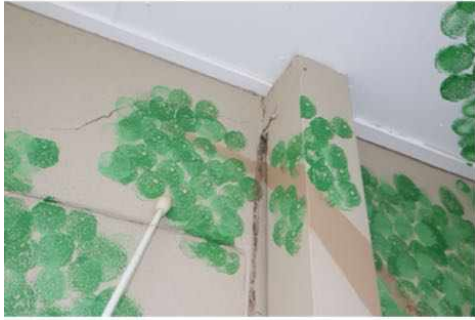
Building: Main Building  
Location: Courtyard > Front,Rear  
Finding: Exterior roof plumbing - Leaking  
Information: Active gutter leaks were evident at the time of inspection. Roof leaks can have a number of causes, including damage to gutter joints, deterioration of roof fixtures and fittings, or loosely associated materials (fascias etc.)

A roof plumber should be appointed as soon as possible to primarily identify the cause of the leak, and to provide subsequent repair works as necessary. Depending on the extent of the damage, replacement of sections of the roof gutter may be required, and may be performed by a roof plumber.

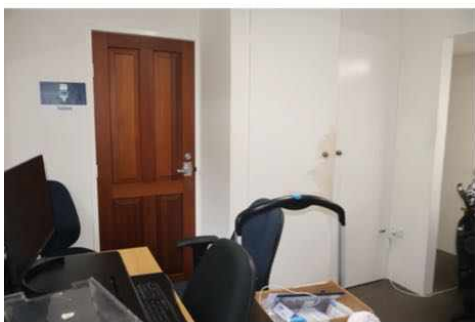
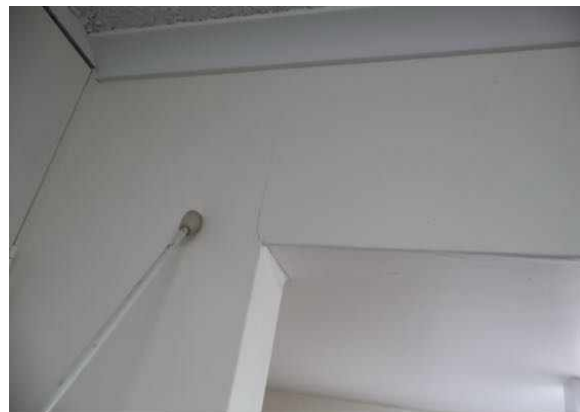
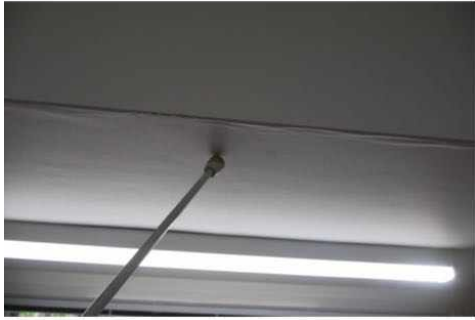
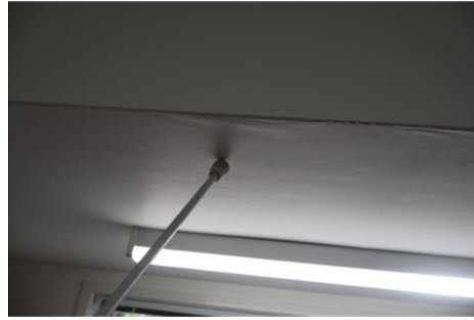
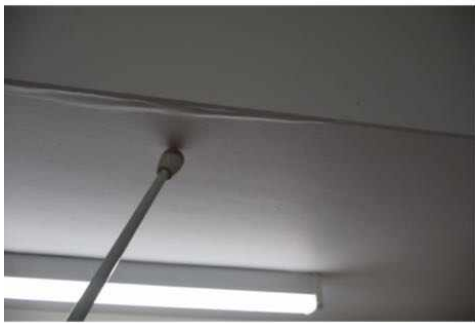
Building: Main Building  
 Location: Office 5 > Rear  
 Finding: Painted surface - Bubbling  
 Information: Sections of paint in this area was found to have bubbled and deteriorated. Paint bubbling is generally an indication of excessive moisture in the area, that is currently hidden by the painted surface.

It is highly advised that the affected paint be cleaned to allow a further, more invasive inspection by a licensed plumber. Failure to act on this defect may necessitate major works in the future.

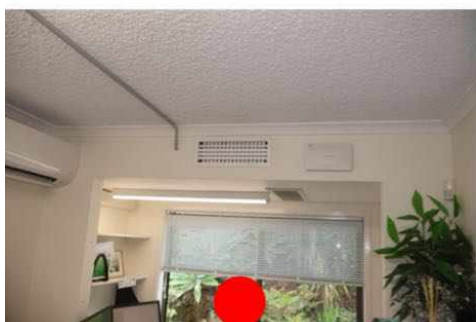
Building:	Main Building
Location:	Office 6 > Rear
Finding:	Evidence of excessive moisture was present at the time of inspection
Information:	Excessive moisture can attract termites and produce conditions that promote termite attack, fungal growth and wood decay. Excessive moisture is generally caused by deteriorated, inadequate or missing roof drainage, leaking plumbing pipes or fixtures, poorly plumbed HWS overflows or condenser units and poor site drainage. It is highly recommended that all plumbing and drainage fixtures and fittings be maintained regularly in order to prevent excessive moisture being present in the external / internal property.

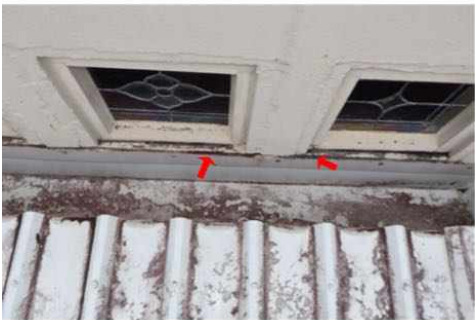
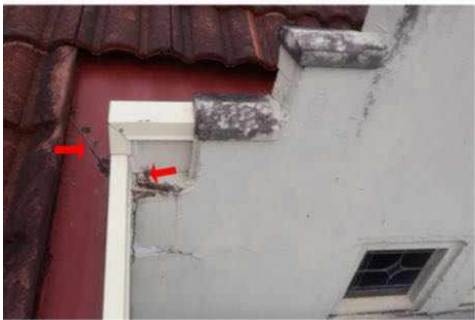
Building: Main Building  
 Location: Roof Exterior > Rear  
 Finding: Flashing holes - flashing  
 Information: Visible holes were observed on the roof flashing.

Possible mould growth and internal damage.

Engage a qualified roofing contractor to repair or replace the affected flashing sections.

All holes and penetrations should be sealed or replaced to restore a continuous waterproofing barrier in accordance with AS. 3500, AS 1562.1 and the NCC requirements for weatherproofing.

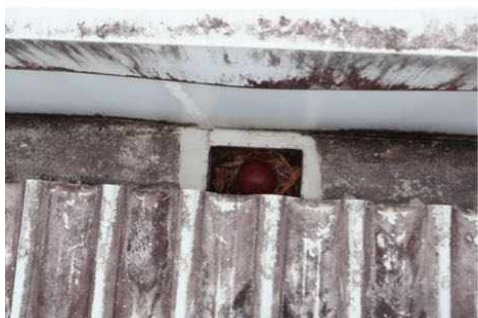
Building: Main Building  
Location: Roof Exterior > Rear Left  
Finding: Gutters - Blocked  
Information: Roof plumbing structures, such as guttering and downpipes, should be free of all debris to prevent blockages. Blockages of the guttering and downpipes will lead to pooling and accumulated water overflows, which is likely to subsequently flood eaves and exterior walls.

Consult a Licensed Plumber for further specific advice on remedial works that may be required. In the interim, it is highly advised that blocked gutters be removed by the homeowner or a general handyperson as a matter of urgency.

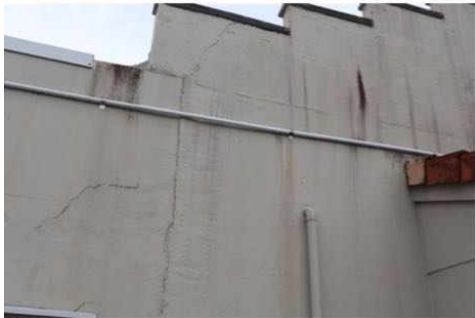
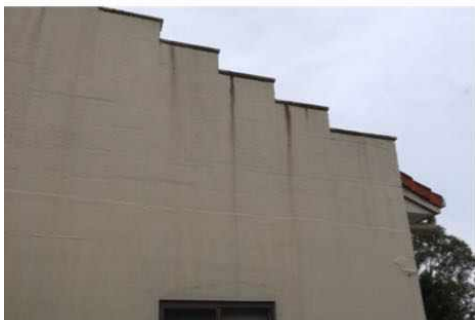
Building: Main Building  
 Location: Walls > Rear Right  
 Finding: Water - seepage  
 Information: Evidence of water seepage and moisture ingress was observed through the render wall.

A renderer is recommended to inspect and make recommendations on repairs.

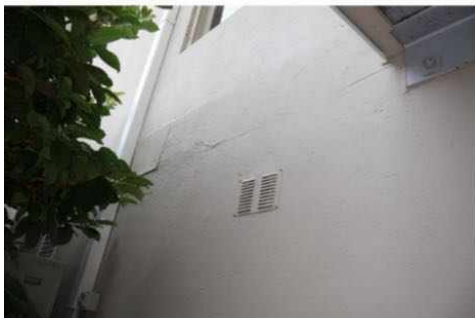
Building: Main Building  
 Location: Walls > Front Left  
 Finding: Cracks to external render - Category 2  
 Information: It has been observed that cracking to external rendered surfaces has occurred. The degree of damage falls within Category 2, described as noticeable cracks which are easily filled. Cracking of this size are generally less than 5mm in width.

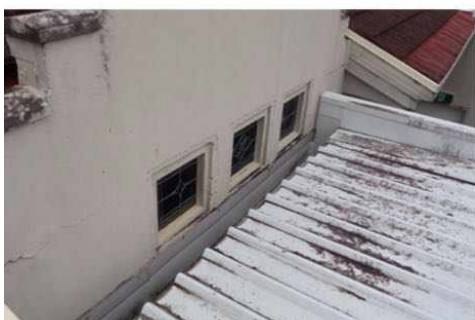
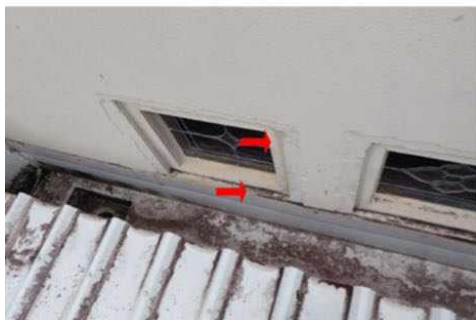
Building: Main Building  
Location: Windows > Existing  
Finding: Window seals - deteriorated  
Information: The window seals have deteriorated and are in a generally poor condition. Due to frequent exposure to weather conditions and subsequent moisture, deterioration of window seals is expected in a property of this condition and age.

It is recommended that all deteriorated window seals be replaced by a general handyman or sealant expert to prevent any further damage and to restore the window to a fully functional level.
