Building and Timber Pest Inspection Report

Inspection Date: Thu, 19 Feb 2026

Property Address: 13 Birdwood Rd, Georges Hall NSW 2198,
Australia

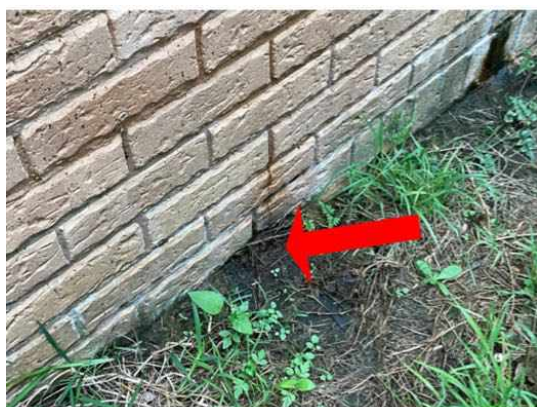
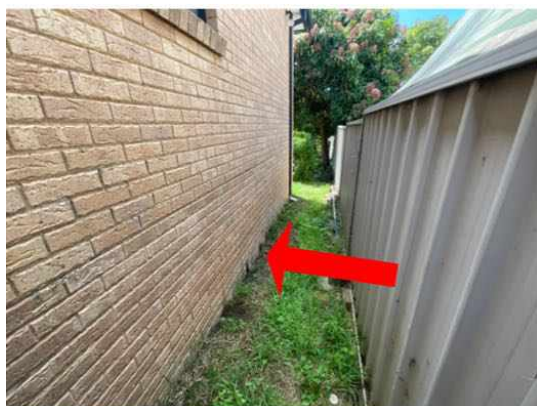
Building: Main Building
Location: All External Areas
Finding: Pipework - Leaking into subfloor
Information: Dampness to localised sections of the subfloor area was identified. It is suspected that this dampness has occurred due to leaking pipes in this area, which may be exacerbated by poor site drainage and inadequate subfloor ventilation.

Dampness in this area is likely to lead to wood rot and general deterioration of structures within the subfloor space. Excessive moisture also creates an environment which is conducive to termite and pest infestation.

A licensed plumber should be appointed immediately to repair any pipes that may be leaking. This will ensure a dry subfloor space as well as improving the water efficiency of the property. Invasive inspection in this area is highly recommended.

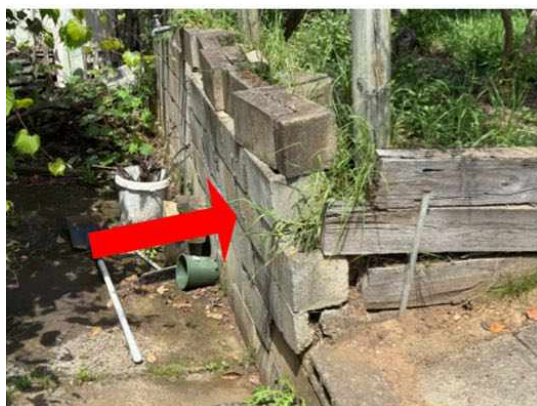
Finding 2.02

Building:	Main Building
Location:	All External Areas
Finding:	Rear Retaining Wall - Deteriorated
Information:	The retaining wall at the rear yard was observed to be in deteriorated condition, including:

- Cracked and displaced masonry units.
- Movement and misalignment of blocks.
- Localised structural instability.
- Weathered and deteriorated timber retaining elements.
- Possible inadequate drainage behind the wall.

The extent of cracking and displacement suggests structural movement, potentially caused by soil pressure buildup, poor drainage, or footing failure.

This condition may worsen over time and could result in further structural instability or partial collapse.

Engage a structural engineer or qualified retaining wall specialist to assess the structural integrity of the wall. Repairs or reconstruction may be required. Drainage behind the wall should also be investigated and upgraded where necessary.

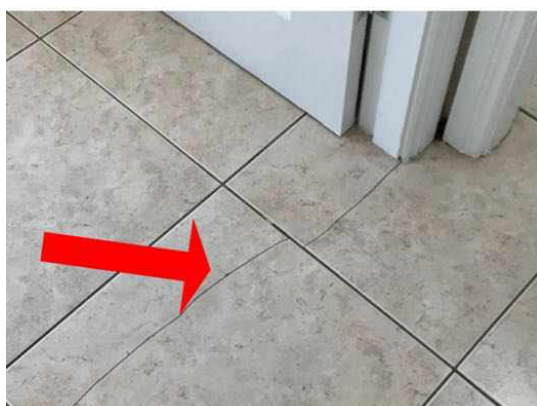
Building:	Main Building
Location:	All Internal Areas
Finding:	Tiles - Cracked or damaged
Information:	Cracking was evident to the tiling in this area at the time of inspection. While the cracking appears to be minor, this area is frequently exposed to water, allowing potential for water penetration into adjoining sections of walls or flooring.

If left unmanaged, water penetration to these areas may lead to subsequent water damage, which is likely necessitate repair work to affected building elements.

A tiling contractor should be appointed to ensure that no further water damage occurs. The re-application of silicone and grouting throughout remaining tile work is also advised, to further protect the area against water penetration.

Where water penetration has led to water damage, appointment of a relevant tradesperson may be required to repair damaged building elements.

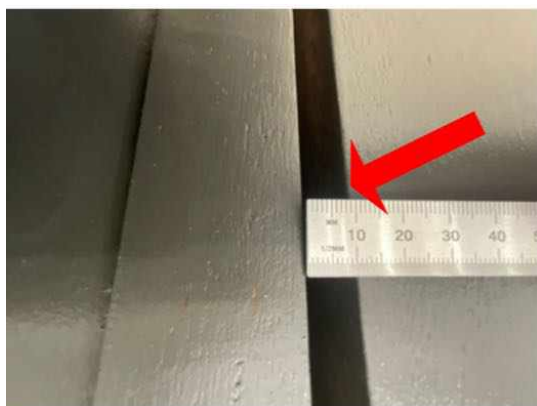
Information: A significant gap was identified between the door and door frame in this area. Where large gaps to the head or foot of door frames appear, it may indicate a variety of defects, ranging from uneven framework, sagging hinges or uneven flooring.

A gap to the head of the door may also indicate movement of the foundation of the property, which is a common occurrence and does not indicate structural damage.

A qualified carpenter should be appointed to perform remedial works to restore the door to a fully operational level.

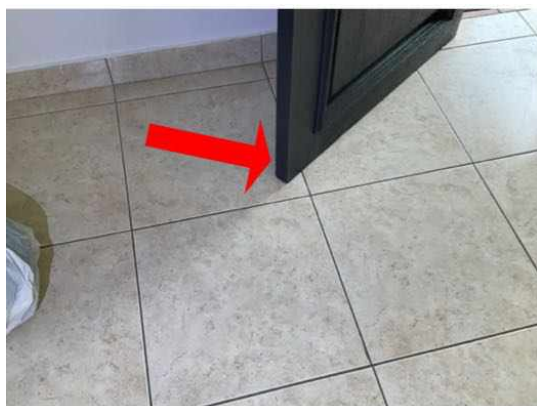
Finding 3.03

Building:	Main Building
Location:	All Internal Areas
Finding:	Door - Binding/jamming
Information:	Binding and/or jamming of this door is evident during standard operation. This defect inhibits the functionality of the affected door as well as creating potential for secondary defects to associated building elements, such as damage to the floor covering.

A door that binds to flooring or to the associated door frame may have several causes, ranging from minor defects, such as poor installation of the door or deteriorated hinges, through to major structural issues, such as damage to subfloor structures.

Where door binding/jamming appears to indicate major structural issues, a registered builder specialising in re-stumping should be appointed to provide an estimate on the cost of rectification.

For minor causes, a qualified carpenter or general handyperson should be appointed to perform minor rectification works at client discretion.

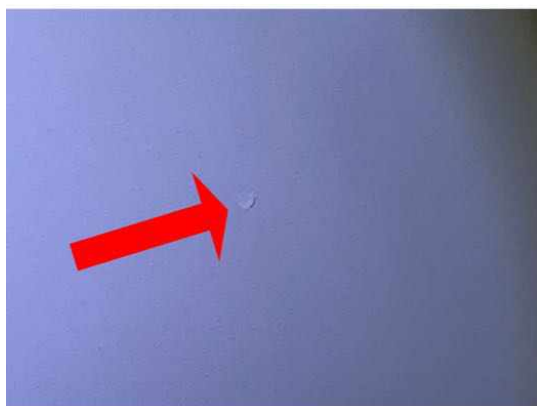
Finding 3.04

Building:	Main Building
Location:	All Internal Areas
Finding:	Ceiling nails - Popping
Information:	Numerous popped nails were identified in the internal ceiling at the time of inspection. Nails and screws hold simply by the friction between them and the surface they are applied to. Over time, the nails and screws can back out, which is often a result of general ageing and deterioration of the building structure.

If left unmanaged, the ceiling sheets may become loose and unstable, increasing the rate of deterioration of the internal ceiling and creating potential for the development of secondary defects.

Re-fastening of popped nails will help to maintain the stability of the internal ceiling and associated building elements. Such minor works will also help to improve the appearance of the affected area and secure the ceiling sheets, so as to prevent the onset of ceiling sagging. These works should be performed by a qualified carpenter or plasterer at client discretion.

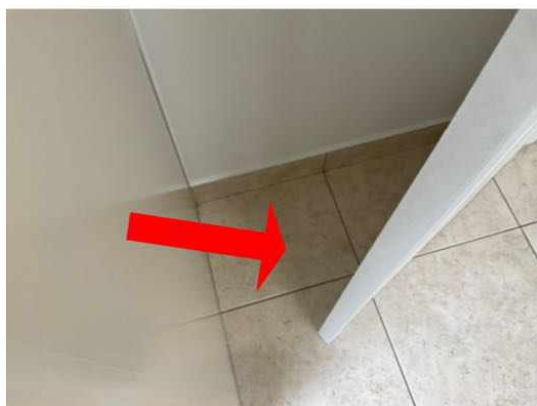
Finding 3.05

Building:	Main Building
Location:	All Internal Areas
Finding:	Door stop - Missing
Information:	The door stop is missing or is inadequate to stop the door handle from damaging the wall. Although some building elements may seem irrelevant or unnecessary, all building elements play a key role in the operation and function of the overall structure and its performance.

Re-installation or replacement of the door stop is advised as soon as possible to prevent any subsequent damage to the door or associated structures. A general handyman may be appointed to perform these works at client discretion.

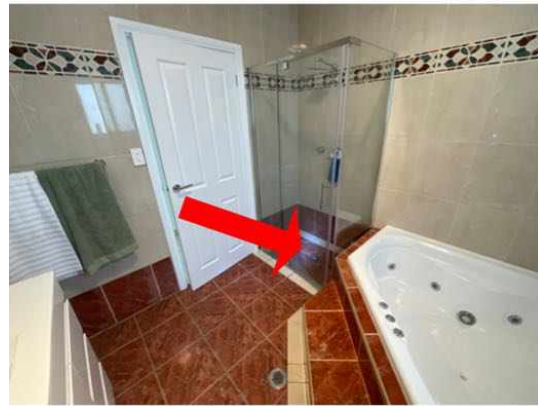
Finding 3.06

Building:	Main Building
Location:	Bathroom
Finding:	Sealant and grouting - Missing or damaged
Information:	It was noted on inspection that sealant or grout is degraded to the tiled shower alcove and or other areas of the bathroom.

Different materials and floor areas move at different rates, generally causing cracking to grout or sealant at this point. A flexible sealant is required to allow for expected expansion and contraction, while keeping the joint water tight and protective of all associated building materials.

There appears to be excessive mould to the sealant and grout which will likely require scraping out and replacement.

Flexible and mould resistant materials should be applied to affected areas to prevent any subsequent water damage that is likely to occur. Regular maintenance and replacement of damage or missing or damaged sealant and grout is highly recommended to the wet areas, as this is a regular wear and tear defect. Sealant and grouting in areas that come into regular contact with water should be maintained for the long term care of your property.

A sealant specialist or tiling contractor should be appointed to complete these works

as soon as possible

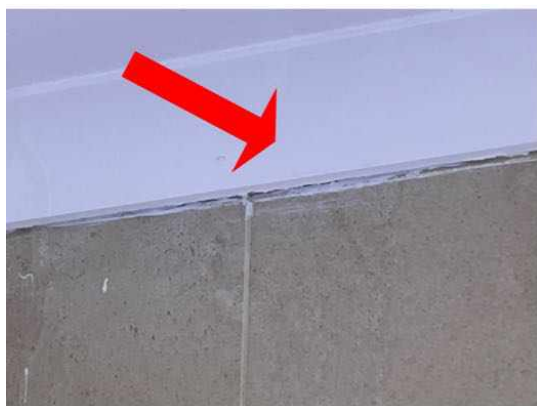
Building: Main Building
 Location: Bathroom
 Finding: Cornices - Sagging
 Information: Sagging and uneven cornices generally indicate that the building materials have swollen, due to contact with water, or the movement of the ceiling joints or that fixings (e.g. nails or glue) have become loose and require reattachment. In some cases, sagging and uneven surfaces may also indicate that there are structural issues causing surfaces to warp, twist, or sag.

Where sagging appears to be major, appointment of a structural engineer is advised to further inspect the property. Otherwise, minor works such as re-gluing of wall/ceiling sheets may be required and should be performed by an aptly qualified plasterer or carpenter.

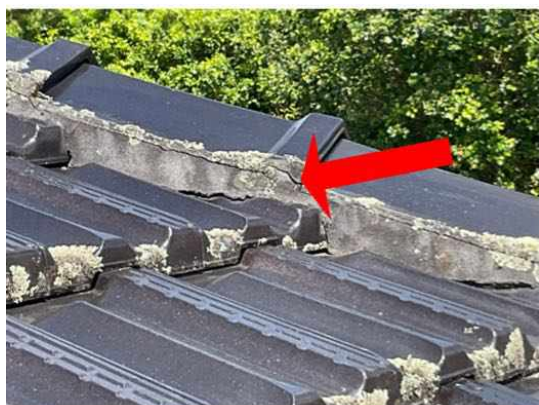
Building:	Main Building
Location:	Roof Exterior
Finding:	Mortar - Deterioration
Information:	Mortar, or 'bedding', is the material which fills joins and intersections between tiles and other building elements on the exterior roof covering, such as gable ends, hip capping and valleys. Upon inspection of the exterior roof, it was noted that sections of the mortar show varying levels of deterioration.

Mortar generally deteriorates as a result of frequent exposure to weather conditions over a prolonged period of time. Mortar that is deteriorating may allow water ingress into the roof void, putting associated building elements and roofing structures at risk of water damage. Deteriorated mortar also detracts from the functionality of roof tiles and other roofing elements, potentially decreasing weather tightness and roof drainage.

Mortar deterioration can be attended to by a handyperson where areas of deterioration are localised and easily accessible. Otherwise, consultation with a roofing contractor is advised where greater works are required.

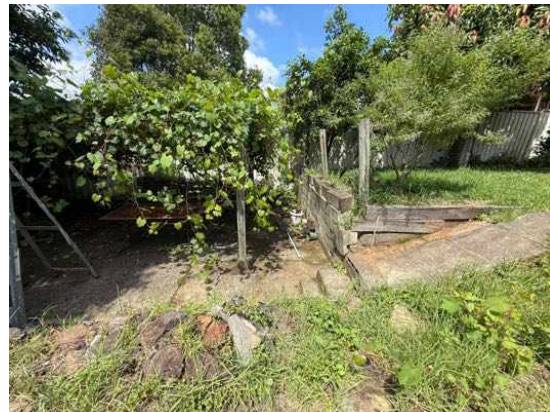
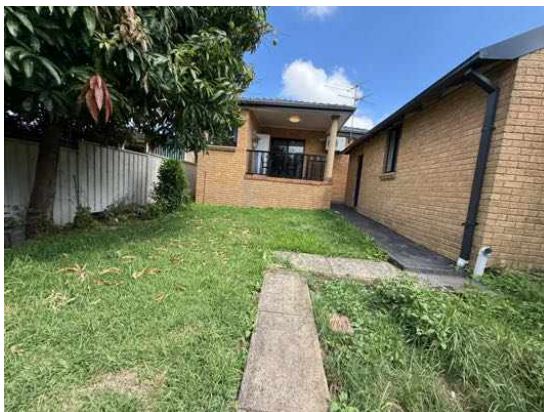
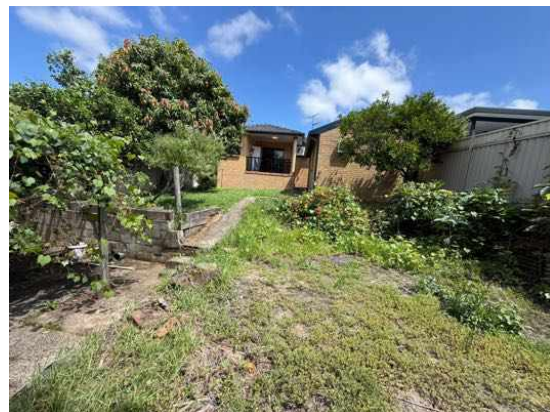
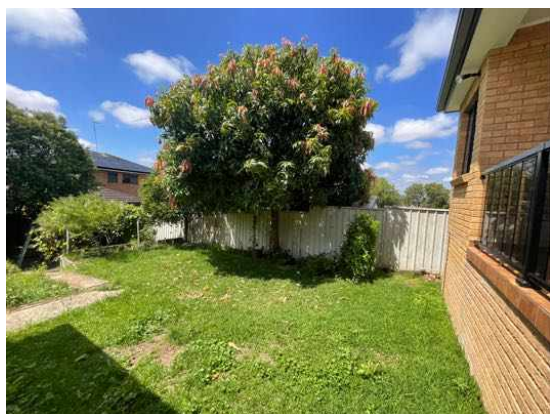
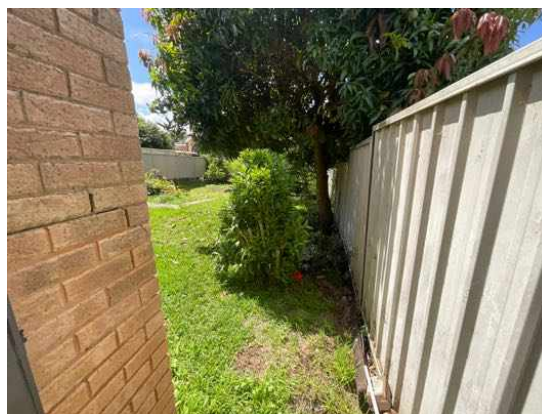
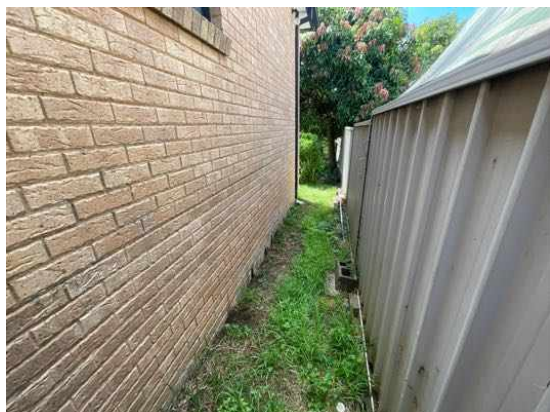
Finding 6.01

Building: Main Building
Location: All Areas
Finding: Garden Beds - Conditions Conducive to Termites
Information: Garden beds were found to be evident in the garden area. These garden beds can include untreated timber, and with a combination of moisture from watering hosing can make conditions conducive to termite activity and termite ingress.

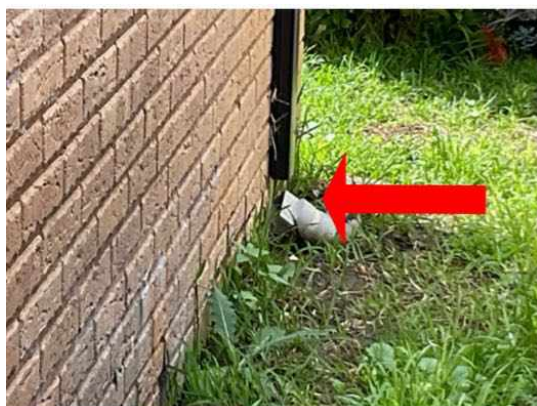
Finding 6.02

Building:	Main Building
Location:	All Areas
Finding:	Overflow (Downpipe) - Not plumbed for drainage
Information:	The overflow is not plumbed or connected to suitable drainage, which has resulted in the surrounding area becoming excessively damp. These damp conditions can lead to secondary defects such as rot, rust or corrosion of associated building elements, the formation of fungal decay, or even the creation of potential slip hazards. When coupled with poor site drainage, pooling of water may also attract termite activity to this area. It is highly recommended that a qualified plumber be appointed to install adequate drainage to the overflow. These works will ensure that the area remains dry and free of any secondary defects.

not connecting downpipes to the stormwater system can lead to various problems, including structural damage, safety hazards, and regulatory issues. It's essential to address this issue promptly by ensuring that downpipes are properly connected and directing water away from the building to mitigate these risks.

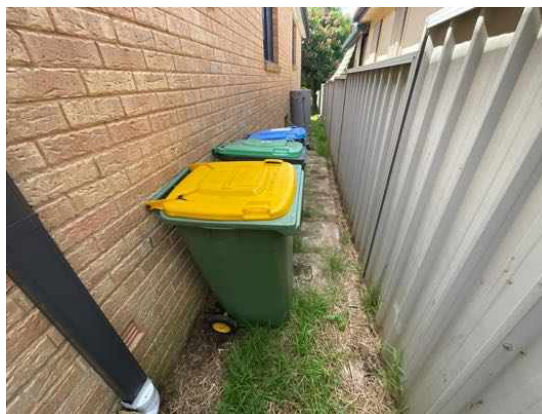
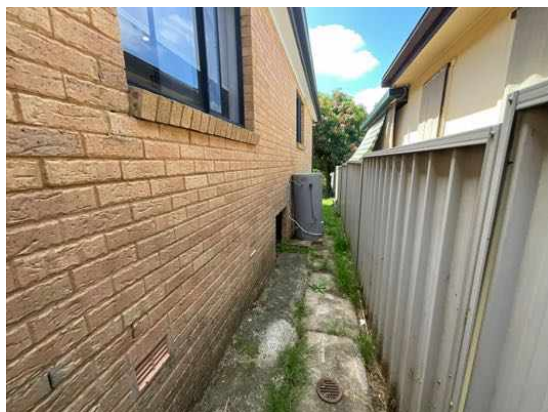
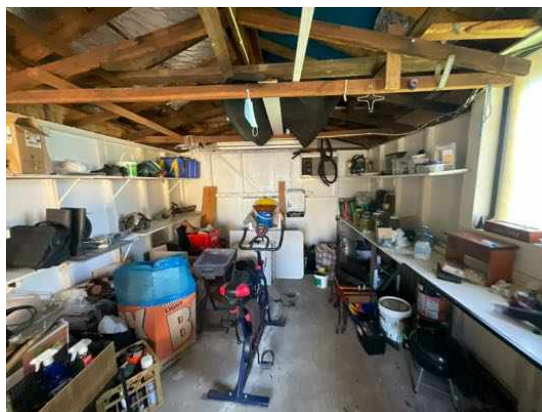
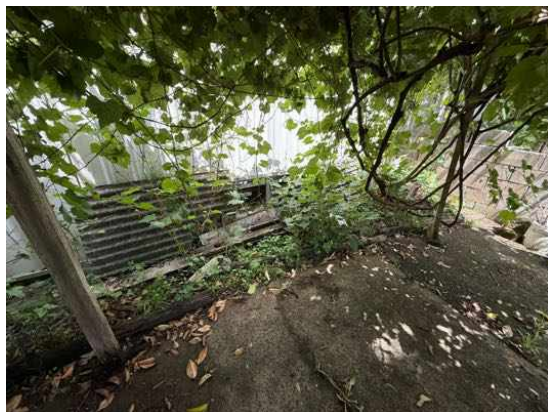
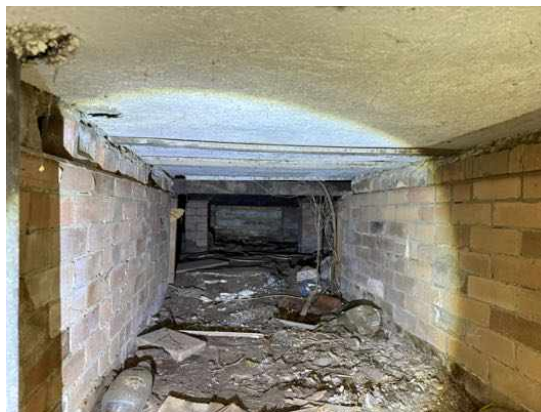
Where bridging has occurred, full inspection is prevented and termites may enter a property in a concealed or undetectable manner.

It is recommended that minimum 75mm clearance below the bottom of weep or ventilation holes be maintained where possible, otherwise annual inspections should be conducted by a licensed pest control company. Vegetation should also be kept clear of walls to allow regular inspection of all areas.

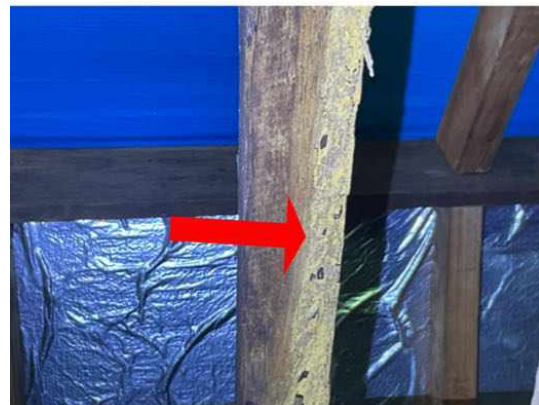
It is advised that the area be visually inspected frequently to ensure that the condition of affected building materials does not worsen. At the time of inspection, damage is not structural and is only considered to be superficial.

A building contractor may be appointed to provide a further invasive inspection if further damage is evident.
