Building and Timber Pest Inspection Report

Inspection Date: Tue, 27 Jan 2026

Property Address: 126 Dartford Rd, Thornleigh NSW 2120,
Australia

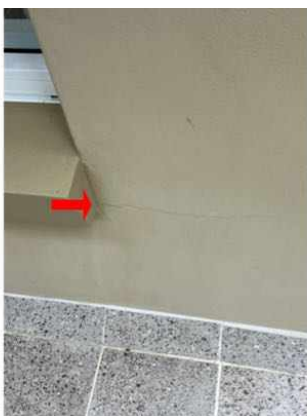
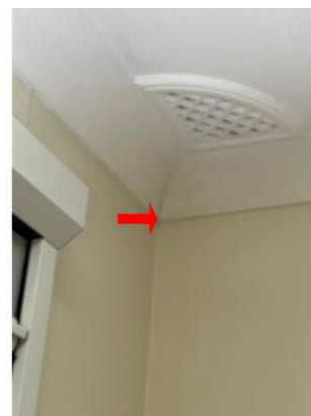
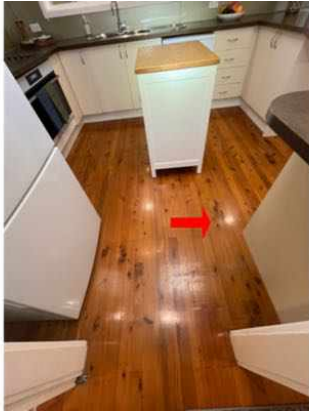
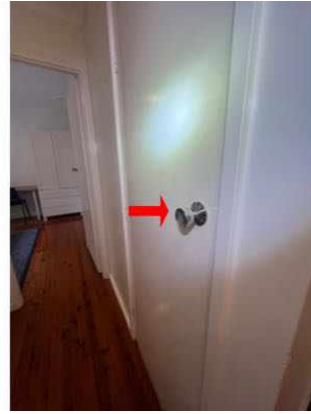
Finding 3.01

Building:	Main Building
Location:	All Areas
Finding:	Deterioration caused by Fair and Wear and Tear
Information:	Certain forms of deterioration commonly associated with fair wear and tear may not be specifically identified or itemised within this report. Minor cracking to render and internal wall linings, natural variations in timber flooring such as squeaking or movement, minor door misalignment or rattling during operation, and similar age-related conditions are typical in buildings of this type and do not necessarily indicate defective workmanship or structural failure.

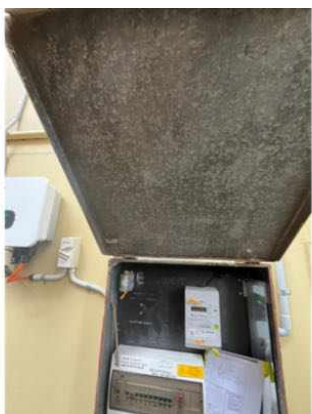
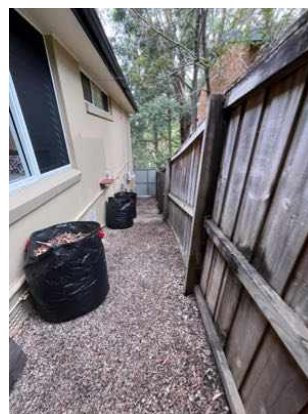
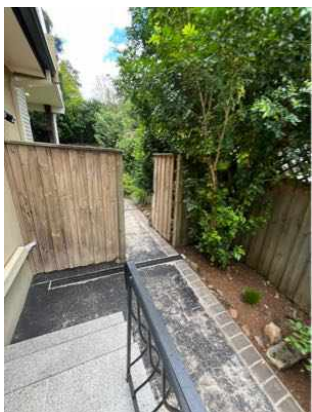
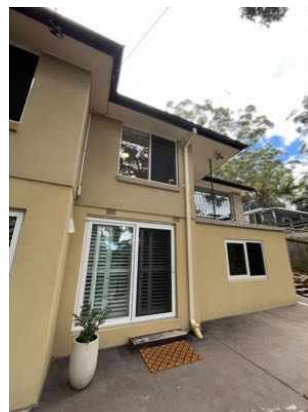
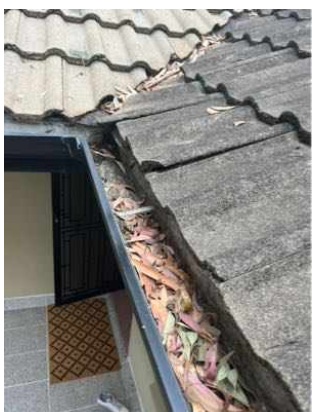
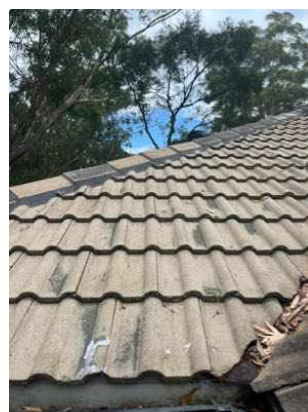
Building: Main Building
 Location: All Areas
 Finding: Conditions Conducive to Termite
 Information: During the inspection, several conditions commonly found in residential properties were noted that may, over time, contribute to an environment conducive to termite activity if left unaddressed. These are typical in many homes and do not indicate active termite presence but highlight areas where general maintenance or preventative measures would be beneficial.

* Absence of a Termite Management System: No visible evidence of a current termite management system was observed at the time of inspection. This is not unusual, particularly in established homes. As a precaution, installation of a termite management system may be considered in accordance with AS 3660 for added protection.

* General Moisture-Related Items (e.g., HWS and Air Conditioner Overflow): Minor overflow drainage from hot water systems and air conditioning units was noted. These are common features in residential dwellings and can be easily managed by ensuring proper discharge to appropriate drainage points.

* Taps and External Drains: Occasional unconnected or unprotected taps were noted. Ensuring that external taps are adequately drained is a simple maintenance task that helps manage moisture near the building perimeter.

* Gutters and Downpipes: Some blocked or debris-filled gutters were identified. Regular gutter cleaning is standard home maintenance and helps prevent water overflow and pooling near foundations.

* Slab Edge and Weep Hole Visibility: Some areas had limited slab edge exposure or partially obstructed weep holes due to landscaping or render. This is common and can be easily rectified to maintain visibility for future inspections.

General Recommendation: □ The conditions identified are typical of residential dwellings and can be readily managed through routine maintenance. No evidence of active termite activity was found at the time of inspection. To ensure continued protection of the property, it is recommended to maintain good site drainage, remove timber debris, and consider installing a termite management system as a precautionary measure. Regular inspections in accordance with Australian Standards are also advisable.

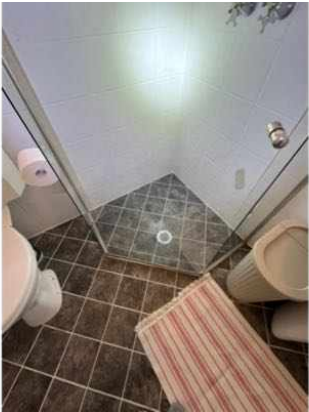
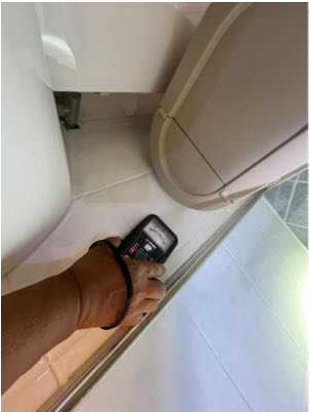
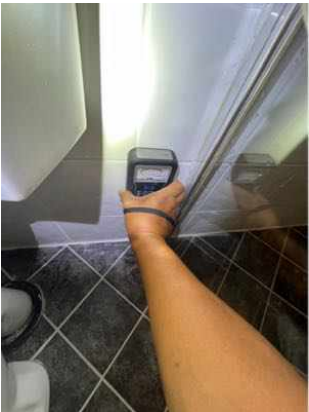
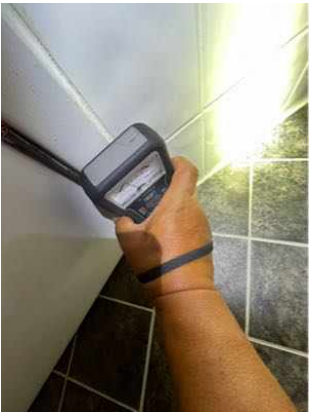
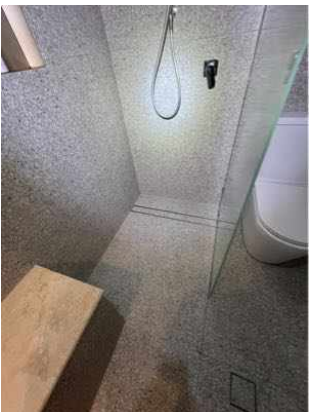
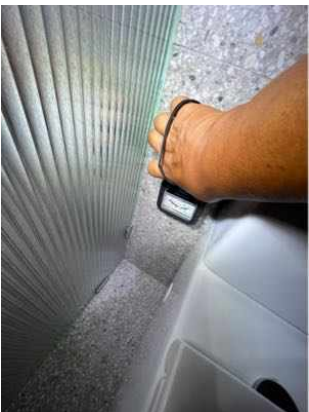
Building: Main Building
 Location: Bathrooms
 Finding: Minimal Moisture Metre Readings
 Information: After conducting an assessment of the shower recess, the moisture content of the walls in and around the shower was examined. The results indicated that there was no significant difference in moisture readings between the walls behind the wet area and other walls, and there were no visible signs of recent water damage on the surrounding walls that could be inspected.

Based on these observations, it can be assumed that the waterproofing of the shower is sound and there is currently no evidence of any leakage. However, it is important to

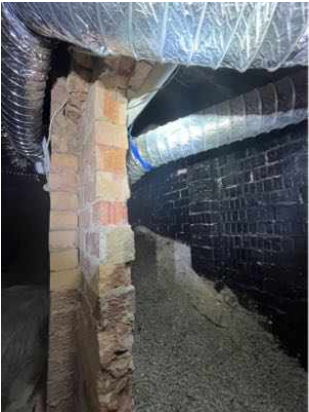
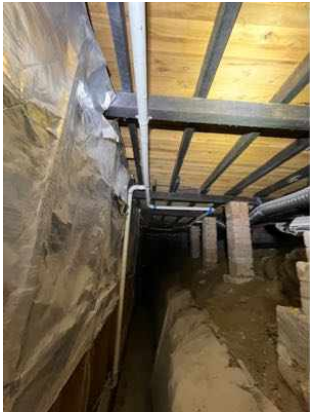
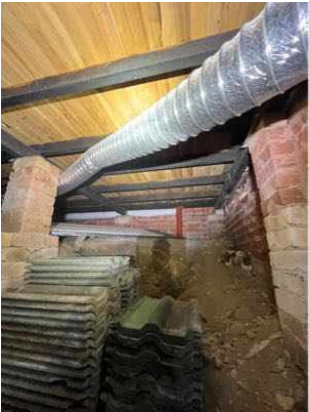
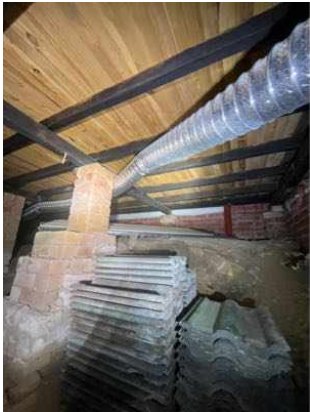
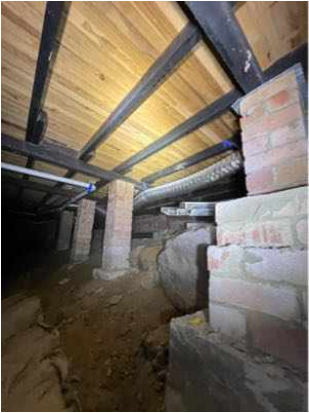
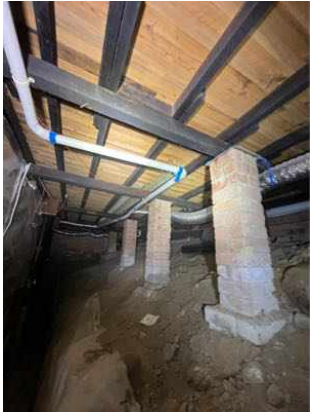
Building: Main Building
 Location: Subfloor
 Finding: Condition of Building Elements in the Subfloor
 Information: Upon completion of the subfloor inspection, the timber floor framing was observed to be in serviceable condition with no visible evidence of significant structural deterioration, fungal decay, or termite activity in the accessible areas.

The bearers and joists appear sound and well-supported on a combination of brick and steel piers.

Ventilation openings are present, assisting in airflow throughout the subfloor space, which is important for moisture management.

Some minor surface dust, cobwebs, and general debris were noted, which are typical for a subfloor environment and do not indicate a defect.

Plumbing and ductwork installations are adequately positioned and appear functional, with no visible active leaks or damage at the time of inspection.
