Building and Timber Pest Inspection Report

Inspection Date: Tue, 13 Jan 2026

Property Address: 2A Frogmore St, Mascot NSW 2020,
Australia

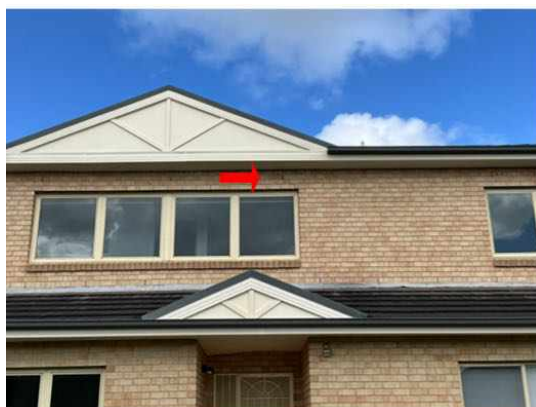
Finding 3.01

Building: Main Building
Location: Exterior walls
Finding: Brickwork - Cracking noticeable
Information: There were several cracks and or crack repairs evident to external brickwork.

Noticeable cracks are a common occurrence in external brickwork and are a likely result of age expected building movement, general expansion, and/or contraction of building materials in different weather conditions.

It is highly advised that a qualified bricklayer be appointed to provide necessary works to cracked brickwork to prevent any further damage.

Always monitor these cracks and contact a building inspector should cracks widen, lengthen, or become more numerous.

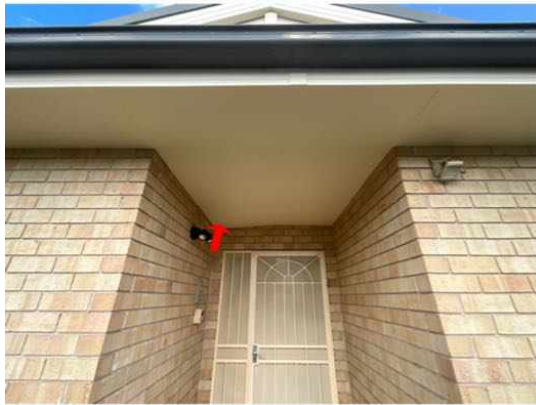
Finding 3.02

Building: Main Building
Location: Front Porch
Finding: Nails - Popping

Information: Popped nails were identified at the time of inspection. Nails and screws are held by the friction between them and the surface that they are applied to. Over time, the nails and screws can back out, which is often a result of general ageing and deterioration of the building structure.

Re-fastening of popped nails will help to maintain the stability of these, and associated, building elements. Such minor works will also help to improve the appearance of the affected area and secure the linings. These works should be performed by a qualified carpenter at client discretion.

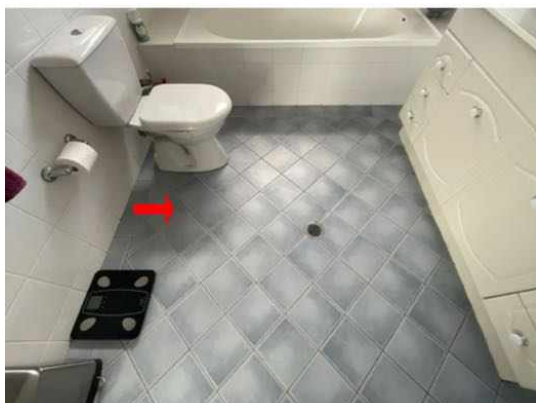
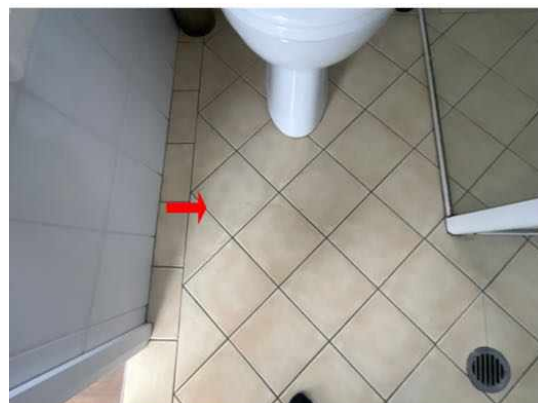
Finding 3.03

Building: Main Building
 Location: Bathroom & Ensuite
 Finding: Tile - Cracked or damaged
 Information: Cracking was evident to the tiling in this area at the time of inspection.

I recommend appointing a tiling contractor to see what necessary works are required to replace any damaged tiles.

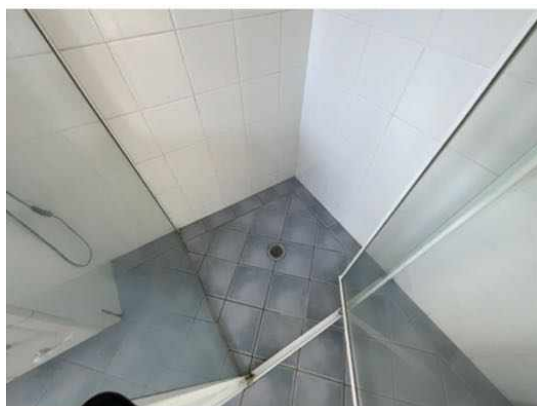
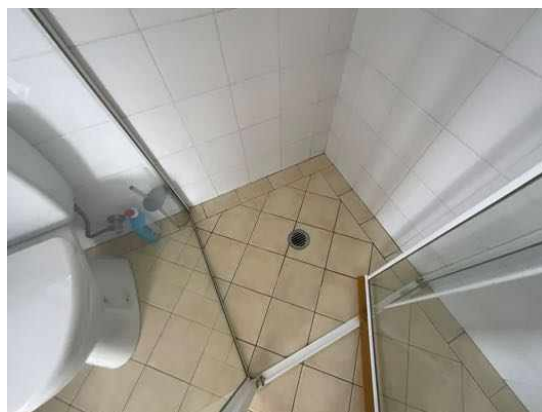
Finding 3.04

Location: Bathroom & Ensuite
 Finding: Sealant and grouting - Missing or damaged
 Information: It was noted on inspection that sealant or grout is degraded to the tiled areas.

Different materials and floor areas move at different rates, generally causing cracking to grout or sealant at this point. A flexible sealant is required to allow for expected expansion and contraction, while keeping the joint water tight and protective of all associated building materials.

Flexible and mould resistant materials should be applied to affected areas to prevent any subsequent water damage that is likely to occur. Regular maintenance and replacement of damage or missing or damaged sealant and grout is highly recommended to the wet areas, as this is a regular wear and tear defect. Sealant and grouting in areas that come into regular contact with water should be maintained for the long term care of your property.

A sealant specialist or tiling contractor should be appointed to complete these works.

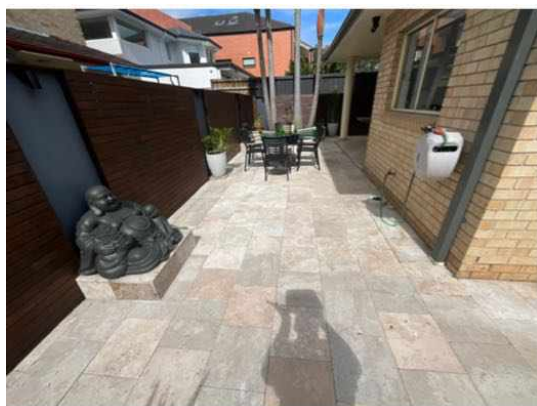
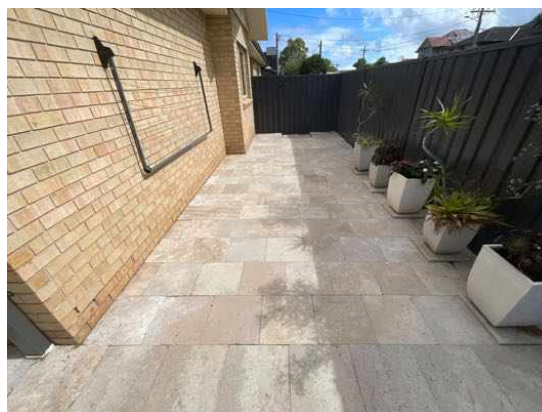
Finding 3.05

Building: Yard
 Location: The Site
 Finding: Site drainage - Inadequate
 Information: The site drainage in this area was found to be inadequate at the time of inspection, creating potential for subsequent water damage to associated building elements.

It is important that water does not lie against the base of walls; surrounding paths and ground levels should be sloped to drain water away from walls.

Where site drainage is inadequate, installation of drains may be required. A qualified plumber should be appointed to further inspect the property and perform any remedial works as necessary. Water damage and secondary defects are likely to occur if left unmanaged.

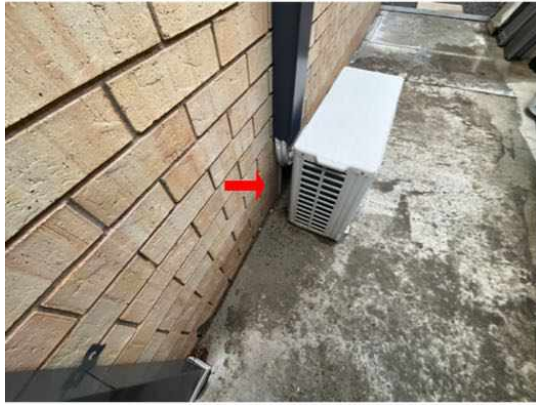
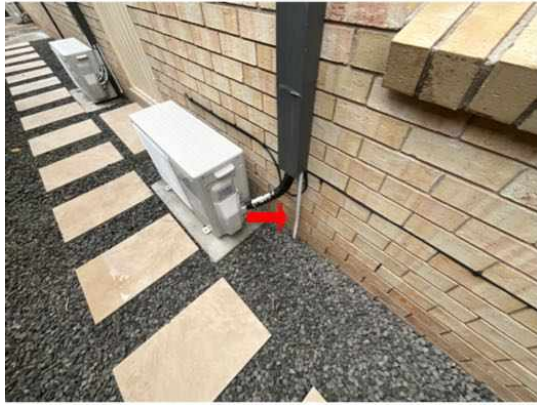
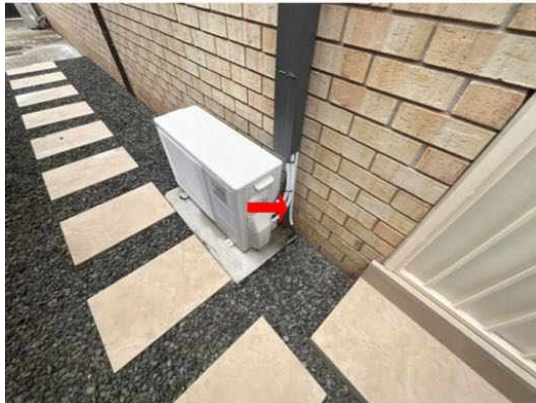
Finding 6.01

Building:	Main Building
Location:	Exterior walls
Finding:	Air conditioner - Disconnected overflow
Information:	The Air Conditioner (A/C) overflow was found to be disconnected from storm water drainage and is creating excessive moisture in the surrounding area.

Such leaking creates an environment which is conducive to an array of defects, including water damage to associated building elements and the attraction of termite or timber pest infestation.

It is highly recommended that a licensed plumber be appointed to connect the A/C overflow in order to prevent such an environment from being created. These minor works should be carried out as soon as possible.

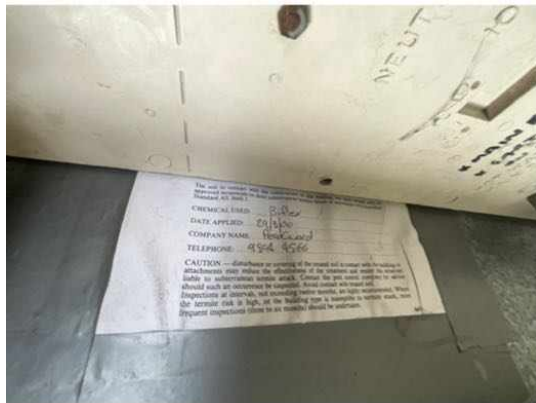
Noted Item

Building: Main Building
 Location: All Areas
 Finding: Evidence of a previous termite management system was identified
 Information: There are a number of factors which indicate the presence of a previously installed or applied termite barrier. The most common are a durable notice (to the inside of your

meter box) observable physical barriers installed to building perimeter and in ground reticulation systems.

Where a Termite Management System has been identified you should refer to the type of barrier date of installation warranty conditions and any documentation provided by a builder or past owner. Consult the company who installed the barrier to confirm whether the system is still under warranty.
